ADAPTIVE USE DESIGN FOR THE BARTELL HOUSE HOTEL
JUNCTION CITY, KANSAS

A MASTER'S REPORT SUBMITTED IN PARTIAL FULFILLMENT FOR
THE DEGREE OF
MASTER OF ARCHITECTURE
COLLEGE OF ARCHITECTURE AND DESIGN
KANSAS STATE UNIVERSITY

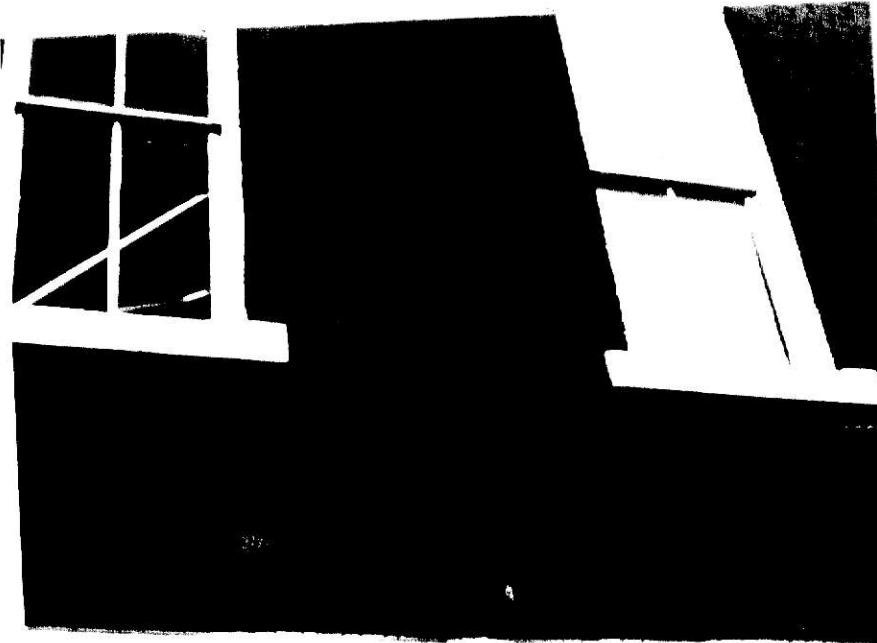
Problem 1

Mortar has deteriorated from the brick joints.

Tuckpoint according to specifications.

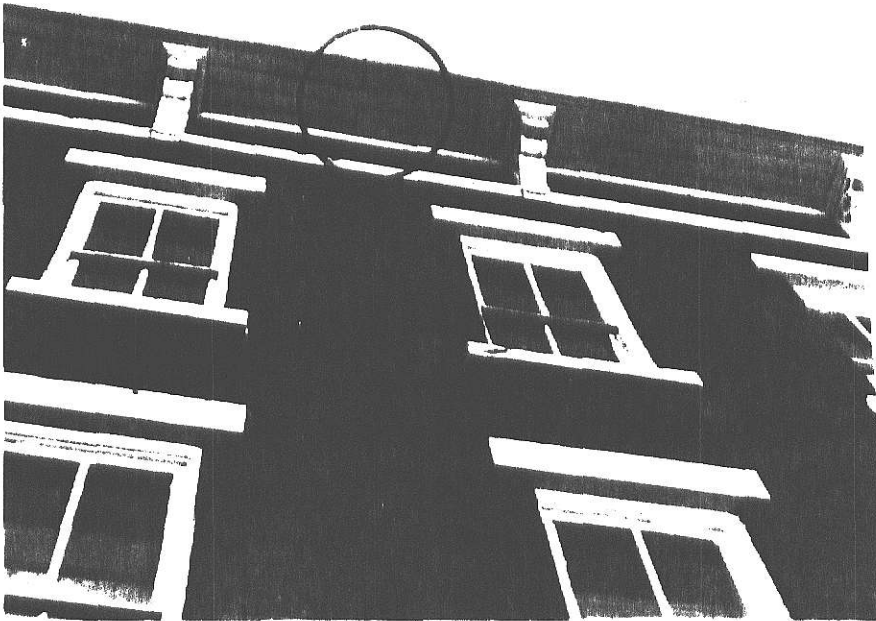
Problem 3

Wood eaves have buckled due to water infiltration.

Replace and repaint according to specifications.

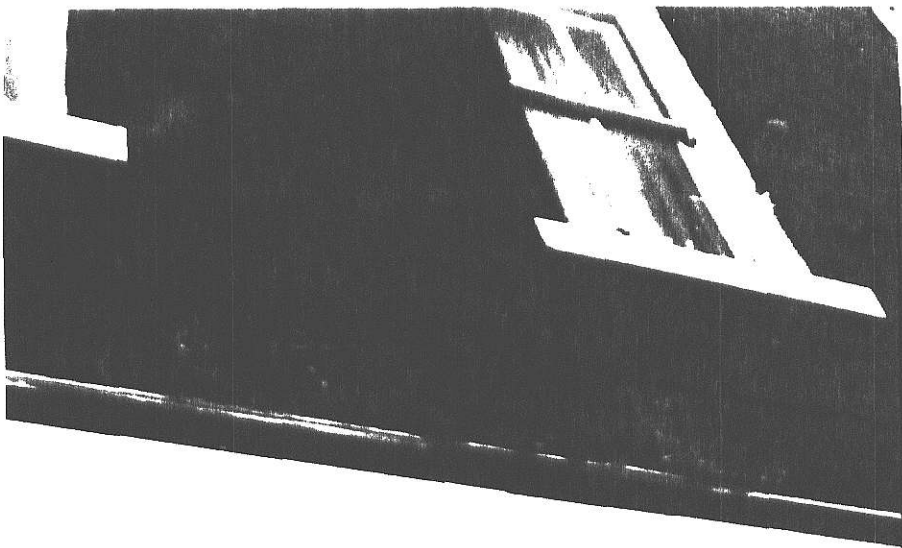
Problem 4

Brick has spalled.

Replace brick according to specifications.

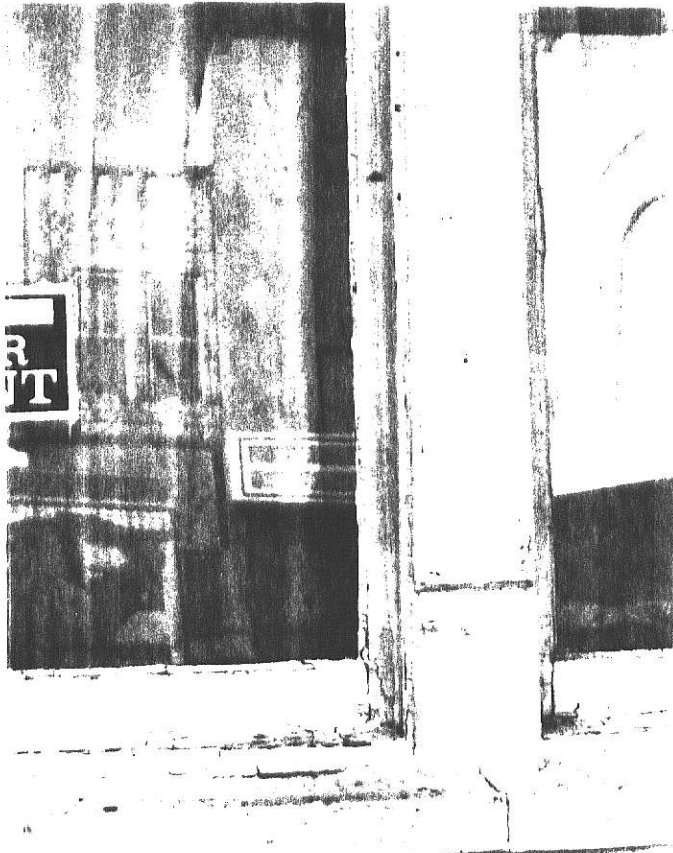
Problem 5

Window frame was weathered.

Repair and replace according to specifications.

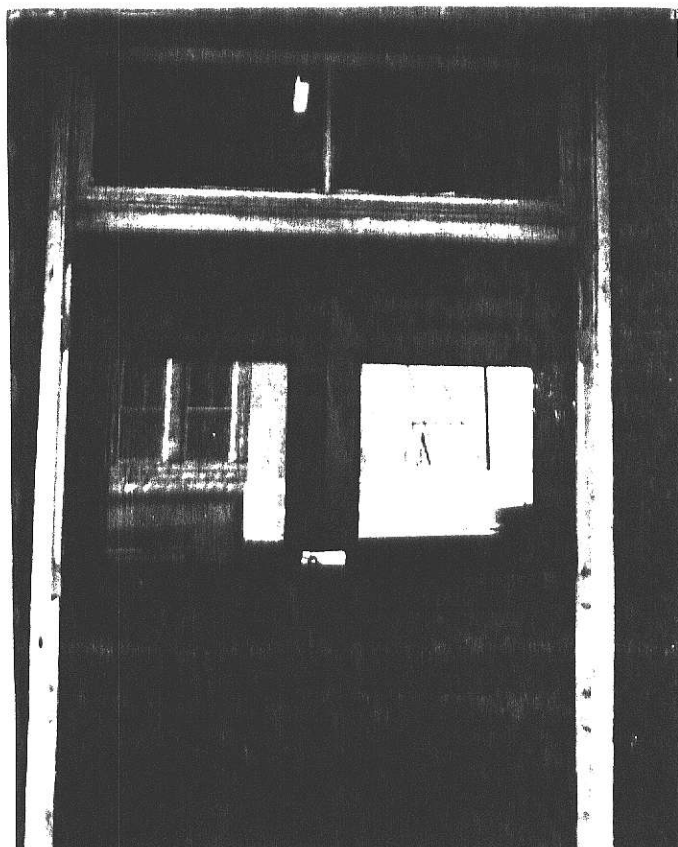
Problem 6

Doorway was weathered.

Repair and refinish.

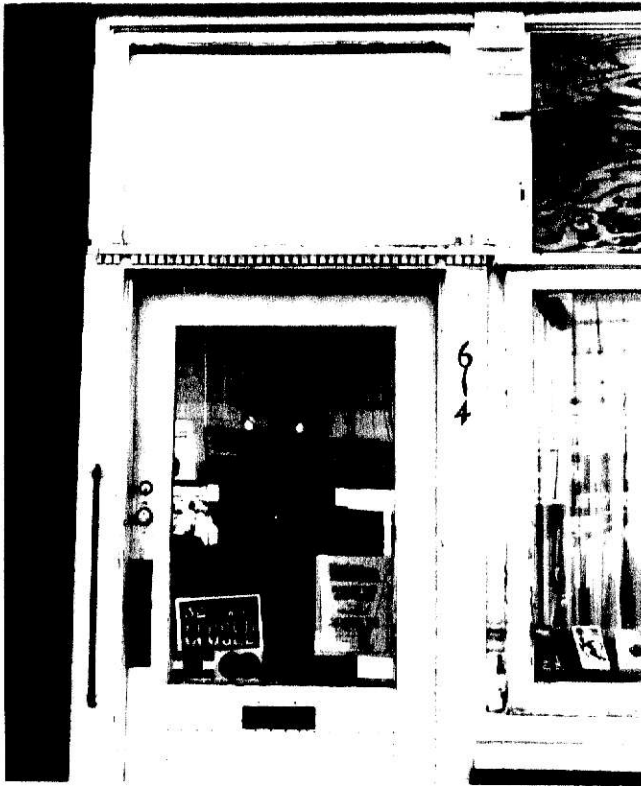
Problem 7

Window has been infilled with plywood; door is weathered.

Remove the plywood, and replace with glazing. Replace door with similar window. Reuse door in courtyard.

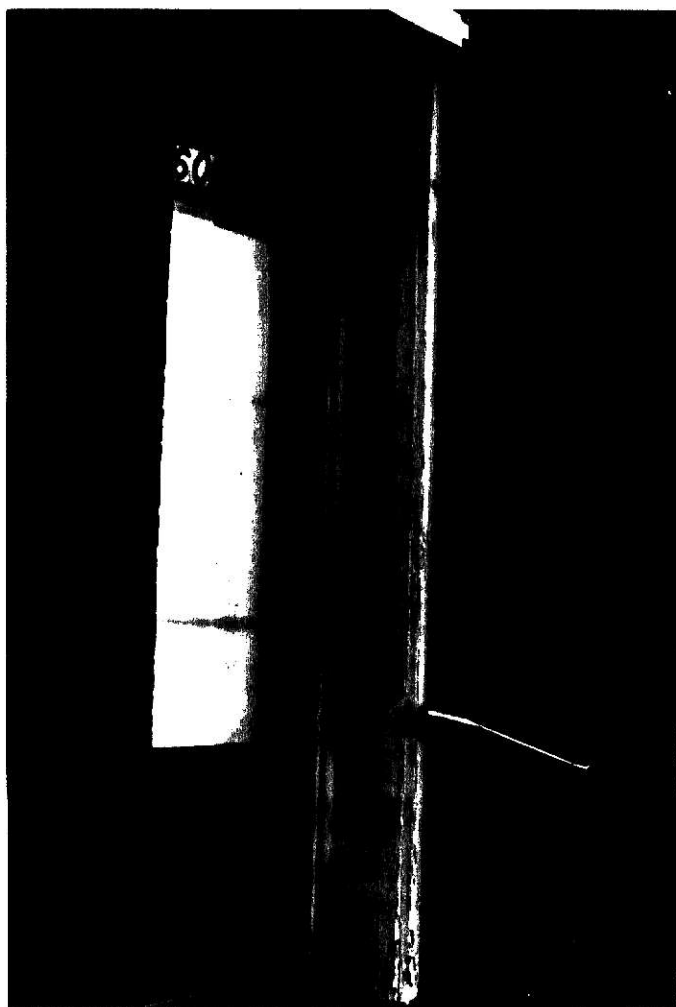
Problem 10

Paint has chipped.

Remove door, refinish and repair according to specifications. Reuse in courtyard. Replace with window similar to existing design.

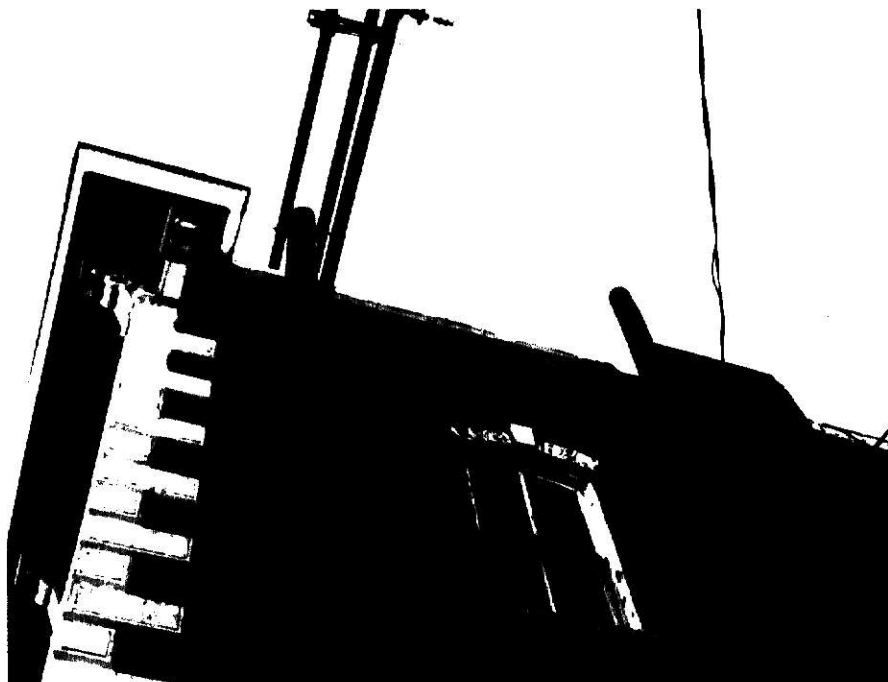
Problem 12

Window has weathered.

Repair and repaint according to specifications.

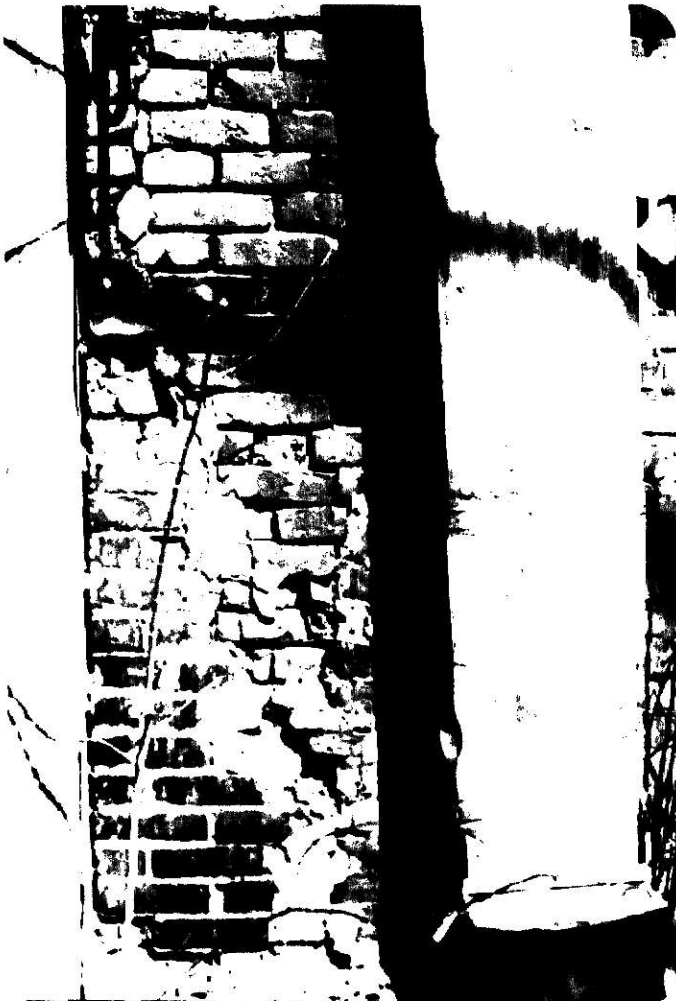
Problem 14

Mortar has severely deteriorated.

Clean, repair and tuck-point according to specifications.

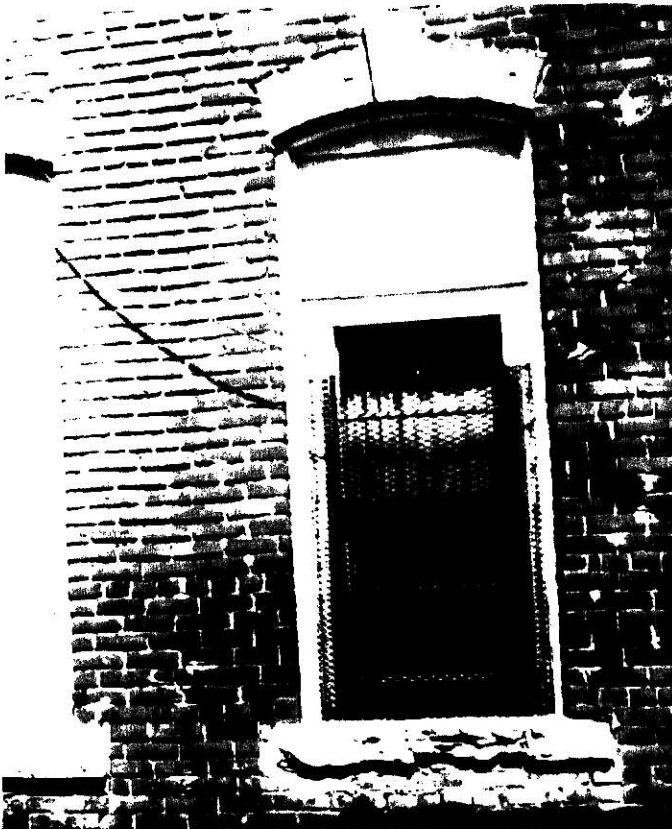
Problem 16

Spalling of the sill.

Replace limestone.

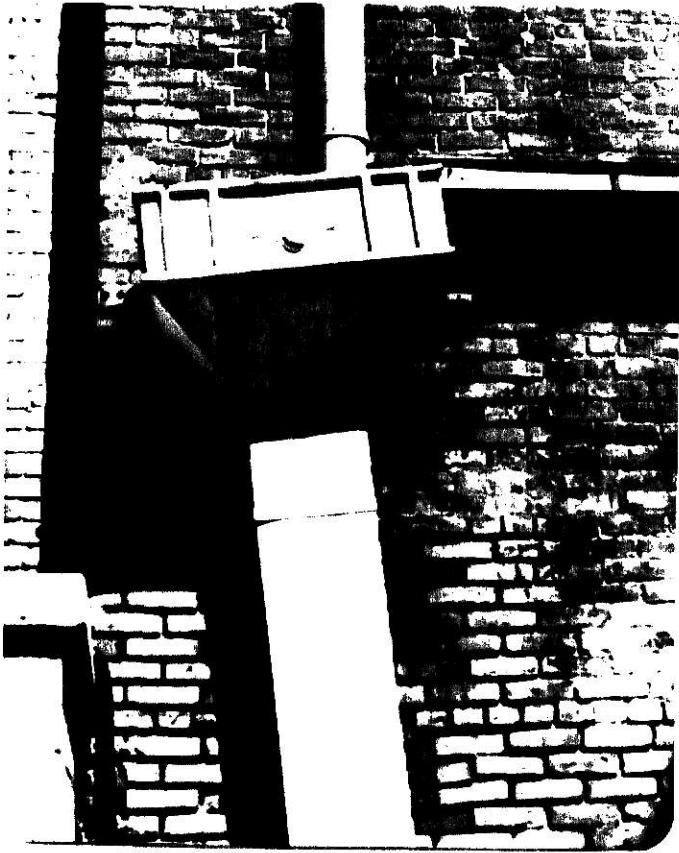
Problem 17

Joints have been repointed with portland cement.

Remove mortar and tuck-point according to specifications.

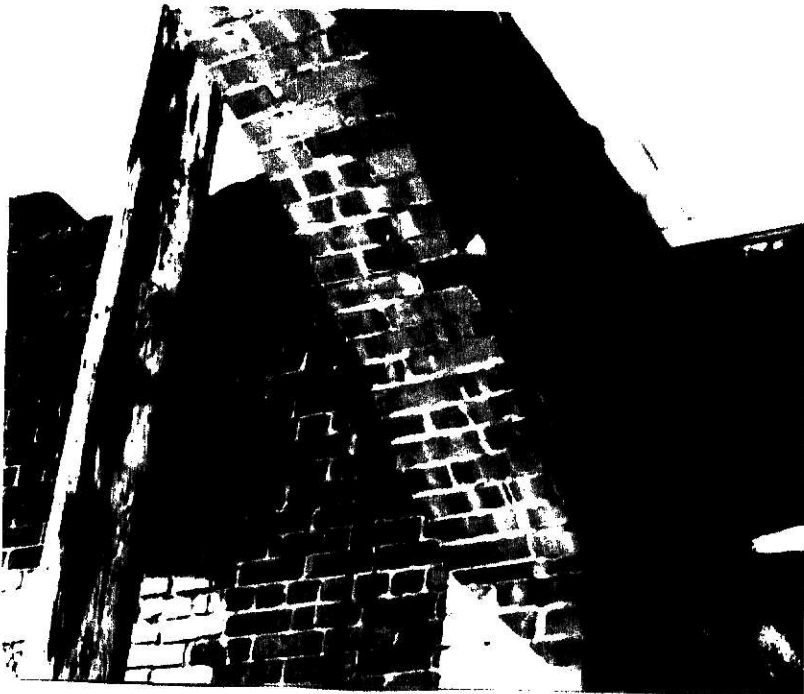
Problem 18

Brick has fallen out of buttress.

Replace the brick according to specifications.

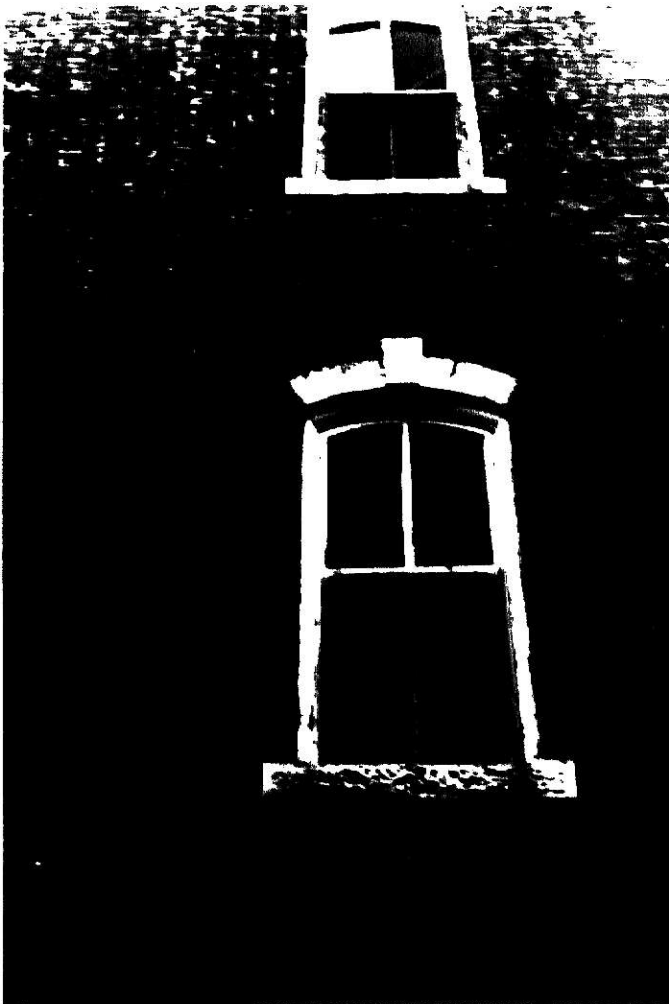
Problem 19

Brick has spalled and discolored.
