A PRACTICAL APPLICATION OF THEORETICAL
SOIL MECHANICS TO EXPANSIVE SOILS

A MASTER'S THESIS

Department of Civil Engineering

The project developed from an initial request from the director of the Community Memorial Hospital in Marshall County at Marysville, Kansas, for an examination of distress in the internal walls and floors of the hospital. The purpose of this examination was to determine the cause and possible correction of the settlement and to especially evaluate the safety of the structure since its continued use was critical to the community.

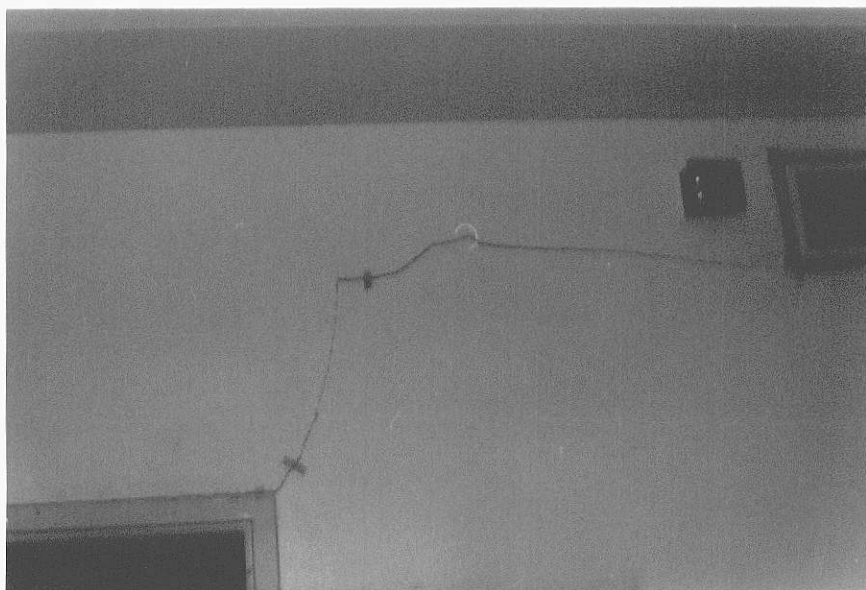
Fig. 3. Crack in Wall Above Door to Surgery

The internal partitions have yielded with the floor with subsequent cracking near each opening, but hang suspended near the columns and at wall intersections. These walls appear to be slowly yielding downward, thus widening the cracks in a progressive failure. Combined with the continued settlement of the floor, cracking of the structure has been extended over several years and appeared to be apt to extend into the future.

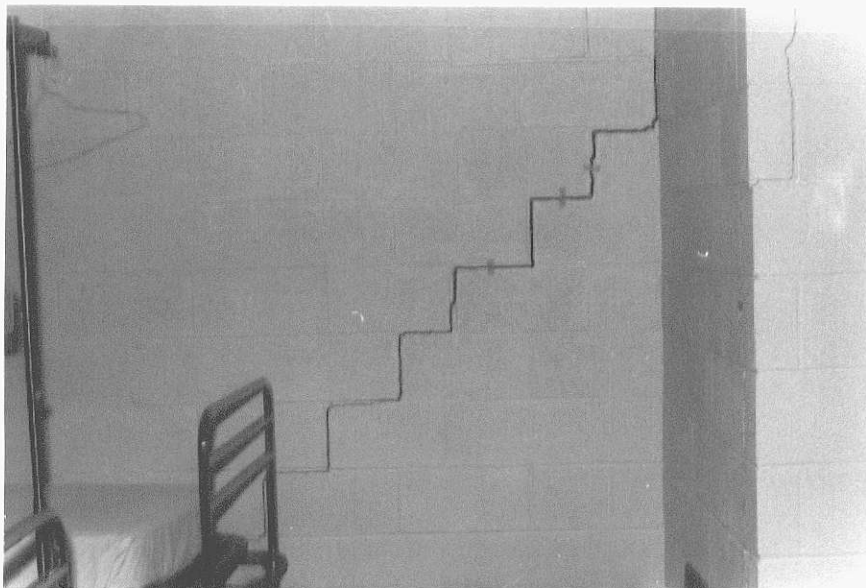
Fig. 4. Crack in South Wall of Recovery Room

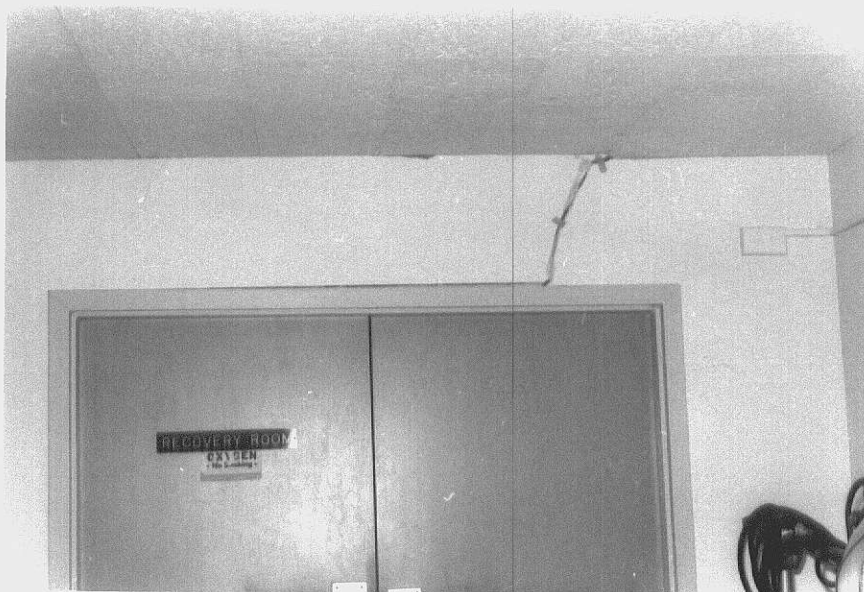
Fig. 5. Crack in Wall and Misalignment of Recovery Room Doors

Most of the doors in the distressed area could not be closed because of a misalignment of the door and jamb. In some cases, the steel frame of the door jamb was rigid enough to cause severe crushing of the plaster, as the wall on one side only settled.

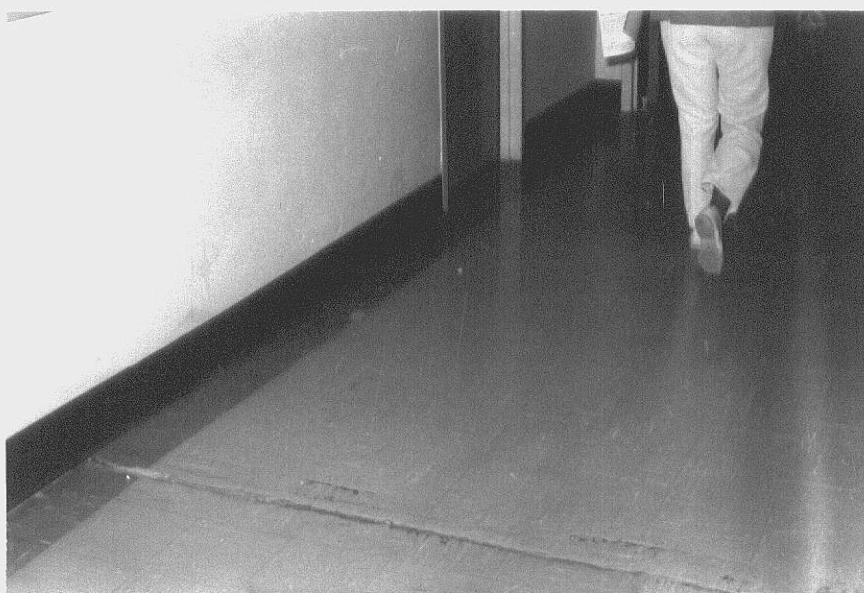
Fig. 6. Disjointment of South Corridor Floor

The floor showed little cracking and disjointment, except in the area of central stores and near the west end of the south corridor.

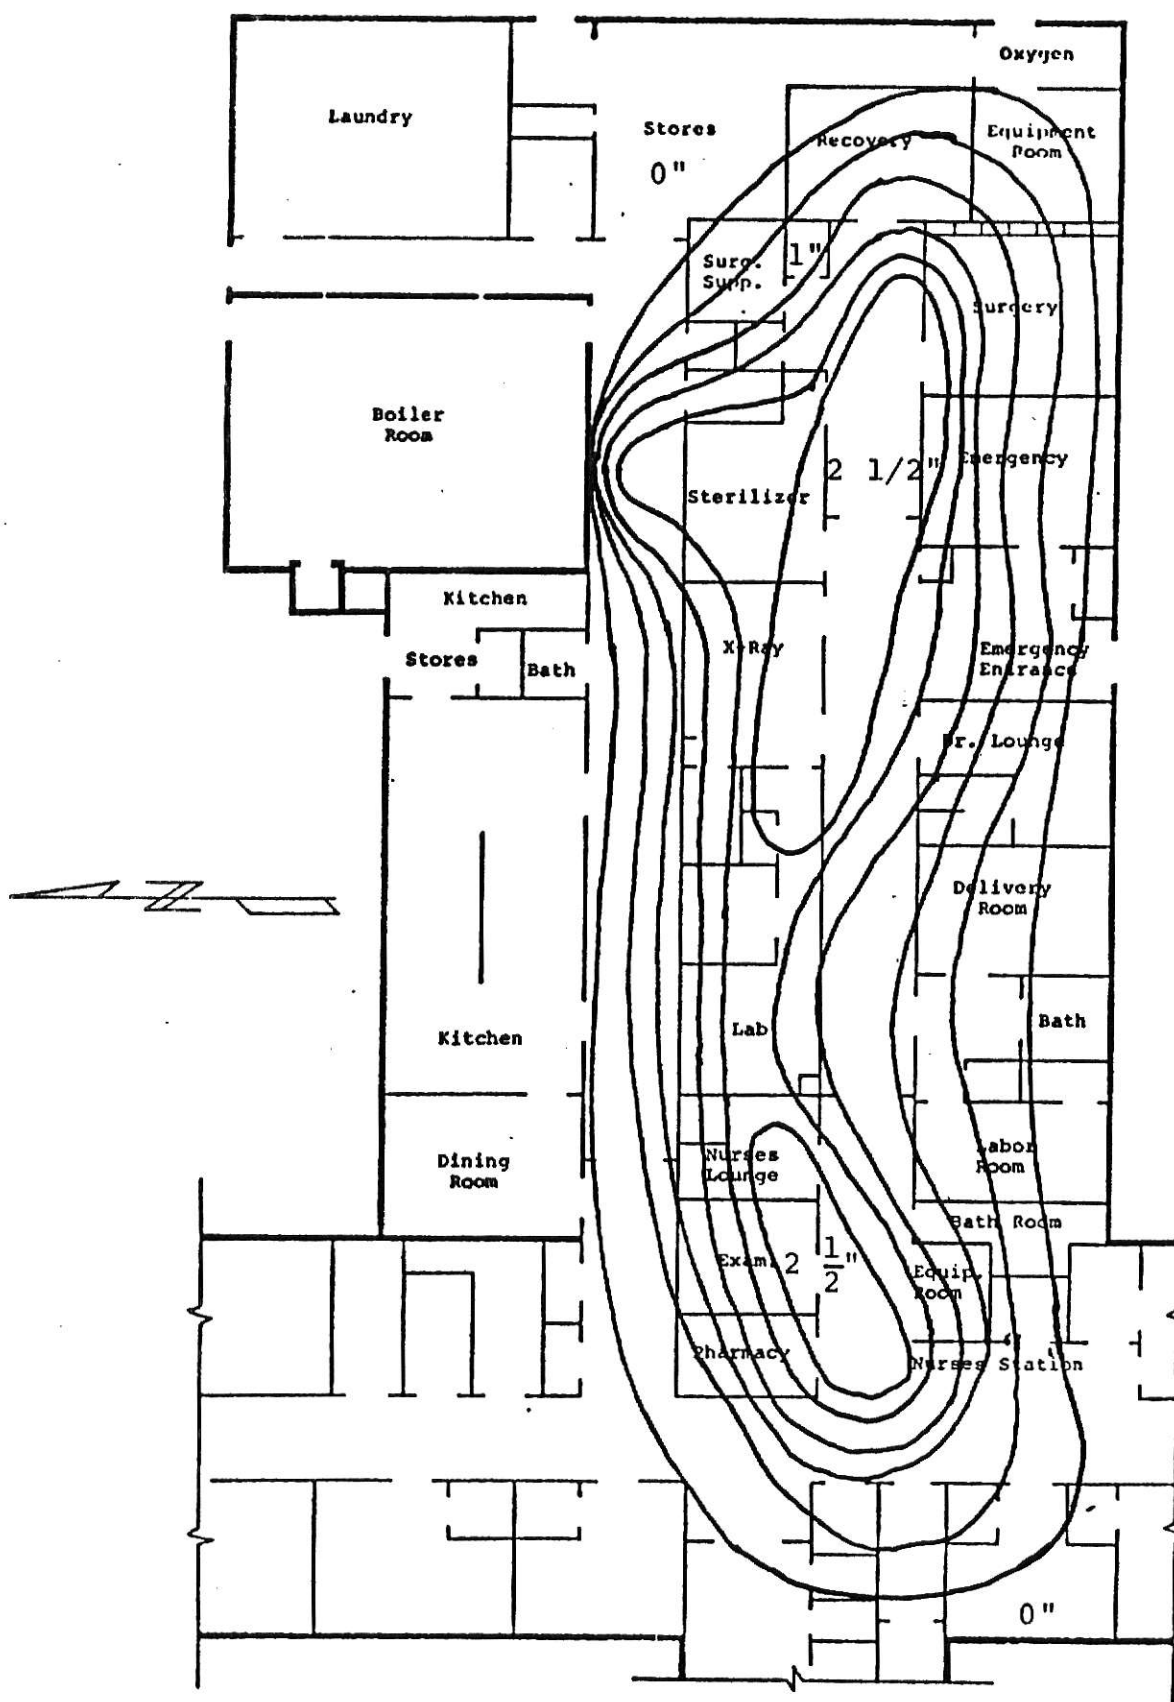
Figure 7. Floor Slab Settlement. Community Memorial Hospital. Marysville, Kansas

A careful survey of the roof surface indicated that no appreciable deflection of the roof had occurred. A survey of the floor slab inside the hospital indicated downward deflection of the floor slab in excess of two inches. Along the south side of the east wing the settlement of the floor

varied from zero near the south wall to a maximum of 2.5 inches along the return air duct buried beneath the south corridor.

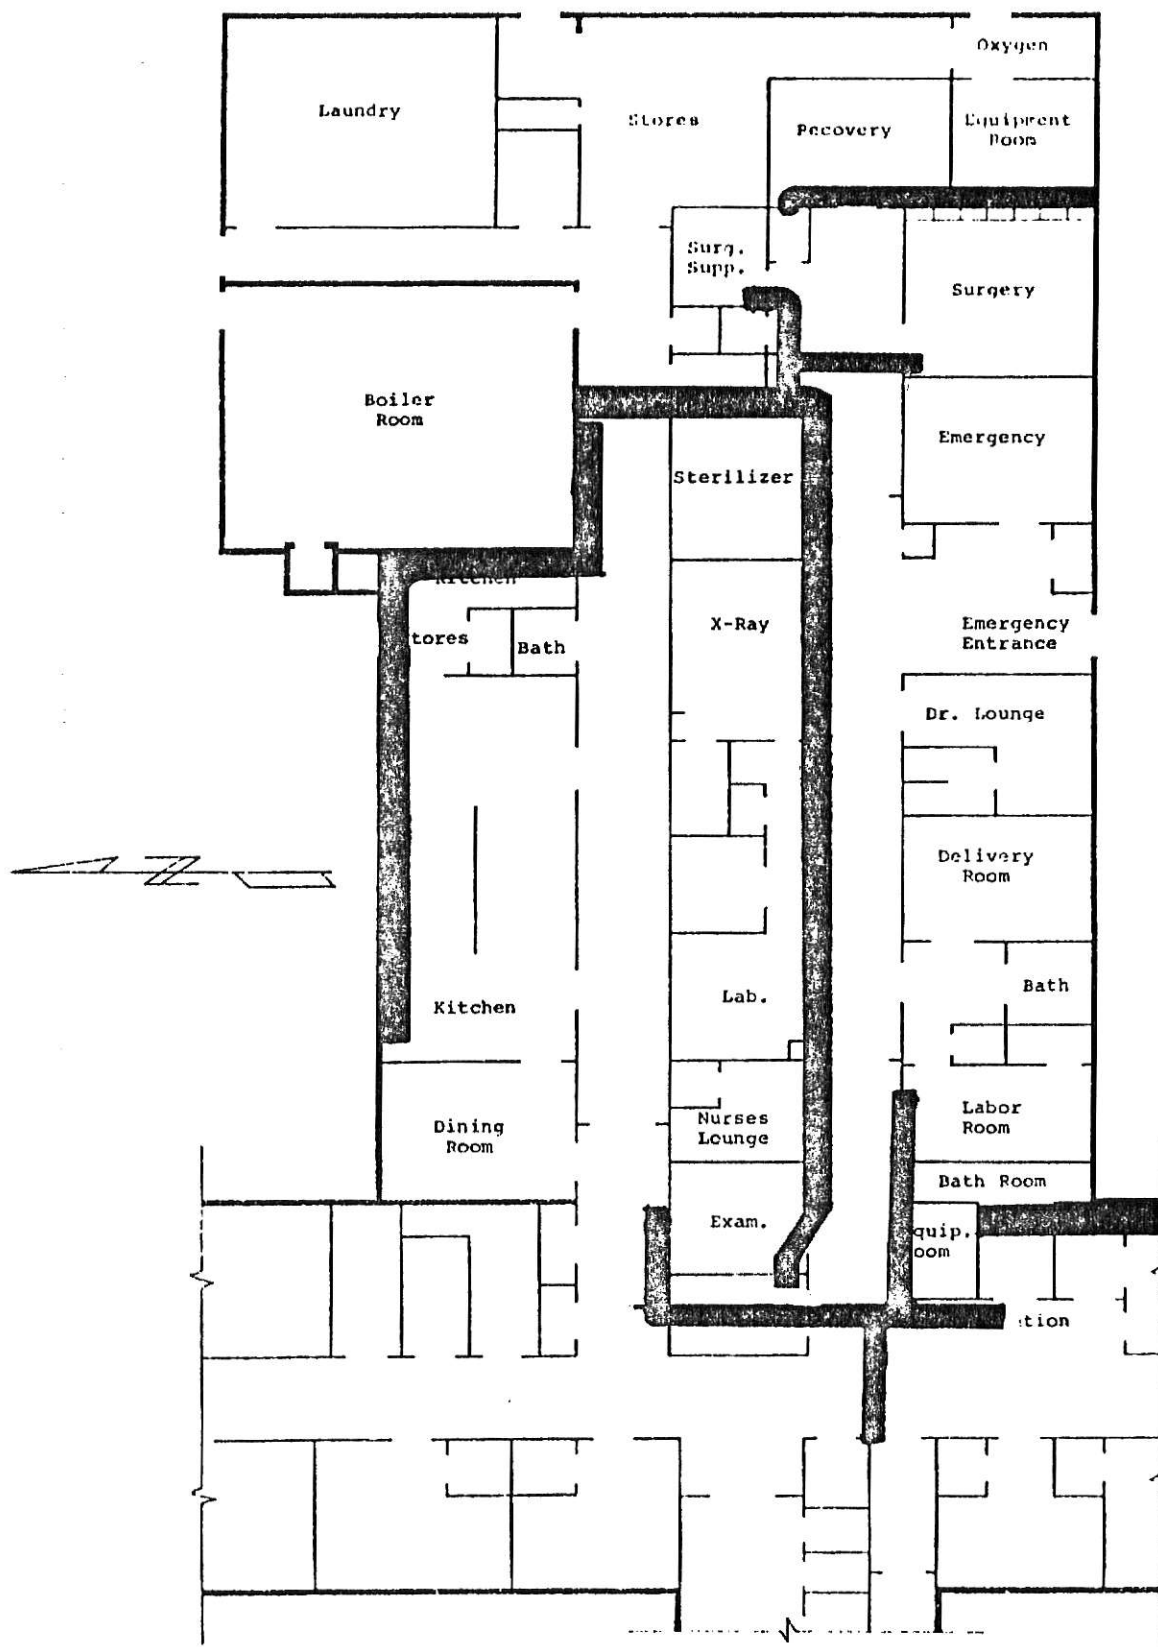
Figure 8. Underground Air Ducts. Community Memorial Hospital. Marysville, Kansas.

The settlement of the floor slab was clearly caused by shrinkage of the soil from drying. The typical soil boring logs indicate a natural moisture content (w) outside the hospital of some 25% while the soil inside to a depth of some 6 feet was found to contain less than 5% moisture. The cause of the drying was, however, not initially apparent, but it seemed to be related in some way to the air return system buried beneath the south corridor. Holes were broken through the floor over the air ducts and they were examined. An exploration through the pipes large enough to admit a man found that they were imperfectly sealed and the joints were, in some cases, misaligned. A current of air was found to exist under the floor when smoke was carried into holes drilled through the floor slab. At this point, it was assumed that all of the under floor air ducts were air returns, but a study of air flows at each duct showed clearly that the system serving the lobby area was the reverse of the others. Further study indicated an interchange of air from this system to the system under the south corridor, and the history of the failure indicated that the first distress was noted near their closest junction. An additional series of test holes showed the soil moisture to increase away from the closest junction of these air ducts, and the water content

It is recommended that all of the larger underfloor air conduits be sealed. The conduit to the surgical closet should be replaced by an overhead conduit, and the existing conduit effectively sealed by filling. The lobby air conduit that has now been sealed off should be filled to prevent future air flow.

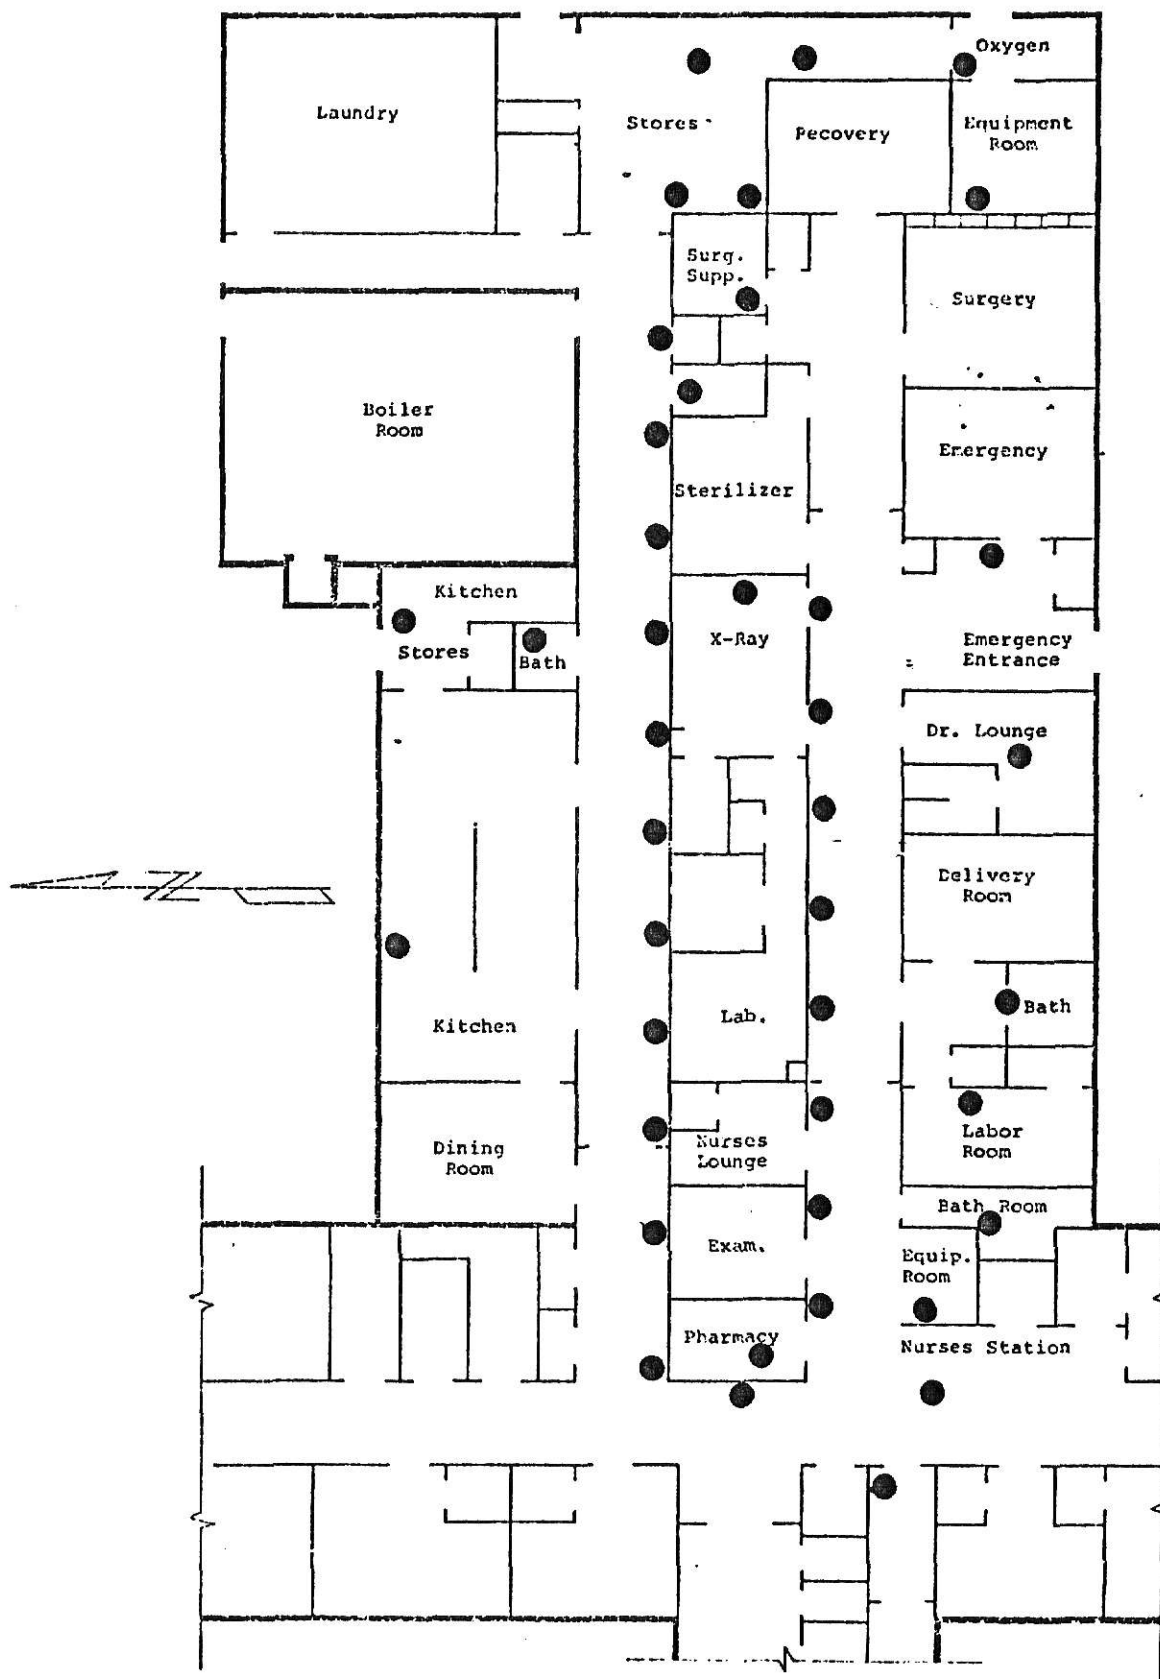
Figure 57

Location of the Watering Holes

Holes one inch in diameter were drilled at locations shown in Fig. 57, and the rewetting was started on July 19, 1971. Quite arbitrarily, it was decided that 100 gallons of water would be admitted to each hole by a hose connected to a water meter, as shown in Fig. 58. Water was added on successive Mondays, Wednesdays, and Fridays, until a total of 23,610 gallons had been added to the soil, as shown in Table 4. At this point, portions of the hospital showed a marked uplift, and holes in these areas ceased to take water. Along the air return in the south corridor, water was conducted

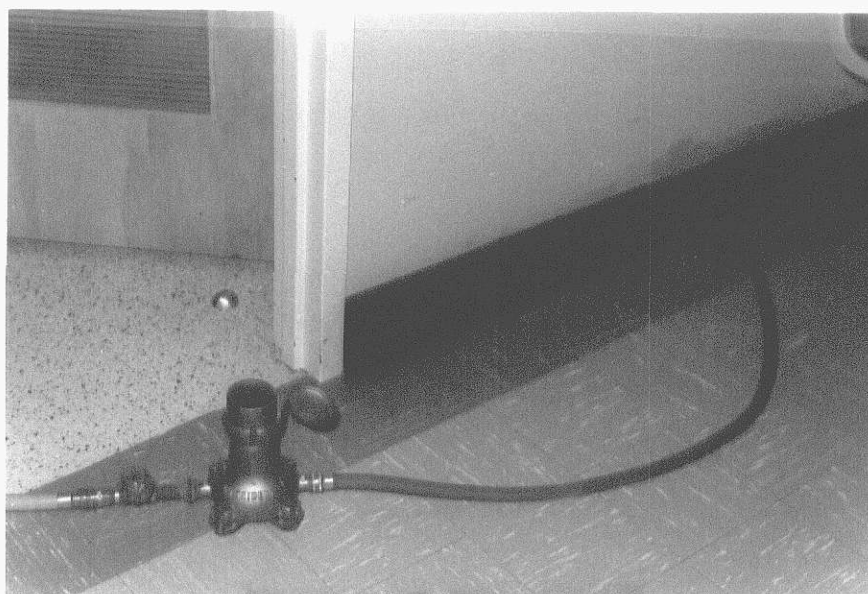
Fig. 58. Metering Water Into Soil

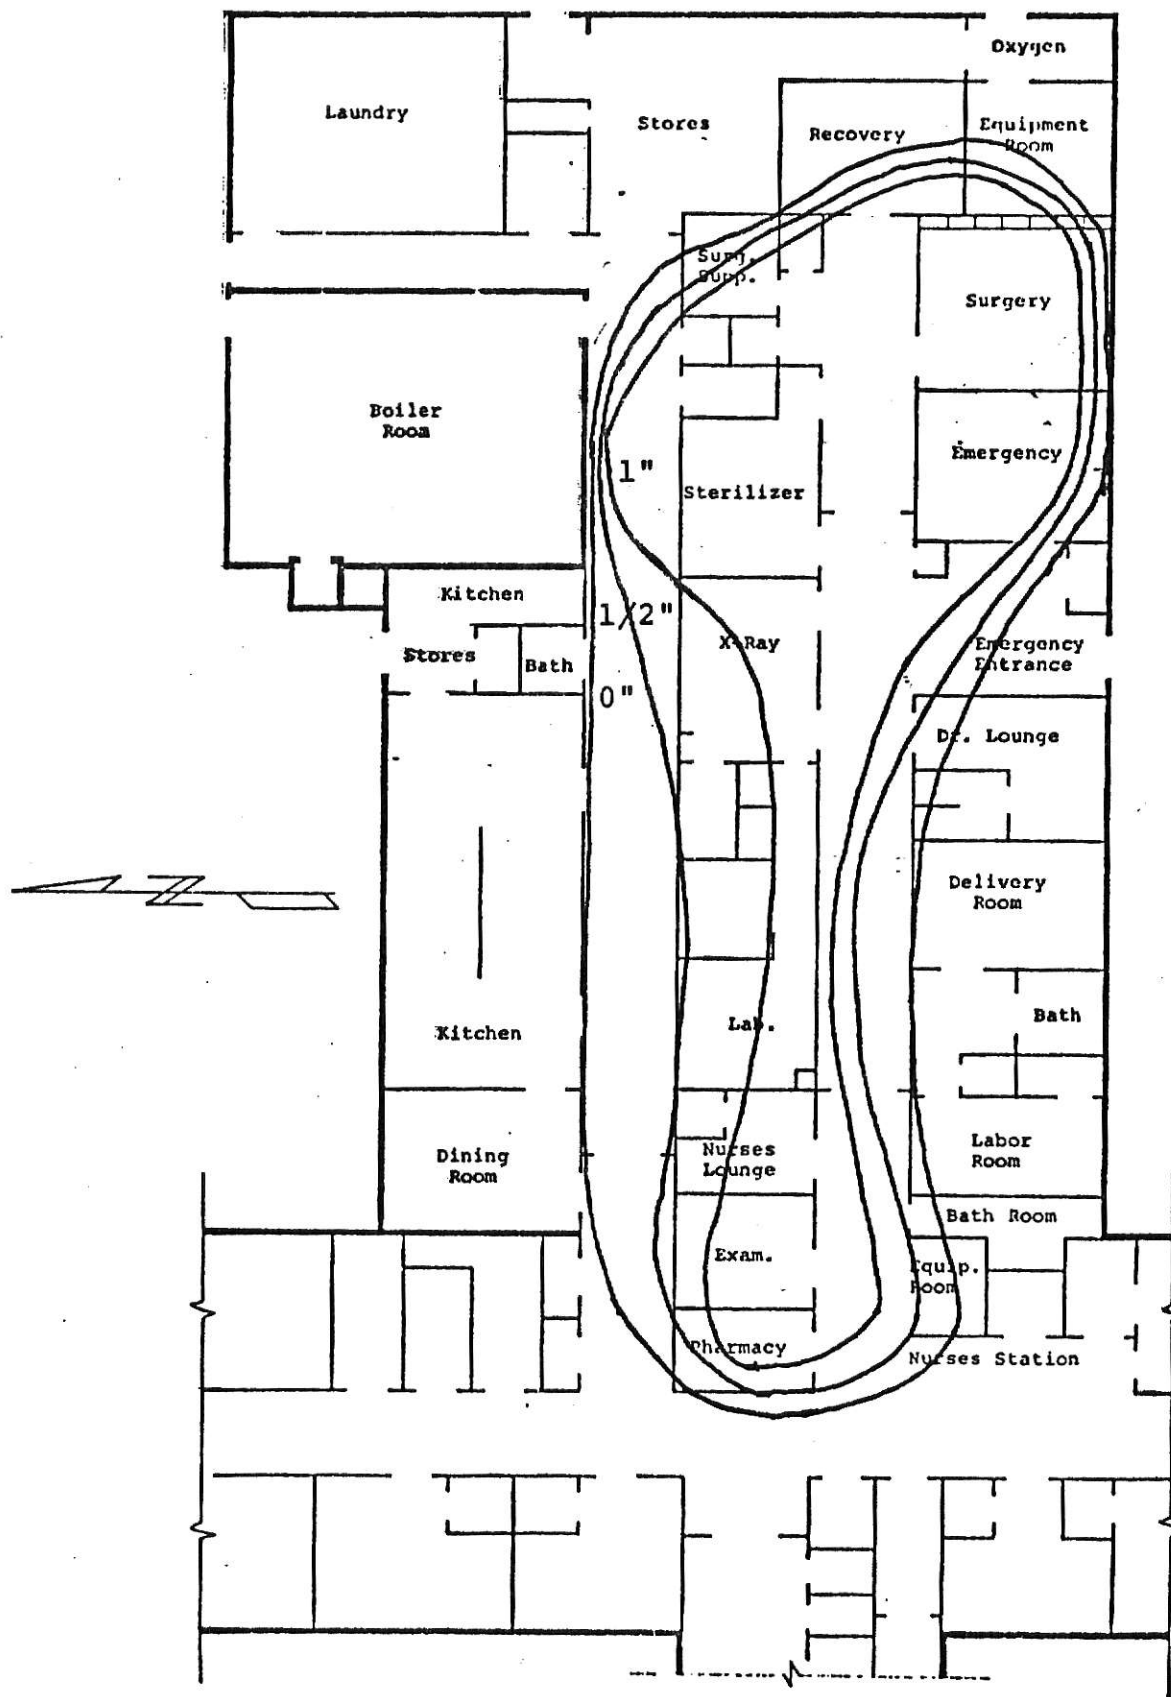
Figure 59

directly into the air return, apparently through the shrinkage cracks in the soil without saturating the soil as expected. It was evident that the soil was now in contact with all areas of the floor, and that the floor had been uplifted. The lowest point in the floor was now one inch, as shown in Fig. 59.

Relative elevation of the floor slab
at the end of June, 1971.

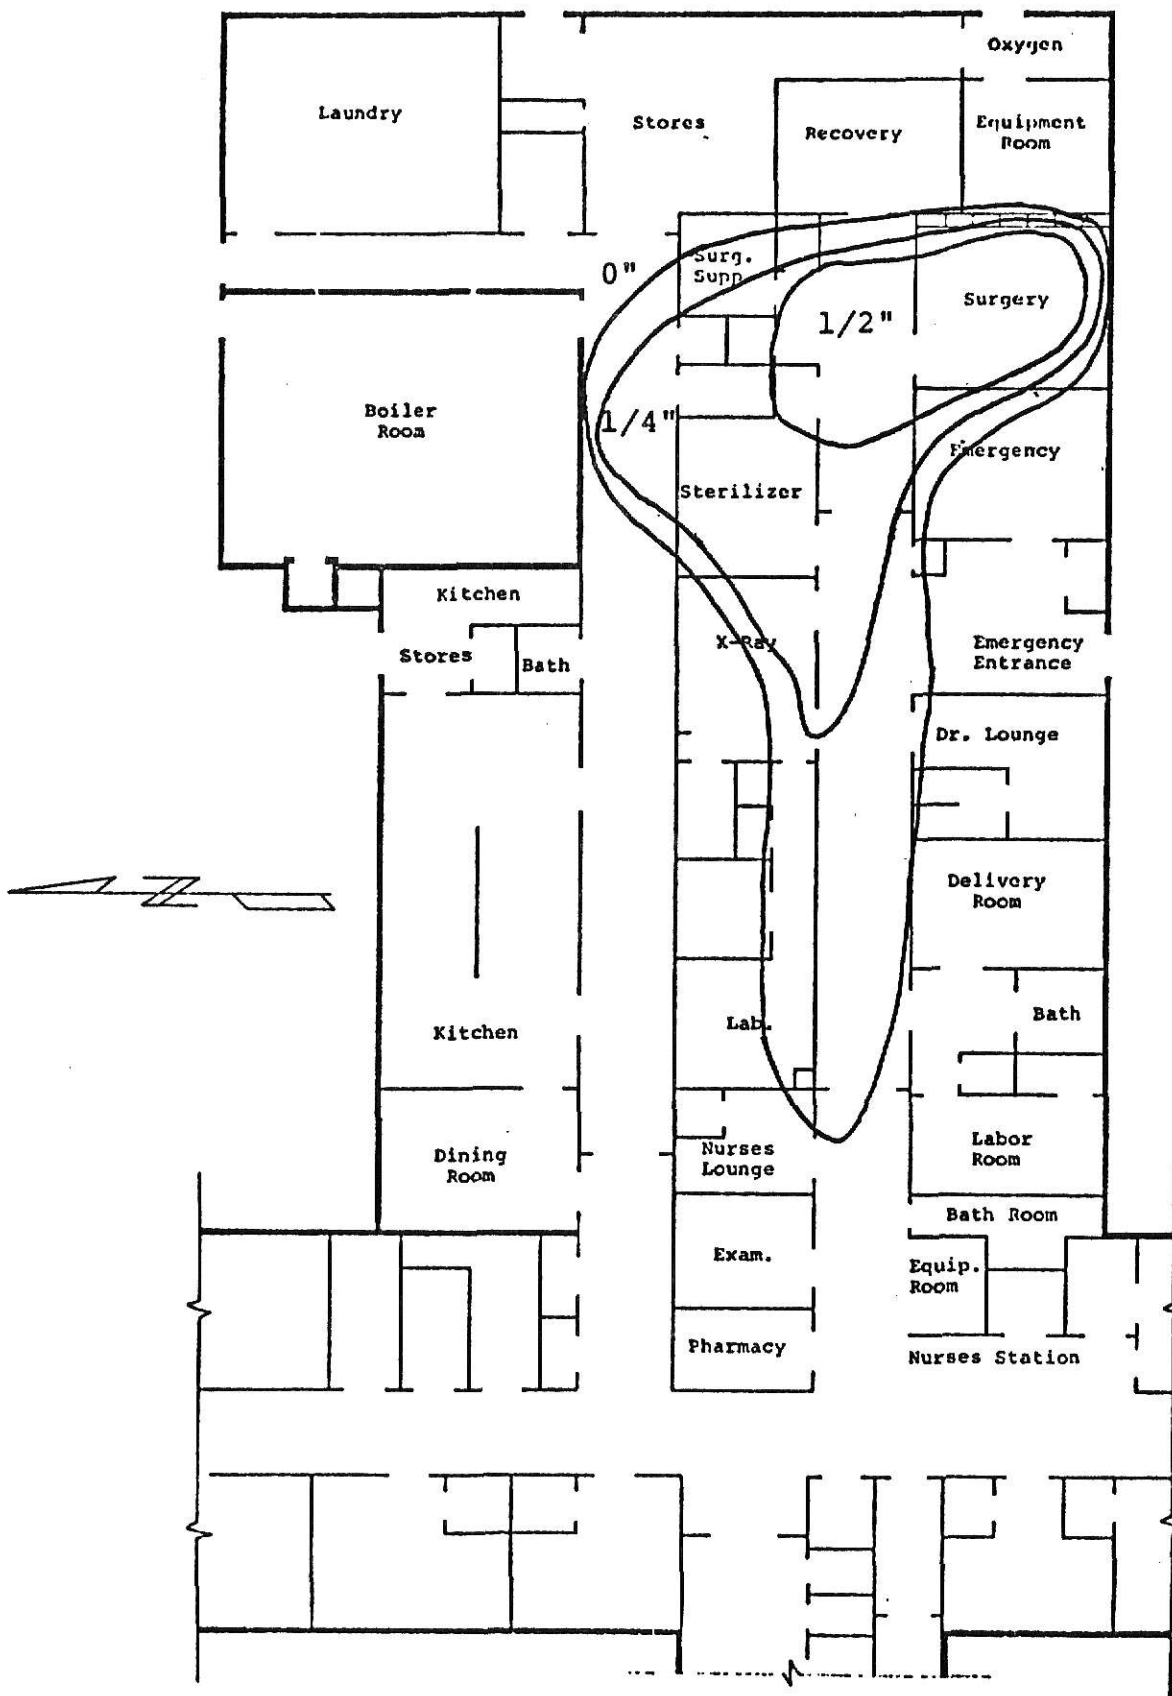
Figure 60

Relative elevation of the floor slab
at the end of 1971.

The soil re-expanded by the addition of water to its original position, except in areas where sufficient water could not be introduced into the soil. It is expected that the moisture content of the soil will be equalized under the entire structure with time and that the soil will be able to retain the water for a long period of time if air circulation under the floor is prevented.
