Field and Laboratory Characterization of Corrosion Potential in Highway Corrugated Metal Pipe

A THESIS

KANSAS STATE UNIVERSITY
Manhattan, Kansas

2018

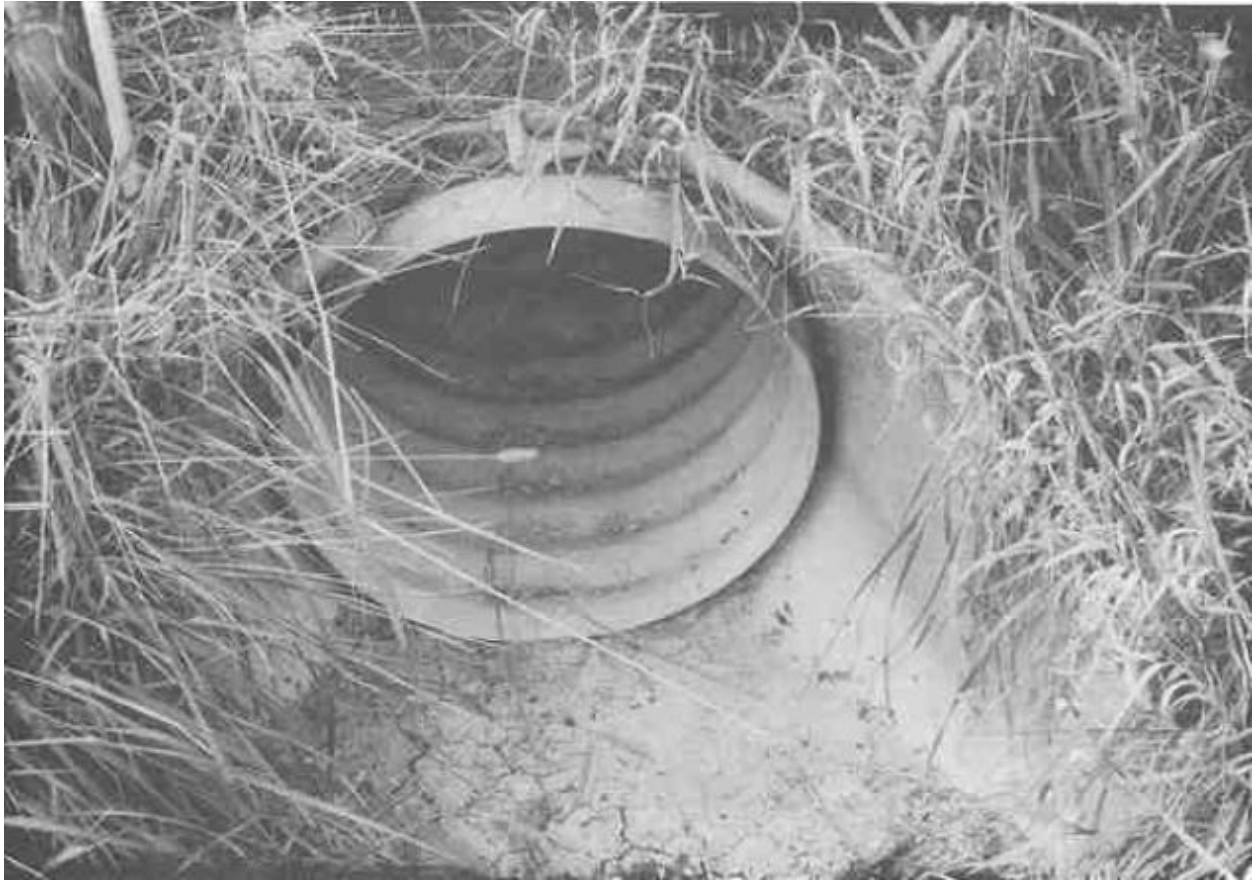
Figure 2-13: Example of a CMP with a 1+ Rating (Stratton, 1989)

Figure 2-13 shows a CPM inspected using the Stratton (1989) rating system shown in Table 2-3. Four locations of the CMPs were rated using this system: the invert (bottom), the interior side, the interior crown or top, and the soil side exterior. The CMP shown in Figure 2-13 was given a rating of 1+.

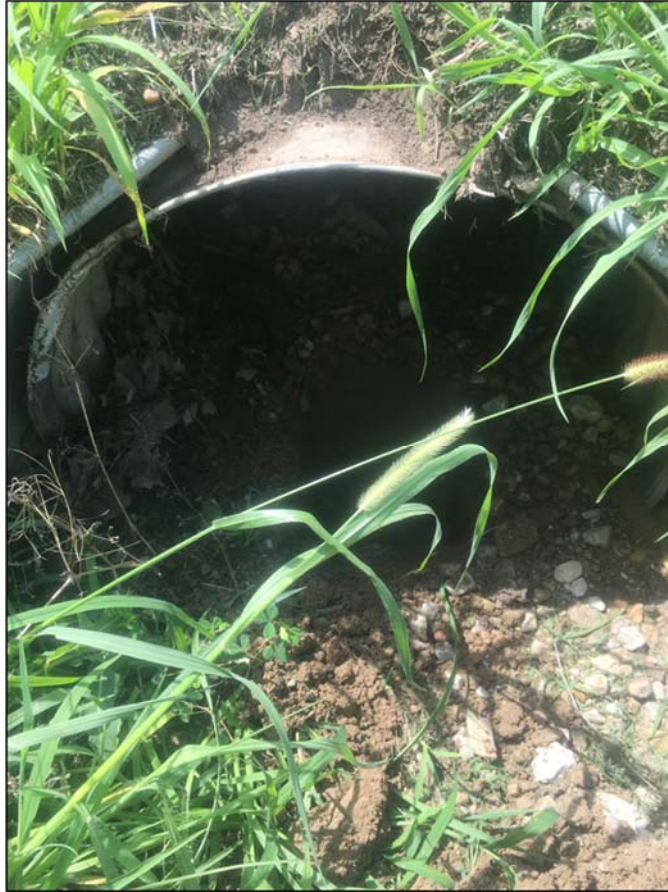
Figure 3-1: CMP with Heavy Invert Silting

It was observed that heavy silting had occurred in a number of CMPs surveyed (Figure 3-1). Most light silting along the invert could be removed with a shovel and observations of the invert condition were made. In the case of extreme silting or disfigurement of the CMP, readings were not taken. All silting was documented in the general notes of each surveyed CMP. All data collected for each site were recorded using the ARCGIS Collector application, and stored online through the K-State Geographic Information Systems Spatial Analysis Laboratory's online ArcGIS account. Using this application allowed for rapid collection and interpretation of spatial data.

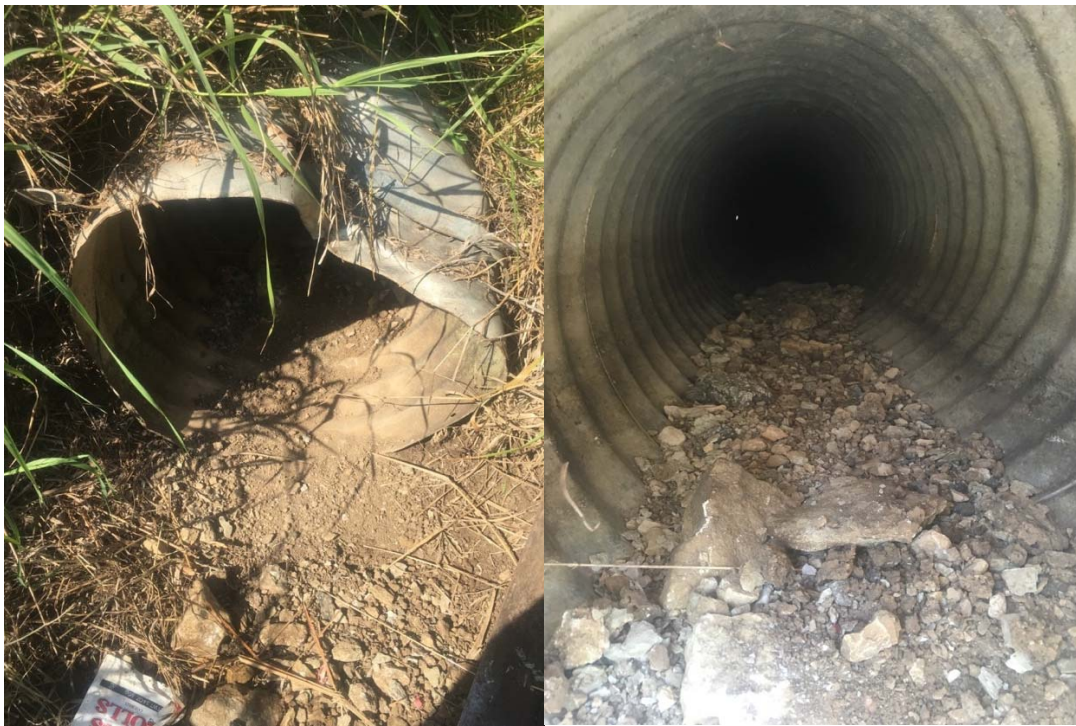
Figure 4-3: Example CMPs with Non-Corrosion Induced External Damage and Invert Silting

During the course of field survey, other factors were observed to contribute to accelerated deterioration of CMP. A number of CMPs were observed to have been physically damaged due to being run over by mechanical equipment as shown in Figure 4-3. These CMPs usually showed signs of corrosion where parts of the surface were sheared off. Accelerated corrosion was observed at locations where CMP seams were disjointed, which likely resulted in exposing areas of metal with insufficient protective coating. Several sites were observed to have large amounts of silted deposits in the invert as shown in Figure 4-3. Invert readings were still recorded for the majority of sites where silting had occurred by removing soil with a shovel. It was noted that during the field survey pipes that had large amounts of silting usually displayed large amounts of corrosion in the invert. Inverts where readings could not be taken due to excessive silting were excluded from the invert ratings data sets. CMPs where invert readings could not be taken due to standing water was also noted and excluded from invert data sets.
