# A PLAN FOR BUILDING EVALUATION AND ASSESSMENT OF SCHOOLS IN MARION COUNTY

# A MASTER'S REPORT

MASTER OF REGIONAL AND COMMUNITY PLANNING

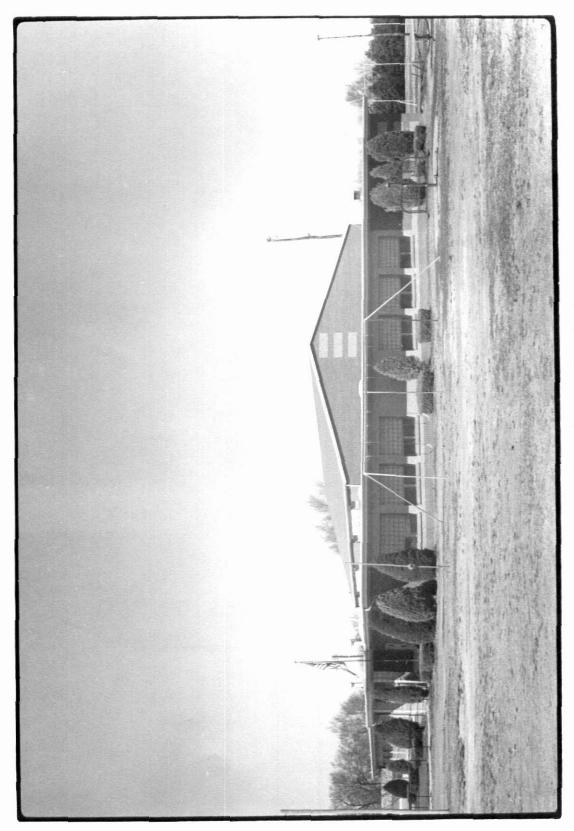
Figure 9. Pilsen Grade School

Evaluation: This building, which has a capacity for 80 pupils, is not being fully used with only 36 pupils enrolled. The use of this school would seem to be unnecessarily costly. First, the building must be heated and other utilities provided. Second, a cook and custodian must be employed. Third, the building must be kept in repair. Fourth, at the present, two full-time teachers, 2 part-time teachers, and a part-time principal are employed to handle the few students. Although it is true that special education classes should be smaller than regular classes, it is wasteful, for example, to provide two classrooms for only 10 pupils. (See Chart and Figure 9.)
