Monitoring the Effectiveness of Streambank Stabilization Projects in Northeast Kansas.

A THESIS

Department of Horticulture and Natural Resources
College of Agriculture

KANSAS STATE UNIVERSITY
Manhattan, Kansas

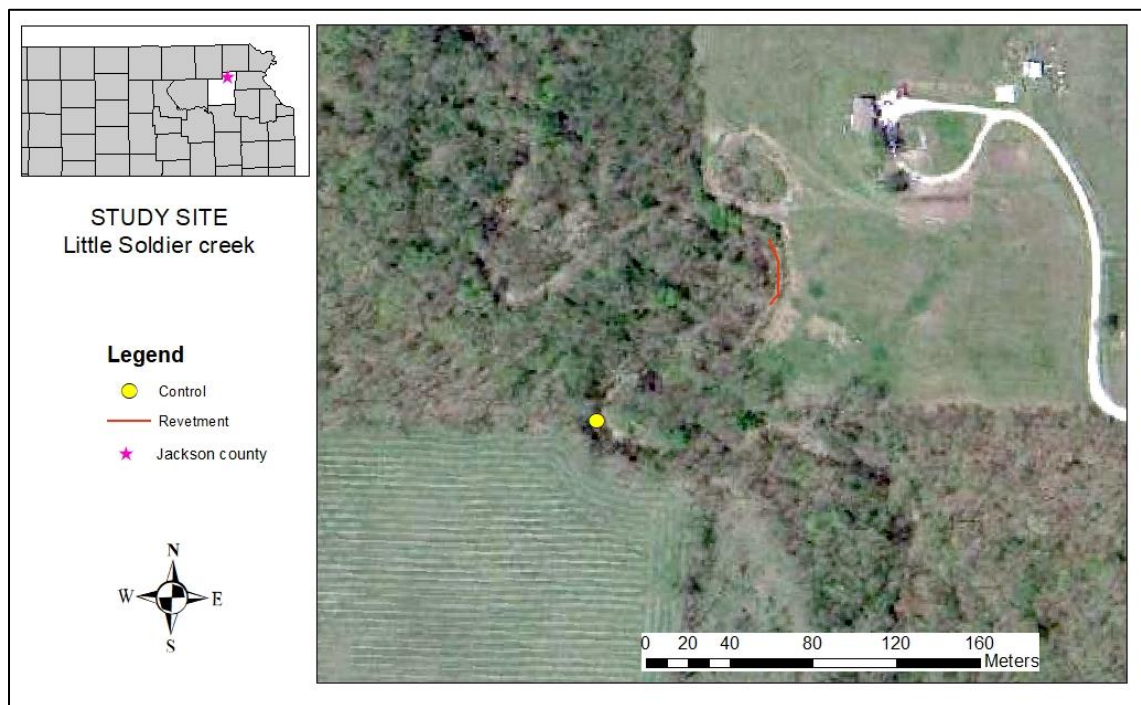
Figure 6. Map of location with stabilized and control sites in the Little Soldier creek.

Little Soldier creek (Figure 6) is located in Jackson County inside the Potawatomi Reservation at 39°21.275'North and 95°48.107'West. This creek has a drainage area of 25.25 square kilometers and a mean annual precipitation of 90.93 centimeters. A cedar revetment was installed in March 2000, it has a length of 60.96 meters. This site was monitored using reinforcement bars.

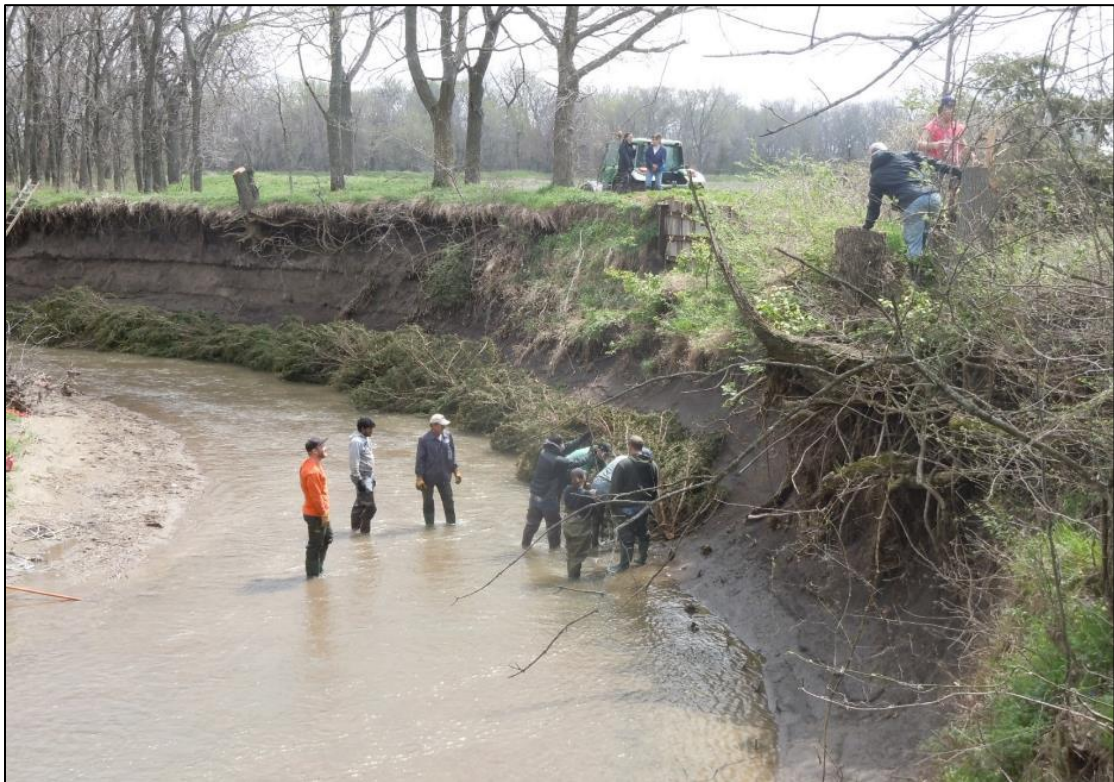
Figure 8. Photo of cedar revetment establishment on Wolfley Creek.

bank and attached the cable to the top of the tree using a cable clamp. Another anchor was placed where the butt of the second tree was located. Then we anchored the tree tightly against the bank moving the next tree into place with its top overlapped by 1/3 the butt of the first tree. Secure cable was used to anchor the butt of the first tree to the top of the second tree. This process continued upstream until the entire base of the streambank was covered with trees. *Salix sp.* stakes were placed above the cedar tree revetment in order to promote vegetation cover (Figure 8).

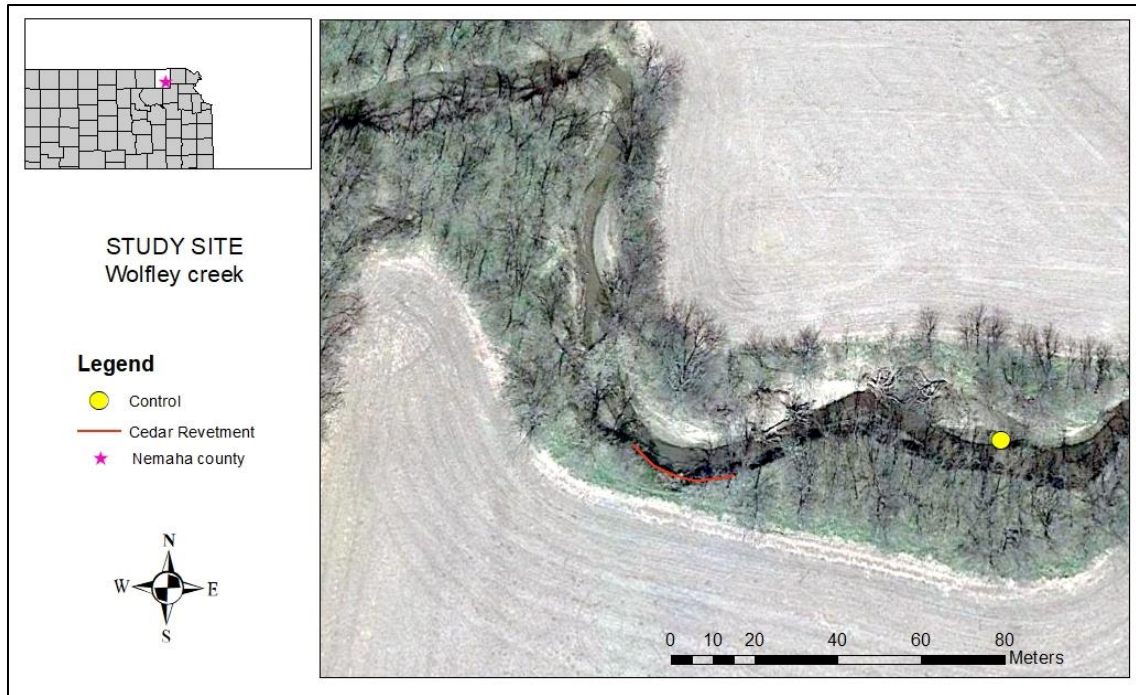
Figure 9. Map of location with stabilized and control sites in the Wolfley creek.

Wolfley Creek (Figure 9) is located in Nemaha County at 39°43.040'North and 95°52.604'West. This creek has a drainage area of 43.98 square kilometers and a mean annual precipitation of 87.38 centimeters. We also installed a new revetment in April, 2017. This revetment is 88.4 meters long and 9.14 meters in depth. The texture of the soils is silt loam. This site was being monitored by reinforcement bars and macro analysis of exposed roots.

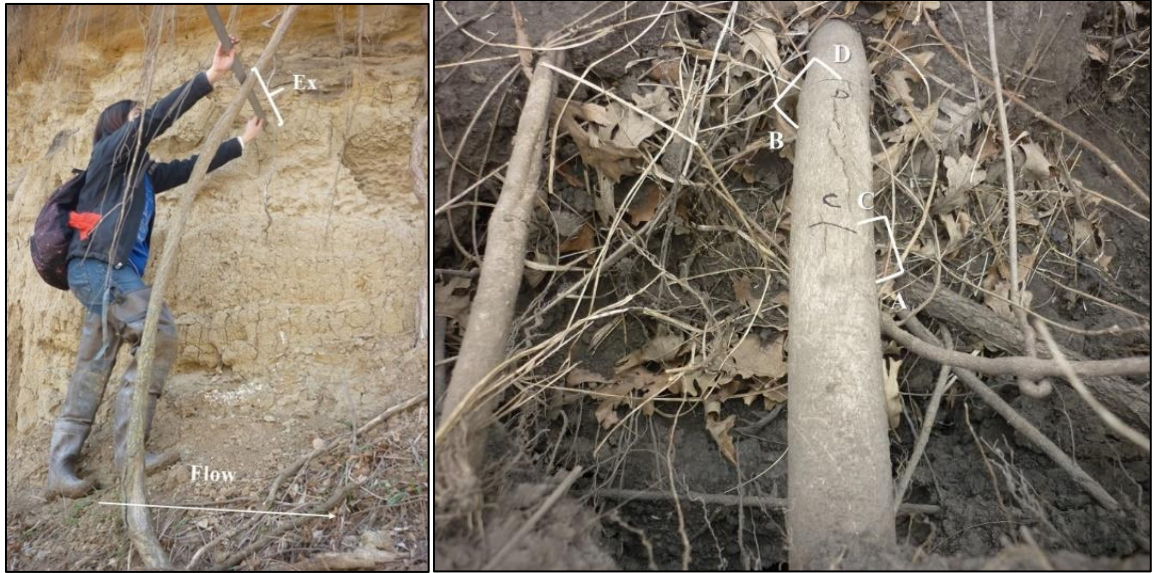
Figure 13. Length of the eroded bank E_x was obtained by averaging the perpendicular distance from the riverside edge of the root to the current bank position. (A) Downstream bottom, (B) Upstream bottom, (C) Downstream top, and (D) Upstream top.

recorded such as the species, location in the bank and a photo. The length of soil loss at each location of roots was recorded using a meter stick oriented perpendicular to the flow and the bank (Figure 12), four labeled measurements to record relative bank position were marked as A, B, C and D in the cross section with a permanent ink marker following Stotts et al., 2011 specifications (Figure 13).

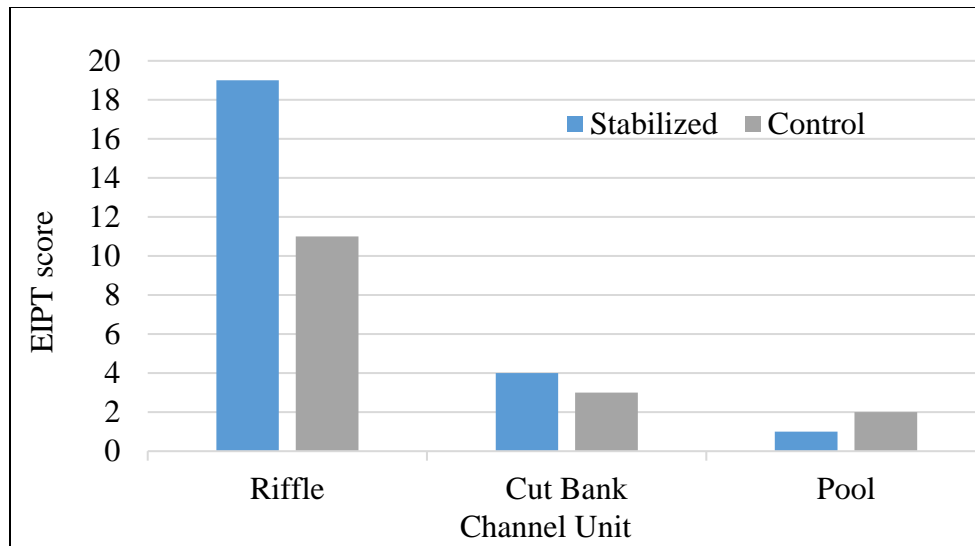
Figure 15. Overall average EIPT comparing control reaches and stabilized reaches on the Delaware River and Plum Creek.

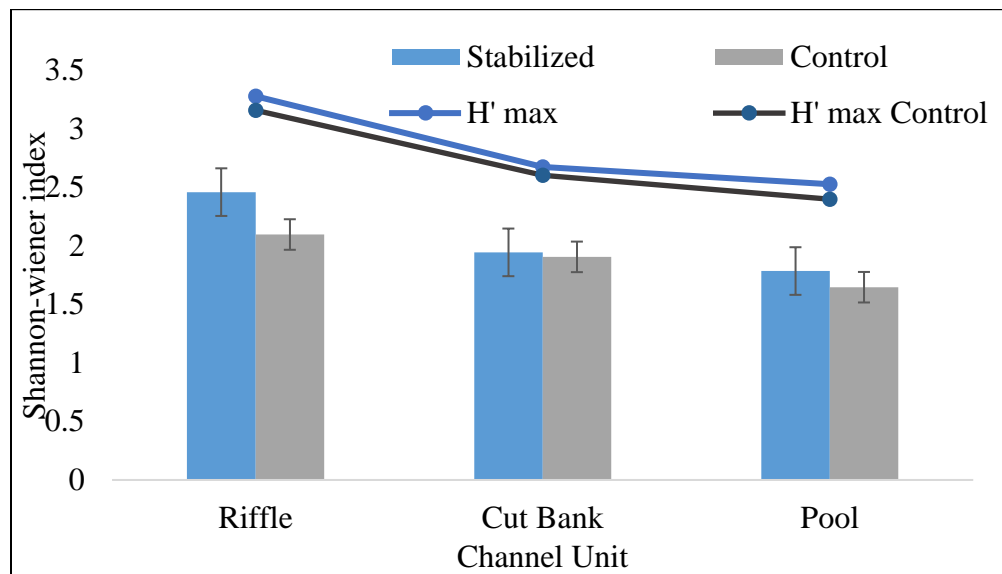
Figure 16. Overall average Shannon-Wiener index comparing control and stabilized reaches from Delaware and Plum Creek.

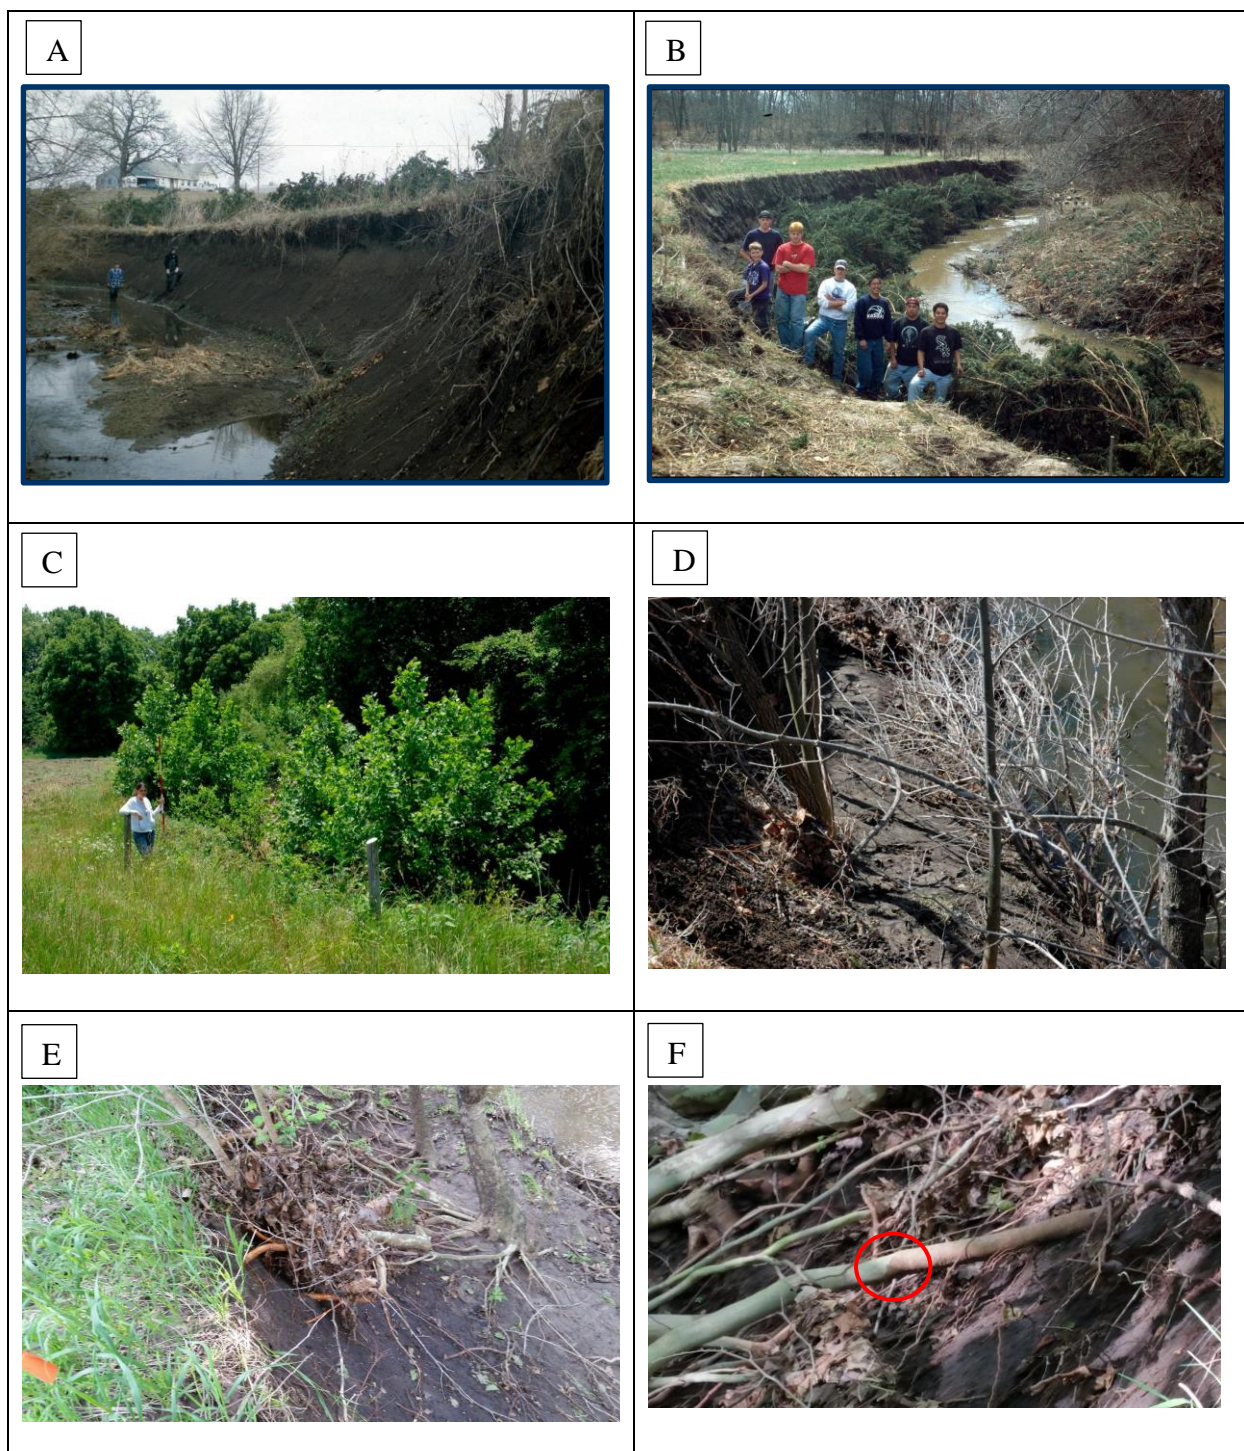
Figure 19. Photographic documentation of Little Soldier Creek. A. Before revetment, B. After revetment, C. After 5 years, D. 2007 sediment deposition, E. Bank erosion from 2017 and F. Root exposure 2017.

The cedar revetment was established on March 2000 (Figure 19 A and B) with the main objective to stop erosion that is causing the creek to move towards the family house in the Potawatomi reservation. After five years the revetment shows recovery of vegetation and growth of riparian buffer (Figure 19 C). During the next years sediment is trapped by the cedar branches and vegetation continues to grow. During 2007, captured sediment was measured within the 60.96-meter-long cedar revetment resulted on 65.75 cubic meters (Figure 19 D). Over the past 17 years of documentation archive, erosion resulted on 140 cm, meaning approximately 8.24 cm per year of sediment was lost and the revetment is still in a functioning state (Figure 19 D). As indicated in Figure 19 E, erosion occurred between March-April 2017 floods and Figure 19 F shows the recent exposure of roots denoted by the change in root color.
