OPTIMIZING ENERGY AUDITS FOR K-12 EDUCATIONAL FACILITIES

A REPORT

Department of Architectural Engineering
College of Engineering

KANSAS STATE UNIVERSITY
Manhattan, Kansas

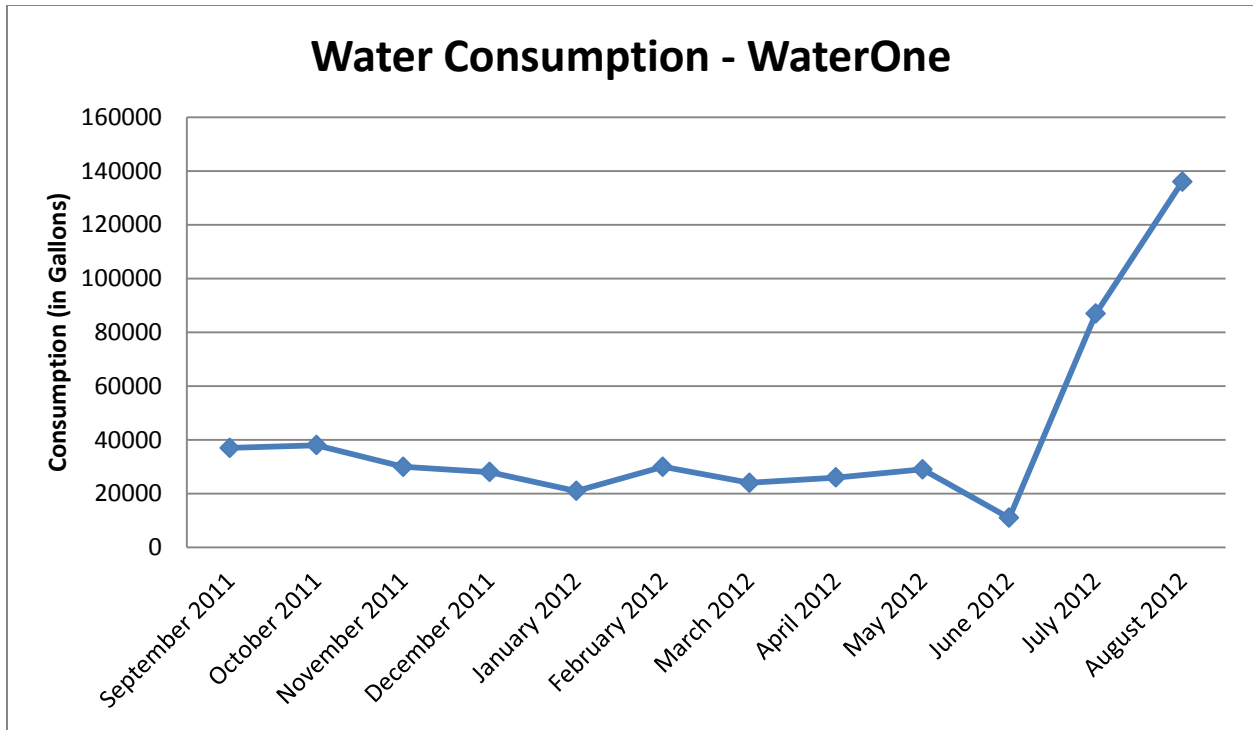
Figure 8-1 John Paul II Water Consumption

Figure 8-1, the water consumption graph, readily shows that typical water use during the school year (late-August to mid-May) was very consistent and only slightly varied. Therefore, one would assume that water usage would greatly decrease during the summer months, since the children are no longer in school; however, the utility bills showed the opposite. The summer months registered a very large increase in water consumption, begging the question why. Consultation with the school staff revealed that the cause was new grass being watered during an atypically hot summer.

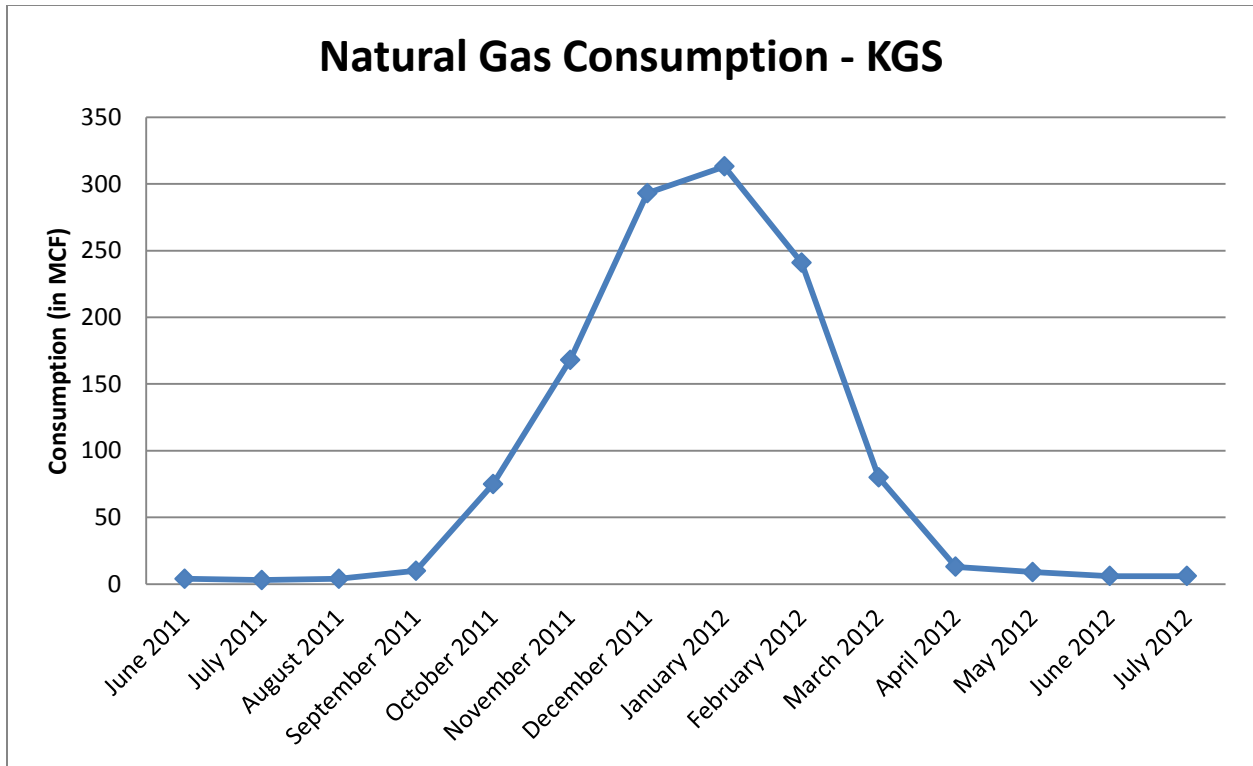
Figure 8-2 John Paul II Natural Gas Consumption

Next, the natural gas consumption, depicted in Figure 8-2, was analyzed. To be able to properly analyze the utility usage requires knowing what to expect. For instance, one assumption is that consumption peaks over the winter/heating months due to natural gas heating and dwindles to near zero in the summer/cooling months. As expected, the figure shows natural gas begins to be used more in mid-October, peaks in January, and then dwindles in mid-March. This finding raises no red flags that warrant further analysis.

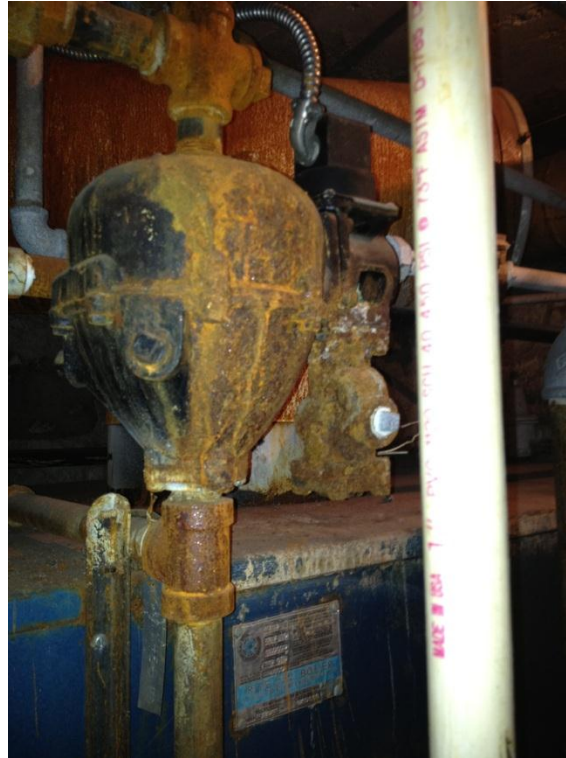
Figure A-9 Boiler 1 Degradation

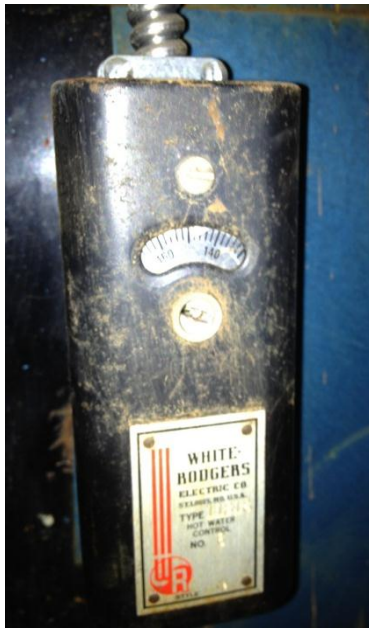
Figure A-11 Boiler 150 Degree Temperature Setting

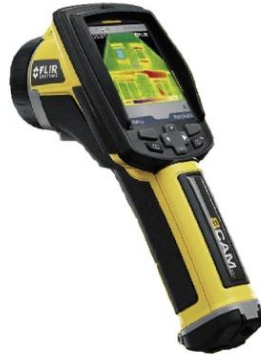
Figure B-4 Thermal Camera

- Thermal Camera: Use to take photos of the building to identify any areas where heat is lost/gained through the envelope. Can also be used to determine if insulation is effective. If a thermal camera is unavailable, visually check for sealing around joints and feel for intruding air.

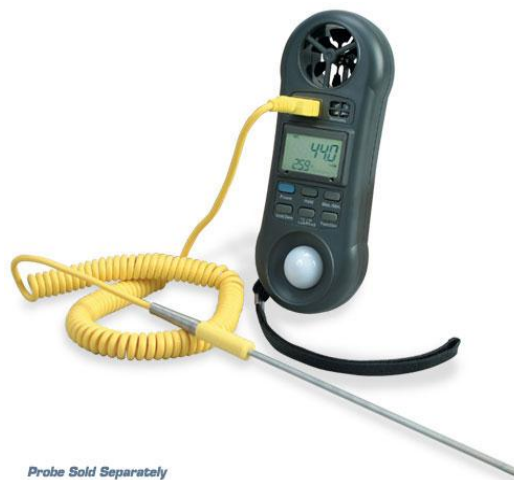
Figure B-5 4-in-1 Device

- 4-in-1 device(s): Use to measure light levels at working plane (typically 3' above floor) and the temperature and relative humidity in each space. Use with the probe to measure the temperature of cold and hot water at plumbing fixtures. If a 4-in-1 device is unavailable, use a lightometer, thermometer, and hygrometer separately to note the light level, temperature, and relative humidity.
