TESTS OF WELDED STEEL AIRPLANE JOINTS

A THESIS

MASTER OF SCIENCE

KANSAS STATE COLLEGE
OF AGRICULTURE AND APPLIED SCIENCE

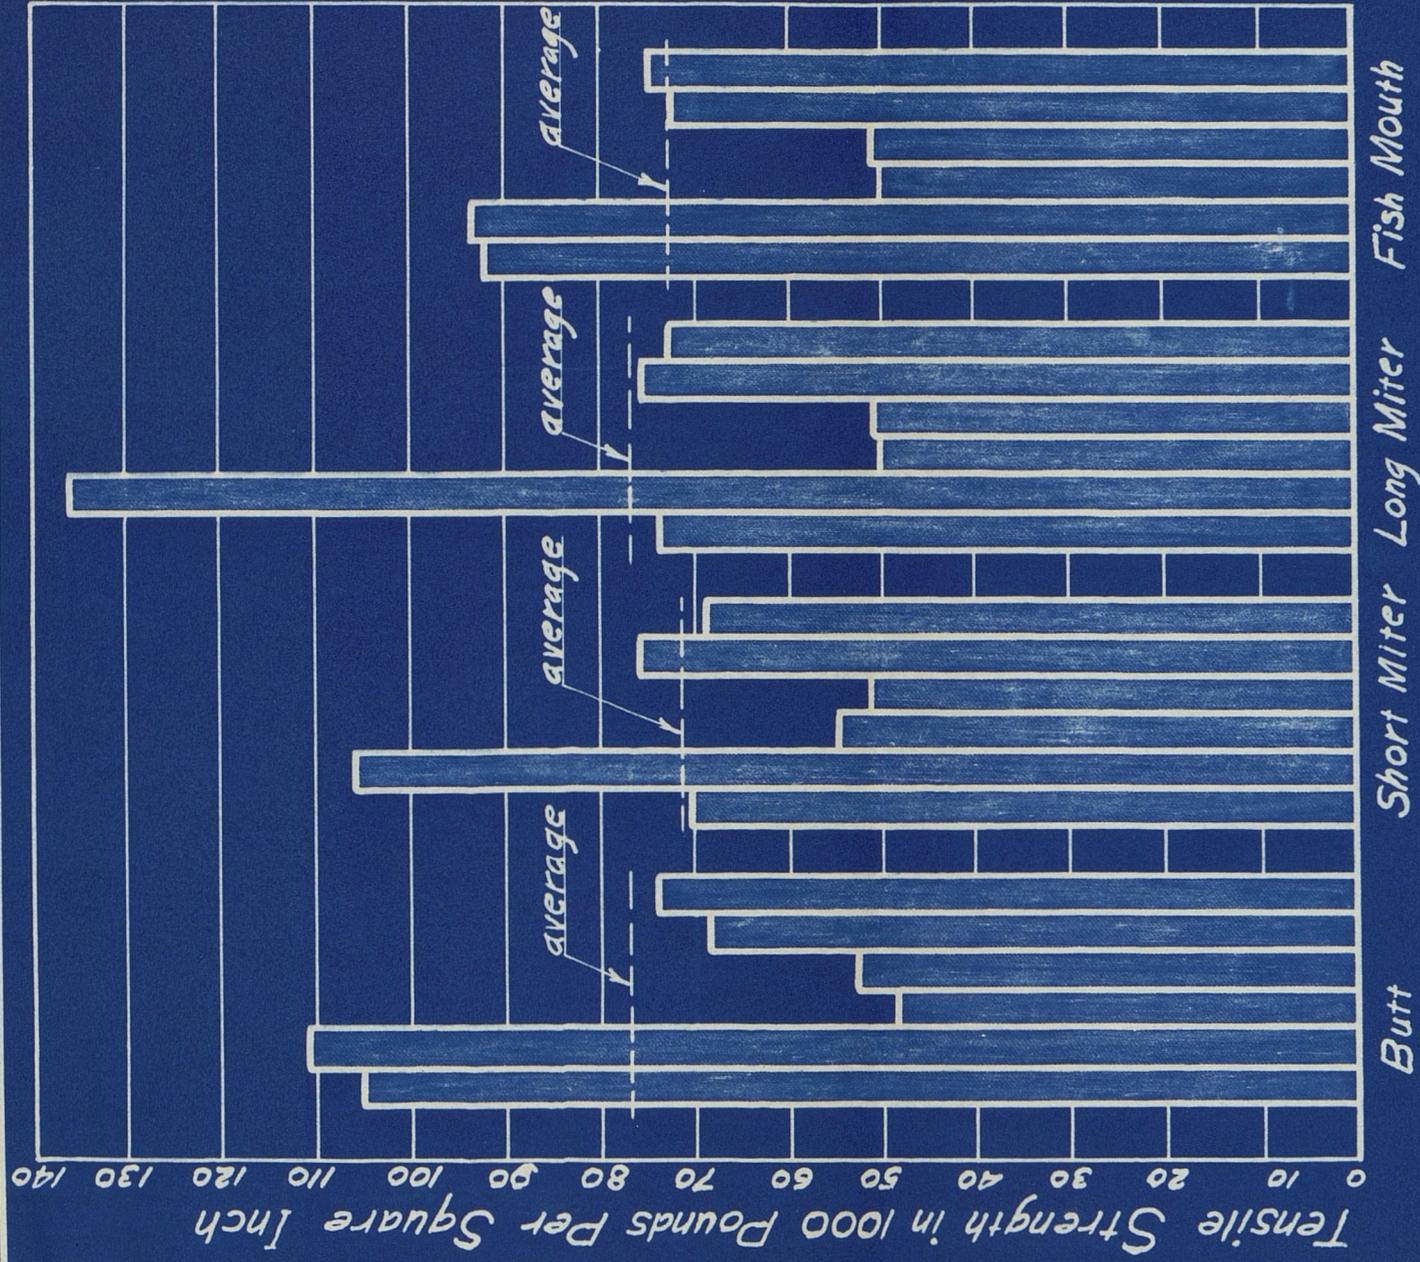
Fig. 2. Comparative Strength of Different Types of Welded Joints.

Figure 2 shows the comparative strength of different types of welded joints. The highest tensile strength obtained in untreated chrome-molybdenum tubing (S. A. E. 4130) was 136,570 pounds per square inch. This was a long

miter joint. The lowest tensile strength found in untreated chrome-molybdenum (S. A. E. 4130) tubing was 69,150 pounds per square inch. This was a butt joint.

The highest tensile strength obtained in untreated carbon tubing (S. A. E. 1020) was 55,730 pounds per square inch. This was a short miter joint. The lowest tensile strength found in untreated carbon (S. A. E. 1020) tubing was 48,690 pounds per square inch. This was a butt joint.

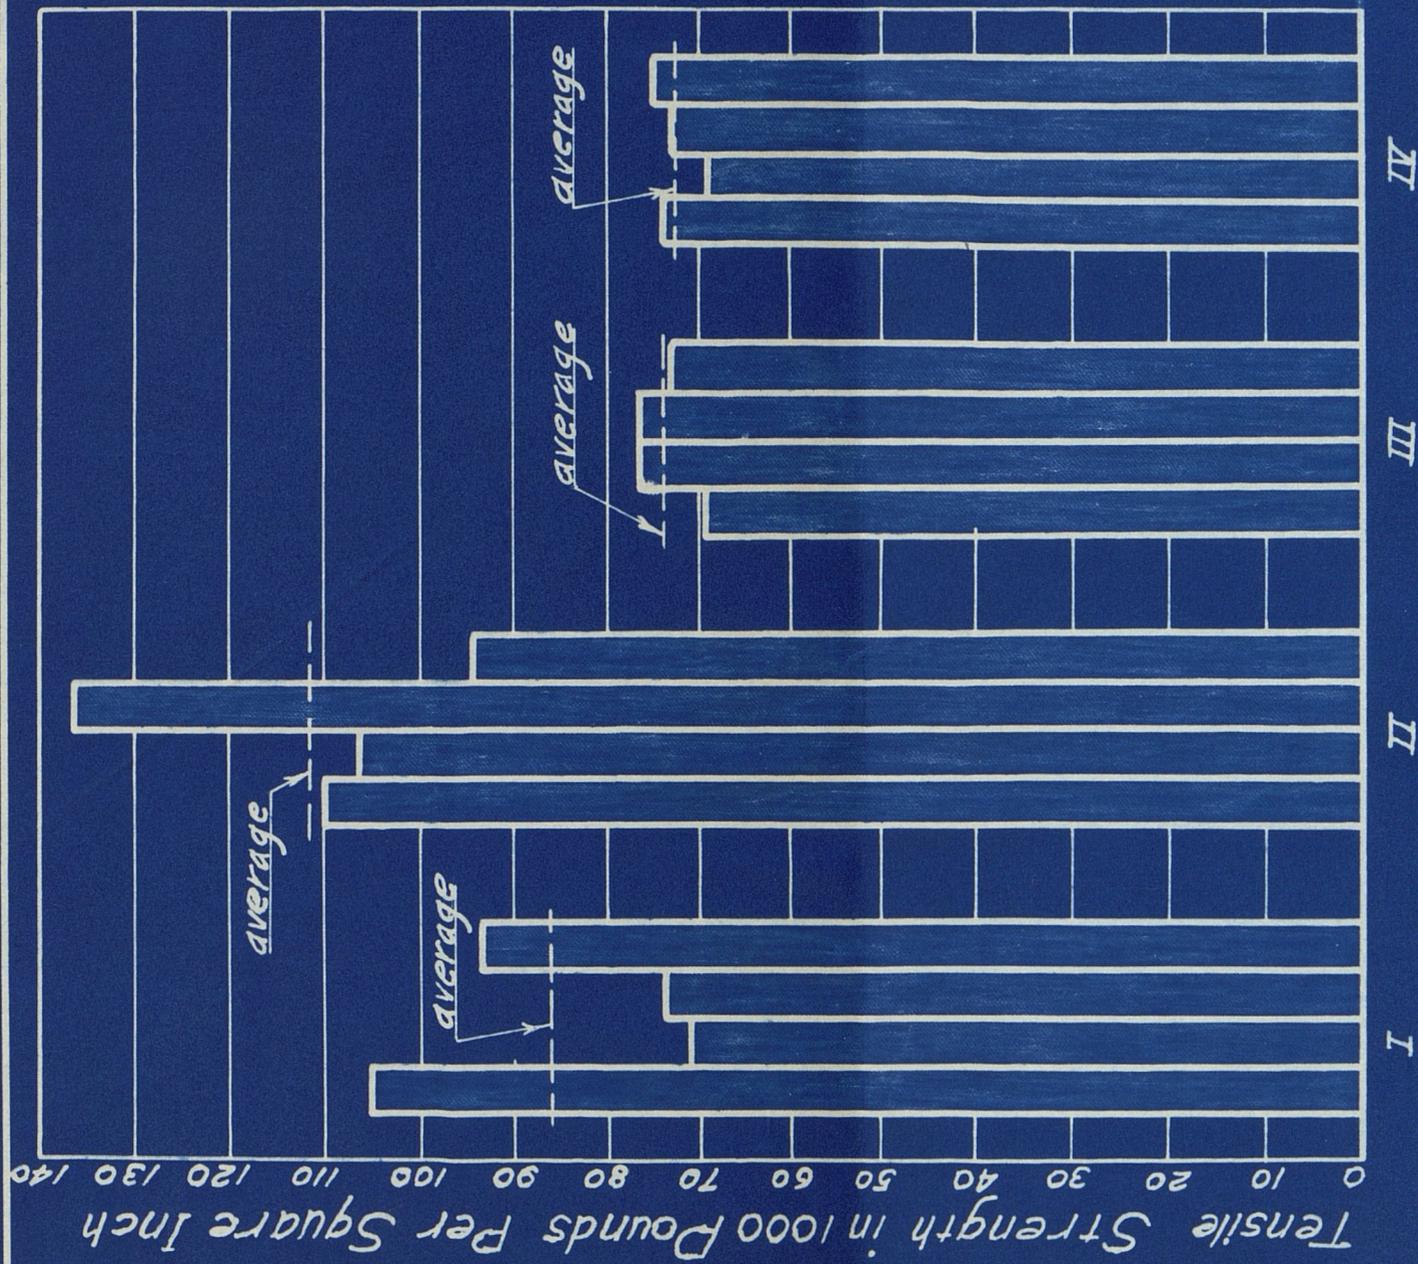
Fig. 3. Comparative Strength of Welds Made by Different Welders. S.A.E. No. 4130 Tubing.

Figure 3 shows the comparative strength of welds made by different welders using S. A. E. No. 4130 tubing. Considerable variation in the tensile strength of the welds are summarized in the following tabulation.

Welder I	85,922 pounds per sq. in.
Welder II	111,978 pounds per sq. in.
Welder III	73,808 pounds per sq. in.
Welder IV	72,899 pounds per sq. in.

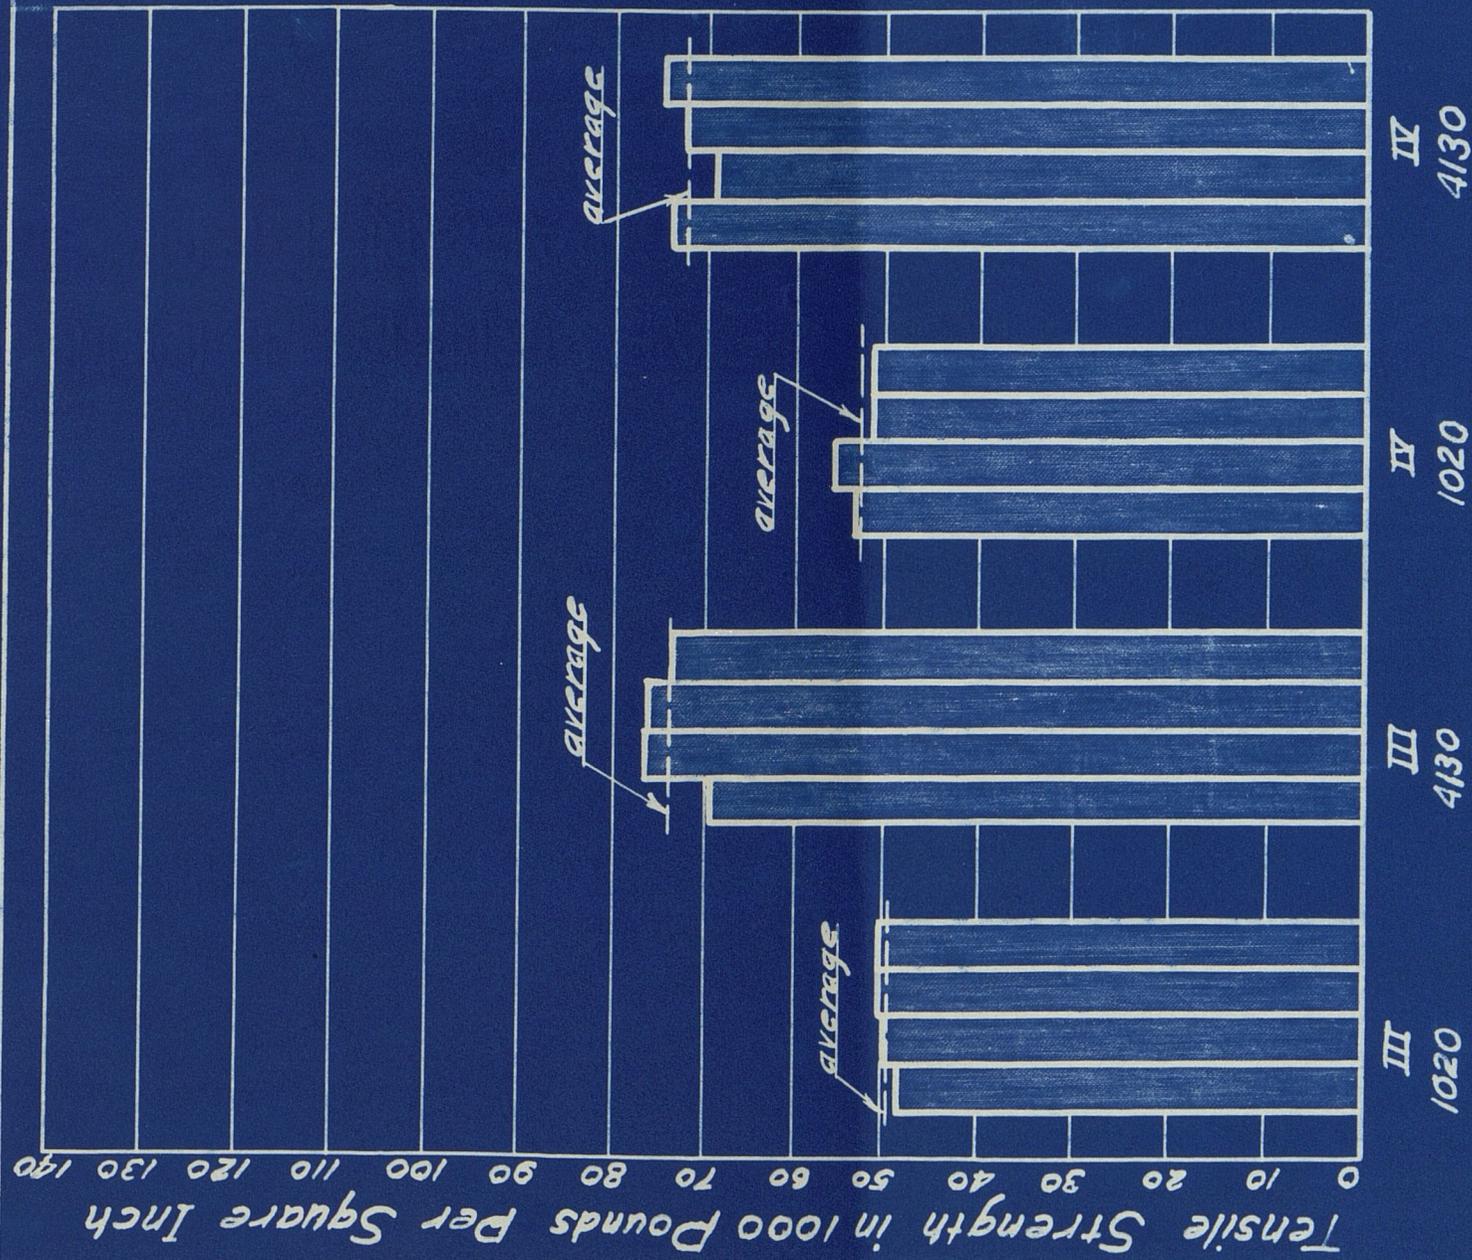
Fig. 4. Comparative Strength of Welds in S.A.E. No. 1020 and S.A.E. No. 4130 Tubing.

Figure 4 shows the comparative strength of welds in S. A. E. No. 1020 tubing and S. A. E. 4130 tubing. Comparisons were made on two different welders. The chrome-molybdenum tubing (S. A. E. 4130) averaged approximately 42 per cent greater tensile strength than the carbon tubing (S. A. E. 1020). For Welder III the increase was 47 per cent while for Welder IV the increase was 37 per cent. The following are the averages in tensile strength.

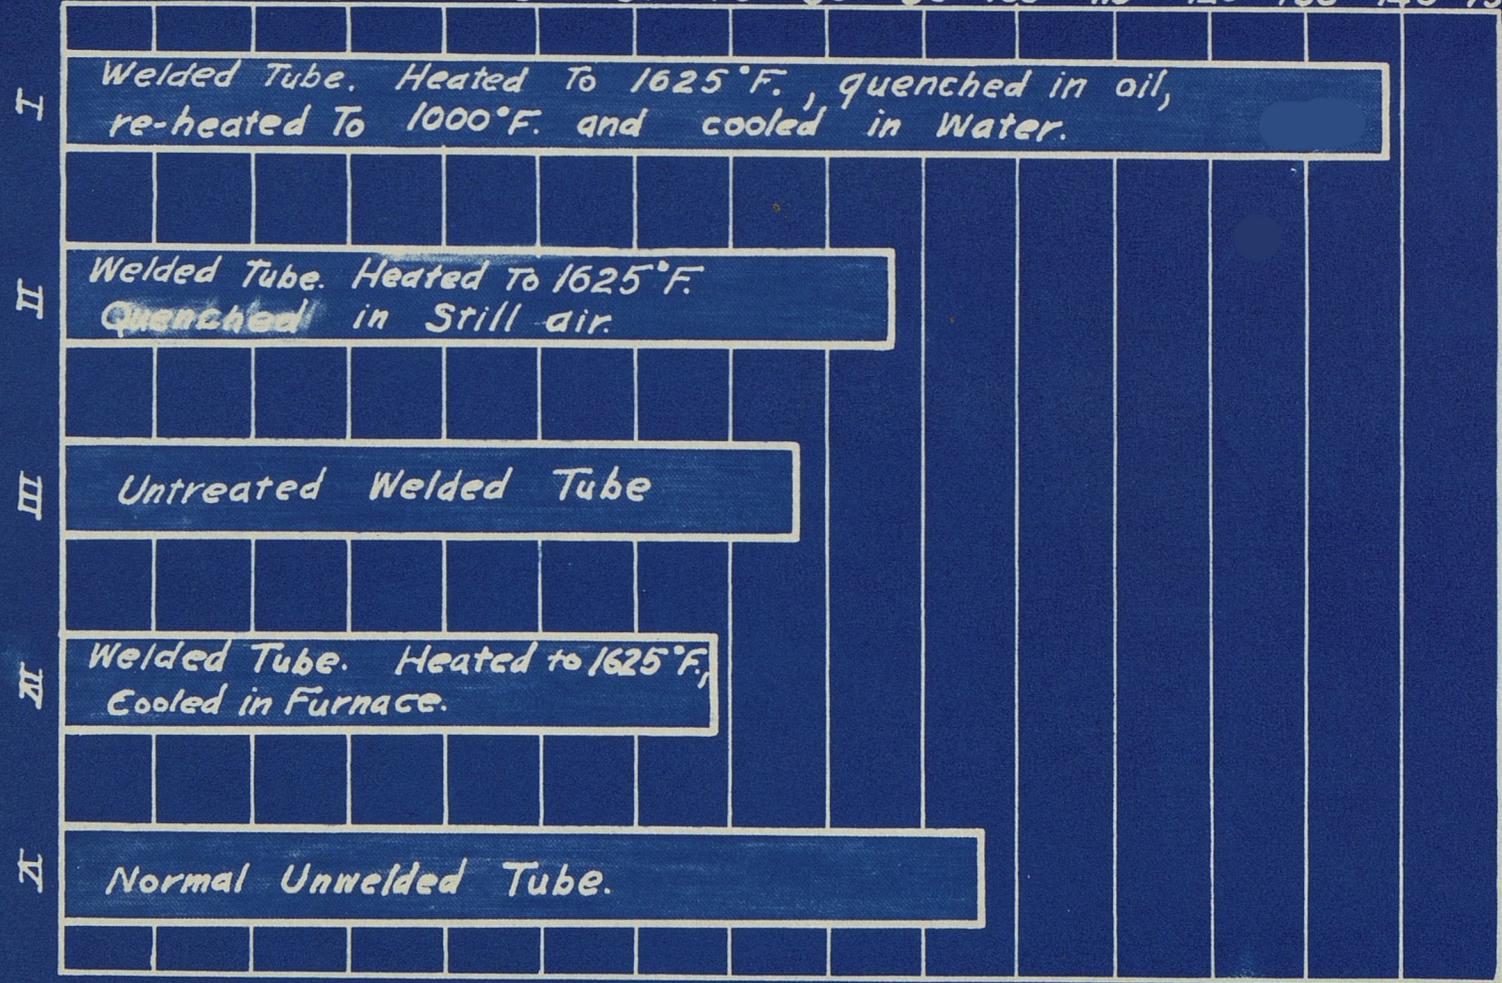
Fig. 5. Comparative Strength of Different Heat Treatments
S.A.E. No. 4130

Column I, Figures 5 and 5A, represents the results of the S. A. E. treatment No. VI. In both cases, greater tensile strength resulted than that of the unwelded tube. In the carbon tubing (S. A. E. 1020) the improvement was not as pronounced as in the chrome-molybdenum tubing (S. A. E. 4130).

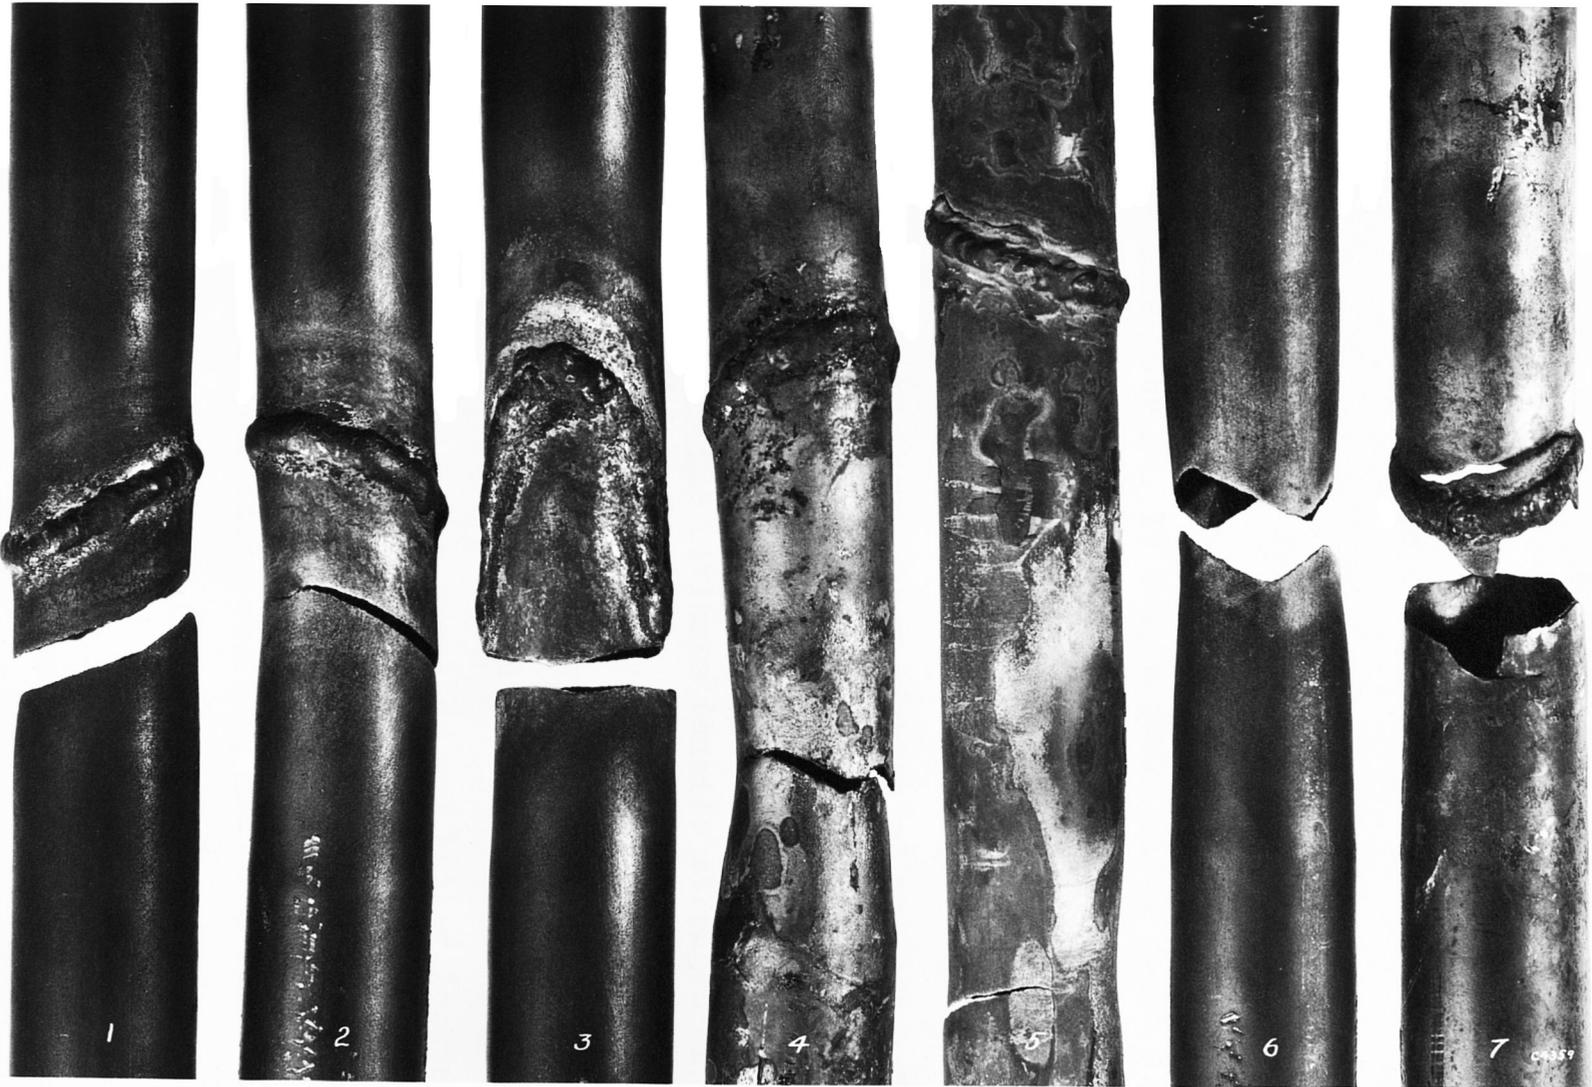
Fig. 6. Types of Fractures Under Different Treatments. S. A. E. No. 1020.

Figure 6 displays the fractures occurring in S. A. E. No. 1020 tubing under various conditions.

Number 6 is Tube No. 5-A, a piece of normal unwelded tubing. The ultimate tensile strength was 59,100 pounds per square inch. This was higher than the welded tubing either untreated or heat-treated with the exception of the tubing which underwent the S. A. E. heat-treatment No. VI. The tube pulled down to a very thin section before parting. The necking was gradual and evenly distributed.

Number 7 is Tube No. 1-A, a short miter joint which was given the S. A. E. heat-treatment No. VI. This tube developed the highest tensile strength of any S. A. E. No. 1020 tubing tested, namely 62,460 pounds per square inch. The tube broke away from the bead on both sides. The fracture resulted at these points because sufficient heat existed along the edges of the bead to probably cause a reduction in the amount of the carbon, resulting in a greatly weakened structure at these points. The heat-treatment had restored the annealed zone to its normal strength and hence along the edges of the bead was the natural place for the fracture to occur.

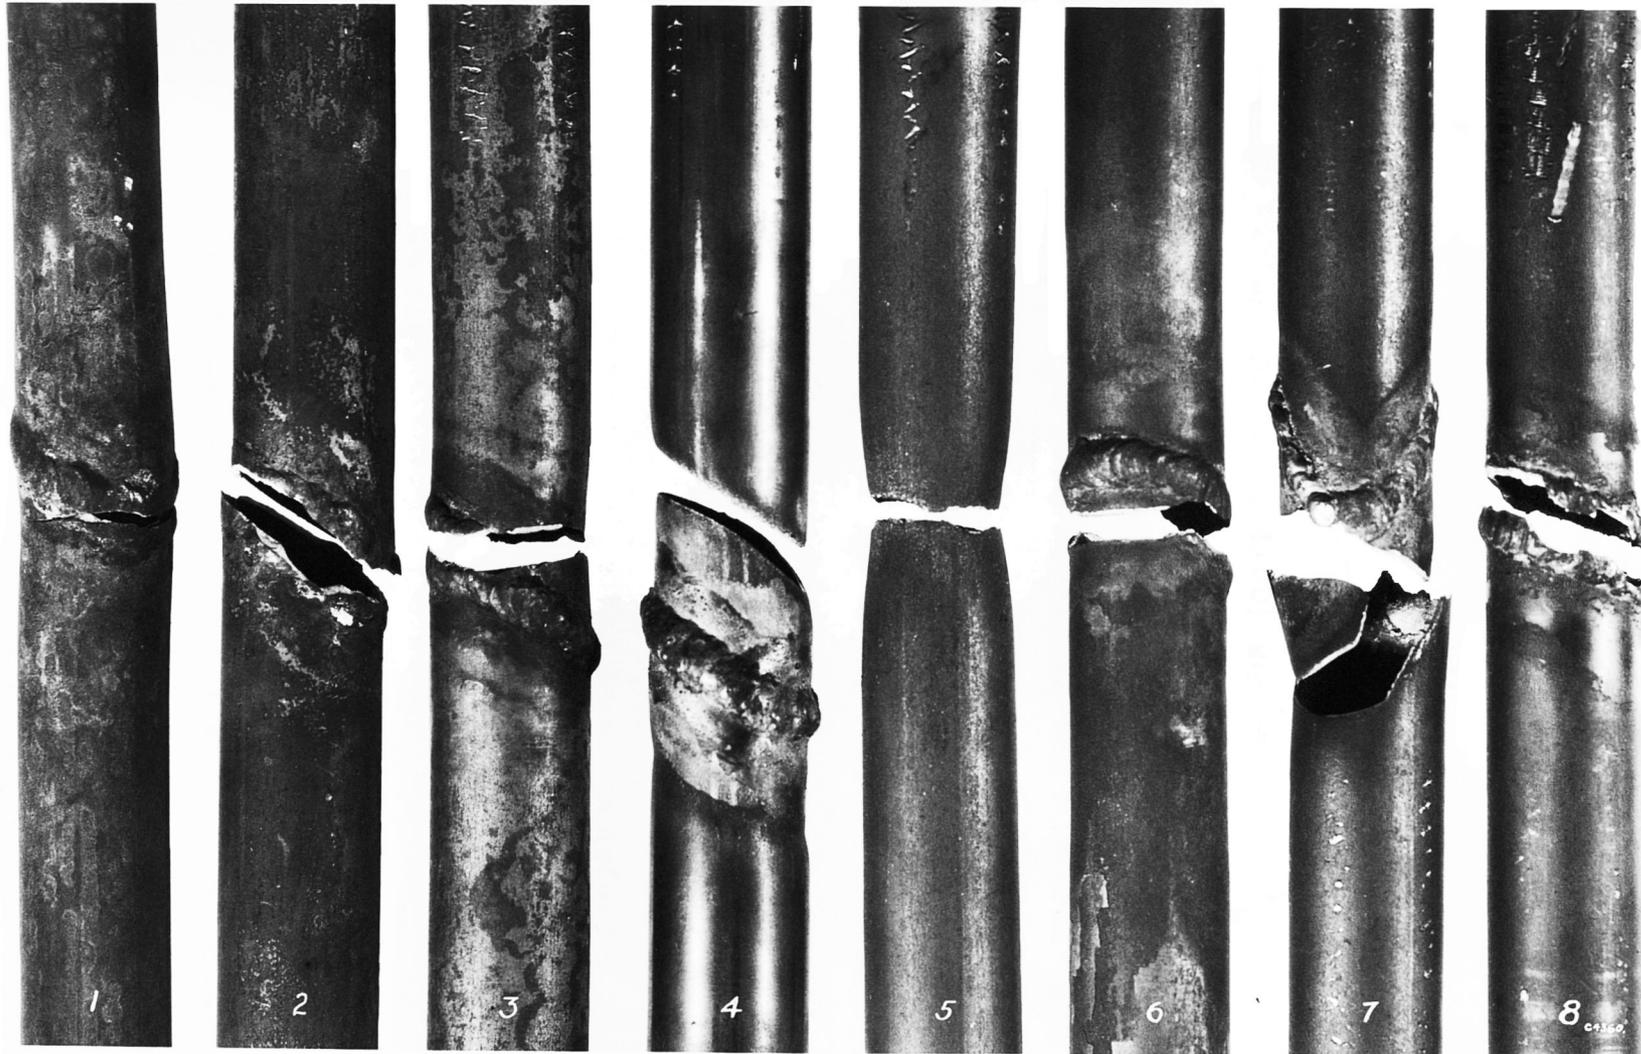
Fig. 7. Types of Fractures Under Different Treatments. S. A. E. No. 4130.

Figure 7 displays the fractures occurring in chrome-molybdenum tubing (S. A. E. 4130) under various conditions.

Number 7 is Tube No. I C-3, a fishmouth joint without heat-treatment. There are two fractures, one in the annealed zone, the other at the edge of the "V". The fracture at the edge of the "V" was due to over-heating at this point, resulting in excessive grain growth, burnt metal and oxidization. The ultimate tensile strength of this specimen was 93,310 pounds per square inch.

Number 8 is Tube No. I C-4, a short miter joint without heat-treatment. The fracture followed the weld. While the weld appeared excellent on the outside, very little fusion had taken place. Saw marks were still visible on the edges of the base metal. This was truly a poor weld. The ultimate tensile strength of this weld was 71,070 pounds per square inch.

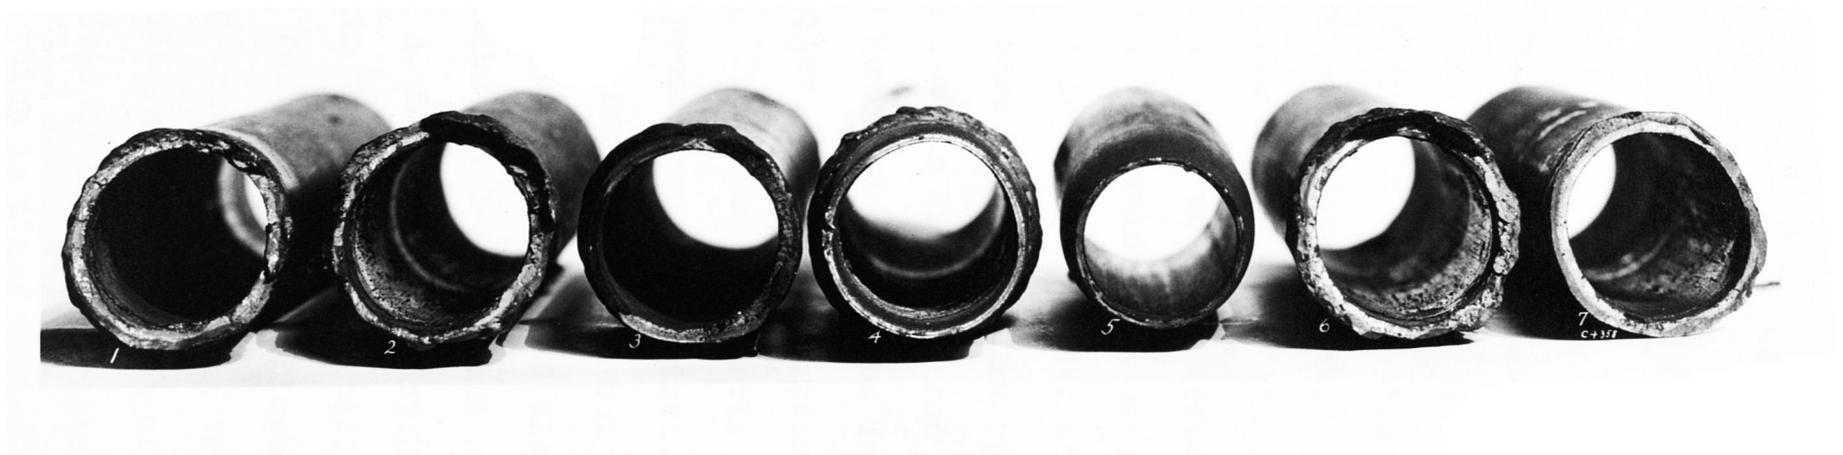
Fig. 8.

Transverse View of the Tubes at Fracture.

The weld in I C-4 was defective. The fracture followed the center of the bead. Penetration was lacking and in some places fusion of the ends of the tubes did not exist. In no place did fusion penetrate the full thickness of the tube. In one place the saw marks made in cutting the joint could be distinguished. The deposited metal appeared very dirty. Photomicrograph, Fig. 8, in a later section fully explains the condition existing in this weld.

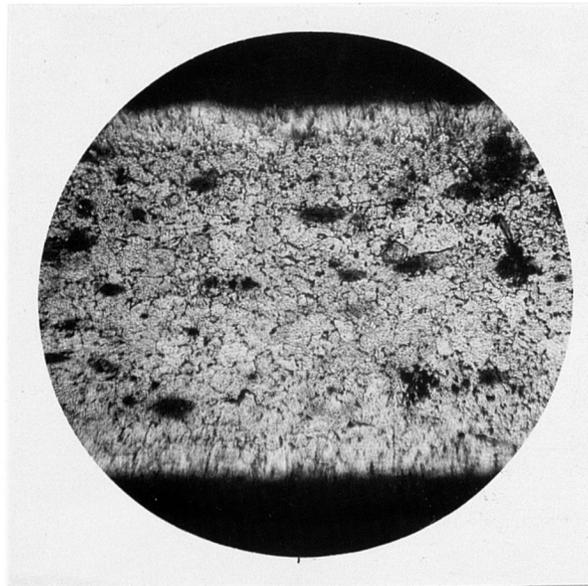
Fig. 9

III A-1. S. A. E. No. 1020

Photomicrograph of Base Metal.

The grain structure is normal, although slightly enlarged due to heating from the welding. The large black splotches are polishing pits. The white grains are ferrite. The long dark areas at the edges of the ferrite grains are pearlite. The rounding of the edges of the tube wall due to polishing makes the grain structure appear indistinct.

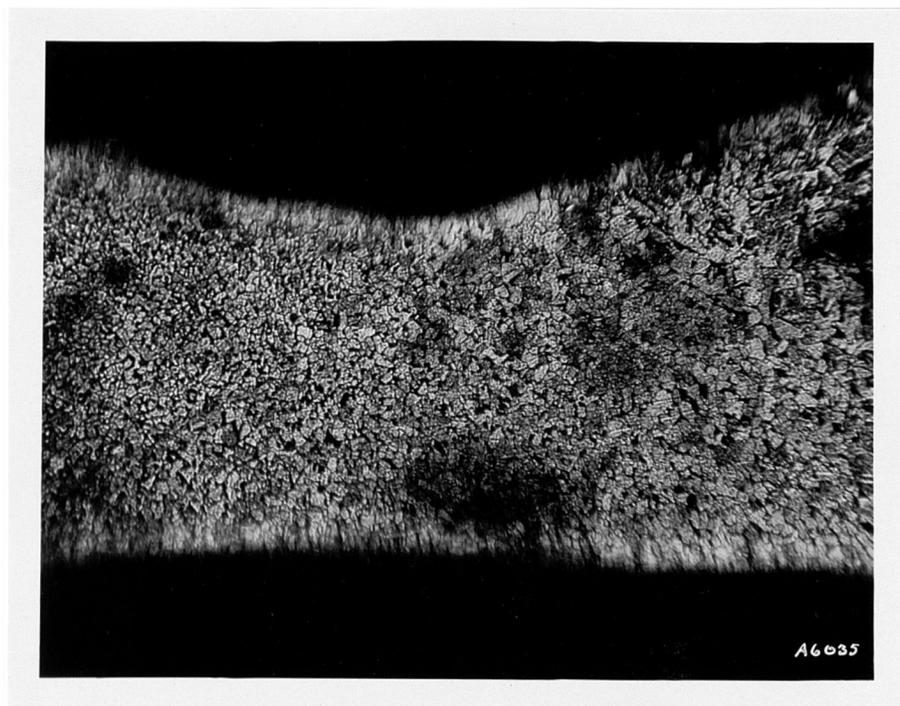
Fig. 10.

III A-1. S. A. E. No. 1020.

To the right is the weld metal, to the left is the base metal. The extreme left shows the normal thickness of the tube wall. The wall is cut down at the edge of the bead to a lesser thickness than the original base metal. This shows insufficient reinforcement and probably improper handling of the welding torch. This condition is very common in welds and is a frequent cause of low tensile strength of a weld which is otherwise sound. The grain

structure is identical with that of Fig. 9. However, the grain size gradually increases from the base metal to the weld metal. This was due to the gradual increase in temperature from the base metal to the weld metal.

Specimen III A-1 broke near the bead. Fracture occurred either along the very edge of the bead or within approximately one-sixteenth of an inch from the bead. This was caused by undercutting. Photomicrograph, Fig. 10, appearing later explains this defect fully.

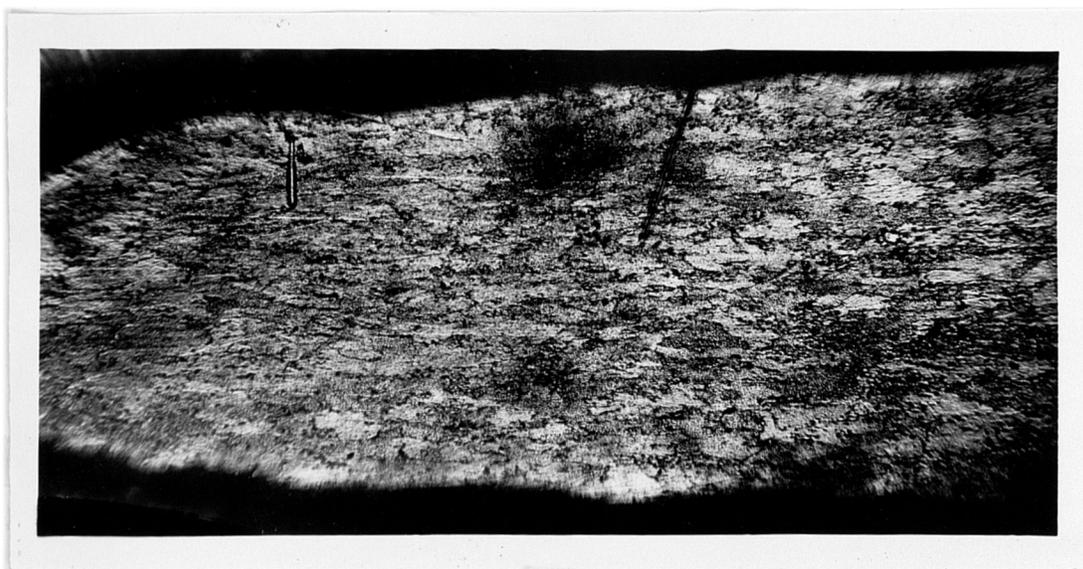
Fig. 11.

III A-4. S. A. E. No. 1020.

To the right the grain structure appears to be elongated although a definite grain structure can readily be detected. These grains show that the elastic limit has been passed but the ultimate tensile strength has not been reached. The large white grains are composed of ferrite

grains. To the left the grains have been ruptured and the ultimate tensile strength has been passed. This specimen was very difficult to polish since the grain structure was so broken down that even with the slightest pressure scratches would continually be made.

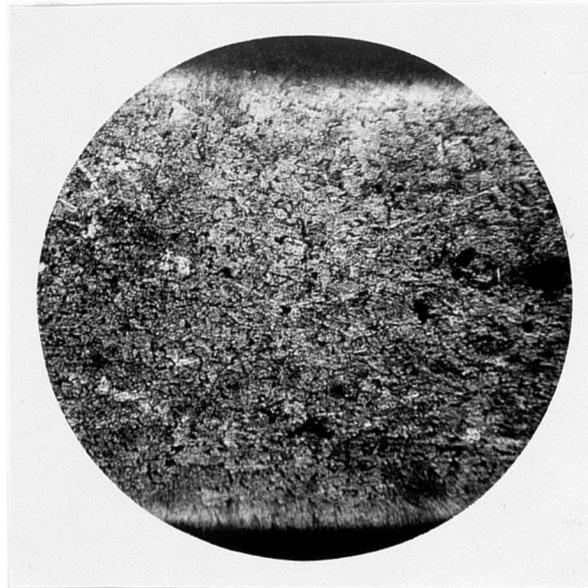
Fig. 12.

III A-4. S. A. E. No. 1020.

The grain structure appears nearly normal in size and shape although some distortion is present. Considerable difficulty was encountered in completely removing the

scratches since the distortion has weakened the wear resistance of the metal. The large white grains are ferrite while the small black streaks appearing at the edge of the ferrite grains are pearlite.

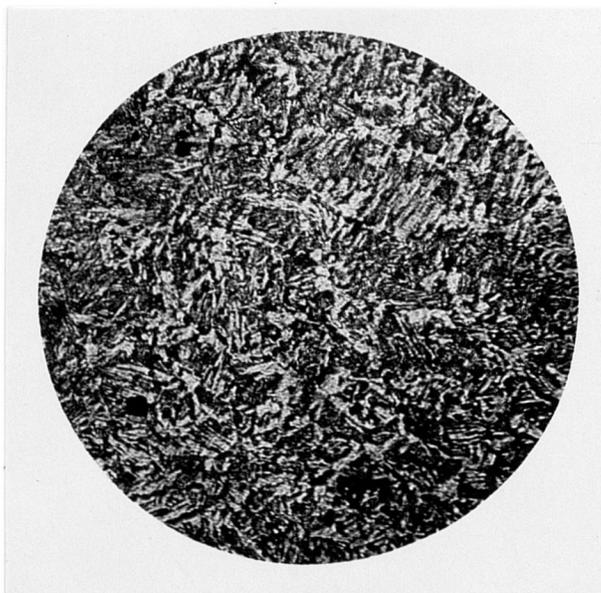
Fig. 13.

II D-3. S. A. E. No. 4130.

The dark spots are merely polishing pits. The size of the grains are slightly larger than normal due to the heat from

the torch. Metallurgists have not definitely named the constituents of chrome-molybdenum steel, although it is known that the grains of this alloy steel completely disappear. Therefore, no attempt shall be made to identify the various constituents of the grain structure. The grain structure is extremely fine and it is very difficult to recognize the constituents.

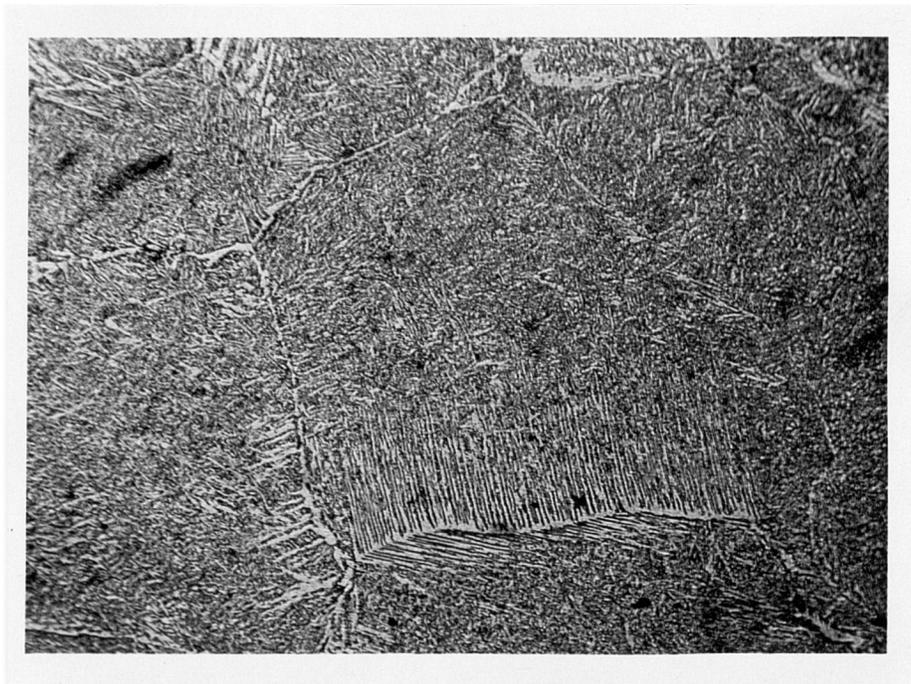
Fig. 14.

II D-2. S. A. E. No. 4130.

Photomicrograph Taken at the Center of the Weld.

The fusion of the weld metal and the base metal was excellent. Only a very slight trace of slag was found. No gas inclusions or blisters are present. However, grain growth has been very pronounced. Special attention should be given to the large grain appearing in the center. The upper portion of this grain is the structure of typical chrome-molybdenum steel. The lower portion of the grain shows the numerous ferrite lines typical of cast steel. The grains form a ferrite network or matrix. This excessive grain growth was due to heating the metal to the molten state and slowly cooling. This photomicrograph is excellent proof of the claims made by many authorities that in welding chrome-molybdenum steel the chromium and molybdenum are transferred to the deposited metal in sufficient quantities to give the weld metal nearly the same composition as the base metal. This weld shows splendid penetration and presents an excellent weld.

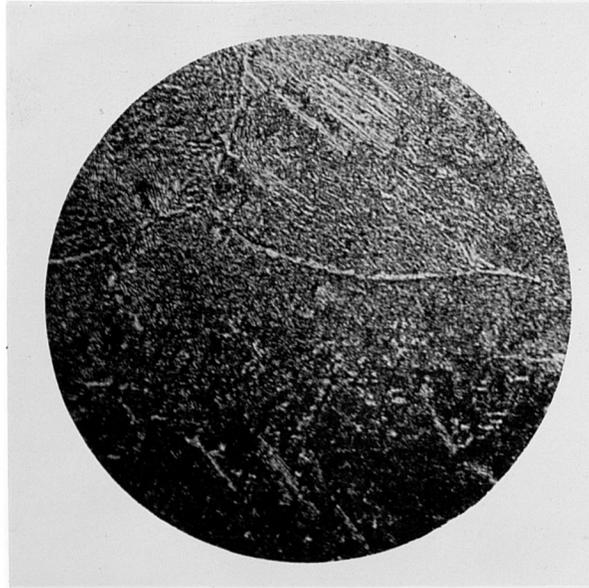
Fig. 15.

II D-3. S. A. E. No. 4130.

Photomicrograph Taken at the Junction of the
Base Metal and Weld Metal.

An excellent fusion of the base metal and the weld metal is apparent. The weld metal shows excessive grain growth. Only a slight trace of slag exists in the weld.

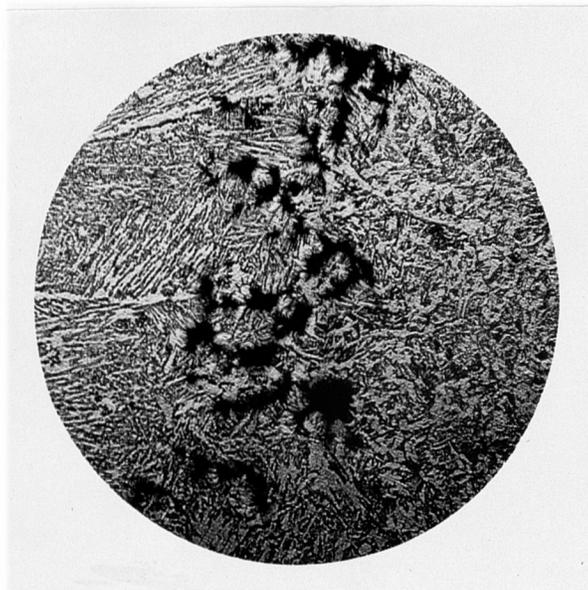
Fig. 16.

II D-4. S. A. E. No. 4130.

The right-hand portion is the base metal while the left-hand portion is the weld metal. The grain size of the weld is far greater than the grain size of the base metal. This was probably due to the weld metal being heated to a higher temperature than was really necessary. The chromium and molybdenum seems to have been well transferred into the weld metal. Pearlitic or sorbitic areas appear at the lower edge of the large grain at the left side of the weld metal. The grains of the matrix are ferrite. A very large

slag inclusion exists throughout the central portion of the weld metal as well as the base metal. This could no doubt have been removed to a considerable extent by puddling and working the molten metal by the filler rod. This would have caused the slag to have floated to the surface of the weld where it would have been harmless.

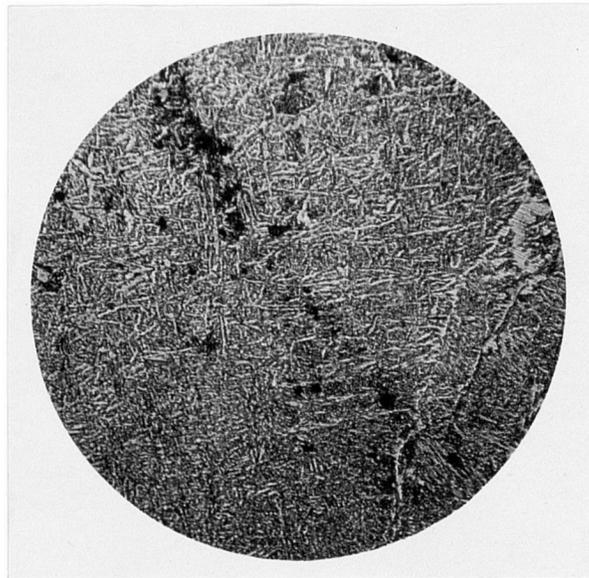
Fig. 17.

II D-1. S. A. E. No. 4130.

The base metal is the portion to the right of the slag
inclusion while the weld metal is the portion to the left.

Grain growth has not taken place to any appreciable extent. The slag inclusions form a line at the juncture of the base metal and the weld metal. This will cause an inherently weak line passing directly through the weld. This slag inclusion could have probably been eliminated to a great extent by puddling the molten metal a longer time, but this would also have caused considerable grain growth. On the lower right side of the photomicrograph is found two very pronounced slip lines due to cooling, passing across both the base metal and the weld metal.

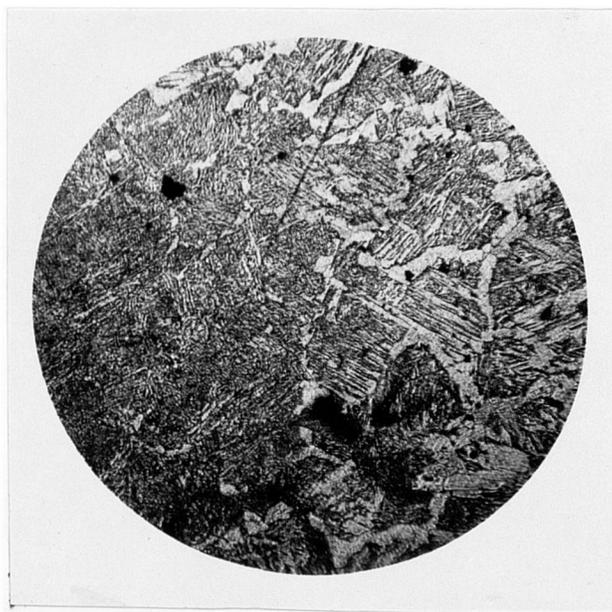
Fig. 18.

II D-1. S. A. E. No. 4130.

Photomicrograph Taken at the Juncture of the Weld.

The left portion is the base metal while the right portion is the weld metal. The chromium and molybdenum does not seem to have been transferred into the weld metal to the extent it should have. This weld was apparently well puddled for most of the slag inclusions have been removed. The grains of the weld metal are much larger than those of the base metal. The grain structure of the weld metal is identical with the grain structure of cast steel. The grains are a matrix of free ferrite. The grains are composed of pearlite, the dark lines of the pearlite being ferrite while the light lines are cementite which is also called iron carbide.

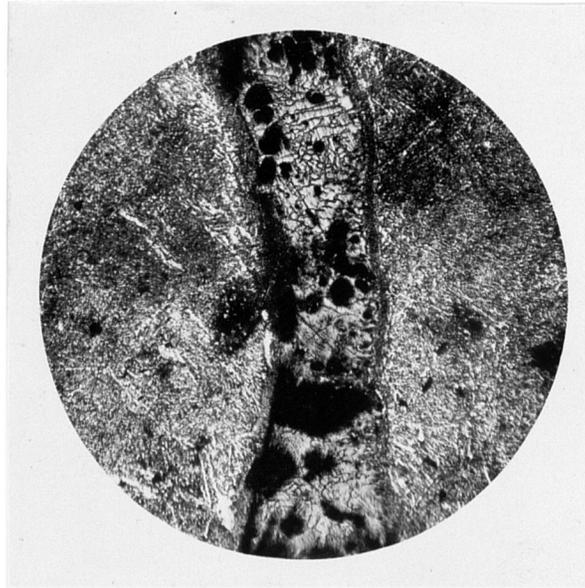
Fig. 19.

V E-1. S. A. E. No. 4130.

Photomicrograph Showing the Ends of the Tubing and
Apparently No Fusion Has Taken Place

The molten filler rod has been cast between the ends of the cold base metal. An excessive amount of slag has been carried down with the molten filler rod. Much of this foreign material appearing in the weld may be dirt, rust and scale which was on the base metal or filler rod. It is very essential that all scale, rust and dirt be removed from both the base metal and the filler rod for they have a very pronounced injurious effect upon the quality of the weld.

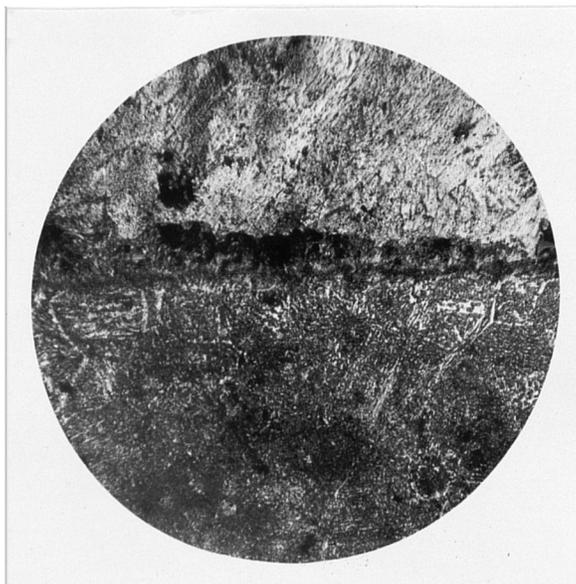
Fig. 20.

V E-2. S. A. E. No. 4130.

Photomicrograph Showing Poor Fusion

This weld on the outside appeared apparently perfect. However, the photomicrograph reveals that the weld metal and the base metal in this section has not fused in the least. The upper portion is the weld metal while the lower portion is the base metal. This section was taken near the outer edge of the bead. The slag was undoubtedly the scale and foreign matter which was on the base metal before welding.
