EVALUATION OF DIFFERENT SAFETY ASPECTS OF CENTERLINE RUMBLE STRIPS

A THESIS

Department of Industrial Engineering  
College of Engineering

KANSAS STATE UNIVERSITY  
Manhattan, Kansas

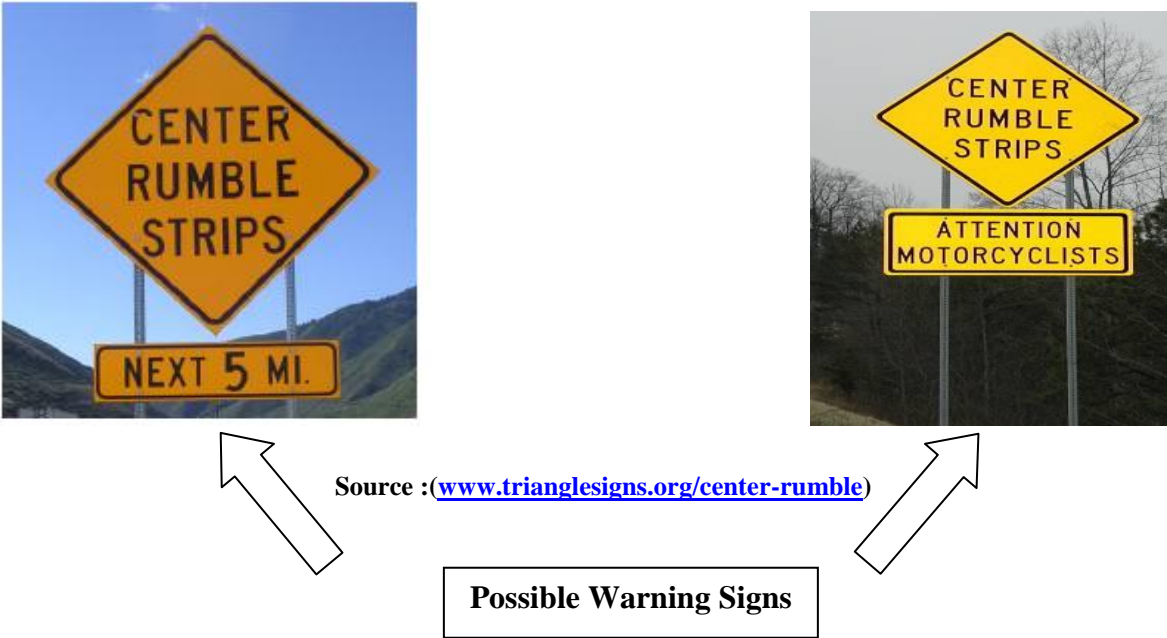
Figure 3.16 Possible Warning Signs

Future research should be focused in conducting field studies on undivided highways with CLRS for evaluating the erratic maneuvers which riders may face when they traverse CLRS. Also studies should be conducted on the need for providing warning signs before riders approach highways having centerline rumble strips. Warning signs like "Centerline Rumble Strips Ahead" (see Figure 3.16) would warn the rider of the upcoming situation. This should reduce any unexpected reactions when they encounter centerline rumble strips.

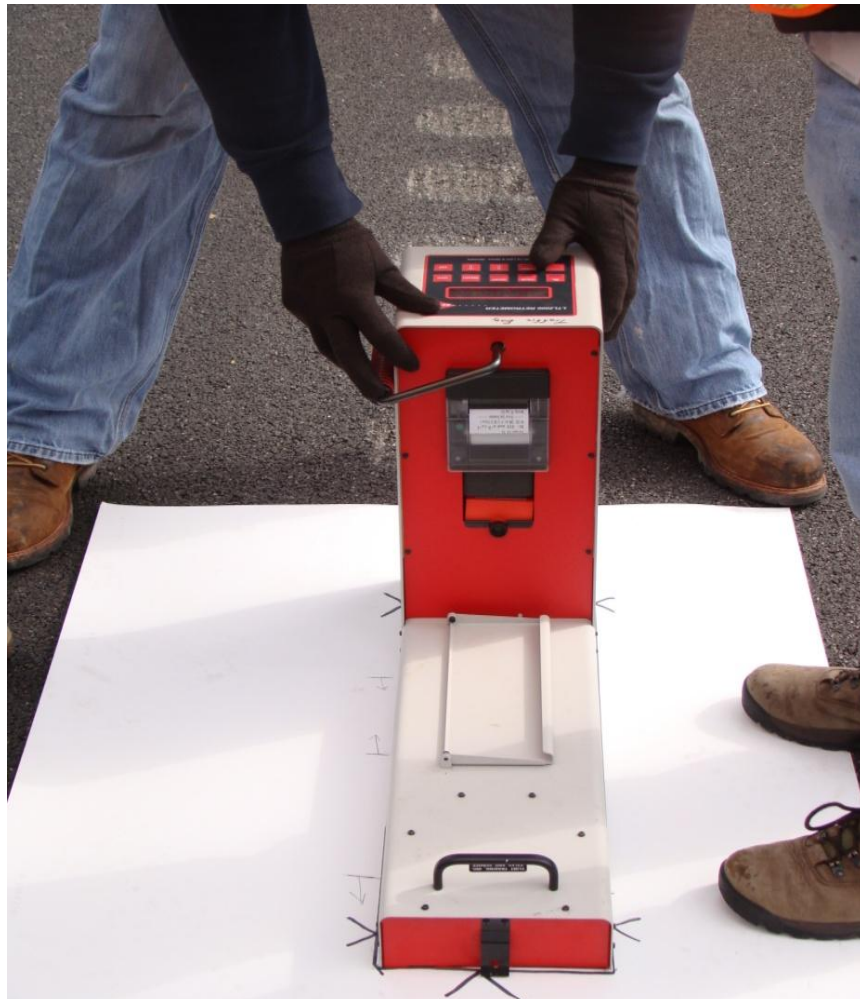
For taking wet RRPM measurements water was poured into the depression of rumble strip (See Figure 5.6) in such a way that the depression is filled up to approximately eighty percent. Water is not filled up to the pavement ground level because doing so will interfere with the reading head of reflectometer.

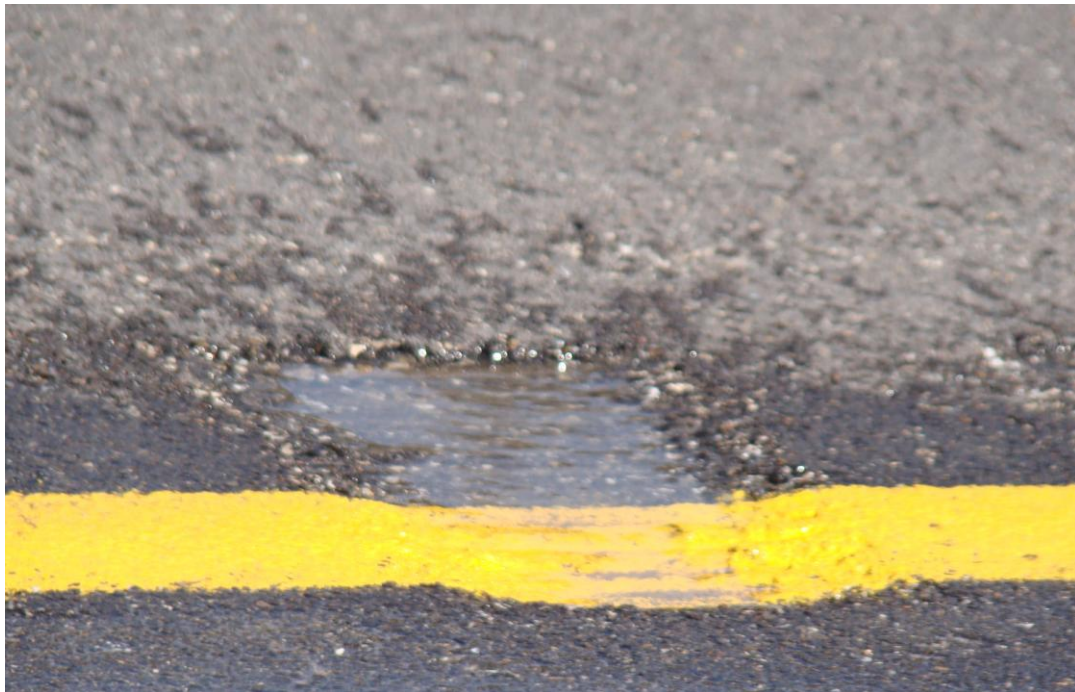
**Figure 5.6 Wetting rumble depression up to approximately eighty percent.**

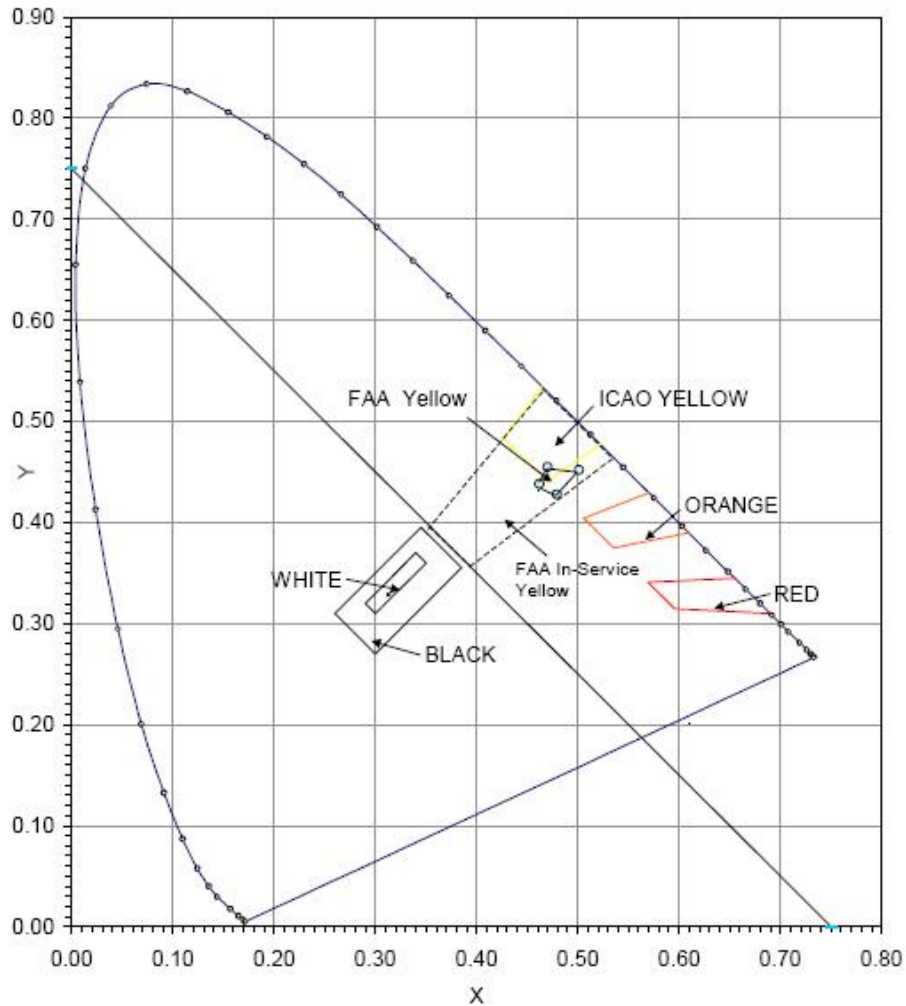
For taking readings, the device is kept at a distance of approximately two inches and aimed at the pavement marking in the rumble strip groove. Chromaticity measurements were taken on all study locations with CLRS. Measurements were taken at the center of all rumble depressions on the entire stretch of RRPM of 7 feet 7 inches length. These reading were plotted on the CIE standard

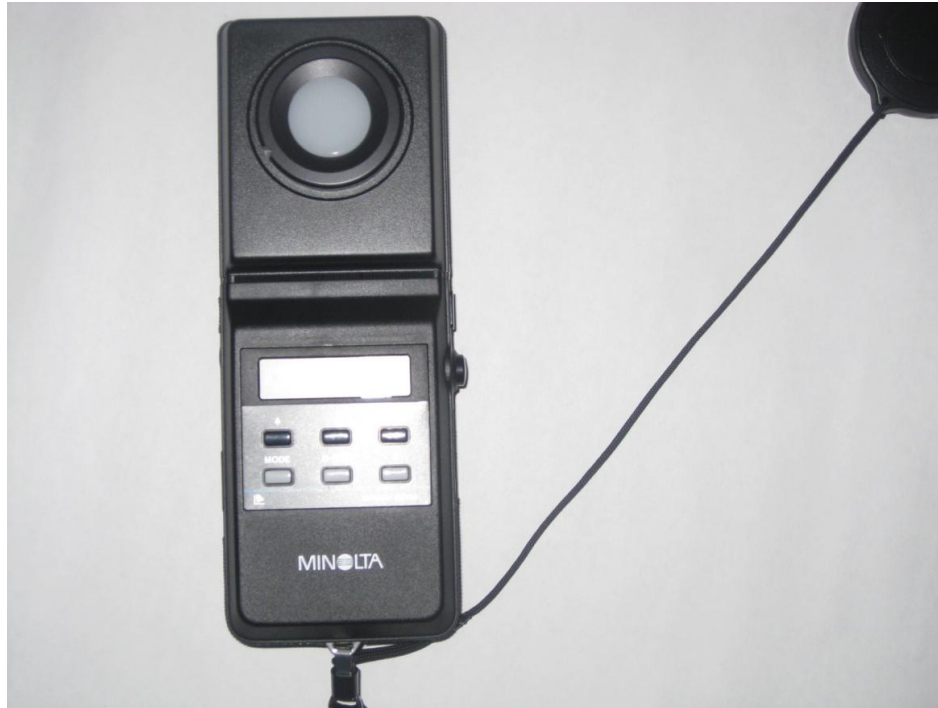
The international board that sets color standards is the International Commission of Illumination (CIE) (Cyrus 2006 & 2007) developed the methodology for describing the color in a numerical system that is based upon a standard observer. A standard observer is defined as a small group of individuals (about 20-30) that have normal, human color vision. This technique matches color to an equivalent red, green and blue (RGB) tristimulus value. Here chromaticity is expressed in terms of a coordinate system adopted by the CIE. The methodology reduces the spectral emission characteristics of a source to a three letter designation with associated numbers. The CIE units discussed here are CIE Yxy. Where Y is the absolute measure of the visual luminance of the source and x and y are the coordinates. Here chromaticity evaluation was performed by using spectrophotometer. Minolta CL-100 spectrophotometer (shown in Figure 5.8) was used for

**Figure 5.8 Minolta CL 100 spectrophotometer.**

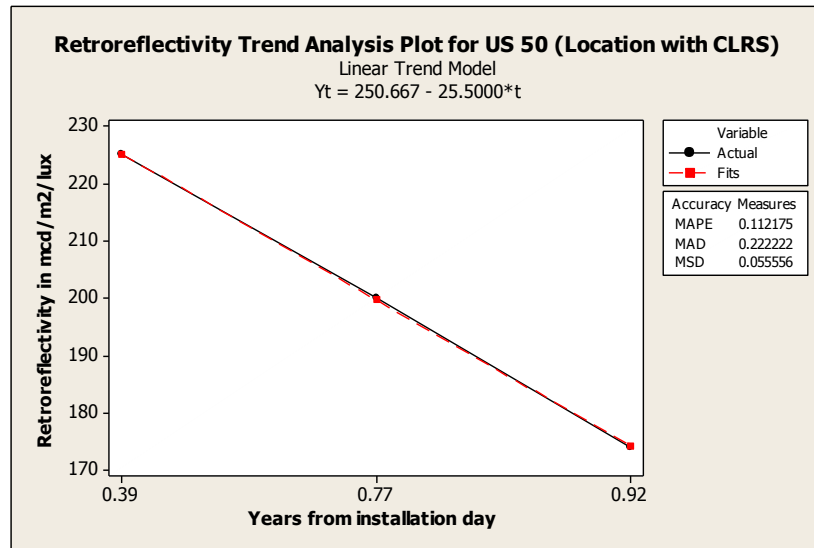
From trend analysis model and Figure 5.16 it can be seen that there is perfect linear (MAPE = 0.112) reduction in retroreflectivity in the location with CLRS. Figure 5.17 shows that there is a non-linear reduction in retroreflectivity in the location without CLRS.

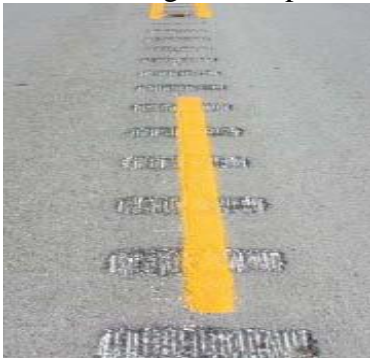
Rectangular Shaped

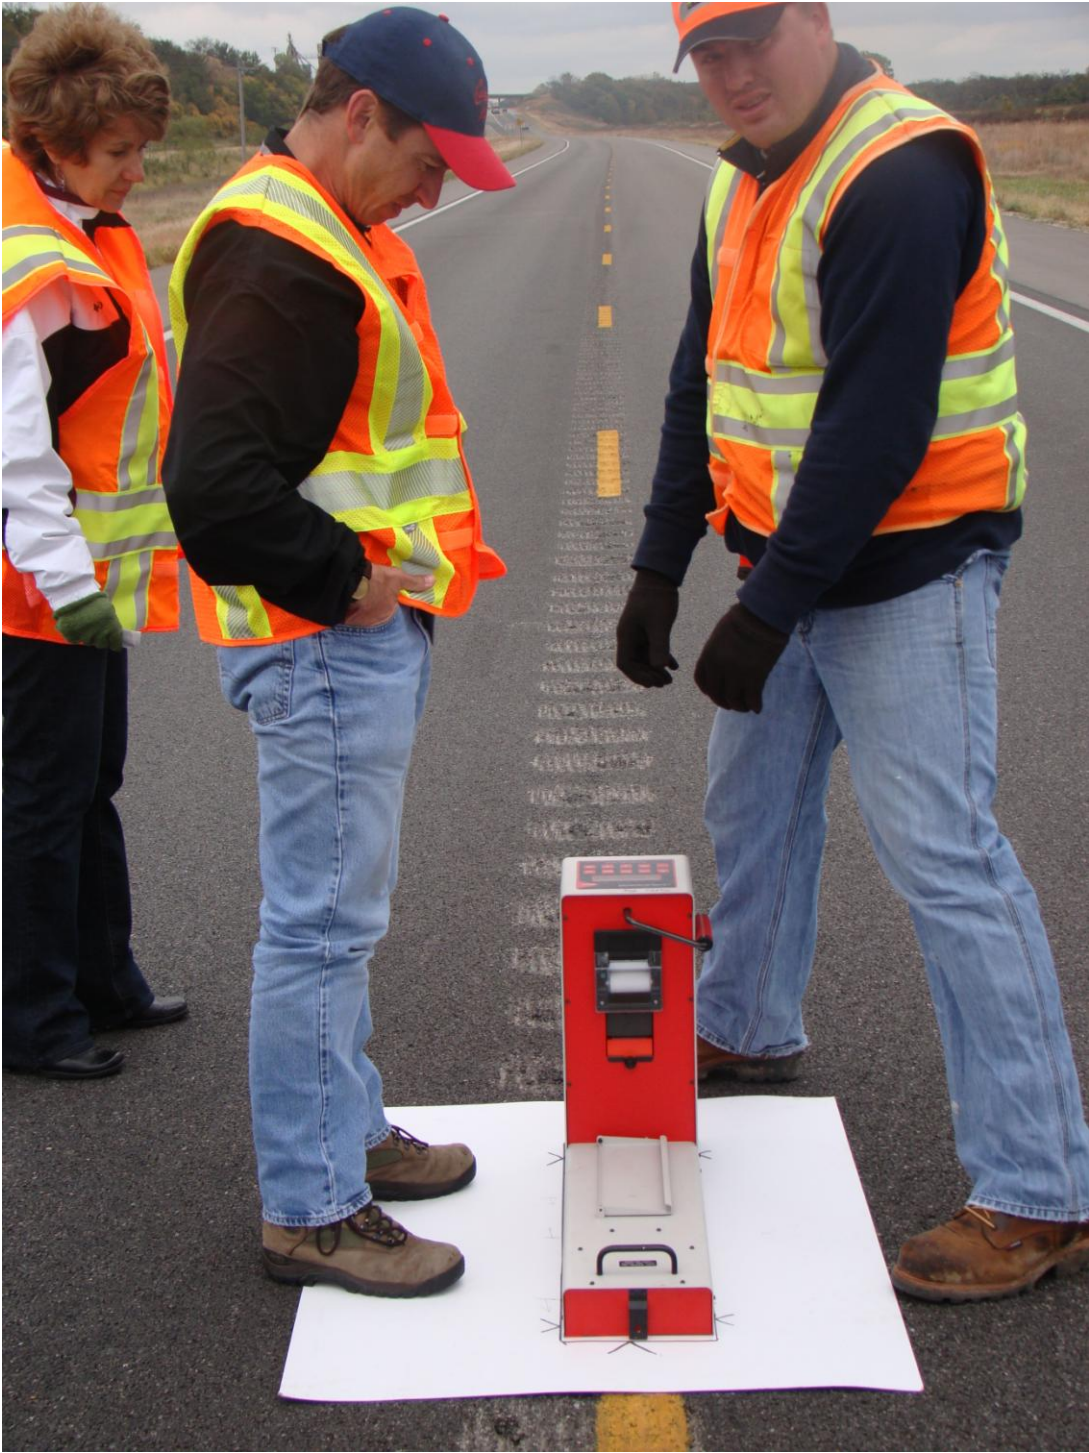
**Figure D.1 Taking retroreflective measurements over CLRS on US 50**

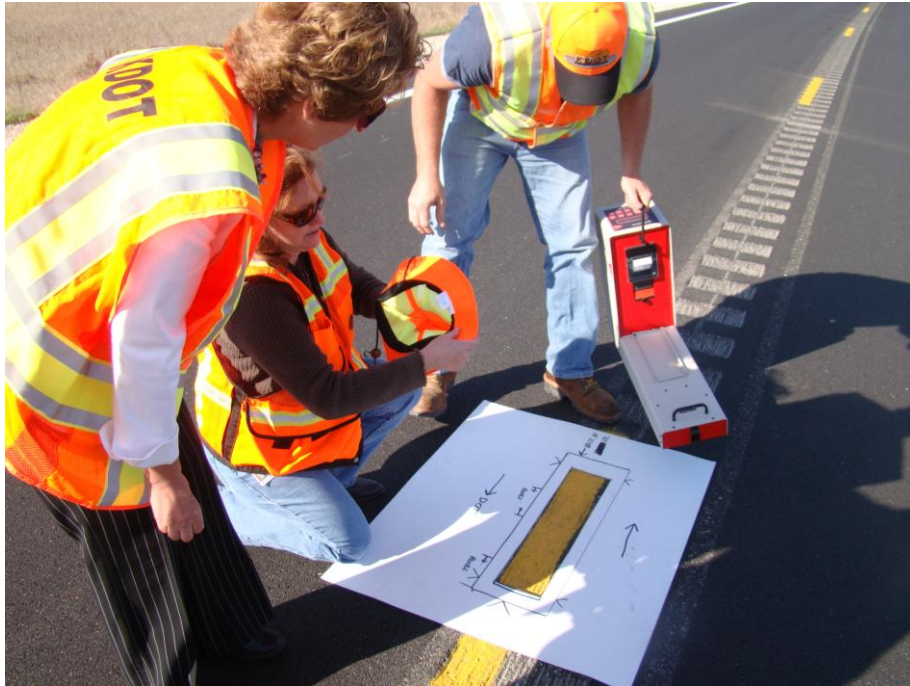
**Figure D.2 Taking retroreflective measurements over CLRS on US 24**

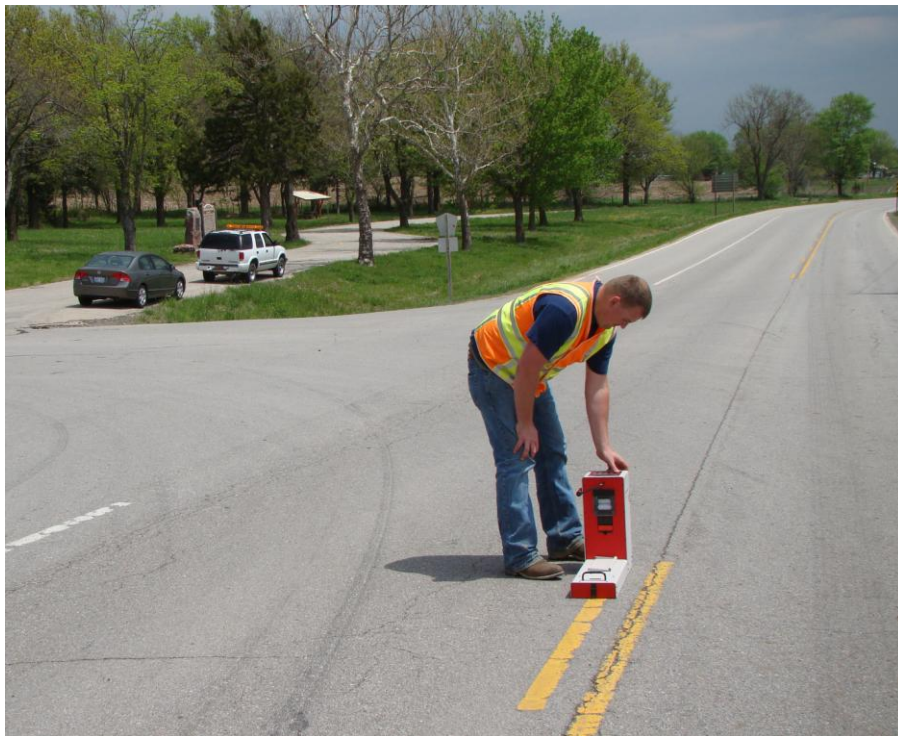
**Figure D.3 Taking retroreflective measurements in location without CLRS on US 40**

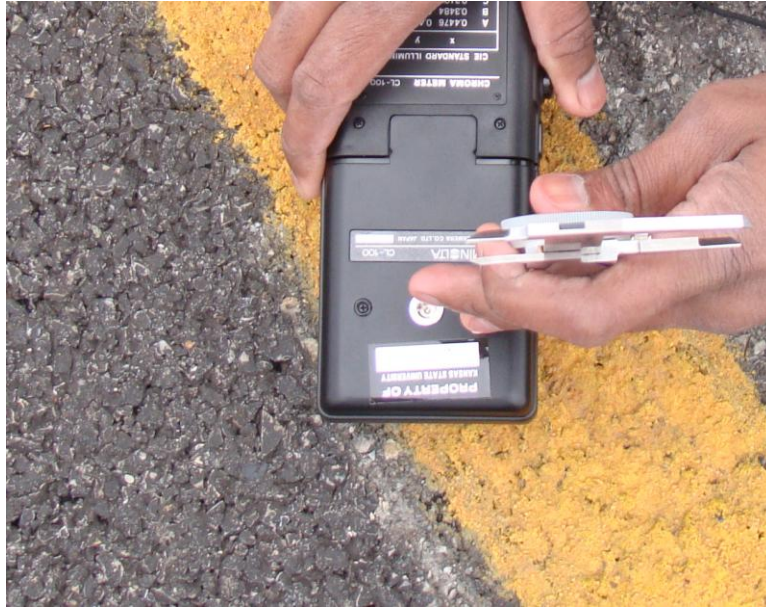
**Figure D.4 Taking spectrometry measurements of RRPM over CLRS**

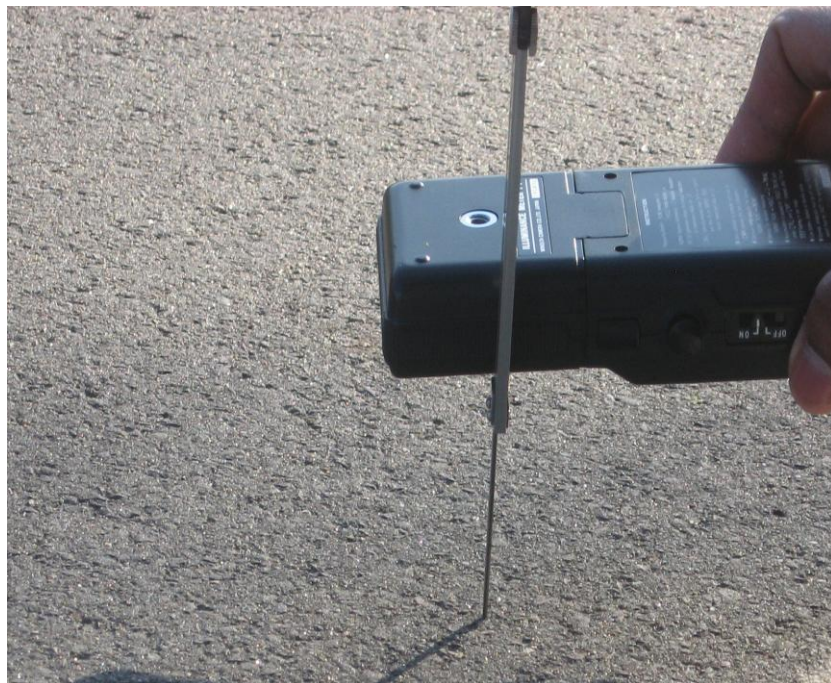
**Figure D.5 Keeping spectrometers' reading head at approximately 2 in above the pavement surface**
