A STUDY OF ASPHALT BRIDGE PLANK

A THESIS

KANSAS STATE COLLEGE
OF AGRICULTURE AND APPLIED SCIENCE

1933

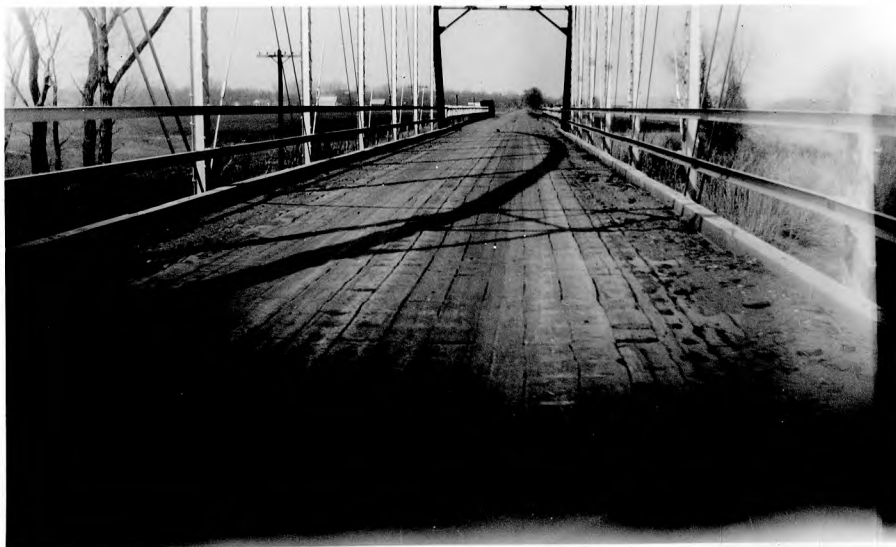
Fig. 3. Asphalt Plank Bridge Floor in Poor Condition.

Figure 3 shows the floor of the first bridge inspected. It will be observed that the floor is badly cut up. It has been in this undesirable condition since about one month after installation. The plank has also shrunk, as is shown by the wide cracks between the joints. The fact that the highway on which this bridge is located is gravelled is responsible, in part, for the poor condition of the surface. Gravel, working its way down into the cracks and lodging between the sub-floor and the planks, causes them to buckle and warp. The accumulations of gravel near the edge of the roadway and the wide cracks can be seen better in Figure 4. This surface has been subjected to heavy

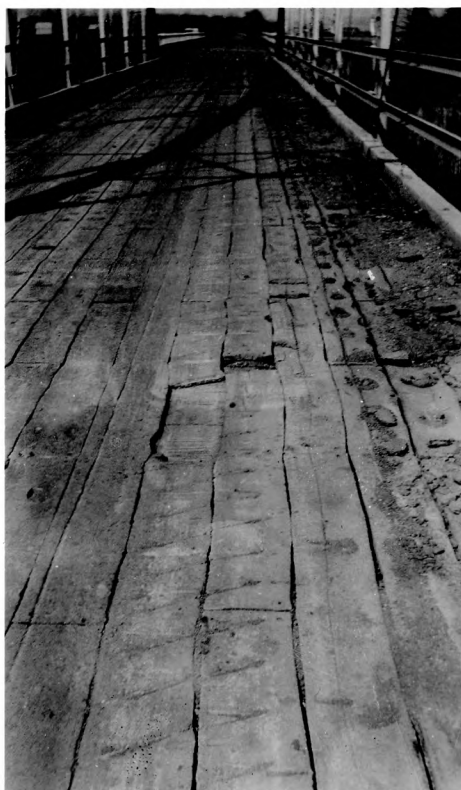
Fig. 4. Failure and Buckling of Asphalt Bridge Plank Floor.

traffic, including many tractors with lugs which, together with the poor maintenance, has practically ruined the surface. The sub-floor of the bridge has been found to be in good condition.

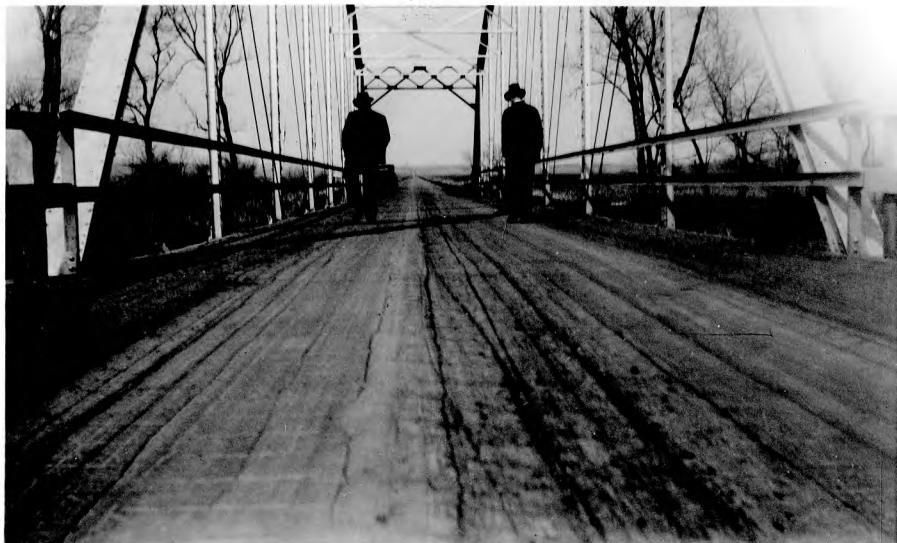
Fig. 5. Bridge Floor Laid in 1930 in Fair Condition.

first one. Figure 5 shows this surface. It was observed that where sand and gravel had been permitted to remain on the floor, buckling and cracks had begun to develop. This floor had received better maintenance than the first one. Wooden planks are kept at the bridge to be used for mutilative traffic. As a whole the floor is in a satisfactory condition and no doubt will give many years of service in the future.

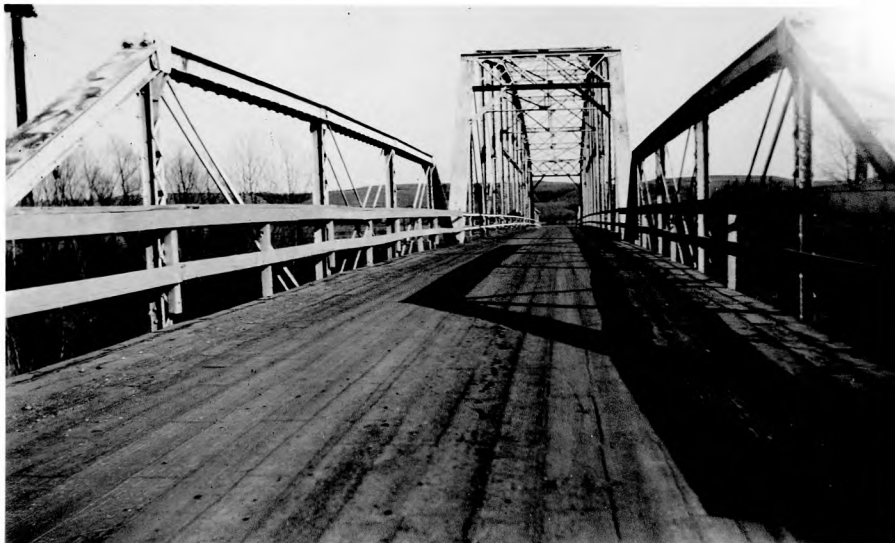
The bridge spanning the Blue River at Randolph, Kansas was the third surface examined. It is shown in Figure 6. This surface was in good condition. The planks in the floor were well knitted together as a result of the traffic,

Fig. 6. Asphalt Plank Bridge Floor in Good Condition.

which fact indicates that non-mutilative traffic is highly beneficial to asphalt plank surfaces. Near the edges of the bridge roadway some sand and gravel had been permitted to collect, which as in the other cases, had caused warping and buckling of the planks in that region. Because of this condition it appears that a seal coat of asphalt would be advantageous if used near the edges of the bridge. Another type of construction which might prove satisfactory would be to use wood plank near the edges.

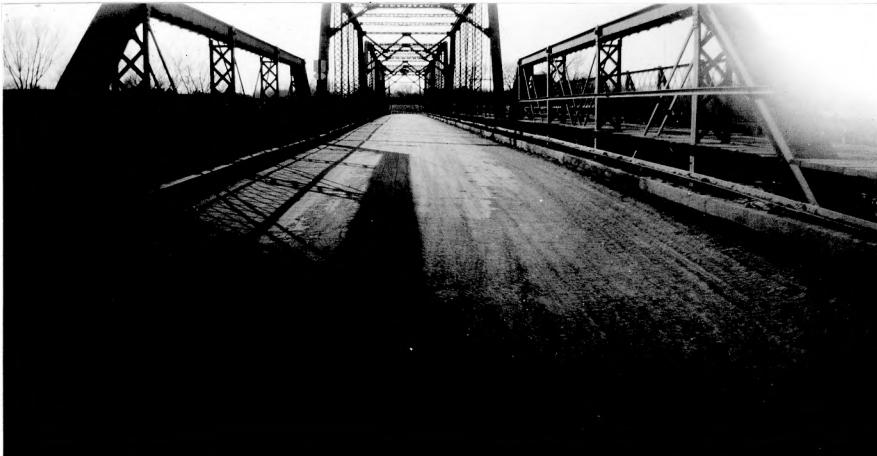
Fig. 7. Asphalt Bridge Floor Laid in 1928 in Excellent Condition.

A second inspection trip was made to the bridge across the Kansas River east of Manhattan, Kansas on Highway No. 13. This bridge was surfaced during the months of October and November, 1928. The surface is of $1\frac{1}{2}$ -inch planks, 8 inches in width and 6 feet in length of the brand designated as "A". A considerable amount of heavy traffic passes over this bridge, yet its surface is in excellent condition. The traffic marks which show the flexibility of the planks are evident. A picture of the surface is shown in Figure 7. This is an example of an ideal asphalt plank bridge floor. Tests results of the plank are given below the figure.

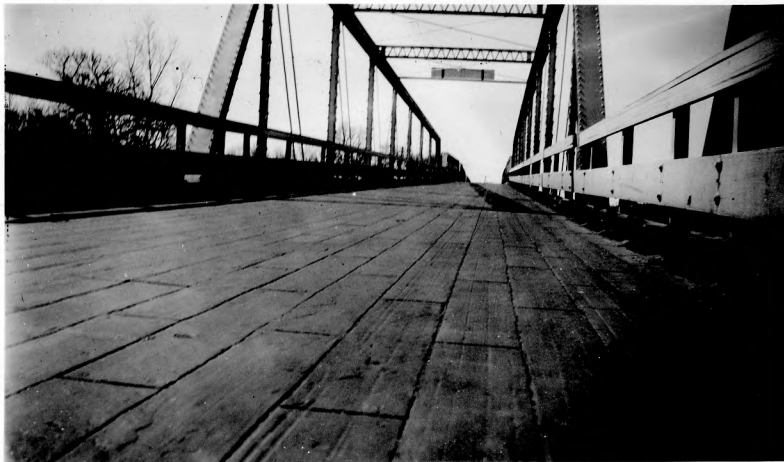
That the action of the traffic had not knitted the adjacent planks together is well shown in Figure 8. The reason is that the planks are very hard and brittle. Although the surface appears to be in good condition, close inspection shows that approximately one-third of the planks have cracked from the nails to the edge of the plank. A few such failures may be seen in Figure 8. Improper application undoubtedly is responsible for these failures. In some places cracks had developed across the entire surface of the bridge. It is believed that such cracks were caused by irregularities in the sub-floor or by failure of some of the planks in the sub-floor. It is also quite possible that many of the failures of the planks were caused by the planks themselves becoming loose and whipping. Figure 9 shows another view of this surface. The failure due to weaknesses in the sub-floor is apparent.

Fig. 8. Asphalt Plank Bridge Floor Showing Traffic Marks Indicating That the Planks are too Hard.

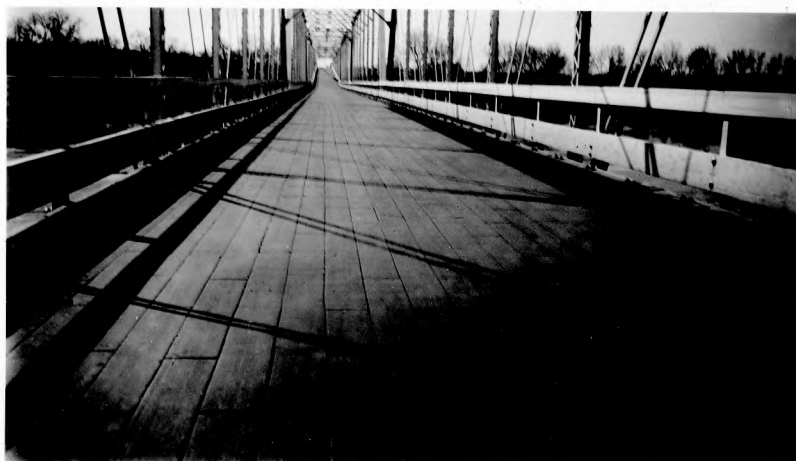
Fig. 9. Failure of Asphalt Bridge Plank Over Loose Sub-Floor. Note Shrinkage Cracks.

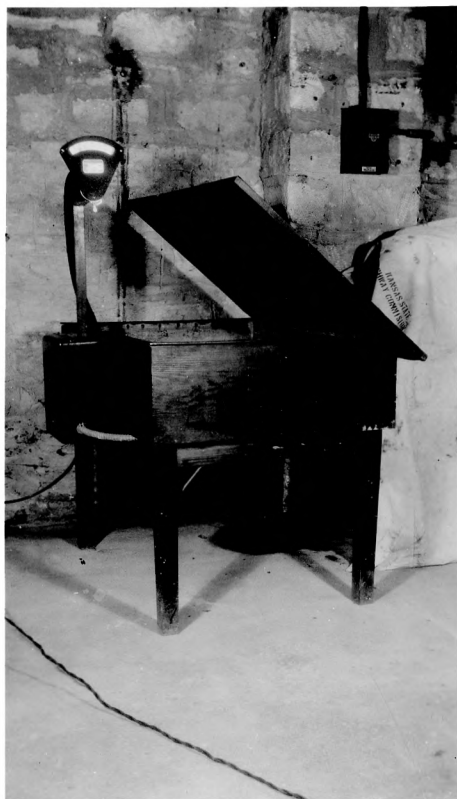
Two 2"x6" specimens of each brand and thickness, with all four edges freshly cut, were cleaned and weighed to the nearest 1/4 gram. They were then immersed in a water bath and maintained at a temperature of 77° F. for 24 hours. The constant temperature bath used is illustrated in Figure 11. The temperature is kept constant by means of a thermostatically controlled electric heater. A heavy galvanized two-mesh screen wire in the bottom of the bath, on which the specimens rest, permits their entire surfaces to be in contact with the water at all times. At the end of the 24-hour period the specimens were removed, wiped

Fig. 11. Electrically Controlled Constant Temperature Bath.

135° F. Each specimen was immersed in the water bath (Figure 11) at the required temperature for 5 hours. It was then placed in the center of the bottom of the portable bath. The steel plunger was placed in the center of the specimen and the head of the testing machine was run down until the balancing beam, previously set at zero, touched the upper bar of the beam-gate. The dial was then set at

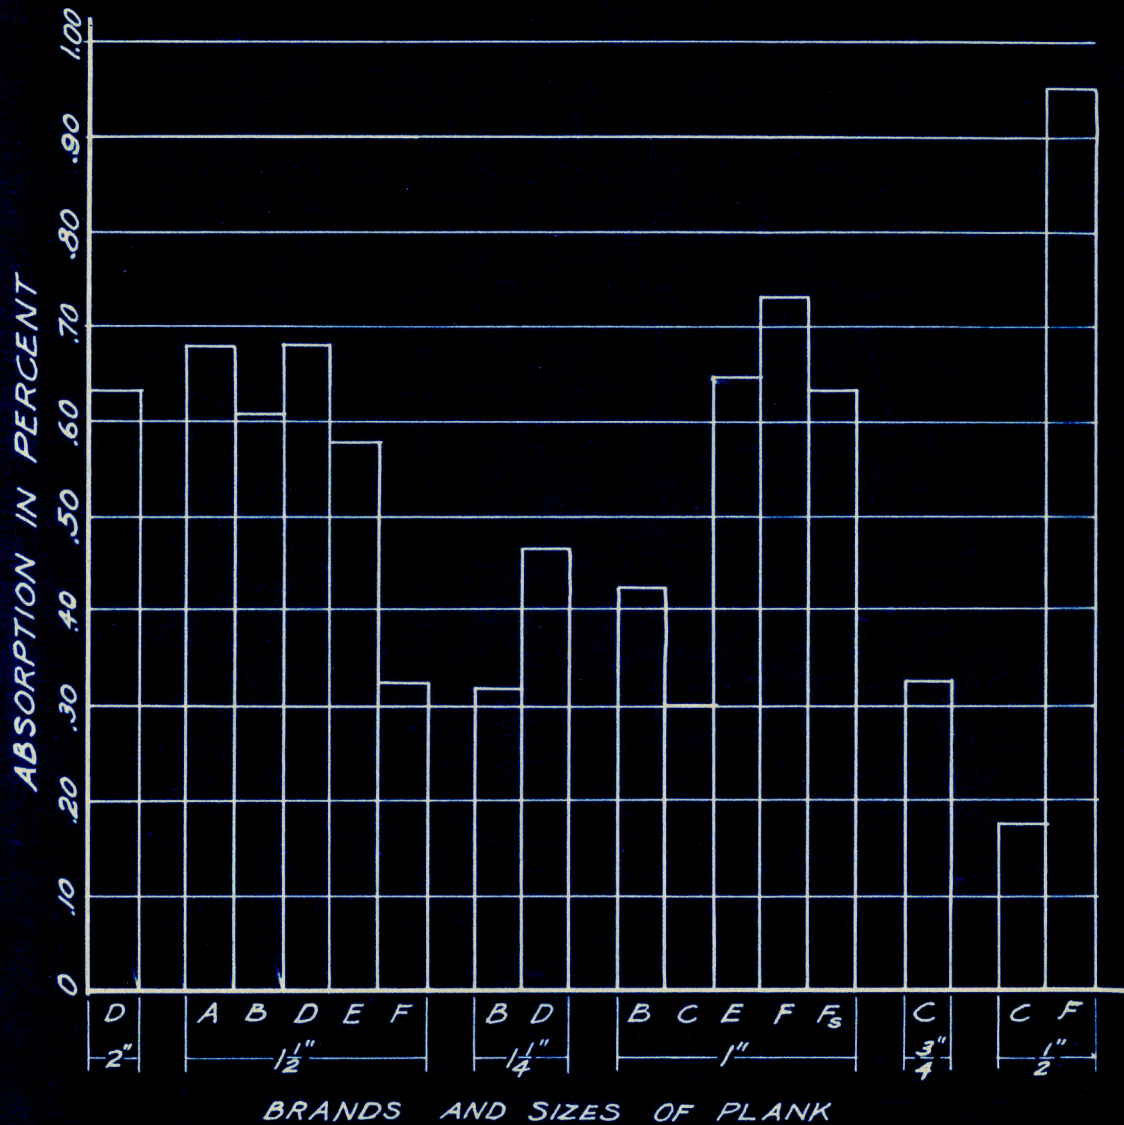
Fig. 13

Figure 13 shows a graph of the percents of absorption for the various brands and sizes of planks tested. It will be observed that the absorption in all cases is small, but there is no consistency between the absorption of the different sizes of the same brands.

ABSORPTION OF ASPHALT BRIDGE PLANK

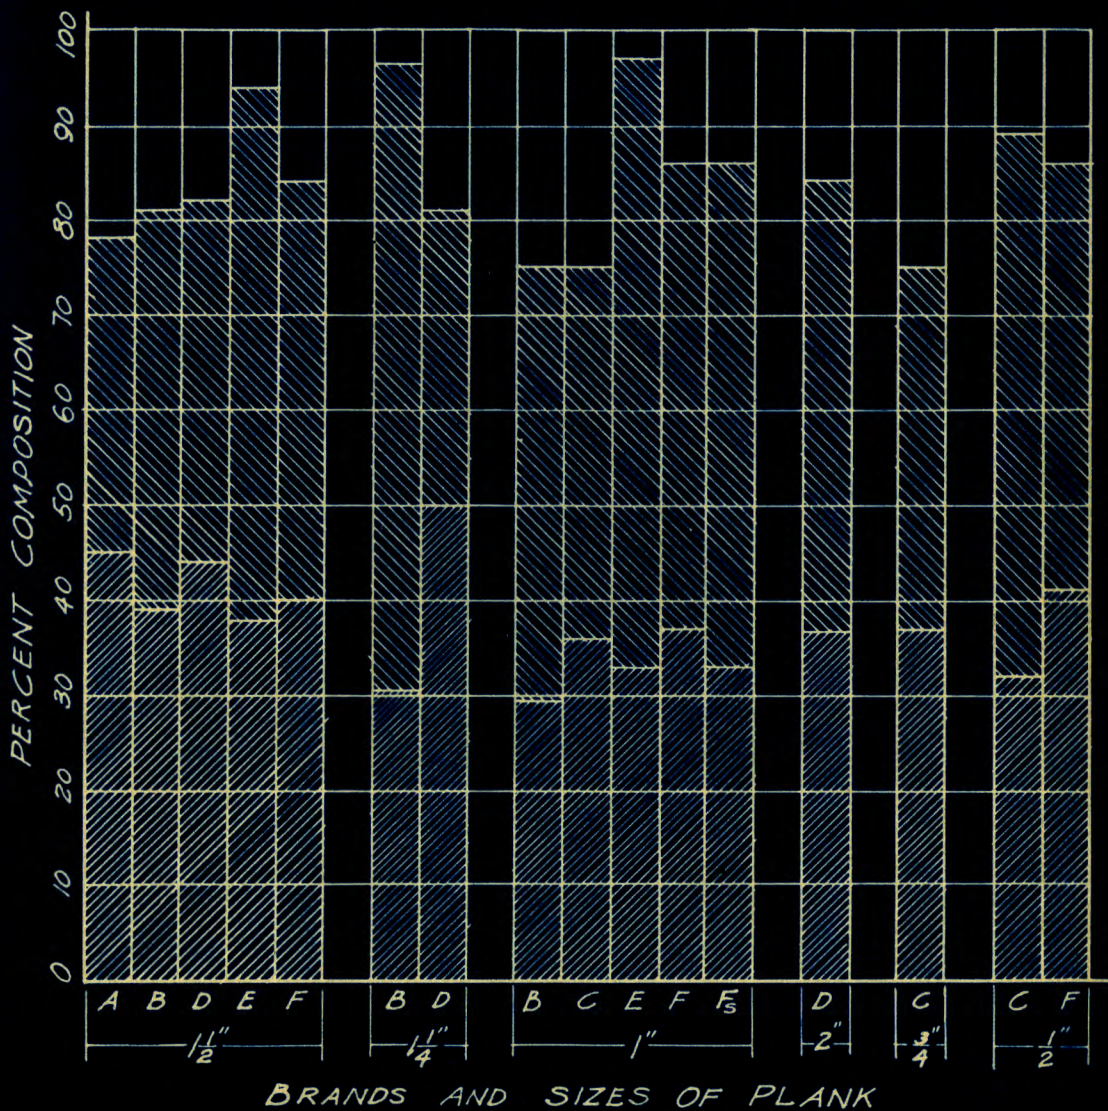
Fig. 17

FELT

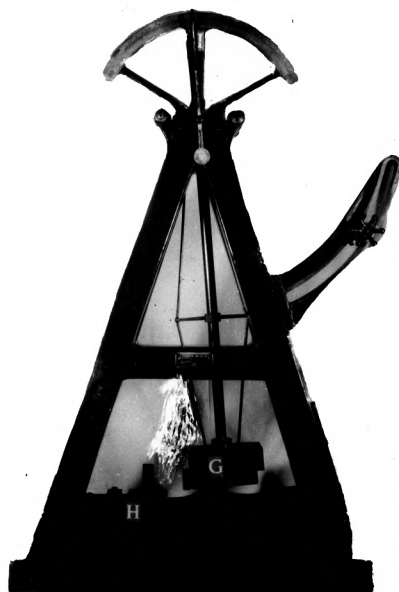
Fig. 18. Machine for Making Impact Tests.

Five specimens of each brand and thickness* were tested. The specimens were immersed in the water bath and kept at a temperature of 77° F. for 24 hours. They were then removed and each specimen firmly clamped in the impact machine at H with the grain vertical. The pendulum

G was then raised until the pointer could be set at 60 on the scale I. It was next released and the reading taken on the scale. The broken specimen was then removed from the machine. The readings taken were subtracted from 60 to get the impact absorbed in breaking the specimens and the average was taken for each group. Marked variations were observed between the amounts of energy absorbed in breaking different samples of the same brand and size. In some cases this variation was as great as 10 foot pounds. It was thought that this variation might have been due to inaccuracy in cutting the specimens. Consequently the widths of all of the broken specimens were measured and found to vary as much as 1/4-inch in a few cases. However, the results showed that there was no relation between the variation in the width of the sample and the impact absorbed up to this amount. It is evident, then, that the planks tested lacked uniformity.

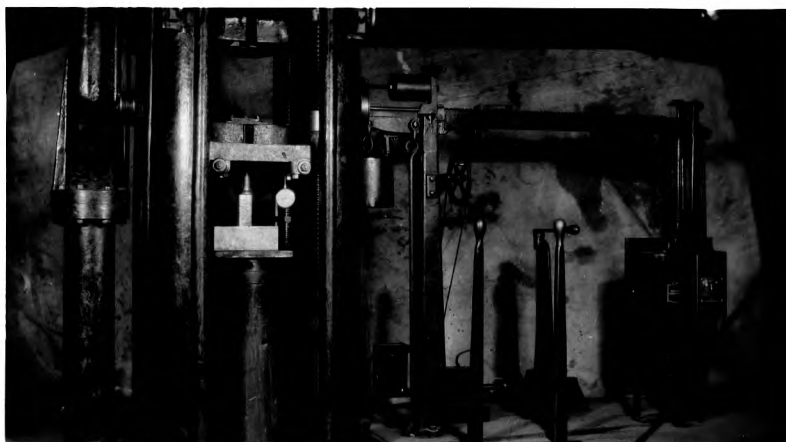
The compression-shear test is an indicator of the resistance of the material to displacement. The method used in making this test followed quite closely the recommendations of the Philip Carey Company. A 200,000-pound Olsen screw machine, counterpoised so as to have a maximum capacity of 10,000 pounds, was used for making the tests. With this arrangement it was possible to read loads to the nearest pound. The machine was provided with a special three-inch spherical top bearing attached to the moving head. A flat-faced, machined steel plunger, 6 inches long, with a cross-section 2"x2" was also provided. A constant temperature bath was constructed by soldering heavy galvanized iron, three inches in height, to a 9"x9" steel plate 1/2-inch thick. By means of a plate and a suitable adjustable upright provision was made for attaching the Federal indicating dial, which was used to measure the deformations. Figure 20 shows the apparatus set up for this test.

Fig. 20. Compression-Shear Test.

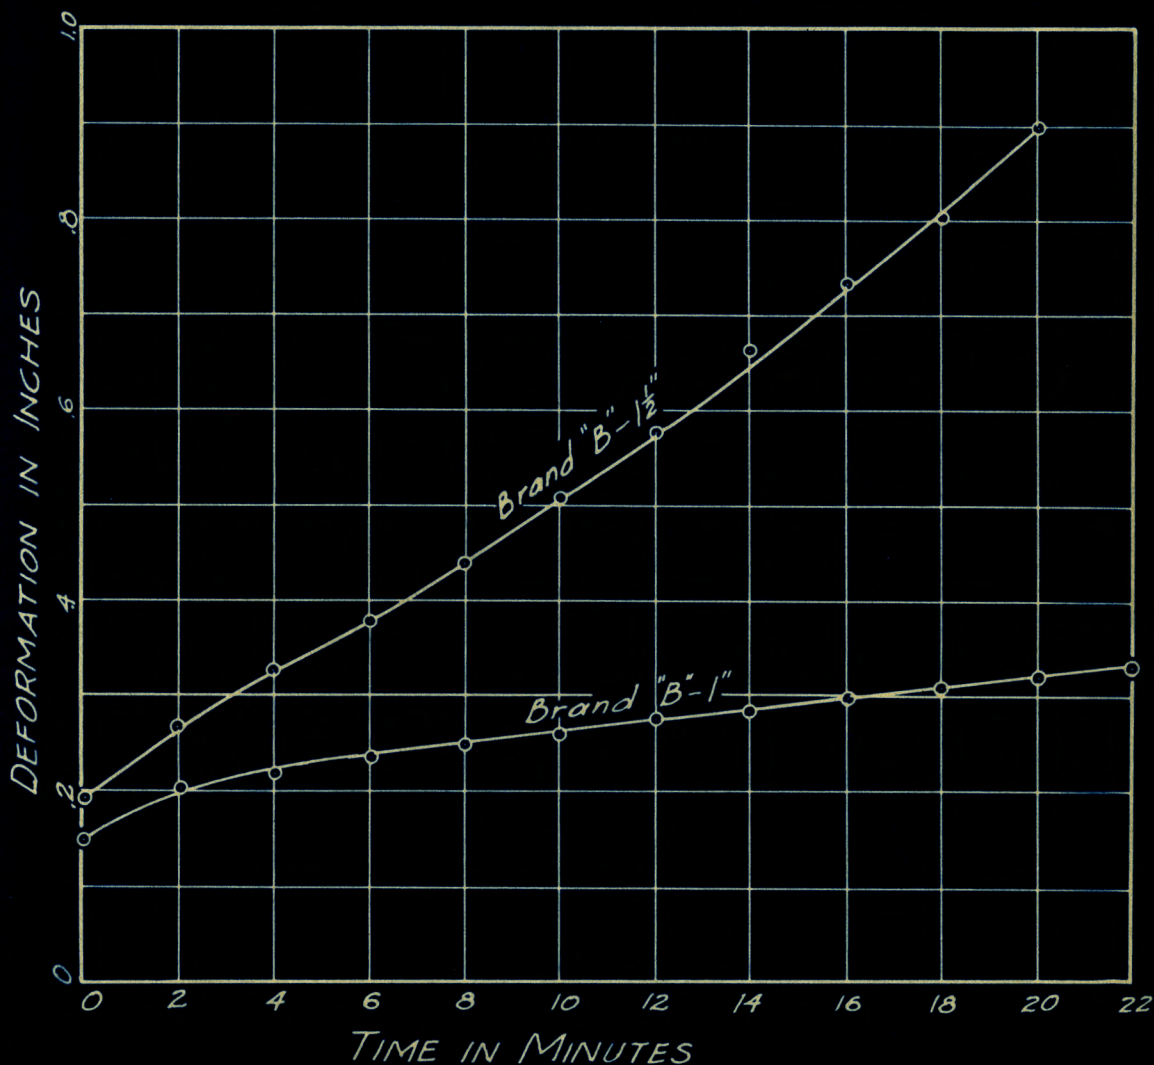
Fig. 22

The curves of Figure 21 and Figure 22 show the rate of deformation for one brand of plank at 77° F. Figure 21 is for the load of 350 pounds per square inch and Figure 22 is for the load of 700 pounds per square inch. Further investigation indicated that all brands gave approximately the same curves. It will be observed that for planks thicker than one inch the deformation increases rapidly with an increase in the length of time which the load is maintained. The one-inch planks hold loads quite well for long periods of time.

RELATION BETWEEN DEFORMATION AND TIME
FOR ASPHALT BRIDGE PLANK

LOAD - 700 LBS./SQ. IN.

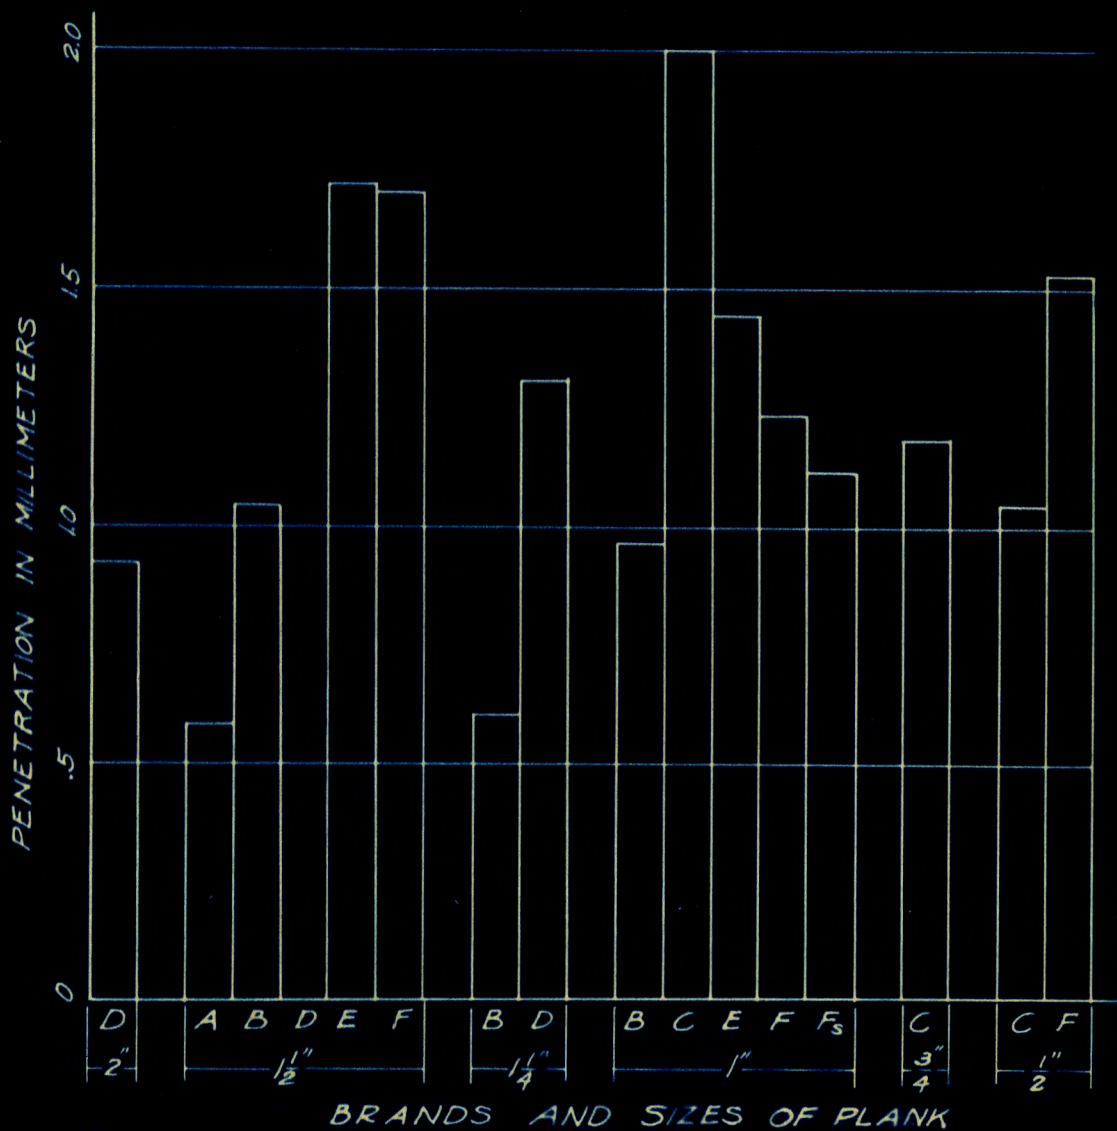
Fig. 26

PENETRATION OF ASPHALT BRIDGE PLANK
AT 135°F
