ANALYZING EFFECTS OF LOW WATER FORDS ON STREAM STABILITY AT
FORT RILEY, KANSAS

A THESIS

Department of Biological and Agricultural Engineering
College of Engineering

KANSAS STATE UNIVERSITY
Manhattan, Kansas

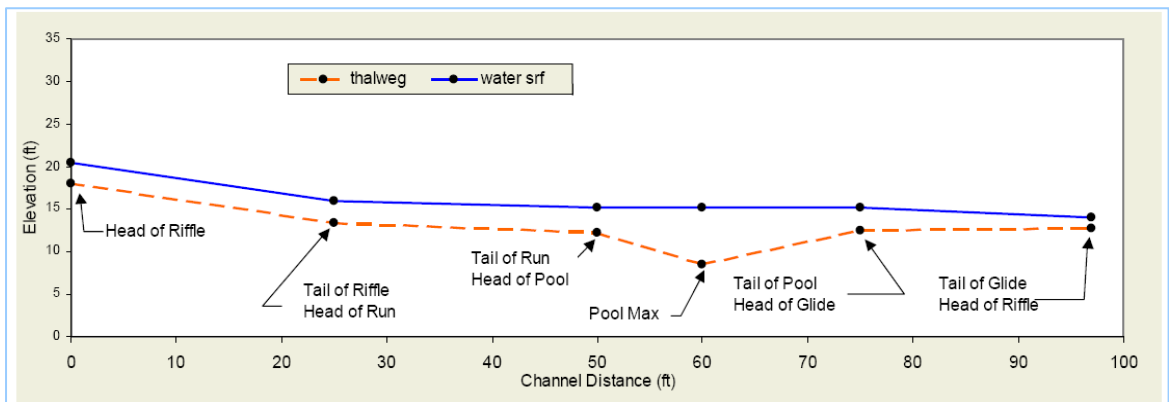
Figure 2-11. Longitudinal profile along a stream reach. Source: Vermont Stream Geomorphic Assessment Handbook, 2003.

A systematic survey of each study reach was performed using conventional survey methods (Harrelson et al., 1994). Longitudinal profile surveys began and ended at riffle crests (head of riffle). Stationing along the longitudinal profile was conducted at 6.1 m intervals or where the stream bed had a change in slope. Sharp changes in channel slope were always observed at transition points (Figure 2-11) between the different stream features (i.e. pool, glide, riffle and run). Pools are generally considered the deepest points within a stream, while riffles are the shallow points. Glides and runs are transition features between pools and riffles. Stream bed, water surface and bankfull elevations were established using a laser level and leveling rod with an attached receiver. Stream bed elevations were taken at the deepest points (thalweg) along each stream reach, while bankfull elevations were taken on the active floodplain. Elevations are based on permanent benchmarks established within each study reach. Selected study reaches were approximately 20-30 bankfull widths long. Morphometric parameters determined from the longitudinal profile survey were: bankfull slope, water surface slope (S), channel

slope and channel sinuosity (K). Bankfull slope was determined as ratio of the difference in bankfull elevation (between the beginning and end point of each study reach), and the length of the study reach. Channel slope was determined as a ratio of the difference in elevation of the channel bed (between the beginning and end point of each study reach) and the length of study reach. Water surface slope was determined as a ratio of the difference in elevation of the water surface (between the beginning and end point of each study reach) and the length of study reach. Channel sinuosity (K) was determined by computing the ratio between stream reach length and valley length. Repeat longitudinal profile surveys of each reach were conducted to quantify changes in stream bed elevation and slope.

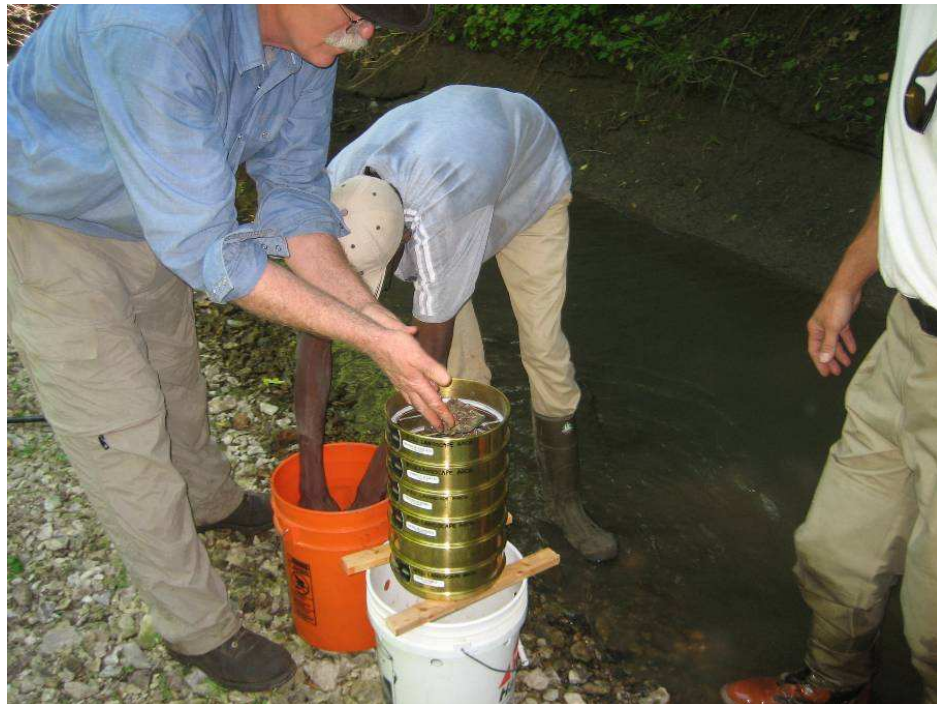
Figure 2-15. Sieve analysis of a bar core sample at Silver Creek, Keats.

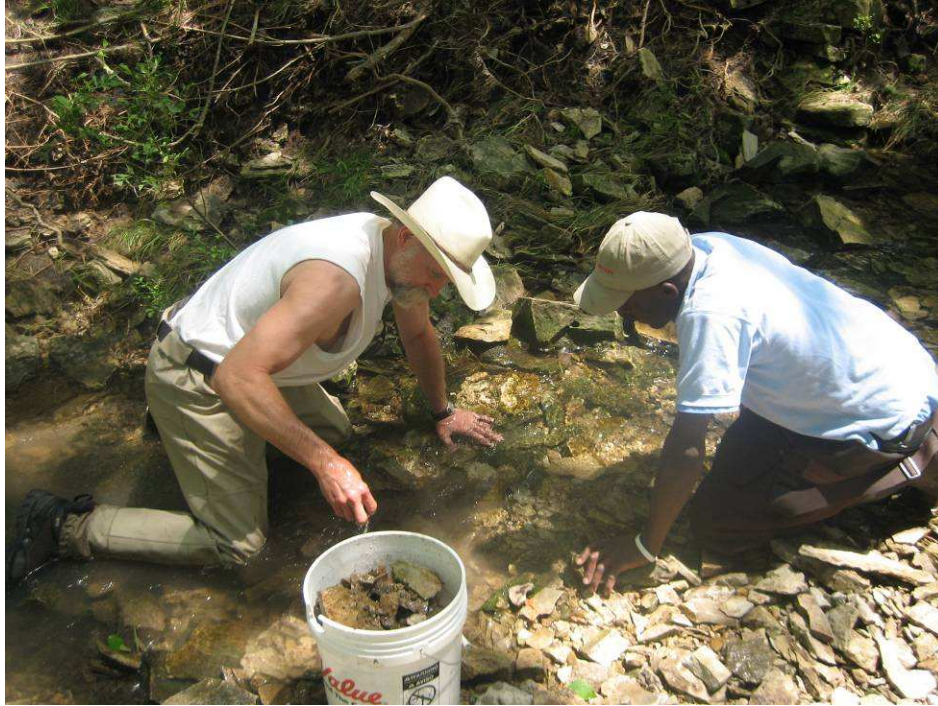
Figure 2-17. Repeat survey of scour chains at Wind Creek upland reach.

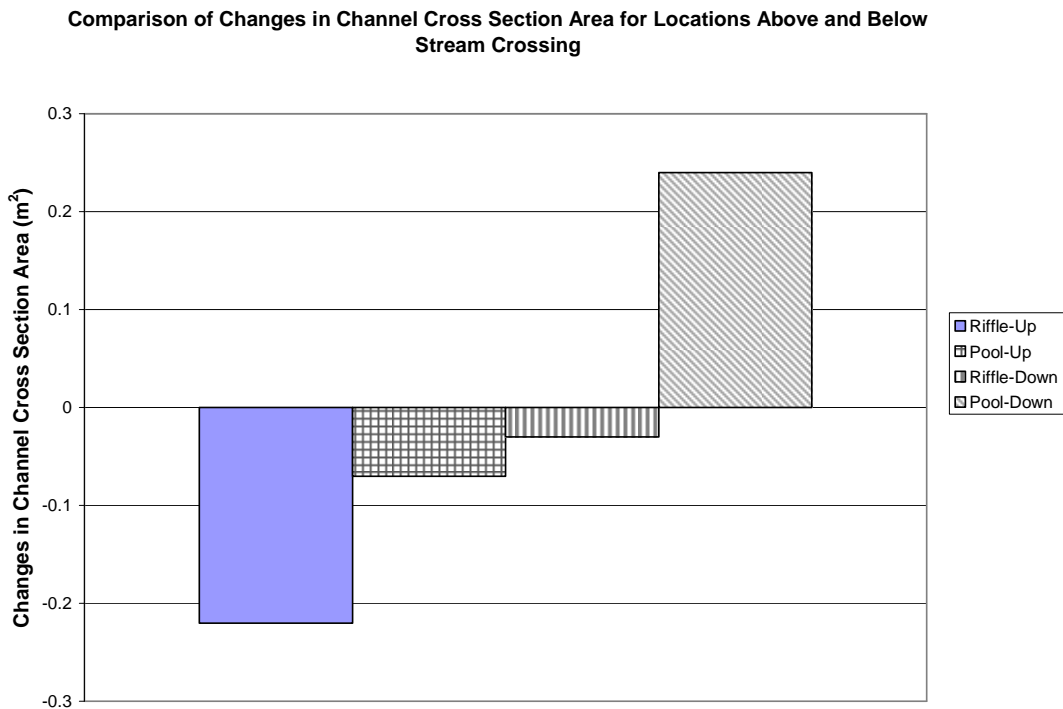
[Negative values indicate fill while positive values indicate scour].

Figure 3-1. A comparison of changes in channel cross section area for cross section transects above and below stream crossing at Farnum Creek.

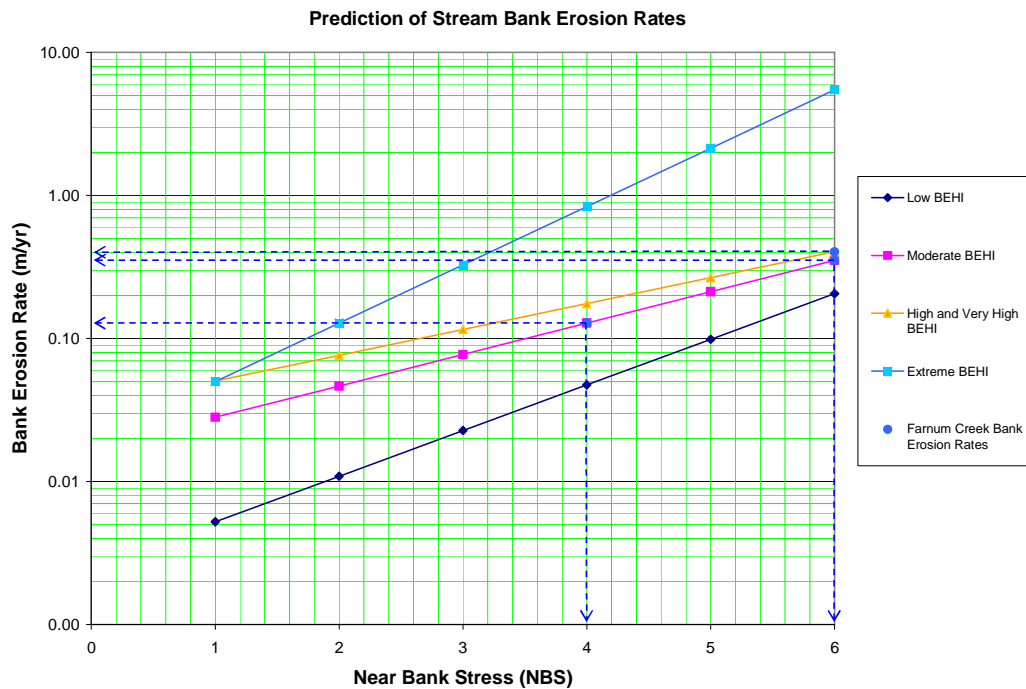
Predicted Annual Bank Erosion Rates (m/yr)	Measured Annual Bank Erosion Rates (m/yr)	Measured Annual Sediment Yield (kg/m/yr)
0.13-0.40	0.07-0.14	200

Figure 3-2. Relationship of BEHI and NBS ratings used to predict annual stream bank erosion rates on Farnum Creek. Adapted after Rosgen (1996 and 2006).

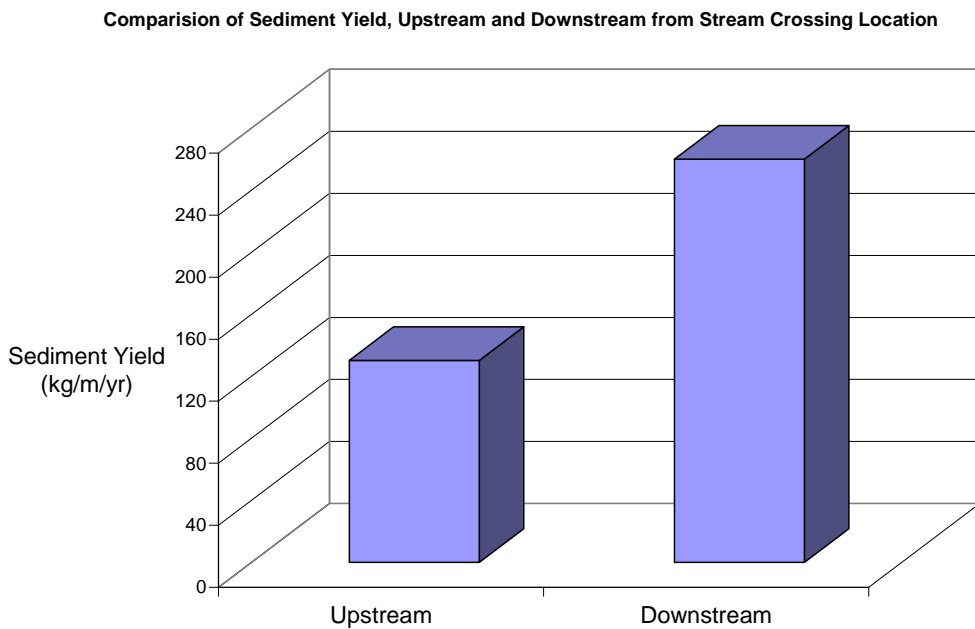
Figure 3-3. A comparison of sediment yield between upstream and downstream locations from stream crossing one at Farnum Creek.

The bank erosion rates (and the sediment yield) on this ephemeral stream are therefore lower than would be expected for a G4c stream. Figure 3-3 shows a comparison of sediment yield generated from segments of the study reach upstream and downstream of stream crossing one at this study reach. It is shown that the sediment yield generated from stream segments below the stream crossing is higher than that generated from stream segments above the stream crossing. Erosion rates generally increase in the downstream direction because discharge (or stream power) increases in the downstream direction. A tributary located immediately above the stream crossing introduces extra discharge and sediment into the main stream at this study reach. In addition, the approach roads to the stream crossing location concentrate and channel runoff (generated from upland areas) into the main stream increasing the magnitude of discharge introduced into the main stream. However, the amount of runoff generated through these roads is still unknown, and additional studies are required to investigate erosion dynamics and hillslope hydrology on these roads. Overall, the increase in discharge (in the downstream direction), among other factors, explains the higher bank erosion rates at locations below the stream crossing.

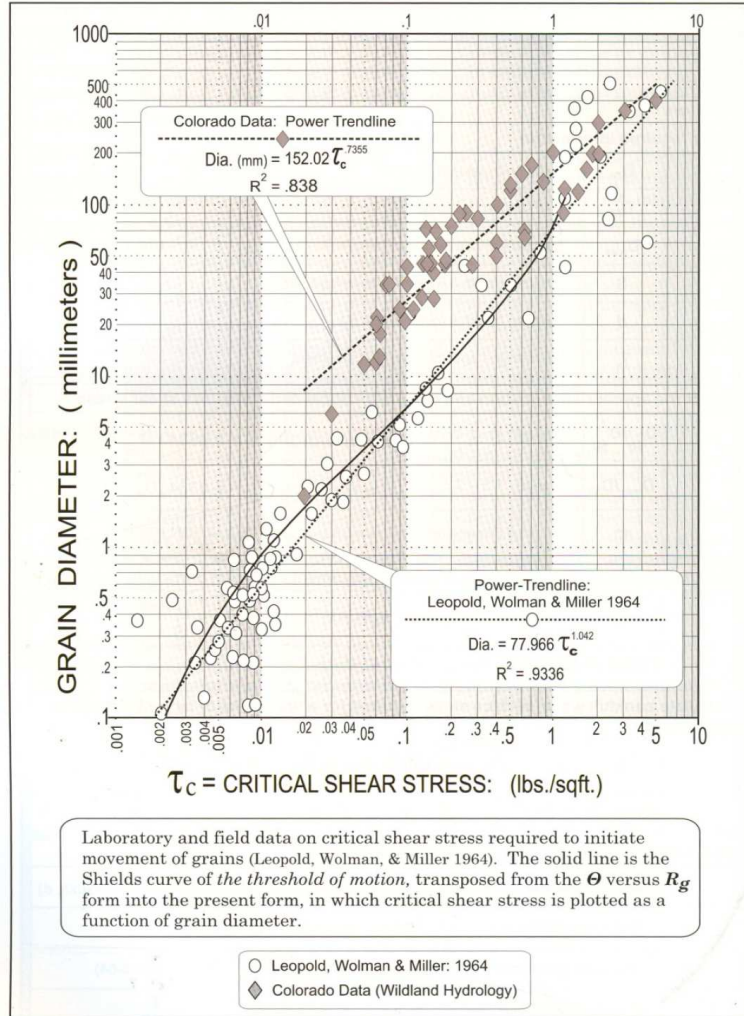
Figure 3-4. Shields diagram showing the critical shear stress required to initiate particle or grain movement (Leopold et al., 1964; Rosgen, 2006).

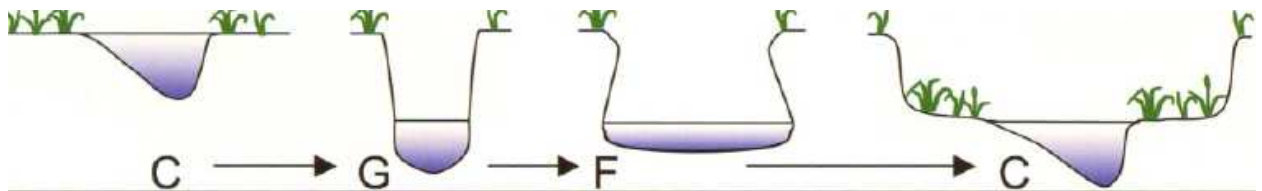
Figure 3-5. Stream channel successional changes (adapted from Rosgen, 1996).

The Farnum Creek stream reach (G4c stream type) is a disturbed stream type in the Flint Hills region. This reach is probably transitioning into an F4 stream and then eventually to a C4 stream type (Figure 3-5). The transition sequence ends at a C4 stream because streams of a C4 classification are considered relatively stable (unless disturbed) in the Flint Hills region. The transition from stream type G4c to F4 involves an increase in channel depth followed by an increase in channel width. During this transition stage, accelerated rates of bank erosion will be observed at this study reach. The next step in the successional sequence is the transition of the F4 channel to a C4 stream type. This transition stage involves an additional increase in channel depth and a reduction in

channel width. This stage also involves adjustment of channel slope. Beyond this stage, the stream will have attained stability and will be able to transport its sediment and discharge in an effective manner without any adverse impacts. These stream changes have direct implications on the low water fords on Fort Riley. As a result of these stream changes, there will be a need to constantly modify the designs and construction techniques of the low water fords in order to accommodate changes in stream dimensions and profile.

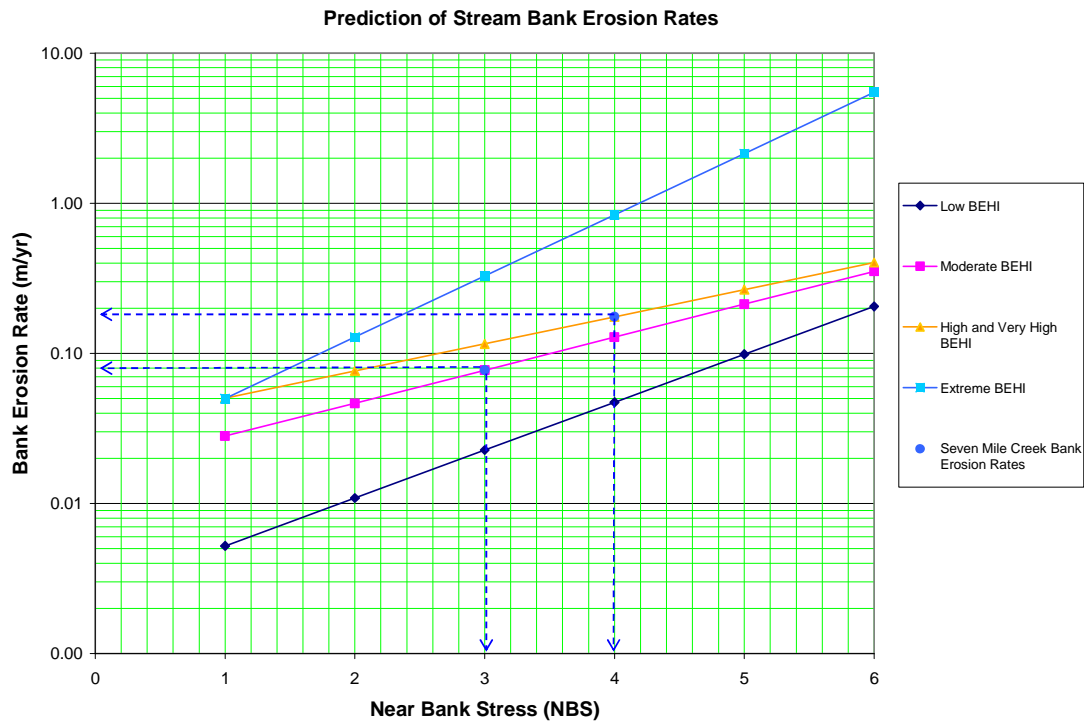
Predicted Annual Bank Erosion Rates (m/yr)	Measured Annual Bank Erosion Rates (m/yr)	Measured Annual Sediment Yield (kg/m/yr)
0.08-0.18	0.04-0.09	100

Figure 3-7. Relationship of BEHI and NBS ratings used to predict annual stream bank erosion rates on Seven Mile Creek. Adapted after Rosgen (1996 and 2006).

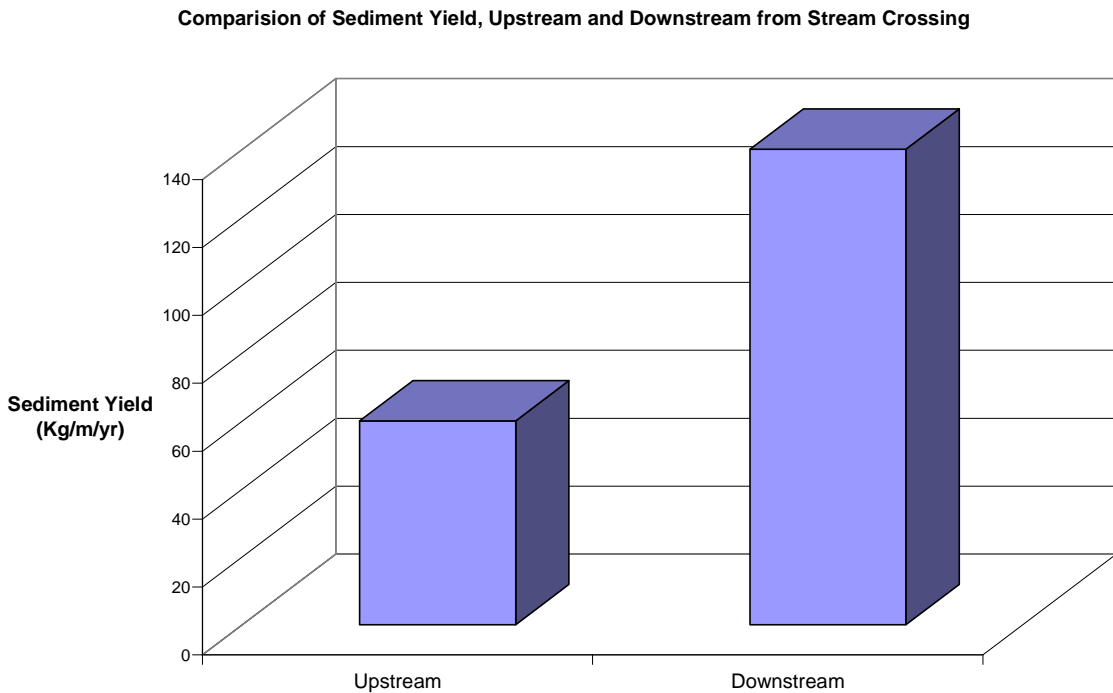
Figure 3-8. A comparison of sediment yield between upstream and downstream locations from stream crossing at Seven Mile Creek.

stream power) increases in the downstream direction. Like the Farnum Creek reach, a tributary located immediately above the stream crossing introduces extra discharge and sediment into the main stream at this study reach. In addition, the approach roads to the stream crossing location concentrate and channel runoff (generated from upland areas) into the main stream increasing the magnitude of discharge introduced into the main stream. The overall increase in stream discharge (in the downstream direction) among other factors explains the higher bank erosion rates at locations below the stream crossing.

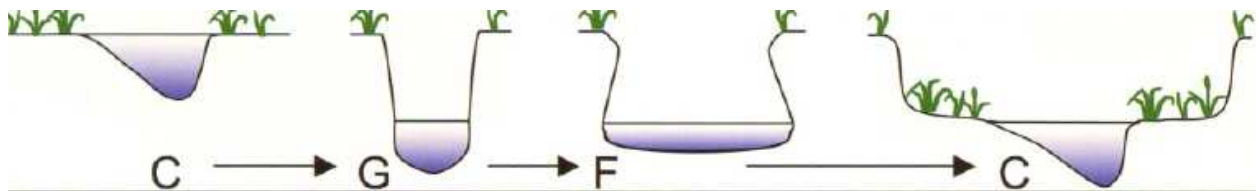
Figure 3-9. Stream channel successional changes (adapted from Rosgen, 1996).

Seven Mile Creek reach; currently a G6c stream shows signs of instability which include meander cutoffs and a sediment shift towards finer sediment. The Seven Mile Creek reach is probably transitioning into an F6 stream type then eventually to a C6 stream type (Figure 3-9). The C6 stream type is considered relatively stable. The transition from stream type G6c to F6 involves an increase in channel depth followed by an increase in channel width. During this transition stage, accelerated rates of bank erosion will be observed at this study reach. The next step in the successional sequence is the transition of the F6 channel to a C6 stream type. This transition stage involves an additional increase in channel depth and a reduction in channel width. This stage also involves adjustment of channel slope. Beyond this stage, the stream will have attained stability (if left undisturbed) and will be able to transport its sediment and discharge in an effective manner without any adverse impacts.

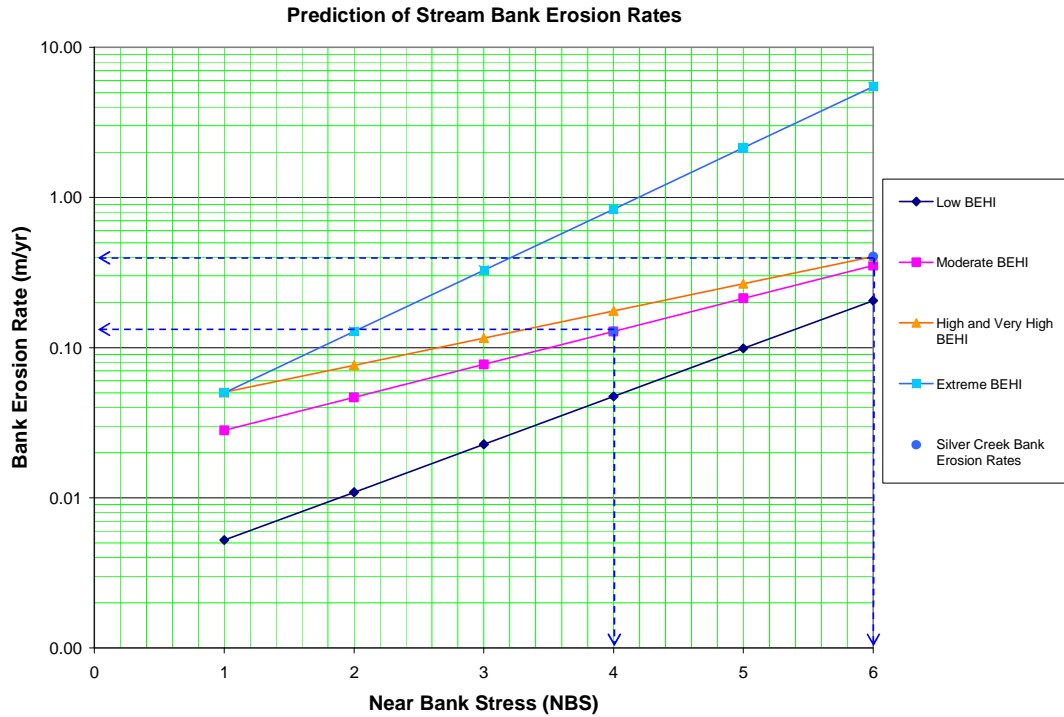
Predicted Annual Bank Erosion Rates (m/yr)	Measured Annual Bank Erosion Rates (m/yr)	Measured Annual Sediment Yield (kg/m/yr)
0.13-0.40	0.04-0.48	800

Figure 3-10. Relationship of BEHI and NBS ratings used to predict annual stream bank erosion rates on Silver Creek. Adapted after Rosgen (1996 and 2006).

The high rates of bank erosion at this reach can be attributed to increased discharge (due to the high number of runoff events experienced in March-June, 2007 as well as increase in drainage area) and the nature of this stream type. Generally, bank erosion rates increase with increase in drainage area, however, the nature of this study reach (*ceteris paribus*) explains the accelerated stream bank erosion at this reach. F4 streams are generally known for very high stream bank erosion rates (Rosgen, 1996, 2006). Disturbance caused by piers of an abandoned railway bridge crossing, upstream of this study reach serves to accelerate bank erosion rates at the middle and downstream locations. Analysis of bank profiles at Silver Creek indicates that the dominant erosion mechanisms are hydraulic action and bank slumping.

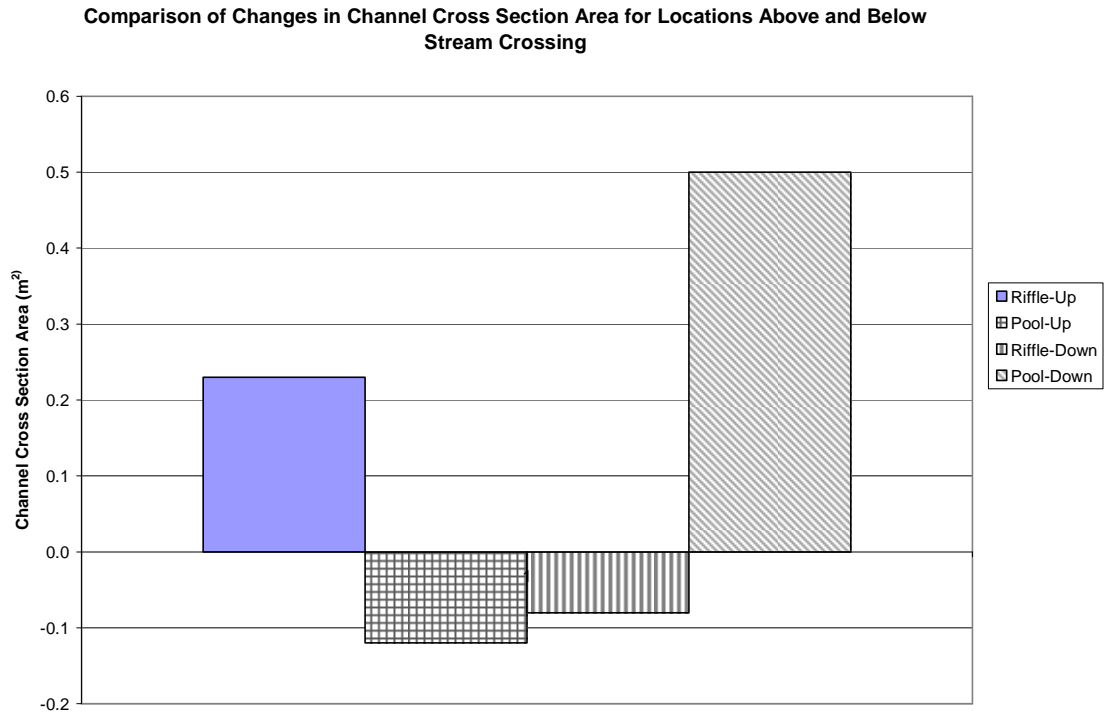
[Negative values indicate fill while positive values indicate scour].

Figure 3-12. A comparison of changes in channel cross section area for cross section transects above and below stream crossing at Wind Creek, upland reach.

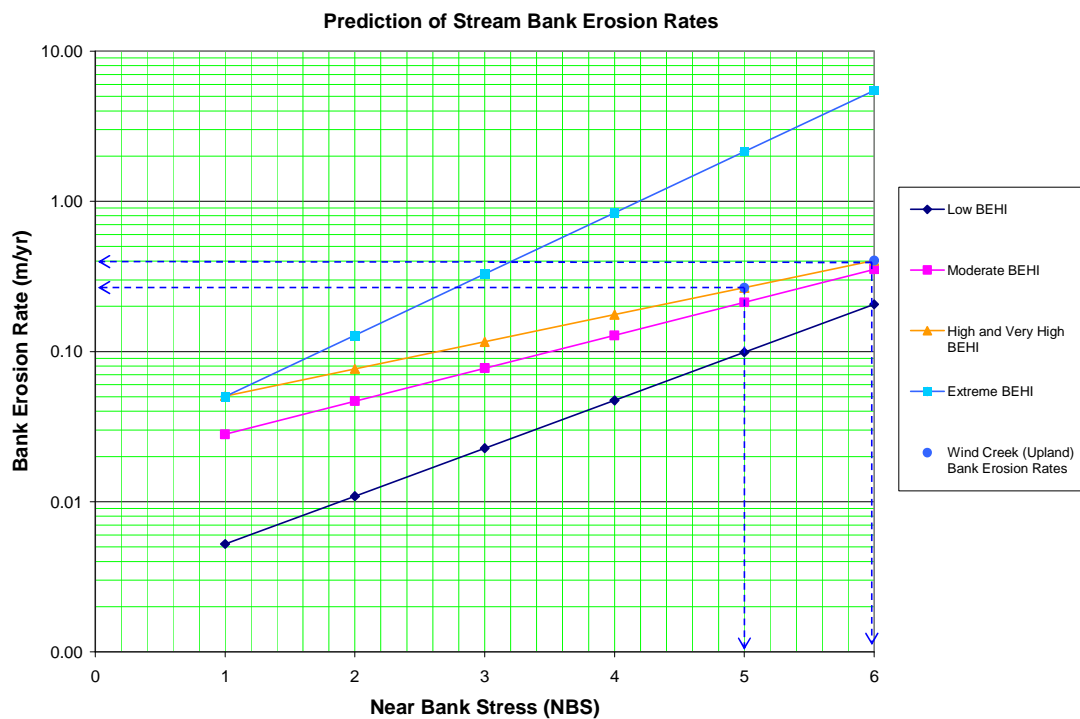
Predicted Annual Bank Erosion Rates (m/yr)	Actual Annual Bank Erosion Rates (m/yr)	Actual Annual Sediment Yield (kg/m/yr)
0.27-0.40	0.08-0.17	370

Figure 3-13. Relationship of BEHI and NBS ratings used to predict annual stream bank erosion rates on Wind Creek, Upland reach. Adapted after Rosgen (1996 and 2006).

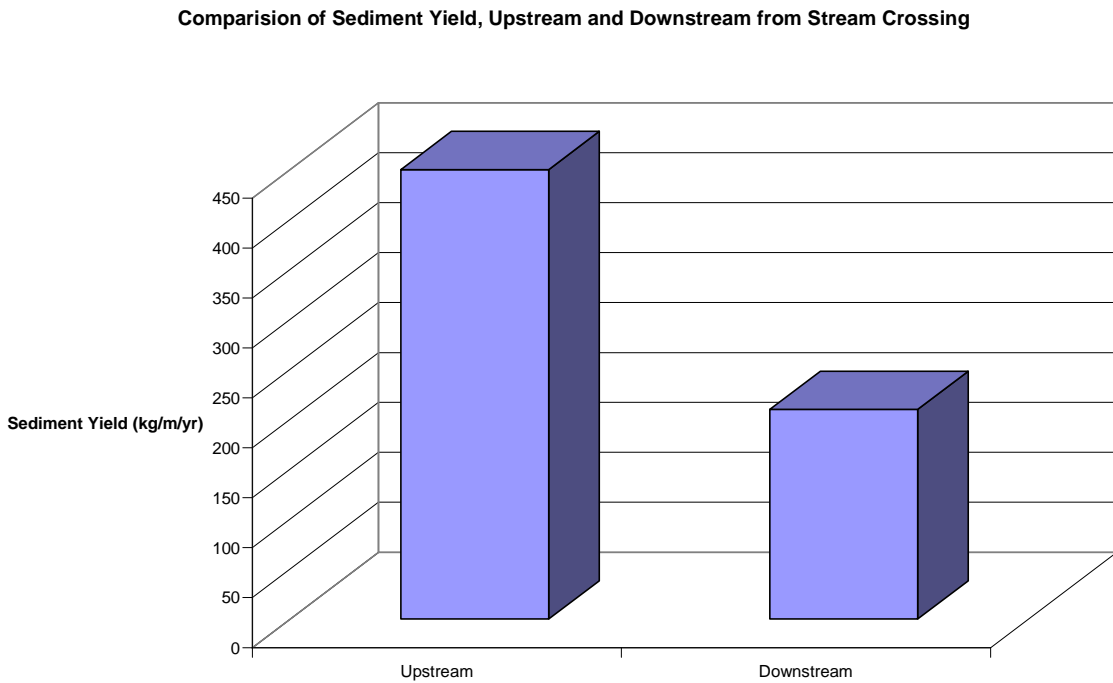
Figure 3-14. A comparison of sediment yield between upstream and downstream locations from stream crossing at Wind Creek upland reach.

above the stream crossing at this study reach was more than that generated from locations below the stream crossing. The stream crossing (and approach roads leading up to it) at this reach is closed to traffic, and therefore riparian vegetation has been allowed to grow back, slowing down discharge from upstream and runoff transported from upland areas. The dense vegetation (on the banks at the regions immediately above and below the stream crossing) provides protection against stream bank erosion. Therefore the bank erosion rate below the stream crossing was lower than that above the stream crossing.

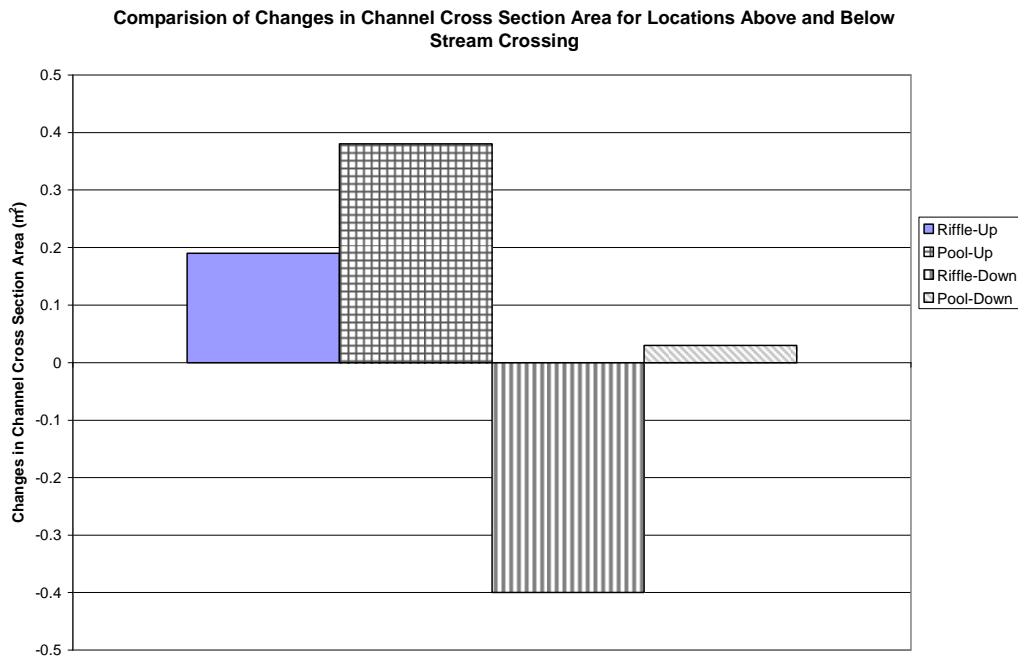
[Negative values indicate fill while positive values indicate scour].

Figure 3-15. A comparison of changes in channel cross section area for cross section transects above and below stream crossing at Wind Creek, midland reach.

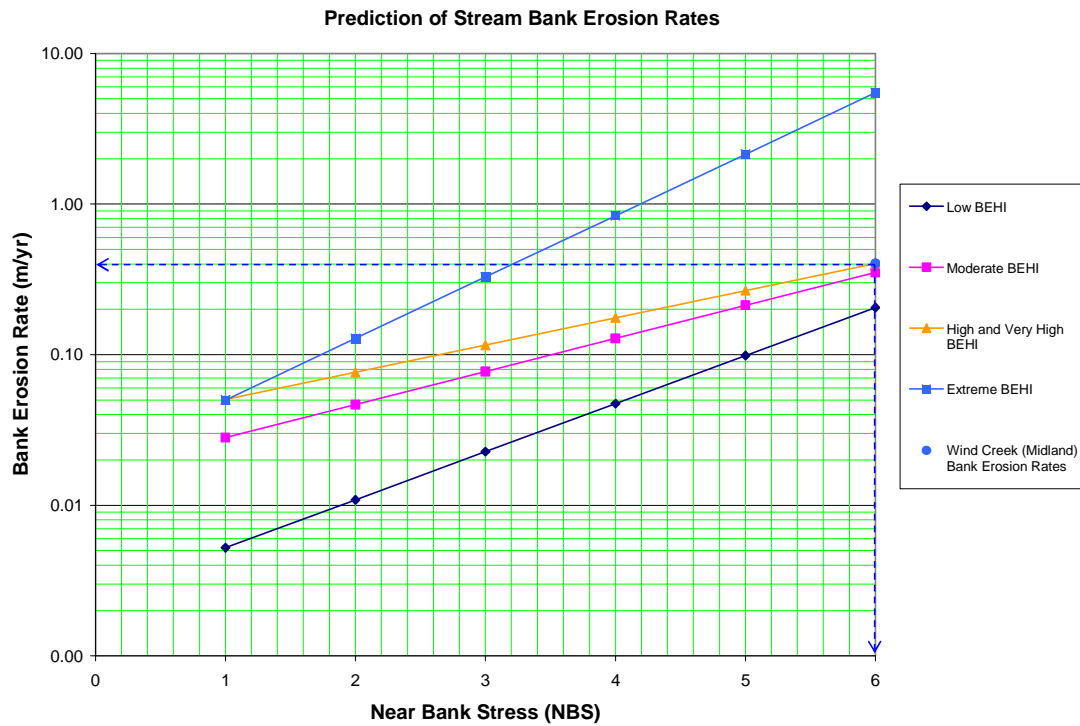
Figure 3-16. Relationship of BEHI and NBS ratings used to predict annual stream bank erosion rates at Wind Creek, midland reach. Adapted after Rosgen (1996 and 2006).

The measured bank erosion rates and annual sediment yield (Table 3-44) at this reach were moderately high due to the high frequency and duration of flow events experienced in March-June, 2007. Figure 3-17 shows a comparison of sediment yield for locations upstream and downstream of a low water ford, for each study reach. It is shown that the sediment yield generated from locations above the stream crossing at this study reach was higher than that generated from locations below the stream crossing. The low bank erosion rates at locations immediately below the crossing can be attributed to the excellent location of the stream crossing and the good condition of the approach roads (leading to the stream crossing). The stream crossing at this reach is well located on a riffle and the approach roads are well vegetated. The excellent location of the stream crossing at this reach explains the stability of the banks immediately above and below the stream crossing. The vegetation on the approach roads serves to reduce the velocity of runoff and filter sediment transported from upland areas.

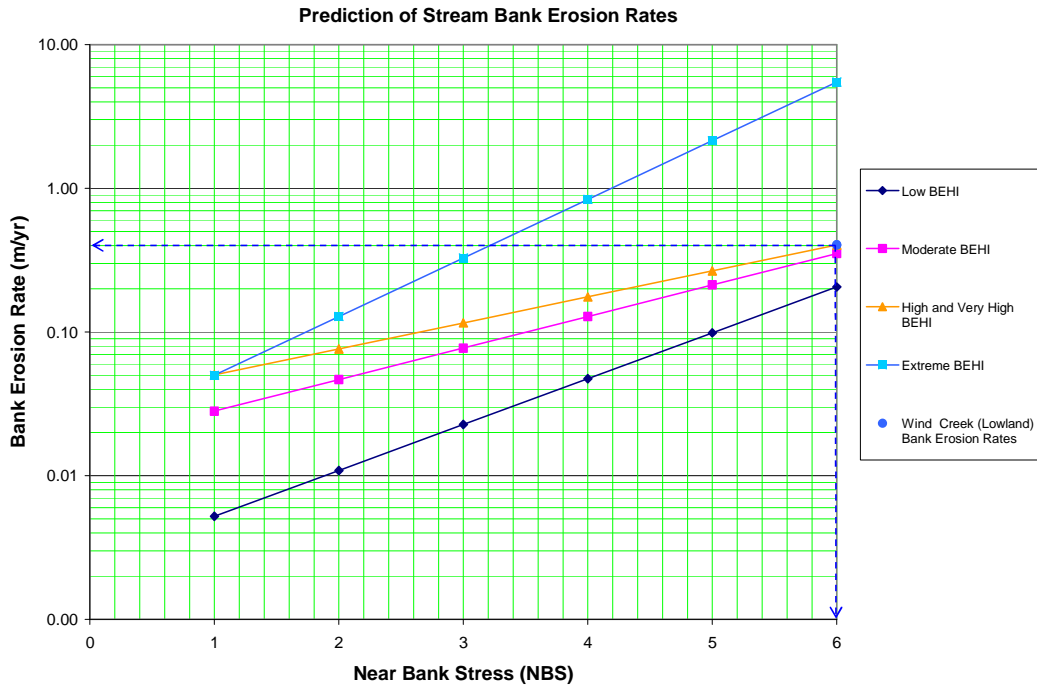
Study Reach	Predicted Annual Bank Erosion Rates (m/yr)	Actual Annual Bank Erosion Rates (m/yr)	Actual Annual Sediment Yield (kg/m/yr)
Wind Creek, lowland	0.40	0.23-0.65	0.88

Figure 3-19. Relationship of BEHI and NBS ratings used to predict annual stream bank erosion rates on Wind Creek, lowland reach. Adapted after Rosgen (1996 and 2006).

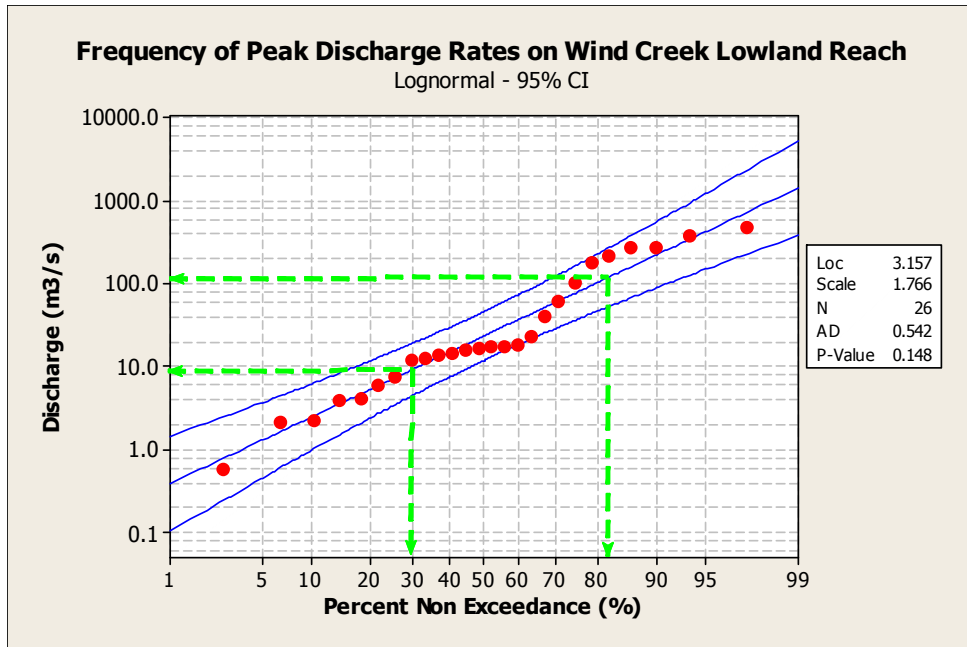
Figure 3-21. Frequency of peak stream flow rates at Wind Creek Lowland reach.

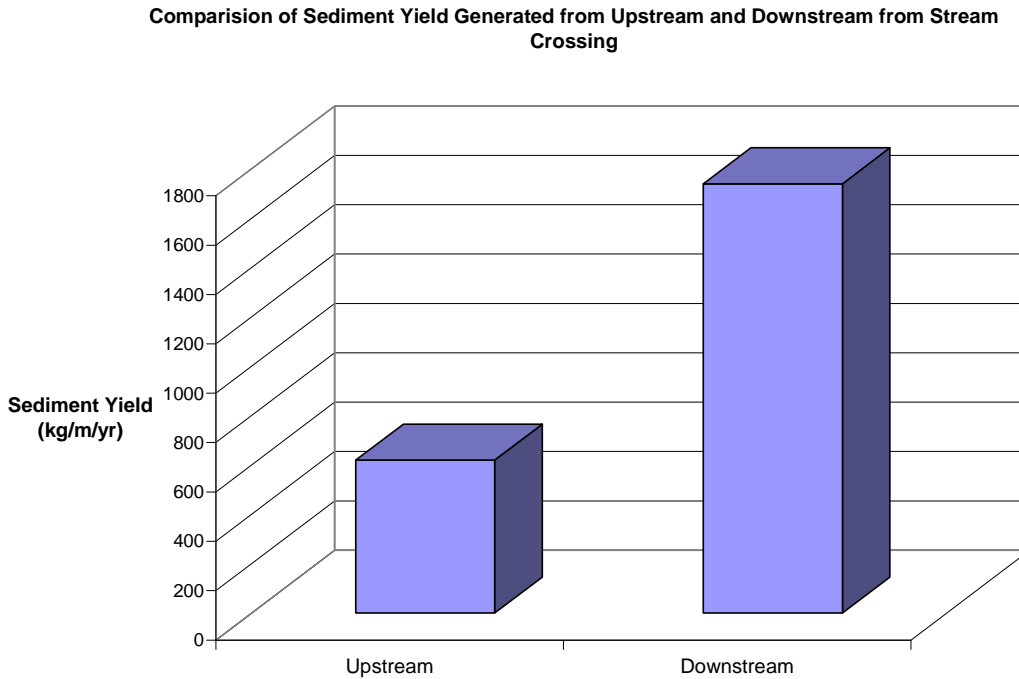
Figure 3-24. A comparison of sediment yield between upstream and downstream locations from stream crossing at Wind Creek, lowland reach.

crossings concentrate runoff from upland areas, increasing the amount of runoff and sediment discharged into streams. Increased runoff and sediment entering streams poses a potential of causing stream instability. Increased sediment in streams has adverse impacts on aquatic life as well as water quality.

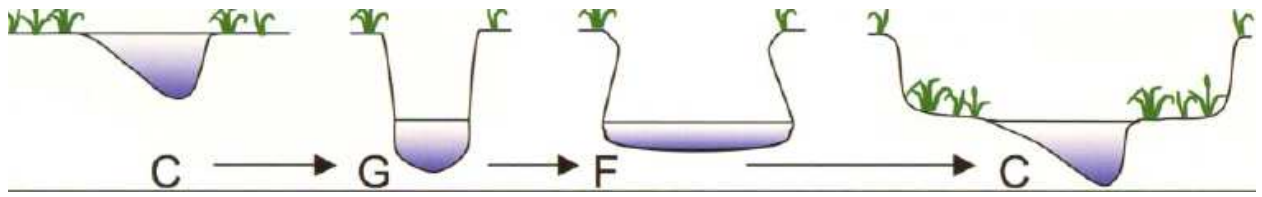
Figure 3-25. Stream channel successional changes (adapted from Rosgen, 1996).

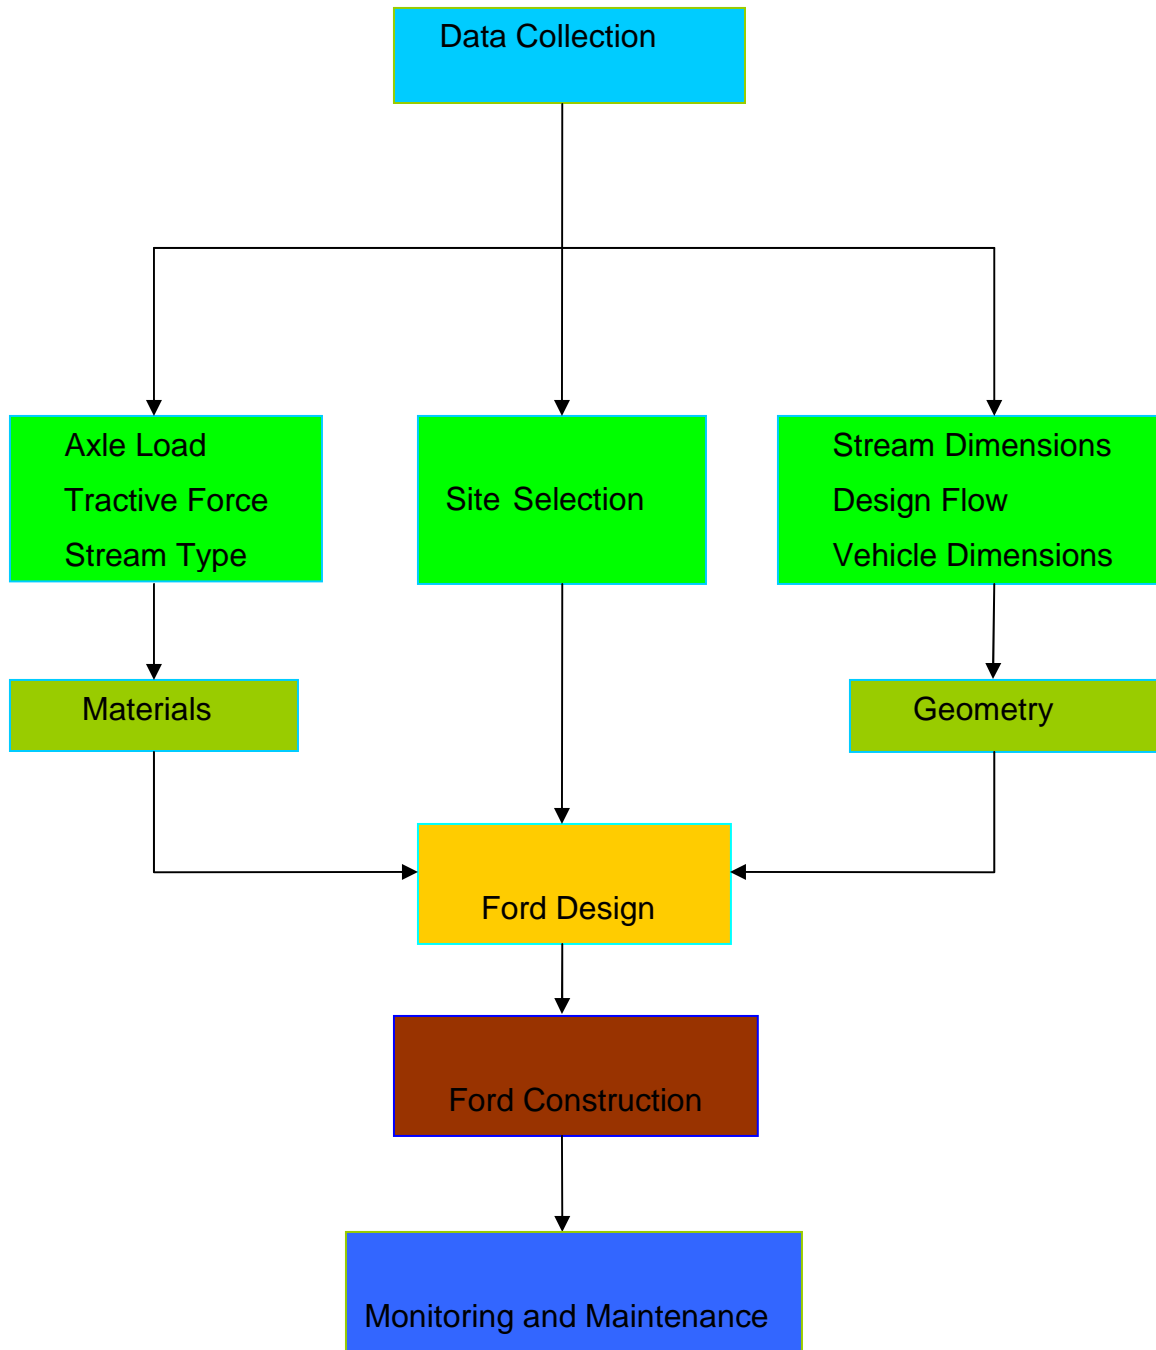
Figure 4-1. Development process for low water fords.

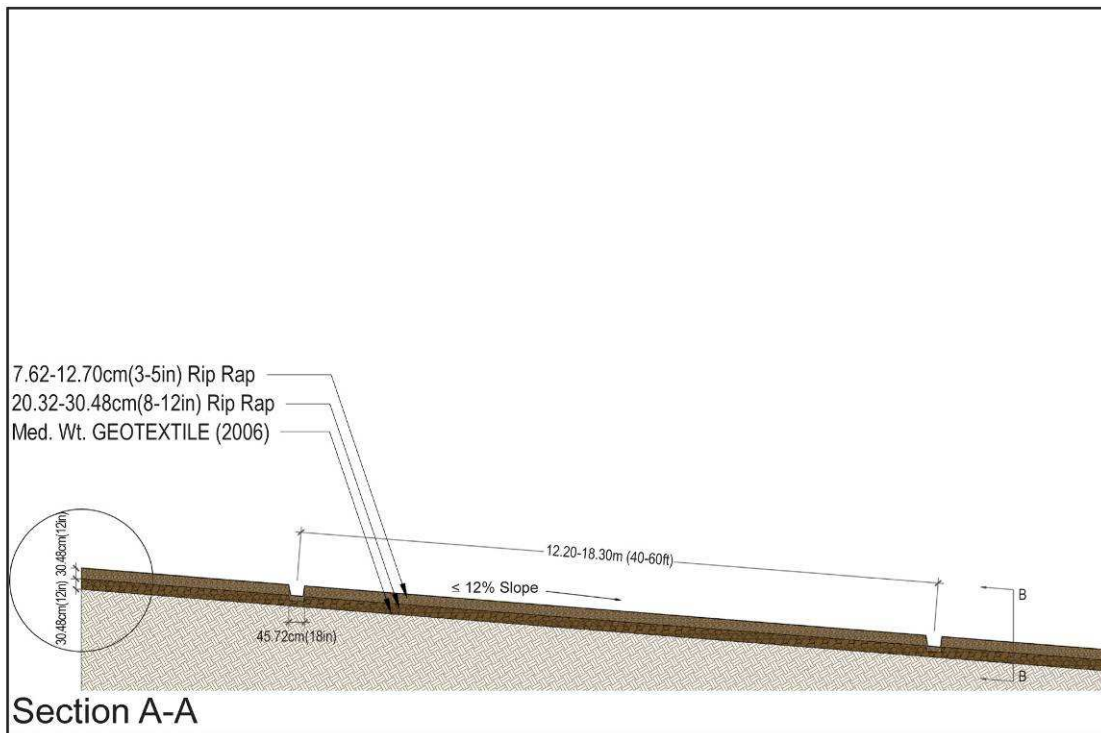
Figure 4-12. Longitudinal profile along approach road leading to a stream crossing site.

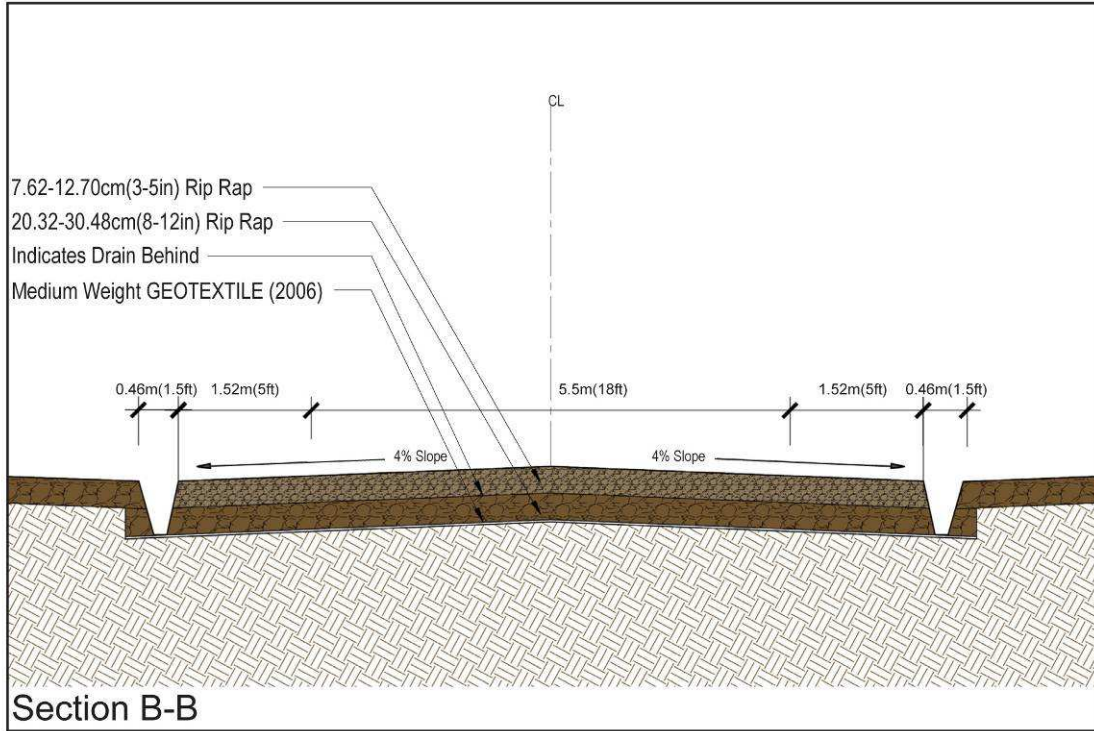
Figure 4-13. Cross section across approach road leading to a stream crossing site.

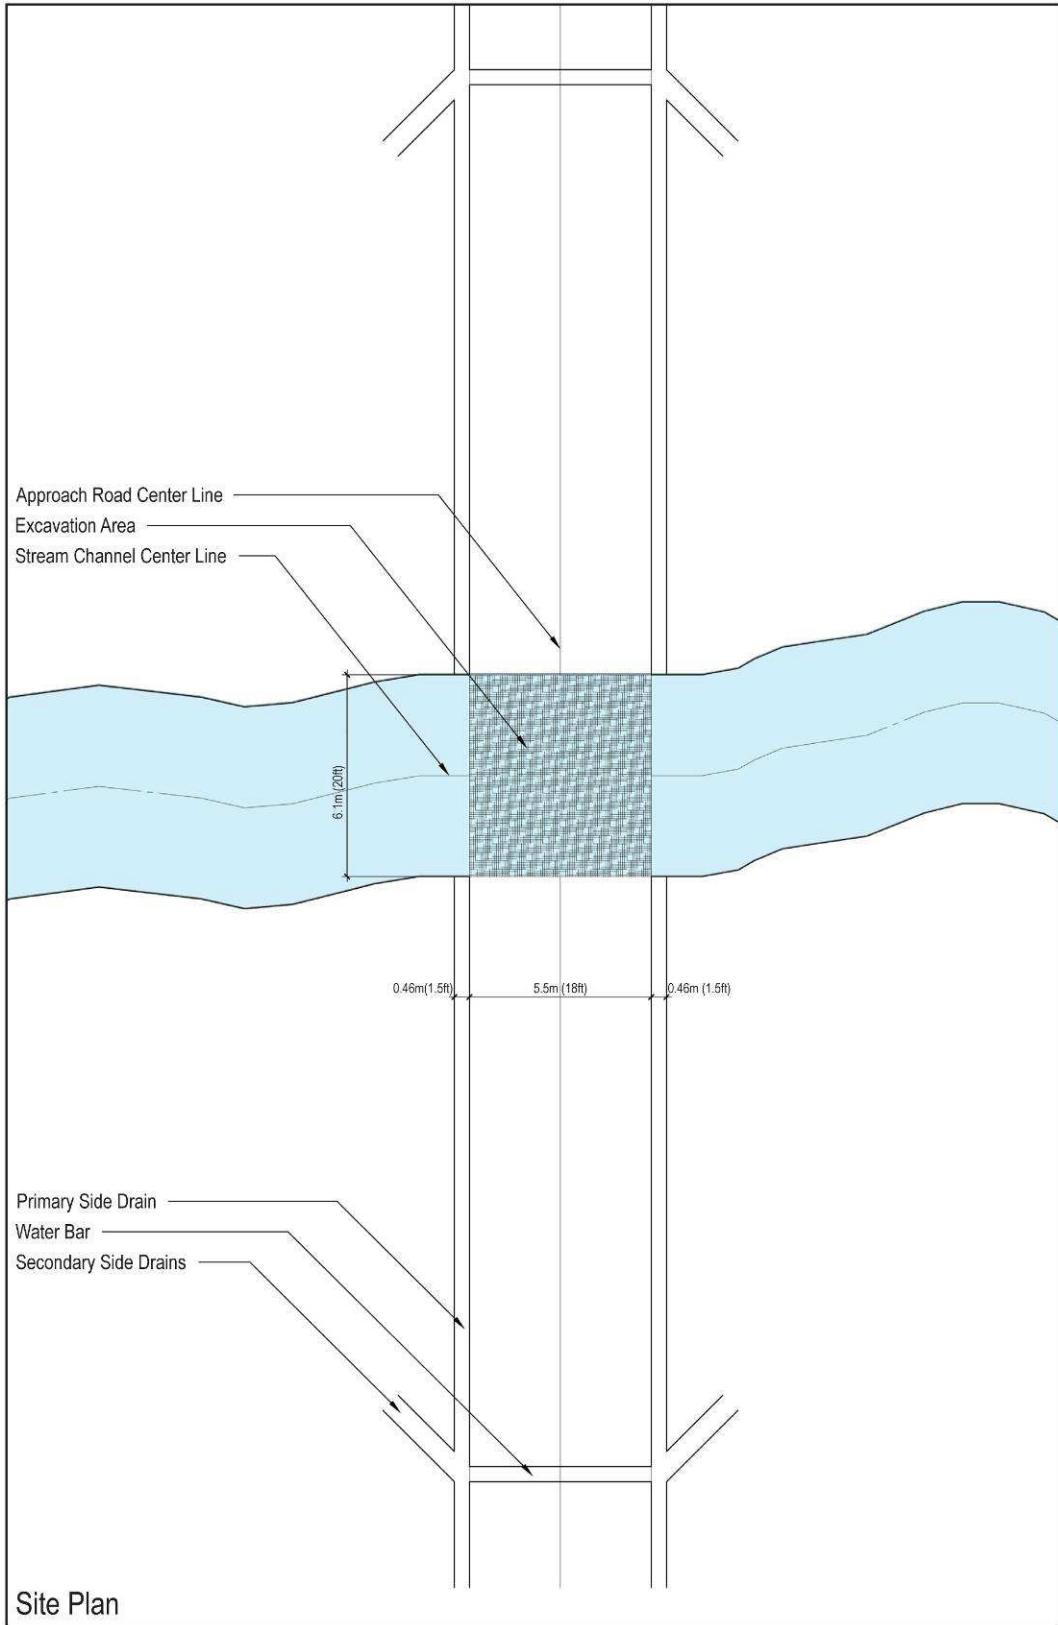
Figure 4-14. Plan of a stream crossing site.
