ANALYZING EFFECTS OF LOW WATER FORDS ON STREAM STABILITY AT
FORT RILEY, KANSAS

A THESIS

Department of Biological and Agricultural Engineering
College of Engineering

KANSAS STATE UNIVERSITY
Manhattan, Kansas

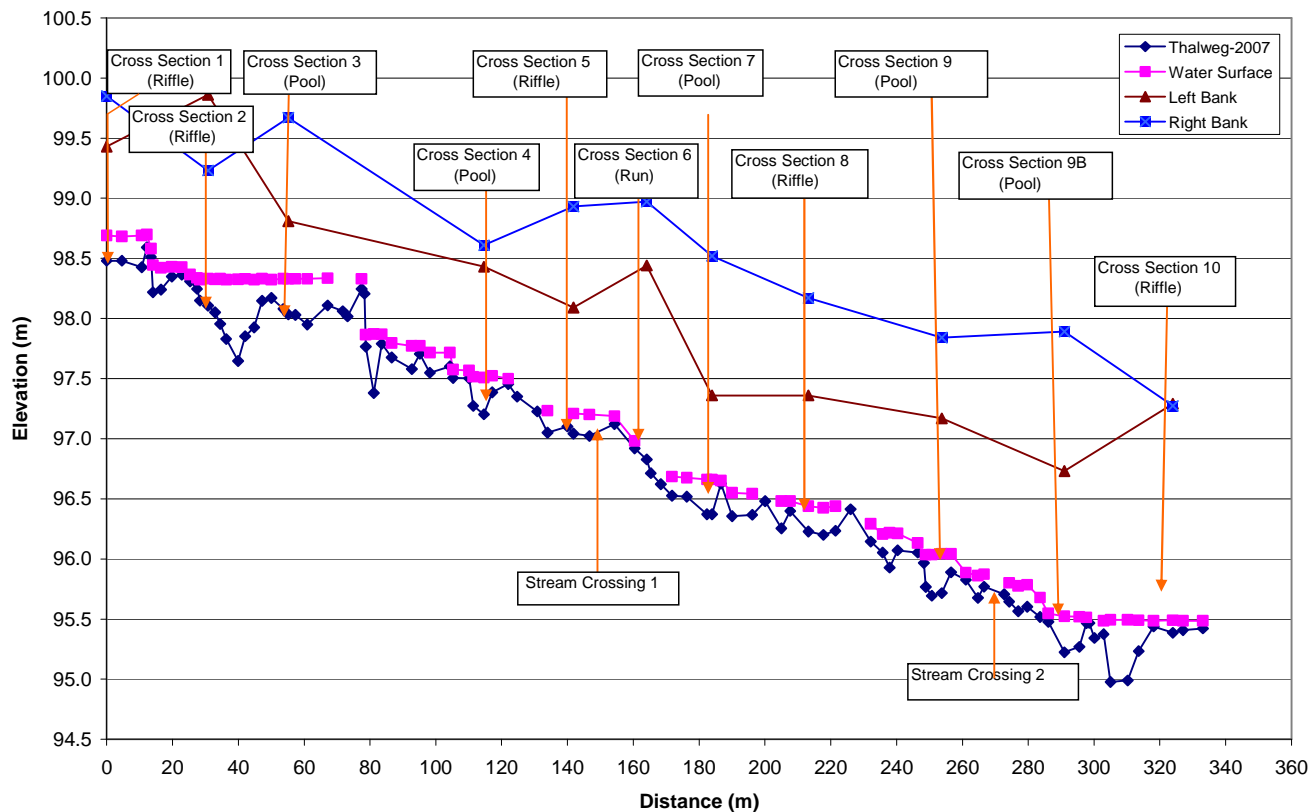
Figure A-17. Longitudinal profile along Farnum Creek.

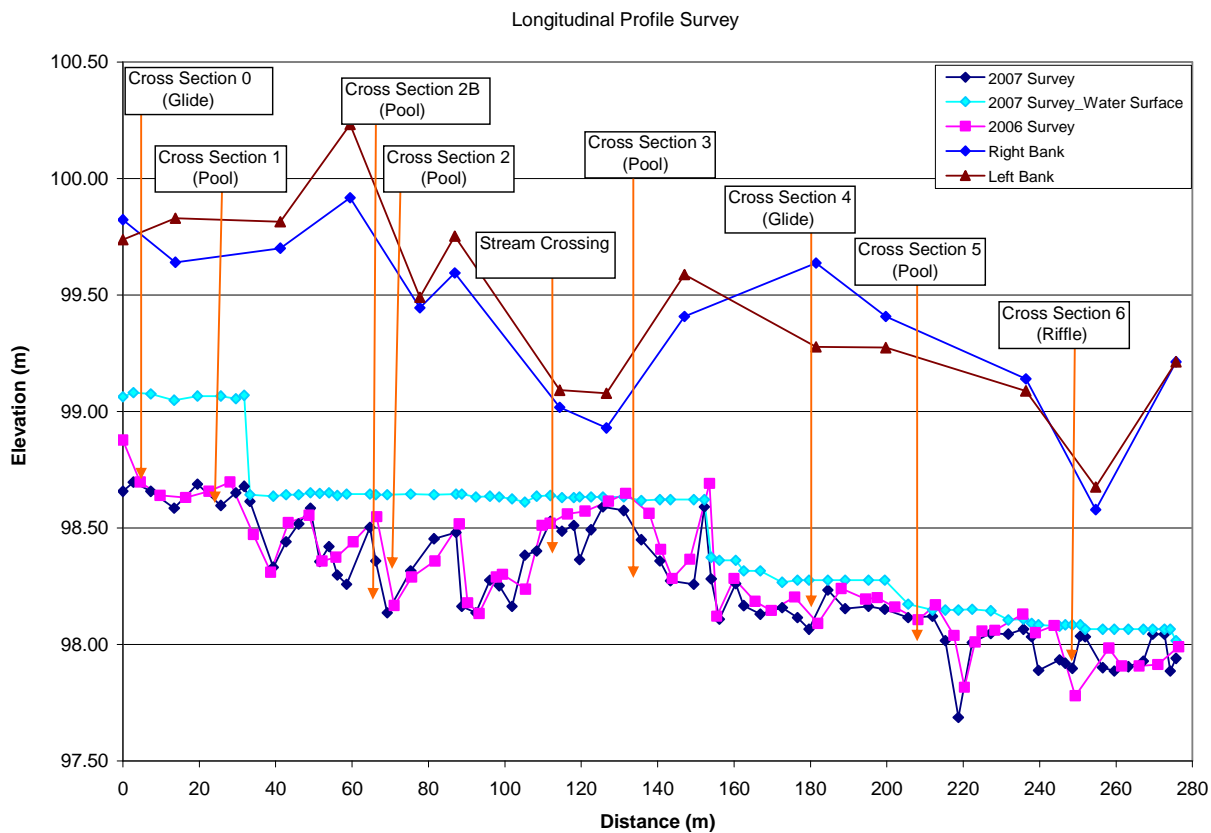
Figure B-10. Longitudinal profile of Seven Mile Creek.

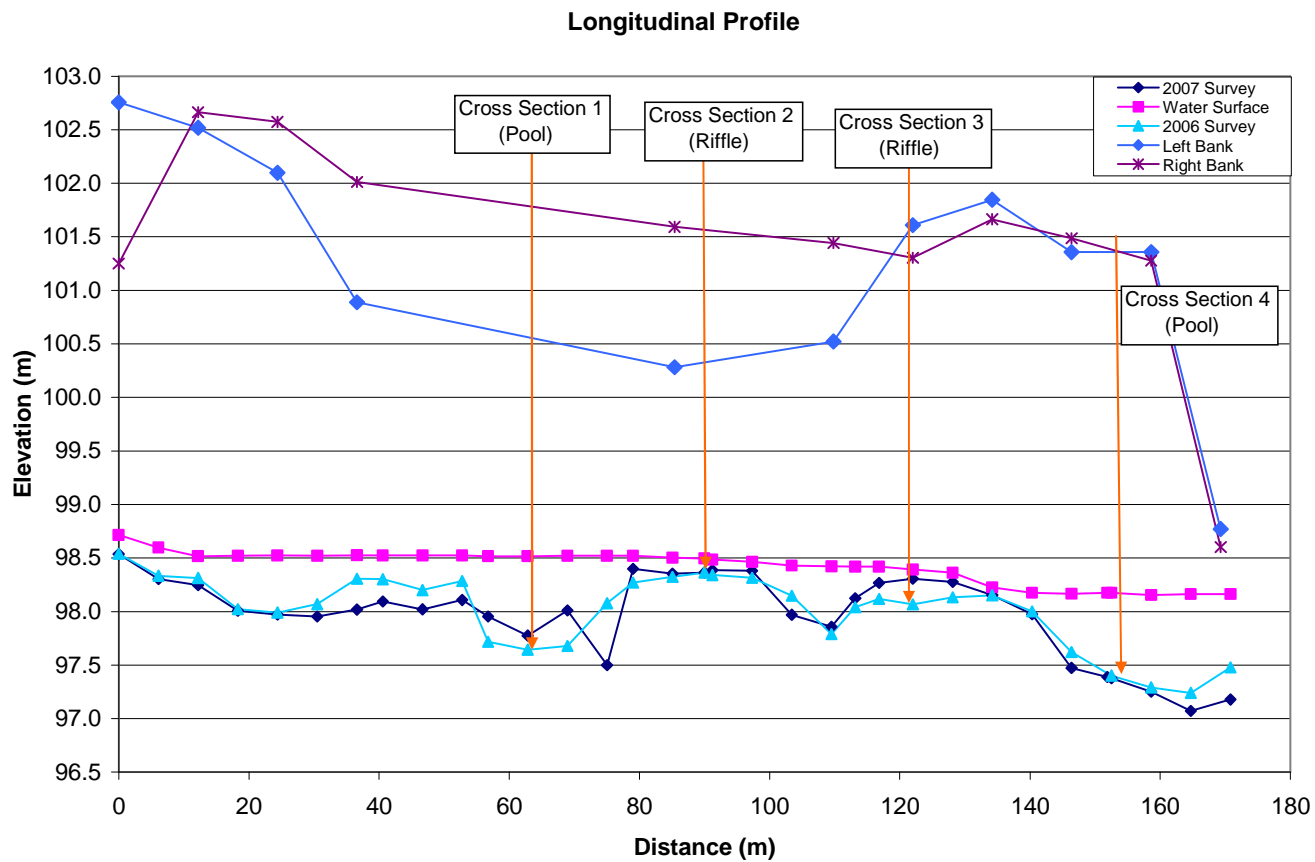
Figure C-7. Longitudinal profile along Silver Creek.

Figure C-7 shows the repeat survey of the longitudinal profile while Figures C-8 through C-11 show changes in channel cross section geometry at the Silver Creek study reach. Tables 3-21 through 3-23 show channel geometry data collected. Changes in cross section area at the Silver Creek study reach are shown in Tables 3-21 and 3-23. These changes in cross section area are of variable magnitude. Moderate to large changes in cross sectional area were observed at both pools and riffles at this study reach. These changes were mainly due to fill and accelerated bank erosion at cross section transects shown in Figures C-8 through C-11. Overall, the pools experienced greater filling compared to the riffles. Results from the scour chains (Table C-1) indicated moderate scour (followed by fill) at the scour chain locations at cross section transect 2. The longitudinal profile (Figure C-7) indicates localized scour and fill at certain points along the reach. Major reworking of the channel bed and bank materials was observed. An increase in channel slope from 0.0062 (in 2006) to 0.0079 (in 2007), (27.4% increase) was observed at the reach. This change in channel slope is associated with channel

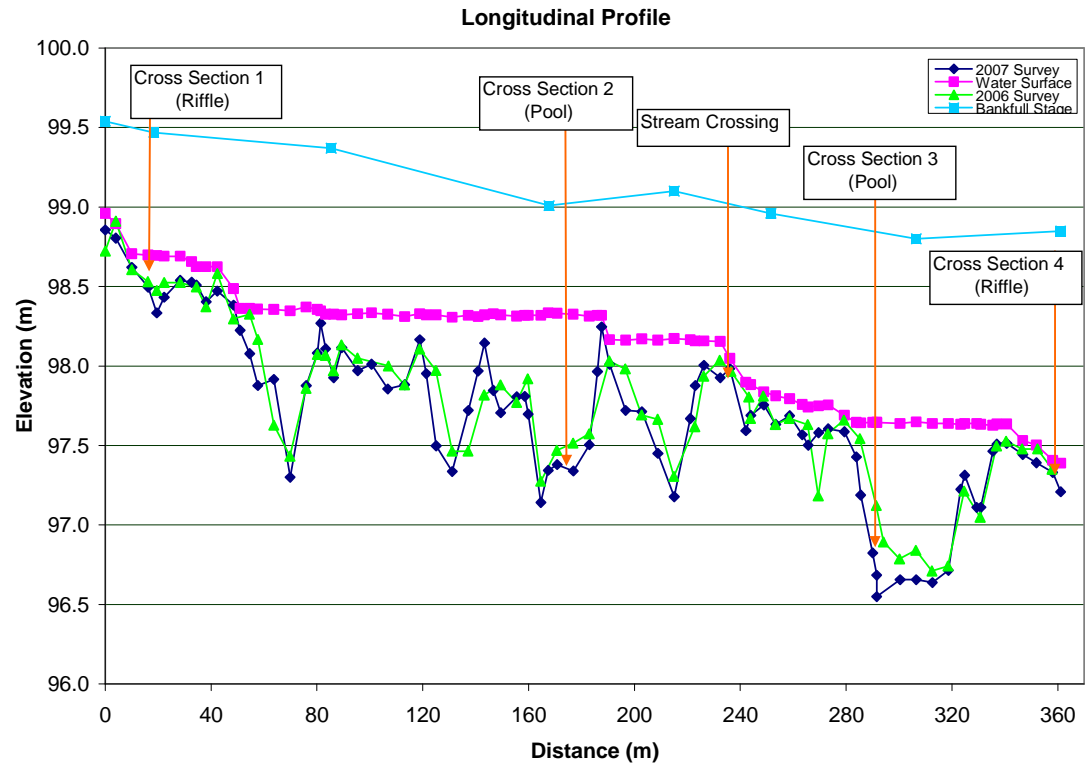
Figure D-17. Longitudinal profile along Wind Creek, upland reach.

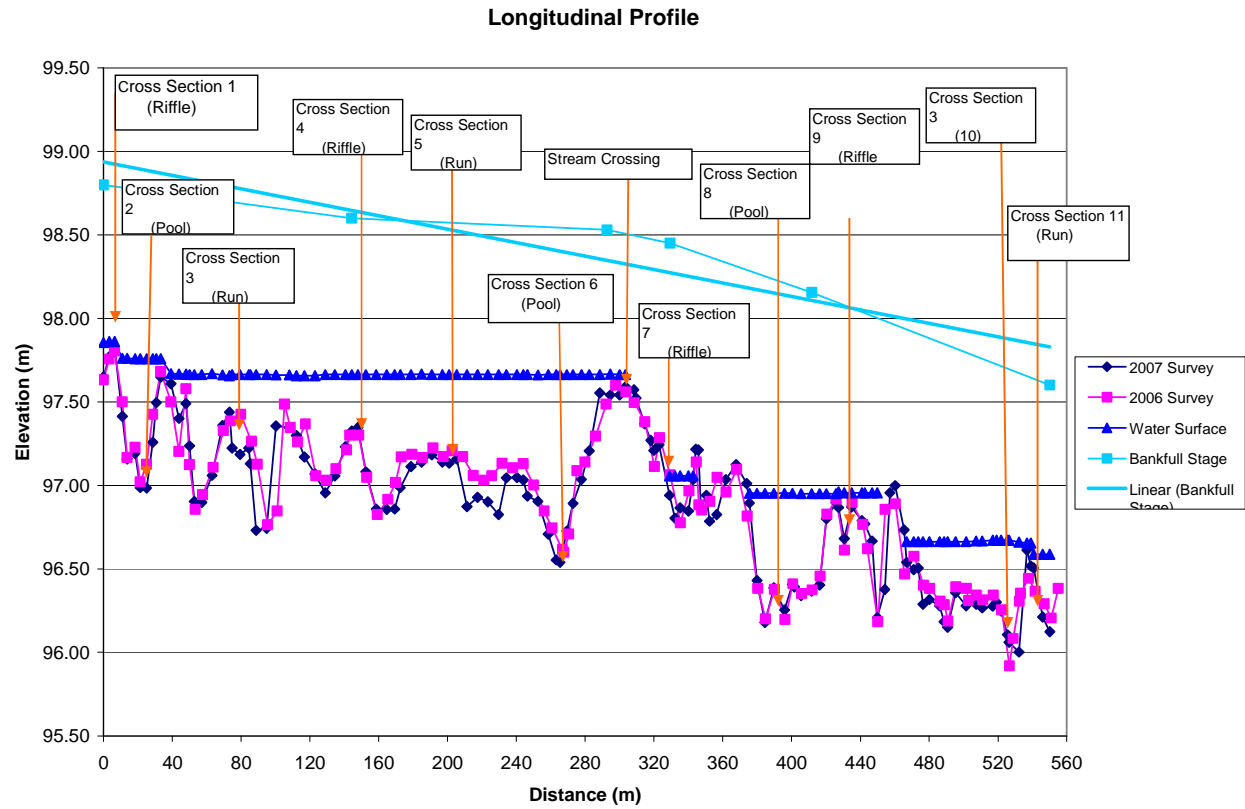
Figure E-23. Longitudinal profile along Wind Creek, midland reach.

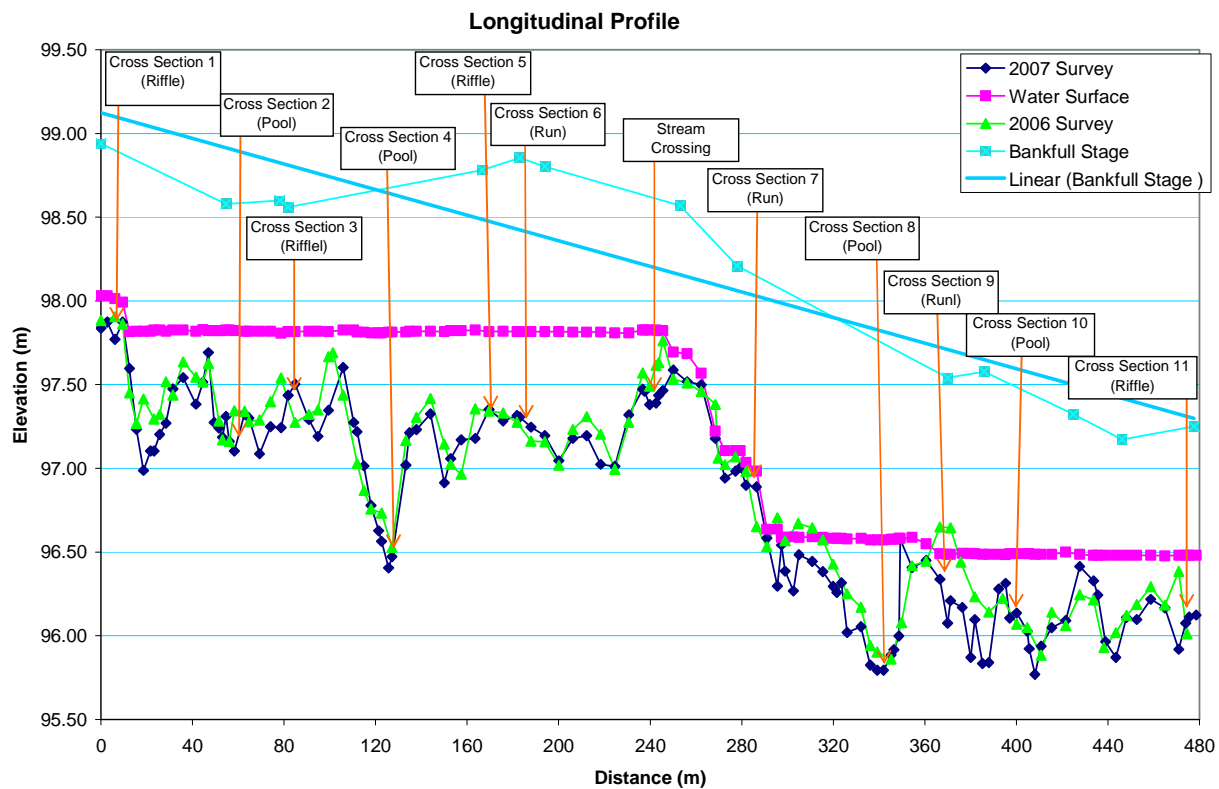
Figure F-20. Longitudinal profile along Wind Creek, lowland reach.
