STRUCTURAL CHECK OF A STEEL THROUGH TRUSS BRIDGE

LOREN E. DICKENS, III

A REPORT

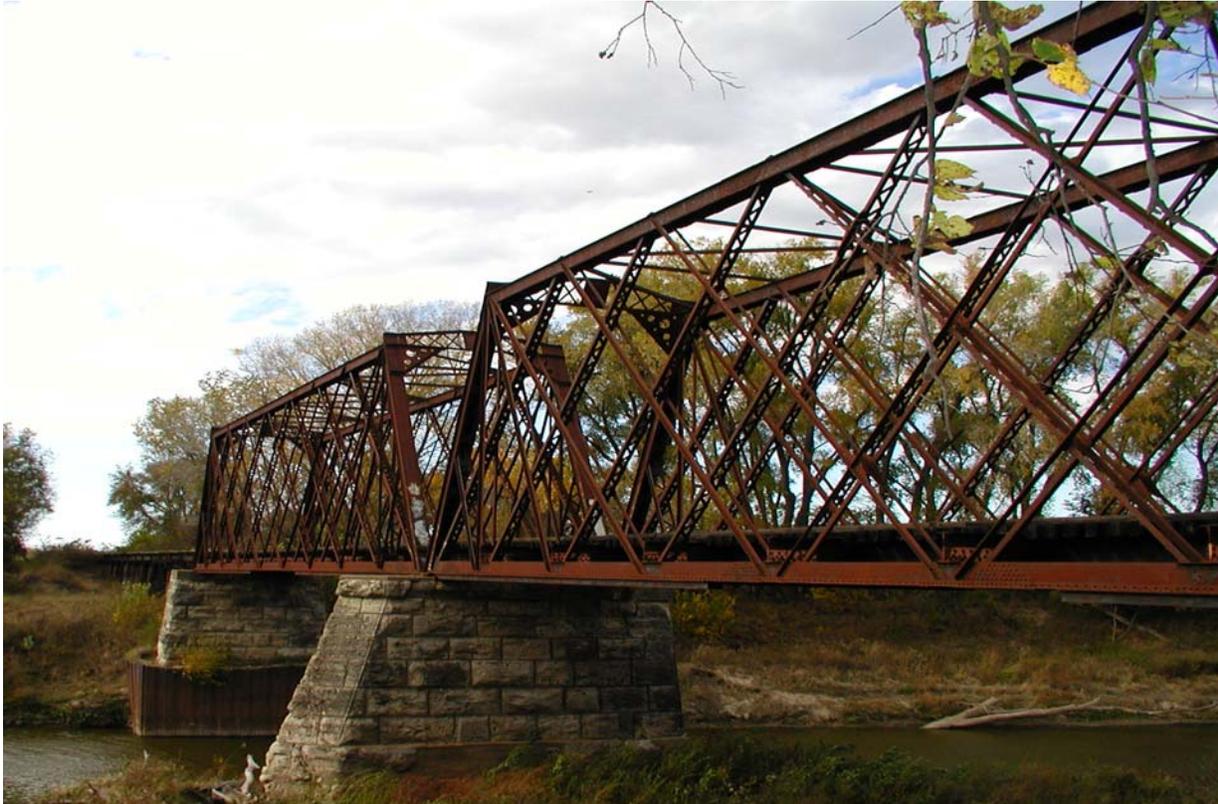
Figure 1.1 Smoky River Bridge

The bridge is 218 ft long consisting of twin 109-ft long, simply supported, steel through-trusses. All four trusses consist of built up members made of multiple angles and plates riveted together. The compression members, top chord excluded, are angles laced together with strap steel lattice plates. Tension members are made of the same angles but include no lacing. The first and last panels are 12.5 ft long while the other seven panels are 12 ft long. At each panel, floor beams that carry the train and track transfer all loads to the joints. The truss is simply

supported, bearing on steel plates on the top of masonry piers. Figure 1.1 shows the bridge crossing the Smoky River.

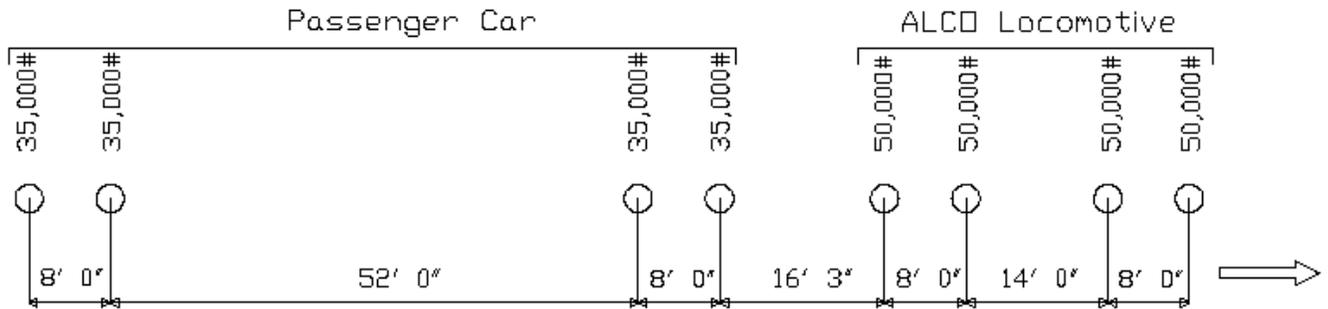
Figure 3.1 The ALCO Diesel Locomotive Axle Loads and Spacing

The current engine being used is a 100 ton 1945 ALCO S-1 diesel locomotive. It is the lone engine being used to pull the passenger and dinner cars. It is supported by four axles carrying equal loads of 25 tons or 50 kips. The spacing of the axles from front to back is as follows: 8 ft, 14 ft, and 8 ft. The total length of the diesel engine is 44.5 ft. The four axles are comprised of two trucks that equally distribute the load to the rails. The axle loading and spacing are shown in Figure 3.1.

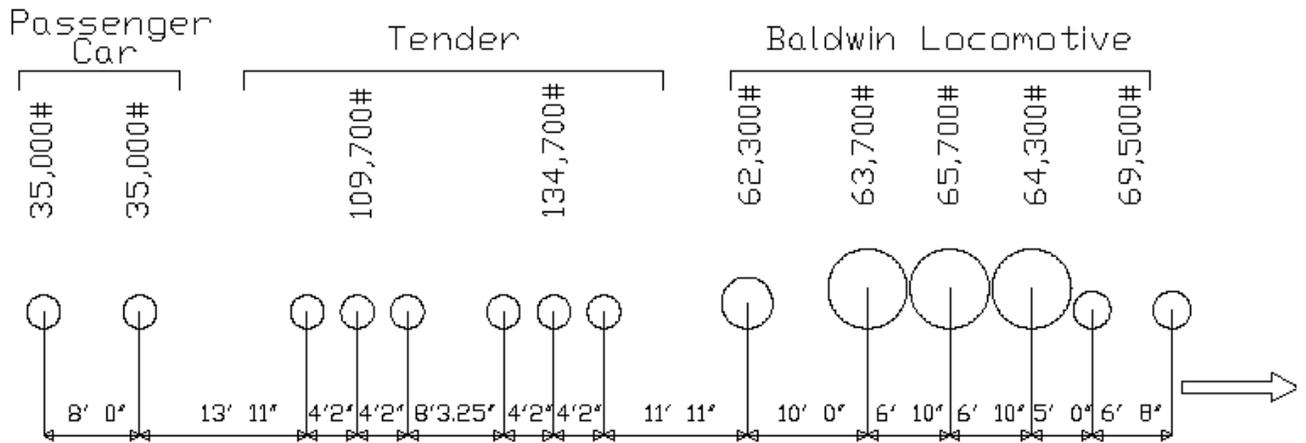
Figure 3.2 The 1919 Baldwin Steam Locomotive Axle Loads and Spacing

The engine that the Abilene & Smoky Valley Railroad Association (ASVRA) wishes to use is a 285 ton (569.9 kips) assembly consisting of a 1919 Baldwin 4-6-2 “Pacific,” Santa Fe #3415 steam locomotive and a tender. The steam locomotive and tender combination has a total length of 82.7 ft and has 12 axles that distribute the weight to the rails. The tender “tends” the locomotive and is where the water and fuel is stored. For the analysis, the tender is assumed to be fully loaded and weighs 244.4 kips. However, it must be stated that the tender will most likely never be fully loaded due to the 10 mile roundtrip excursions offered by the Abilene & Smoky Valley Railroad Association. Figure 3.2 illustrates the axle loads and spacing for the 1919 Baldwin steam locomotive.

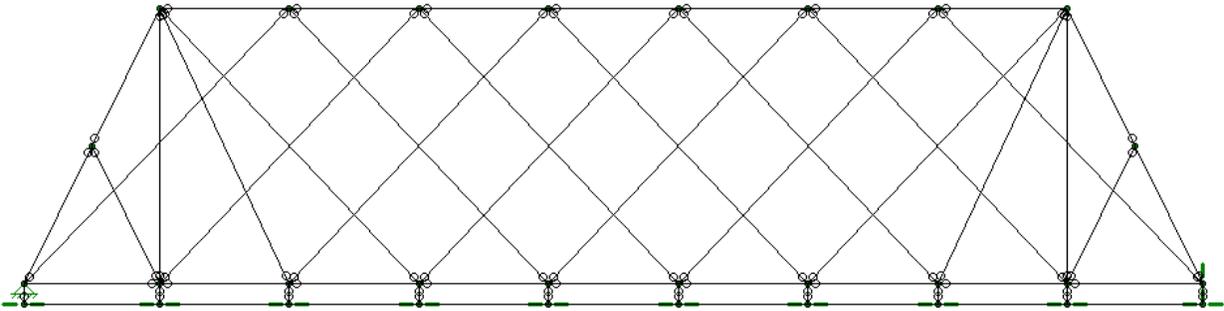
Figure 3.3 The RISA Model with “secondary structure”

For modeling purposes, each of the vertical hangers in the secondary structure was taken as being two feet long. The length of these hangers does not effect the analysis because the members are there only to transfer loads. The results (stresses, deflections, etc.) for this auxiliary structure were ignored due to the fact that the hangers are short links. The secondary structure was modeled in RISA using an arbitrary section with a negligible area and section properties so as not to add any dead load to the analysis. This system of beams and hangers represents how the bridge’s longitudinal girders and floor-beams transfer the train loads to the joint of the structure. Figures 3.3 and 3.4 depict the model used in RISA. The dead loads shown in Figure 3.4 (-6k) represent the dead loads due to the longitudinal girders, floor-beams, tracks, ties, etc. (The negative signs in RISA indicate that the loads are pointing downward). The moving (live) loads are half the axle loads of the Baldwin locomotive, tender, and two axles of the passenger car (Figure 3.2).

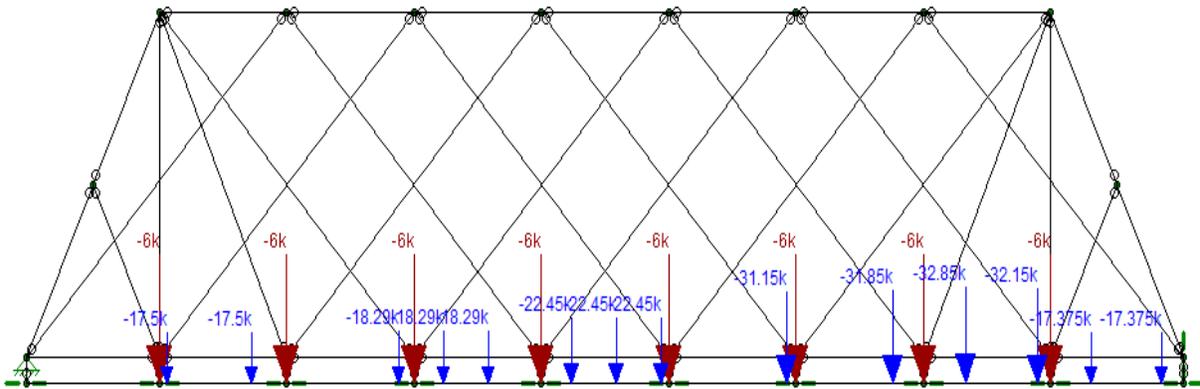
Figure 3.4 Dead Loads and Moving Load on “secondary structure”

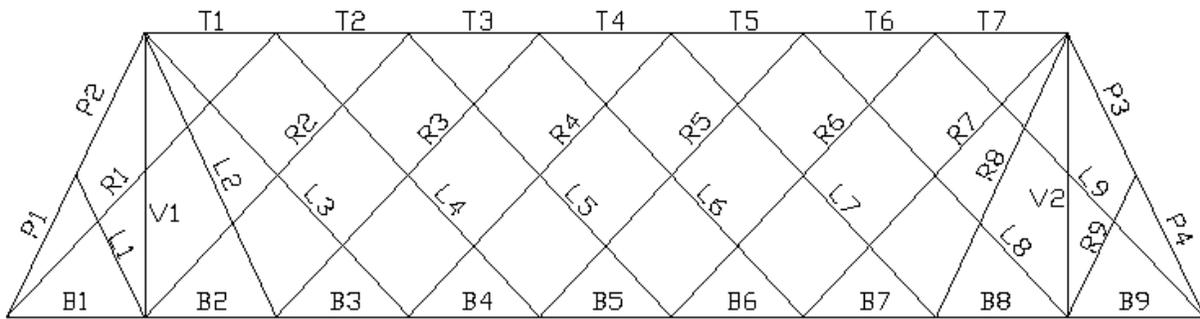
Figure 3.5 Member Labels in the RISA Model.

A letter and number identify the members and their locations. The letters indicate the type of member: the letter B identifies a member belonging to the bottom chord, V is for the vertical members, T denotes that the member is in the top chord, P is for the end-portals, and L and R identify diagonal members. The numbering starts from the left and increases to the right. There are nine different types of sections used in the construction of the truss members. The sections are built up by riveting plates and angles together in multiple combinations. Figures 3.5 and Figure 3.6 show the member and joint labels as used in the RISA model.

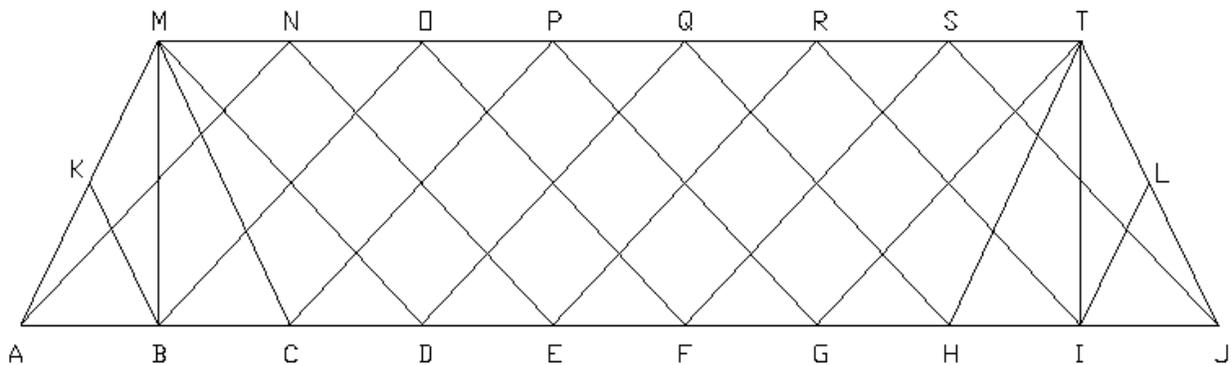
Figure 3.6 Joint Labels in the RISA Model.

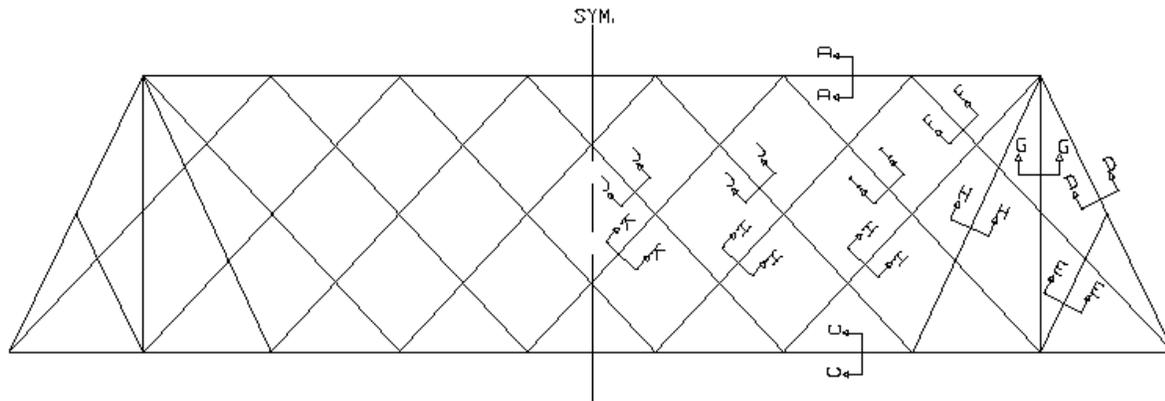
Figure 3.7 Truss Member Section Labels

Using information and drawings provided by Mr. Joe Minick of ASVRA, the section properties of each member were calculated and input into RISA. The areas and moments of inertia were calculated. This would allow for the calculation of axial stresses as well as buckling loads for the compression members. After the stress calculations were completed, the results were compared to find the percent increase that occurred because of the heavier steam locomotive. Figure 3.7 shows the different sections used for the truss members. Appendix A includes detailed drawings of these sections. Table 3.2 lists the section properties including area and moments of inertia.

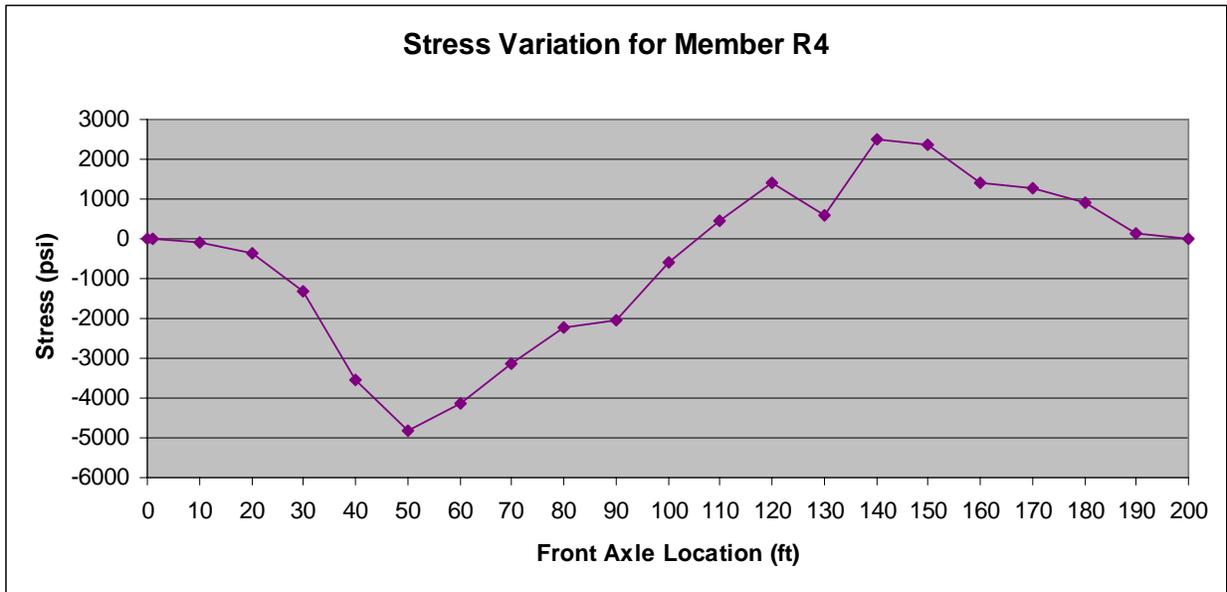
Figure 3.8 Stress Variation for Truss Member R4

It should be noted that these diagrams are drawn for the loads shown in Figure 3.2. Additional stress reversals will take place due to the other axles from the rest of the passenger/dinner cars, although the stress magnitudes will be significantly lower.

Using the stress variation diagrams, the number of cycles a member endures during each passage of the train can be determined. Each time a member undergoes a stress reversal, or cycle, the remaining fatigue life of that member is diminished. These diagrams can be used to determine how many cycles the members are expected to support within the next several years. All members have a finite fatigue life and can fail due to too many fatigue cycles.

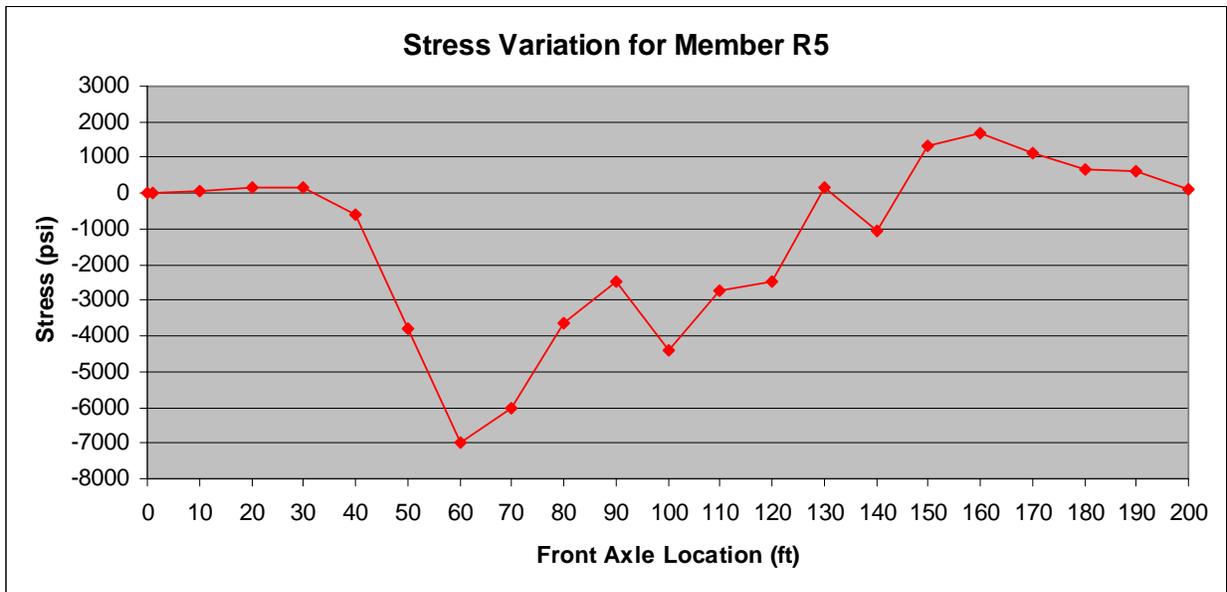
Figure 3.9 Stress Variation for Truss Member R5

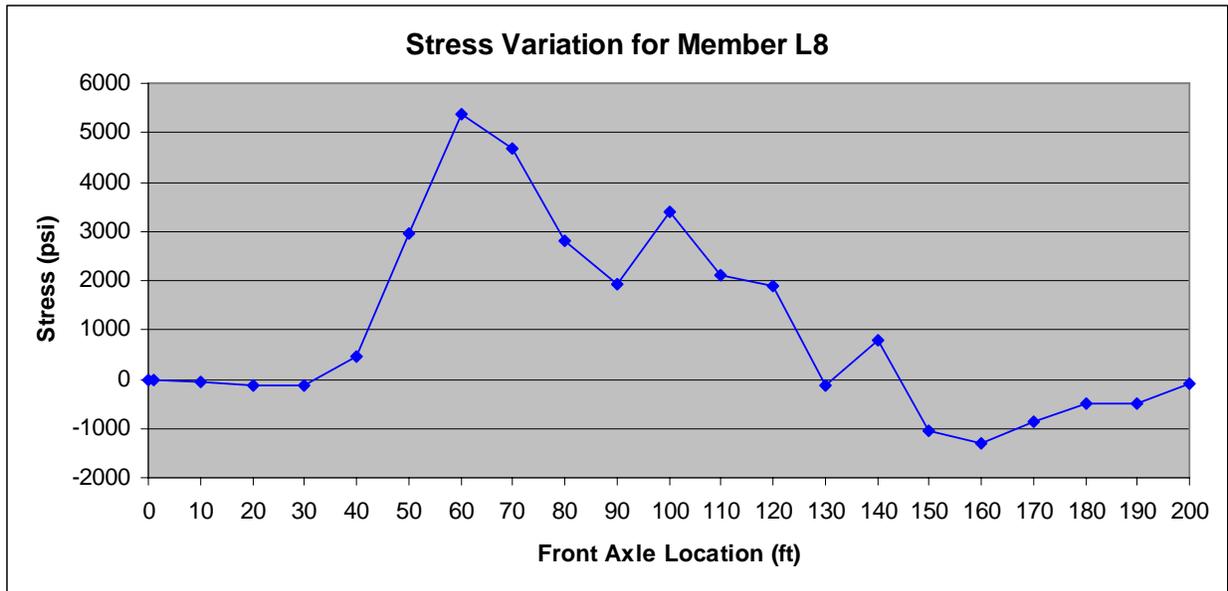
Figure 3.10 Stress Variation for Truss Member L8

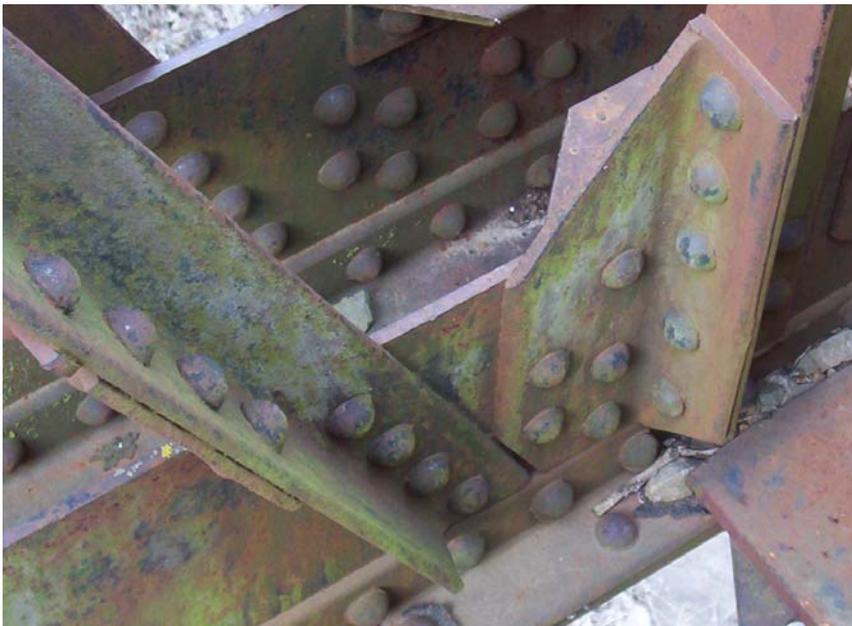
Figure 3.11 Typical Diagonal-to-Bottom Chord Connection

Lastly, stresses in the connections were checked. The diagonals of the truss are connected directly to the plates that make up the bottom chord. The steel angle is riveted to the bottom chord by one leg. The second leg of the diagonal angle is riveted to a second shorter piece of angle, which in turn is riveted to the bottom chord plate. All connections are completed using between eight to twenty $\frac{3}{4}$ inch rivets. A typical connection is illustrated in Figure 3.11.

The bottom chord connections were checked for rivet shear and bearing stresses. When checking for rivet shear stresses, the rivets were assumed to be hand-driven. This was the most conservative assumption since the method of installation is unknown. For hand-driven rivets, the maximum allowable stress is 11,000 psi as opposed to machine driven rivets which have a maximum allowable stress of 13,500 psi (AREMA, 1937, 15-9). The most conservative maximum bearing stress allowed by this manual is 20,000 psi. Again, this is based on the assumption that the rivets used on the bridge were hand-driven. The allowable stresses were

After calculation of the connection stresses, one connection did not pass specifications. The diagonal to bottom chord connection of R7 failed to meet the maximum rivet shear stress. The connection consists of 16 rivets and has a maximum allowable force of 77.44 kips. The maximum force induced by the Baldwin loading sequence is 79.35 kips. All other bottom chord connections met the maximum stress requirements.

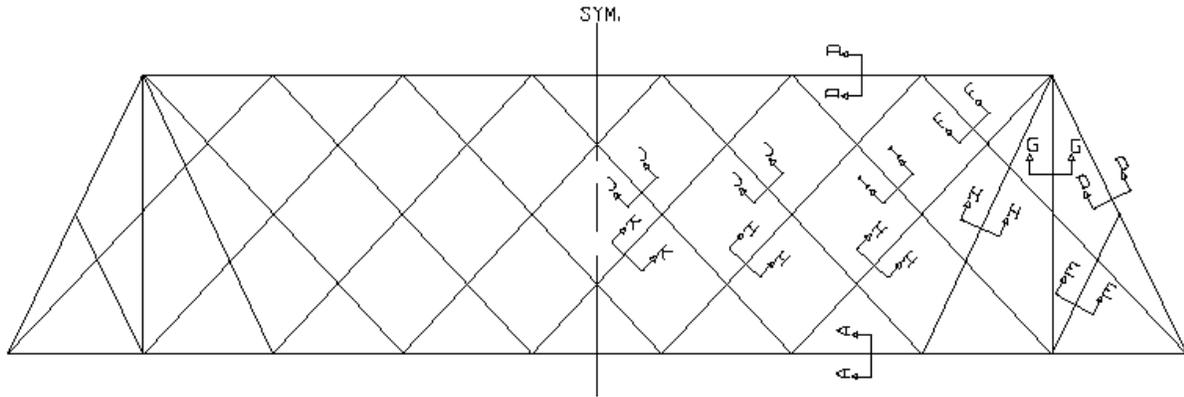
Figure A.1 Truss Member Section Label

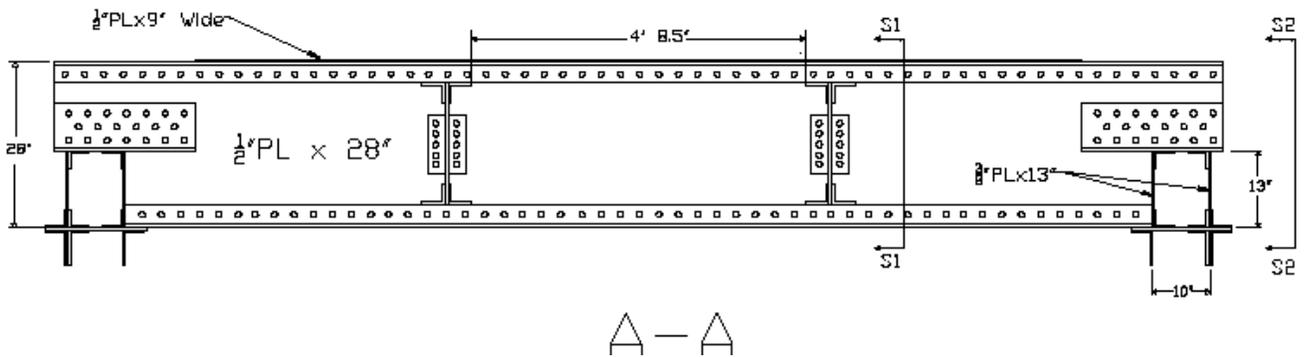
Figure A.2 Section A Through Both Lower Chords

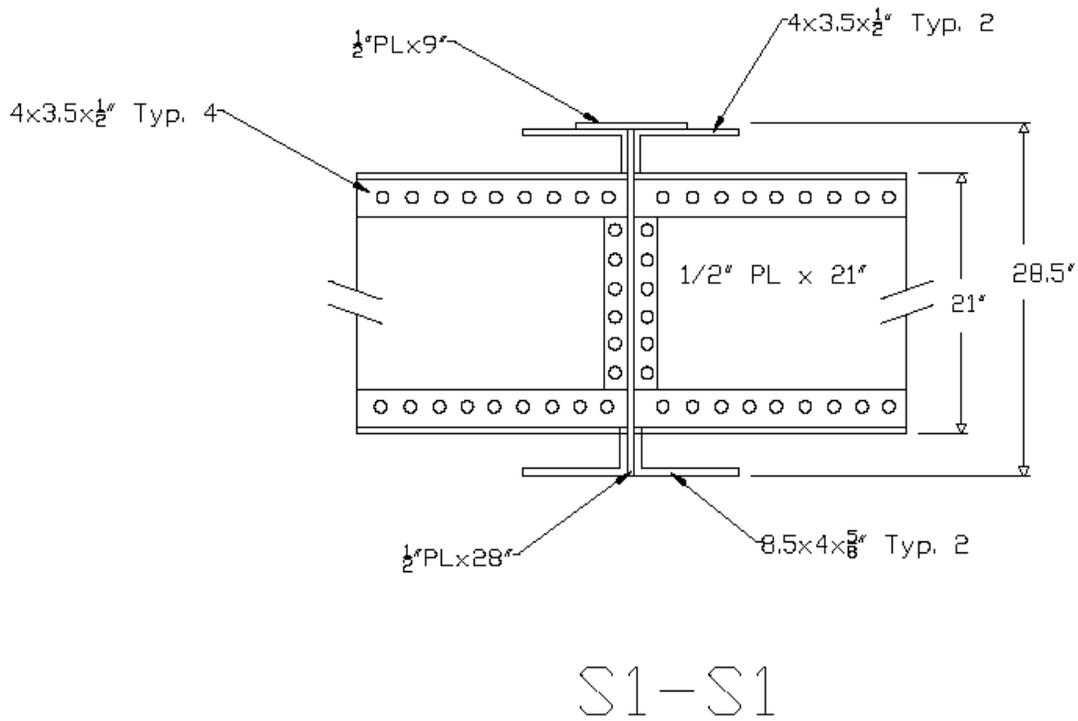
Figure A.3 Sectional View S1 of Figure A.2

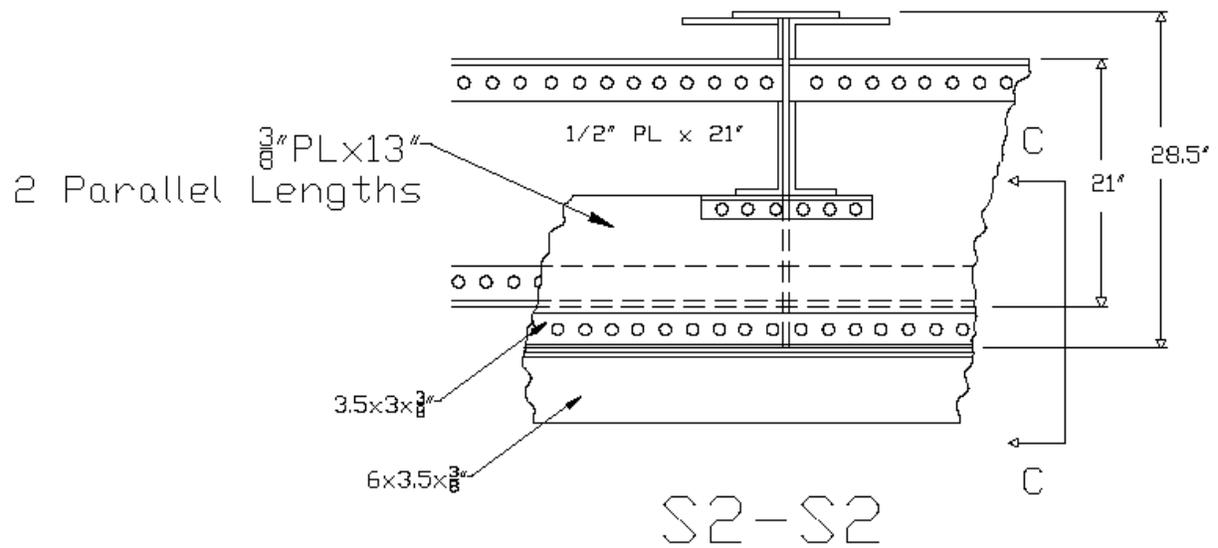
Figure A.4 Sectional View S2 of Figure A.2

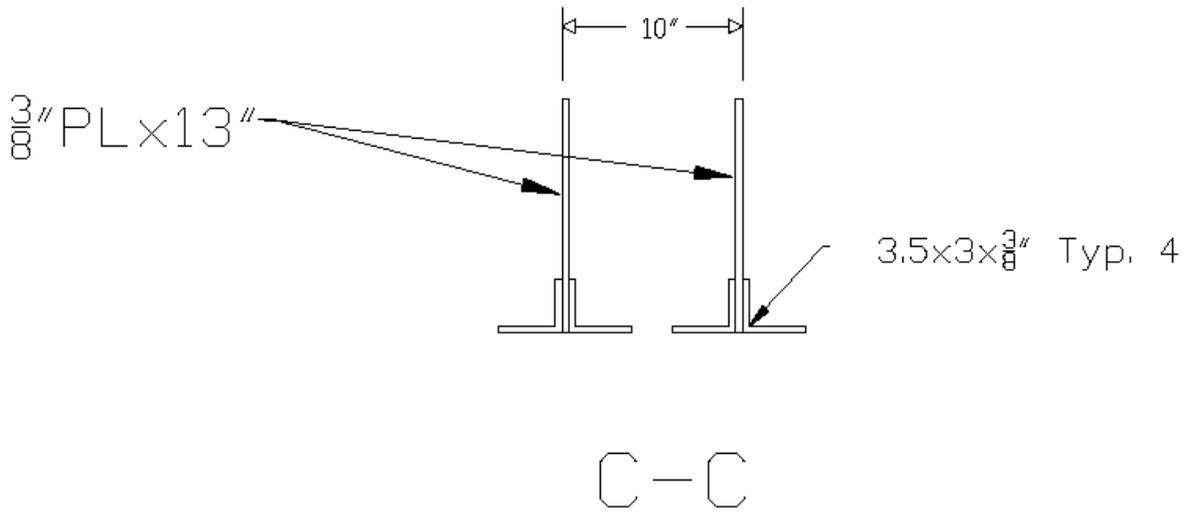
Figure A.5 Section C

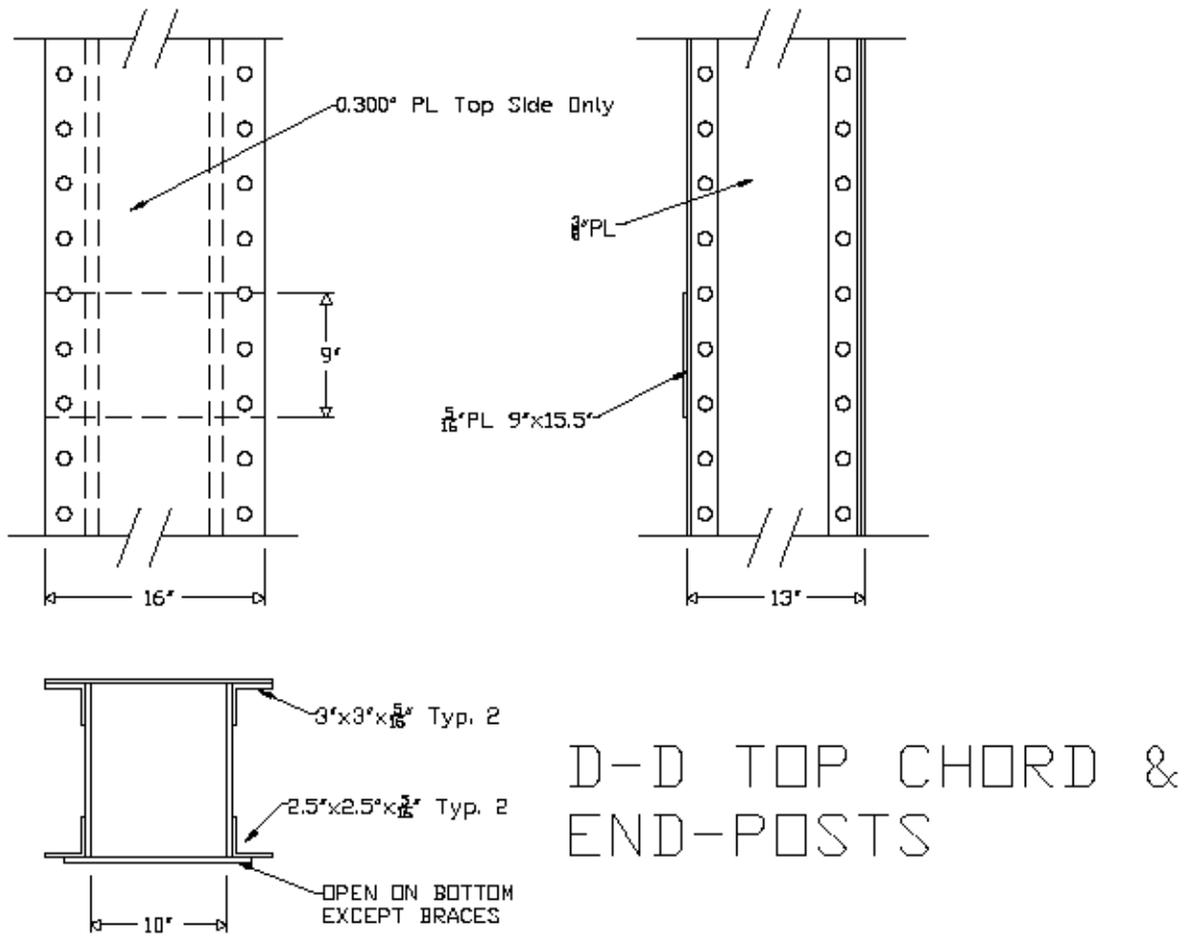
Figure A.6 Section D

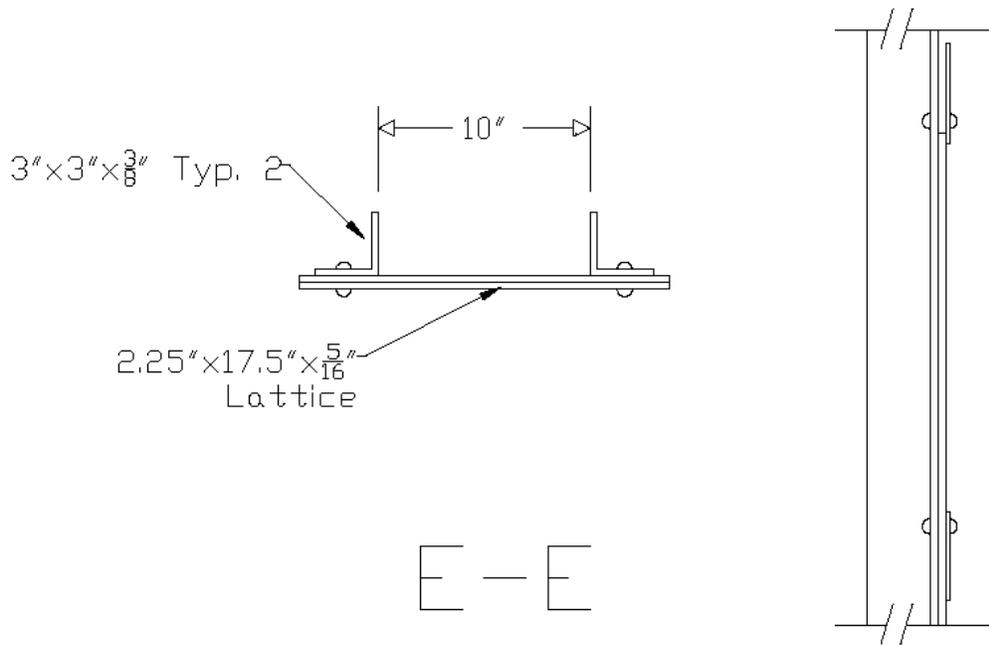
Figure A.7 Section E

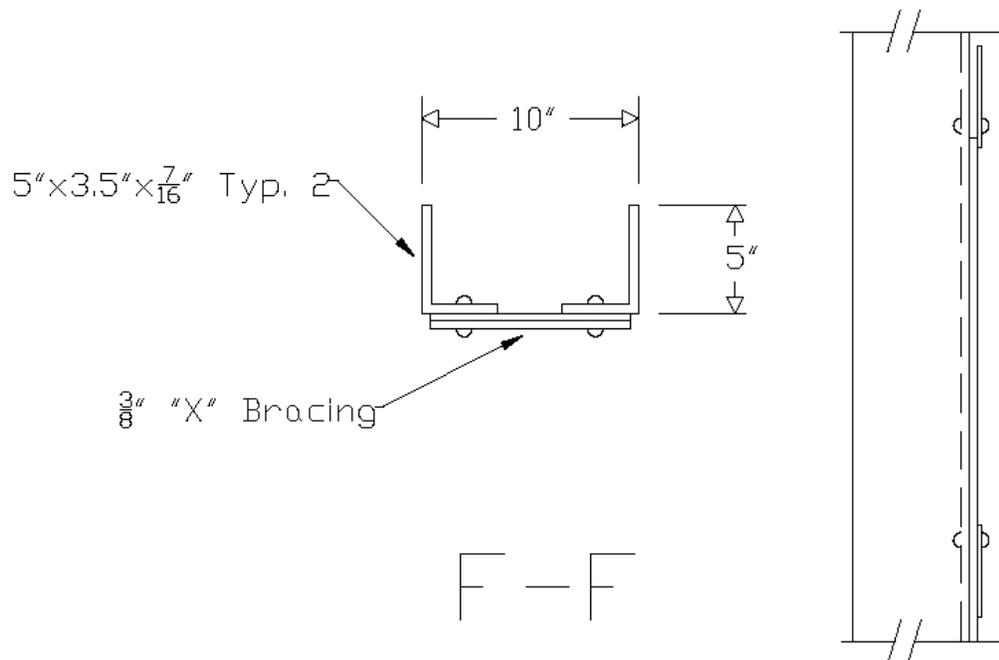
Figure A.8 Section F

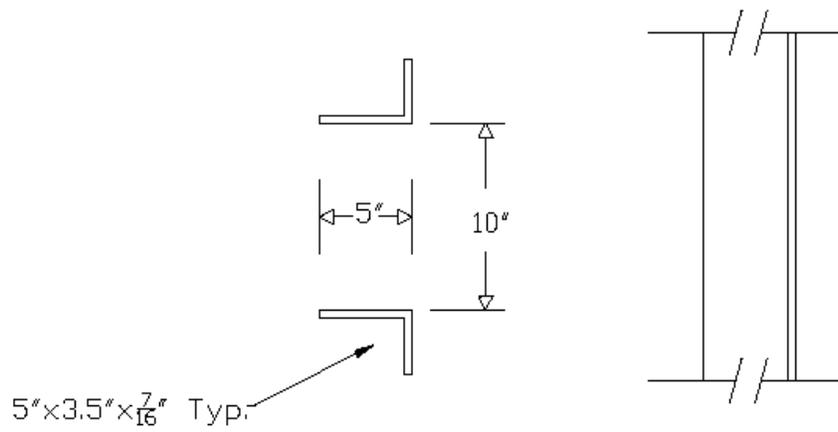
Figure A.9 Section G

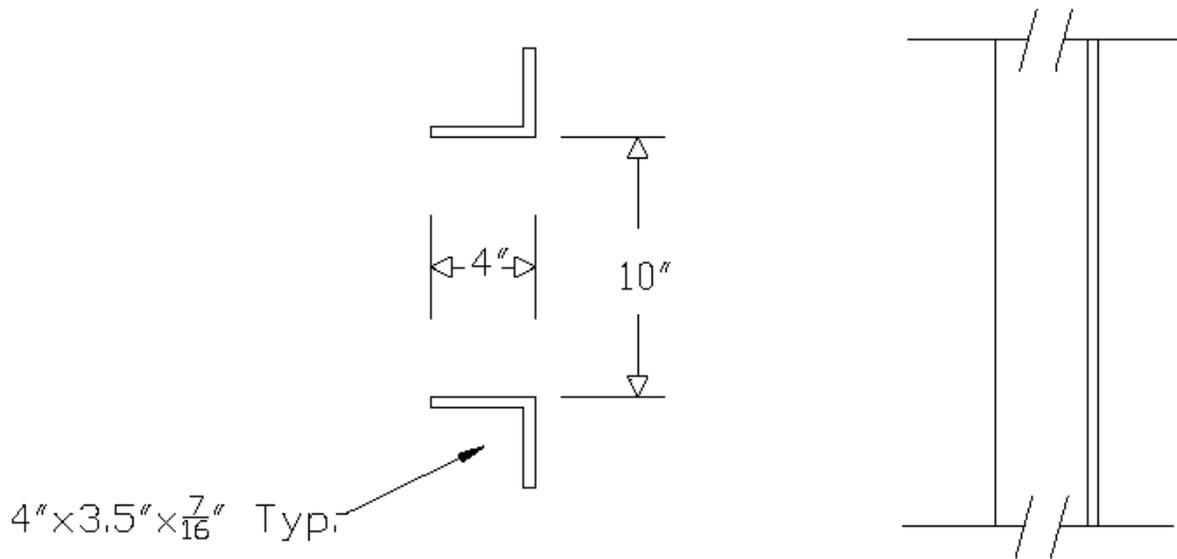
Figure A.10 Section H

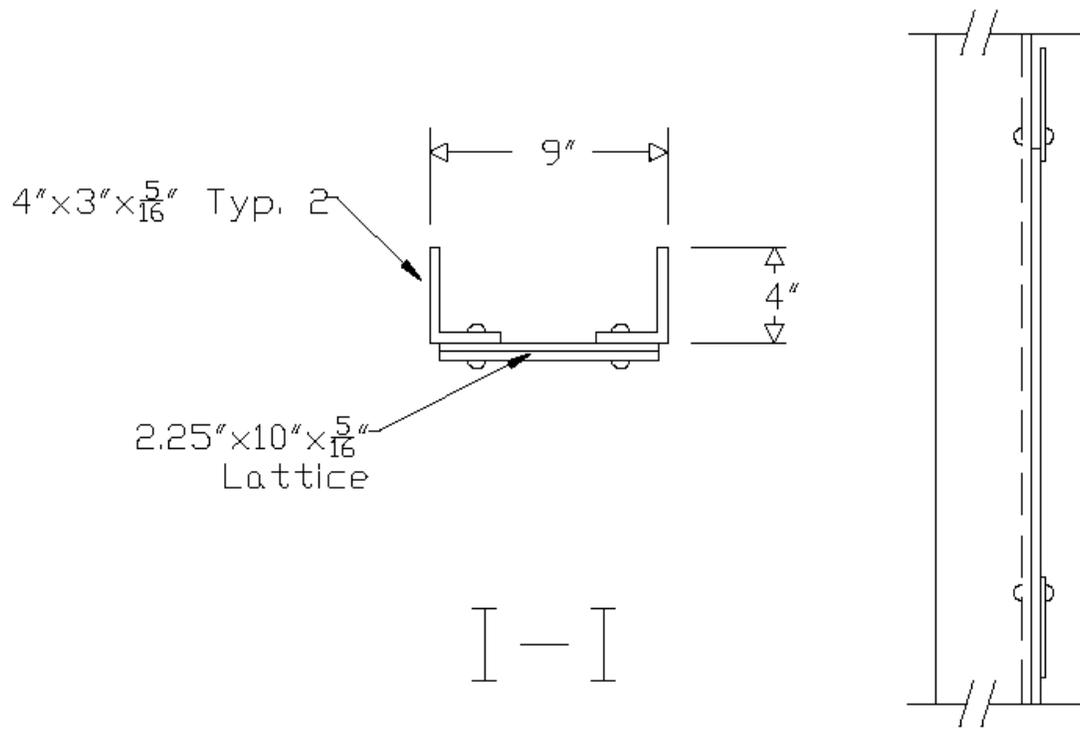
Figure A.11 Section I

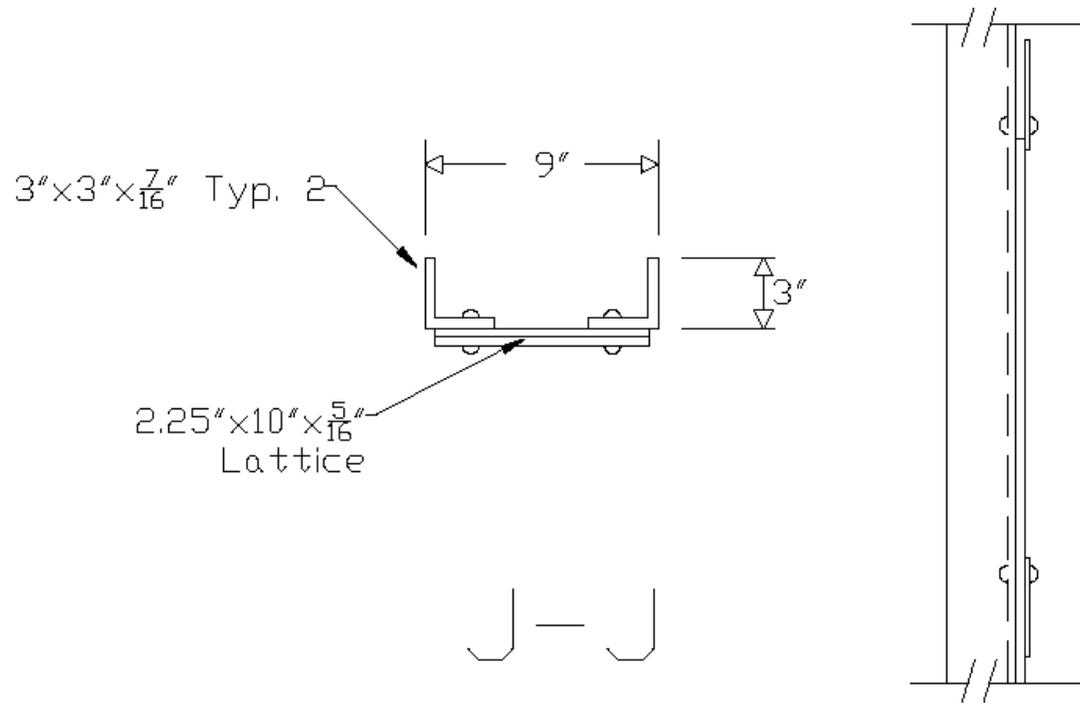
Figure A.12 Section J

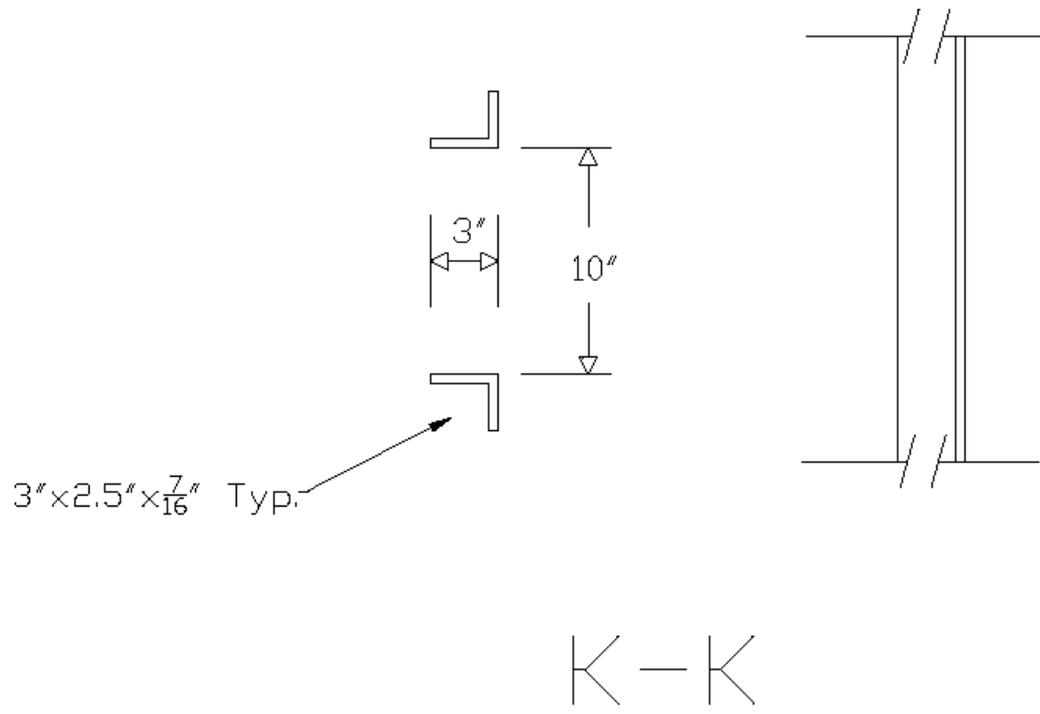
Figure A.13 Section K

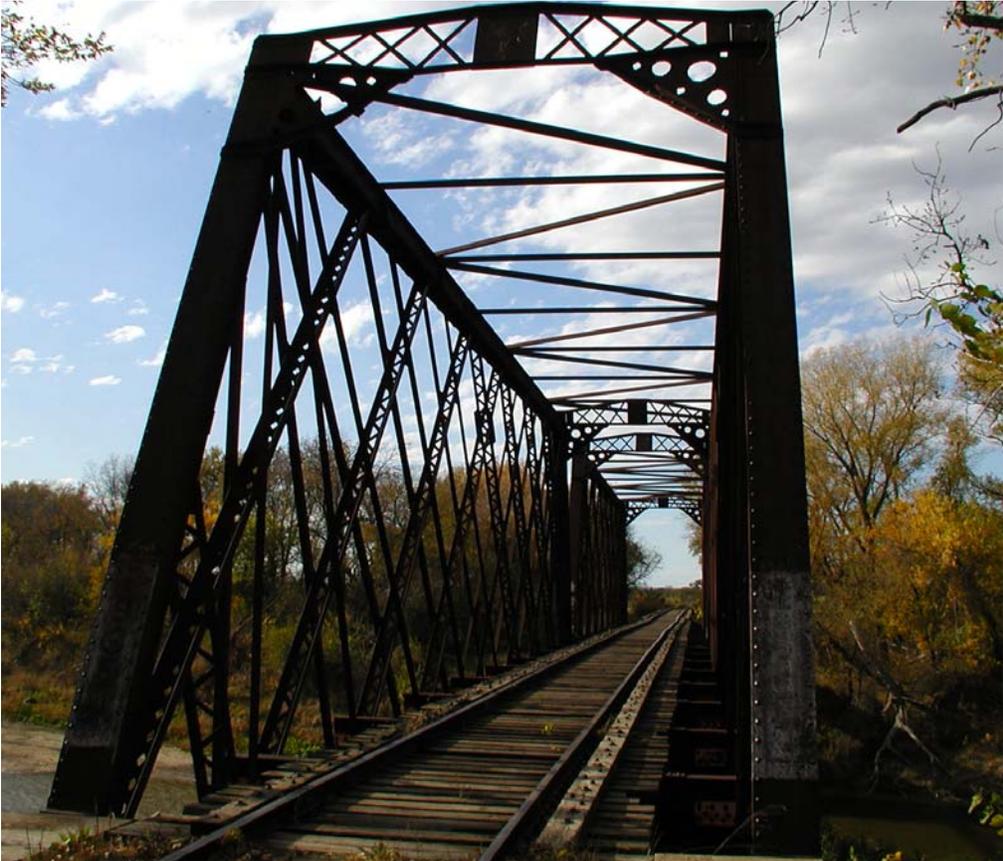
Figure C.2 End View of The Smoky River Bridge (Looking West)

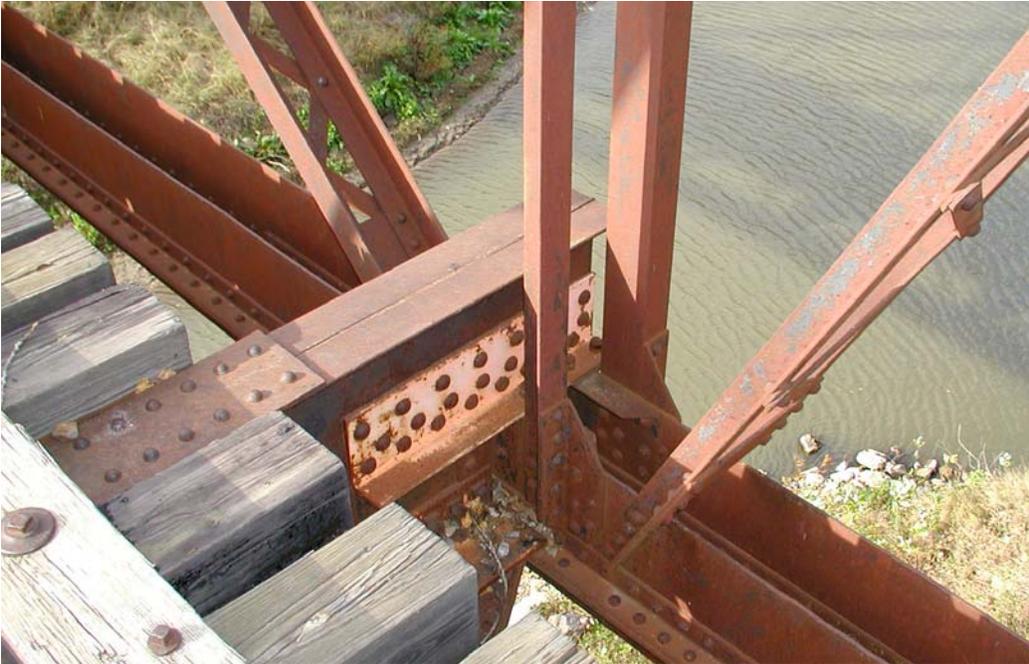
Figure C.3 Typical Floor-Beam to Truss Connection

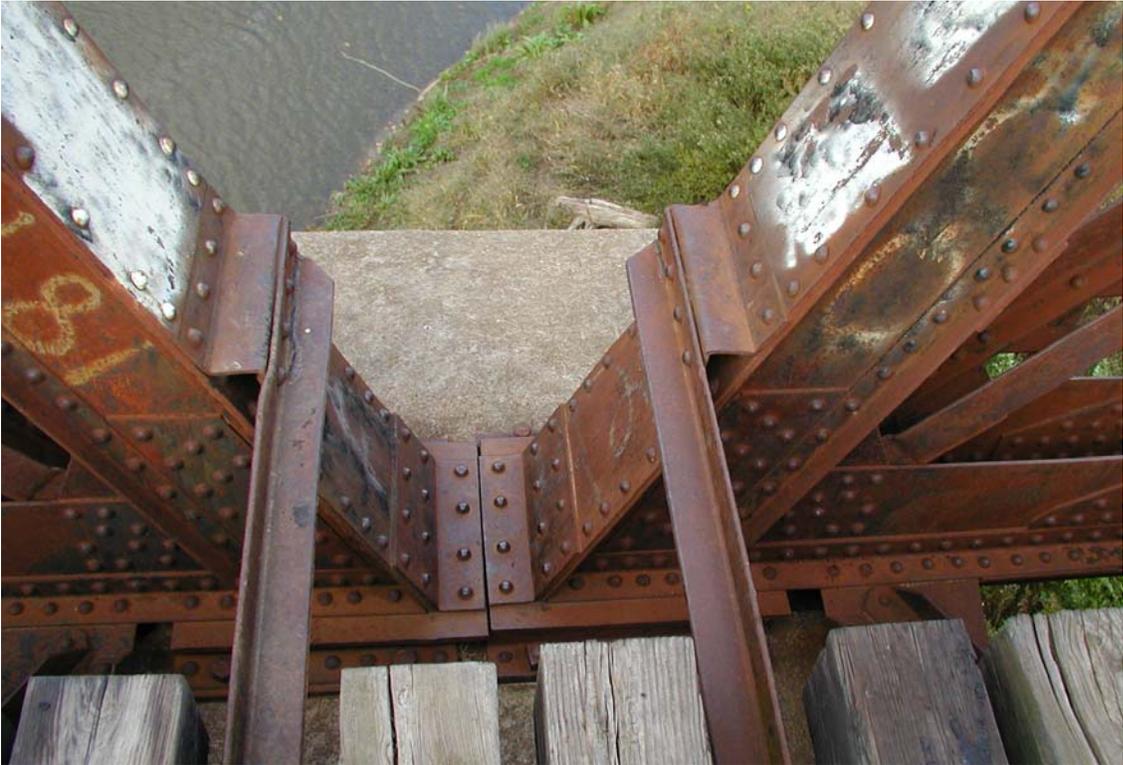
Figure C.4 Trusses Bearing on Middle Pier

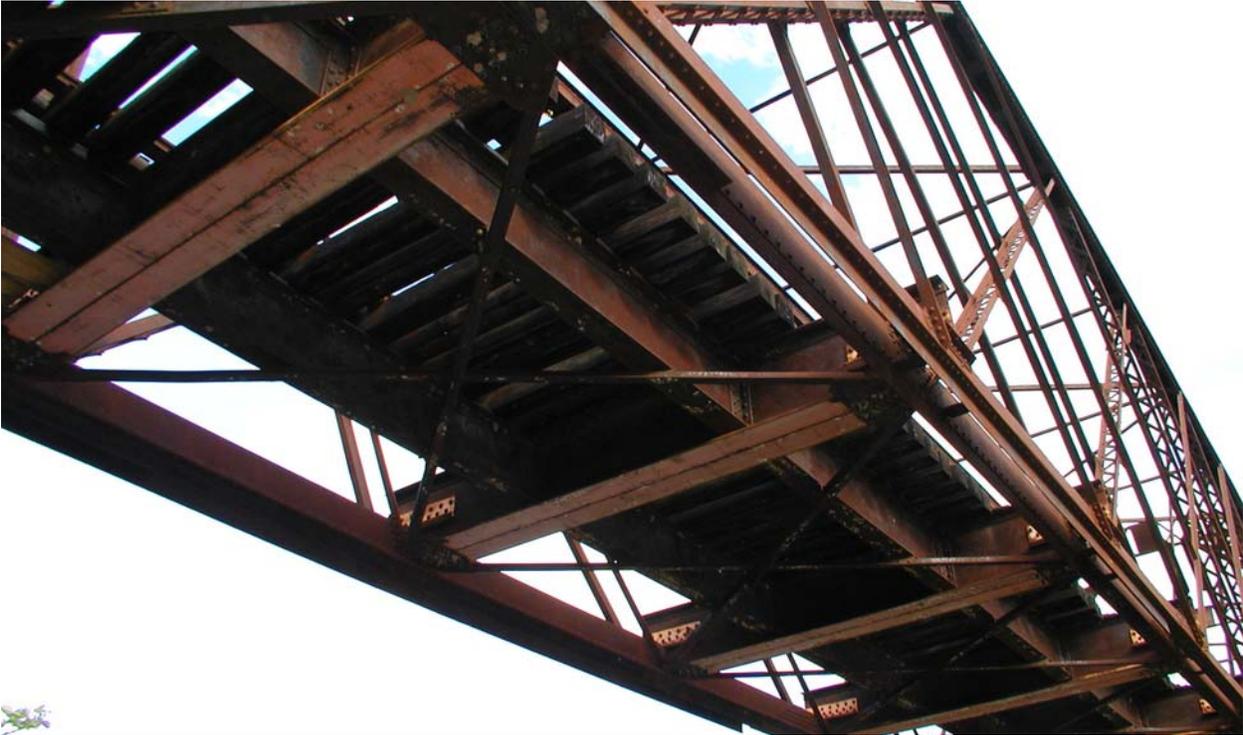
Figure C.5 Underside of Smoky River Bridge and Floor-Beams

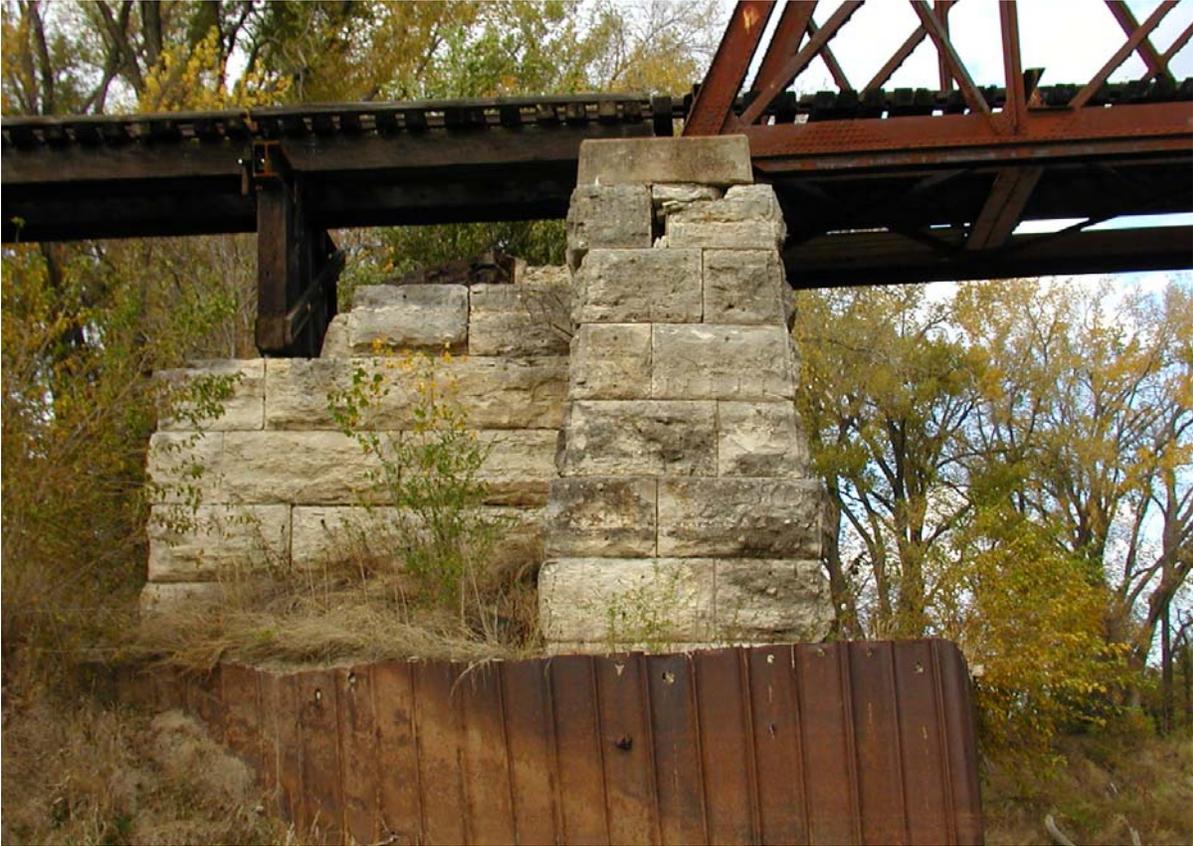
Figure C.6 West Pier

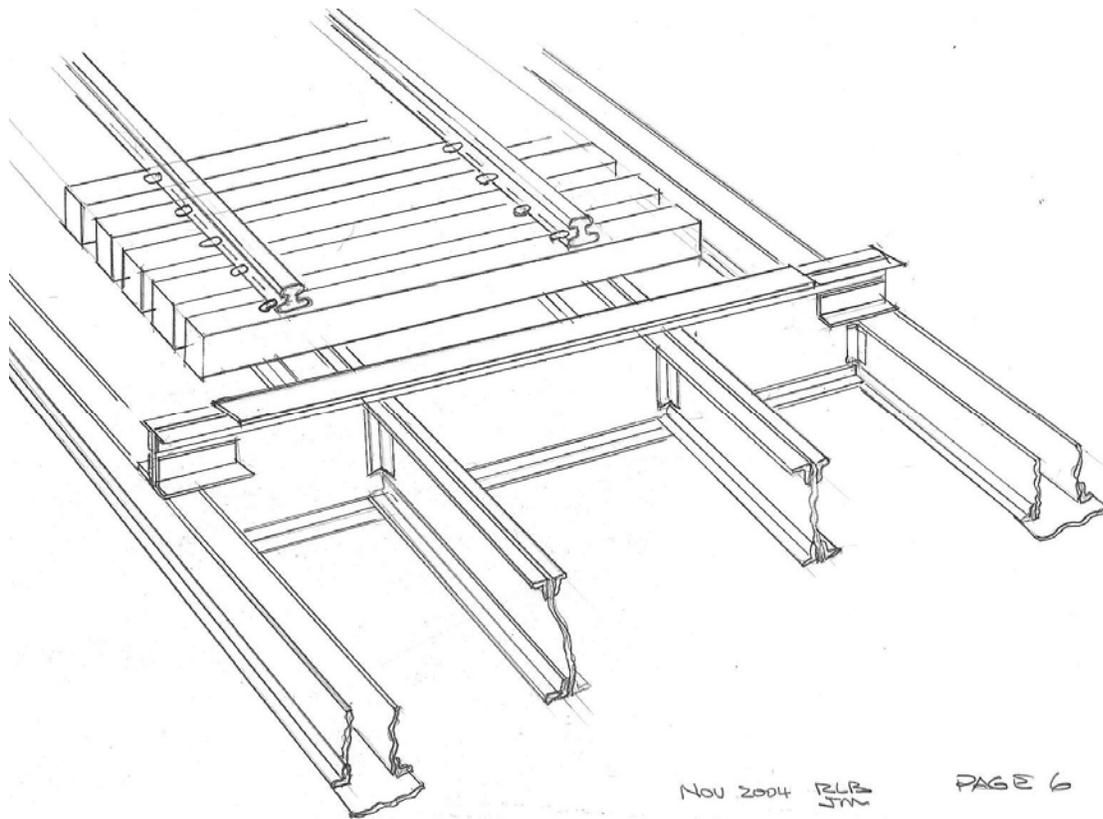
Figure C.7 Sketch of Floor-Beam System and Railway
