Investigating rates and mechanisms of lateral erosion in a small bedrock river using erosion pins,  
structure-from-motion photogrammetry, and optically stimulated luminescence dating:  
Konza Prairie, northeast Kansas

A THESIS

KANSAS STATE UNIVERSITY  
Manhattan, Kansas

2020

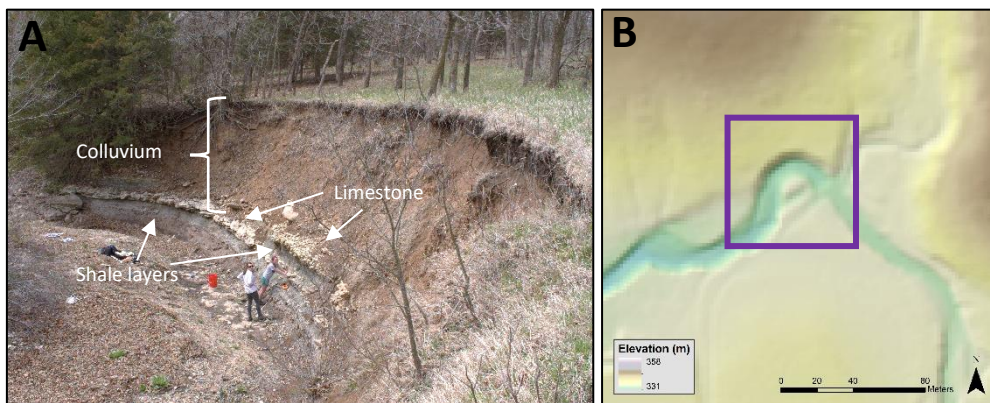
**Figure 3.5** (A) Overview of the entire study reach at the Nature Trail site. The white arrows and brackets indicate the layers of shale, limestone, and colluvium; (B) DEM view of the meander bend of the Nature Trail site (purple square).

The Nature Trail site is located approximately 770 meters downstream of the North Fork site and located on the main trunk of Kings Creek (Figure 3.2A). The contributing upstream drainage area is 11.22 km<sup>2</sup>. Here, there are also two cross-channel transects approximately 25 meters apart from each other that serve as study locations at this reach. The bank height for the entire reach is ~6.5 meters. At both the upstream and downstream cross sections, there is a thick layer of colluvium (~ 3 m) resting atop of the alternating shale and limestone layers that are both ~30 cm in thickness (Figure 3.5A). The channel bed is limestone, with intermittent alluvial cover.

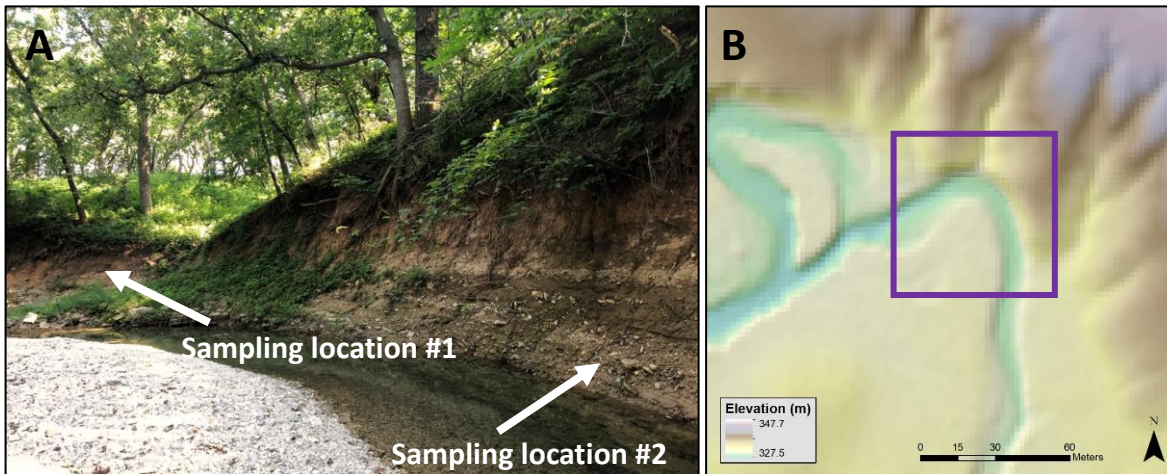
**Figure 3.6** (A) OSL sampling locations #1 and #2, indicated with white arrows, along the meander bend at the Large Woody Debris site; (B) DEM view of the meander bend of the Large Woody Debris Site (purple square).

the channel bank: three samples at an upstream location and one sample ~20 m downstream (Figure 3.6A).

At the downstream sampling location – sampling location #1 – the channel bank is ~4 m high. The sample, KNZ001, was taken 1.7 m above the bedrock. The fluvial deposits consist of mostly medium- to large-sized cobbles, and a few small boulders. The sampled material itself is fine-grained floodplain material and some small gravel-sized grains.

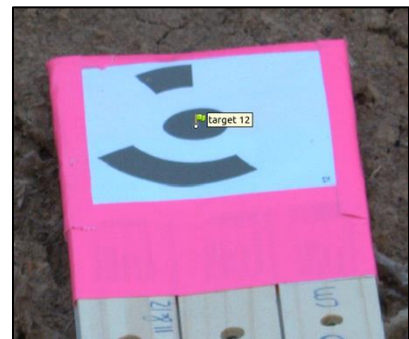
**Figure 4.2** A ‘marker’ generated by Agisoft Photoscan.

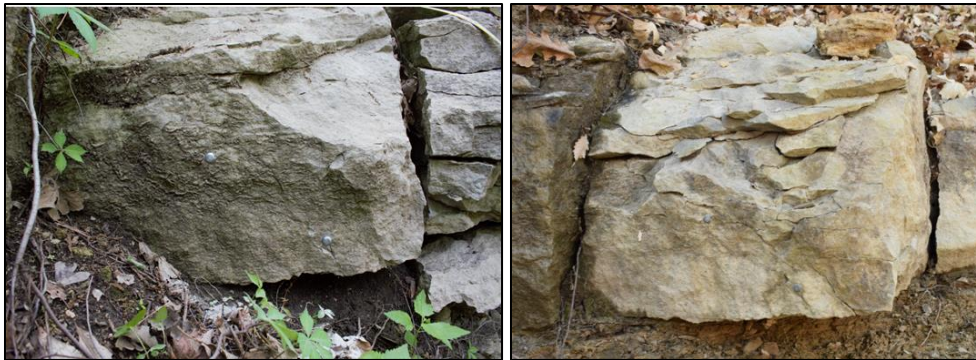
**Figure 6.2** Limestone layer in the channel bank at the upstream North Fork site on May 16, 2018 (Left) and November 16, 2019 (right) with loosely held rock fragments, likely as the result of abrasion.

The greatest limestone erosion occurred in the in-stream boulders close to the channel bed at North Fork (Figure 6.5). The observed mechanism of limestone erosion is plucking because blocks from the surface of the rock were missing. It is possible that abrasion contributed to the weakening and fracturing of the rock (Figure 6.2), which would make plucking more efficient. Erosion in limestone is not gradual, rather it is plucked away rapidly, which likely occurs during high flow events. The recorded limestone erosion over the measurement period ranges from 0 mm to 46.5 mm (see Tables 6.1, 6.2 and 6.3). Not including the 0 mm measurements in calculations, the average annual limestone lateral erosion rate is 20.82 mm/yr, and 96.80 mm/yr during the summer months (May – October 2019). These rates were calculated using the same method as the shale erosion rates. No limestone erosion occurred at the downstream Nature Trail site (Table 6.2 and Figure 6.3), likely because the erosion pins are at the top of the bank and are seldom under attack from water or sediment impacts. Similarly the

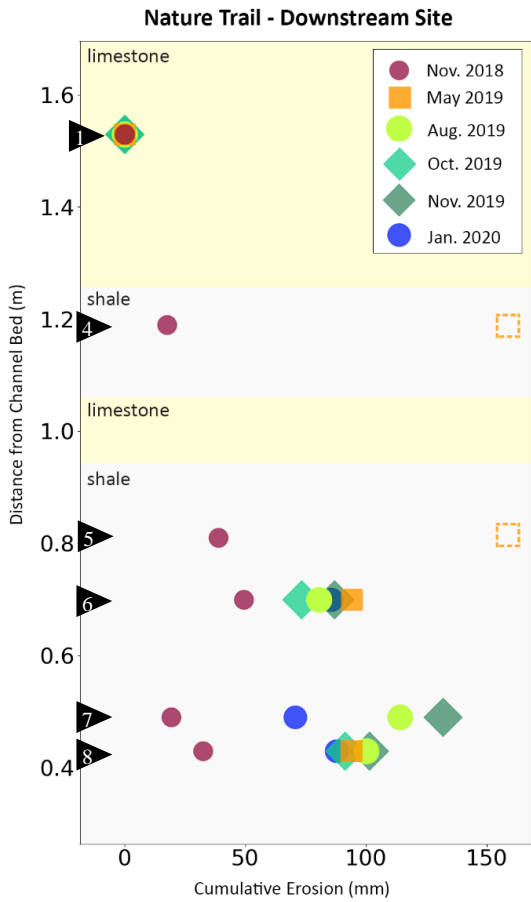
**Figure 6.3** Measurement of cumulative erosion at each erosion pin at the downstream Nature Trail site since installment in April 2018. The hollow shape and color indicate the month that the pin went missing. The red circles and number correspond to the pin number in the black triangle on the y-axis of the graph.

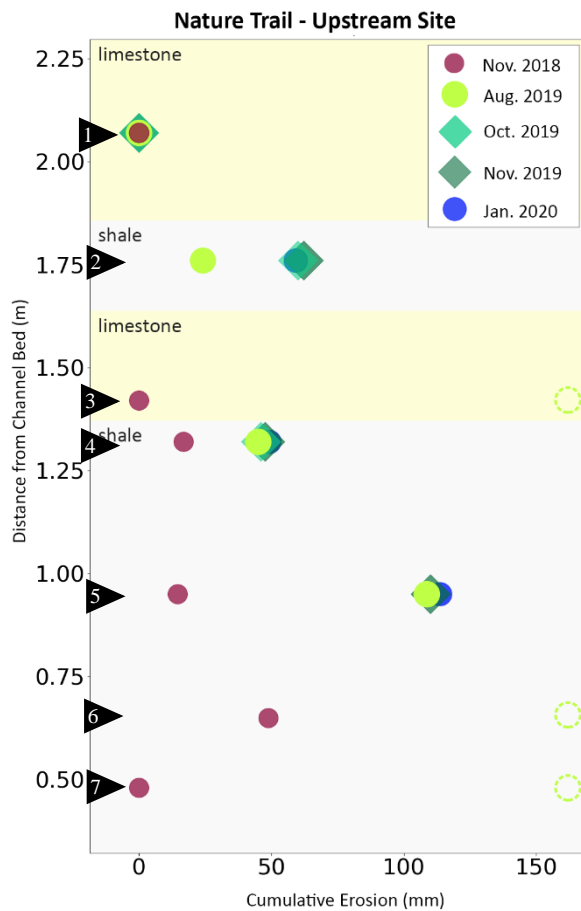
**Figure 6.4** Measurement of cumulative erosion at each erosion pin at the upstream Nature Trail site since installment in April 2018. The hollow shape and color indicate the month that the pin went missing. The red circles and number correspond to the pin number in the black triangle on the y-axis of the graph. Erosion pins were not measured here in May 2019 because of a high water stage and discharge.

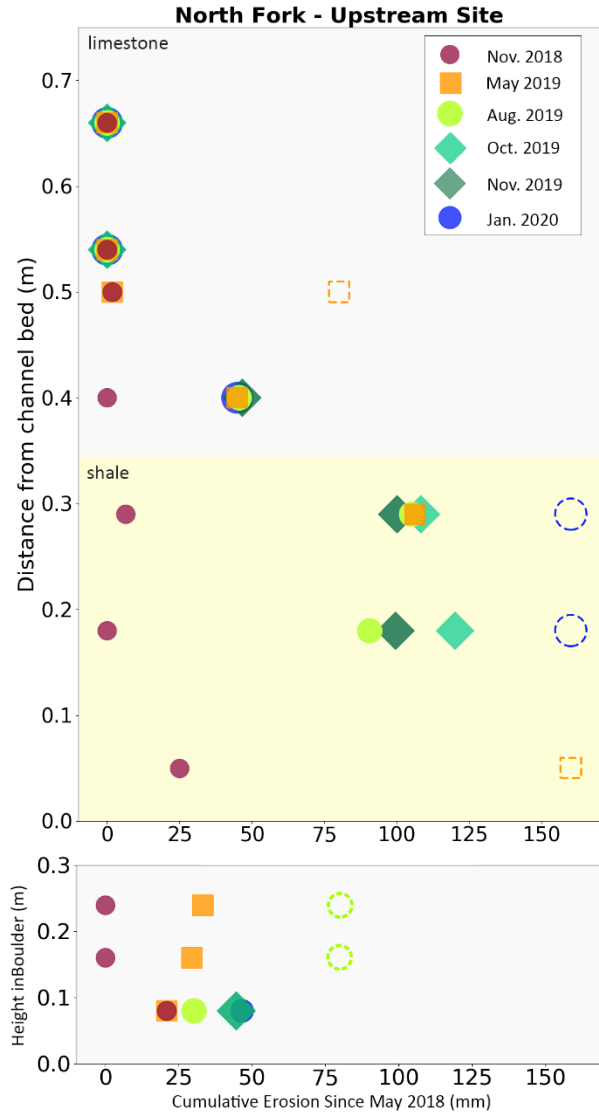
**Figure 6.5** Measurement of cumulative erosion at each erosion pin at the upstream North Fork site since installment in April 2018. The lower portion of the graph are erosion pin measurements for the in-stream boulder (bottom right image) with pins 8, 9, and 10. The hollow shape and color indicate the month that the pin went missing. The red circles and number correspond to the pin number in the black triangle on the y-axis of the graph.

erosion pins installed in the limestone at the top of the banks at North Fork lacked measurable amounts of erosion (Table 6.3 and Figure 6.5).

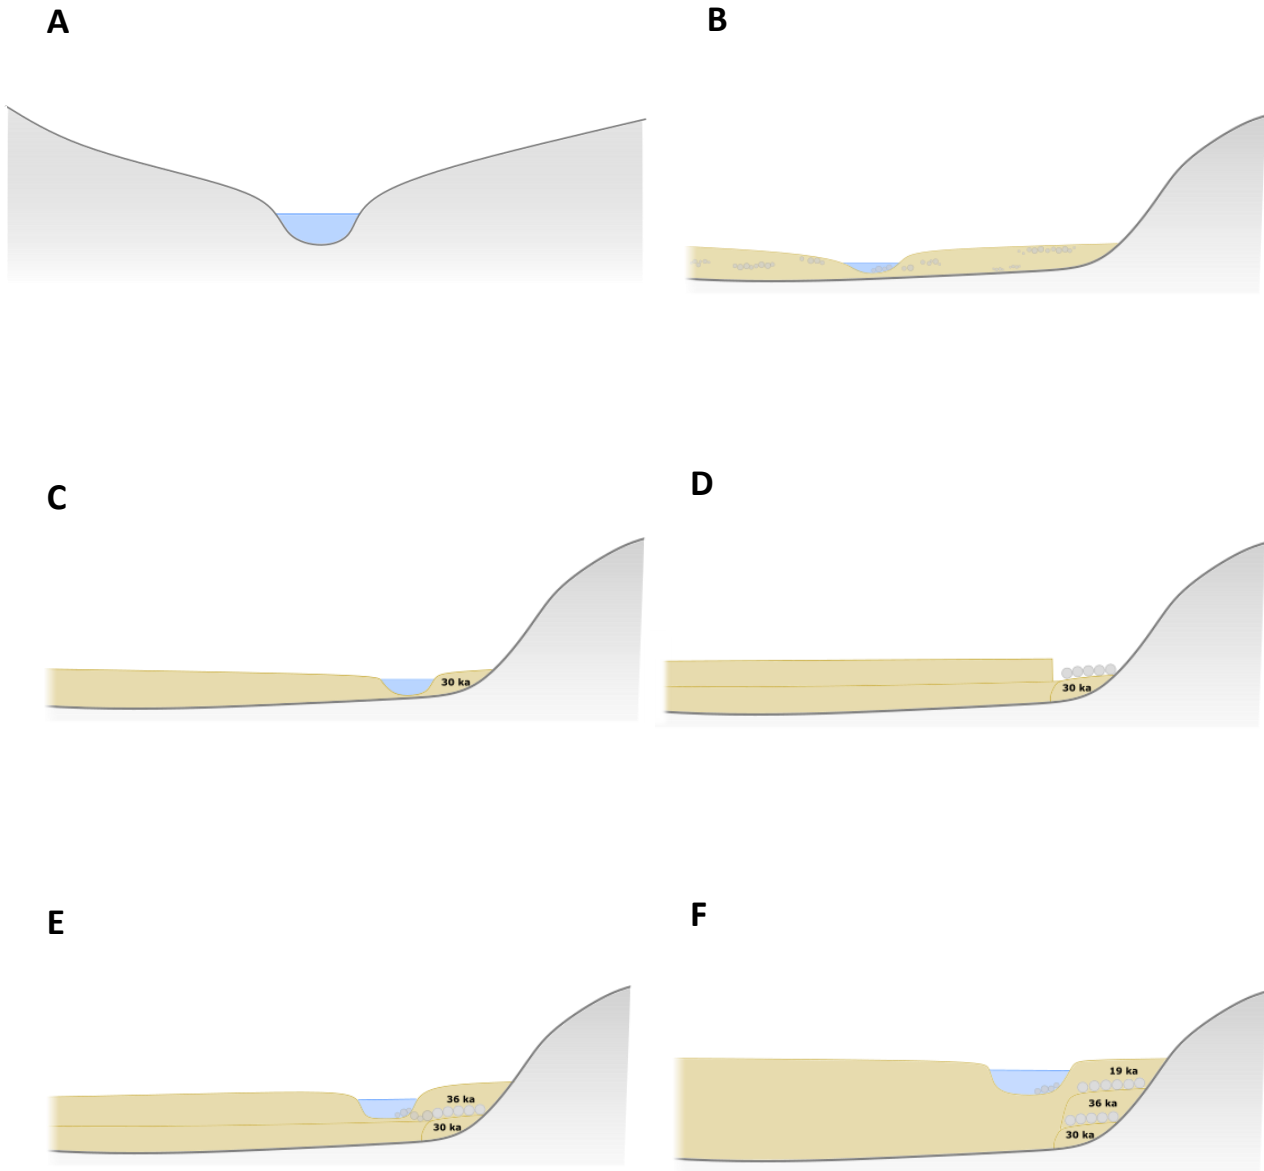
**Figure 7.1** Conceptual interpretation of the evolution of the valley at the OSL sampling location. (A) Initial bedrock channel, prior to widening; (B) Kings Creek channel after a period of channel widening; (C) Deposition of KNZ003 (age 30 ka); (D) Deposition of the cobbly layer immediately above KNZ003. Channel aggradation and migration of Kings Creek away from the north side of the valley; (E) Kings Creek returning to the north side of the valley and depositing KNZ004 (age 36 ka); (F) After a ~15 ky depositional hiatus, Kings Creek has aggraded and deposited KNZ005 (age 19 ka).

**Figure 7.1 continued:** (G) Sometime after 19 ky, Kings Creek was filled to ~4.5m above the current channel as a result of an actively aggrading stream; (H) Kings Creek incised into the alluvial fill sequence; (I) Valley filled with reworked loess by ~9 ky to create the K4 terrace (Smith, 1991); (J) A shift in stream behavior caused Kings Creek to incise then refill to create the K3 terrace (Smith, 1991); (K) Kings Creek then shifted behavior and experienced a period of downcutting to the modern stream elevation.

location. While the stream was not depositing at the OSL sampling site, it could have spent that time aggrading and filling up the valley with fluvial sediment further south. KNZ001 and KNZ005 are similar in age and lie at roughly the same elevation above bedrock (1.55 – 1.7m), which reinforces confidence in the accuracy of OSL dating method. This suggests that ~19,000 years ago, KNZ001 and KNZ005 were at the elevations of floodplains being deposited on top of a bedrock surface roughly 1 m below. There is a final cobble layer above the KNZ005 sampling layer, thus the stream was active at a higher elevation after ~19 ka. Sometime after 19 ka, the valley was filled to ~4.5 m above the current channel with fluvial material as a result of an actively aggrading stream (Figure 7.1G). Mandel (2008) suggests that streams were aggrading

Given the two fill terraces at Kings Creek dated by Smith (1991), it is necessary to reconcile OLS ages from this study with the radiocarbon ages found by Smith (1991) from a terrace of similar elevation downstream. It is possible that the valley filled with reworked loess by ~9 ky to create the K4 fill terrace (Figure 7.1I; Smith, 1991). The K3 terrace, age ~2 ka (Smith, 1991), is a fill terrace with cut terraces in some areas (Figure 7.1J). Kings Creek then shifted behavior and experienced a period of downcutting to the modern stream elevation (Figure 7.1K).

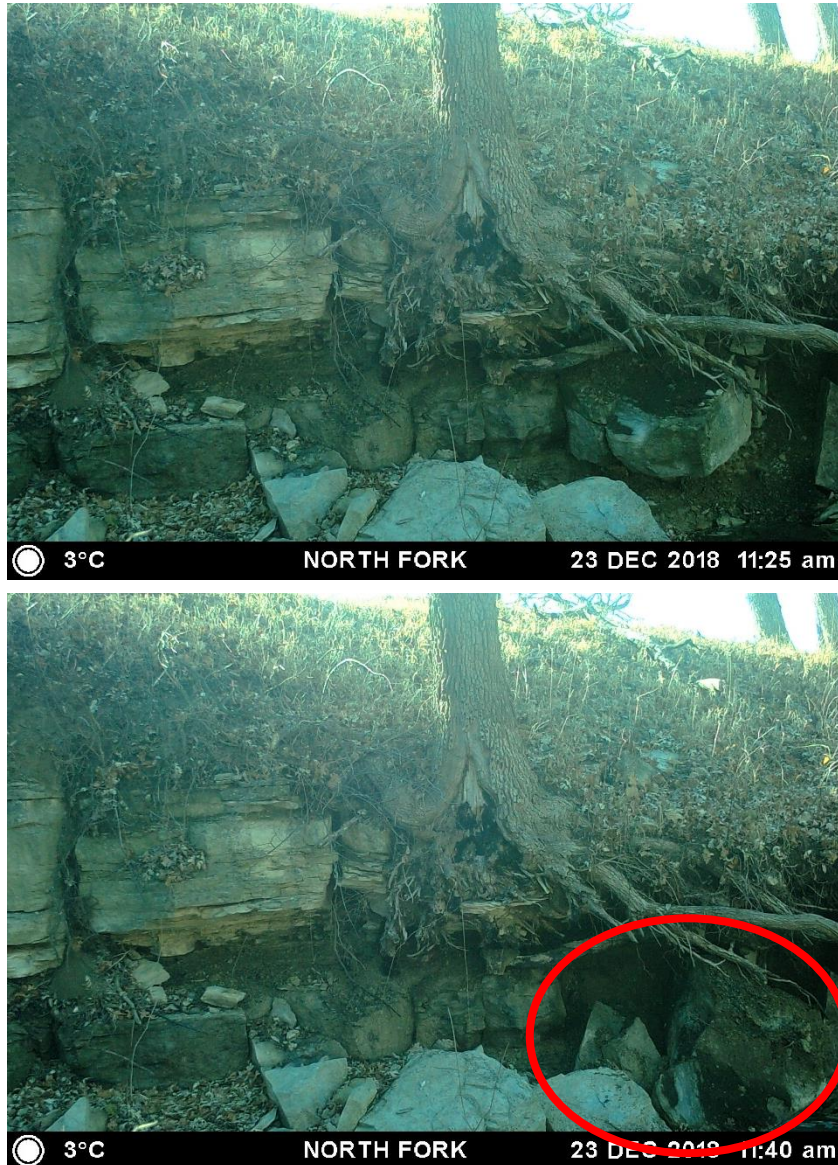
**Figure A1** Example of mass block failure of limestone bedrock from the channel bank at the North Fork downstream site (red circle). The bottom image was captured 15 minutes after the top image.

An additional observed lateral erosion mechanism is mass wasting of limestone blocks into the stream. The first instance occurred on December 23 when a large limestone boulder ~1.5 m in diameter at the downstream North Fork site collapsed into the stream (Figure 6.6). As a result, erosion pins at this site are buried underneath this boulder. The cause of collapse is unknown, but it was likely due to the severe undercutting of the bank before the start of this study.

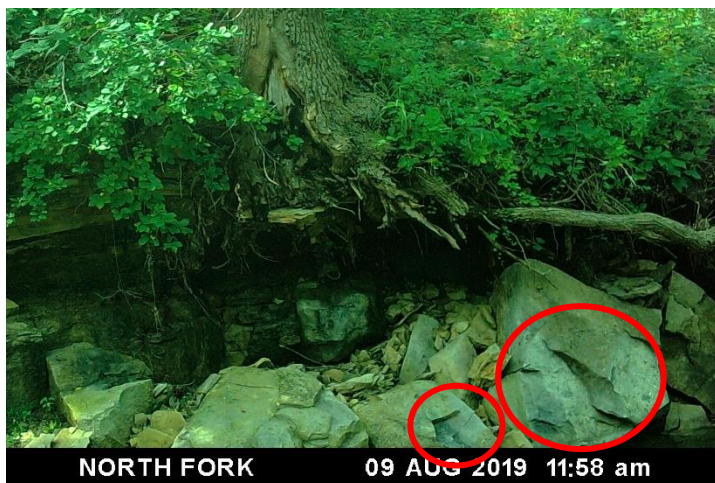
**Figure A3** Evidence of plucking (red circles) at the downstream North Fork Site not present in the May 2019 trail camera images.
