Finite Element Analyses and Proposed Strengthening of a Reinforced Concrete
Box Girder Bridge Subjected to Differential Settlement

A THESIS

submitted in partial fulfillment of the requirements for the degree

2018

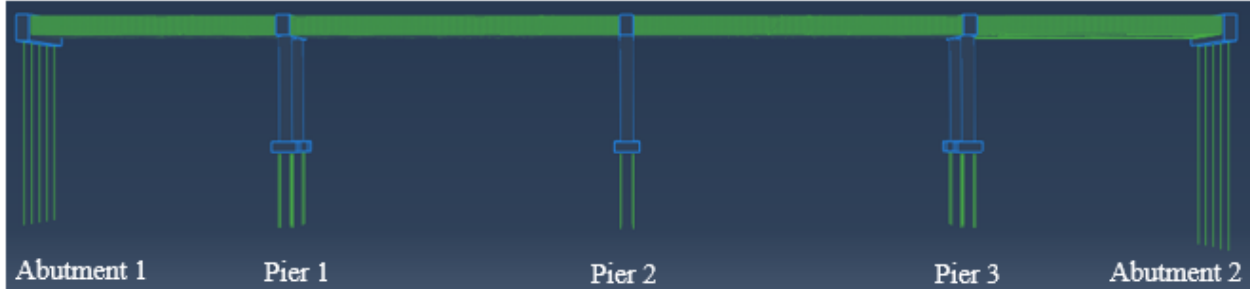
Figure 3: Elevation View

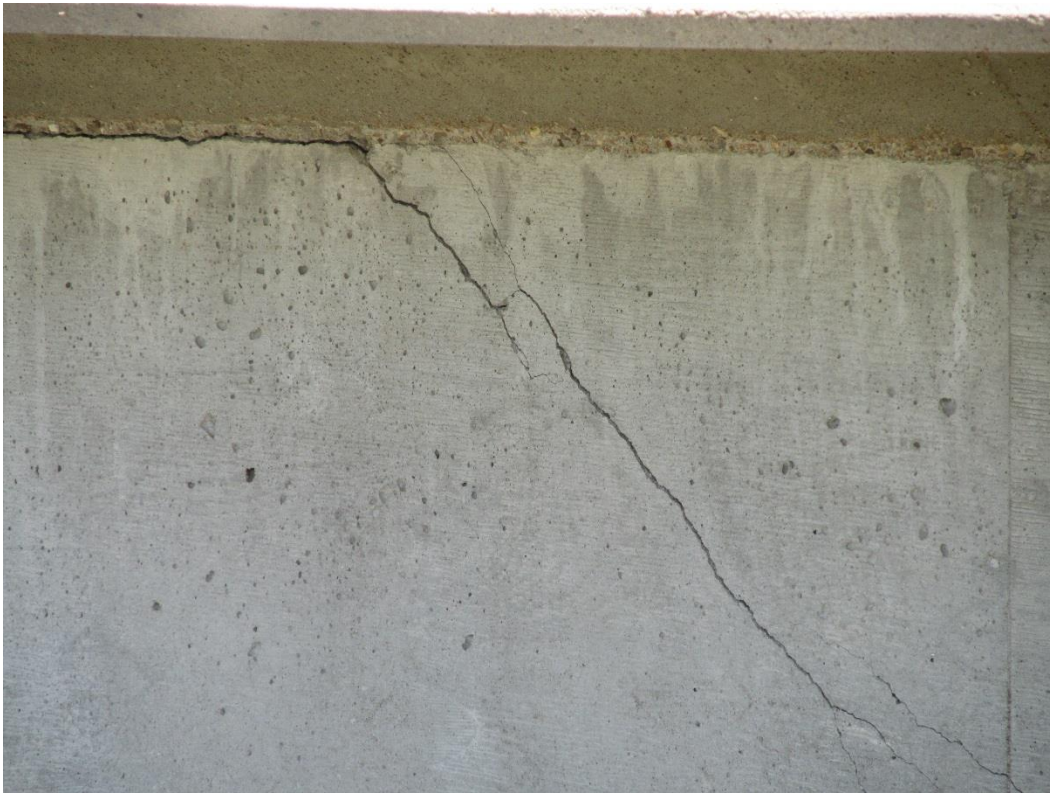
Figure 7: Shear Crack in Web of Box Girder

When creating each model, the elastic modulus of concrete was taken to be 33% of the original modulus of concrete for a concrete with a compressive strength of 4000 psi. The original modulus was found by taking 57000 times the square root of the compressive strength. This was done to account for the cracking in the concrete as well as the creep that the concrete has experienced since it was placed in situ. The moment of inertia of cracked concrete is approximately half that of the gross moment of inertia. Cracking was observed during the site inspection and through calculations of the effective tensile stresses in the elements exceeding the modulus of rupture of concrete. Figures 7 and 8 show examples of cracking that was observed in the bridge.

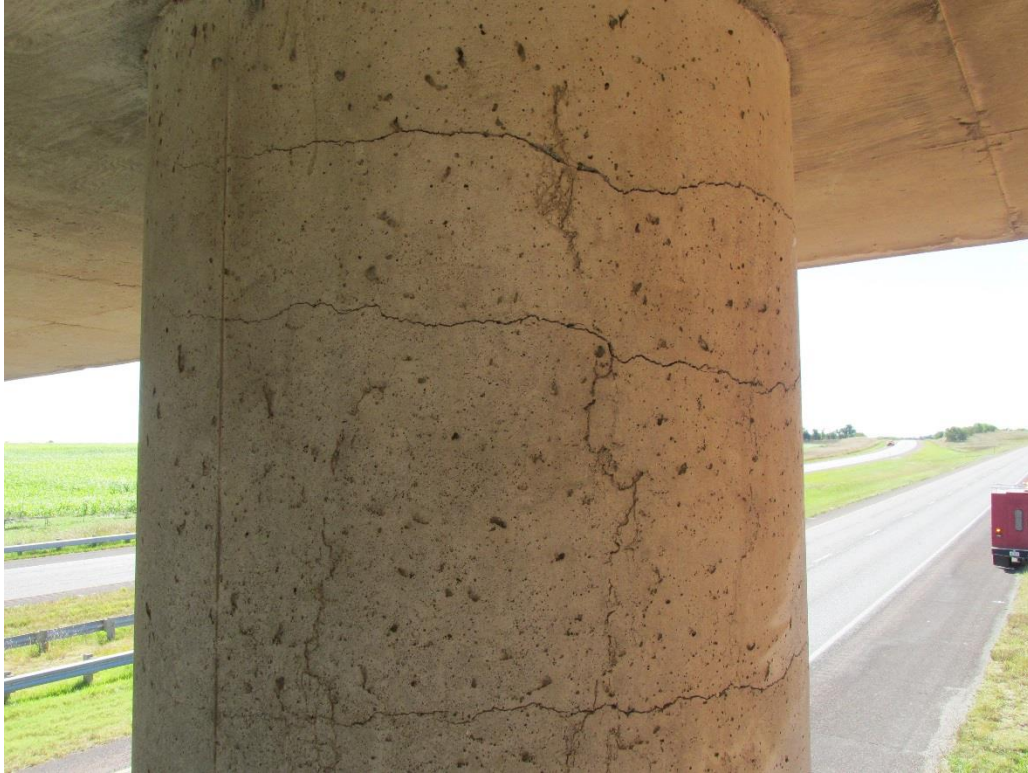
Figure 8: Radial Cracks at Top of Pier

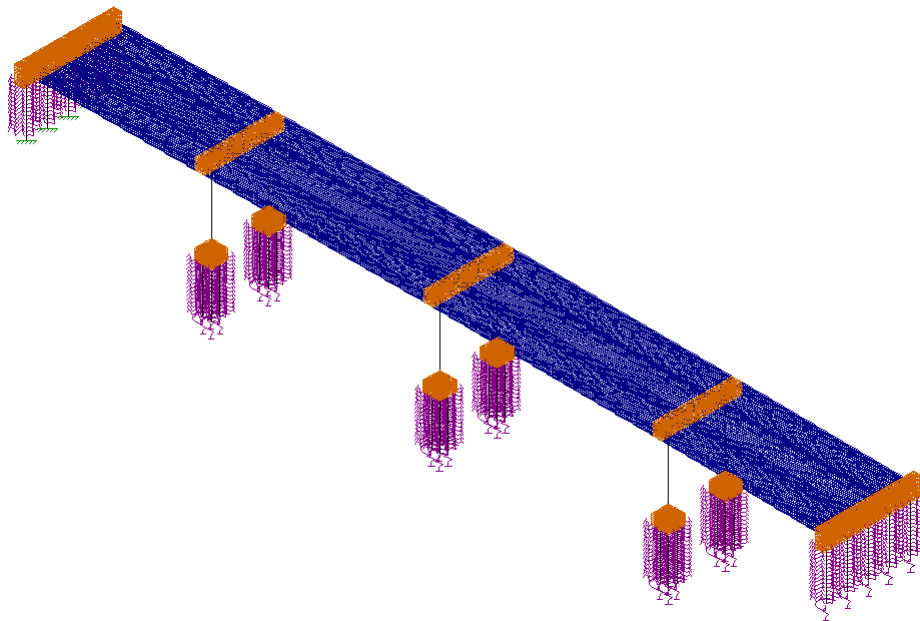
The commercial finite element software, RISA3D, was used to model the bridge in this part. Three element types were used; linear solid elements, linear shell elements, and beam elements. An 8-node linear brick element was used for the solid meshes in the abutments, pier cross-beams, and pile caps. A 4-node linear plate element was used for box girders. A 2-node cubic beam element in 3D space was used for the piles under the piers and abutments as well as the piers themselves. The mesh used was made as fine as possible without exceeding the number of plate elements the program allows or without making the element aspect ratio closer to a solid element rather than a thin plate element. In total, the model is made of 516 beam elements, 33,600 plate elements, 6,784 solid elements and 43,044 nodes. Like the Abaqus model, the rebar is not included in the RISA model. This model is shown below in Figure 10.

Figure 10: RISA 3D Model with Plates Modeling All Spans

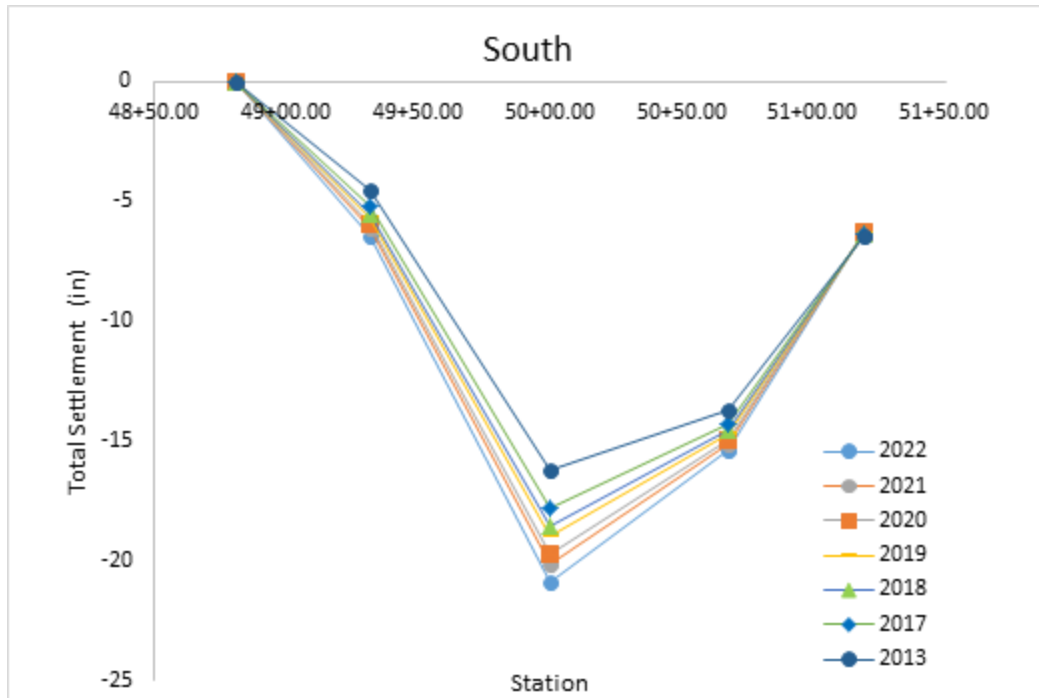
Figure 12: Scheme VI Actual and Projected Total Settlements from April 2013 – April 2022 at the South Piers and Abutments

The total incremental settlements of April 2014 to April 2017 are summed up and multiplied by 1.5. This augmented sum is used as a constant settlement increment for each year starting April 2018 to April 2022 multiplied by a modifying fraction such that the total four-year increment is kept the same. The settlement layout for Scheme VI along the north and south sides of the bridge is shown in Figures 11 and 12.

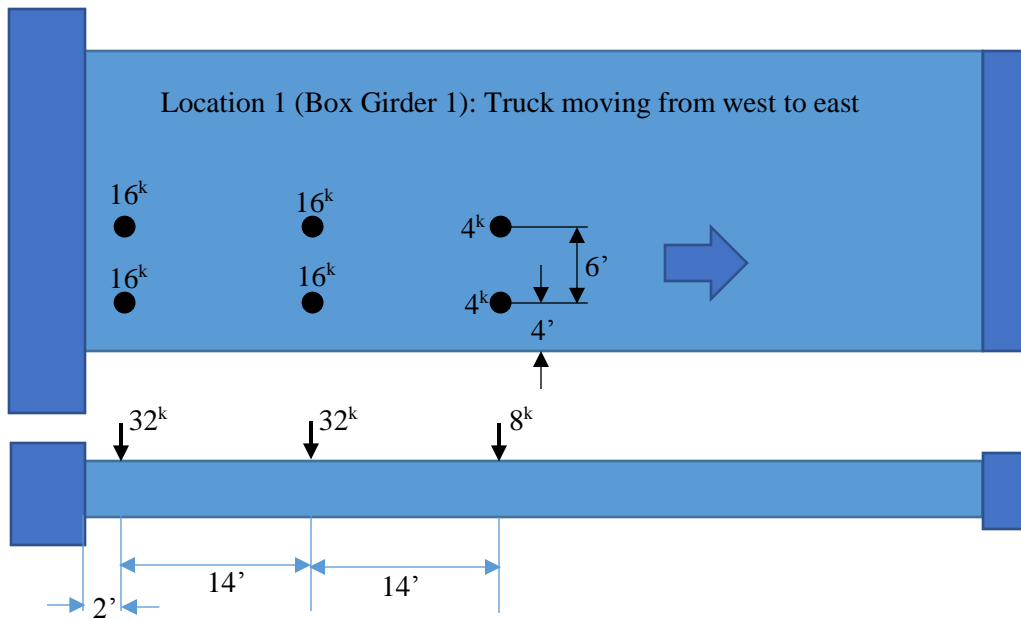
In order to study the effect of live load superimposed with April 2017 settlements, a truck load (HS-20) of 72 kips total load was applied. The live load was applied at 8 different locations. Four of those locations were as the truck moves from west towards east of the bridge, and the other four locations were as the truck moves from east towards west bound. Figure 13 shows the magnitude and distance of applied live load from the edges at location 1 on span 1 while truck is moving from west towards east. This is deemed to be a critical analysis to perform to guarantee the safety of the bridge to crossing traffic.

Figure 13: Positioning and Magnitudes of Superposed HS-20 Truck Loading

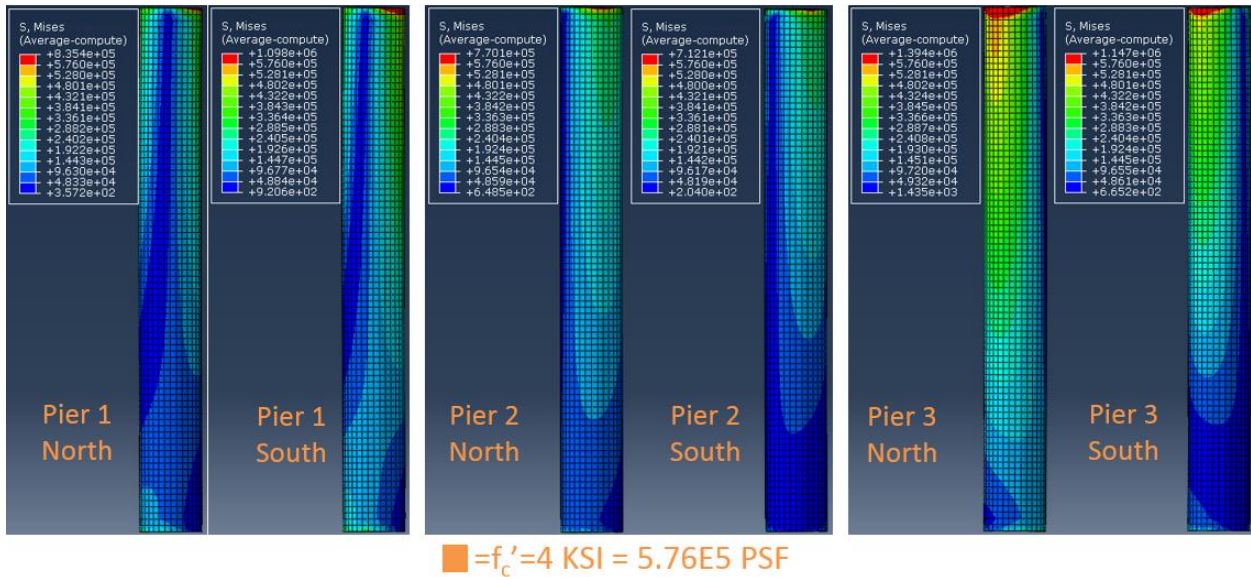
Figure 17: Von Mises Stress at Piers

The results from April 2017 show the same stress concentration beyond the concrete strength, which matches the current condition at the top of the pier, as seen in Figure 18. It is also important to mention

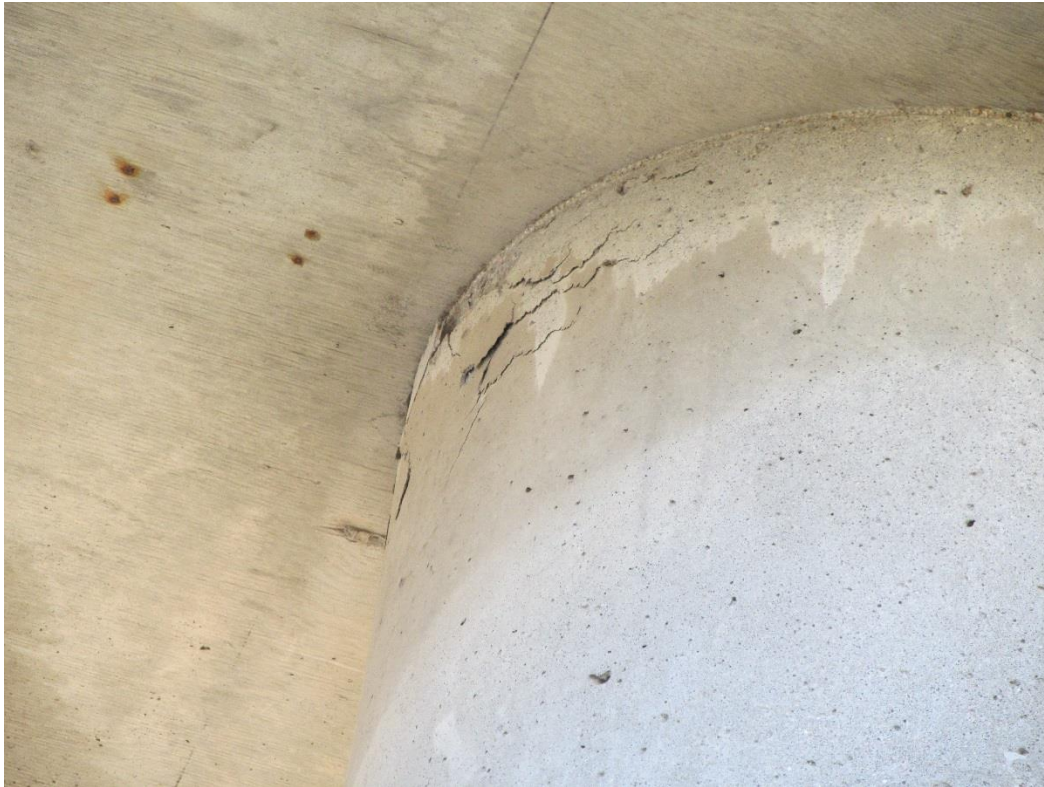
Figure 18: Concrete Distress at Top of Pier

that the model doesn't consider the reinforcement embedded in the piers. The steel will take some of the load and lower the concrete's share of the stresses induced on the section.

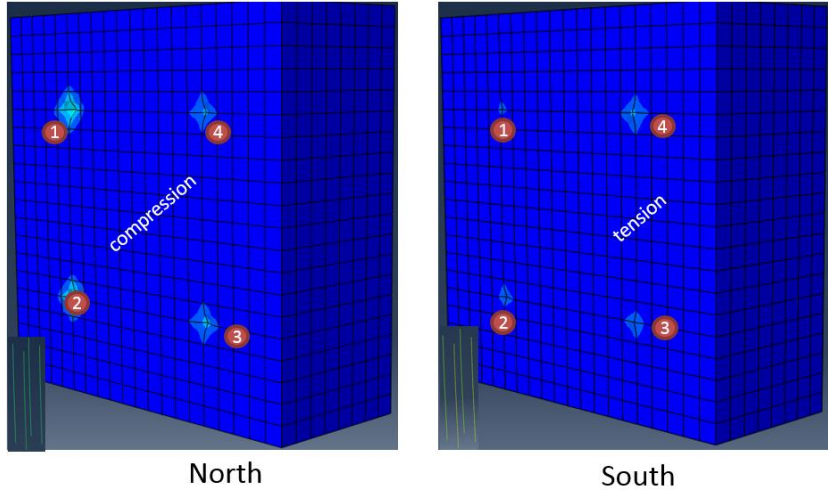
Figure 22: Pier 2 Piles-Pile Cap Junctions with Deformation

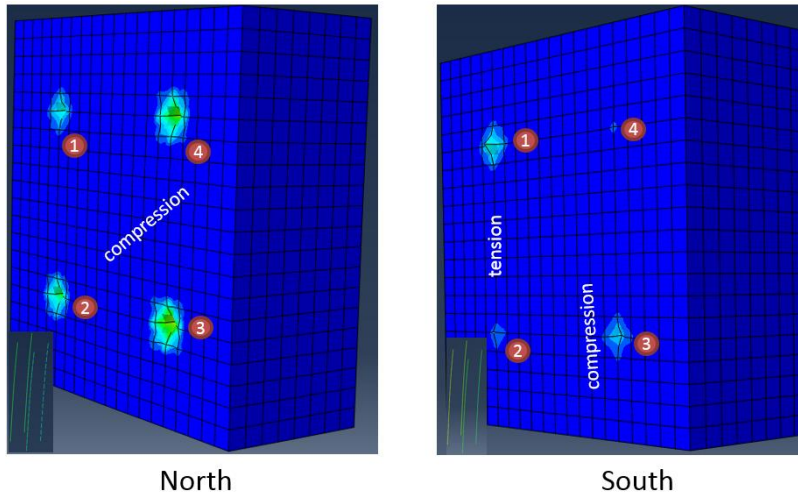
Figure 23: Pier 3 Piles-Pile Cap Junctions with Deformation

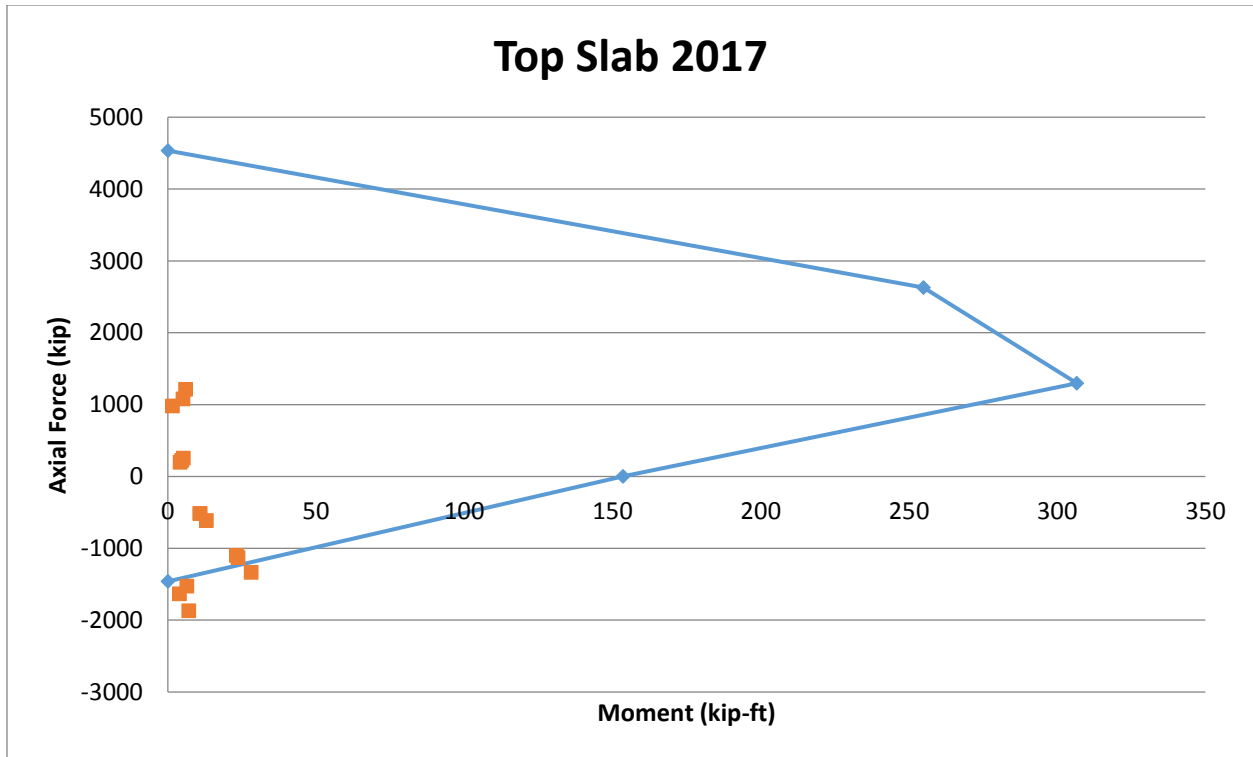
Each of the top slab sections has a width of 98 inches, a thickness of 7 inches and a clear cover to reinforcement of 2 inches. The amount of reinforcement varies along the span. However, the maximum reinforcement of 20 # 9 bars and 14 # 5 bars is used to plot the interaction diagram since exceeding the limits of this diagram refers to a possible failure regardless. Figure 26 shows five points exceeding the diagram limits on the tension side suggesting the critical state of the top slab under April 2017 settlements.

Figure 26: Interaction Diagram for the Top Slab at Span 2

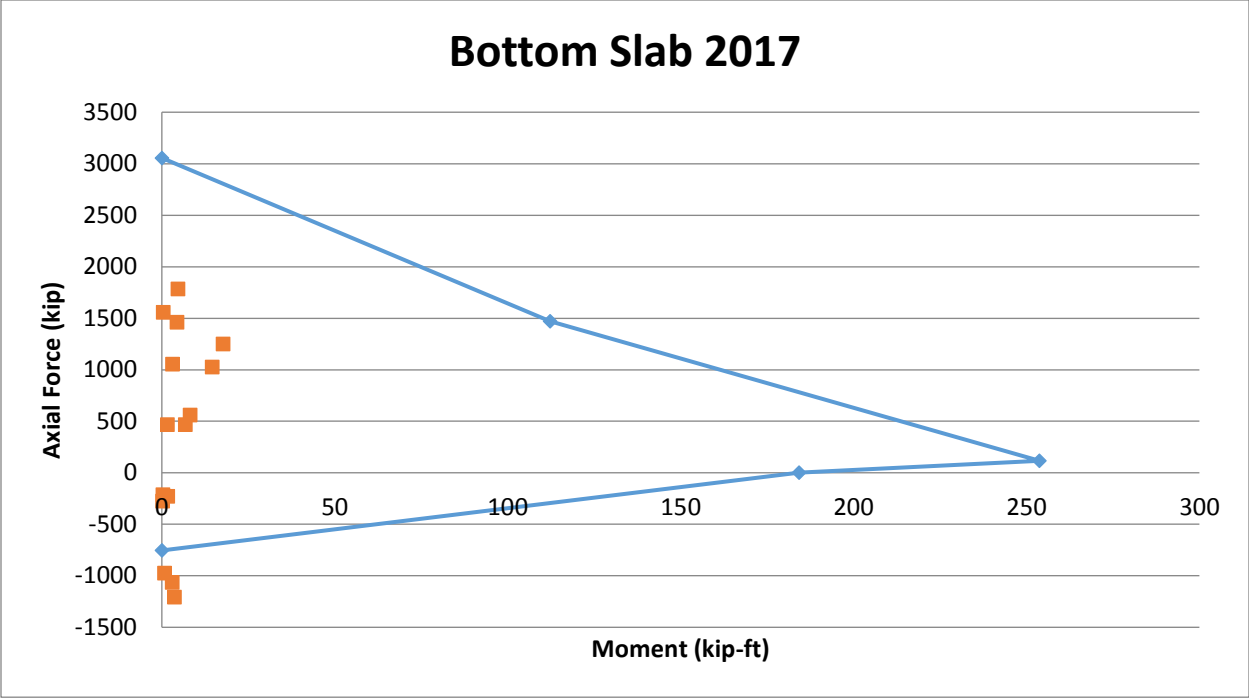
Each of the bottom slab sections has a width of 98 inches, a thickness of 6 inches and a clear cover to reinforcement of 1 inch. The amount of reinforcement varies along the span. However, the maximum reinforcement of 16 # 8 bars is used to plot the interaction diagram since exceeding the limits of this diagram refers to a possible failure regardless. Figure 27 shows three points exceeding the diagram limits on the tension side suggesting the critical state of the bottom slab under April 2017 settlements.

Figure 27: Interaction Diagram for the Bottom Slab at Span 2

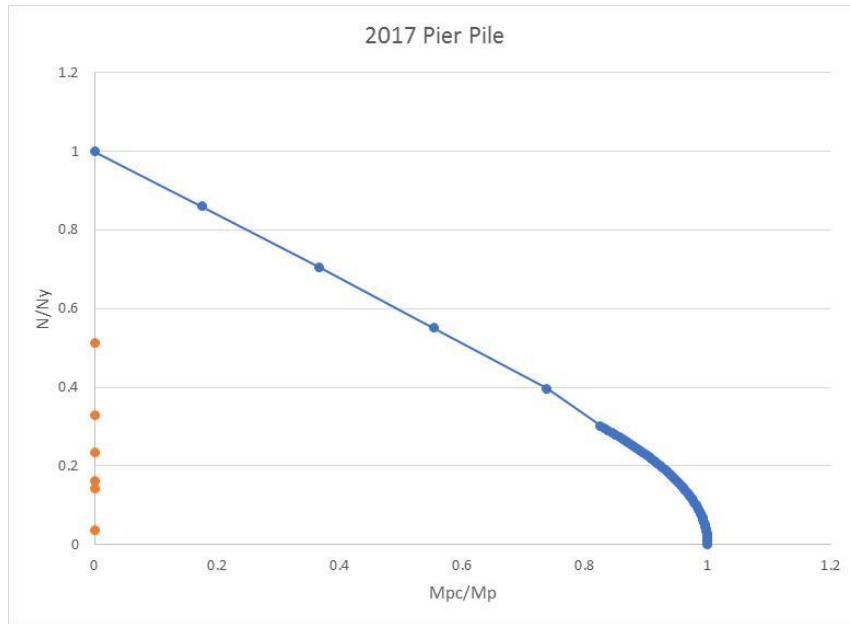
The interaction diagram for the pier piles is computed using Excel assuming a uniaxial moment-axial compression force with yield strength of 36 ksi. Figure 30 presents the points mapped on the interaction diagram. It is evident from Figure 30 that the pier piles are all safe since they are well within the interaction diagram.

Figure 30: Interaction Diagram for the Pier Piles

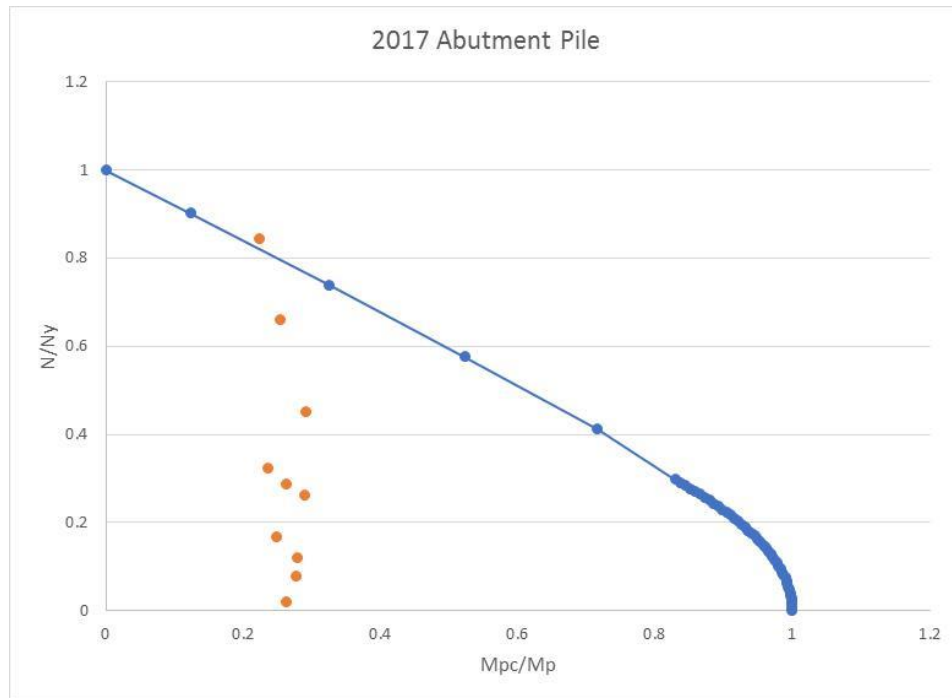
The interaction diagram for the abutment piles is computed using Excel assuming a uniaxial moment-axial compression force with yield strength of 36 ksi. Figure 31 presents the points mapped on the interaction diagram. It is evident from Figure 31 that the abutment piles are generally safe except for one point slightly outside the interaction diagram indicating proximity to being critical.

Figure 31: Interaction Diagram for the Abutment Piles

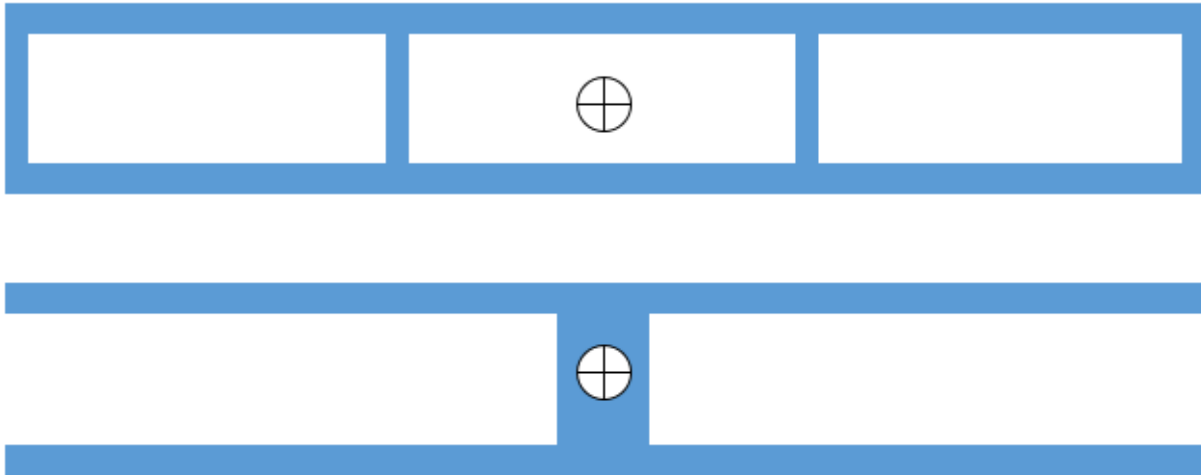
The plate results from the RISA model were used to analyze the bridge as one composite I-girder section, instead of treating each element of the box girder separately. All four of the webs from the box girder were combined to be one web with a thickness of 34 inches and height of 35 inches. The top and bottom slabs were both taken to have a width of 294 inches, with thicknesses of 7 inches and 6 inches, respectively. The rebar in the bridge was kept at the same depths as specified in the bridge plans. Figure 32 shows the adjustment made to the box girder.

Figure 32: I Girder Transformation

6. Using a transformed I-Girder section (which is equivalent to the box girder section under axial force plus uniaxial bending moment) in addition to the RISA 3D analysis shows the transformed section fails in the same sections where the axial tension exceeded the capacity of the top and bottom slabs in the original analysis.

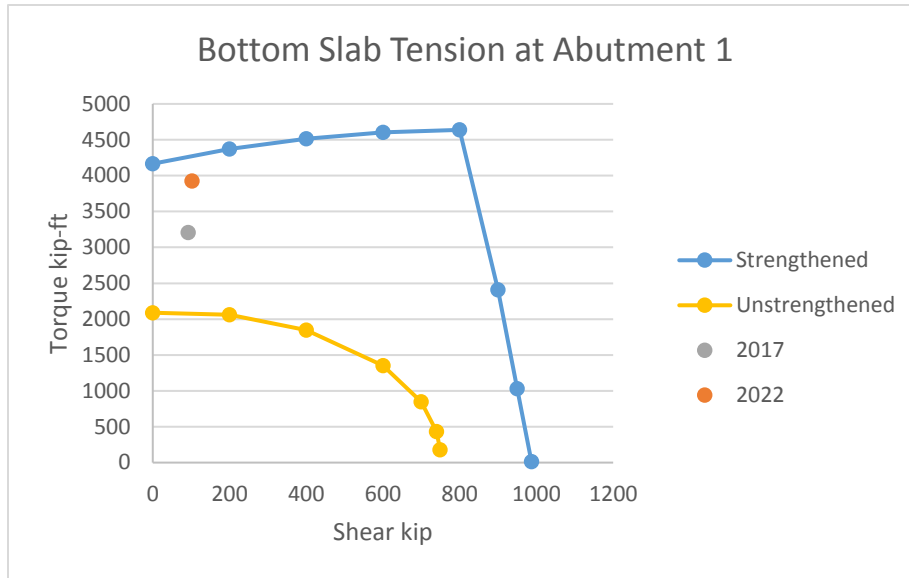
The interaction curve for span 1, abutment 1 is shown in Figure 36.

Figure 36: Shear and Torsion Interaction Curve at Abutment 1

The relatively flat part of the curve, until close to 1000 kips, is controlled by the yielding of the tensile reinforcement in the bottom slab, Equation 7. After this, the steep decline of the curve is controlled by the spacing of the shear stirrups, Equation 5. The concrete stress limited by Equation 6, did not control in this section, or any of the other sections that were analyzed. Since both the shear and torsion values from 2017 and 2022 exceed the capacity of the bridge in its current condition, a strengthening plan was developed so that all sections would have a capacity that exceeded the expected values from projected settlement scheme 6 in 2022. The strengthening plan involves near surface mounted CFRP and GFRP bars to be installed on the bridge similar to the flexural strengthening plan. This section failed where the tensile steel controlled, so near surface mounted FRP bars were added to the bottom section in order to increase the section's capacity. Table 5 shows the total number of FRP bars that will be added to the bridge at each section and the reason for their installation.
