Case study to document the condition of McConnell creek and the effect of redcedar revetments

A THESIS

KANSAS STATE UNIVERSITY
Manhattan, Kansas

2021

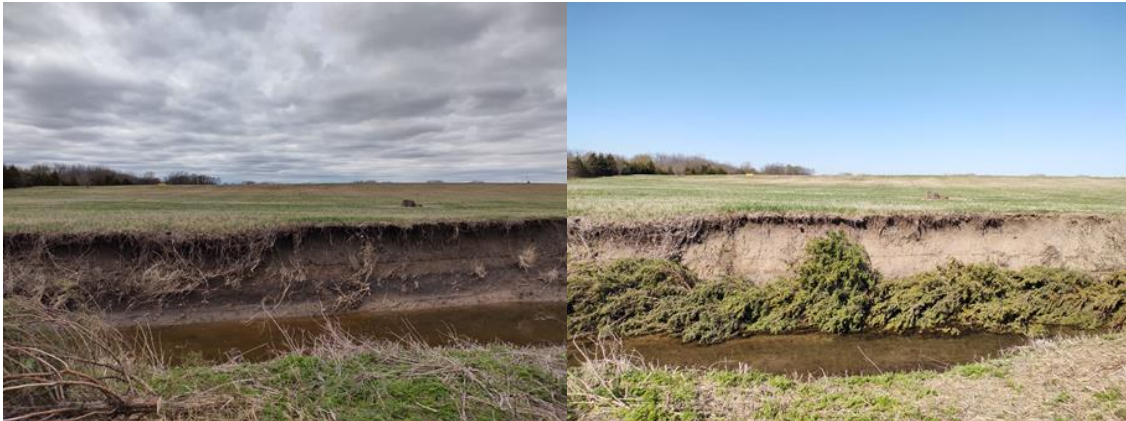
Figure 2. Second redcedar revetment installation during early spring with low water levels (before/after)

The first redcedar revetment installation took place in June of 2020, which was delayed originally from March due to Covid-19 restrictions. The second revetment was installed during March of 2021 as scheduled. The sites were previously marked and monitored to determine if they were suitable for an installation. These sites were selected for revetment installation as they appeared to have the most vertical, eroding banks, with little vegetative cover in the area of interest. The installation process was adapted from U.S. Department of Agriculture (2002) and Goard (2006). The revetment length is determined by beginning and ending the revetment in the areas in which the streambank was not eroding as evidenced by well-established vegetation. The installation process started from downstream with the trees base facing upstream. The trees selected averaged a height of 4.5-6 meters. Trees were anchored at the toe of the eroding bank at water base flow level. Once a tree was located in the desired position (Figure 2) it was secured with duckbill anchors that had attached a steel cable of 1.8 meters long. The anchoring was done with the use of a jackhammer with which the duckbill anchor was inserted 1.5-1.6 meters into the soil. The end of the cable was then wrapped around the trunk and secured with clamps at the base of the trunk and the crown of the next tree with cable clamps providing two holding points for each tree. Once the revetment was installed behind the tree line sandbar willow (*Salix interior*) cuttings were inserted into the soil to accelerate revegetation. Sandbar willow is

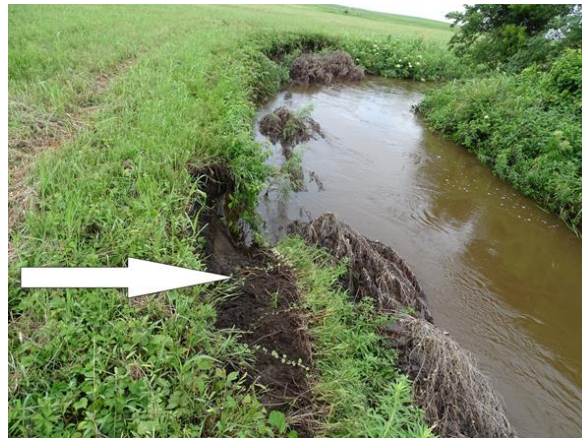
Figure 5. High flow event in McConnell Creek on June of 2021 in R1

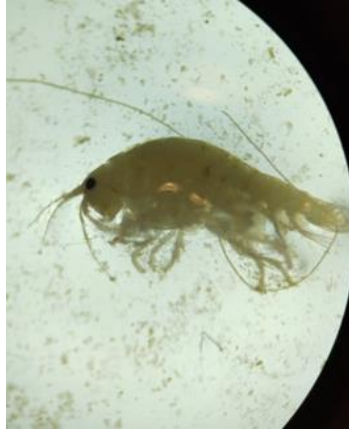
Figure 10. Freshwater amphipod of the genus *Dogielinotidae* found in McConnell Creek

Macroinvertebrates results in R1 count with data previous to the installation as well as two samples done after the installation took place. Before the revetment was installed the most abundant family was *Chironomidae* once the revetment was installed the most prevalent family found was *Dogielinotidae*.

As previously stated individuals sampled overall increased between samplings with revetment to those with no revetment installed. R1 pre-revetment sampled 39 individuals between the pool and cut bank, once the revetment was installed the first visit yielded 239 individuals being sampled. Overall richness in R1 increased from 5 families pre-revetment to 12 families post revetment. Though the increase wasn't even as the great majority of sampled individuals were of the family *Dogielinotidae* (Figure 9). With R2 and control site the results are similar, the control site yielded 75 individuals R2's first sample yielded 236 individuals. Overall richness was very similar as the control site had 11 families and R2 had 10 families. In both cases there is an increase in individuals present per sampling. Richness only had an apparent increase when comparing R1's pre and post revetment data. When comparing richness between control and revetments the number of families sampled were similar.
