Shoreline rehabilitation for recreation and ecological functionality

MASTER OF LANDSCAPE ARCHITECTURE

Landscape Architecture Master Project Report

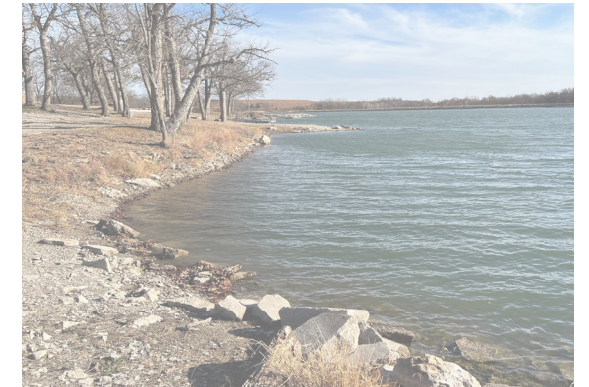
**Figure 2.3** Rock-lined shoreline at Pottawatomie State Lake No. 2 (Ramage 2023)

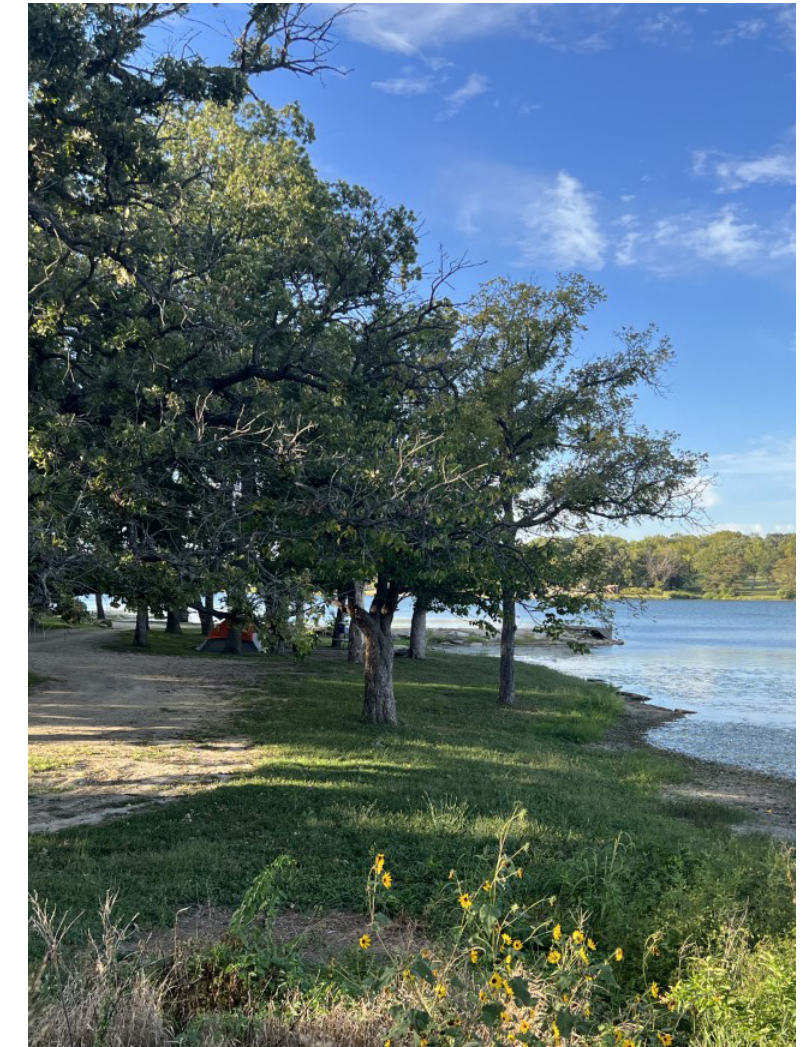
There are two maintenance buildings located on site where equipment is stored. The primary day use area is located along the northern shores of the lake and provides amenities such as accessible fishing docks, boat and kayak ramp, a restroom facility, and seven rock jetties that allow people direct access to deeper water. There are residential properties adjacent to the day use area, which is a good reason to maintain that use rather than plan for it to transform into campsites. The current camping zone consists of three sections. The primary camping area is located in the southwest corner by the dam. This is where the second restroom facility can be found on site. The park is restricted to informal tent camping on the west side of the lake. The benefit of keeping the camping designated to this zone is that there are a large number of established trees to keep people comfortable during the summer. No camping is allowed in the day use area. As seen in the image on the right, visitors are able to set up camp wherever they would like, which leads to trampling of vegetation.

Figure 3.5 Shoreline Camping  
Photo (Ramage 2023)

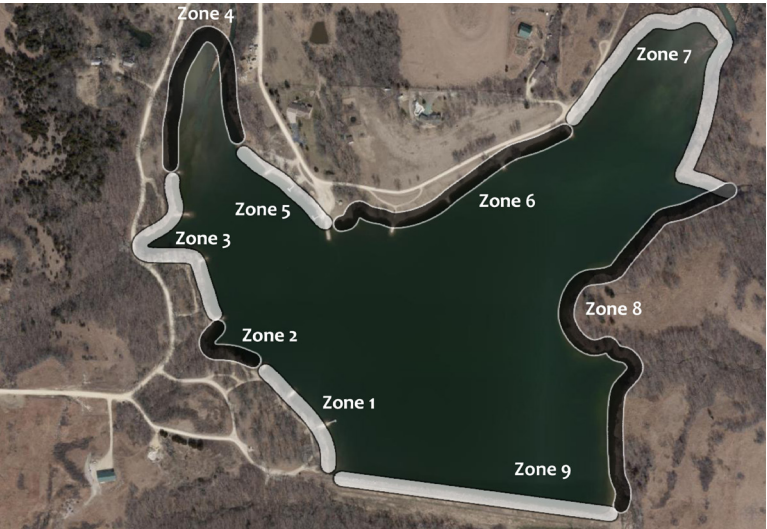
The shoreline condition analysis was completed in November 2022. A limitation of this analysis is that the research was conducted in late fall, which means most signs of aquatic vegetation were freeze killed. Additionally, there is no bathymetric map (contours of lake bottom), so visual classifications for the slope adjacent to the shoreline had to be made. The shoreline was divided into nine zones based on similarities of characteristics and condition.

Figure 3.8 Shoreline Zone Map (Ramage 2023)

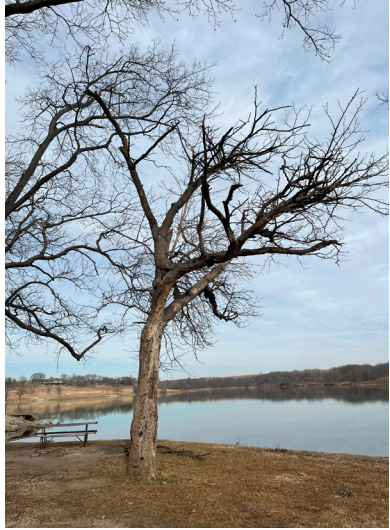
Some trees near the shoreline are in poor condition.

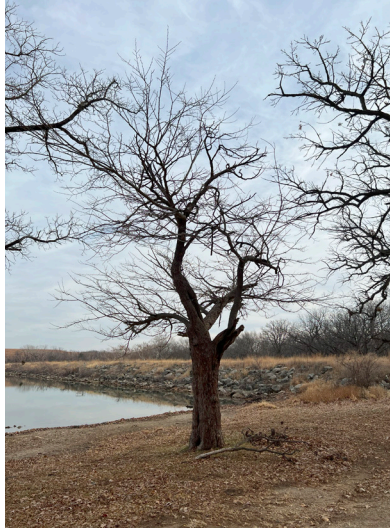
There is manicured grass up to the water's edge.

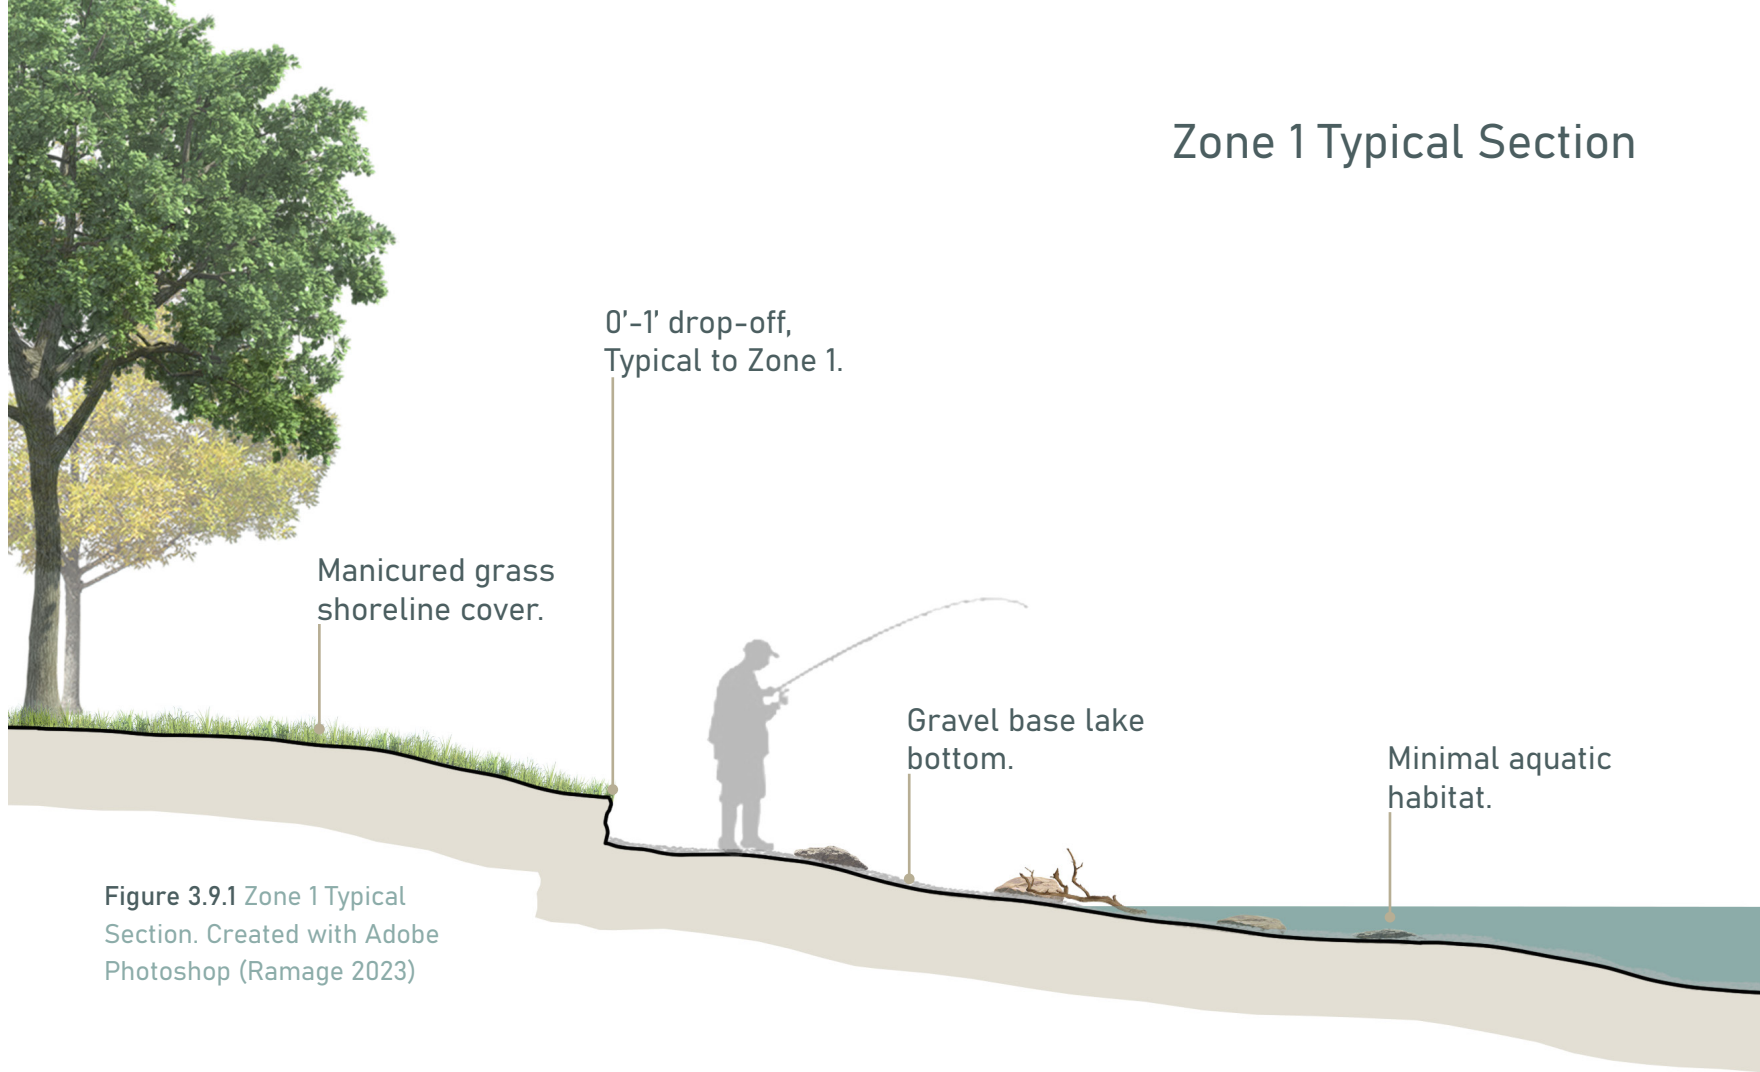
Zone 1 exhibits shoreline bank erosion up to one foot in height, accompanied by a shallow near shore lake bottom. The immediate shoreline is covered by manicured grass and exposed gravel. There are no signs of emergent or riparian vegetation. Additionally, there is minimal coarse woody debris to contribute to aquatic habitat. Zone 1 has three rock jetties that allow visitors to access deeper water. However, these jetties are not wheelchair accessible, limiting shoreline experiences for those with disabilities. Trees adjacent to the shoreline are in poor condition and are nearing replacement age.

The majority of the shoreline in Zone 1 has a one-foot drop off due to erosion.

Figure 3.9.1 Zone 1 Typical Section. Created with Adobe Photoshop (Ramage 2023)

- Establish littoral, emergent, riparian and upland vegetation to stabilize the shoreline.
- Maintain shoreline access points within vegetated buffers to provide variety for anglers and visitors.
- Re-finish rock jetties to allow for wheelchair accessibility.
- Connect campsites to the shoreline through the implementation of designated pedestrian trails.
- Strategically place small to large rocks and other natural and artificial Largemouth Bass habitat.
- Establish vegetated fiber rolls along eroded shoreline to reduce degradation.

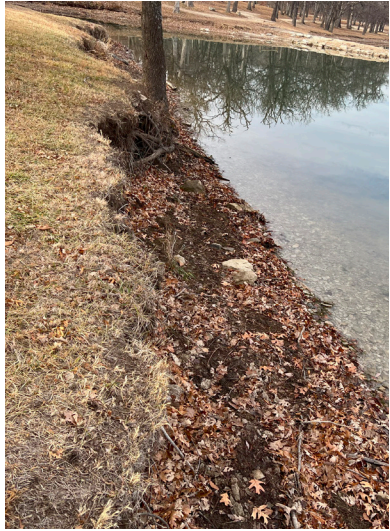
There is an unsafe dropoff to the water in this zone.

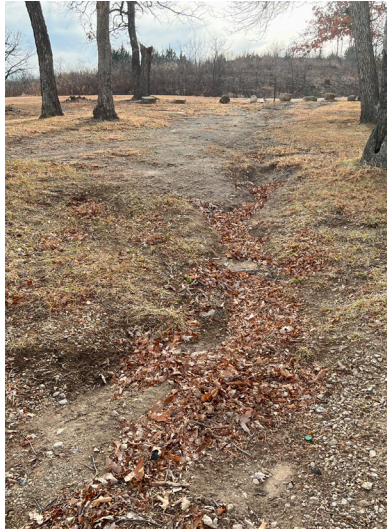
There are signs of erosion and gullies starting to form.

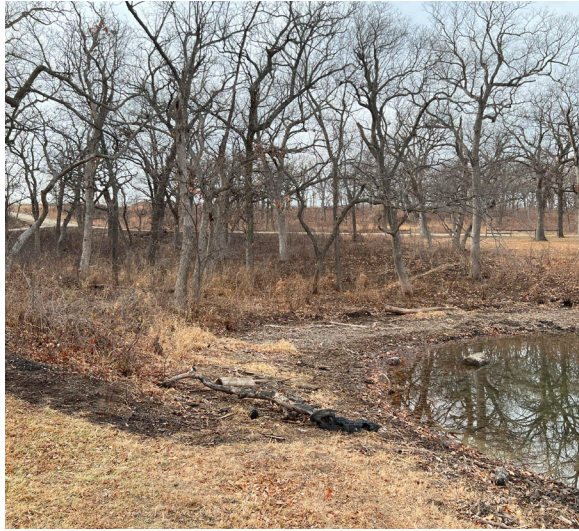
The cove in this zone is densely vegetated and shows signs of burn management.

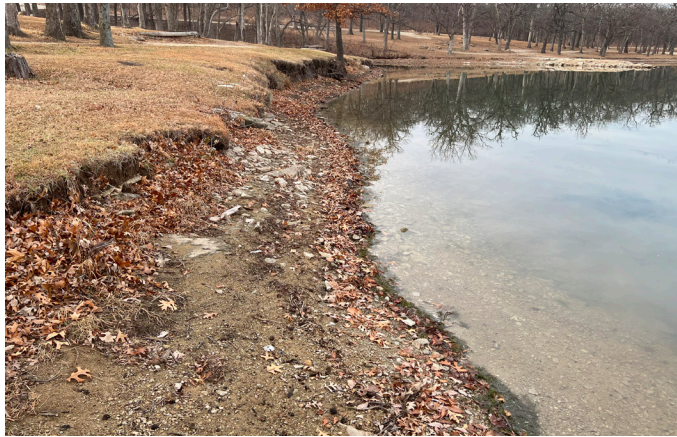
The majority of the shoreline in this zone is severely degraded and has minimal aquatic habitat.

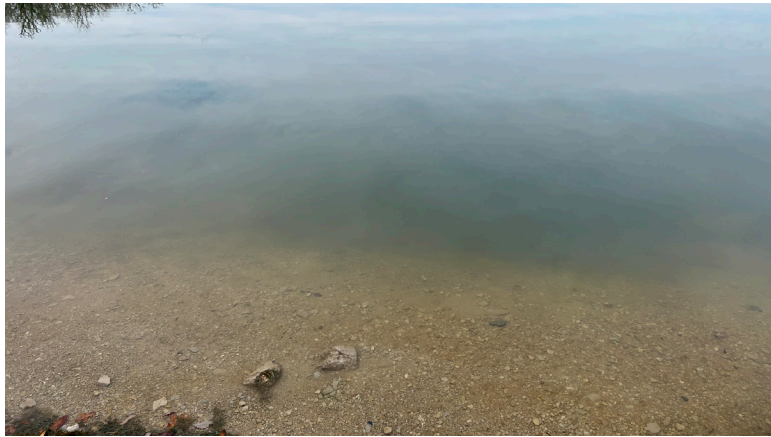
The lake floor is a gradual slope that drops off to deeper water about twelve feet from shore.

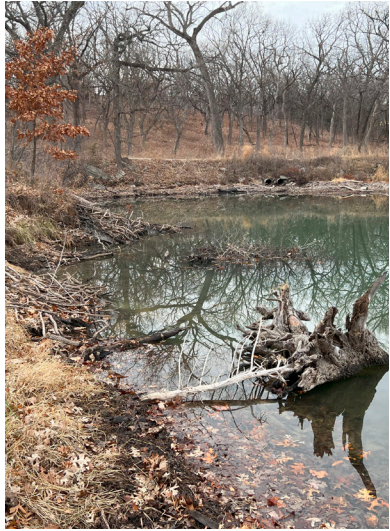
There is a variety of coarse woody debris in this zone.

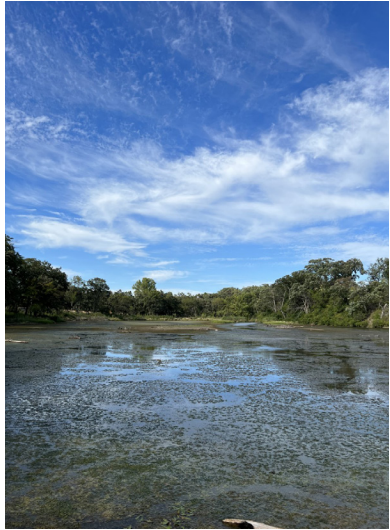
The image on the left shows Zone 4 prior to the low water level. In its naturally marshy state, there is an opportunity to establish wetlands to attract other types of wildlife like ducks, geese, frogs, and turtles. Additionally, establishing a diversity of wetland vegetation will help filter water as it enters the lake from the creek intermittently flowing into this zone. Rather than dredge out the sediments in this area, it is important to establish thriving wetlands on the site. Preserving some areas as mudflats can continue to provide important habitat to a variety of wildlife.

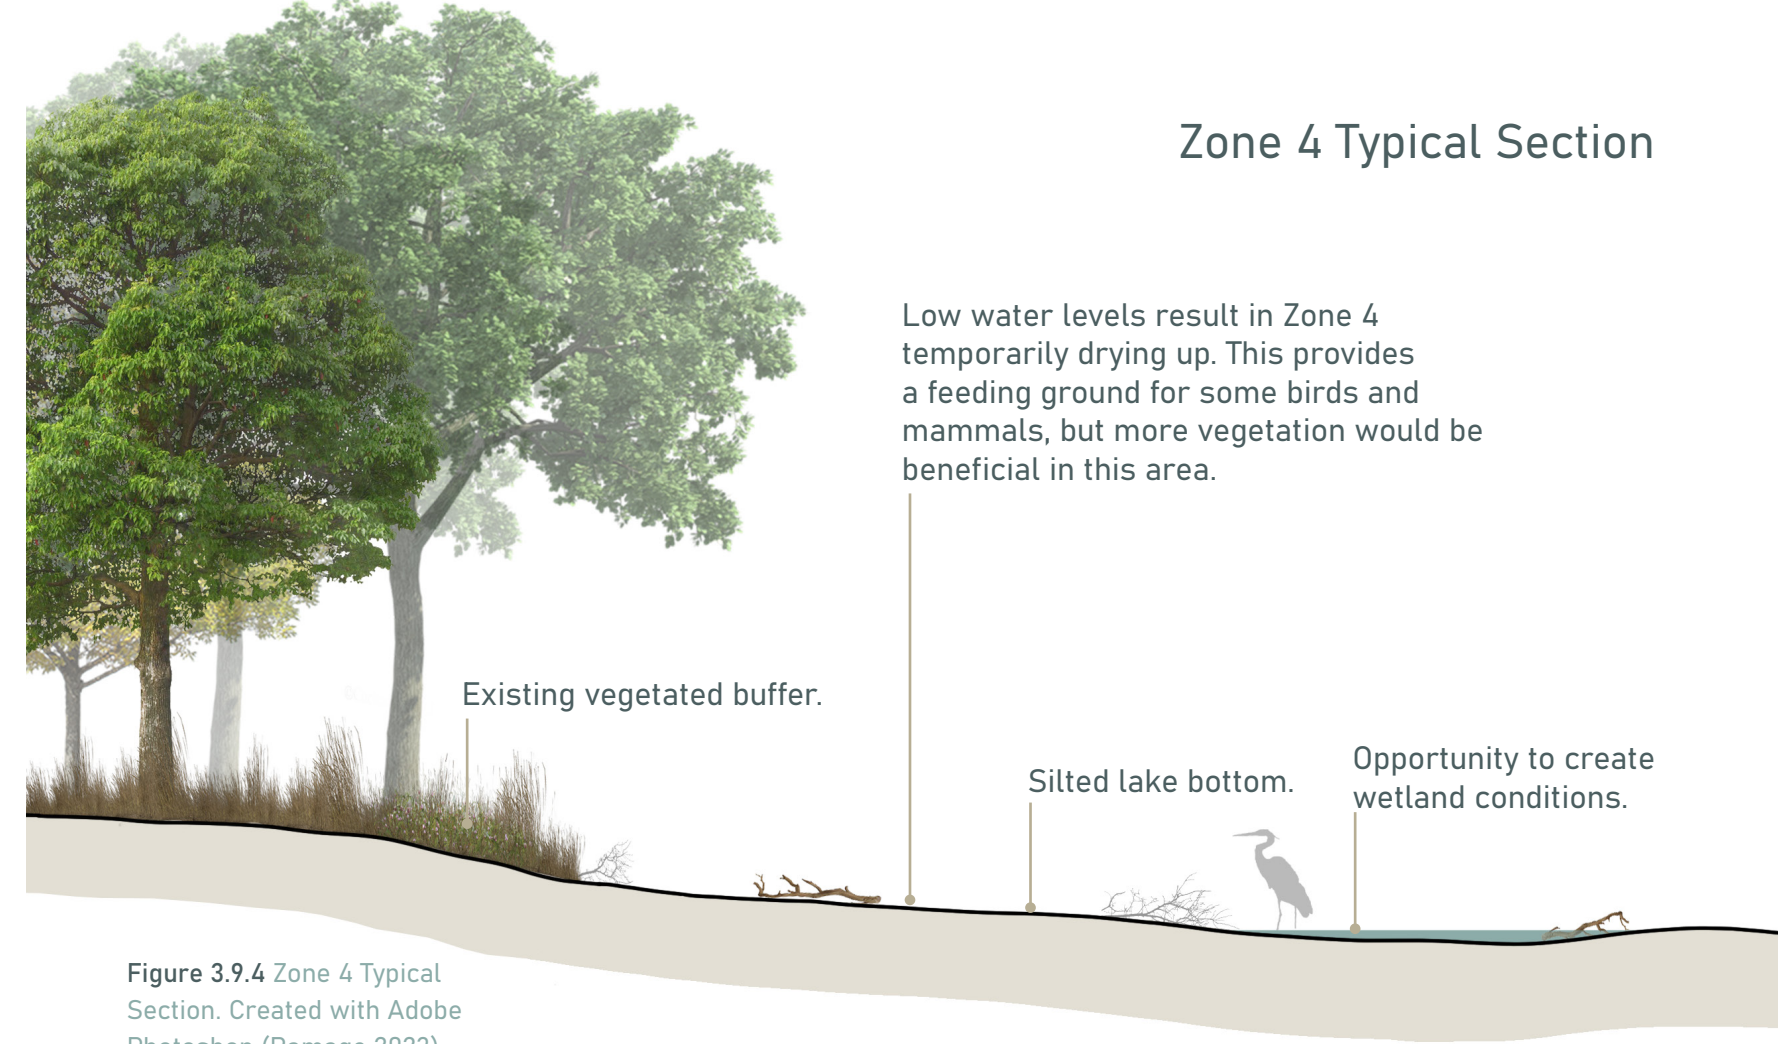
Figure 3.9.4 Zone 4 Typical Section. Created with Adobe Photoshop (Ramage 2023)

- Establish emergent, riparian and upland vegetation to broaden the shoreline buffer.
- Establish wetland conditions to cleanse water from the creek inlet and to provide habitat.
- Design wetland observation blind to allow for wildlife observation opportunities for visitors.
- Explore the feasibility of creating wildlife islands to diversify habitat and help keep nesting birds safe from predators.
- Connect accessible trail loop with a wetland boardwalk.

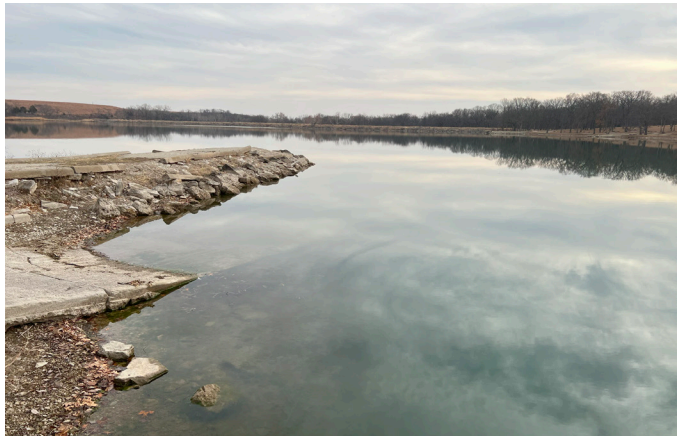
The rock pier and boat ramp are severely dilapidated and are in need of repair.

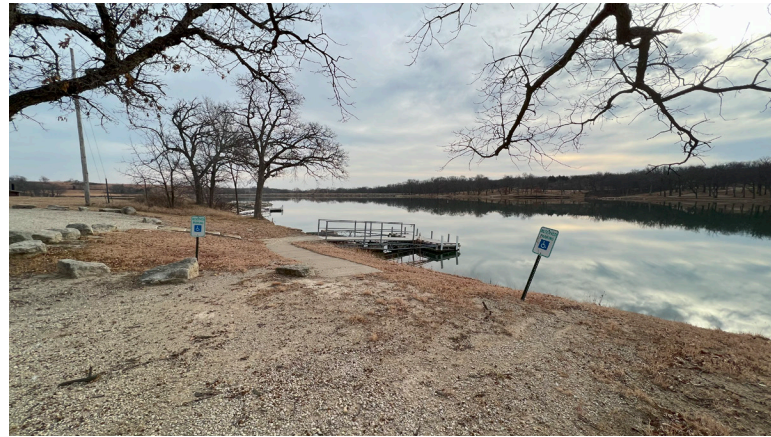
There is ADA parking and accessible docks in Zone 5. There are opportunities in other zones to design more accommodating areas and experiences.

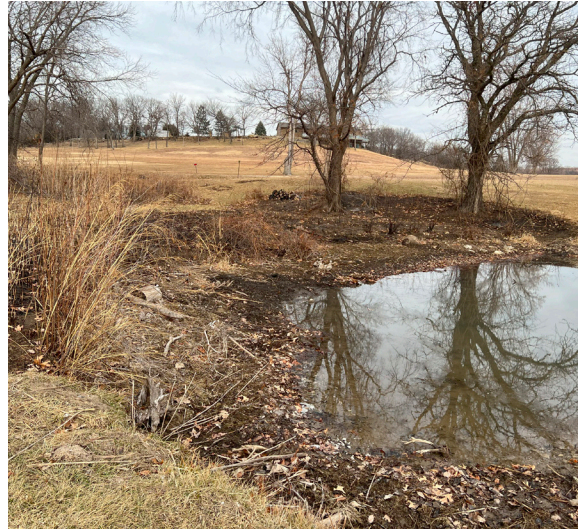
There are signs of burn management in the cove of Zone 6.

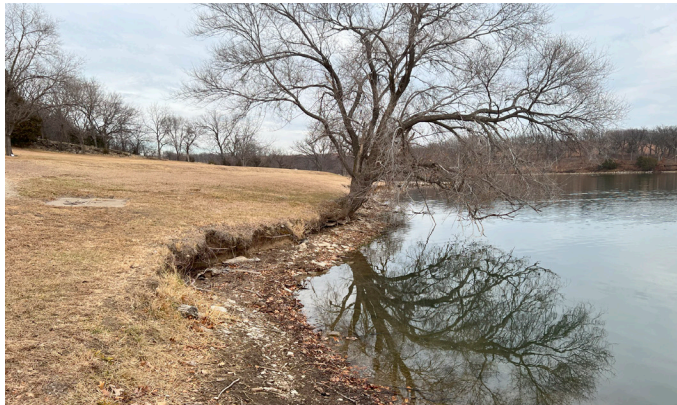
Trees like the one in the image above should be cut or trimmed when they are deemed a hazard and used as habitat structure around the lake.

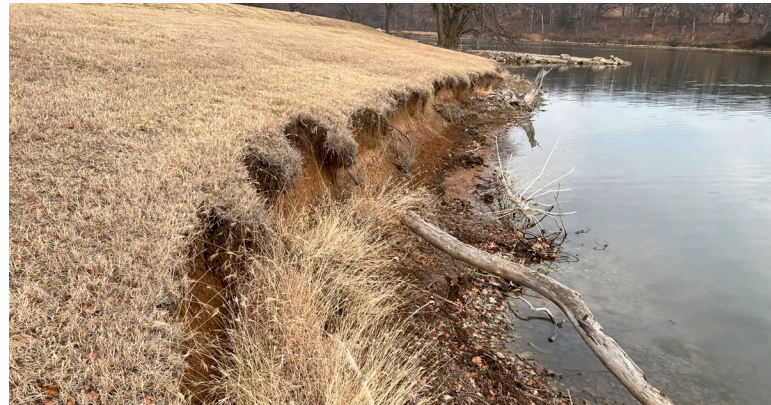
This area of shoreline is a hazard to day-use visitors and needs to be reconstructed. In this instance, a tiered boulder wall with a vegetated buffer may be a suitable approach.

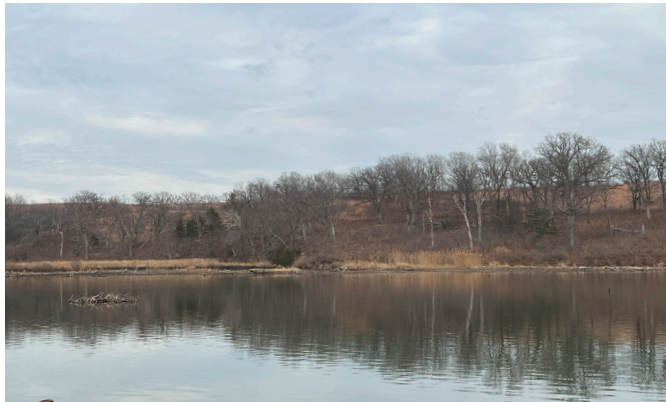
Although Zone 7 is not as silted as Zone 4, there are signs of sedimentation and shallow areas near the inlet likely due to erosion in the watershed.

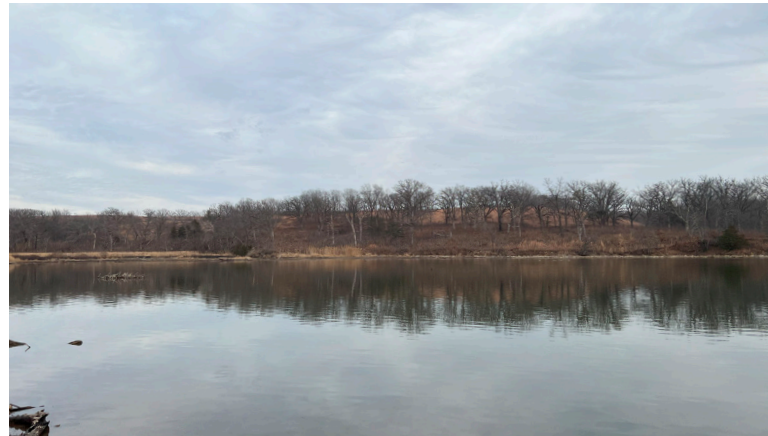
The eastern shoreline of Zone 7 is heavily wooded. This is beneficial to the stability of the shoreline.

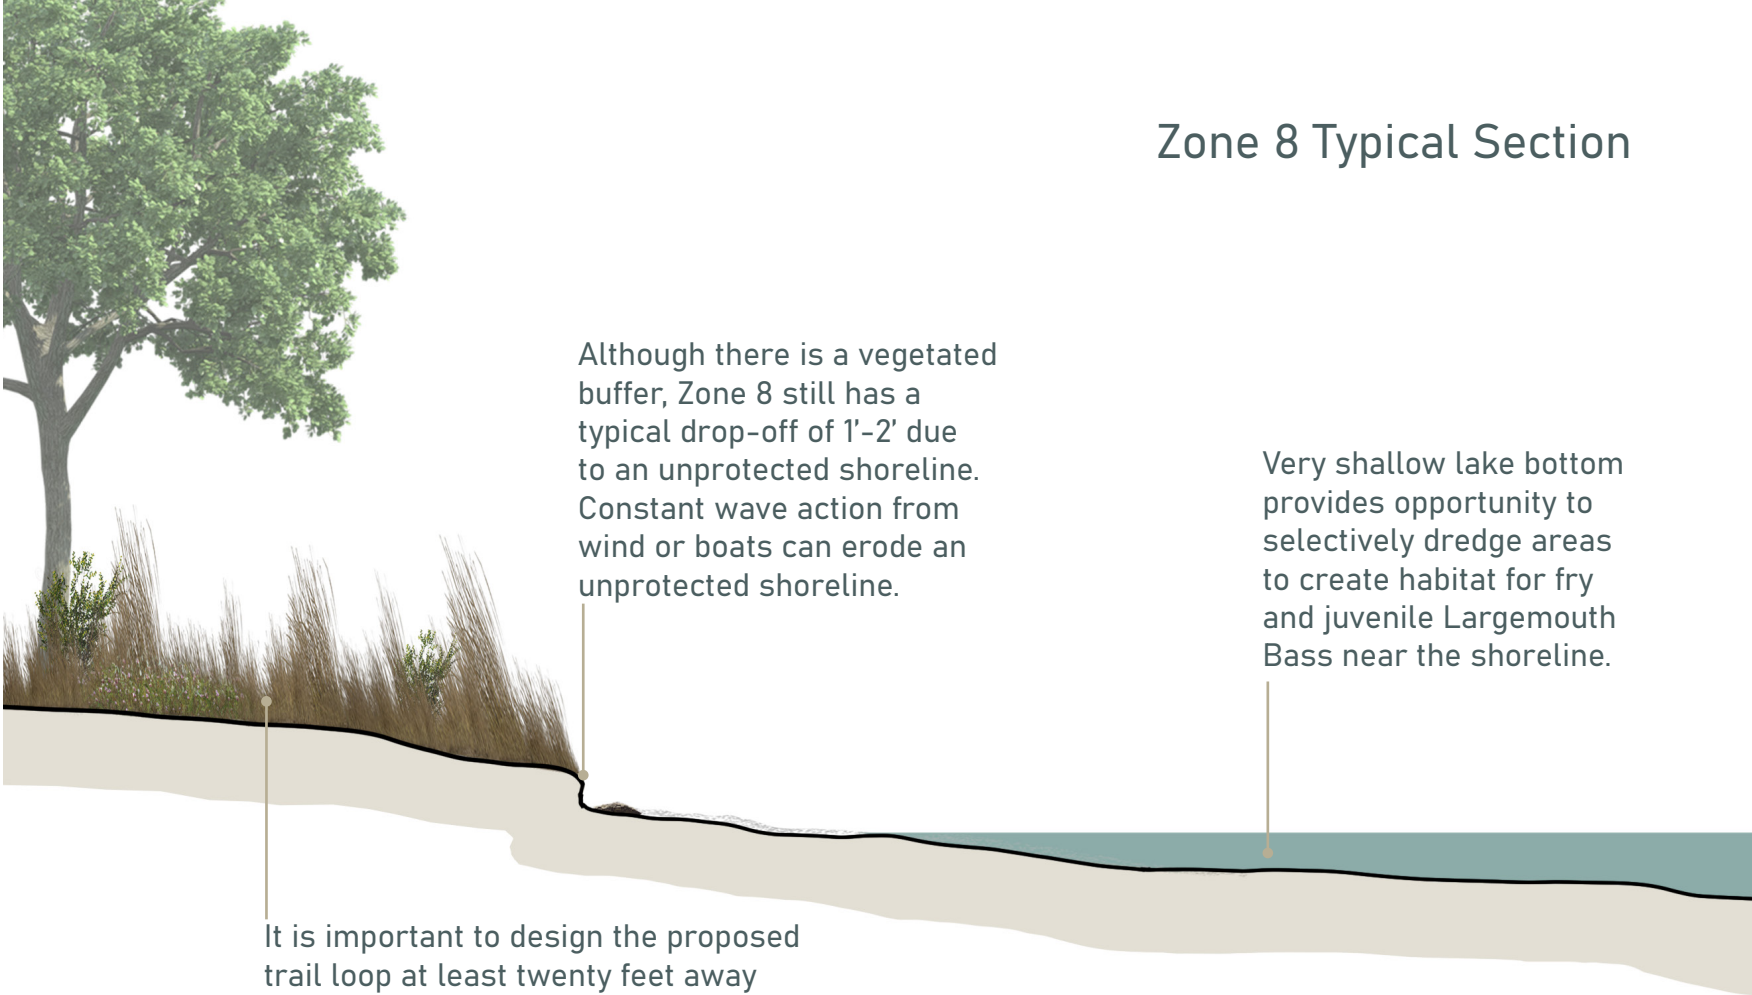
# Zone 8 Typical Section

Although there is a vegetated buffer, Zone 8 still has a typical drop-off of 1'-2' due to an unprotected shoreline. Constant wave action from wind or boats can erode an unprotected shoreline.

Very shallow lake bottom provides opportunity to selectively dredge areas to create habitat for fry and juvenile Largemouth Bass near the shoreline.

- Establish littoral, emergent, riparian and upland vegetation to stabilize the shoreline.
- Establish vegetated fiber rolls along eroded shoreline to reduce degradation.
- Place rocks and native willow cuttings to armor the shoreline from chronic wave action.

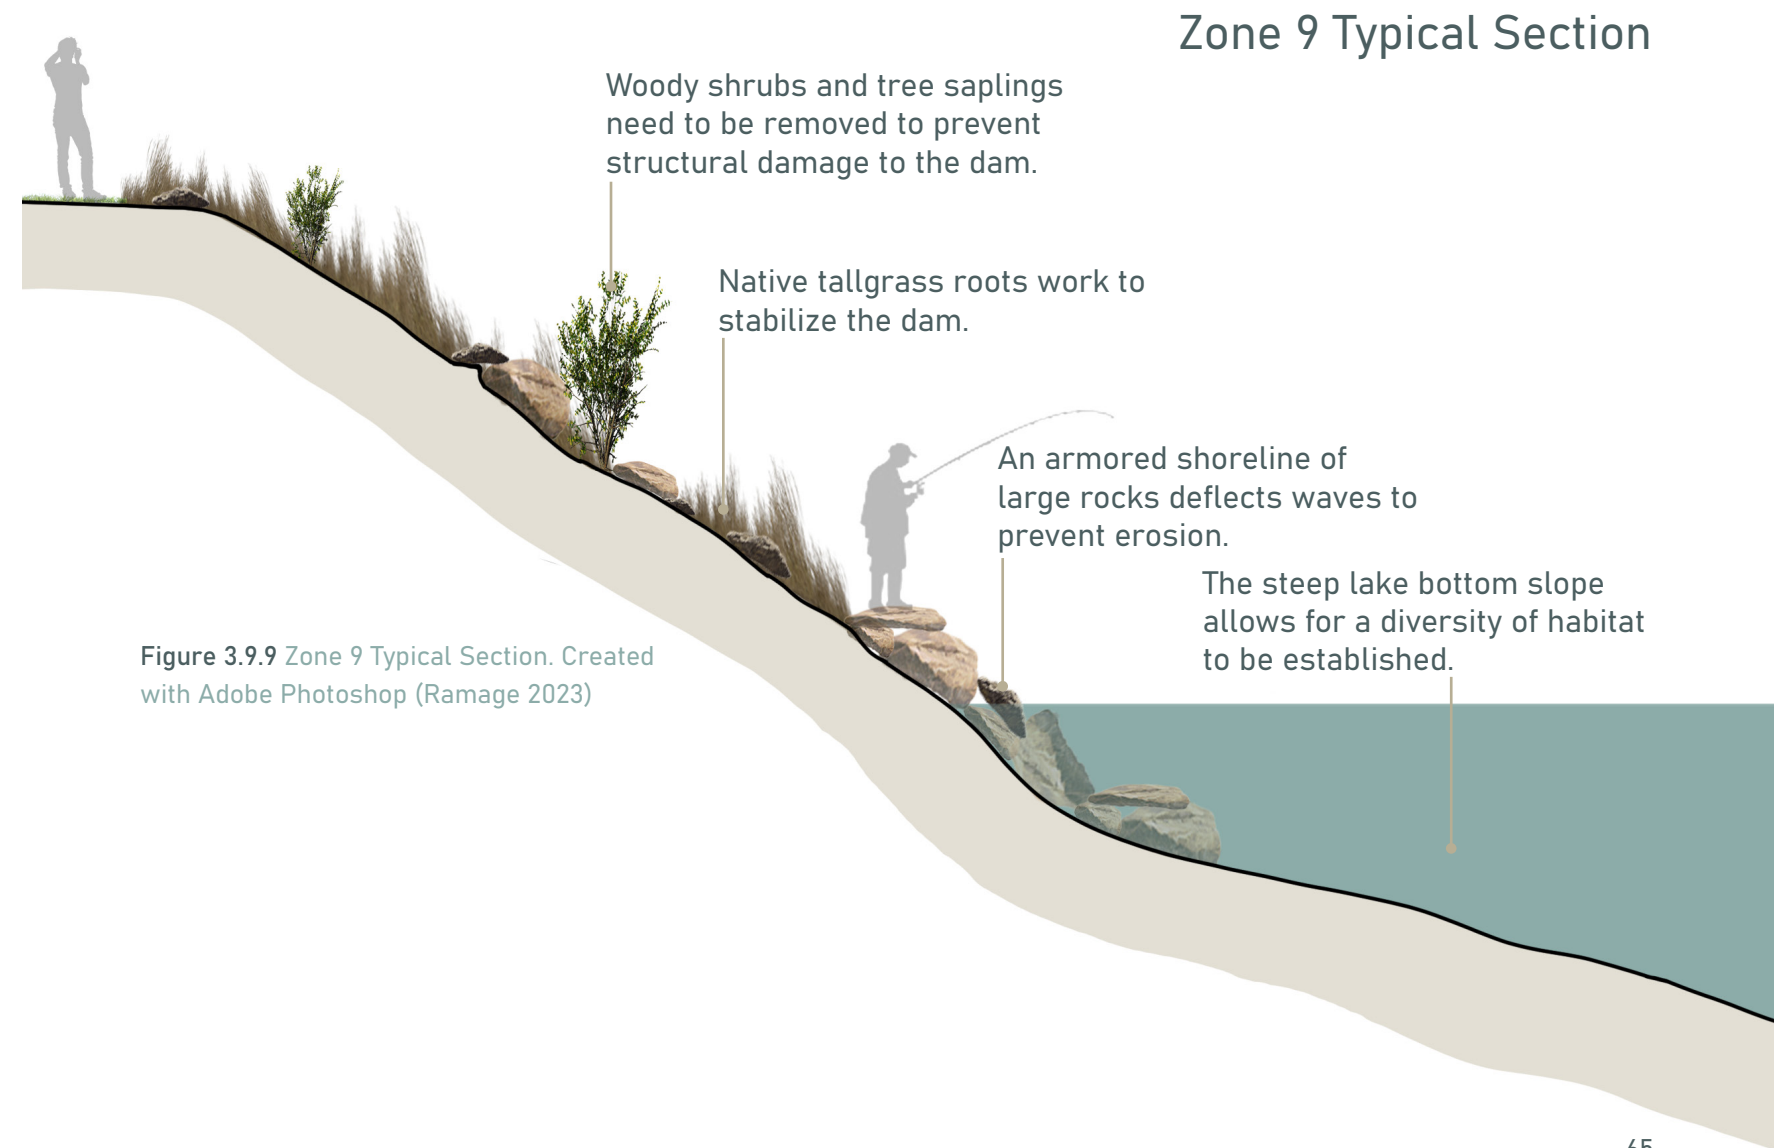
Zone 9 does not show any signs of shoreline bank erosion and has a steep near shore lake bottom. The immediate shoreline is covered by rip rap and non-manicured vegetation. There are no signs of emergent or riparian vegetation. There is minimal coarse woody debris to contribute to aquatic habitat. There is informal access to the water’s edge if visitors choose to traverse down the rock-faced slope. There are saplings and woody shrubs that need to be cut and killed to prevent structural damage to the dam.

There are tree saplings establishing on the dam that need to be removed before they create issues and compromise the dam's structural integrity (Nebraska Department of Natural Resources n.d.). The design intent for the projective design regarding the dam is to establish an accessible trail along the crest to allow people of all abilities to experience the east side of the lake. Additionally, there are existing areas that allow people to get to the water's edge along the dam, which will remain available to site users in the projective design. Structural diversity in aquatic habitat will be important to establish along the area of the dam to provide multi-seasonal habitat for Largemouth Bass.

Figure 3.9.9 Zone 9 Typical Section. Created with Adobe Photoshop (Ramage 2023)

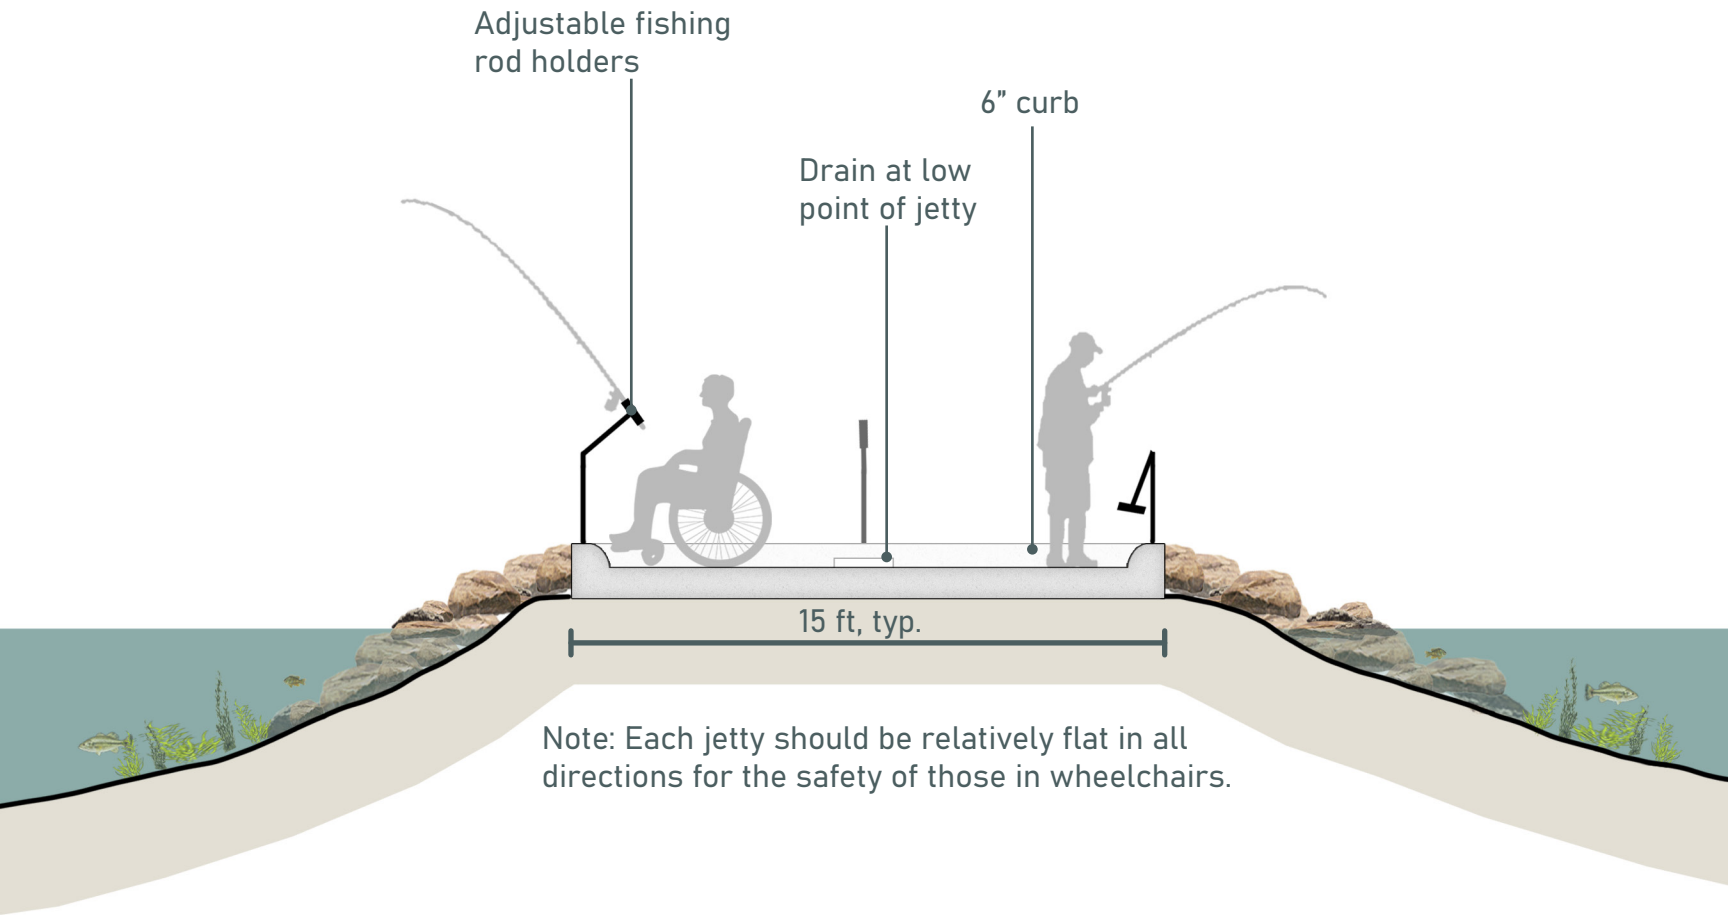
# Typical Accessible Rock Jetty

Figure 7.6.1 Typical Accessible Rock Jetty Section. Created with Adobe Photoshop (Ramage 2023)

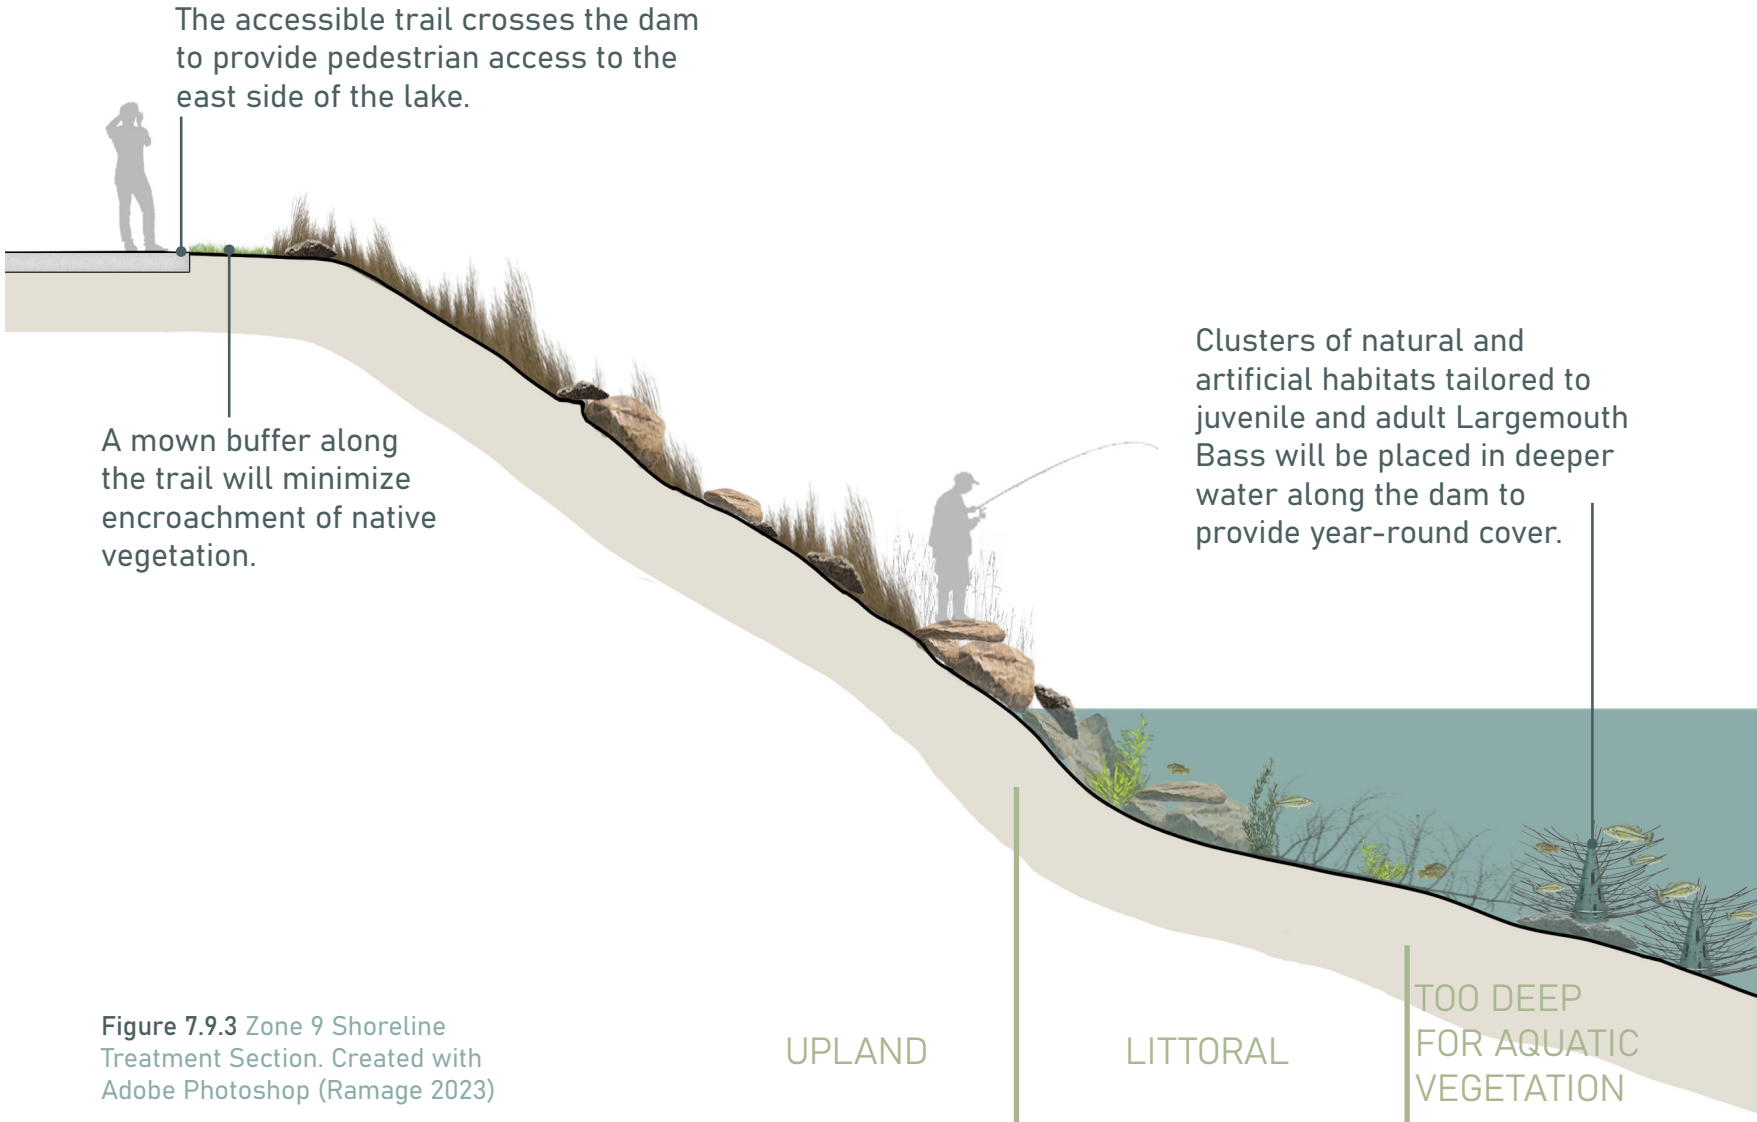
Figure 7.9.3 Zone 9 Shoreline Treatment Section. Created with Adobe Photoshop (Ramage 2023)
