EVALUATION AND DEVELOPMENT OF PREDICTIVE STREAMBANK EROSION CURVES FOR NORTHEAST KANSAS USING ROSGEN'S "BANCS" METHODOLOGY

Department of Environmental Design & Planning College of Architecture, Planning & Design

A DISSERTATION

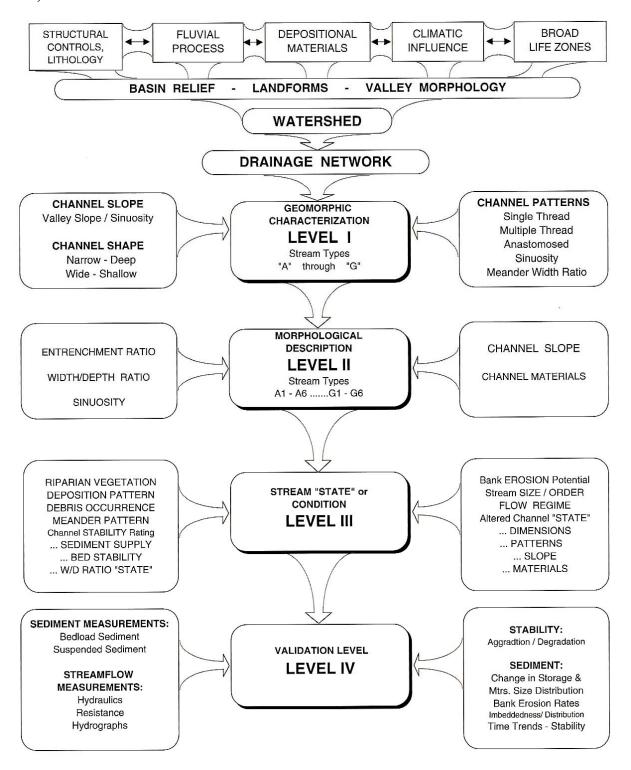
Figure 1.1 Flowchart for Rosgen Classification system showing all parameters (Rosgen, 1996)

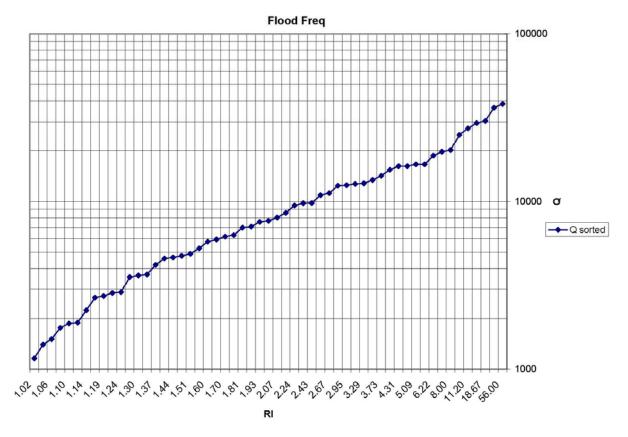
Figure 1.19 Flood frequency analysis for Black Vermillion river at Frankfort, KS. 1.5-year return interval discharge is approximately 4900cfs calculated from the annual peak maximum (USGS, 2010).

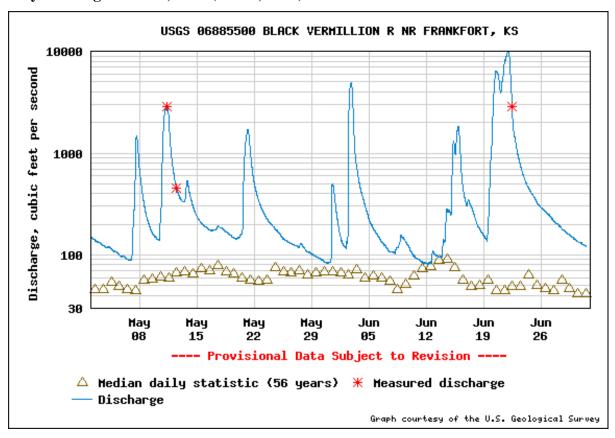
Figure 1.20 Example hydrograph from Black Vermillion downstream of Frankfort, KS, May 8 through June 26, 2010 (USGS, 2010).

Hydrograph - graph of stream discharge past a given point plotted against time, Figure 1.20. A hydrograph displays how quickly water discharge rises and recedes. Historic hydrographs in Northeast Kansas watersheds had lower peak flows and the recession limb fell much slower than they do today (US-COE, 1998). Current hydrographs in our hydrophysiographic region are considered flashy, as they rise higher, faster, and recede quicker than in the past. This flashiness is attributed to increased impervious and semi-impervious surface not allowing precipitation infiltration, thus producing more runoff. The triangles in the hydrograph (Figure 1.20) illustrate a 56-year mean discharge, while the plotted blue line illustrates 2010 discharges.

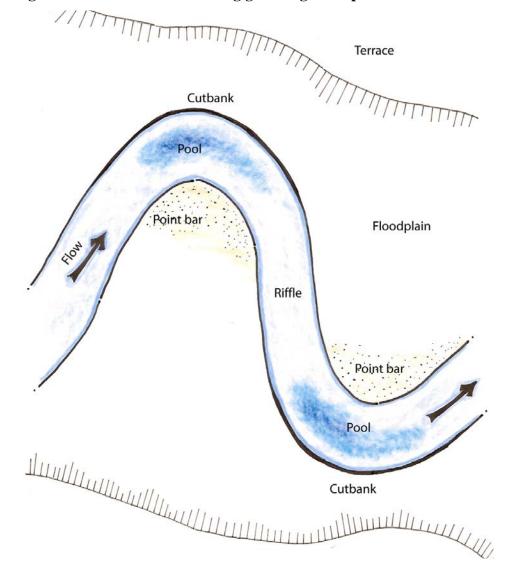
Figure 1.22 Plan view illustrating general geomorphic features.

Floodplain – is a flat, geomorphic feature adjacent to the channel that is currently being formed by the stream in its present condition and present climate (Figure 1.22, 1.23 and 1.24). Floodplain formation is maintained by the bankfull discharge, or 1.5-year recurrence interval discharge (Dunne & Leopold, 1998). The floodplain allows for the dissipation of excess energy during a flood event (Knighton, 1998).

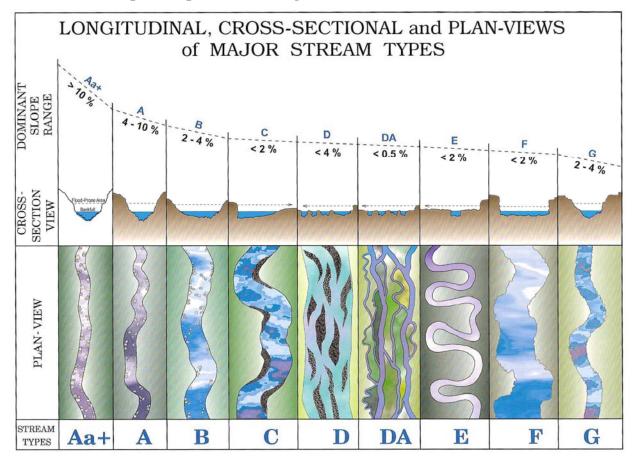
Figure 1.25 General characteristics of streams in Rosgen Classification system showing cross sectional shapes and plan views (Rosgen, 1996).

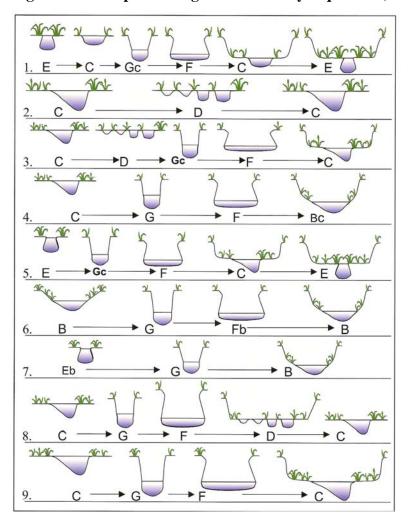
Figure 1.27 Sample of Rosgen evolutionary sequences (Rosgen, 2006).

conditions. Depending on why the stream changed initially, a stream may not regain its original form due to changes in sediment loads or changes in runoff creating different effective or bankfull stream discharge than before. Figure 1.27 illustrates some of Rosgen's (2006) stream evolution sequences.

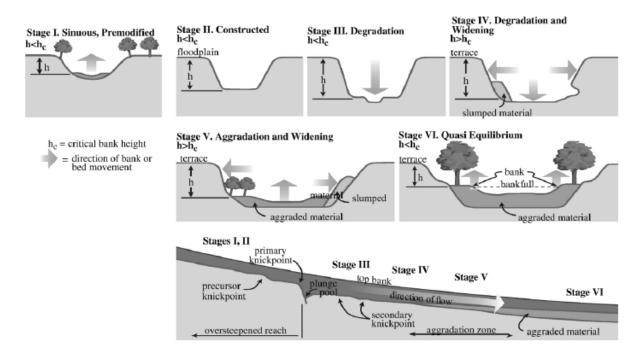
Figure 1.28 Simon-Hupp (1986) model of channel evolution (Simon and Rinaldi, 2006).

Simon-Hupp (1986, revised) - The Simon-Hupp model (Figure 1.28) is more general in terms of stream morphology than the Rosgen model. There are six stages associated with this model. Stage I is a pre-modified, sinuous stream. Stage II is a constructed stream, typically overwide and trapezoidal. Stage III begins degradation of the stream bed. Stage IV degradation and bank erosion (widening). Stage V, the channel aggrades and widens. Stage VI, the stream has reached a new quasi-equilibrium at the new elevation, climate, and hydrologic regime. Streams may go through all six stages or stages may be seen at six different points along the

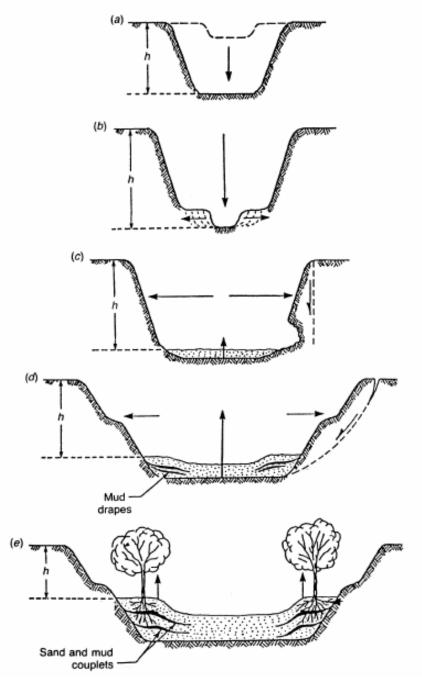
Figure 1.29 Schumm – Harvey – Watson (1984) Channel evolution model (Schumm, 1993).

Note: (a) is Stage I, (b) is Stage II, (c) is Stage III, (d) is Stage IV, and (e) is Stage V.

Schumm-Harvey-Watson (1984) - The Schumm-Harvey-Watson model (Figure 1.29) is very similar to the Simon-Hupp model in that it is based on stages, however, there are only five stages in this model. Stage II (constructed channel) of Simon-Hupp (1986) is omitted. In addition, Schumm-Harvey-Watson model stage III (c) shows the bed aggrading while the Simon-Hupp model shows the bed continuing to degrade during the equivalent stage (IV). Again, an argument could be made for an additional stage regarding channel migration of stable cross-section channel dimensions (Thorne, 1999).

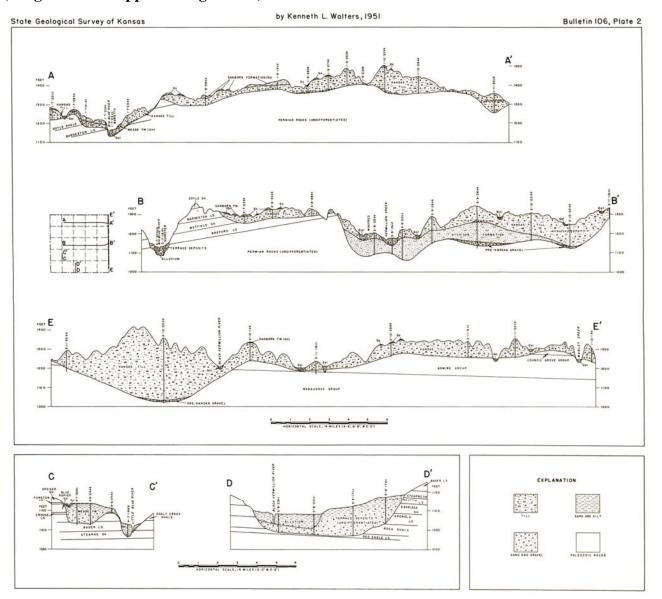
Figure 2.3 Cross sections of glaciated region Marshall County, Kansas (Walters, 1954) (Larger version Appendix Figure A.2).

Deep valleys have been created in the Flint Hills due to stream erosion (Aber, 2007c). Topographic relief in the area can be up to 30.5m (100') and deeply entrenched streams are common, drainages tend to follow in troughs and synclines of the formations (Aber, 2007c). Flash flooding is common in this region due to the semi-permeable layers of limestone and shale as well as the shallow, clay-rich soils of the areas. Valleys usually have deeper soils than ridge tops due to the steep slopes typically found on the formations. Surface runoff occurs mostly during storm events that happen in the spring and early summer and then again in fall (Aber, 2007c). In Figure 2.3, we can see a typical Flint Hill formation in eastern Marshall County in Section B-B¹.

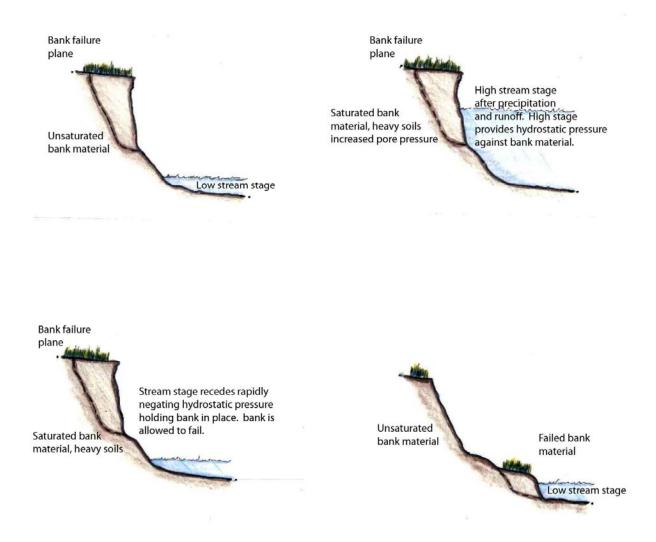
Figure 2.5 Illustration of bank failure and pore water pressure.

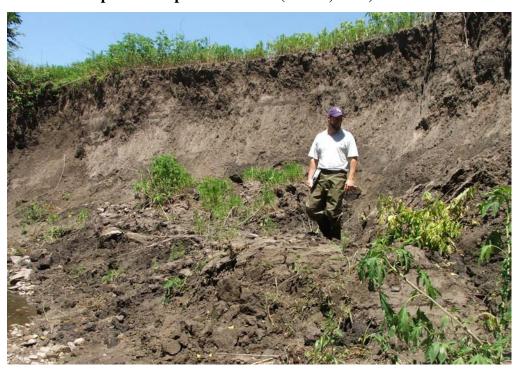
Figure 2.6 Irish Creek 2 study bank after June 2010 rains. Four-foot erosion pins were lost and the bank profile toe pin was buried (Keane, 2010).

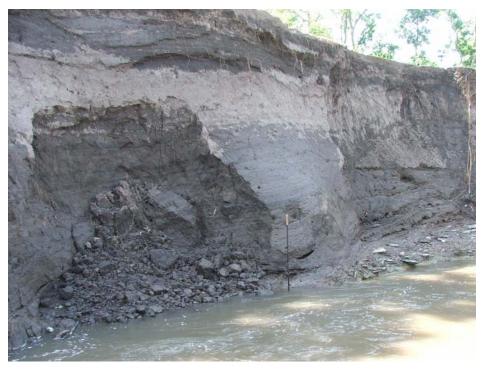
Figure 2.7 North Fork study reach 1 illustrating episodic and sporadic failures along field with no woody vegetation holding bank material (Keane, 2010).

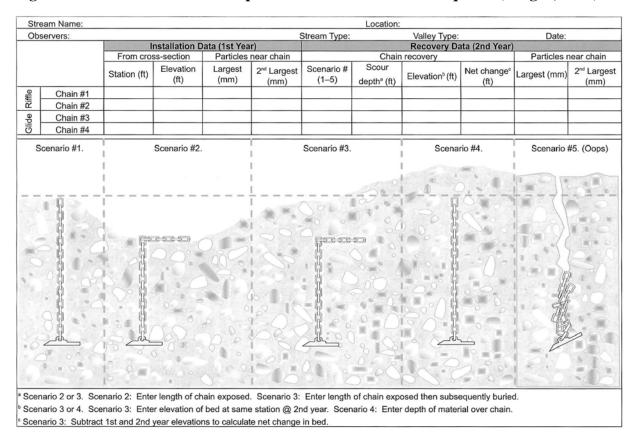
Figure 3.3 Scour chain form with possible scenarios and data required (Rosgen, 2006).

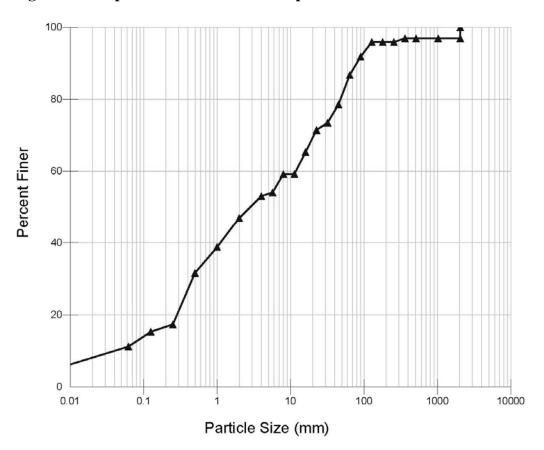
Figure 3.4 Graphed results of a modified pebble reach count for Irish Creek study reach 2.

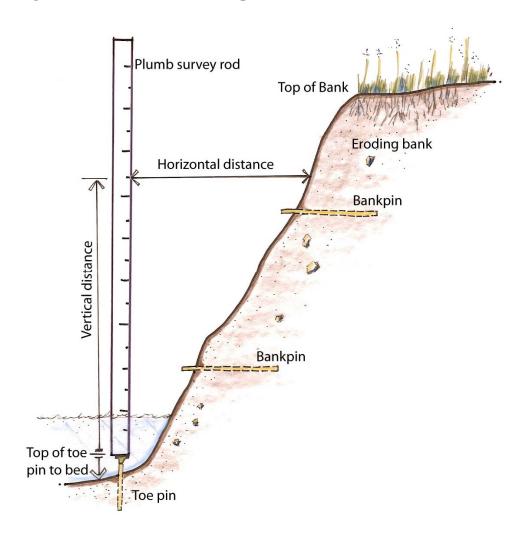
Figure 3.5 Illustration of a bank profile.

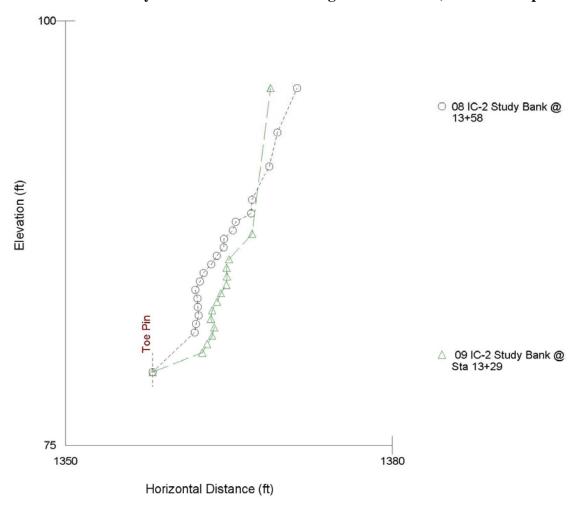
Figure 3.6 Overlay of consecutive years of bank profiles at Irish Creek study reach 2 study bank. These overlays are used to discern change in bank area (erosion or deposition).

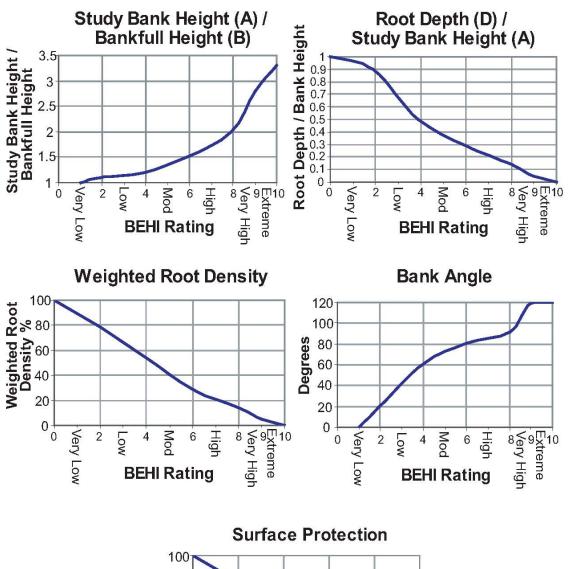
Figure 3.8 BEHI assessment value to score conversion sheet (Rosgen, 2008b).

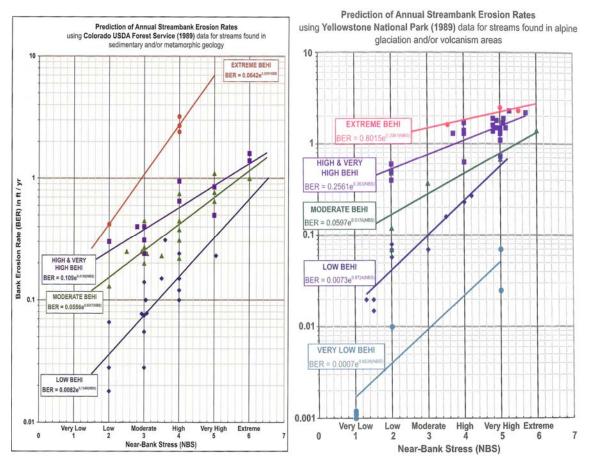
Figure 3.11 Erosion prediction curves developed using Colorado and Yellowstone data (Rosgen, 2001).

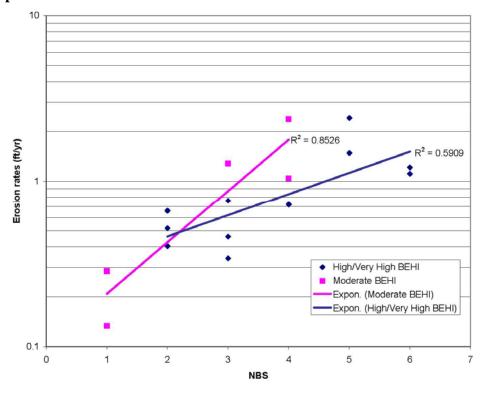
Figure 4.2 BEHI / NBS curve developed using average erosion rates over four-year study period with Black Vermillion data in Northeast Kansas.

Average erosion rates calculated in Tables 6 and 7 do not factor excess bank retreat rates that would be provided by those banks that failed and were listed as "Gone." If assumptions were made regarding bank retreat rates for those banks listed as gone, the bank retreat average would increase. North Fork 3 Study bank could warrant a 4' bank retreat assumption because all bank pins were gone as well as the toe pin. If a 4' retreat rate was assumed and averaged, then the average retreat rate would jump from 2.38' to 2.92' (+0.54'). Looking at Irish Creek 2 Study bank, a safe assumption of 3' of bank retreat could be made. Figure 2.6 illustrates that the bank failed and left a bench approximately 1/4 the total bank height. Assuming the 4'-bank pins were lost and 4' of mass failure occurred, a deduction in bank retreat area difference of 1/4 of the 4' would also need to be assumed. With this assumption, approximately 3' of bank retreat could be assumed as the total. When averaged, this 3' of bank retreat would equate to an average of 1.74' instead of 1.11' (+0.63'). These assumptions were not included in the initial calculations. However, if included the values change; Moderate BEHI R² decreases slightly from 0.8526 to 0.8429 while the High BEHI R² increases from 0.5909 to 0.6752 if these higher average figures were included in Figure 4.2.

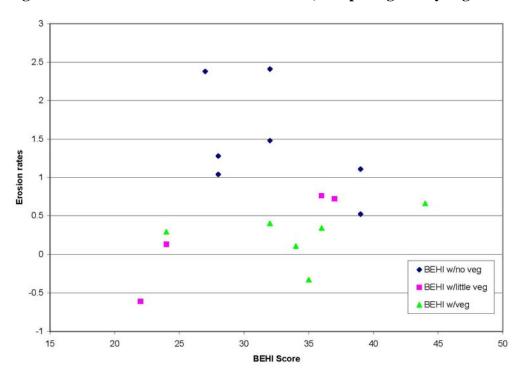
Figure 4.5 Plot of BEHI versus Erosion rates, comparing woody vegetation amounts.

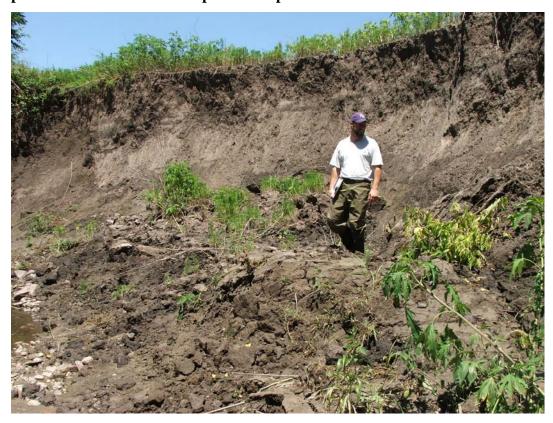
Figure 5.2 Irish Creek 2 study bank after June 2010 rains (Keane, 2010). Four-foot erosion pins were lost and the bank profile toe pin was buried.

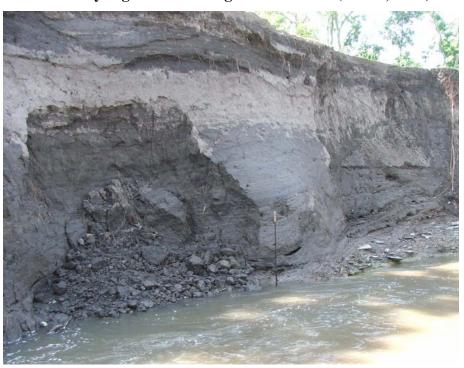
Figure 5.3 North Fork study reach 1 illustrating episodic and sporadic failures along field with no woody vegetation holding bank material (Keane, 2010).

Episodic mass failure was not exclusive to Irish Creek, but happened throughout the Black Vermillion watershed. Areas such as North Fork study reach 1 exhibited similar episodic erosion along the banks. North Fork study reach 1 study bank, located approximately 170' down stream of the pool cross section, experienced little erosion compared to just 10' upstream. Had our study bank been placed 10' upstream of where it was, the bank and pins would have been lost to erosion; in essence, bank failures are sporadic regarding intensity and extent along the reaches. Figures 5.3 and 5.4 illustrate sporadic mass failure along North Fork study reach 1. North Fork study reach 3 seemed to be farther along regarding stream evolution, as many banks experienced continuous mass failure along the stream, which came to rest at the bank toe in the over widened channel. These longitudinally continuous failures helped to narrow the stream while establishing a new bankfull bench (Figure 5.5 and 5.6). However, areas with woody vegetation tended to adhere bank material not allowing mass failure. Banks with woody riparian roots tended to be vertical in profile with tree roots extending vertically almost to the bank toe, or about 16' from the top of the bank as illustrated at Black Vermillion Main Stem 3 and Irish Creek 2 (Figure 5.7

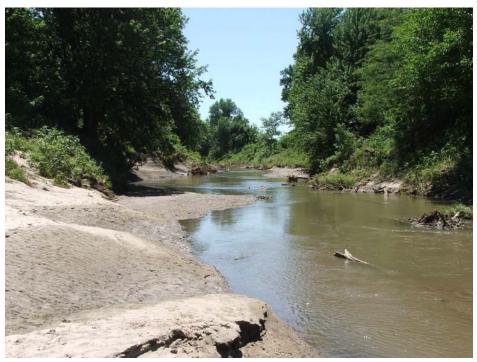
Figure 5.5 North Fork study reach 3 illustrating deposition along stream sides and formation of meanders in the straightened channel (Keane, 2010).

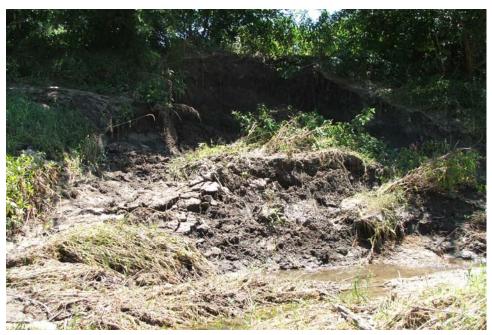
Figure 5.6 North Fork study reach 3 typical bank failure along reach establishing a new bankfull bench along both sides and re-vegetating streambanks (Keane, 2010).

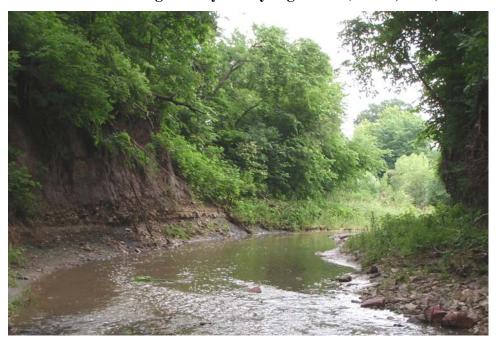
Figure 5.8 Irish Creek study reach 2 upstream of study bank (Figure 5.2) illustrating vertical banks held together by woody vegetation (Keane, 2010).

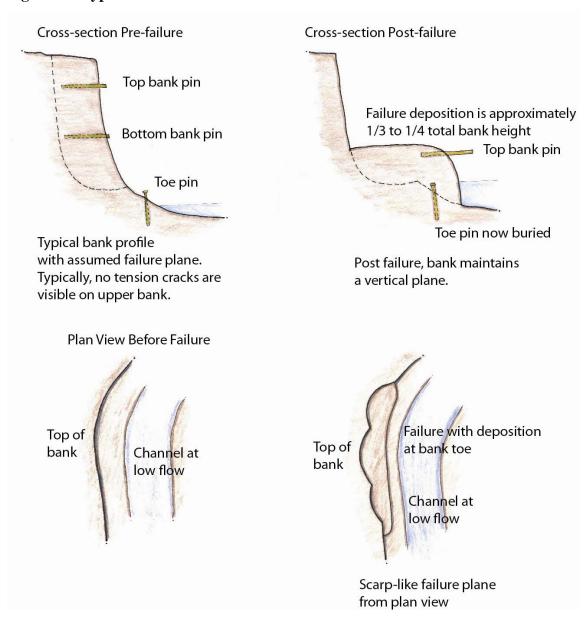
Figure 5.9 Typical bank failure result in Black Vermillion watershed.

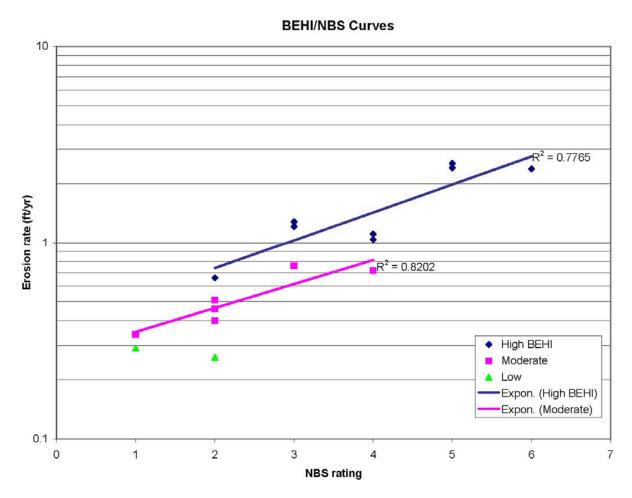
Figure 5.10 New adjusted BEHI/NBS curves for Northeast Kansas. Vegetation modification of 2.5 or 8.5 is included in this edition of curve.

Note: High BEHI slope : y=0.3838e $^{0.3283x}$; Moderate BEHI slope : y=0.2646e $^{0.2806x}$

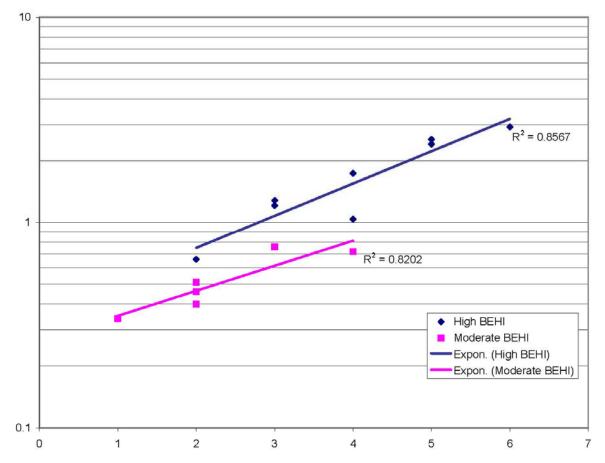
Note: High BEHI slope : $y=0.3634e^{0.3624x}$; Moderate BEHI slope : $y=0.2646e^{0.2806x}$. Including higher erosion rates increased R^2 value of High BEHI, indicating the assumptions of higher erosion rates may be truer to real erosion rates.

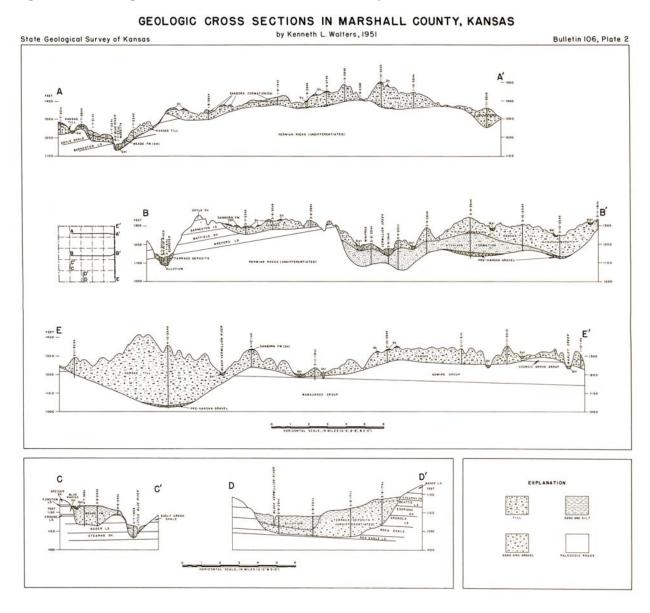
Figure A.2 Enlarged Cross section of Marshall County, KS (Walters, 1951).
