Evaluation of streambank stabilization structures on upstream and downstream bank erosion

A THESIS

Department of Biological and Agricultural Engineering  
Carl R. Ice College of Engineering

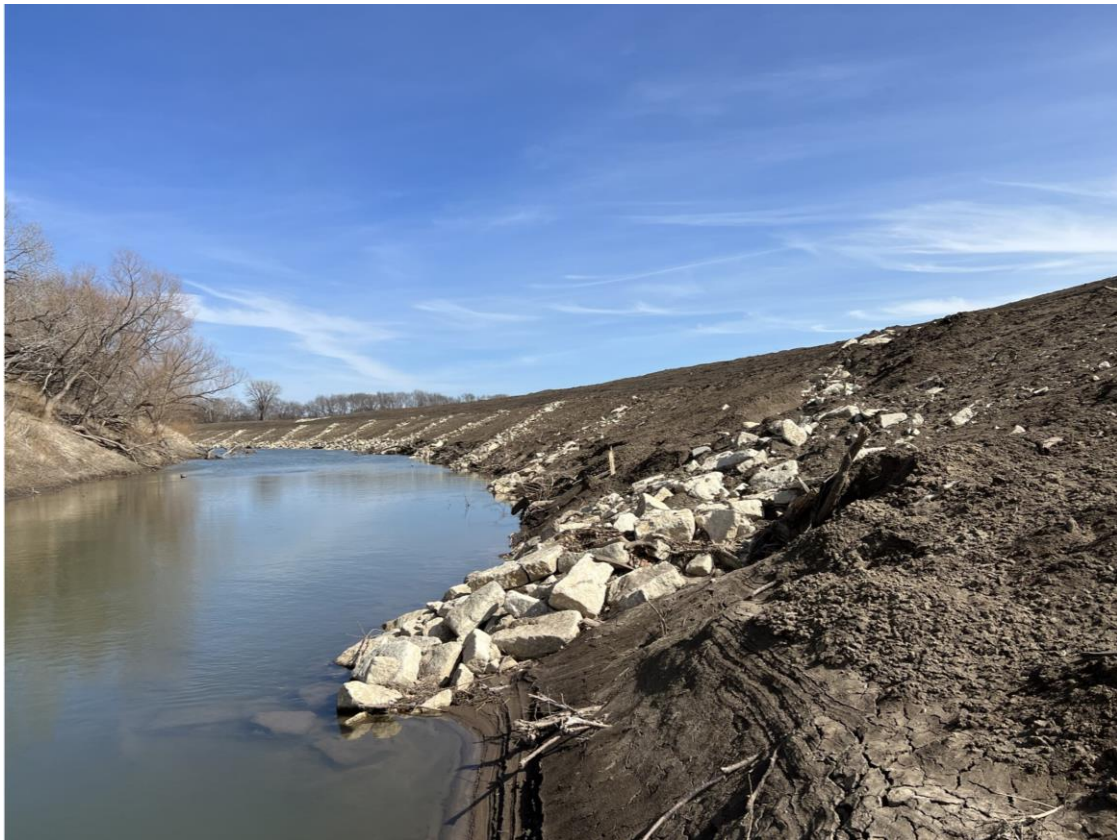
**Figure 1.2** Downstream view of rock vanes on the Cottonwood River, Kansas.

Rock vanes, also known as stream barbs, cross vanes, and j-hook vanes, are single protrusion, partially submerged rock piles positioned at an upstream angle on the outer bank of a meander to deflect stream flow away from the toe (NRCS, 2013; Figure 1.2). Rock vanes are sloped from the streambed to as high as bankfull elevation, ensuring that the vane's tip (i.e., sometimes referred to as the vane nose) remains submerged even during low flow conditions (Johnson et al., 2001). The presence of a submerged vane tip can lead to the misidentification of rock vanes as J-hook vanes. Unlike rock vanes, J-hook vanes have a distinctive hook shaped rock tip (Khosronejad et al., 2013, 2015). For the purpose of this literature review, the term "vanes" or "rock vanes" will refer to stream barb structures without the hook shaped tip. In general, the cross-sectional shape of a vane is either triangular or trapezoidal, depending on the crest width.

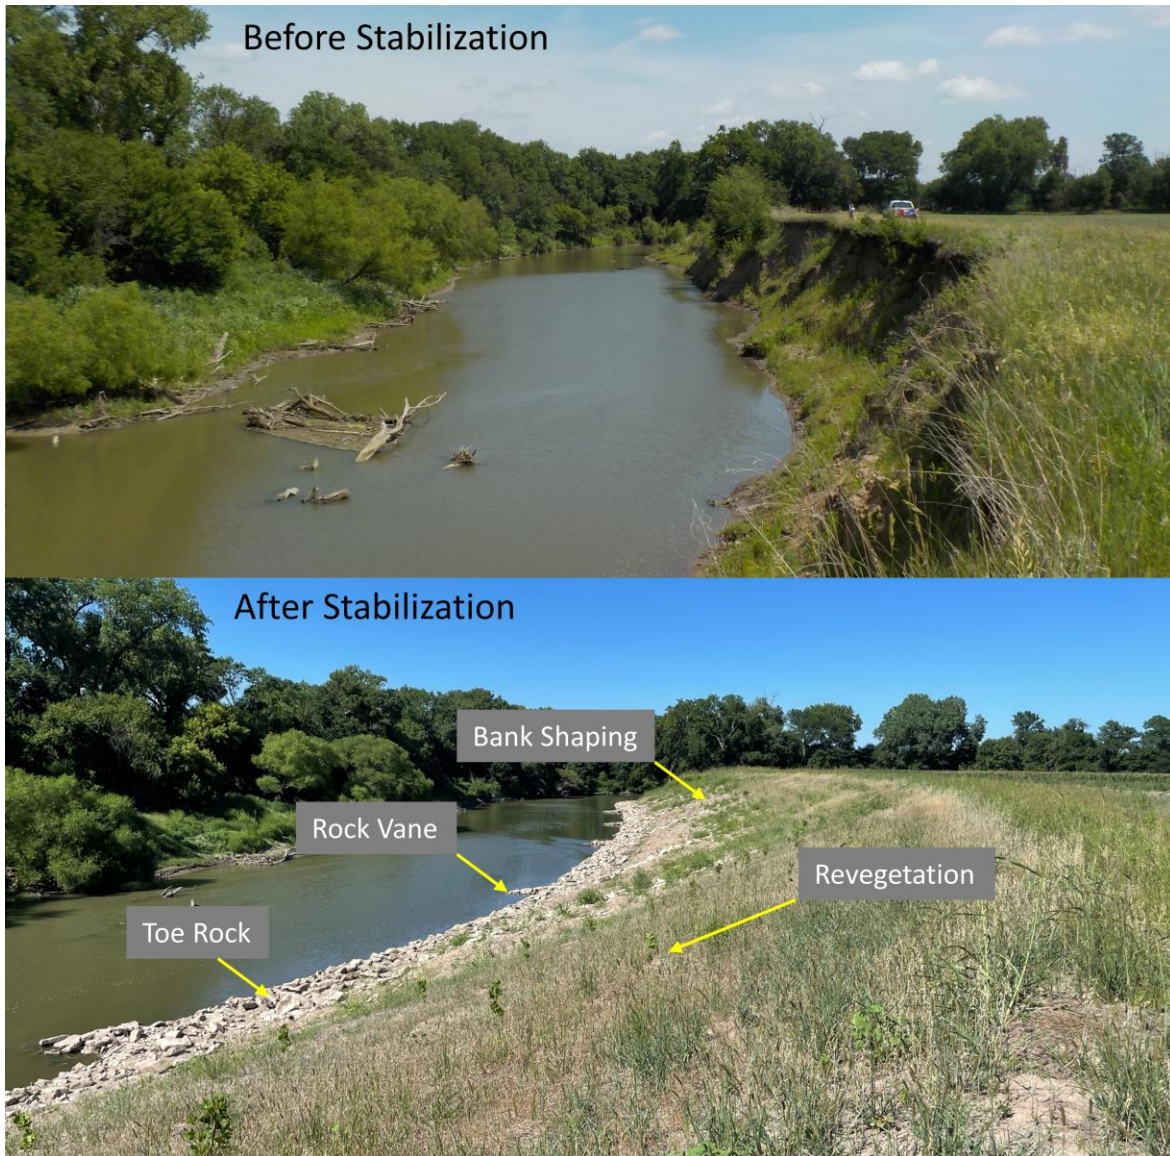
**Figure 2.2** Downstream view of the before and after construction at C112 illustrating the SBS techniques used on both C112 and C102.

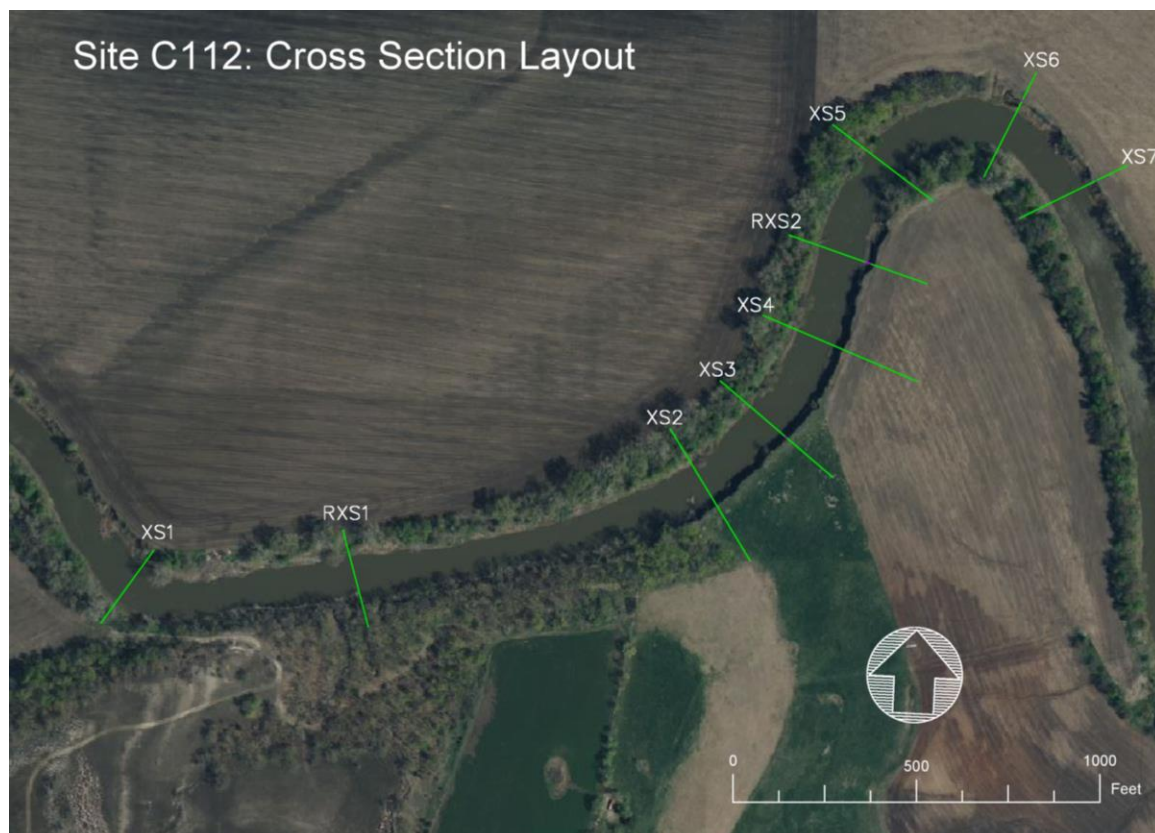
**Figure 3.1** Aerial image of Site C112 with the cross section in the upstream (bottom left), middle (center), and downstream meanders (top right). XS refers to cross section, while RXS refers to riffle cross section.

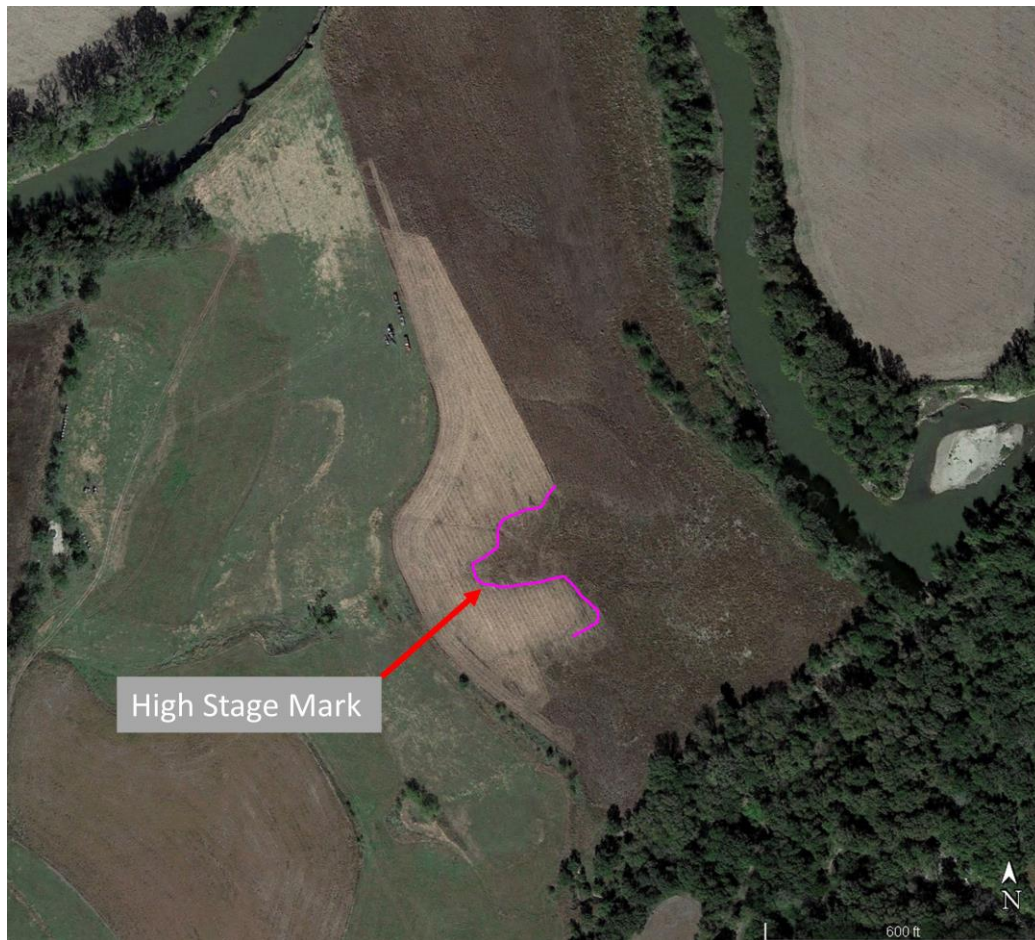
**Figure 4.4** Aerial image from October 12<sup>th</sup>, 2019, highlighting the high stage mark at Site C112.

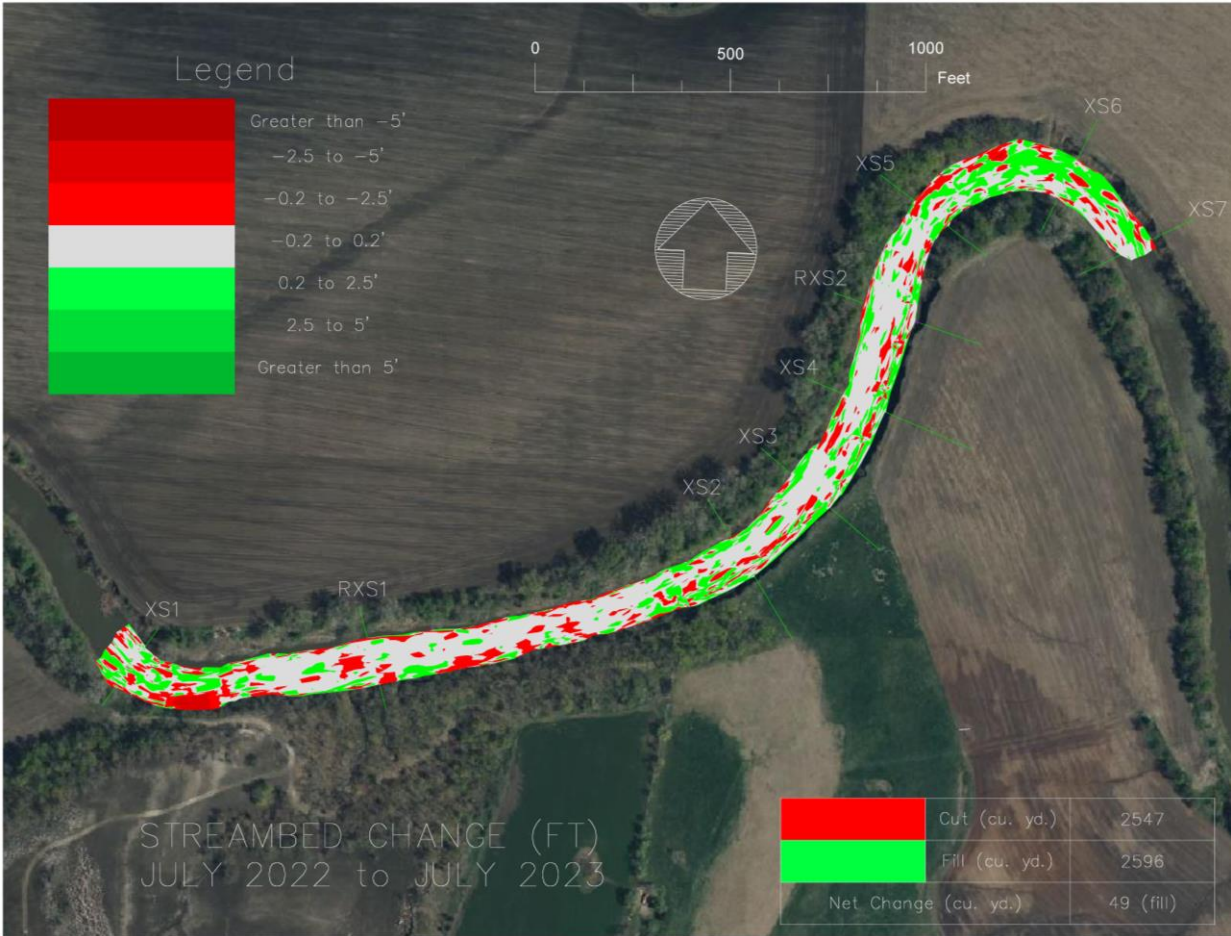
Appendix B Figure B.4 Site C112 Streambed Cut and Fill Map from 2022 to 2023
