INVENTORY AND ANALYSIS OF THE BLACK VERMILLION RIVER SYSTEM RIPARIAN CORRIDORS

A THESIS

MASTER OF LANDSCAPE ARCHITECTURE

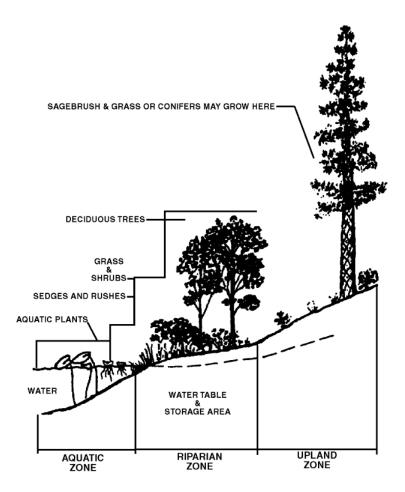
Figure 1.1 Cross section of a typical riparian zone (Department of the Interior, 2007).

vegetation in the riparian zone is directly influenced by the water table in the riparian zone because the roots can come into direct contact with the water table. Verry (2004), suggests that the riparian zone be extended using Rosgen's floodprone width plus 30meters. Floodprone width of a stream is defined as stream width at two times the maximum depth at bankfull discharge (Rosgen, 1996).

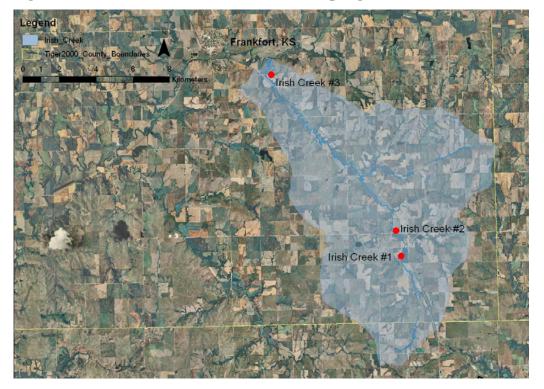
Figure 1.4 Irish Creek sub-watershed and sampling locations.

Irish Creek (Black Vermillion South Fork) is a tributary located in southern Marshall County with a total drainage area of approximately 46.5 miles² (120.5Km²), Figure 1.4. Irish Creek enters the Black Vermillion to the east of Frankfort, Kansas, from

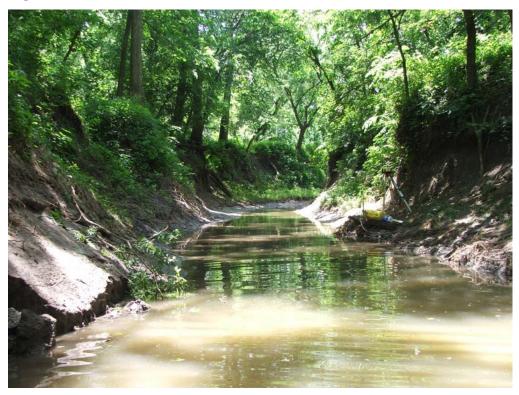
Figure 1.5 Irish Creek reach 1 (Keane, 2007).

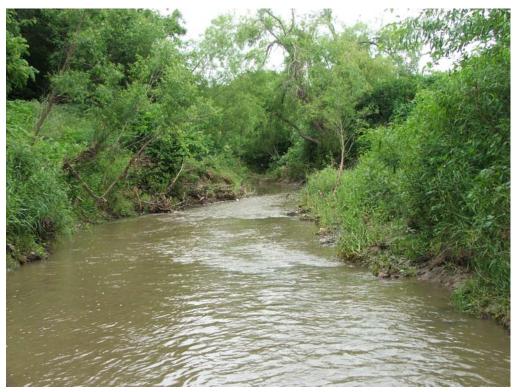
Figure 1.6 Irish Creek reach 2 (Keane, 2007).

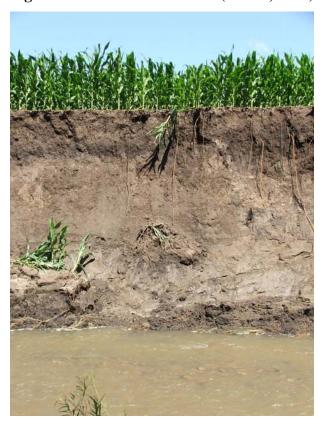
Figure 1.7 Irish Creek reach 2 (Keane, 2007).

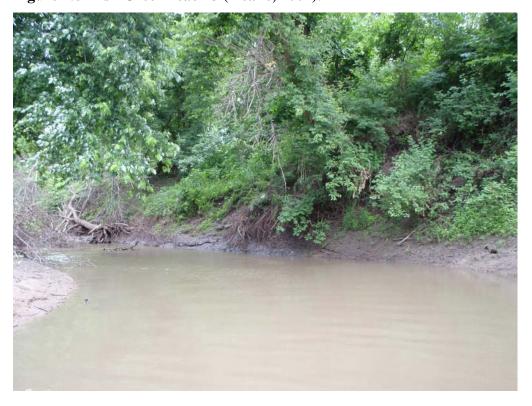
Figure 1.8 Irish Creek reach 3 (Keane, 2007).

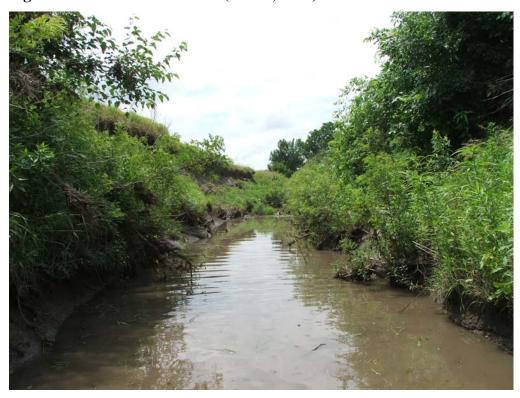
Figure 1.10 Main Stem reach 1 (Keane, 2007).

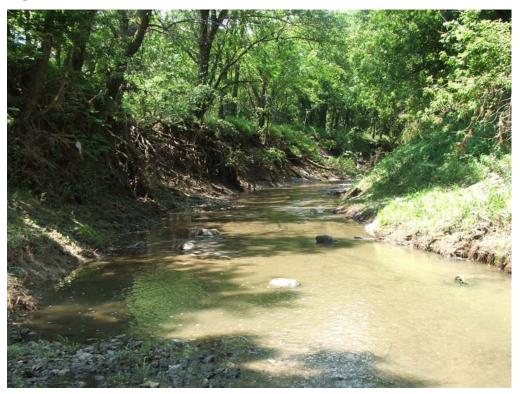
Figure 1.11 Main Stem reach 2 (Keane, 2007).

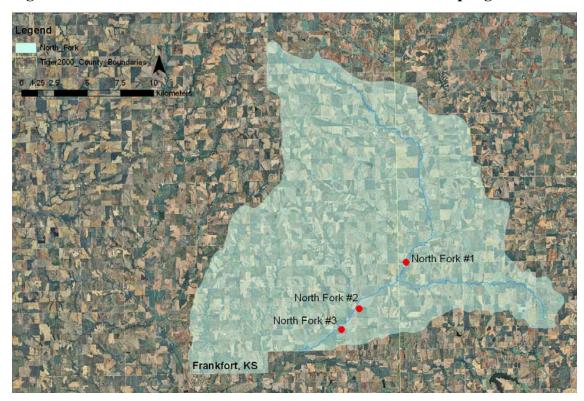
Figure 1.13 Black Vermillion North Fork sub-watershed and sampling locations.

The North Fork of the Black Vermillion runs south and is the largest subwatershed of the Black Vermillion watershed, containing approximately 121 miles² (313.4Km²), Figure 1.13. The North Fork flows through alluvial and glacial deposits as it makes its way to the Black Vermillion River. Topography is rolling with deeply dissected and entrenched streams. Total fall in the sub-watershed is 329 feet (100.25m) in 23 miles (37Km) (SCS, 1966). Ridges and flatter tops typically are covered in thin layers of loessial soils. This sub-watershed is also located within the tallgrass prairie region of Kansas. Typically, woodlands are located in the lowlands near streams when present. Predominant land use in the watershed is tillage agriculture with minimal pasture. Representative photos of the North Fork sub-watershed are included as Figures 1.14, 1.15, and 1.16.

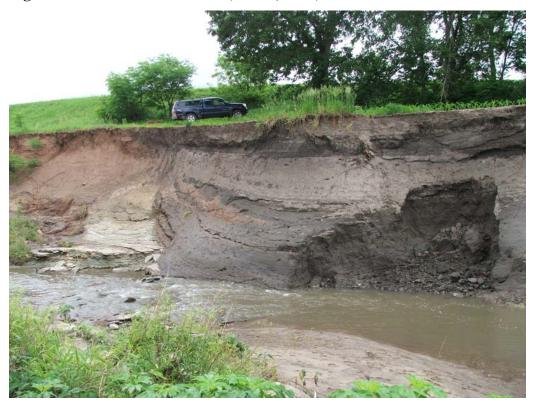
Figure 1.14 North Fork reach 1 (Keane, 2008).

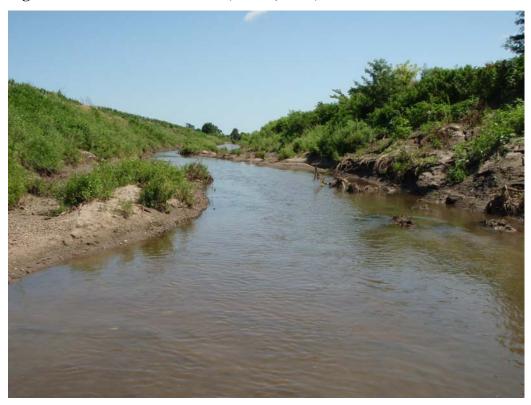
Figure 1.15 North Fork reach 2 (Keane, 2008).

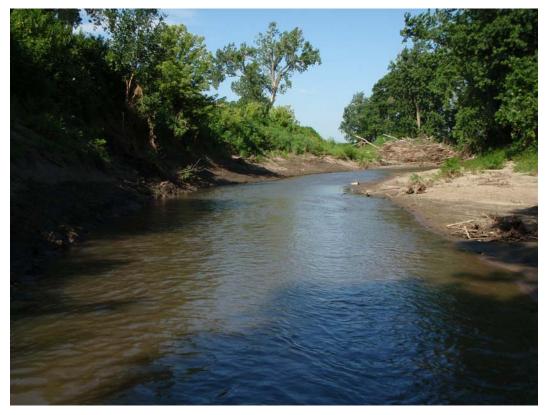
Figure 1.16 North Fork reach 3 (Keane, 2008).

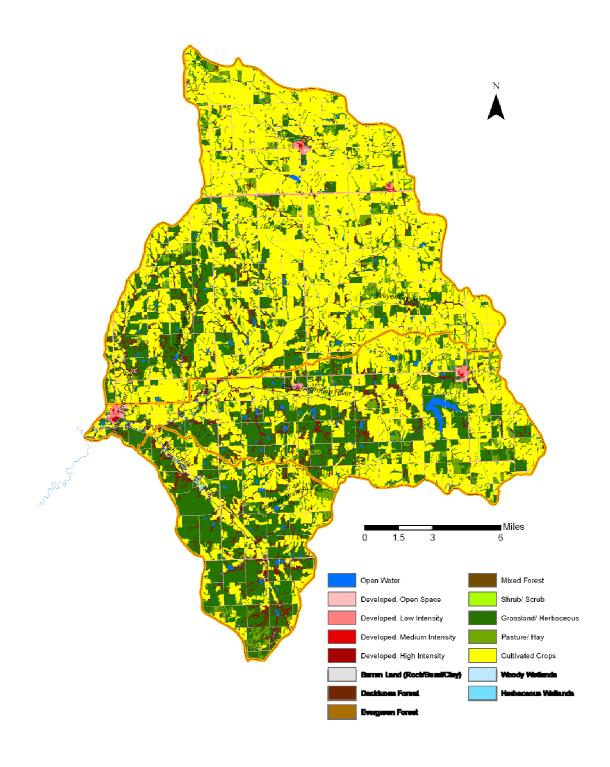
Figure 1.17 Land Use Map of Black Vermillion watershed.

Land use and land cover vary throughout the entire watershed. Cultivated lands, pastured lands, small cities, and natural areas are included within the watershed to varying degrees. The majority of land located within the watershed is currently cultivated or pastured, Figure 1.17. The United States Army Corps of Engineers (USCOE), Soil Conservation Service (SCS), now the Natural Resources Conservation Service (NRCS), and individual landowners have modified most of the streams in the watershed in some fashion, either by straightening the channel and/or by placing levee systems between fields and the streams. The stream length in the watershed has been shortened a total of 15.8 miles (25.4Km) (USCOE, 1998). These modifications tend to decimate the riparian vegetation and lead to an increased velocity of the stream, which in turn increases erosion rates along streambed and banks while destroying riparian habitat. With no vegetation to increase bank stability and increase roughness, the stream can erode its bed and banks at a rapid rate. The watershed also contains numerous water impoundments, reservoirs or farm ponds. Many of these impoundments are "flowthrough" and allow for a sustained flow of water through to the streams, which is quite different from historical flow regimes. Historically, precipitation in the watershed would infiltrate into the soil more than it does today. Infiltration of water provided more storage capacity for groundwater, lessened surface runoff and provided a non-flashy hydrograph. The historic flow regimes with groundwater flow to the streams would have provided a sustained base flow year round. (USCOE, 1998).

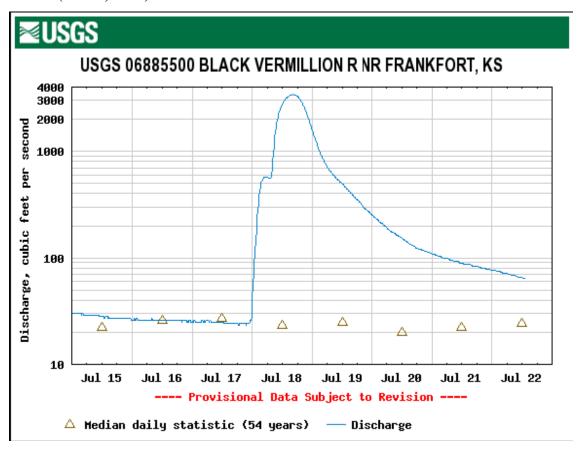
Figure 1.18 Example of a Hydrograph used by USGS at Frankfort, KS, showing a discharge change from about 25c.f.s to almost 3500c.f.s in one day after a 3" rain event. (USGS, 2008).

<u>Hydrograph</u>- A graph where discharge is plotted against time, Figure 1.16. It helps explain how quickly discharge rises and then falls. Historically hydrographs had lower peaks and fell at a much slower rate than they do today.

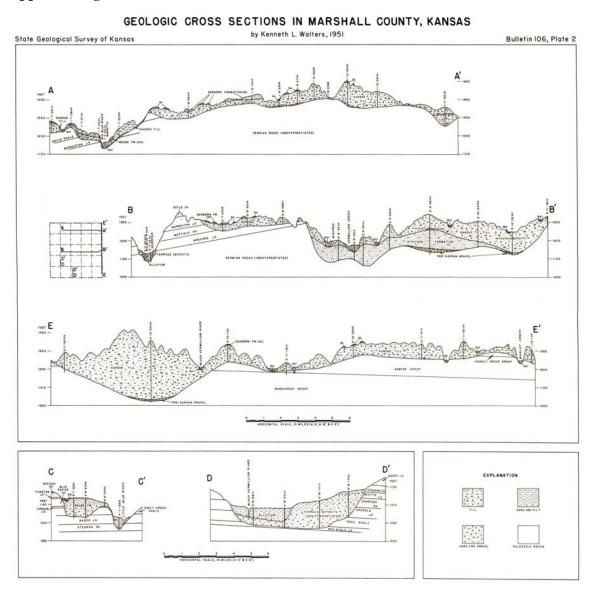
Figure 2.2 Cross sections of glaciated region (Walters, 1954) (For larger version, see Appendix Figure A.2).

Deep valleys have been created in the Flint Hills due to stream erosion (Aber, 2008). Topographic relief in the area can be up to 100' (30.5m) and deeply entrenched streams are common, drainages tend to follow in troughs and synclines of the formations (Aber, 2008). Flash flooding is common in this region due to the semi-permeable layers of limestone and shale as well as the shallow, clay-rich soils of the areas. Valleys usually have deeper soils than ridge tops due to the steep slopes typically found on the formations. Surface runoff occurs mostly during storm events which happen in the spring and early summer and then again in fall (Aber, 2008). In Figure 2.2, we can see a typical Flint Hill formation in eastern Marshall County in Section B-B¹.

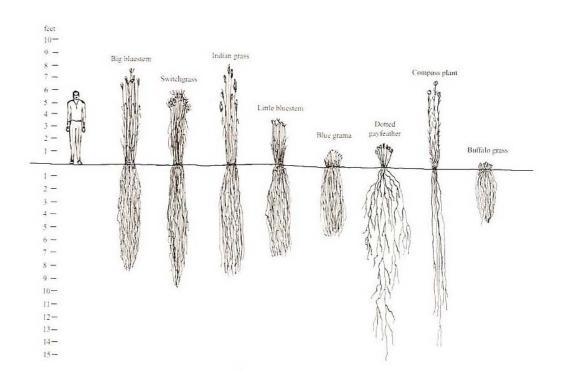
Figure 2.3 Example of native prairie plant rooting depth (Haddock, 2005).

Root systems between herbaceous and woody plants differ in their structure. In general, woody root structure is thicker and less fibrous versus the more fibrous and deep root systems of native grasses and forbs. Figure 2.3 is an example of native prairie grasses and forbs rooting depth. Row crops and non-native cool season grasses have a much shallower and less fibrous root system than native prairie vegetation allowing for less infiltration of water into the soil (Harpstead et al. 2001). A shallow root system of about 6" (15.24cm) is typical in cool season grasses such as Brome (*Bromus* sp.) and annual crop species such as corn (*Zea mays*). In addition to infiltration differences, sediment yield from agricultural row crops is higher than the native grassland (Leopold et al, 1964). Forbs, such as compass plant (*Silphium laciniatum*), can reach a rooting depth of 15' (4.6m) while the fibrous root systems of grasses such as big bluestem (*Andropogon gerardii*) can delve to a depth of 8'-10' (2.4-3m). These native fibrous root systems were adequate to hold streambanks together under the historic hydrograph.

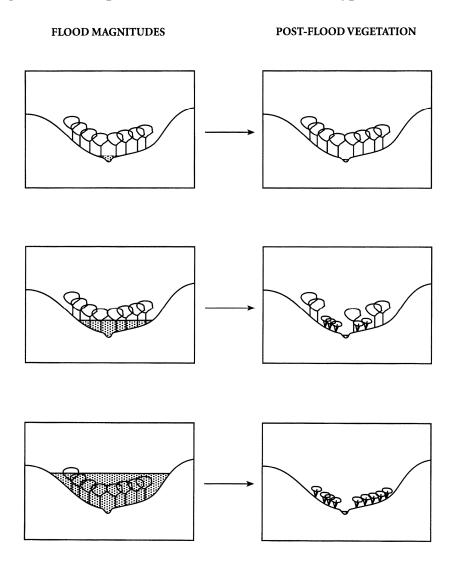
Figure 2.4 Example of Intermediate Disturbance Hypothesis (Bendix, 1997).

Riparian vegetation should be ever-changing in age and composition due to the disturbance of flooding, see Figure 2.4 (Bendix, 1997). We can imagine, looking at Figure 2.4 that the first scenario would represent a channel that has been modified in a way that no longer allows contact with the floodplain. This disconnect from the floodplain lowers species diversity and age diversity in vegetation. The second scenario would represent a healthy riparian zone that has a connected floodplain and allows for changes in the riparian vegetation and age diversity of the vegetation. Scenario three might represent high stream discharge due to land use change. The land use change would be responsible for an increase in impervious surfaces increasing the runoff to the stream. This increase in discharge would cause flooding at a greater depth than before, destroying vegetation higher on the banks that was not affected before the land use change. Such an increase in discharge would lead to increased erosion from the banks due to the removal of vegetation and not allowing the vegetation time to re-establish.

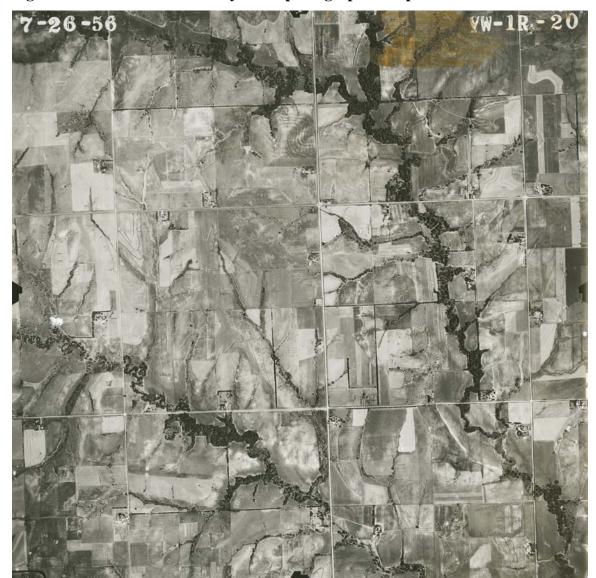
Figure 3.3 1956 Marshall County aerial photograph example.

Aerial photographs showing the Black Vermillion watershed in 1956 were used to compare the riparian corridors to other years averages. The year 1956 was chosen because the aerial photographs were available and the timing was before channelization by the SCS (NRCS) had taken place in the watershed. The riparian corridors in the photographs were measured by hand and that measure was recorded on a data sheet. Figure 3.3 is an example of the photographs from 1956.

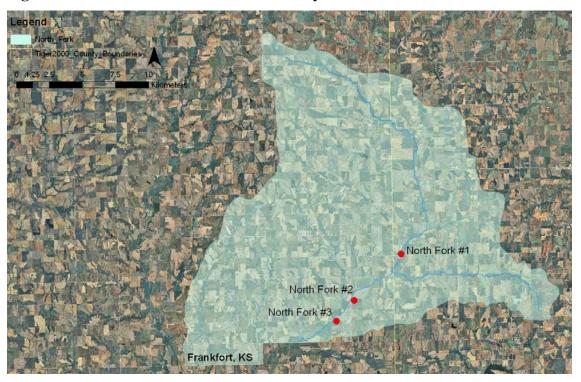
Figure 3.6 North Fork Black Vermillion study reach locations.

Vegetation sampling was done adjacent to the stream channel on each of the nine study stream reaches in the Black Vermillion Watershed (Figures 3.6, 3.7 and 3.8). I used the data collected to compare species and tree diameter at breast height (dbh) sizes with the 1857 Territory Survey notes. The comparison should begin to provide a measure of departure from historical conditions as far as age diversity and species richness and answer the question of what changes occurred in land cover and land use.

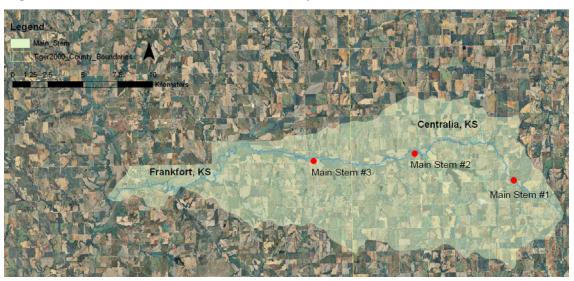
Figure 3.7 Black Vermillion Main Stem study reach locations.

Stem Black Vermillion is located, Figure 3.7) was only 27 links wide or about 18-feet (5.5m) in width. I am not sure where the measure was taken, it could have been top of one bank to the top of the opposite bank or from water's edge to water's edge, the assumption is the former. Currently, top of bank to top of bank at our Reach 3 of the Main Stem is about 84' (25.6m), with a depth of 19.7' (6m) to the thalweg, or deepest portion of the stream. This is quite the departure from historical conditions of the stream.

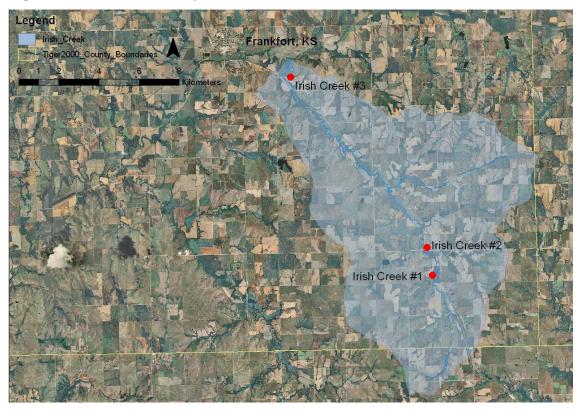
Figure 3.8 Irish Creek study reach locations.

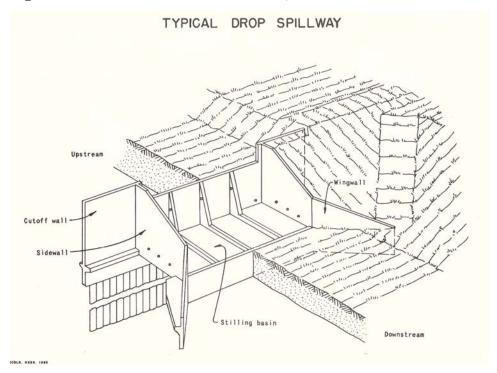
Figure 4.4 Grade control structure (SCS, 1966).

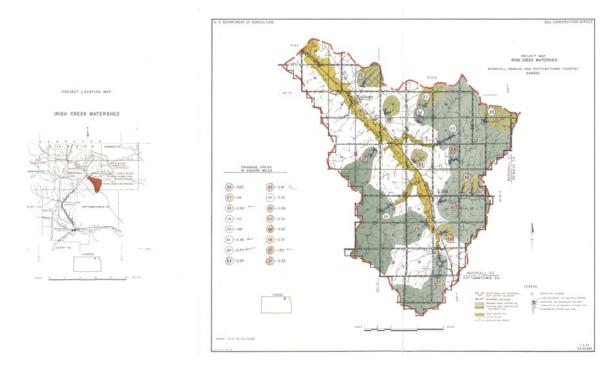
Figure 4.6 Irish Creek Work Plan (See Appendix for larger version), (SCS, 1966).

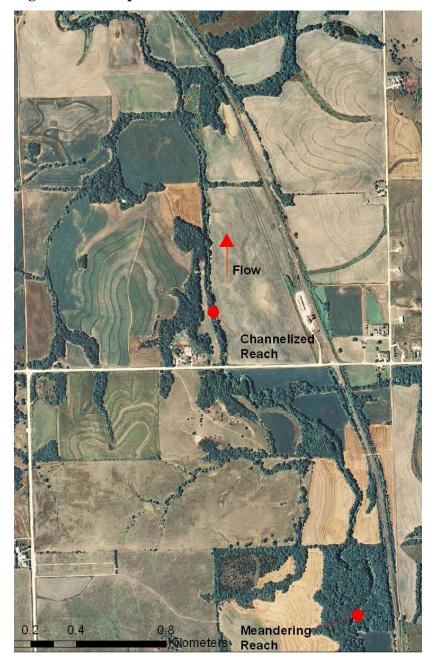
Figure 4.7 Example of channelization and natural meander bends in Irish Creek.

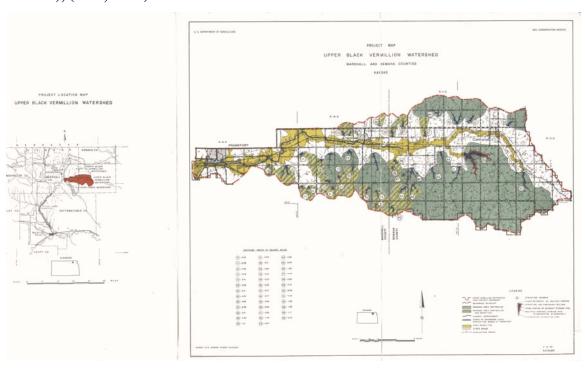
Figure 4.8 Black Vermillion Main Stem Work Plan (See Appendix for larger version), (SCS, 1966).

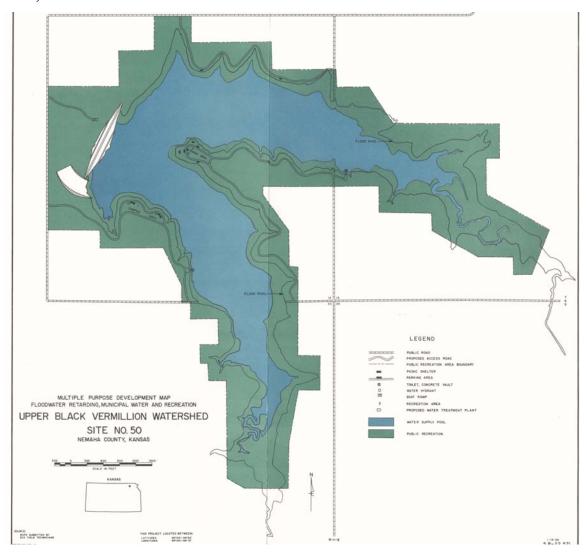
Figure 4.9 Centralia Lake Work Plan (See Appendix for larger version), (SCS, 1966).

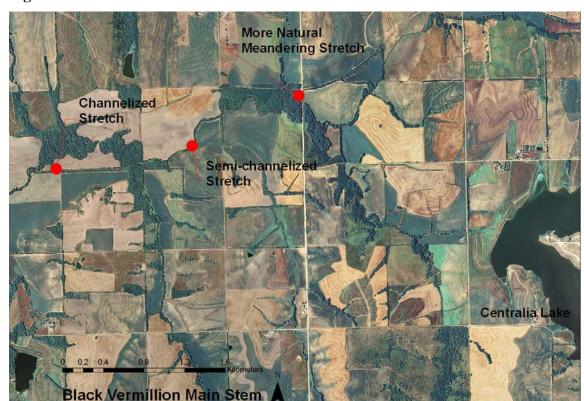
Figure 4.10 Natural meanders to channelized reaches on Main Stem 2006 aerial.

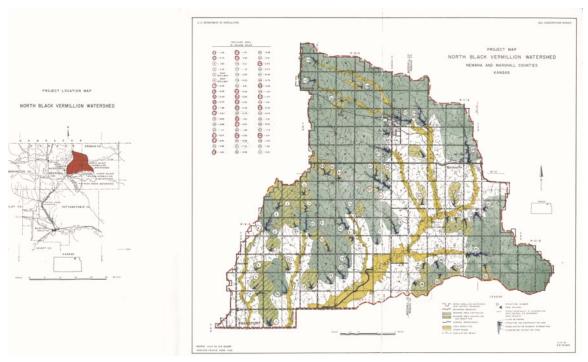
Figure 4.11 Black Vermillion North Fork Work Plan (See Appendix for larger version), (SCS, 1966).

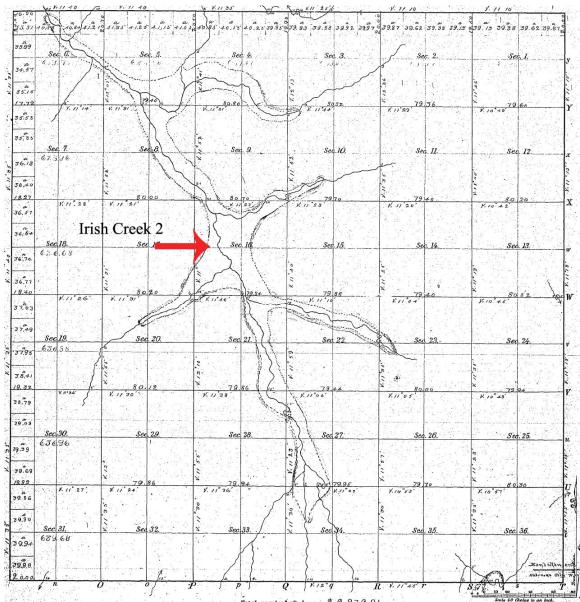
Figure 5.1 Irish Creek reach 2, 1857 survey map.

Note: Riparian corridor outlined in black with stream delineated through center of riparian corridor.

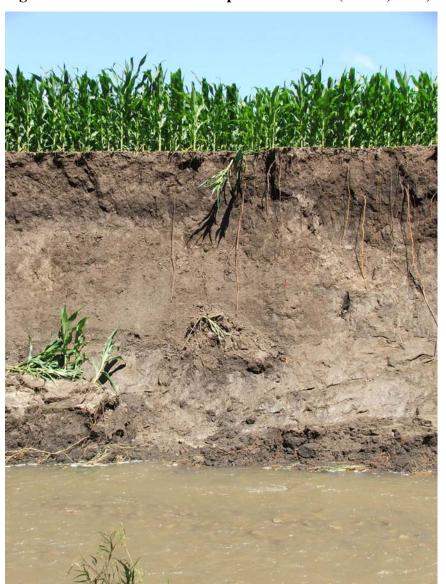
Figure 5.4 Irish Creek reach 2 riparian corridor (Keane, 2007).

Note: Corn is approximately 5' tall, old woody roots still visable.

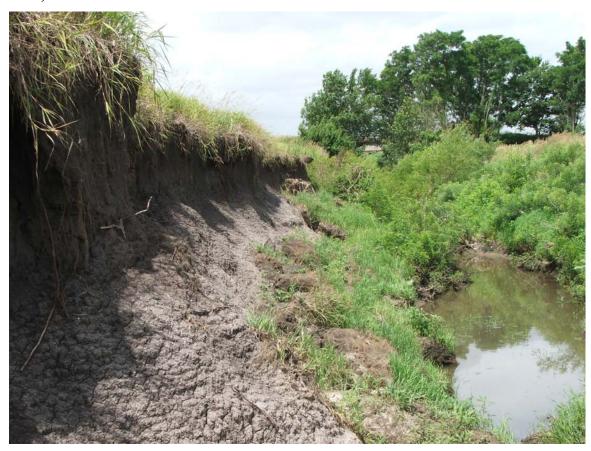
Figure 5.7 Main Stem reach 1, willows establishing at a lower elevation (Keane, 2007).

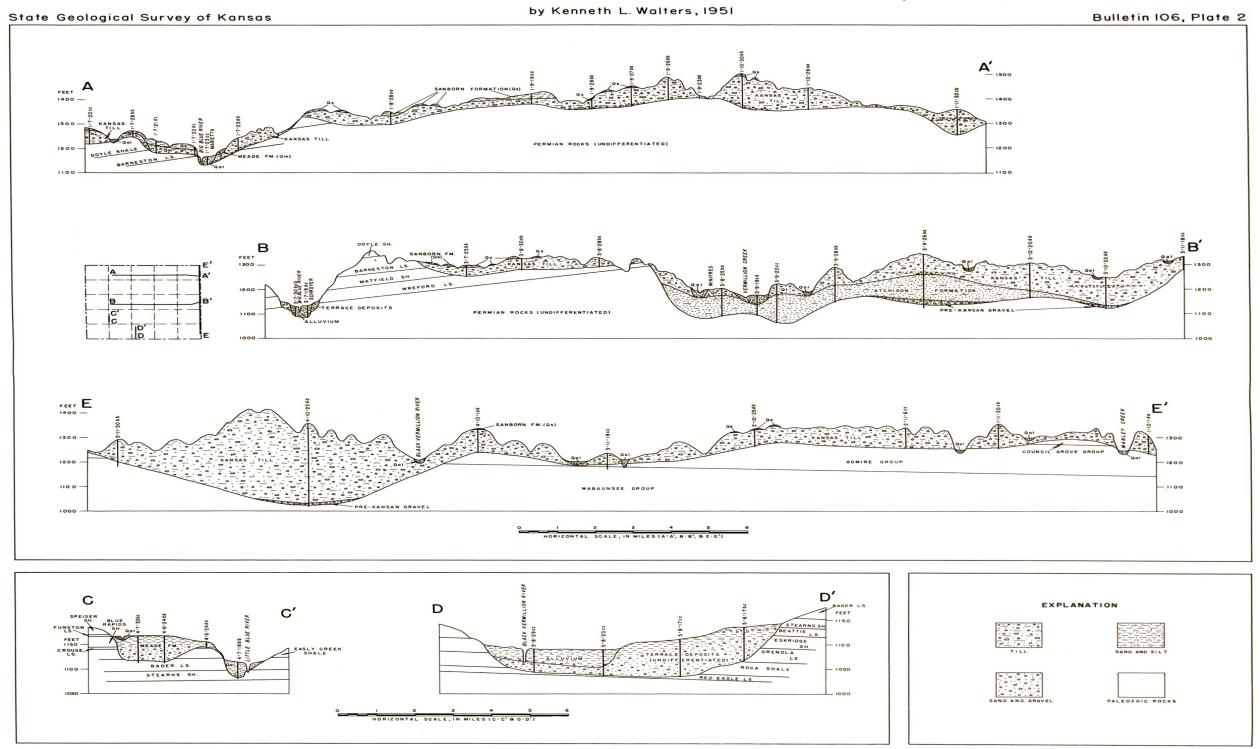
Figure B.3 Geologic cross sections enlarged

GEOLOGIC CROSS SECTIONS IN MARSHALL COUNTY, KANSAS
