THE CORROSION OF REINFORCEMENT IN CONCRETE

A MASTER'S THESIS

Department of Civil Engineering

KANSAS STATE UNIVERSITY
Manhattan, Kansas

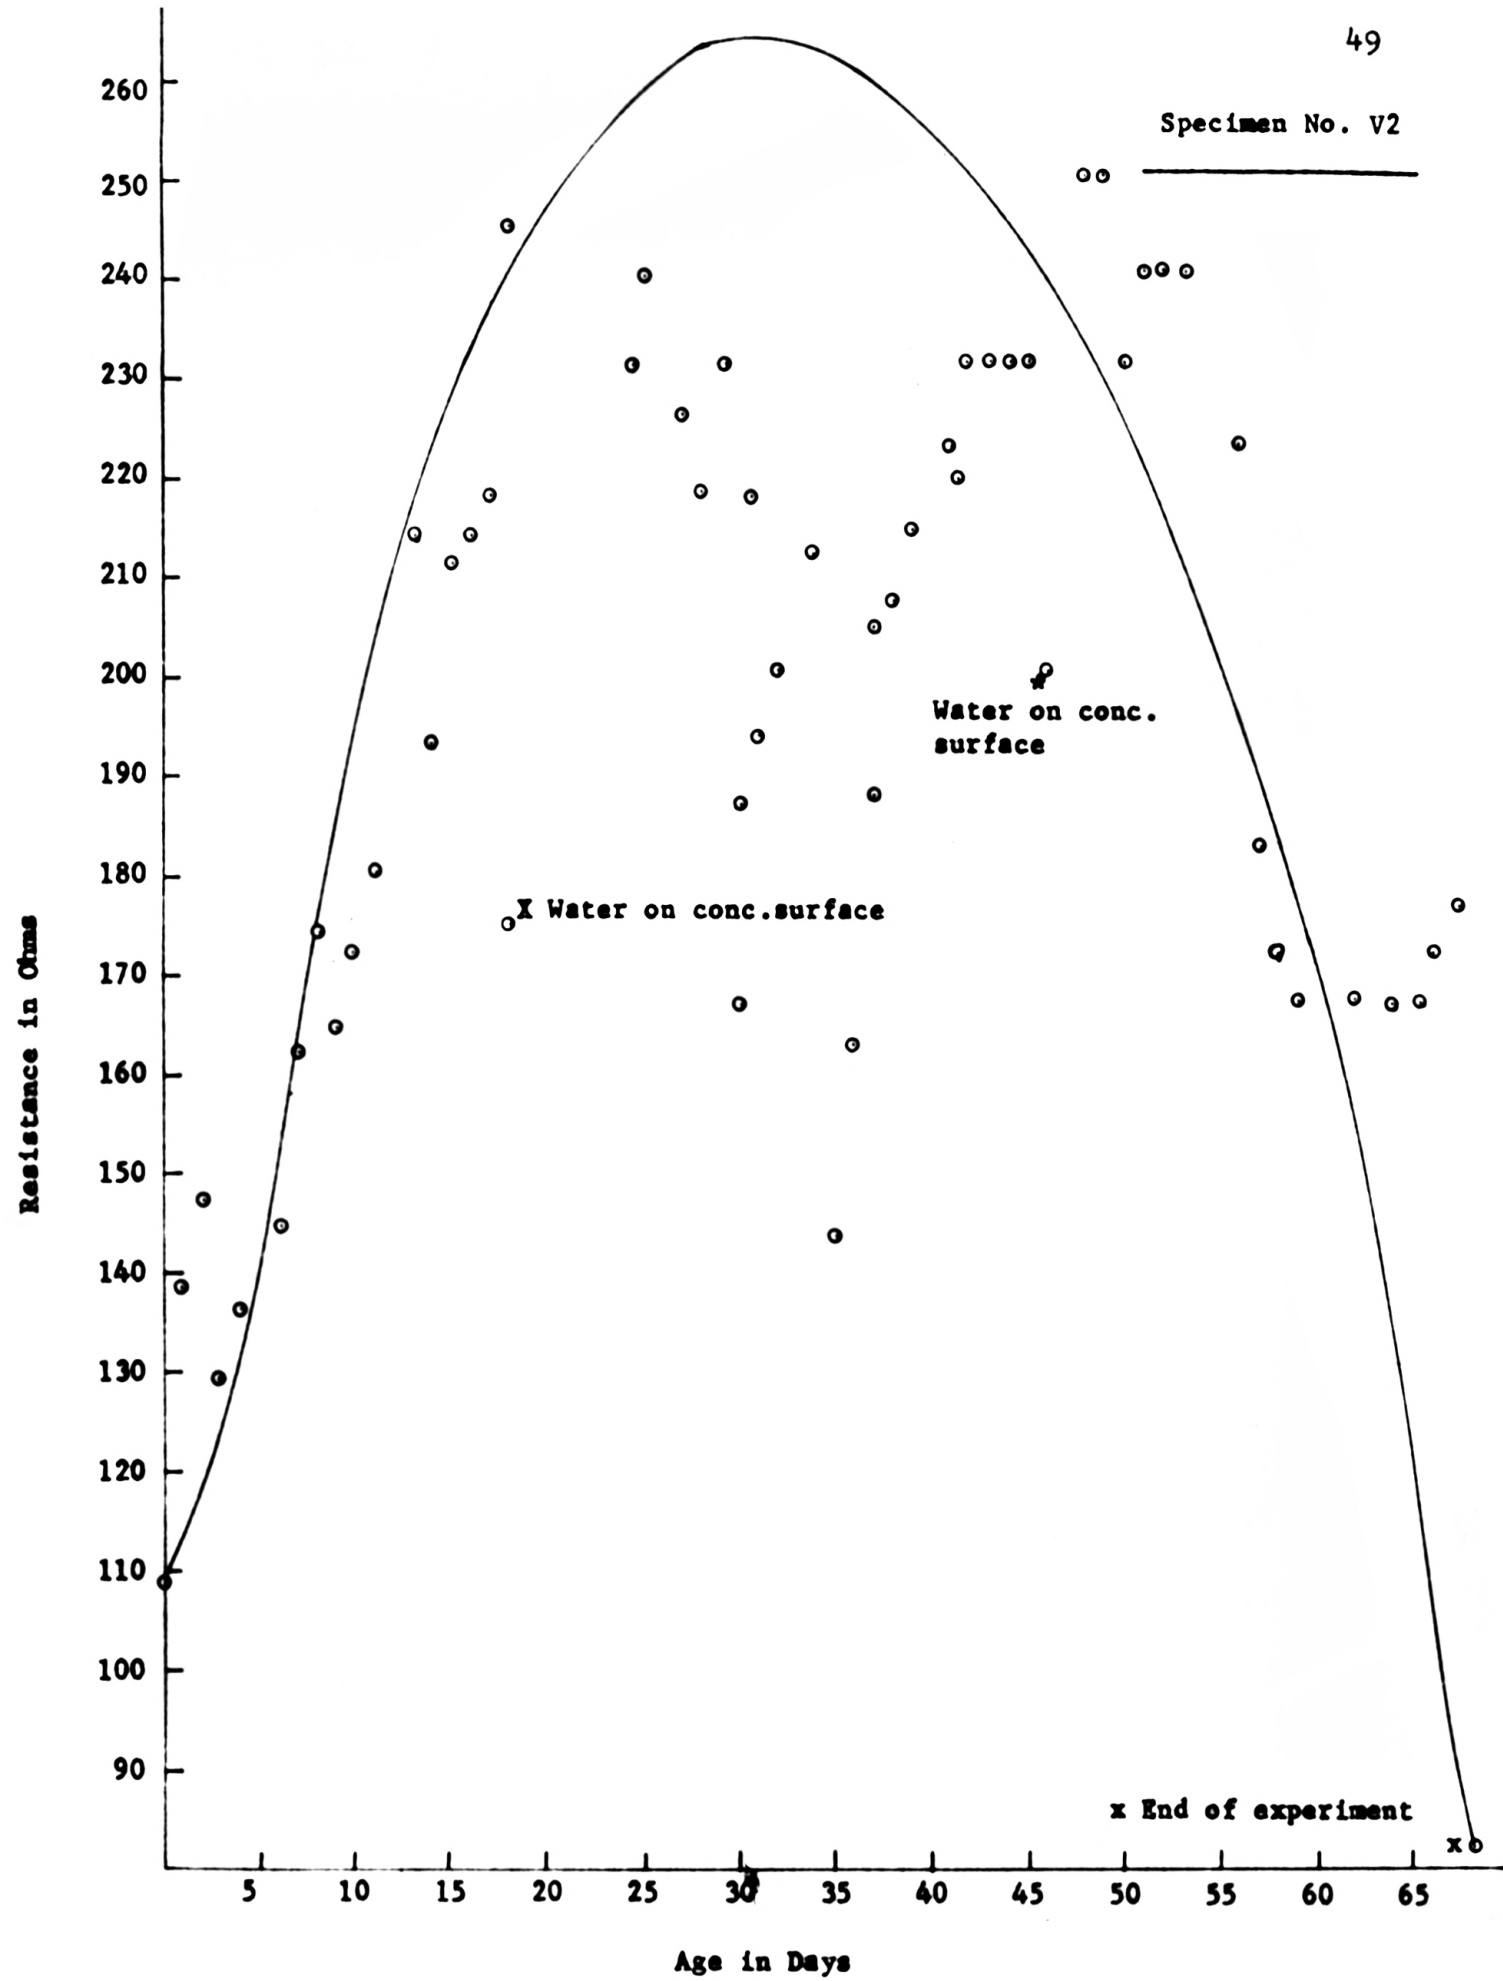
Fig. 2. Variation of Resistance of concrete against age

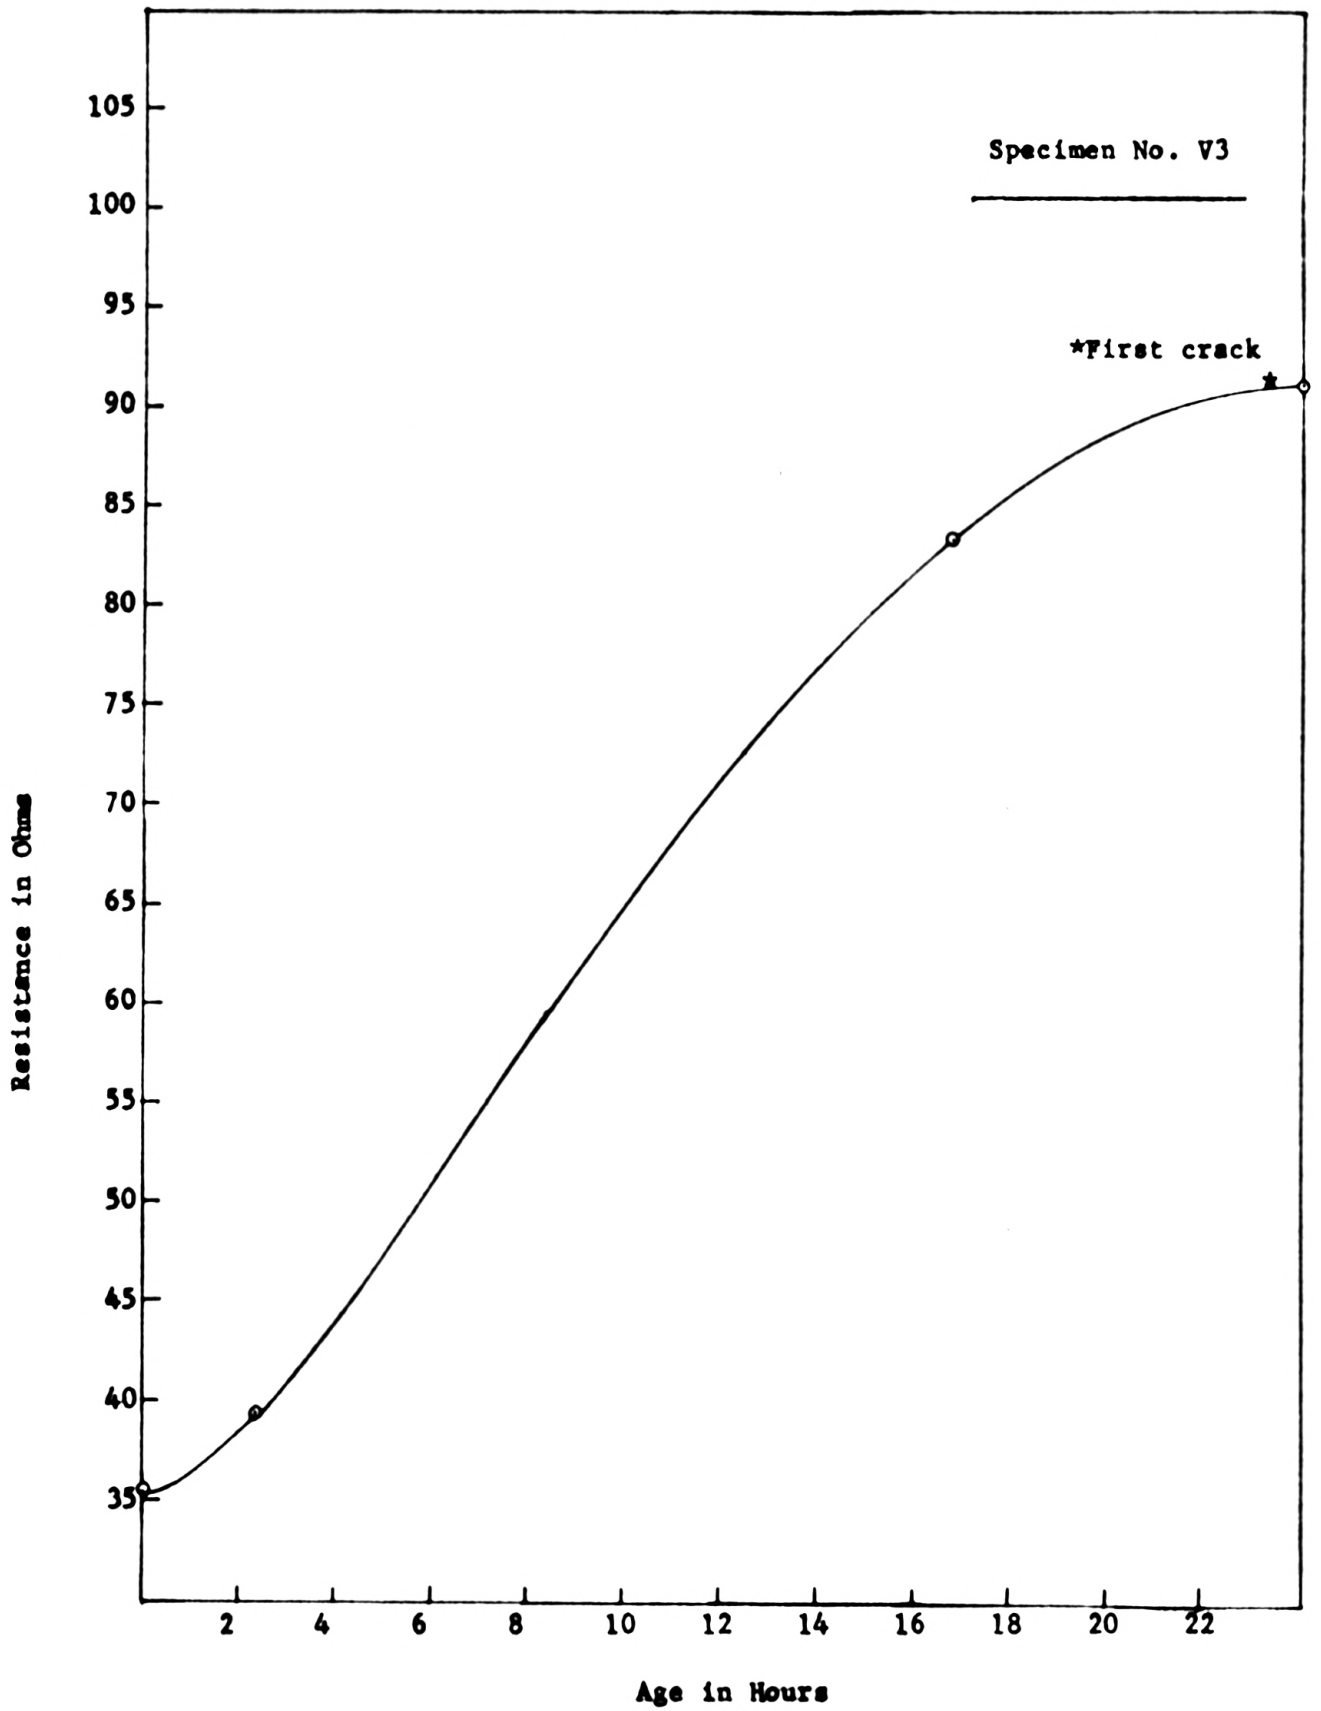
Fig. 3. Variation of Resistance of concrete against age

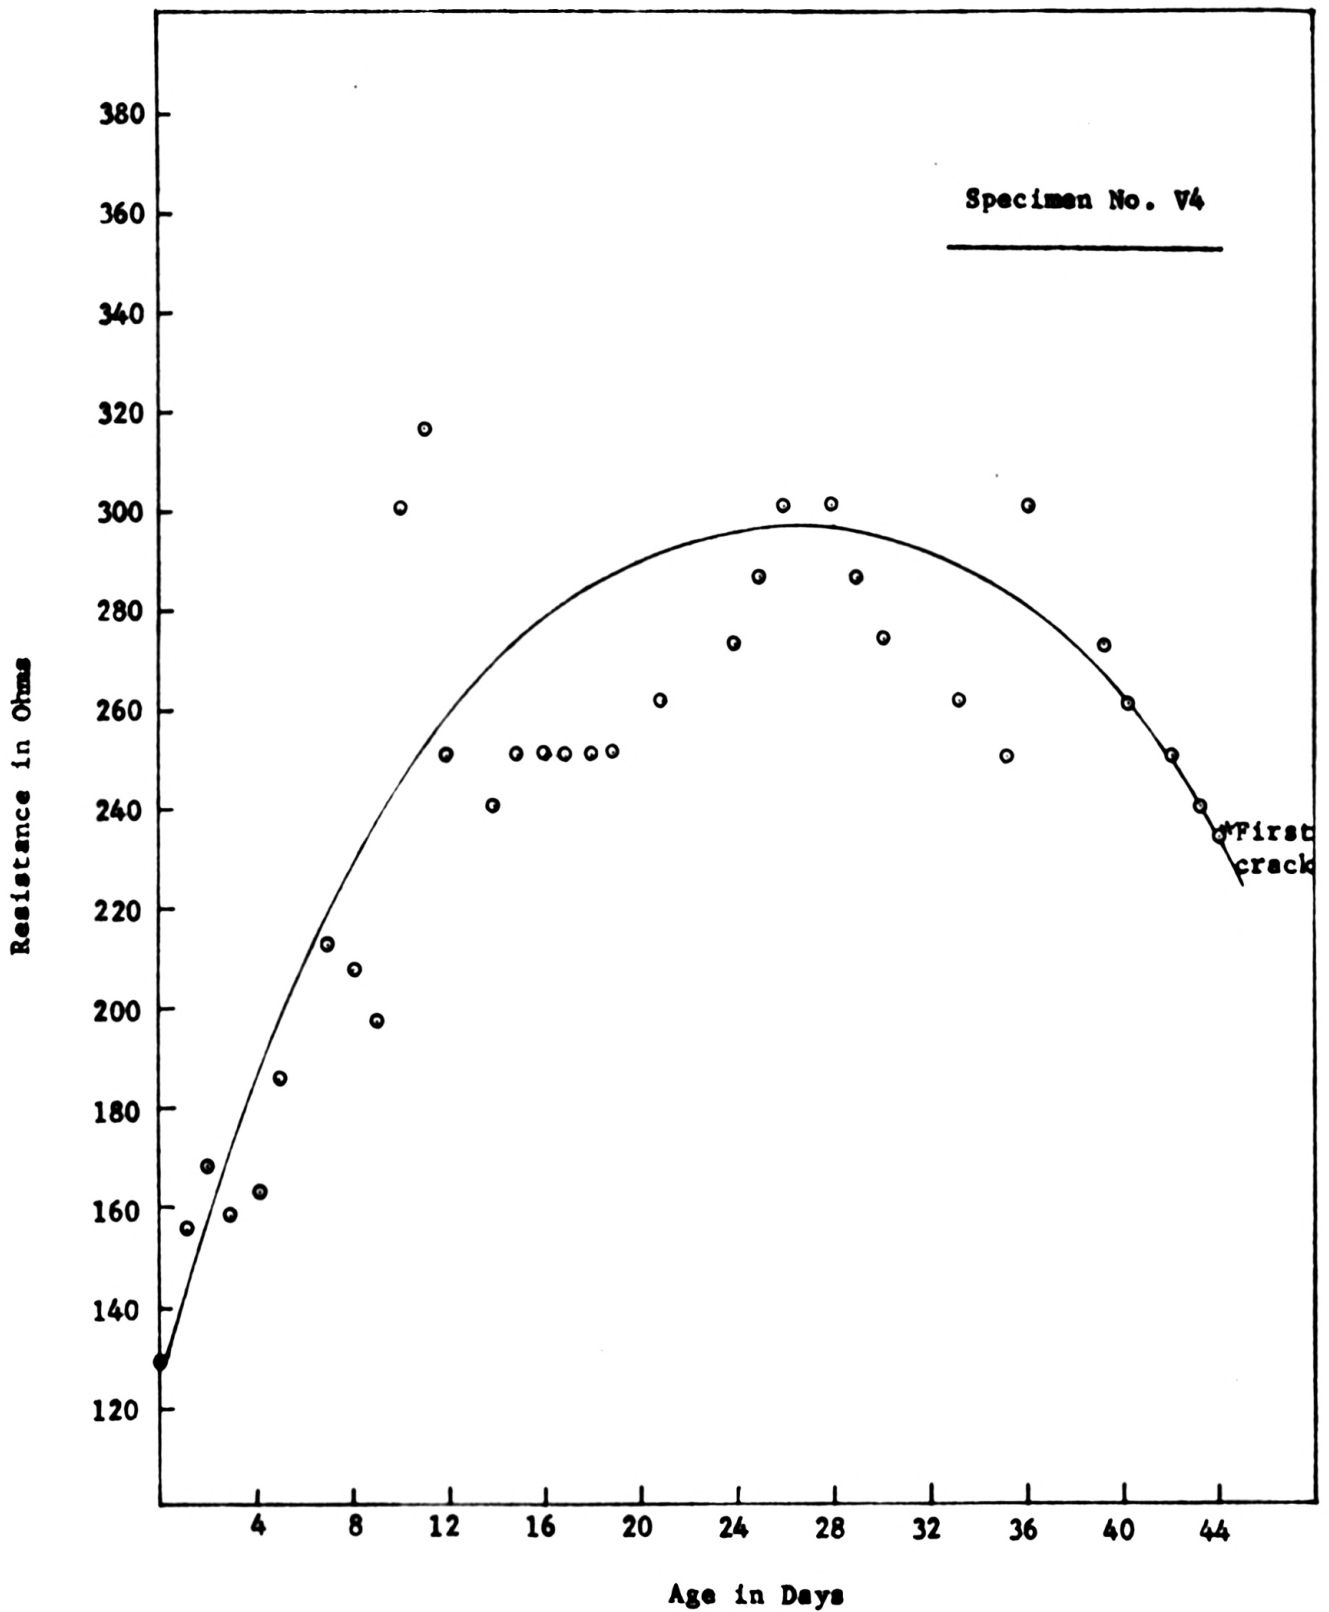
Fig. 4. Variation of Resistance of concrete against age

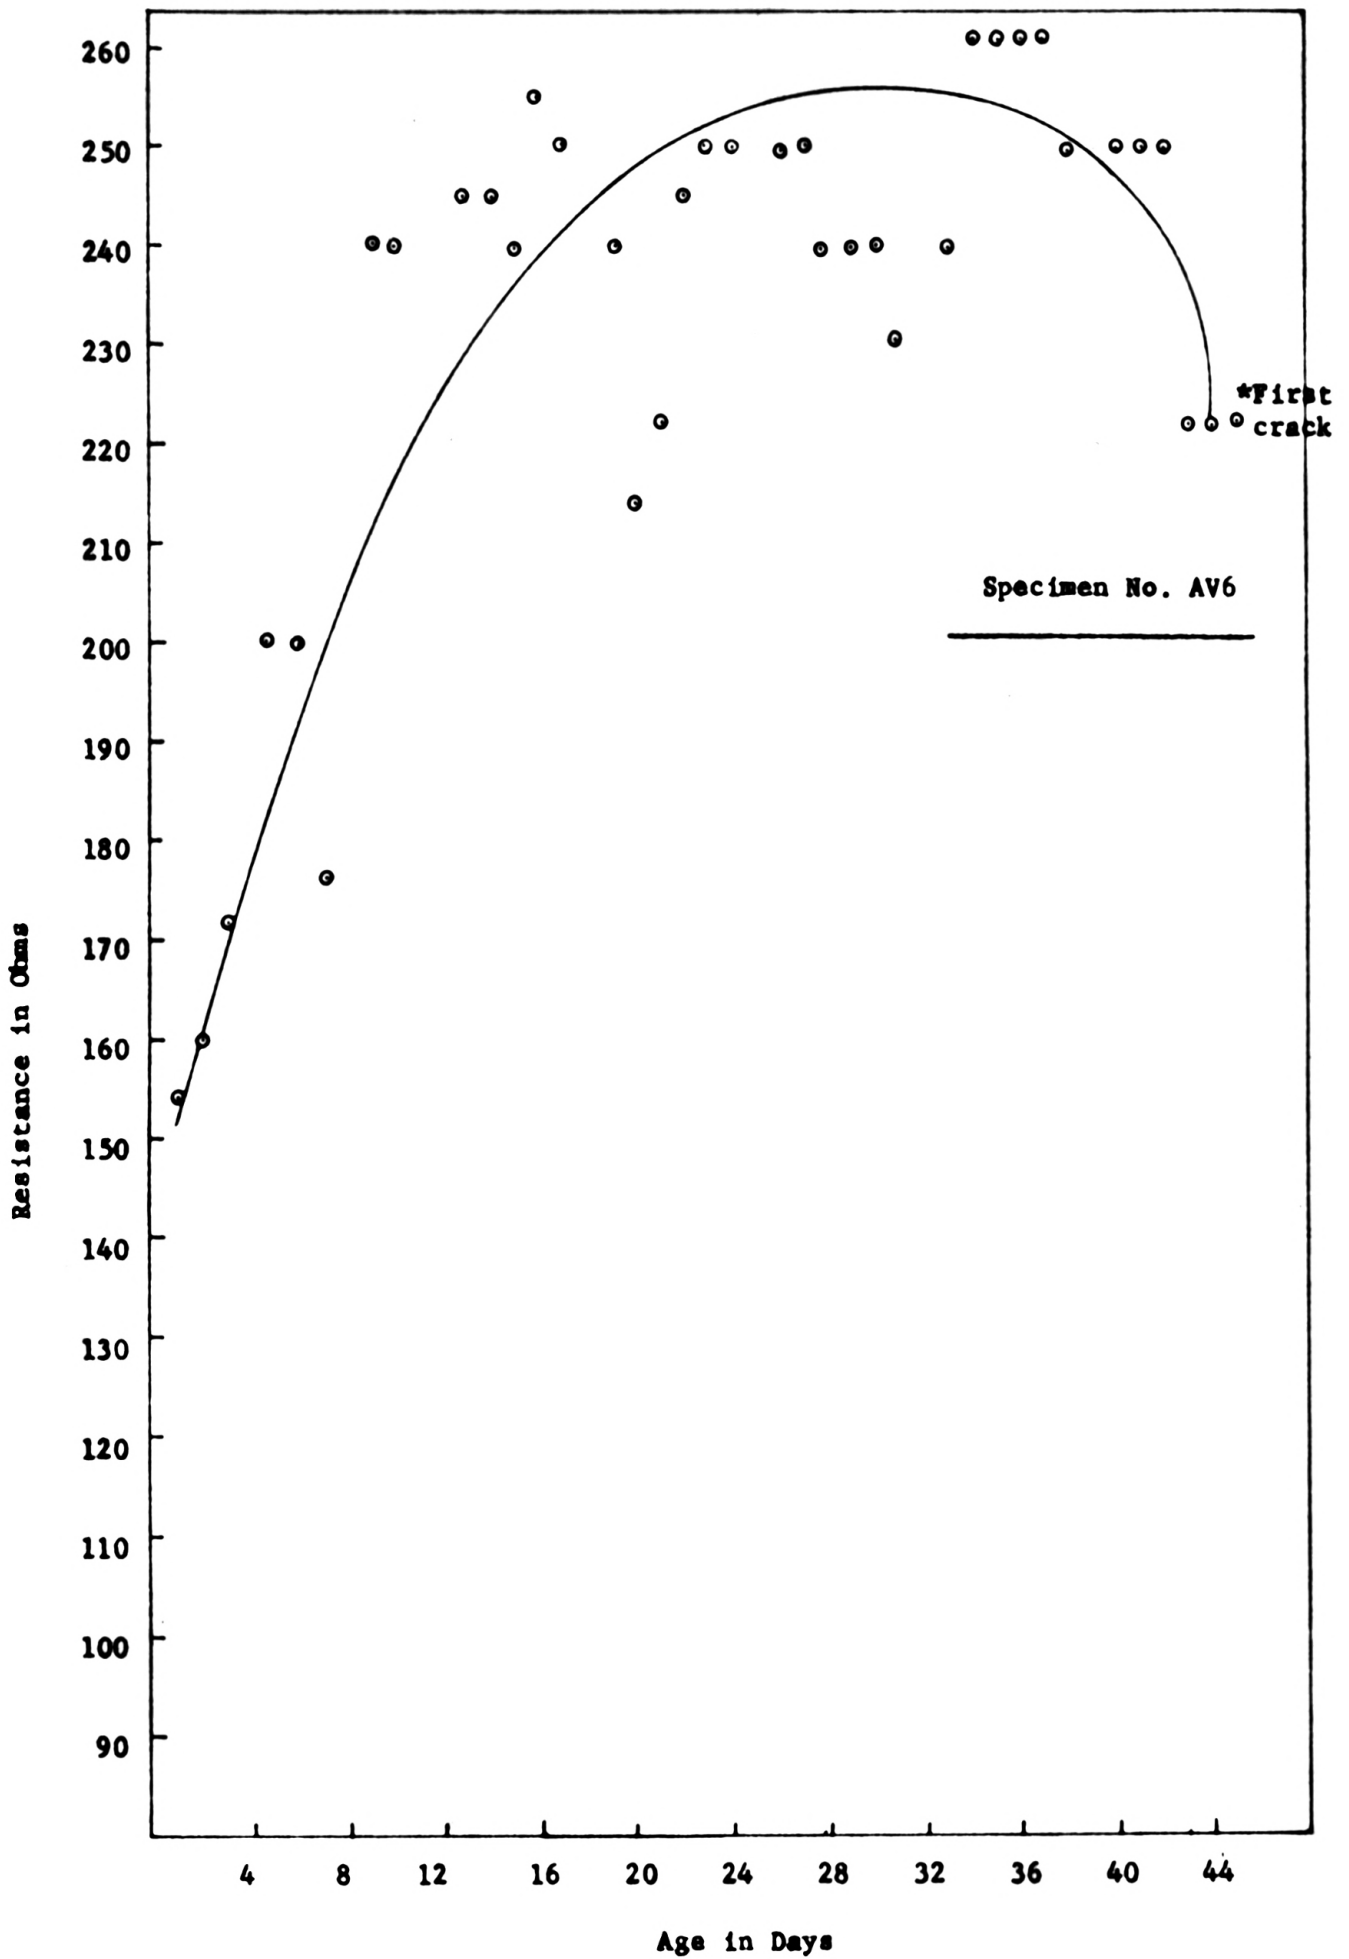
Fig. 5. Variation of Resistance of concrete against age

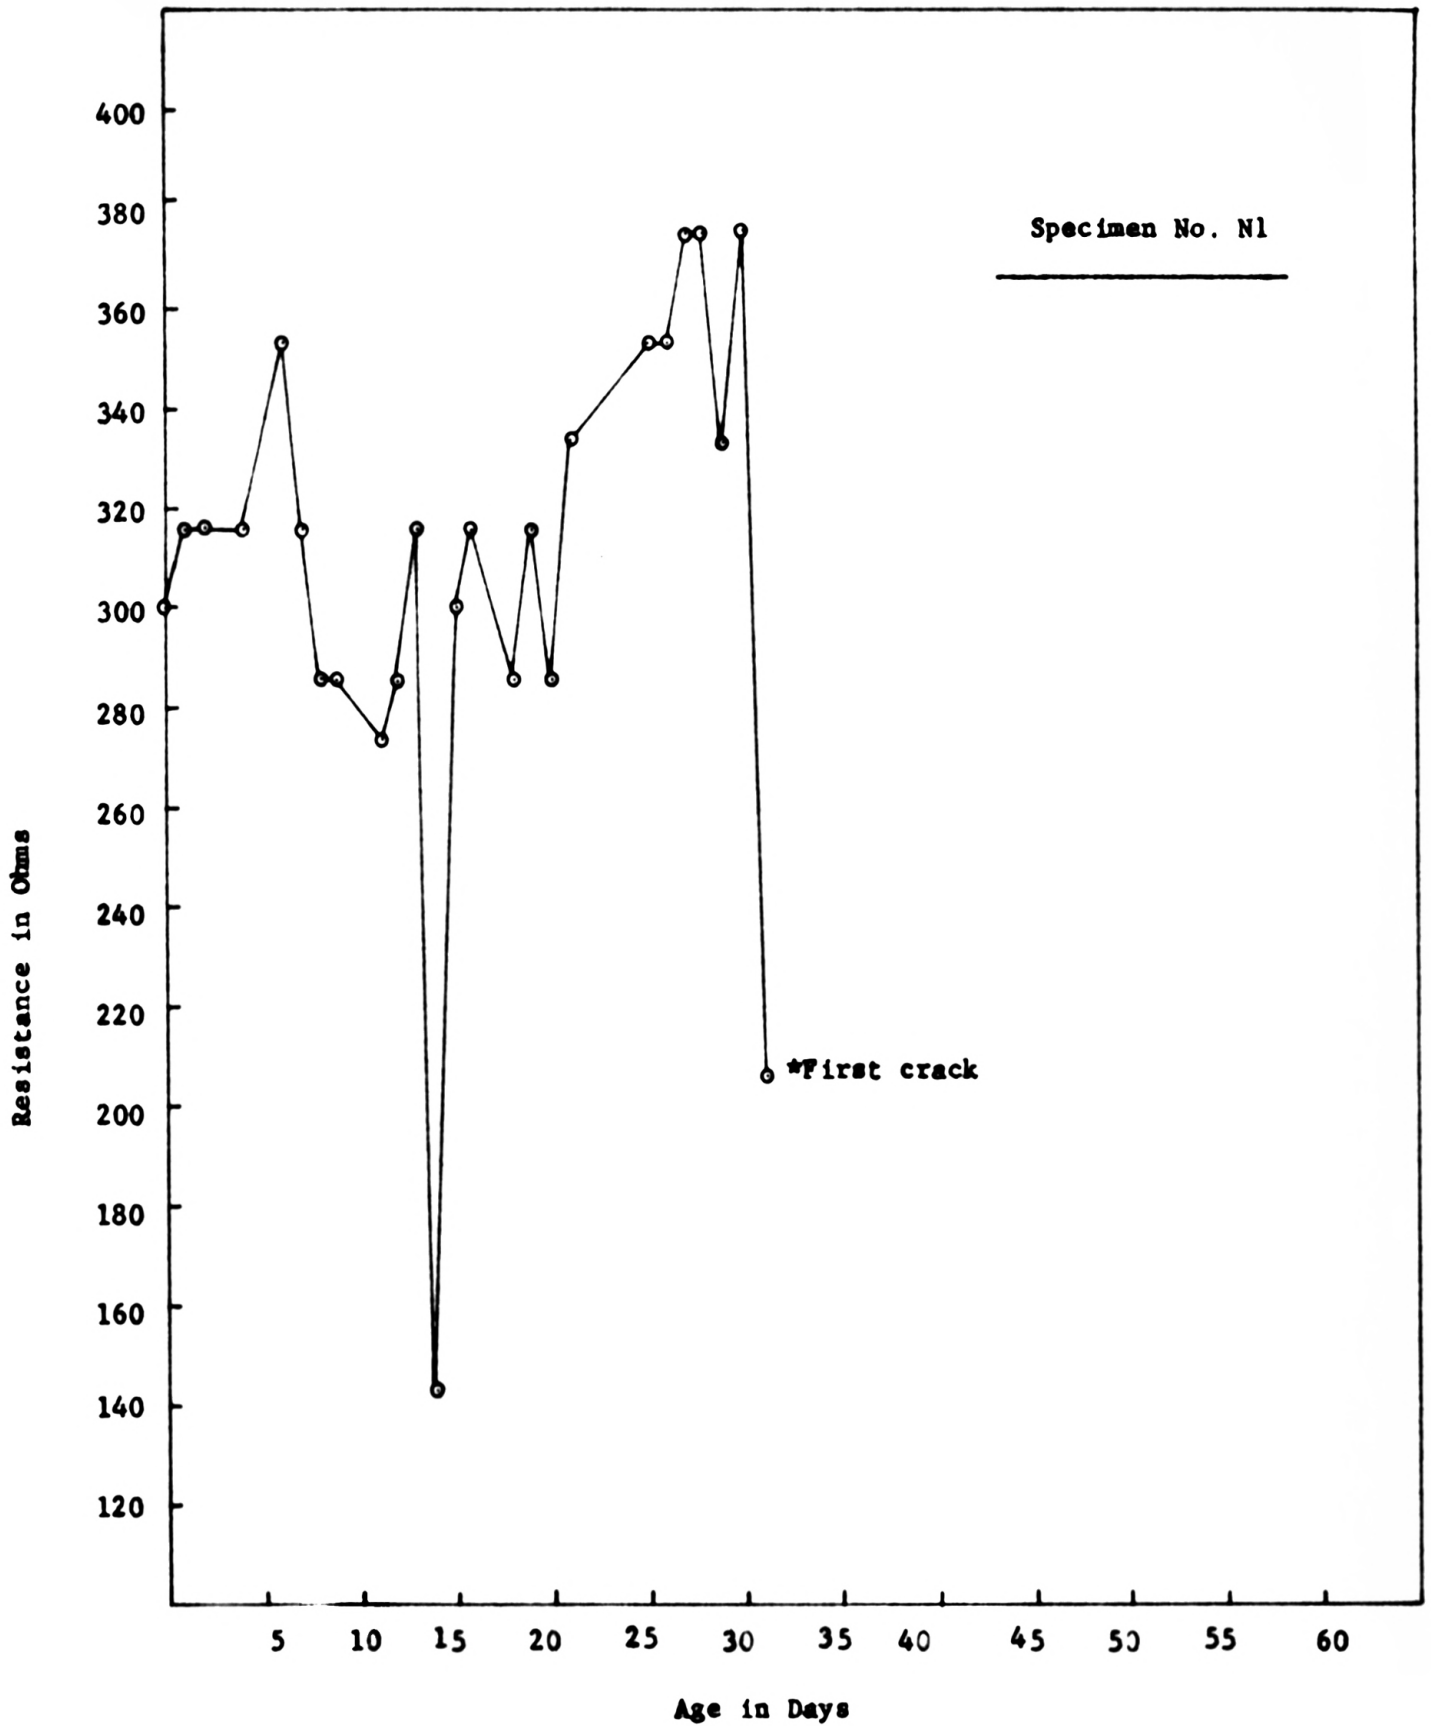
Fig. 6. Variation of Resistance of concrete against age

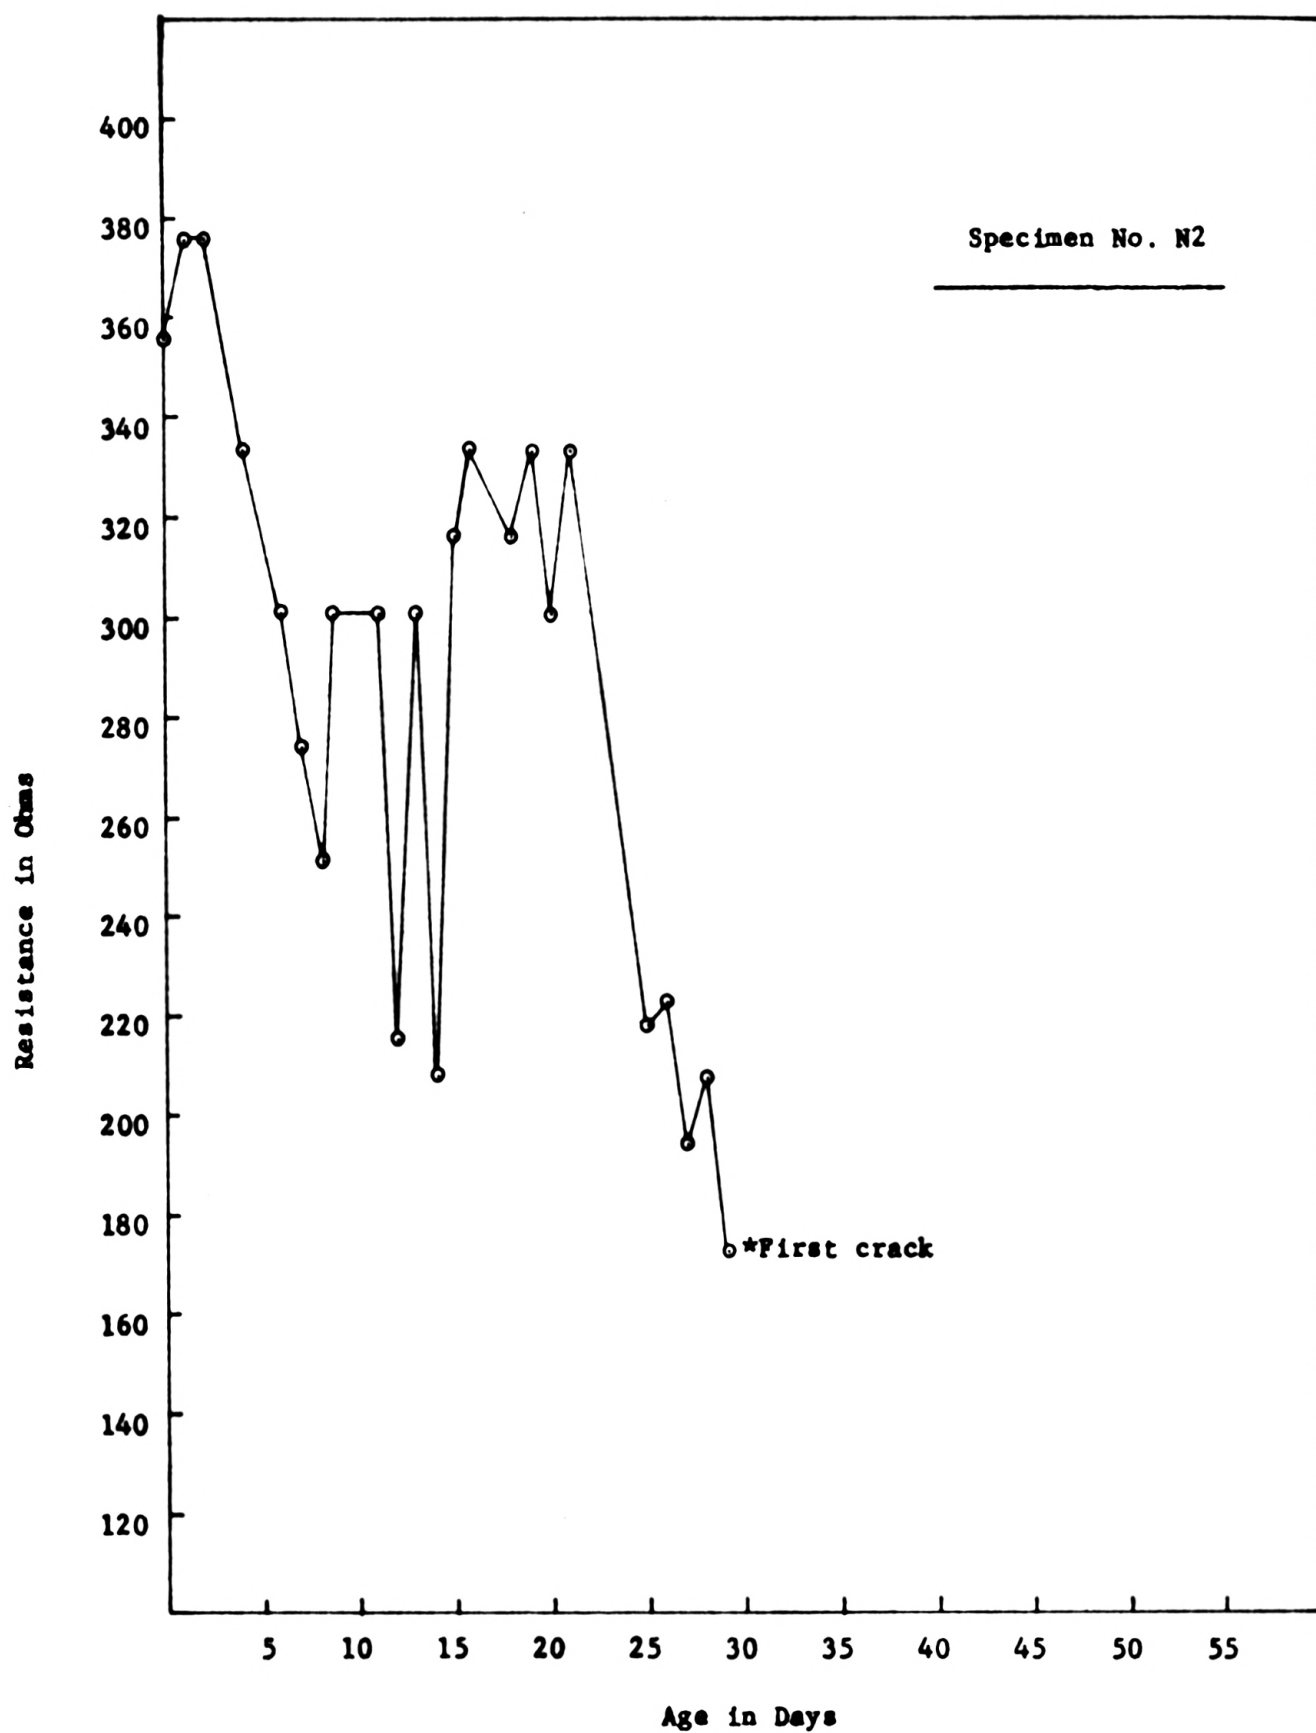
Fig. 7. Variation of Resistance of concrete against age

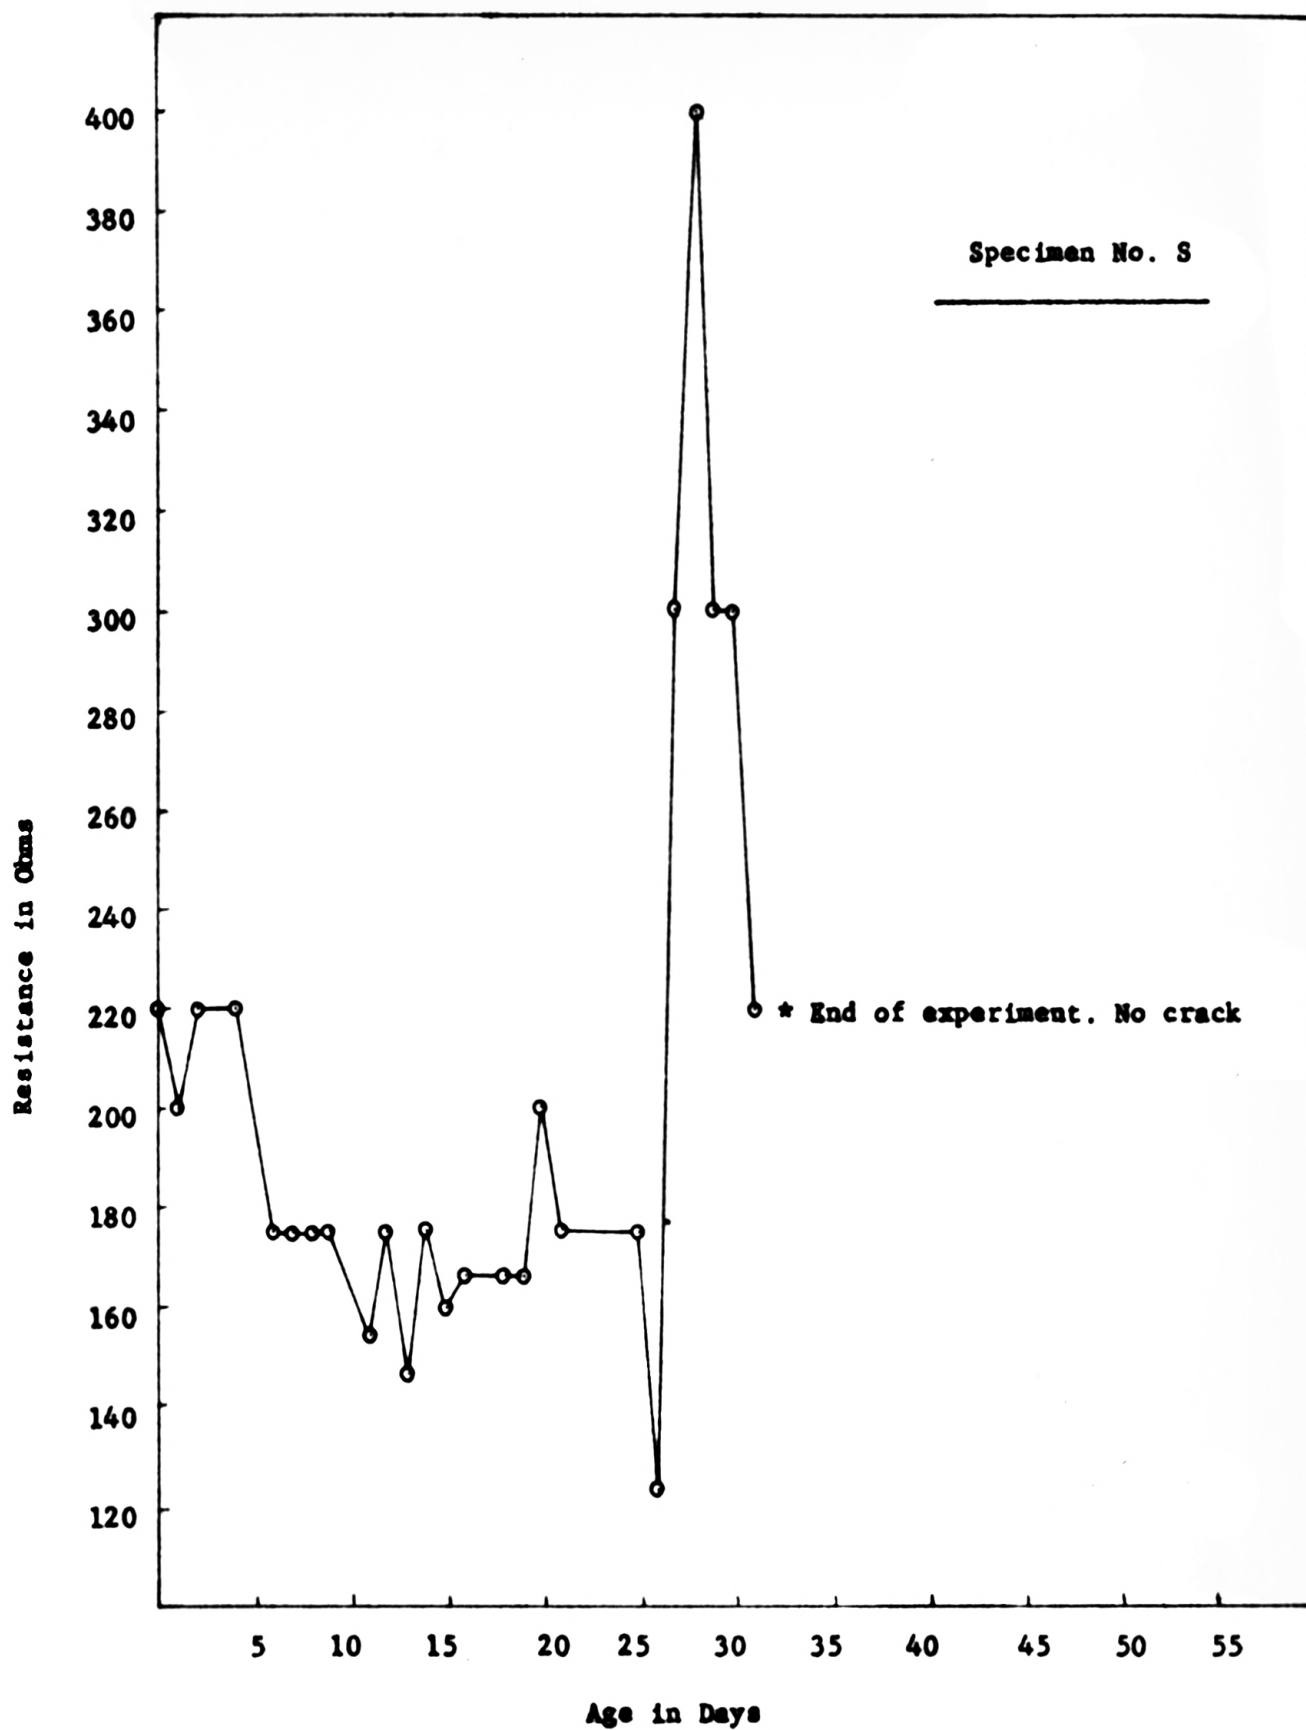
Fig. 8. Variation of Resistance of concrete against age

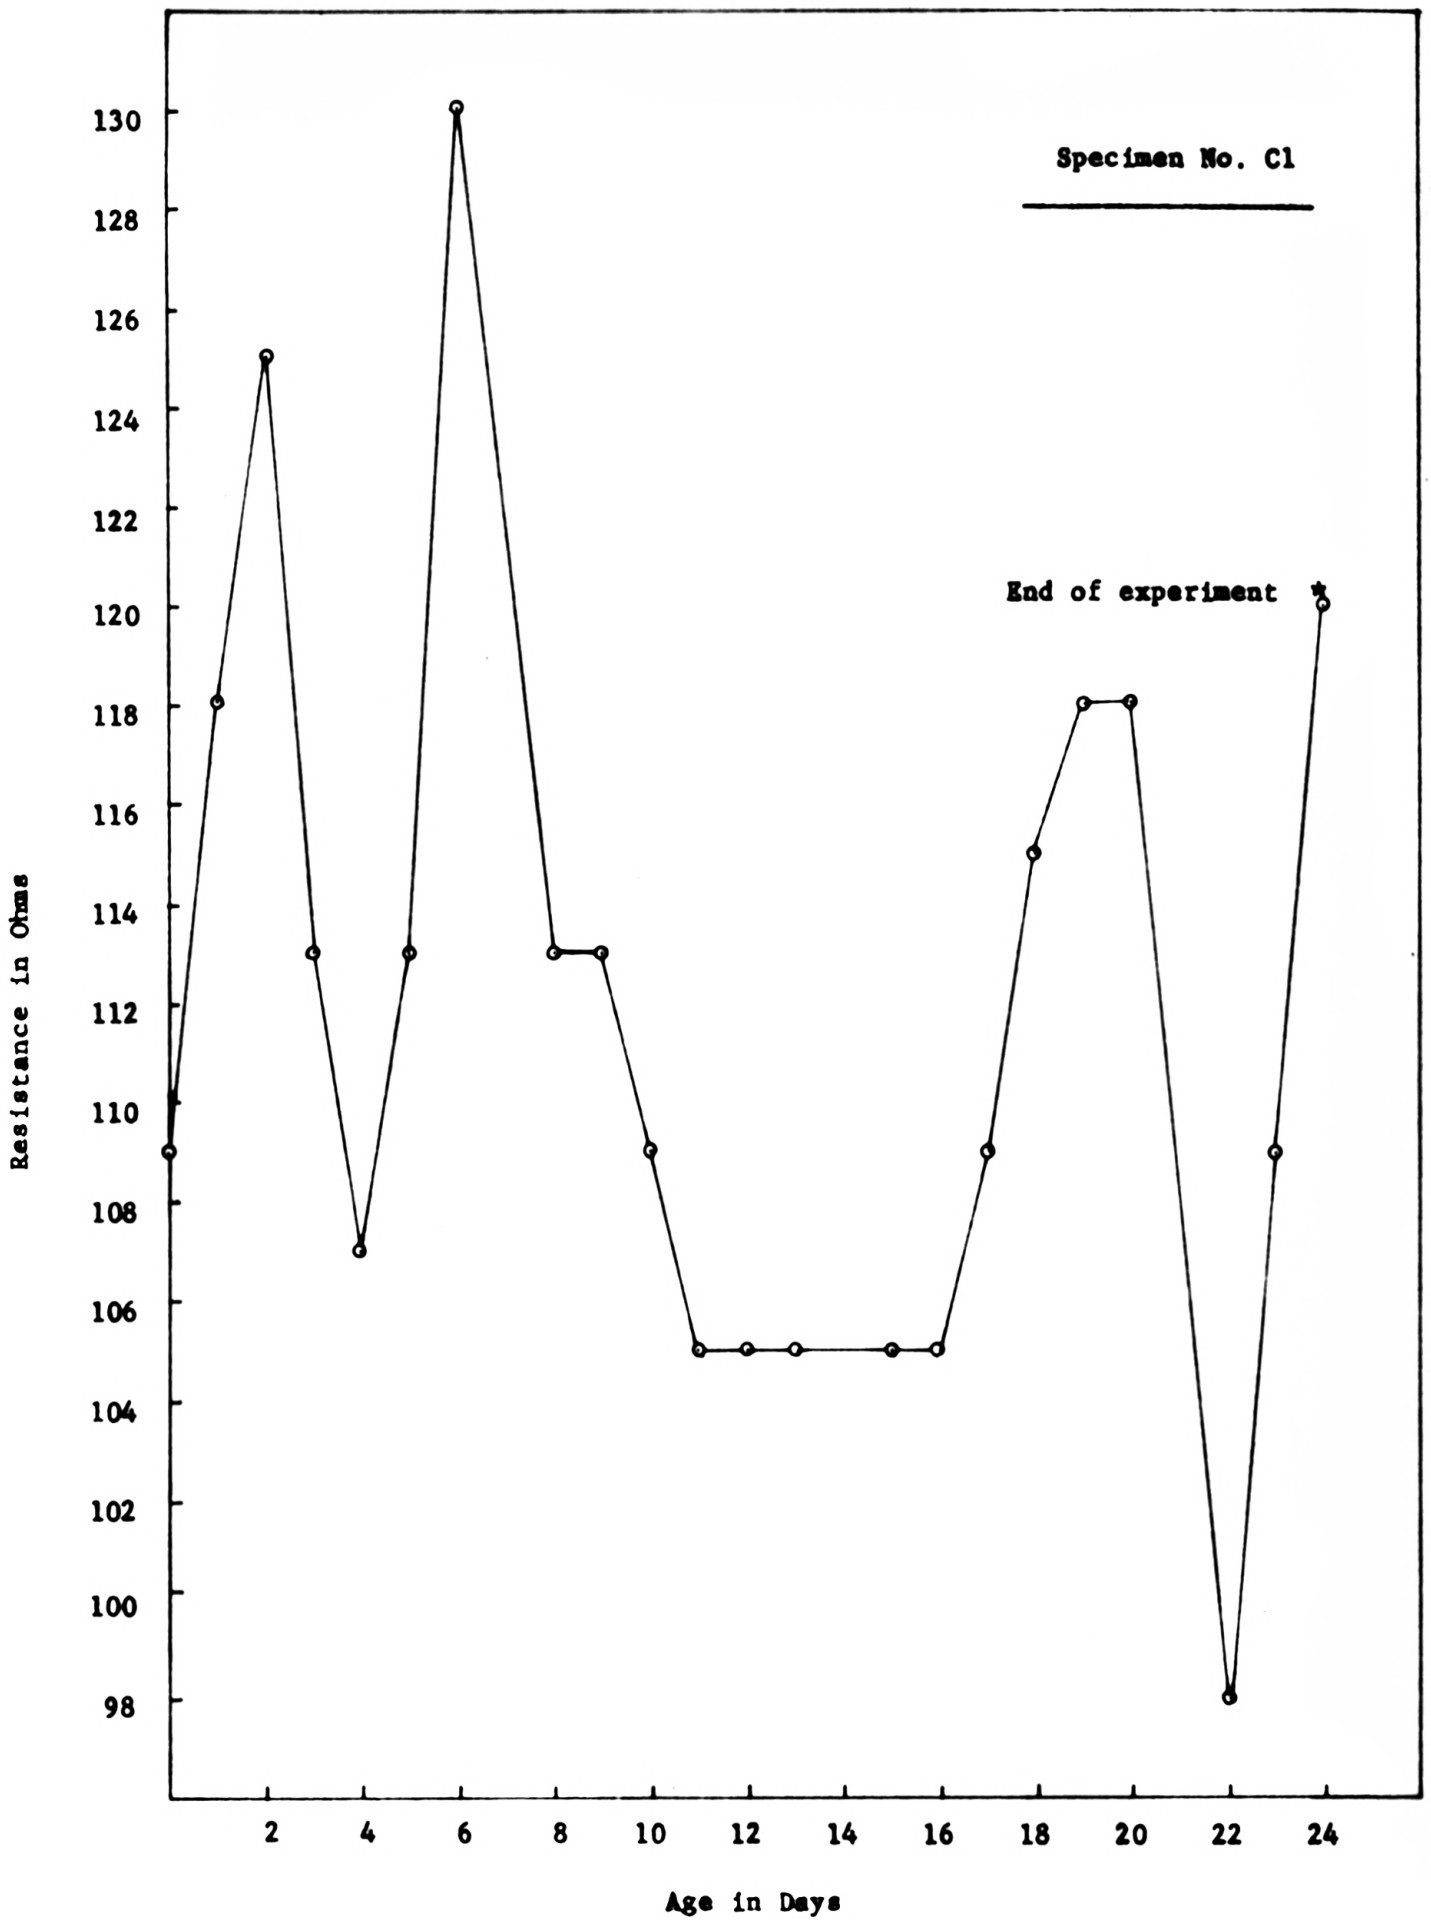
Fig. 9. Variation of Resistance of concrete against age

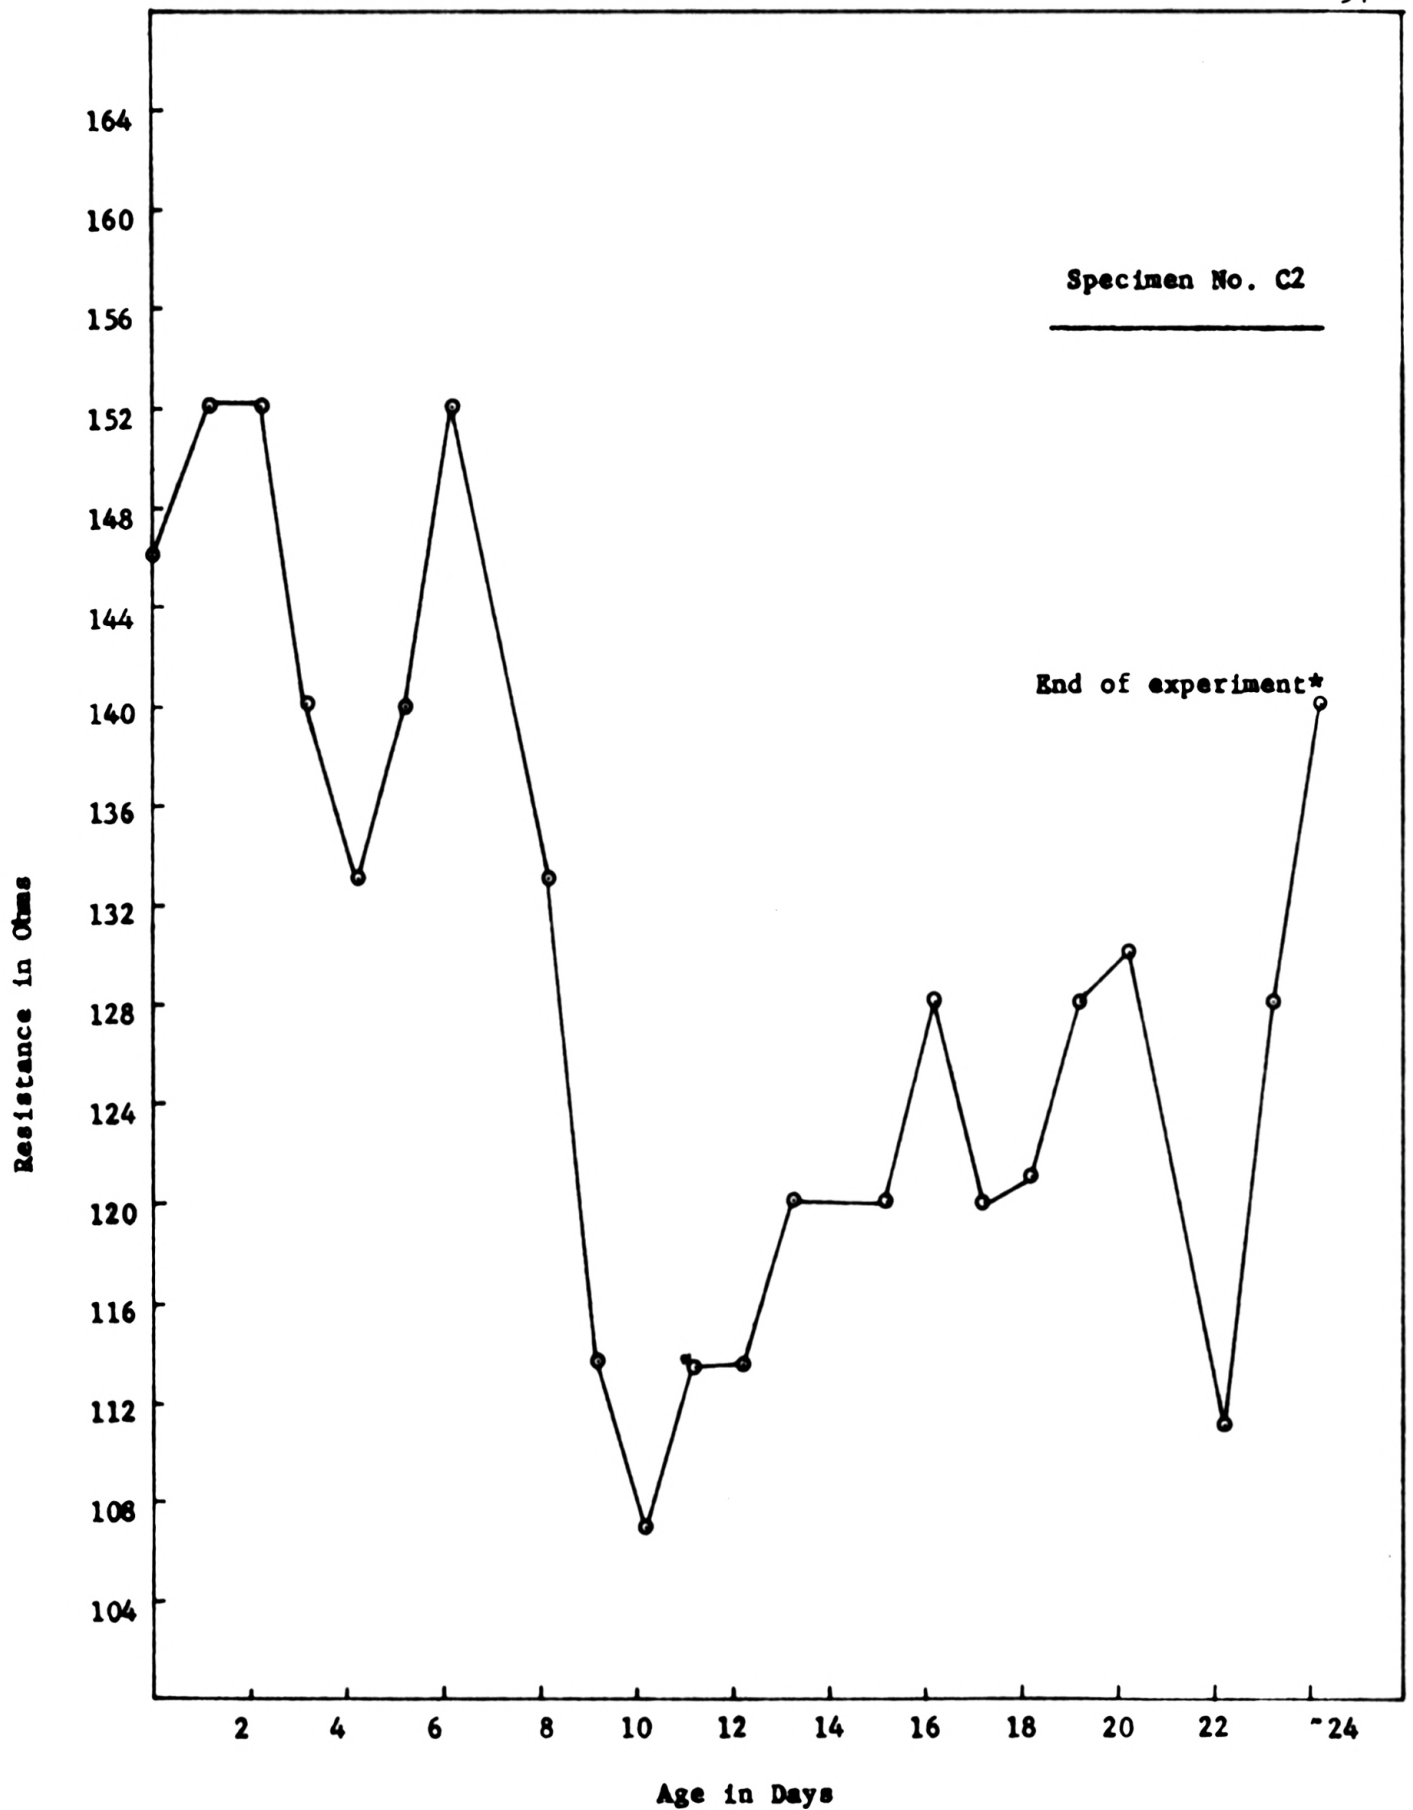
Fig. 10. Variation of Resistance of concrete against age
