THE CORROSION OF REINFORCEMENT IN CONCRETE

A MASTER'S THESIS

Department of Civil Engineering

KANSAS STATE UNIVERSITY
Manhattan, Kansas

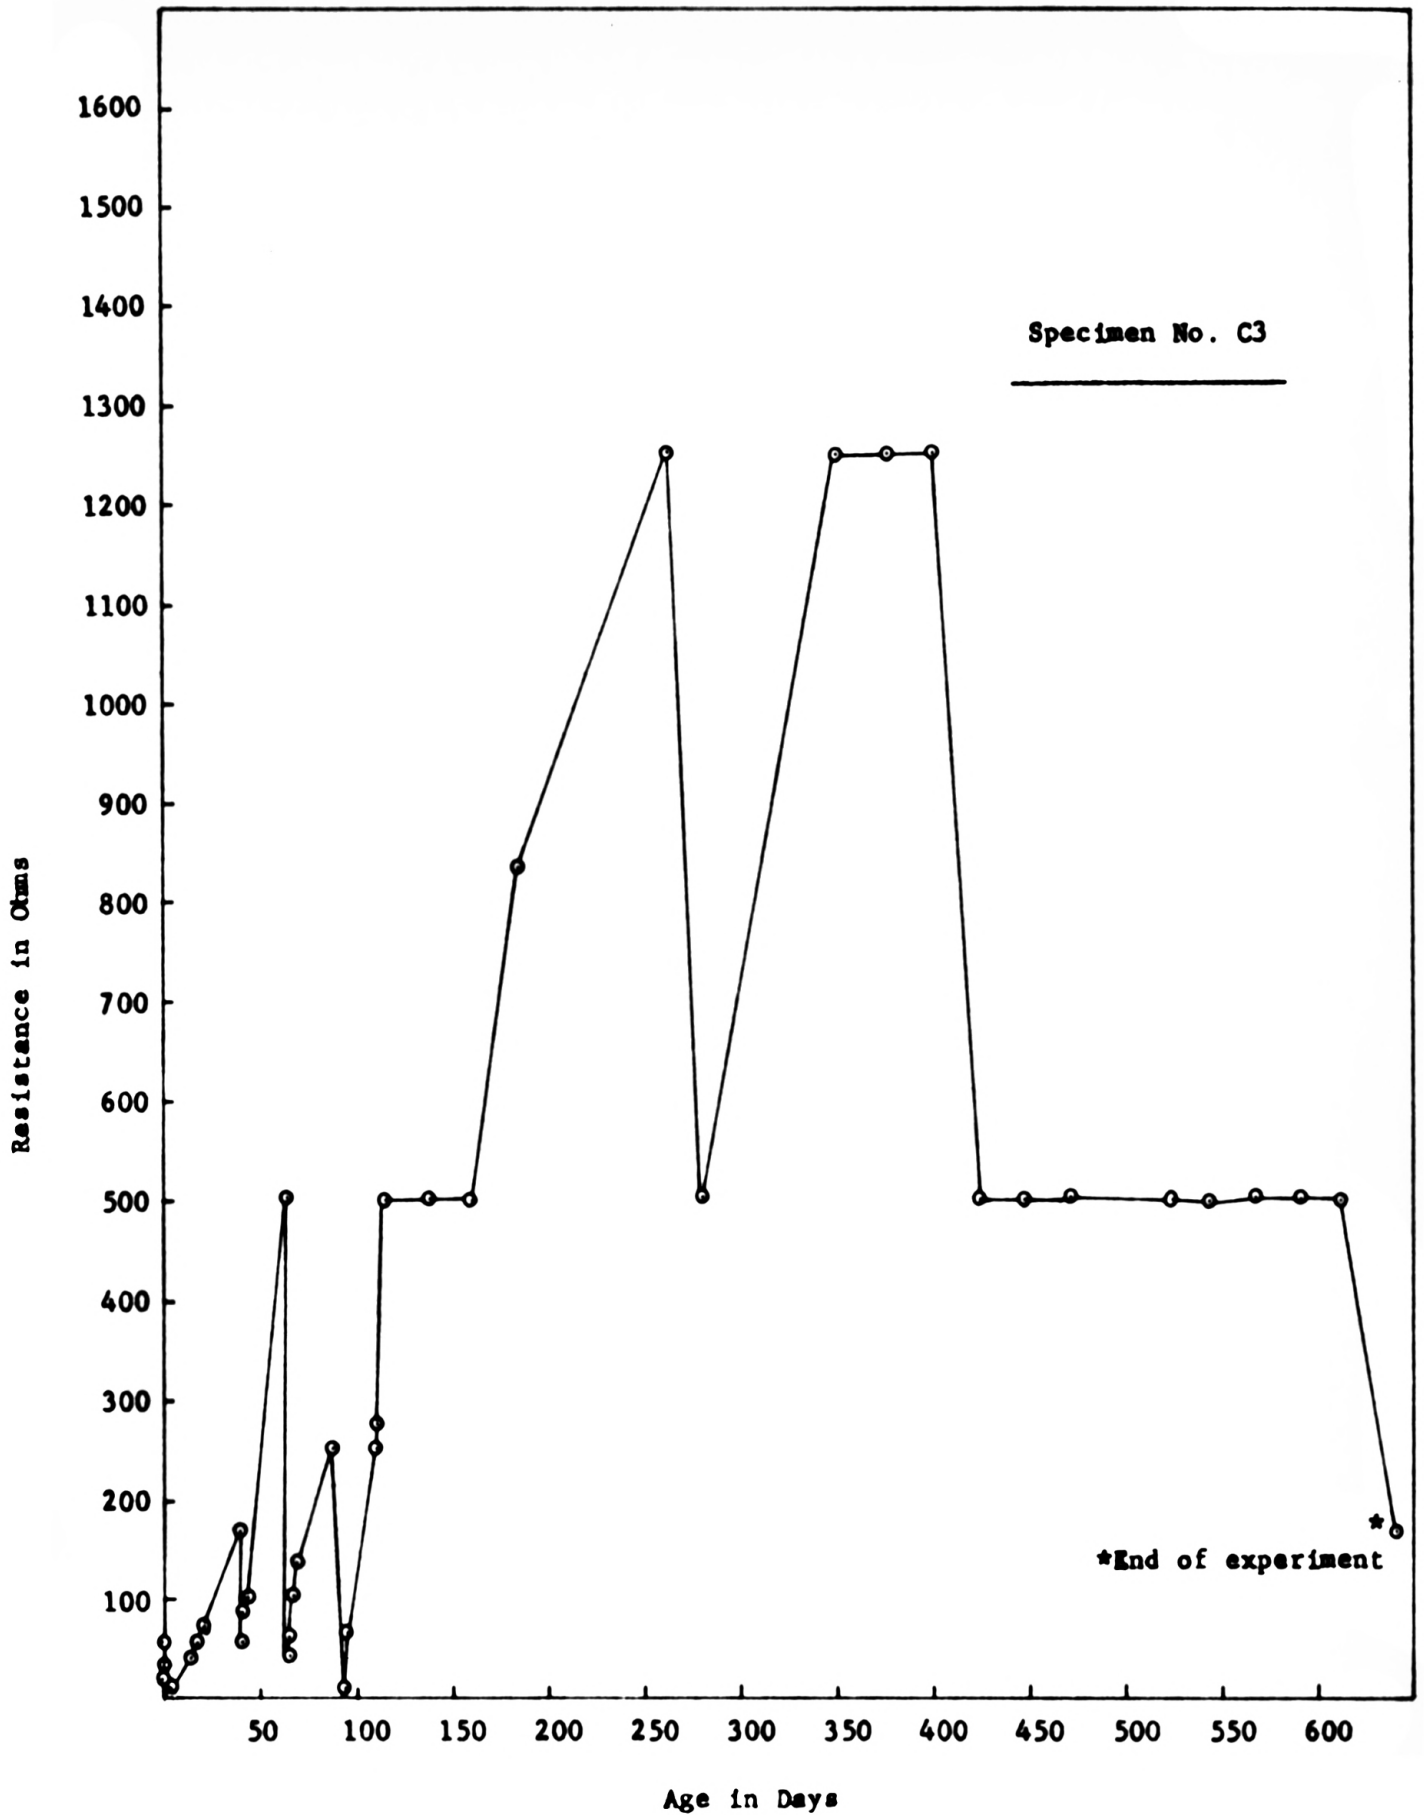
Fig. 11. Variation of Resistance of concrete against age

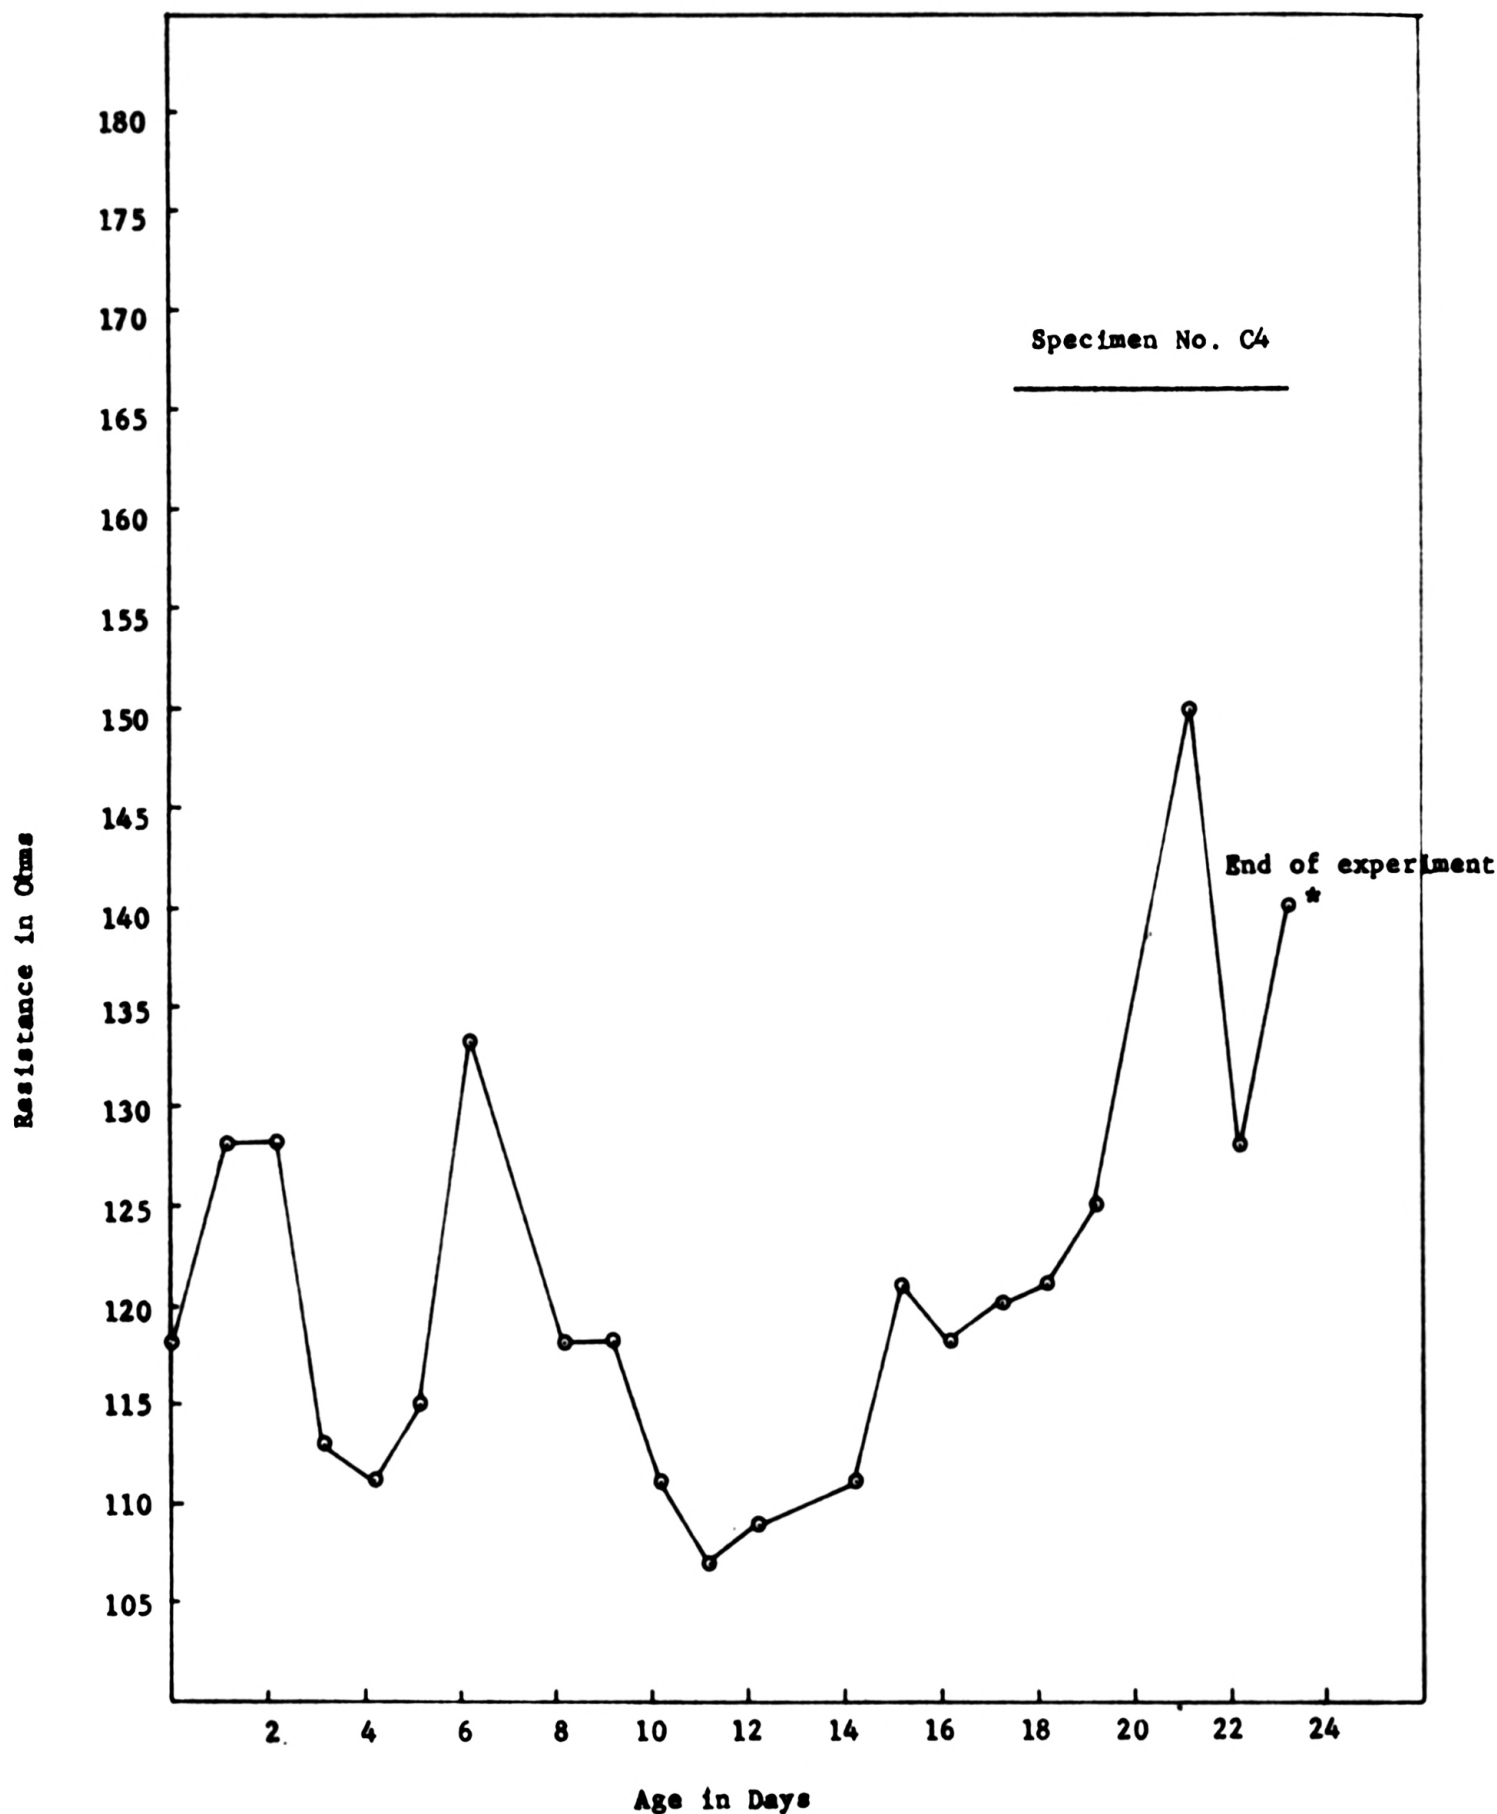
Fig. 12. Variation of Resistance of concrete against age

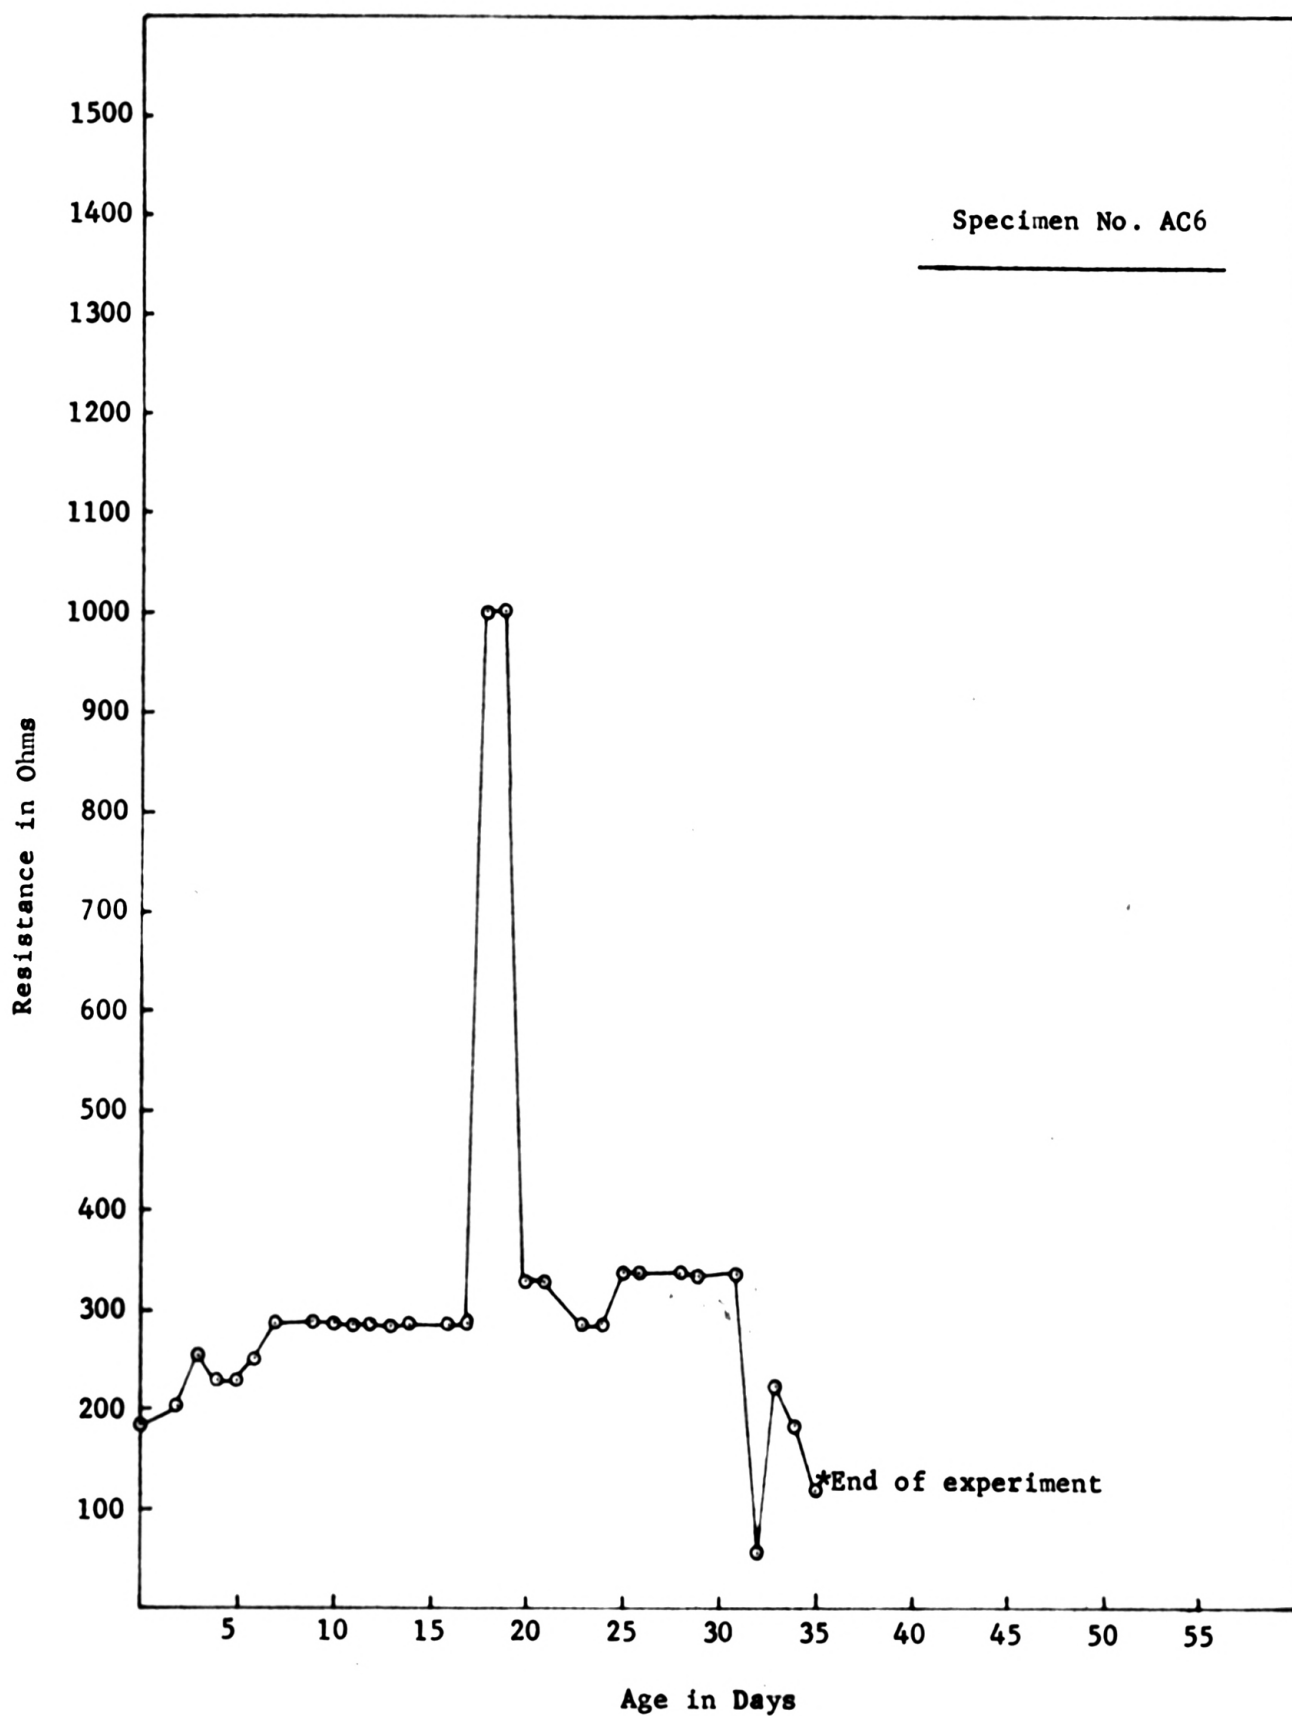
Fig. 13. Variation of Resistance of concrete against age

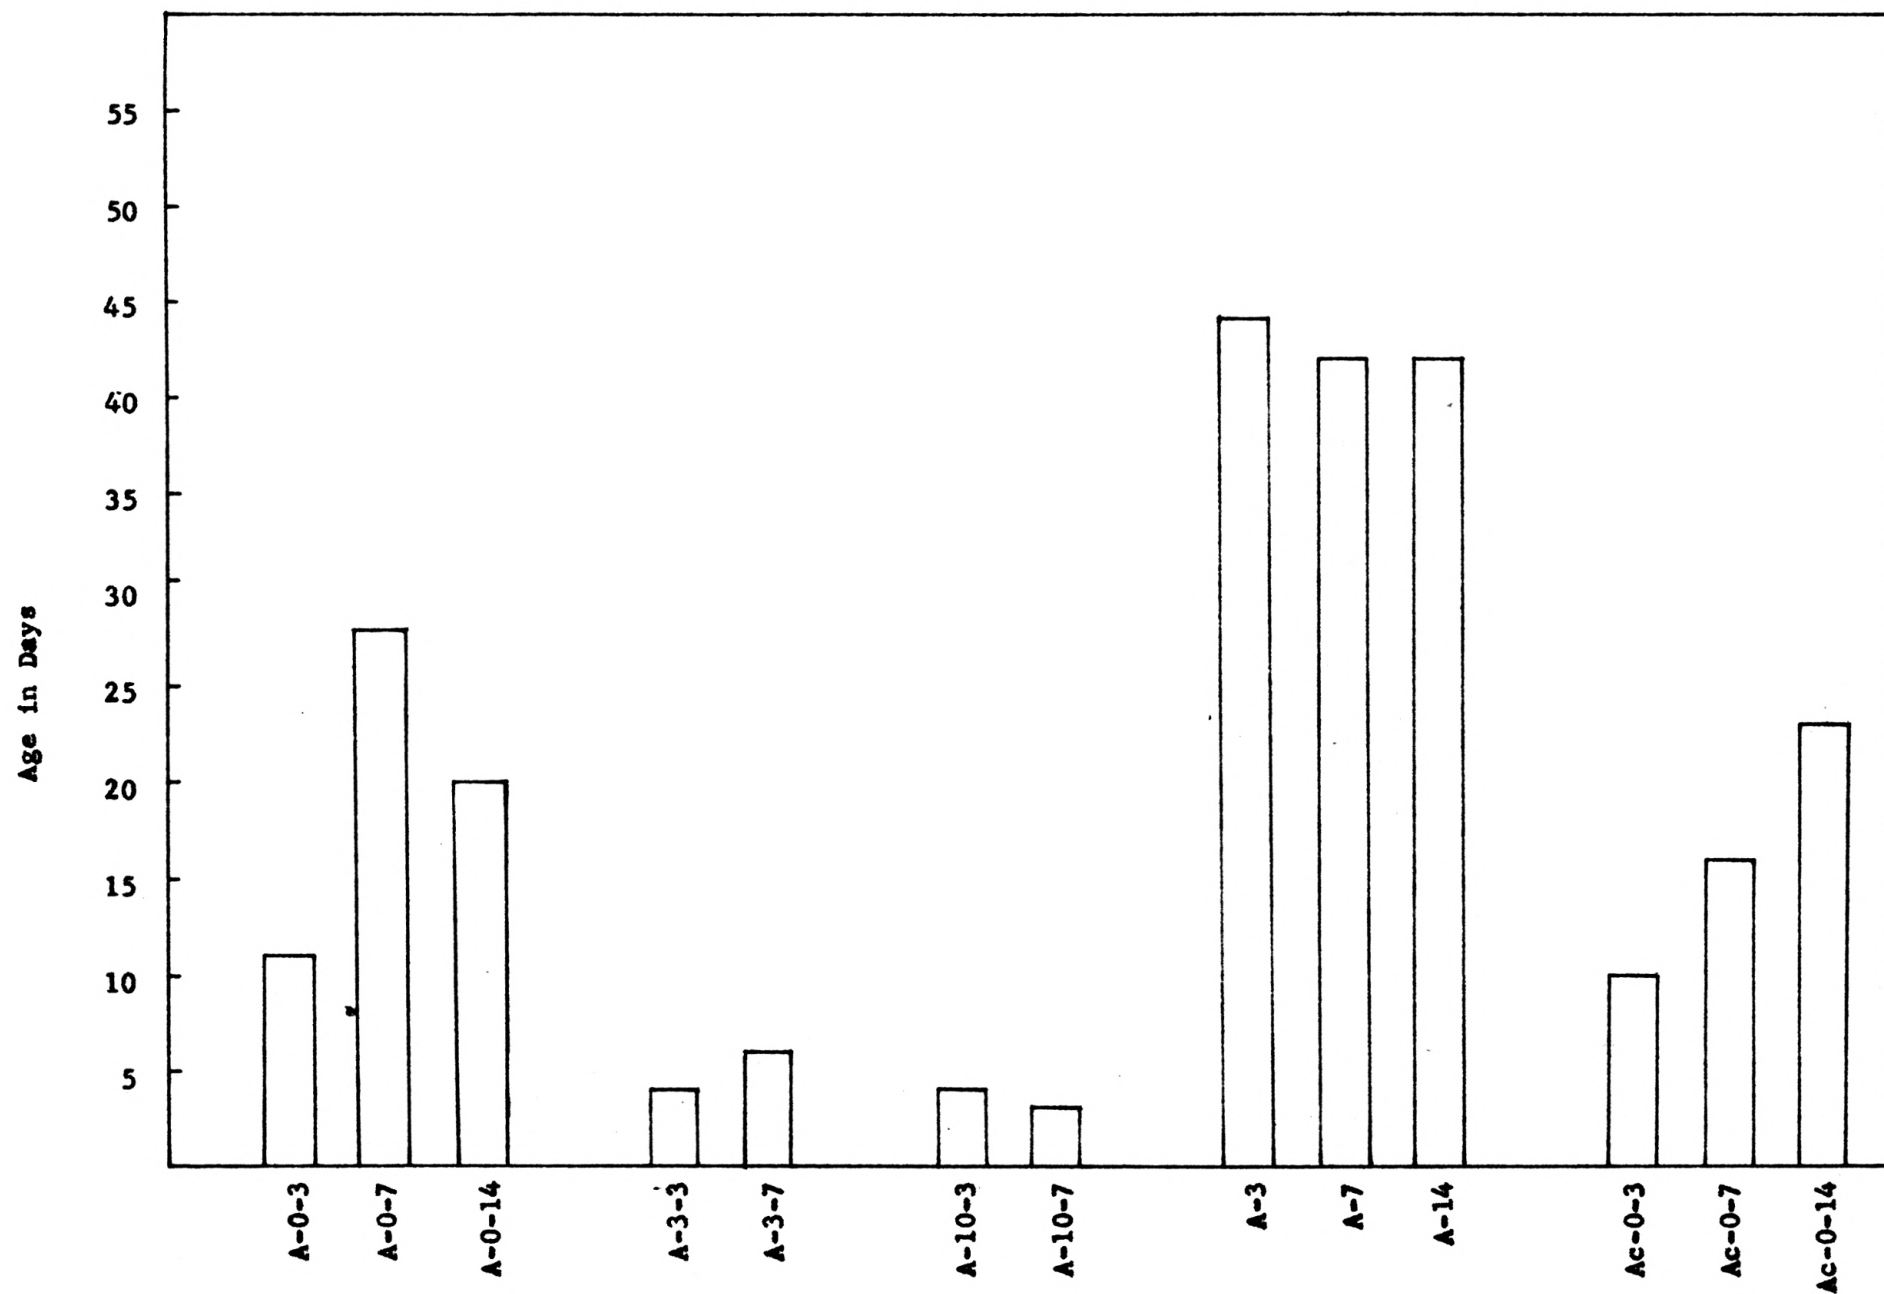
Fig. 14. Comparison of the life of the small specimens

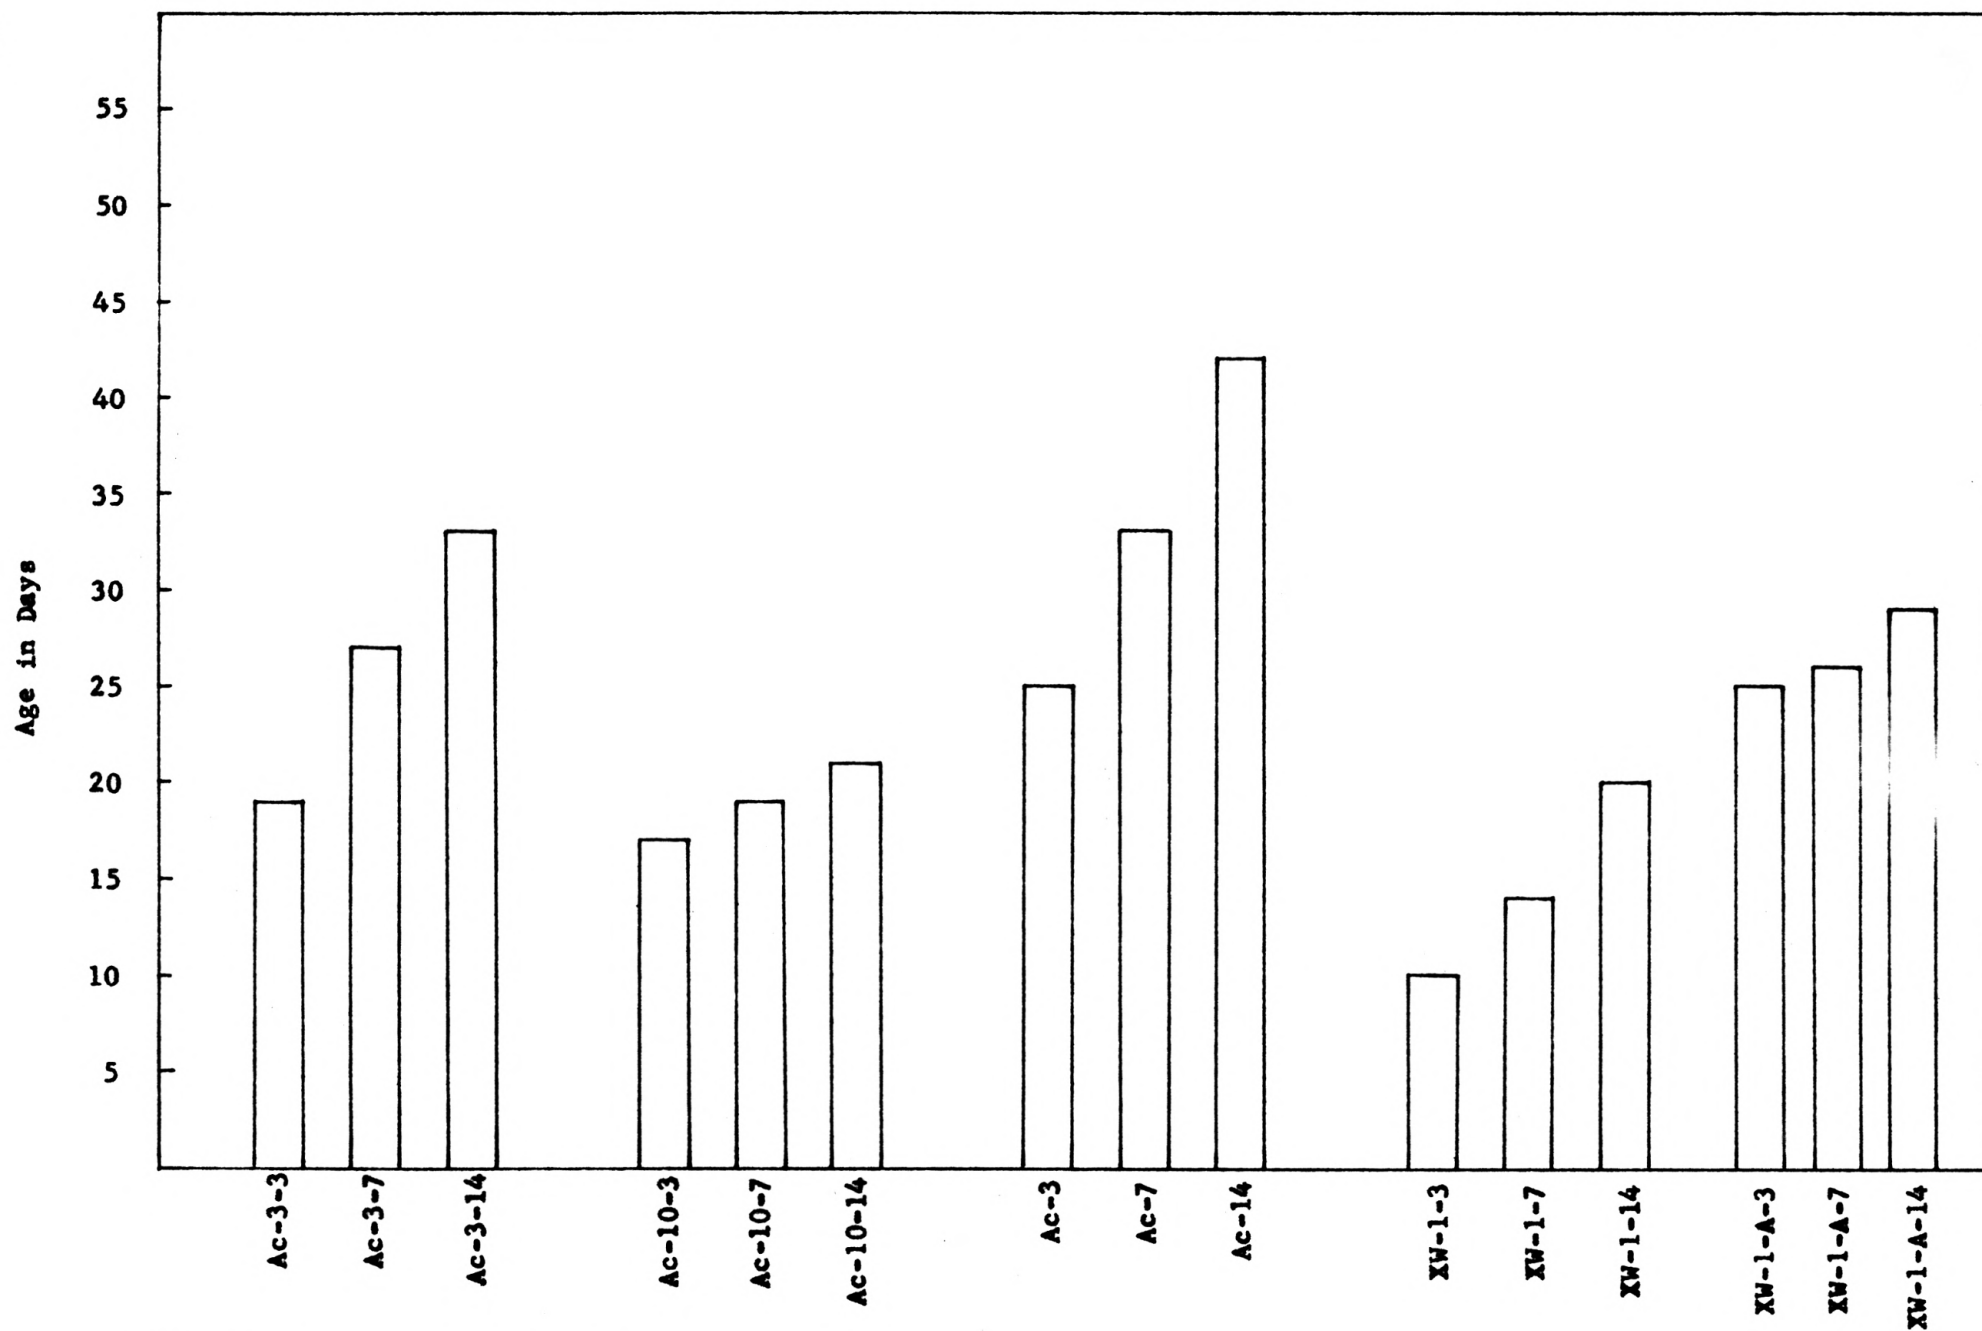
Fig. 15. Comparison of the life of the small specimens

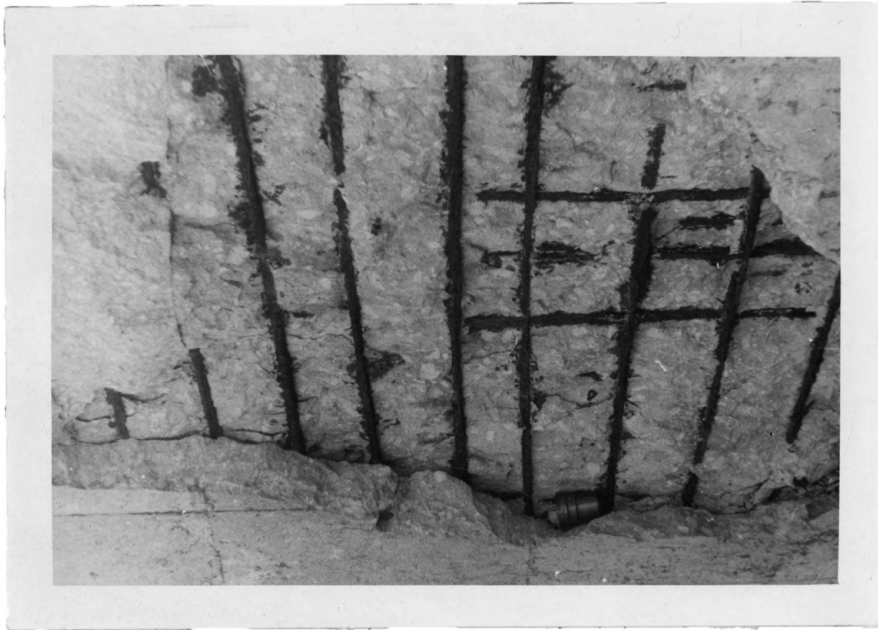
Fig. 1

Fig. 1. Vertical concrete wall dry dock. The wall was dry at all the time except when the vessel comes in or goes out. It was subjected to salt spray mist. The climate of the region is mild. Fresh water used in mixing this concrete. The wall occasionally filled with sea water when the vessel enters. The concrete was 5.5 sack concrete, good quality, and with good aggregates gradation. The # 6 bar reinforcement was badly corroded after 15 years. The reinforcement was covered by 4" concrete layer.

Included in this thesis are some photographs taken by Professor C. H. Scholer illustrating the damage to the concrete affected by the corrosion of the reinforcement (Plates I and II). The electrochemical theory of corrosion proposes that corrosion of iron is largely accomplished by the action of a network of short-circuited electrolytic cells on the iron surface. Iron ions go into solution at the anodes of these cells in amounts chemically equivalent to the reaction of the cathodes.

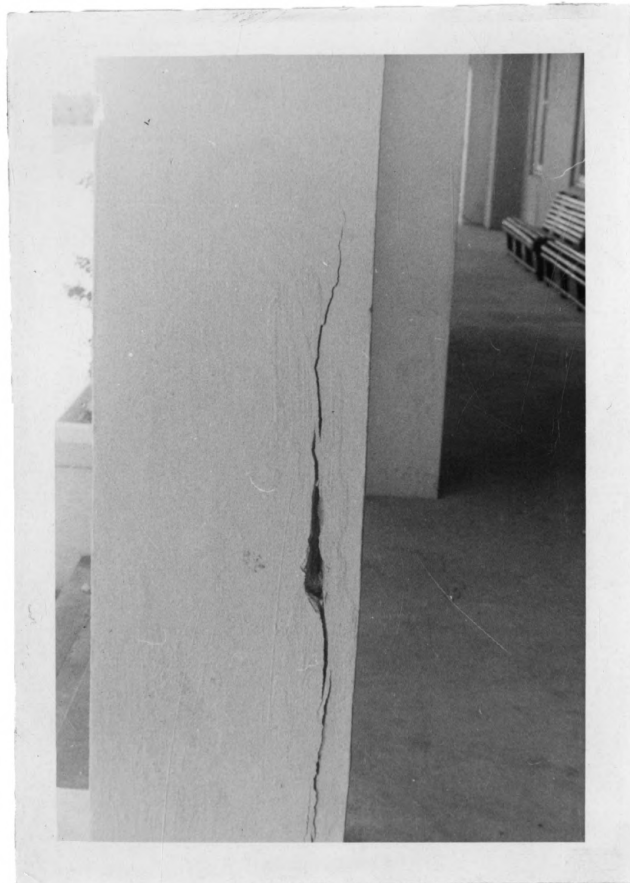
Fig. 2

Fig. 2. Column supporting roof over entrance of club house in the mild marine exposure. The concrete made with salt free aggregates with fresh water. The column was exposed to salt spray and mist. The large crack along the column is due to the corrosion of the reinforcement. The age of the concrete was twenty years. The cover of the concrete was 1.5".

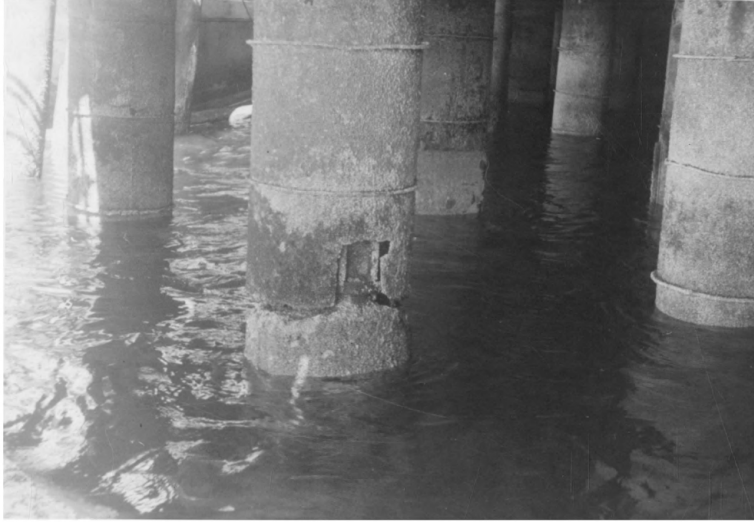
Fig. 1

Fig. 1. Piers under heavy fitting out dock. The reinforcement of the piers were H-columns steel. Steel bars were surrounded the H-column. No. 14 gage metal form was surrounding the piers when the concrete poured, then left in its position. The pier was immersed in sea water. The climate was humid with severe winter weather. No jacket seen in the picture, because it had been corroded and disappeared with the reinforcement bars. The age of the concrete was about twenty five years.

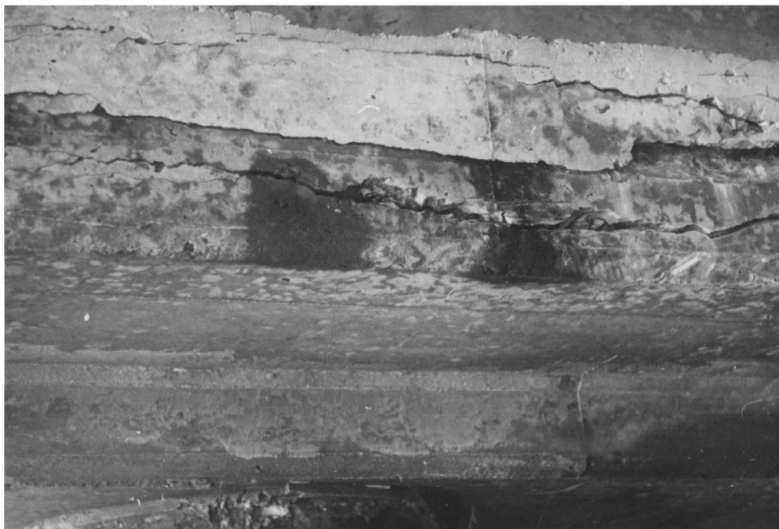
Fig. 2

Fig. 2. Edge of girder under heavy piers used for construction. Corrosion of steel causing spoiling of concrete. The age of the concrete was about twenty years.

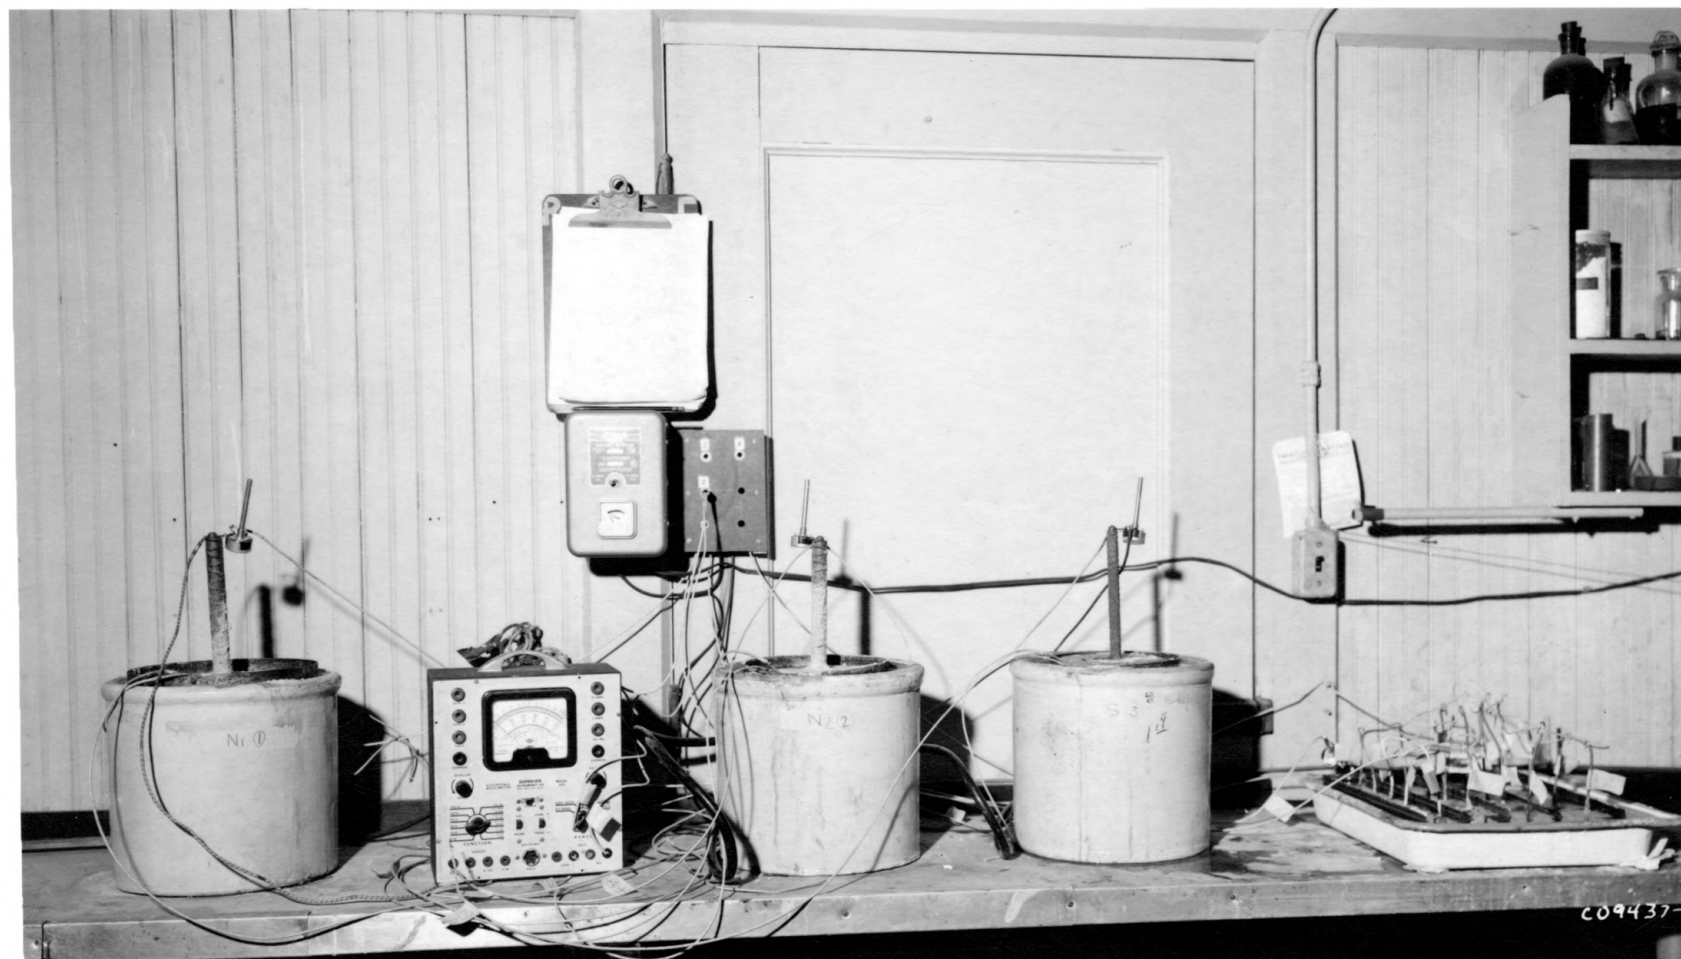
PLATE III

Low voltage apparatus (6 volts). Three large specimens and twenty four small specimens were tested each time.

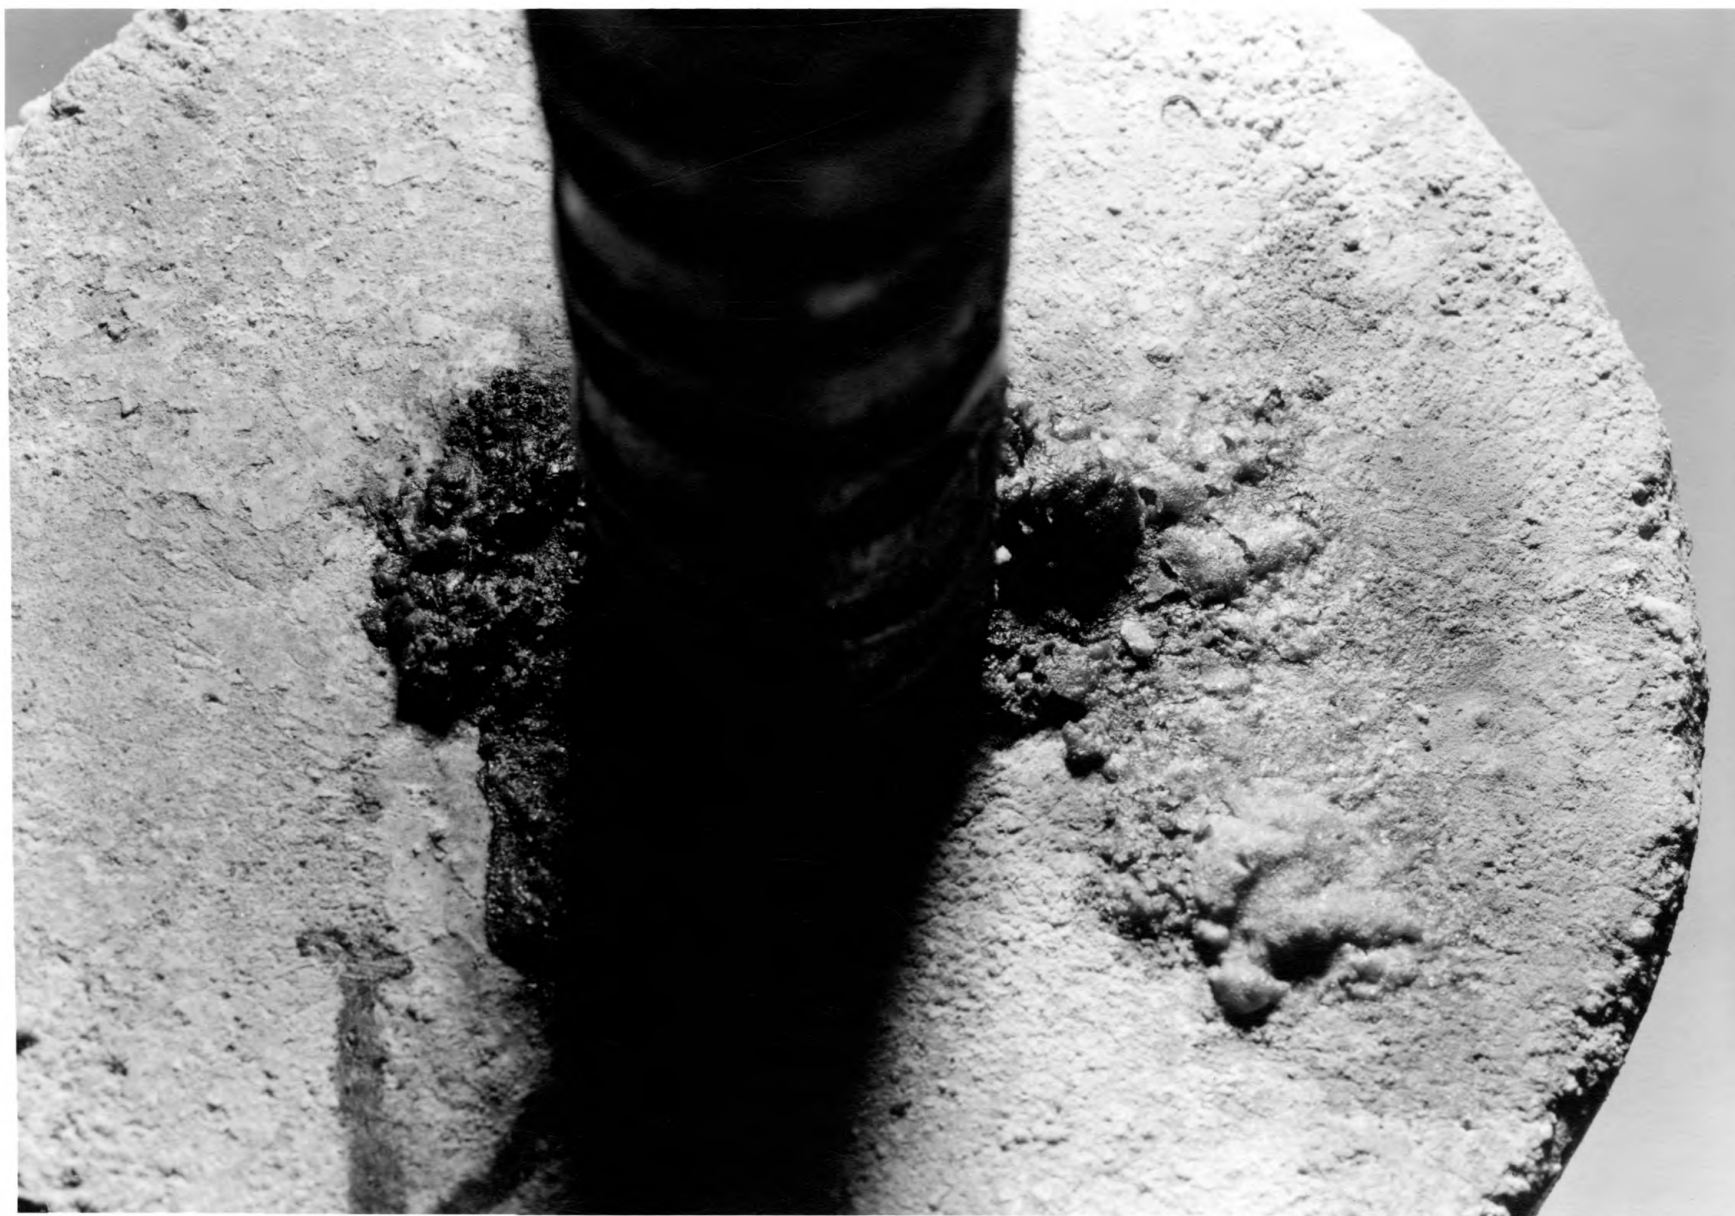
The corrosion of the steel bar embedded in concrete specimen (VI). The rust moved up to the surface of the specimen after the crack happened.

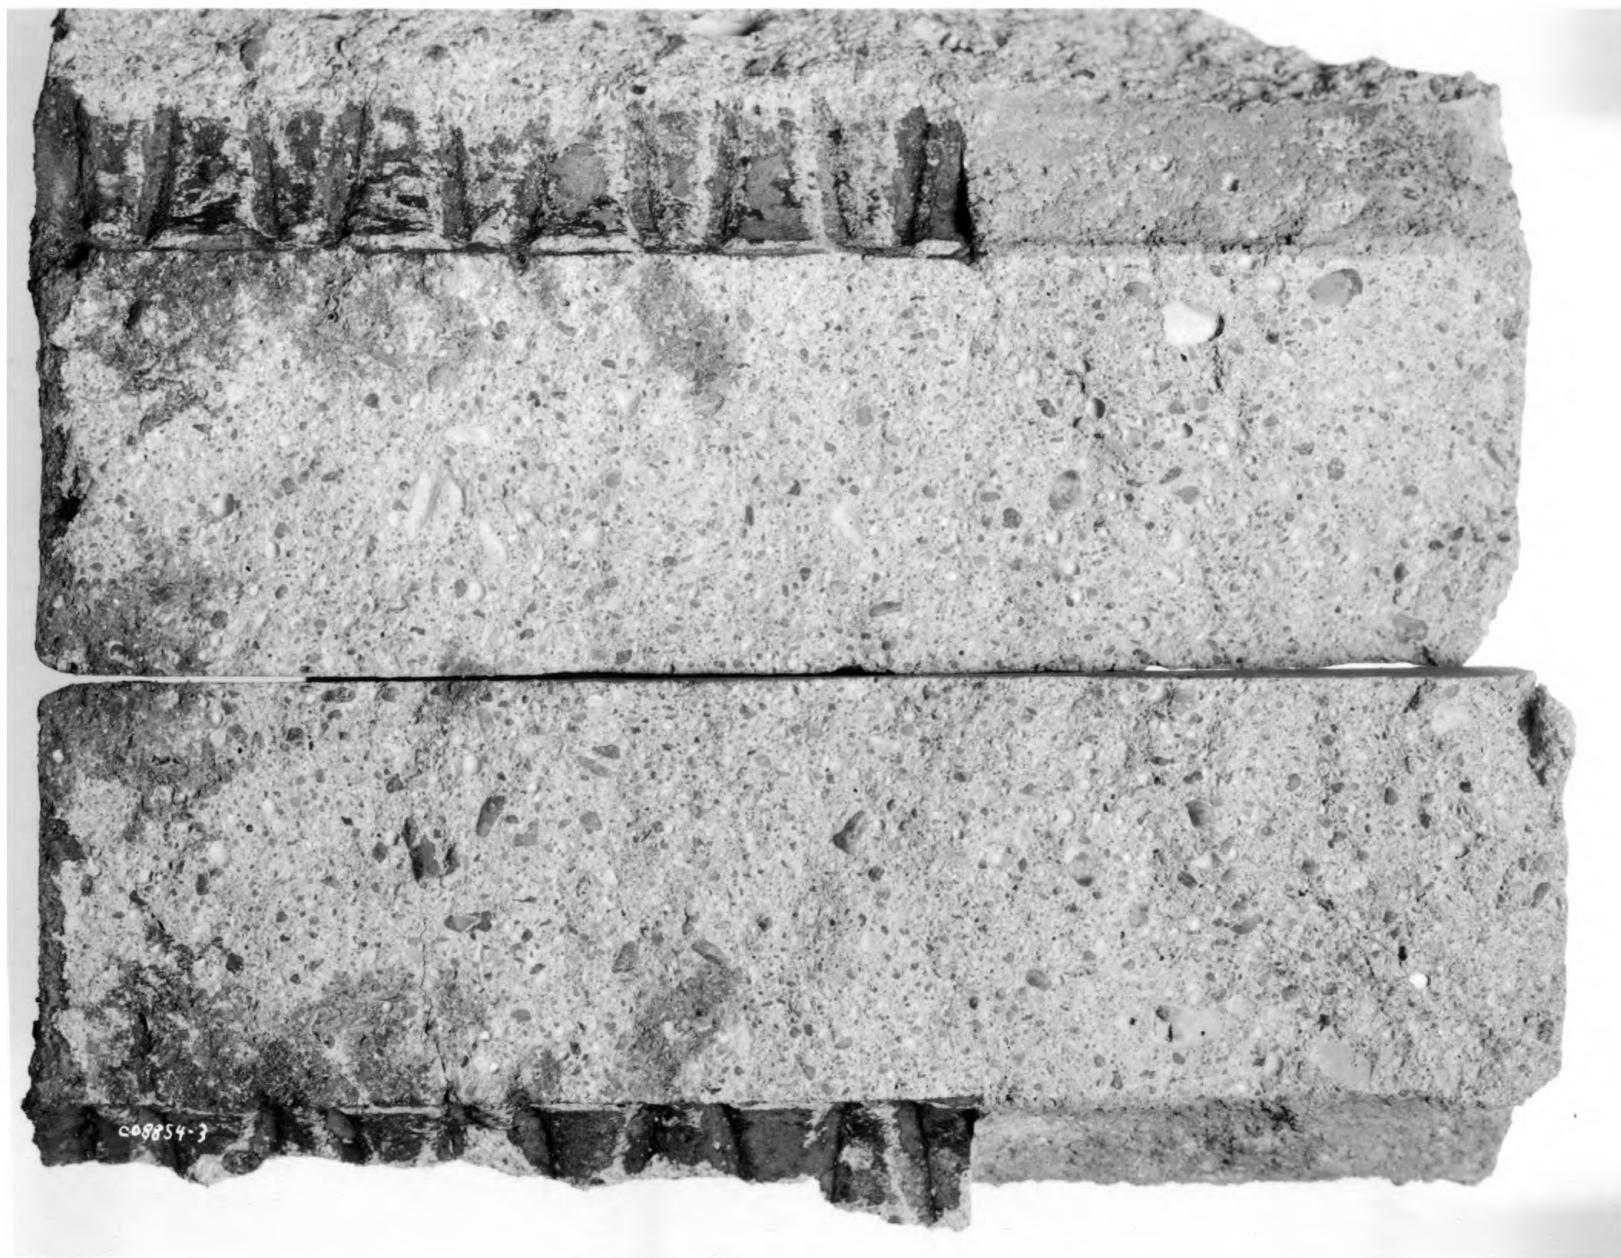
PLATE V

The concrete specimen (VI) had been opened after the crack happened. The rust layer appearing on the concrete is due to the corrosion of the steel bar.

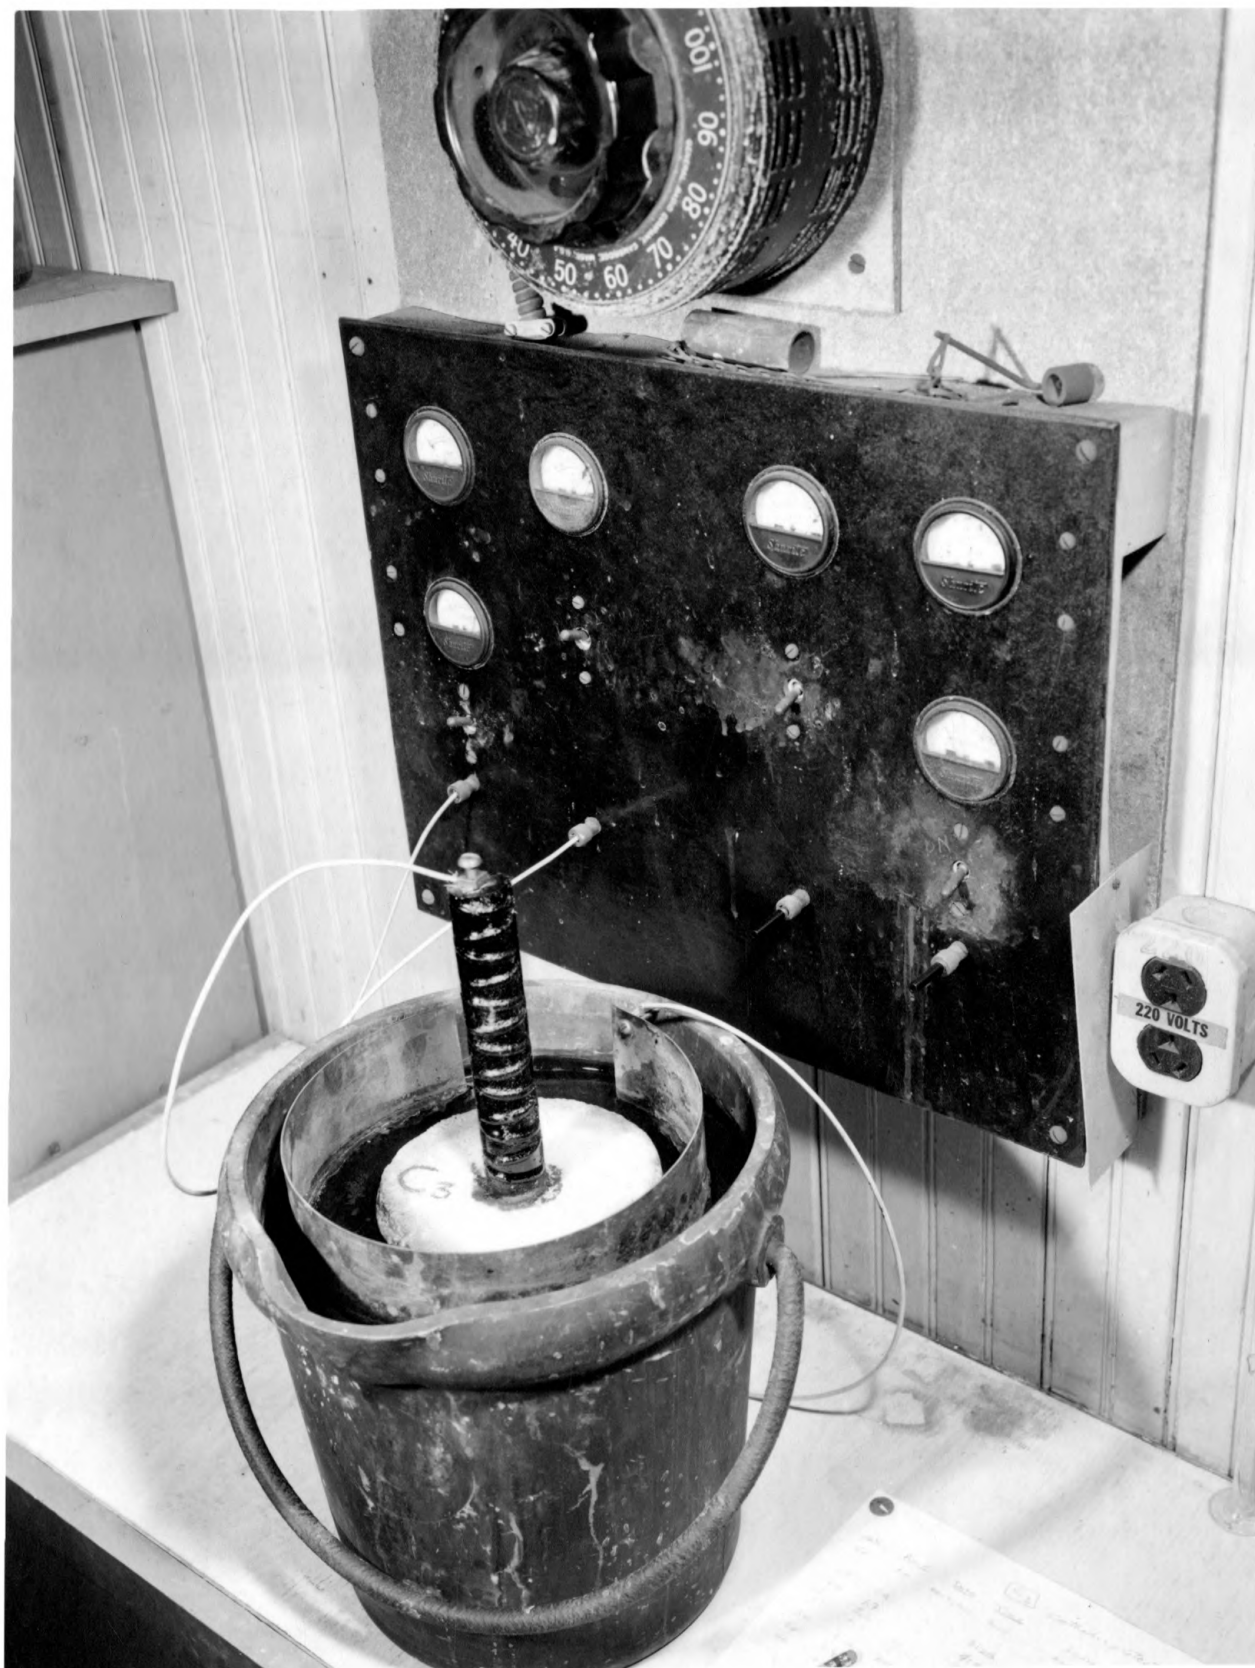
High votage apparatus (50 volts) with specimen (C3) tested under cathodic protection.
