THE CORROSION OF REINFORCEMENT IN CONCRETE

A MASTER'S THESIS

Department of Civil Engineering

KANSAS STATE UNIVERSITY
Manhattan, Kansas

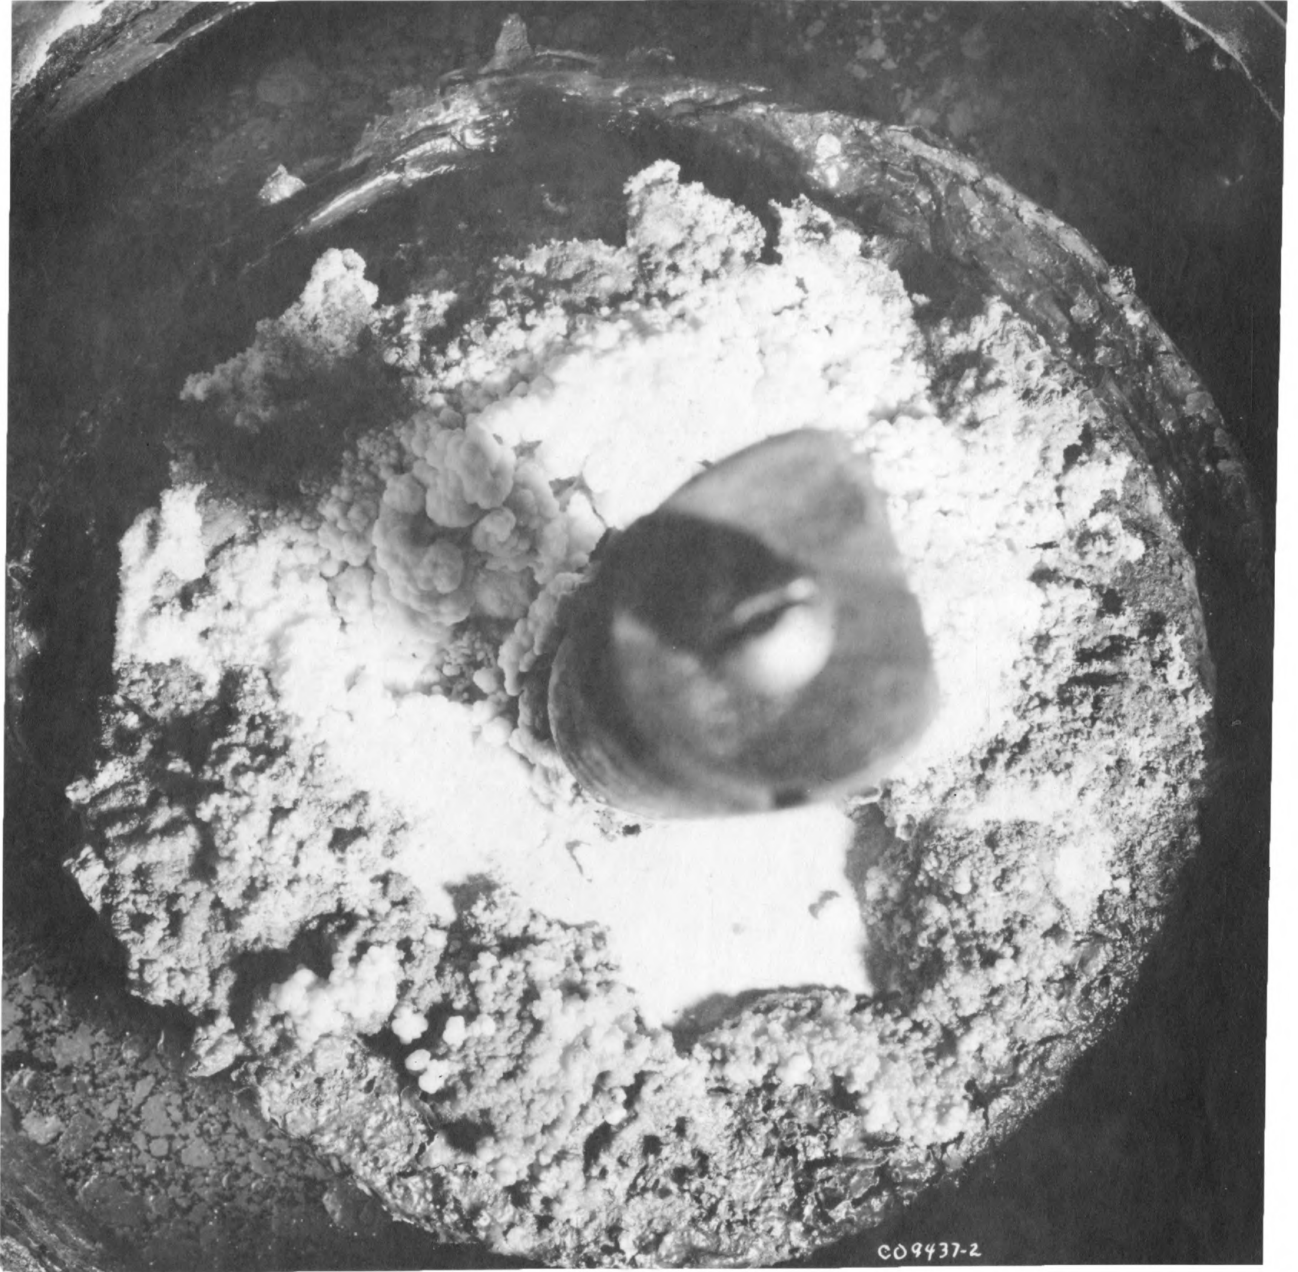
PLATE VII

Top view of concrete cylinder tested under cathodic protection of high voltage current (50 volts). The great amount of salt on the surface of the concrete, and a layer of rust floating on electrolyte were due to the corrosion of the iron shell around the specimen.

The rust in cathodic protection tests floated on the salt brine - electrolyte - and reached the concrete cylinder. A circle of white salt accumulated at the surface of the concrete, especially in the very high voltage test.

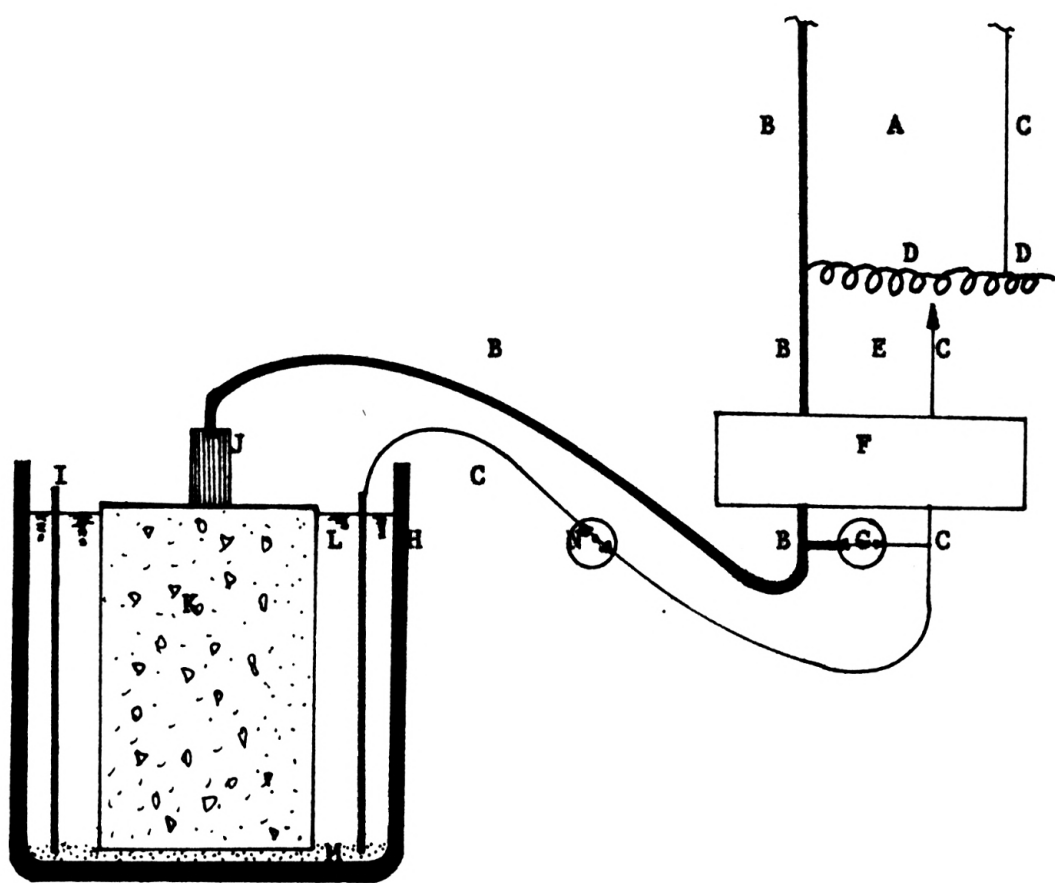
PLATE VIII

Diagram showing the connection of high voltage apparatus (50 volts) to the concrete cylinder specimen for anodic effect.

- A. Electric supply (110 volts A.C.)
- B. Positive wire
- C. Negative Wire
- D. Transformer
- E. 50-volt A.C.
- F. Bridge rectifier
- G. Voltmeter
- H. Rubber jar
- I. Iron shell around the concrete cylinder
- J. Steel bar embedded in the concrete cylinder
- K. Concrete cylinder
- L. Electrolyte (10% salt brine)
- M. 1" layer of sand
- N. Ammeter

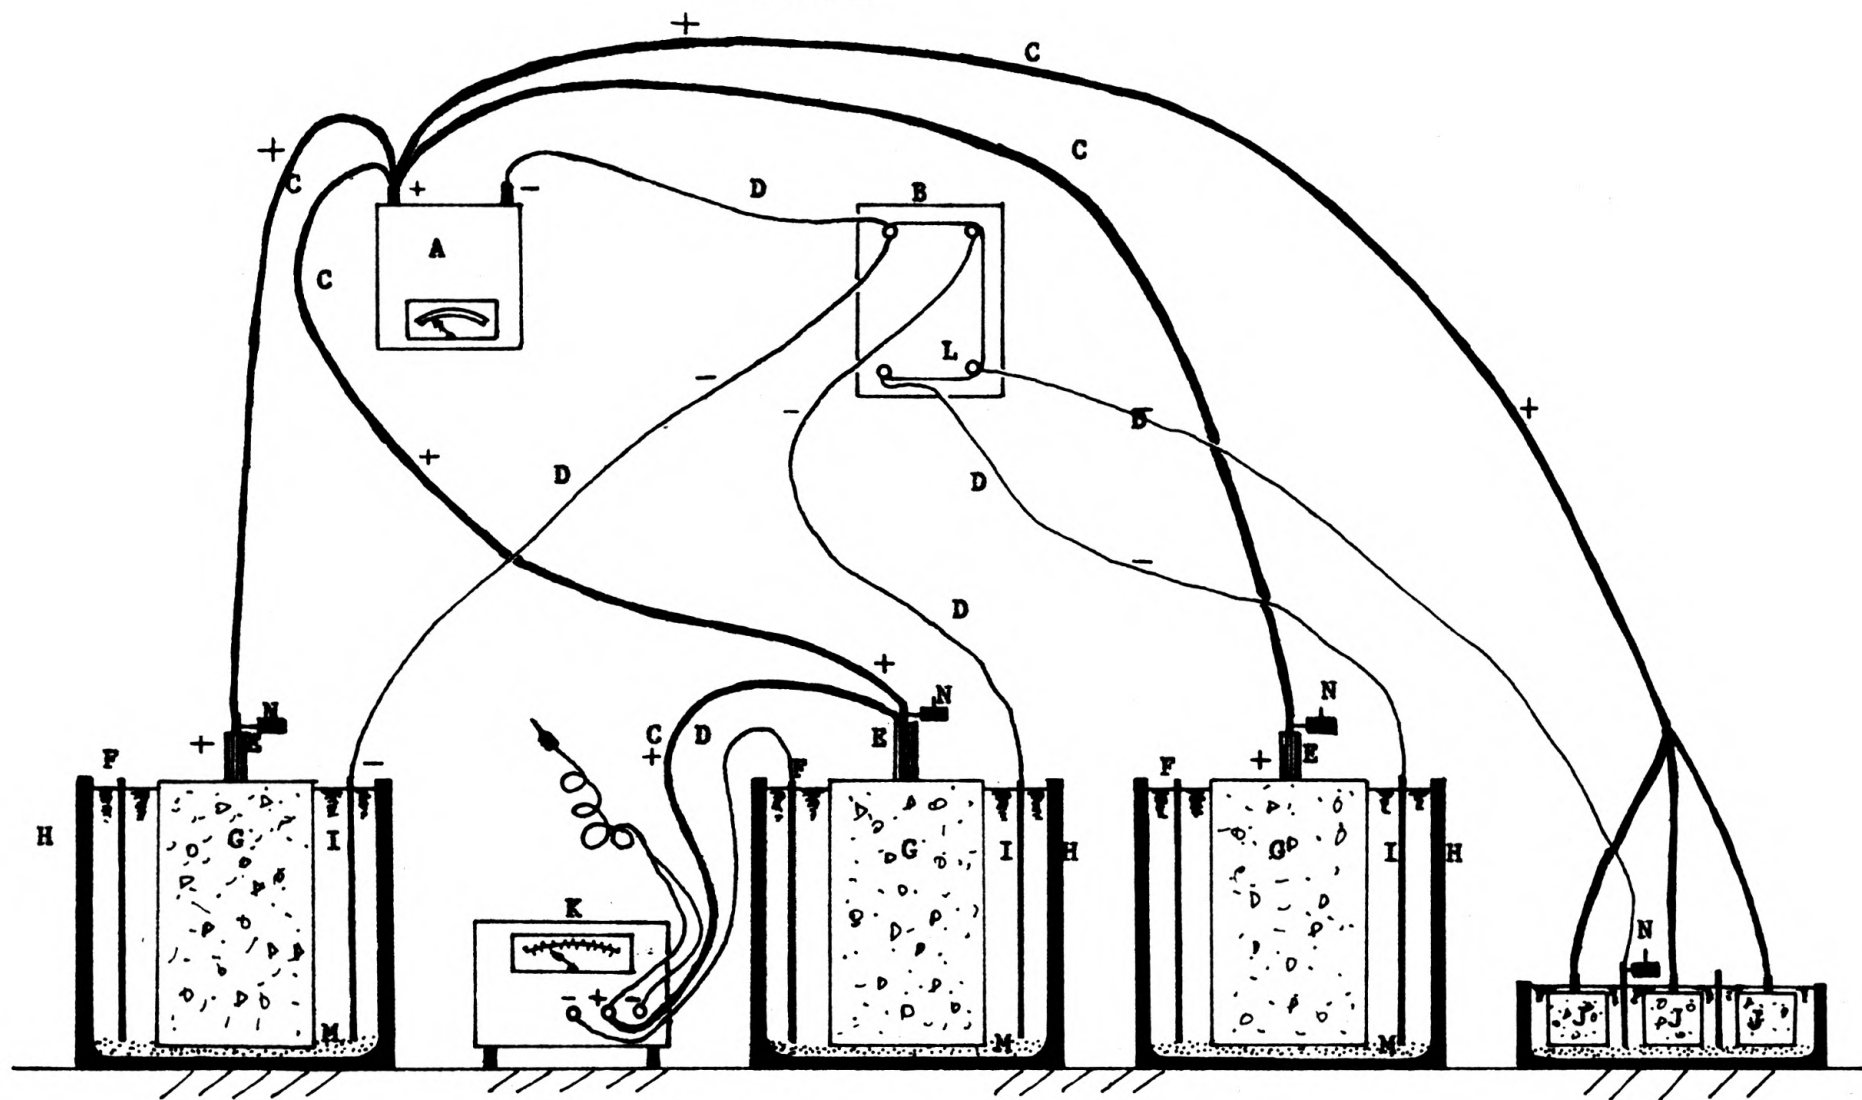
PLATE IX

Diagram showing the connection of wires in low voltage apparatus (6 volts).

- A. Battery charger.
- B. Masonite plate.
- C. Positive wires.
- D. Negative wires.
- E. Steel bars embedded in concrete specimens.
- F. Iron shells surrounding the specimens.
- G. Concrete cylinder specimens.
- H. Clay jars.
- I. Electrolyte (3% salt brine).
- J. Concrete cubes.
- K. Voltmeter and an ammeter.
- L. Phone jack.
- M. 1" layer of sand.
- N. Potentiometers.

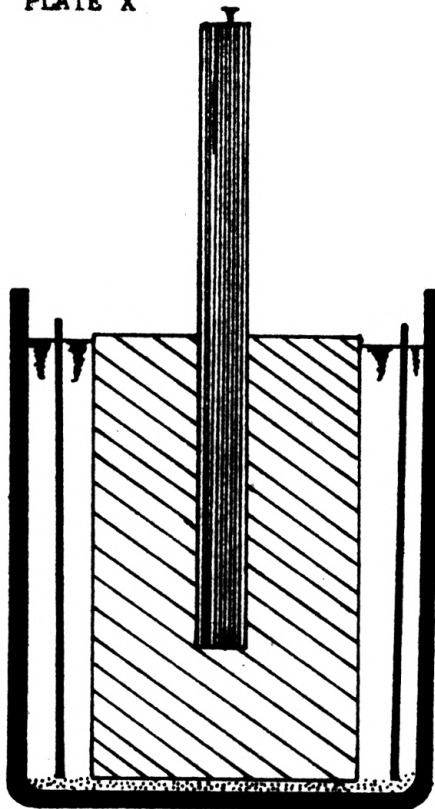
Fig. 1

Fig. 1. Diagram showing the large specimen in clay jar.

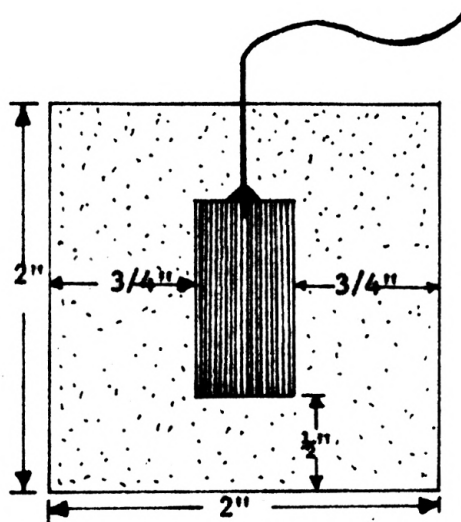
Fig. 2

Fig. 2. Diagram showing the small specimen.

Small specimens of two inch cubes were tested to find the time elapsed before cracking. A #4 plain bar of one inch length was embedded in the concrete as shown in Plate X, Figure 2. Since the cubes were immersed in three per cent salt brine,

insulated wire was punched into the steel bar and epoxy of two parts mixed together equally was placed around the wire to the bar surface to prevent any contact between the insulated wire and the moisture if there is an open part of the wire at that place.
