Designing for Change: Design solutions for anthropogenic and climate change impacts on riparian ecosystems and hydrology in Northeast Kansas.

A REPORT

MASTER OF LANDSCAPE ARCHITECTURE

KANSAS STATE UNIVERSITY

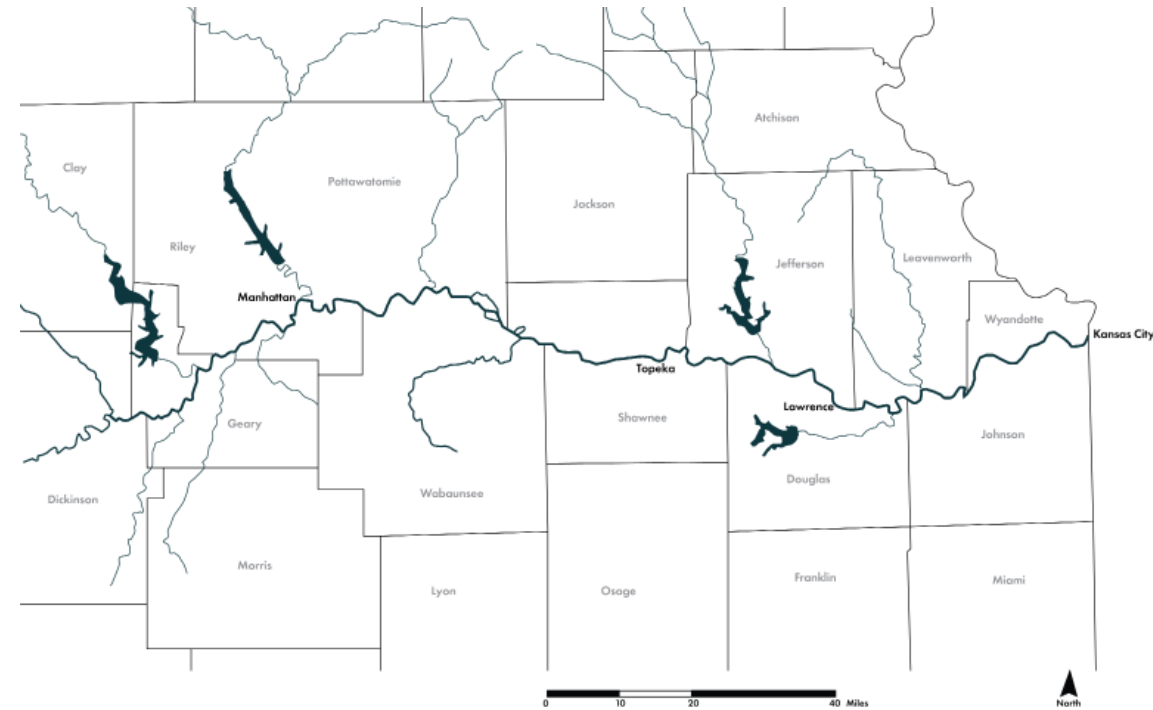
**Figure 2.2 The Kansas River System**

The figure shows the entire Kansas River and its tributaries from its beginning at the confluence of the Smoky Hill and Republican Rivers then flowing east and emptying into the Missouri River (figure by author, adapted from ArcGIS 2020).

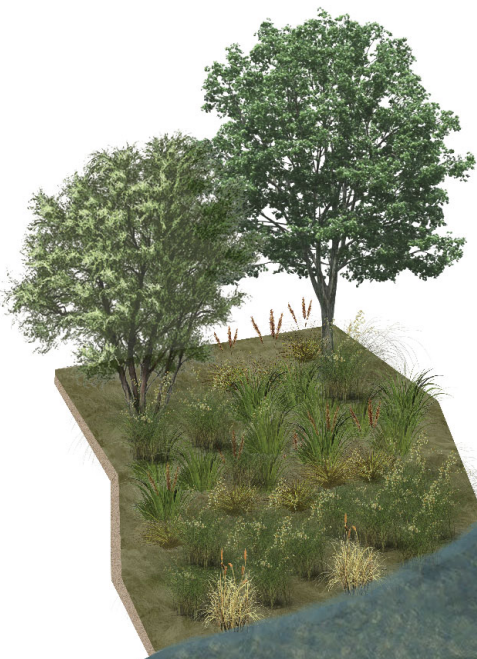
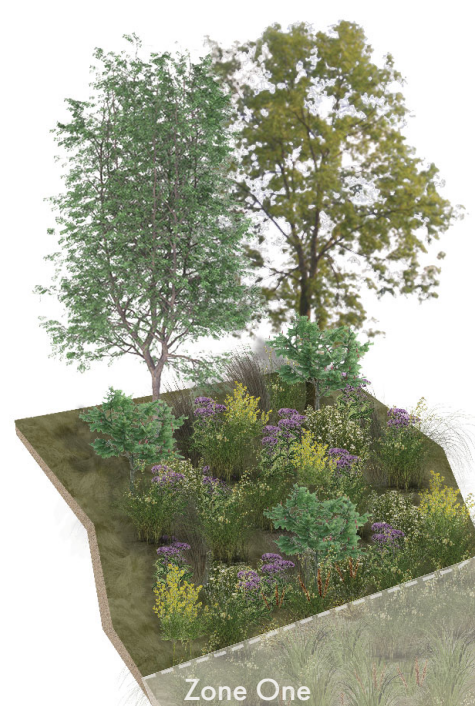
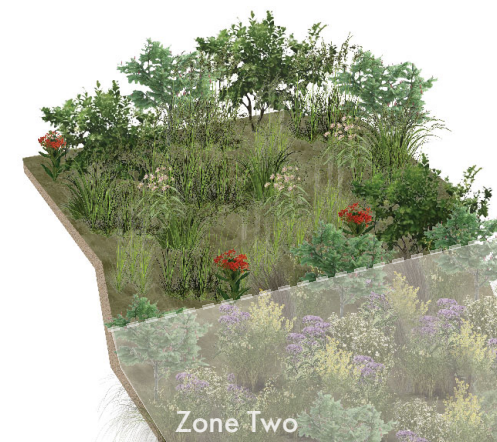
Figures 5.3-5.5 Riparian Buffer Zones Vegetation Pallets

The section-cut provides a general outline for the three buffer zones and their location used in this project (Figures by author 2021).

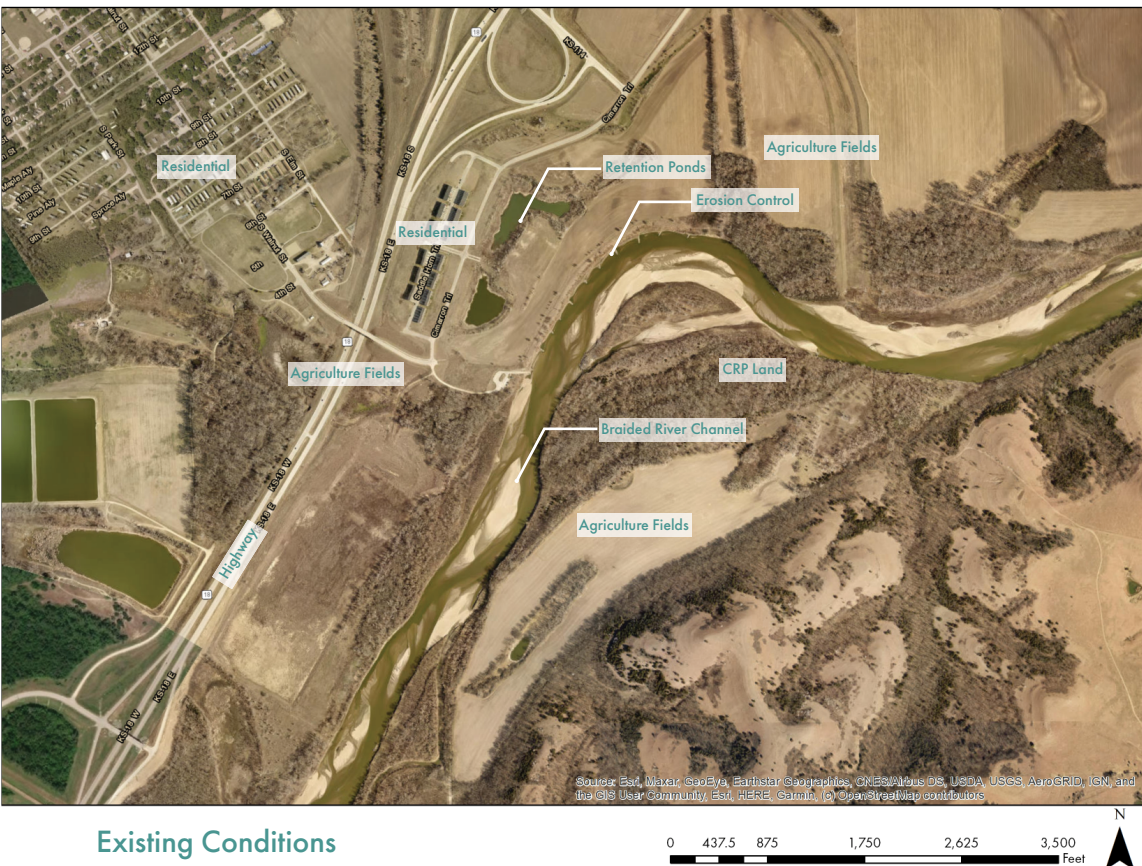
**Figure 5.12 Existing Conditions at Ogden Site**

Little to no native riparian vegetation on site based on initial SVAP Version II (USDA & NRCS 2009). The existing vegetation was predominantly invasive species including, but not limited to: amur honeysuckle (*Lonicera maackii*), garlic mustard (*Alliaria petiolata*), and black locust (*Robinia pseudoacacia*). The existing riparian buffer was thin and lacked species diversity. Approximately 90% of the northern side of the Kansas River is bare and cropland comes up to the edge of the river. The southern side of the river bend is predominantly covered in woody vegetation species.

Suggestions for native riparian vegetation restoration for the Kansas River at Ogden, Kansas includes revegetating the northern and southern areas adjacent to the river. The area to the south of the river bend will require invasive species removal and treatment. The both sides of the river's vegetation composition will include all four types of the planting groups listed in this project. This site will have the most upland vegetation compared to the other three sites. The Conservation Reserve Program (CRP) land on the southern side of the site shall be managed to the standards of the Farm Service Agency.

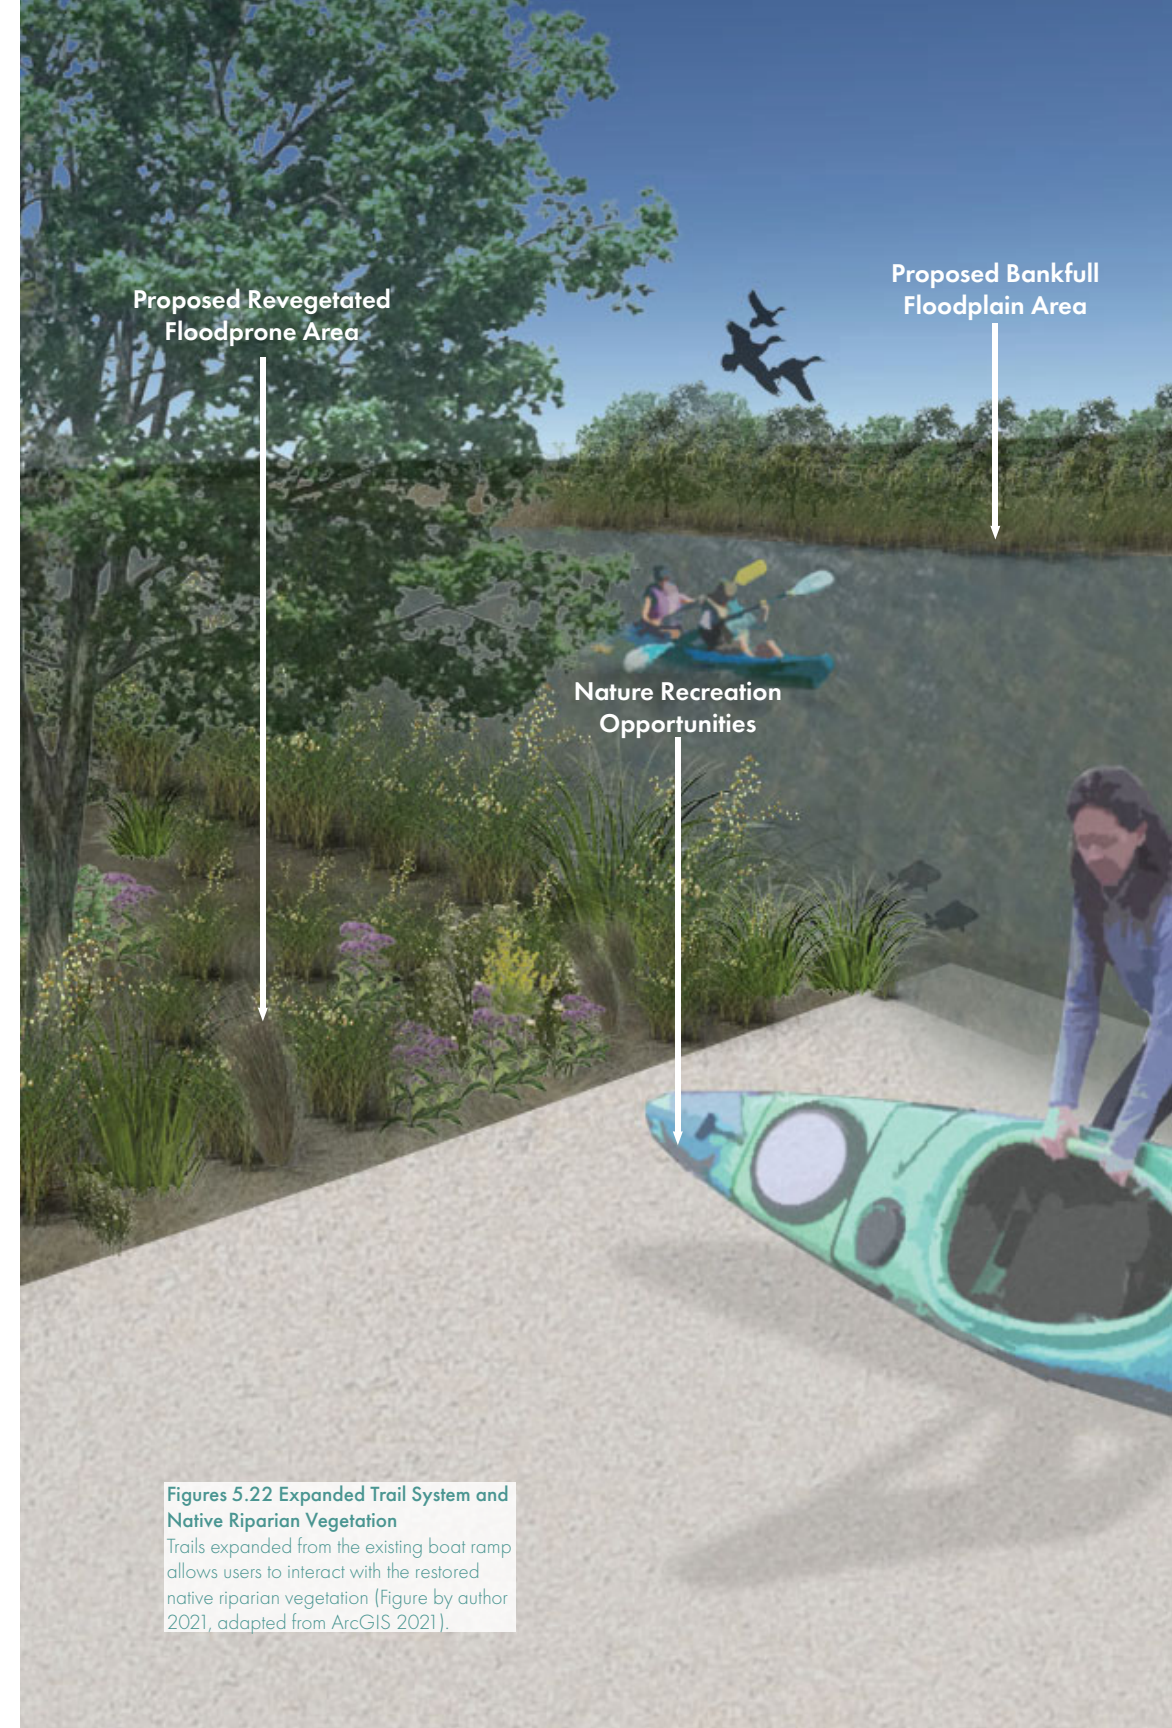
**Figures 5.22 Expanded Trail System and Native Riparian Vegetation**

Trails expanded from the existing boat ramp allows users to interact with the restored native riparian vegetation (Figure by author 2021, adapted from ArcGIS 2021).

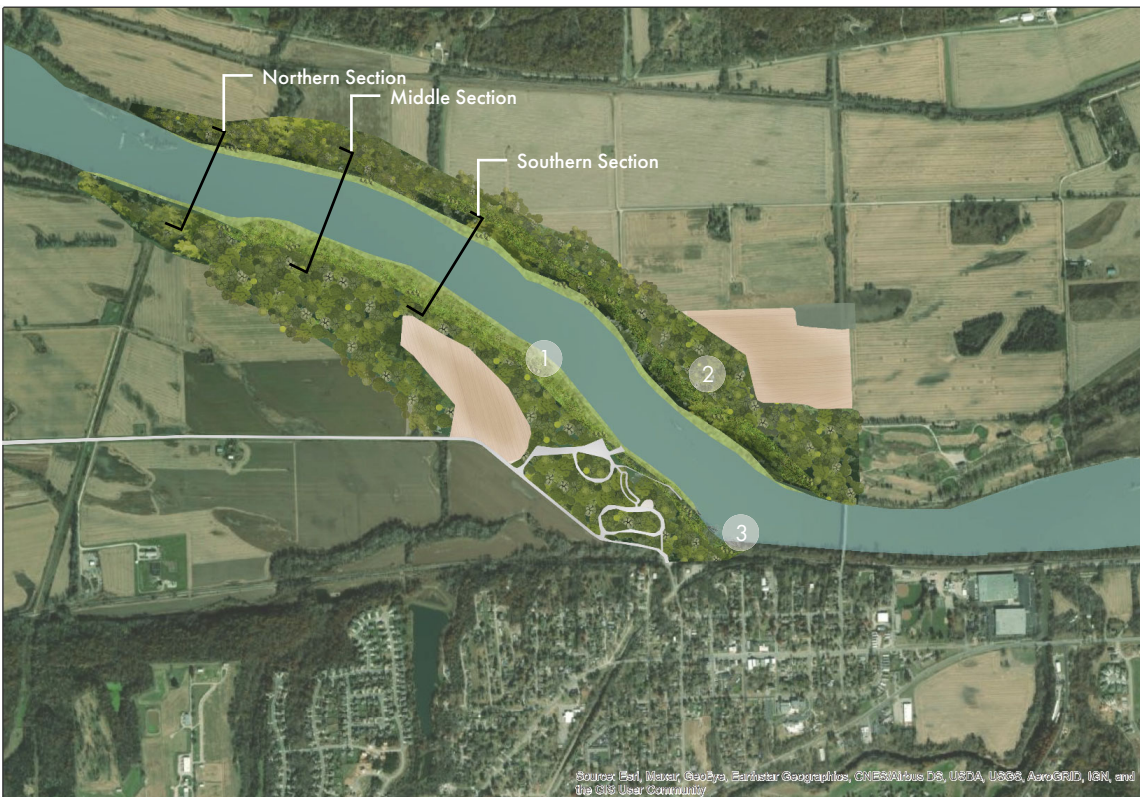
**Figure 5.31 Master Plan of Projected Design at DeSoto Site**

Estimated Total of Bankfull Floodplain Area Added: 63.31 Acres.

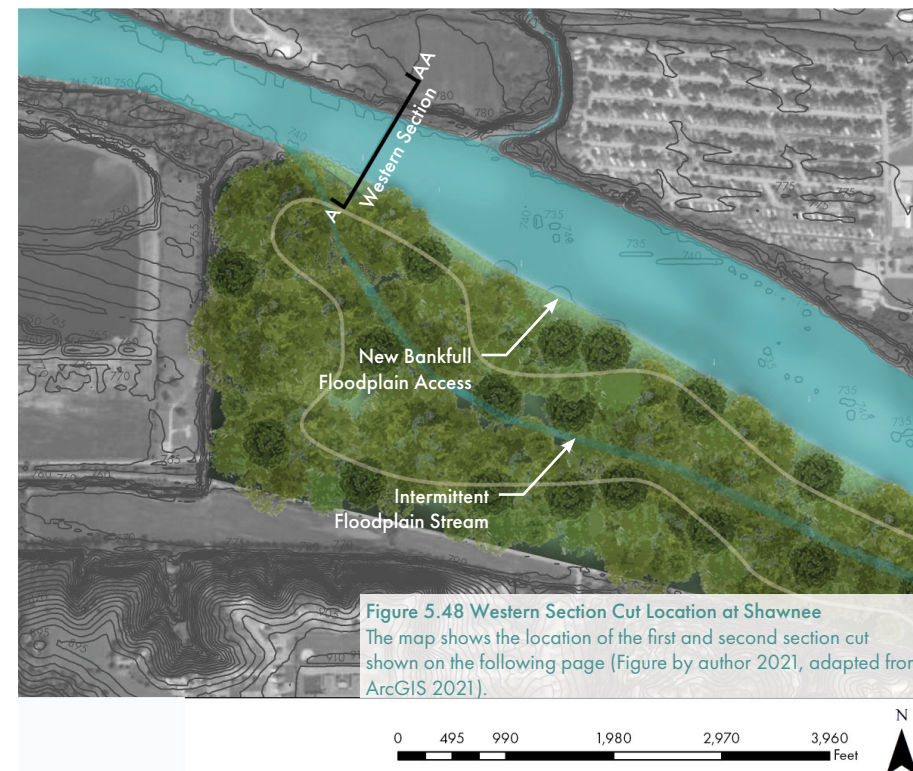
**Figure 5.48 Western Section Cut Location at Shawnee**

The map shows the location of the first and second section cut shown on the following page (Figure by author 2021, adapted from ArcGIS 2021).

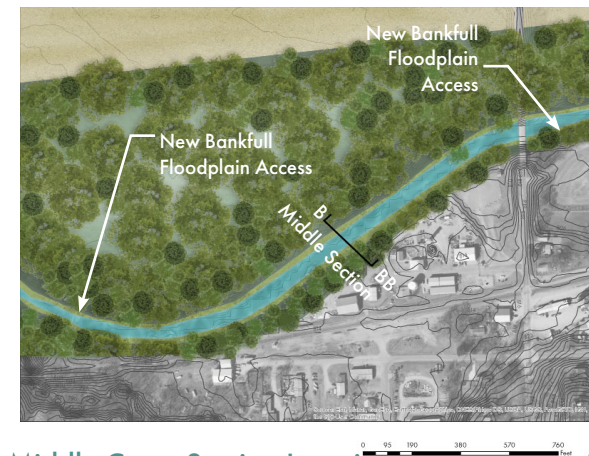
**Figure 5.65 Middle Section Cut at Eudora**

The map shows the location of the second section cut shown on the following page (Figure by author 2021, adapted from ArcGIS 2021).
