Strand rods and high-performance fiber-reinforced cementitious composites: alternative options
for seismic retrofit of existing structures

A REPORT

MASTER OF SCIENCE

Department of Architectural Engineering
Carl R. Ice College of Engineering

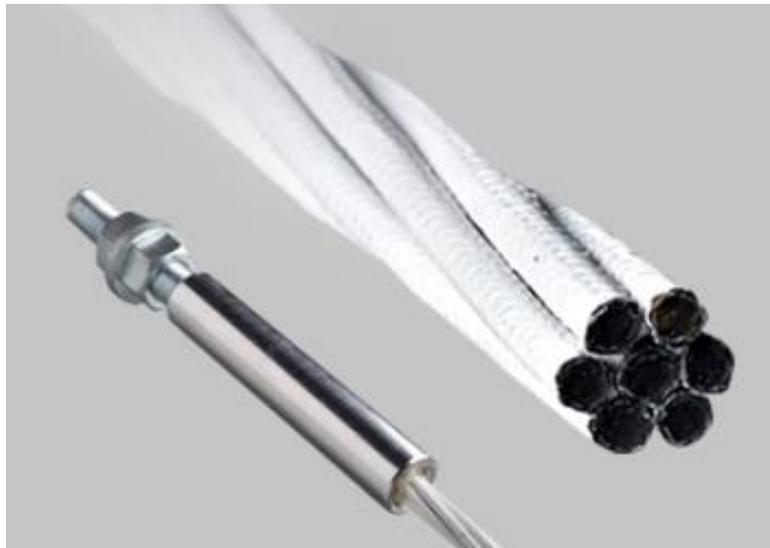
The CABKOMA strand rod is made of a carbon fiber composite. Thin, oriented carbon fiber strands are used for the interlining. They are covered by an outer layer composed of synthetic and inorganic fibers intended to protect against weathering of the carbon fibers. The combination is then impregnated with thermoplastic resin.

Figure 4.1-1: Section of the CABKOMA Strand Rod.
Reprinted from ‘CABKOMA’ by Komatsu Matere

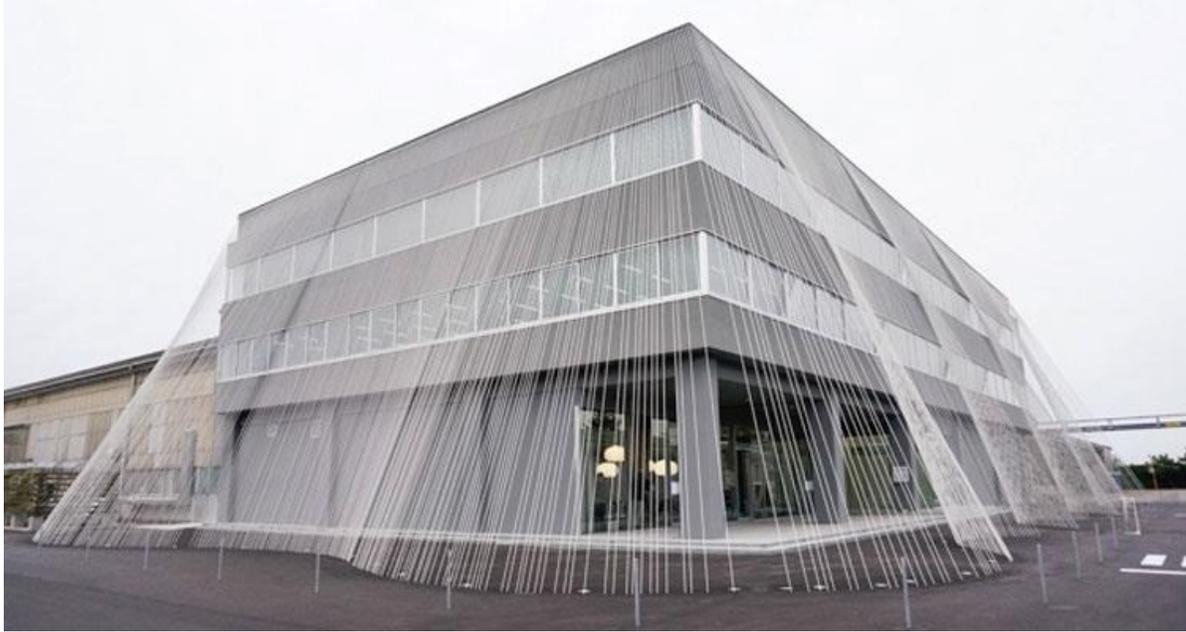
It was developed by the Komatsu Seiten Fabric Laboratory in Ishikawa, Japan. It’s first application was designed by Kengo Kuma for use on the exterior of Komatsu Seiten’s head office building (Overstreet, 2016). The three-story structure is currently used as a workspace, exhibition, and research facility.

Figure 4.1-2: Komatsu Seiten's Head Office with CABKOMA Strand Rods. Reprinted from 'CABKOMA' by Komatsu Matere

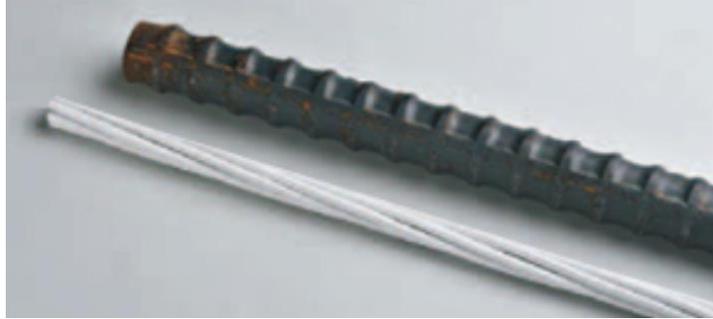
According to the company that produces it, the CABKOMA strand rod is the lightest seismic reinforcement system in the world (KOMATSU MATERE Co., Ltd., 2019). It has a high tensile strength, a “delicate but strong structural body,” and a superb aesthetic quality. The material has a specific weight of about one-fifth of that of typical steel rebar. In fact, a 160-meter (525 feet) roll of the strand rod weighs only 12 kg (26.5 lbs) (KOMATSU MATERE Co., Ltd., 2019). Yet it still has greater tensile strength per unit area.

Figure 4.1-3: Size Comparison of Strand Rods vs. #4 Rebar. Reprinted from 'CABKOMA' by Komatsu Matere

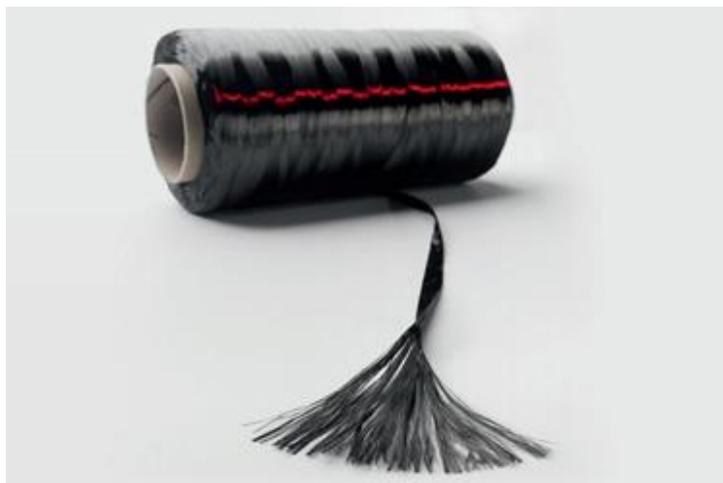
The reinforced fibers can be inorganic, organic, metal, or a combination. Acceptable fibers include carbon fiber, graphitic fiber, silicon carbide fiber, alumina fiber, tungsten carbide fiber, boron fiber, glass fiber, basalt fiber, para-aramid fiber, meta-aramid fiber, ultrahigh molecular weight polyethylene fiber, polyarylate fiber, PBO fiber, PPS fiber, polyimide fiber, fluorine fiber, PVA fiber, stainless steel fiber, or iron fiber (United States Patent No. 20160326323, 2015). Overall, the ideal combination of materials for performance in terms of strength and durability are carbon fibers in a reactive thermoplastic epoxy resin.

Figure 4.2-1: Carbon Fiber Product. Reprinted from ‘Carbon Fibers’ by Teijin.

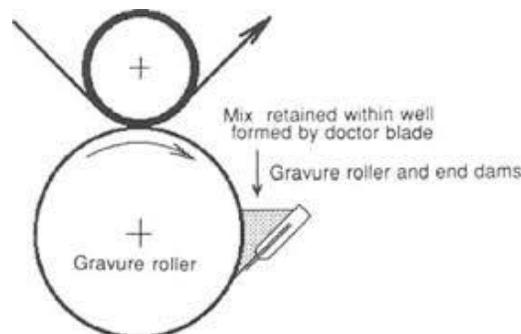
The thermoplastic resin solution is then applied to the reinforced fibers. There are various ways to accomplish this. The first is the dip method in which the bundle of fibers is dipped into the solution. The second method is the dip-nip method in which the fibers are dipped into the solution and then squeezed by equipment, for example a mangle or wringer. There is also the transfer method in which the solution is applied to one surface of the bundle using a kiss roll or a gravure roll.

Figure 4.2-2: Example of Gravure Roll. Reprinted from 'Coating and laminating' by D.W. Ball

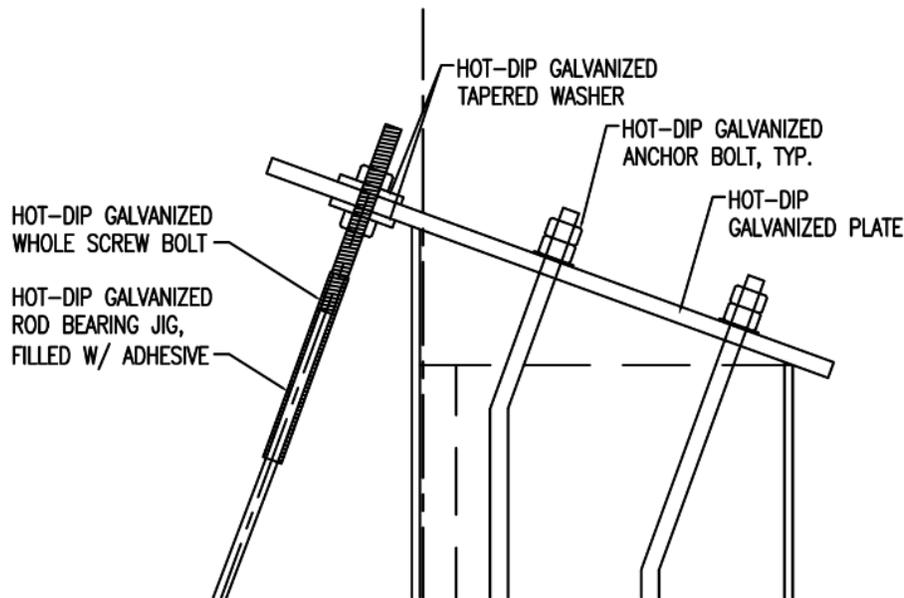
Strand rods can be applied as external bracing to structures of various heights and compositions. They help alleviate the stress placed on a building when a seismic event does occur by providing an alternate path for the forces to be transferred to the ground. It is important for the rods to be properly placed and installed to ensure their effectiveness. Below is a detail of how to effectively apply strand rods to the exterior of a structure. In addition, the application configuration allows for the strand rods to be readjusted and tightened should they become less taut over time.

Figure 4.3-1: Application Detail. Recreated from ‘CABKOMA’ by Komatsu Matere.

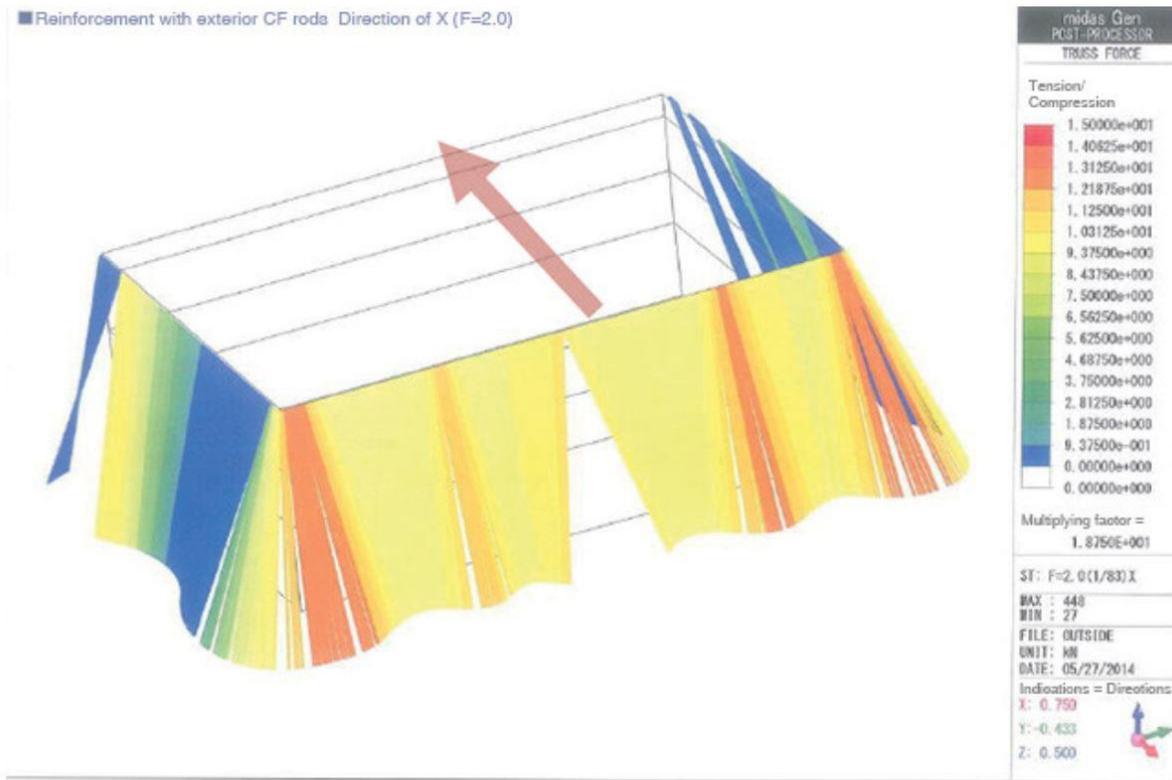
The following figures illustrate a finite element analysis, using midas Gen software, of how the strand rods operate in the event of seismic activity.

Tensile strength applied to the rod in the event of an earthquake in the direction of X

Figure 4.3-2: Finite Element Analysis of Exterior Application of Strand Rods.
Reprinted from 'CABKOMA' by Komatsu Matere

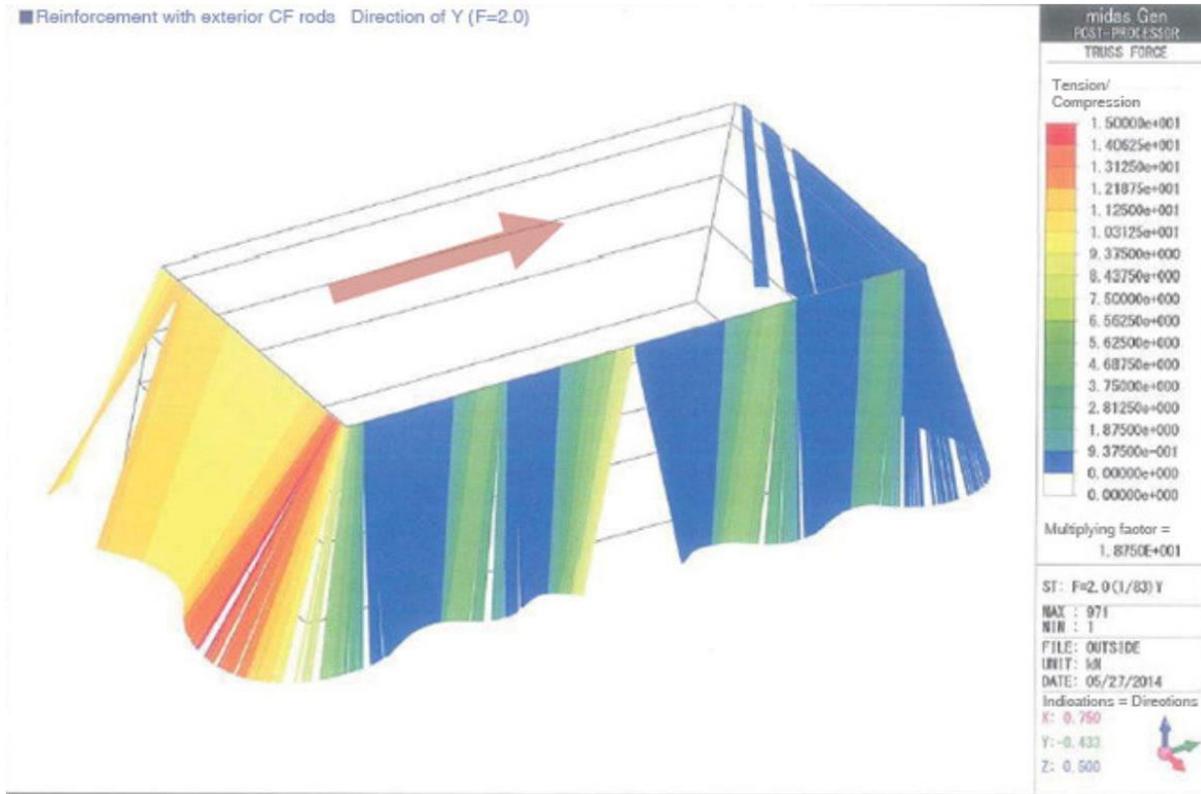
Tensile strength applied to the rod in the event of an earthquake in the direction of Y

Figure 4.3-3: Finite Element Analysis of Exterior Application of Strand Rods.
Reprinted from 'CABKOMA' by Komatsu Matere

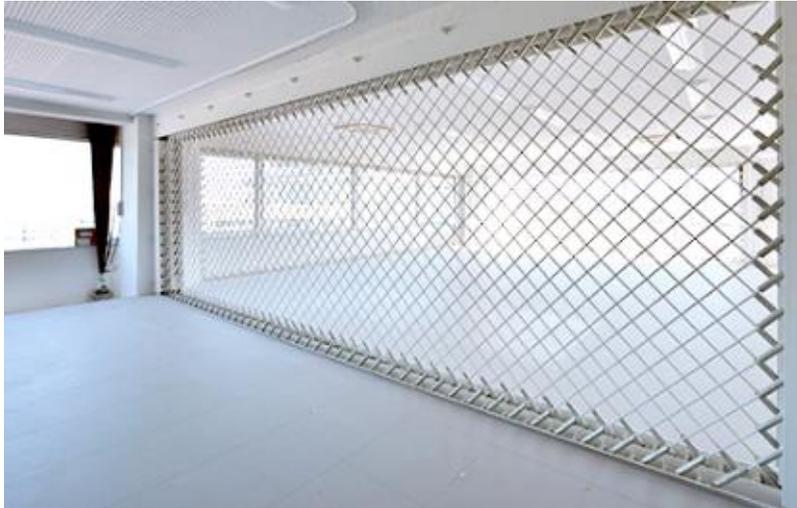
architect. The use of strand rods in a shear wall is beneficial because it is less bulky than a typical shear wall and provides visibility through the member which still allows for a more open feel in the space.

Figure 4.3-4: Interior Strand Rod Application. Reprinted from ‘CABKOMA’ by Komatsu Materie

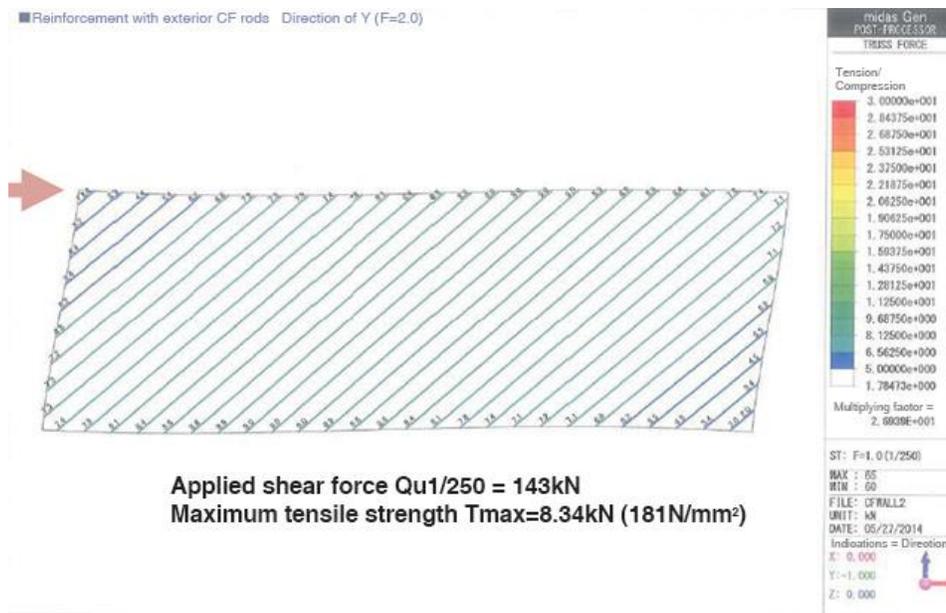
The following figure illustrate a finite element analysis of how the strand rods operate in the event of seismic activity.

Brace stress at story drift of 1/250

Figure 4.3-5: Finite Element Analysis of Interior Application of Strand Rods. Reprinted from ‘CABKOMA’ by Komatsu Materie

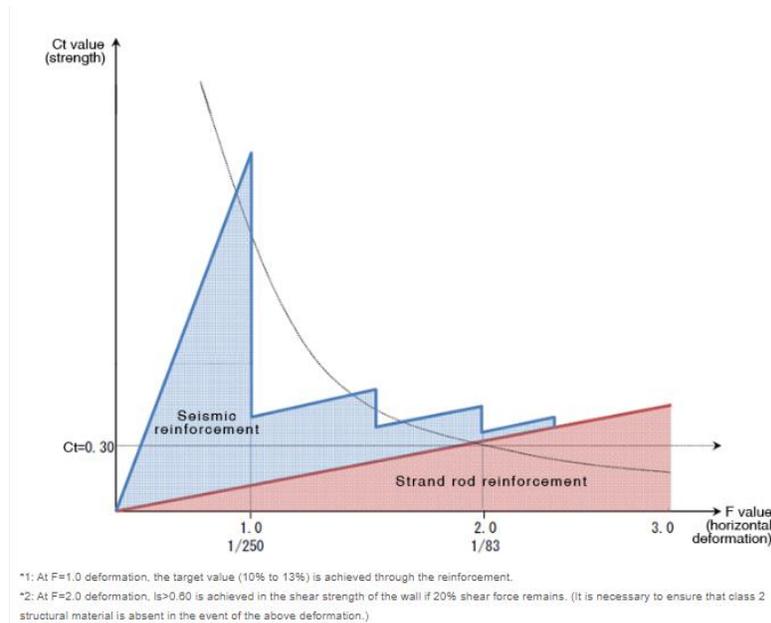
The primary goal of the application is to add additional seismic strength without affecting the existing structure. The reinforcement was planned such that the target reinforcement values would be reached within a story drift of 1/250. Figure 4.3-6 illustrates the strength versus the horizontal deformation and the differences between the strand rods and traditional seismic reinforcement.

Figure 4.3-6: Strength vs. Horizontal Deformation in Strand Rods and Seismic Reinforcement. Reprinted from ‘CABKOMA’ by Komatsu Matere

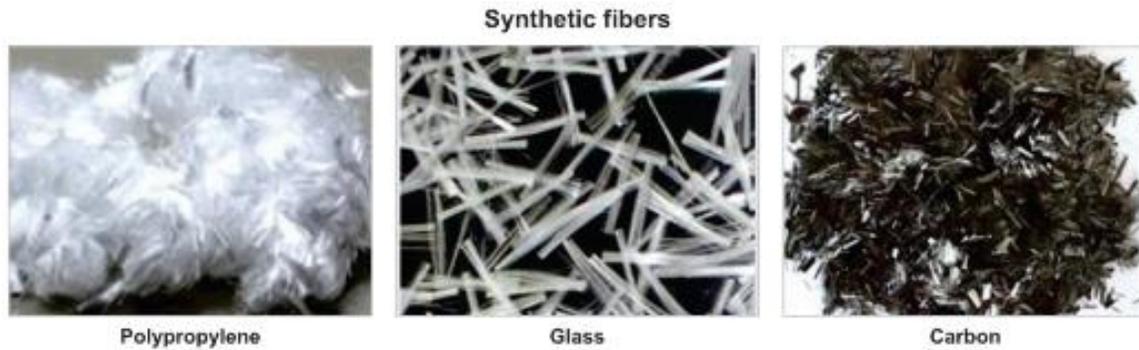
The fibers are discontinuous and randomly oriented and distributed throughout (Naaman, 2006). There are various options for the fibers. They can be natural organic, natural mineral, or manmade. Their physical and mechanical properties will impact the mixture. For example, the shape, length, diameter, density, surface roughness, chemical stability, flammability, tensile strength, elastic modulus, stiffness, ductility, and elongation all play a part in determining the overall strength and characteristics of the composite (Naaman, 2006).

Figure 5.1-1: Examples of Synthetic Fibers. Reprinted from ‘Ultra High-Performance Fiber-Reinforced Concrete’ by T. Buttignol, J. Souisa, and T. Bittencourt, 2017, p. 961

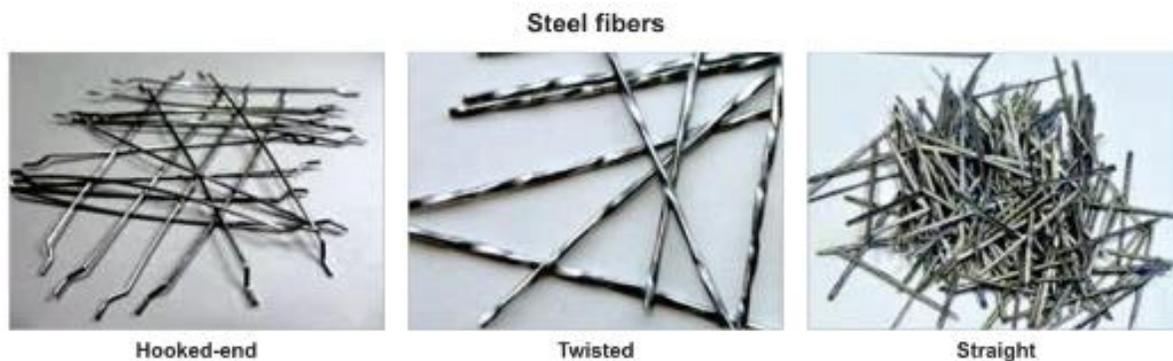
Figure 5.1-2: Examples of Mechanically Deformed Steel Fibers. Reprinted from ‘Ultra High-Performance Fiber-Reinforced Concrete’ by T. Buttignol, J. Souisa, and T. Bittencourt, 2017, p. 961

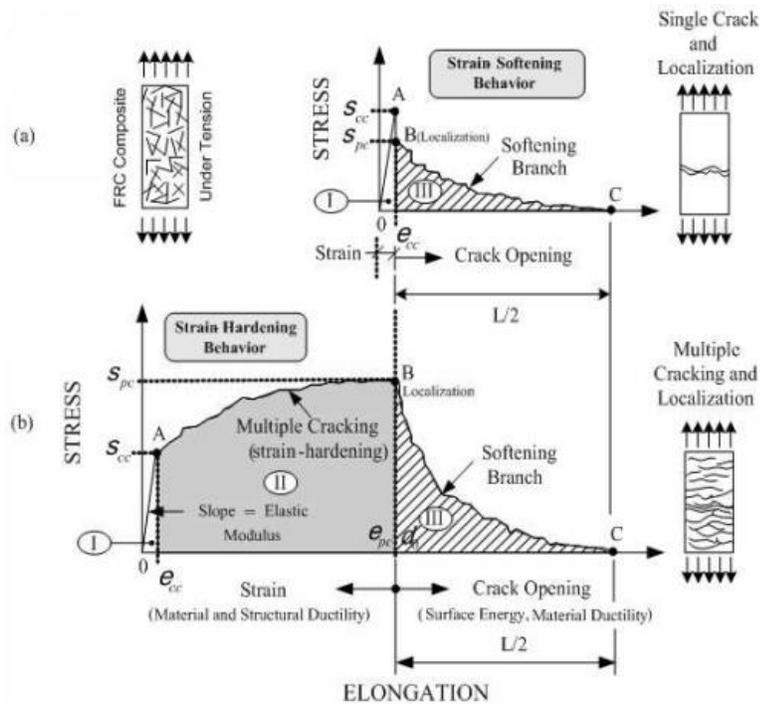
There are several ways to classify fiber-reinforced composites based on characteristics. Recently, it has been proposed to classify them based on their stress-strain response in tension, i.e., either strain softening or strain hardening. For strain softening, “[crack] localization occurs immediately after first cracking and, with increasing elongation; the stress after first cracking is smaller than that at first cracking” as shown in Figure 5.1-3 (Naaman, 2006). Strain softening is characterized by “a stable crack propagation and a reduction of the tensile strength as a result of a gradual fiber debonding” (Buttignol, Sousa, & Bittencourt, 2017). For strain hardening, “the stress after first cracking increases with strain, and multiple cracking occurs up to the maximum post-cracking stress” also shown in the figure (Naaman, 2006). The finely distributed microcracks before crack localization occurs allowing the material to be used in the non-linear range without loss of performance (Buttignol, Sousa, & Bittencourt, 2017). Once localization occurs, the stress decreases with increasing elongation similar to the strain softening case.

Figure 5.1-3: Stress-Elongation Curves in Tension for Fiber-Reinforced Cement Composites. Reprinted from ‘High-Performance Fiber Reinforced Cement Composites: Classification and Application’ by A. Naaman, p. 392

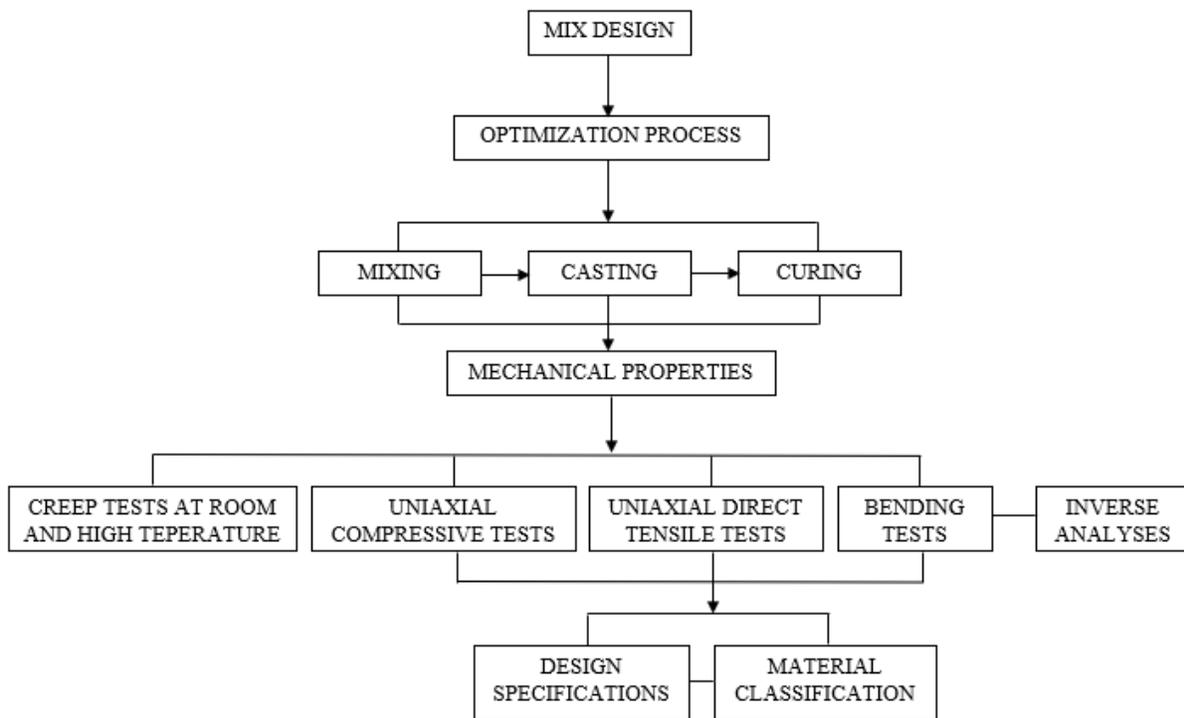
There is significant variability in the amount of cement, the aggregate sizes and types, fillers, binders, and admixtures in different cement mixes (Buttignol, Sousa, & Bittencourt, 2017). As a result, there are infinite variations of mix designs that produce different characteristics within the composite. Overall, the general process is as follows.

Figure 5.2-1: Fiber-Reinforced Cement Composites Manufacturing Process Flowchart. Recreated from ‘Ultra High-Performance Fiber-Reinforced Concrete’ by T. Buttignol, J. Sousa, and T. Bittencourt, 2017, p. 959

The optimization phase refers to modifying the mix design in order to achieve the desired results. For example, “an optimization process can reduce concrete porosity and enhance matrix microstructure links, contributing to increasing concrete strength and reduce creep effects” (Buttignol, Sousa, & Bittencourt, 2017). It is an iterative process and refinement will occur after every mix design.

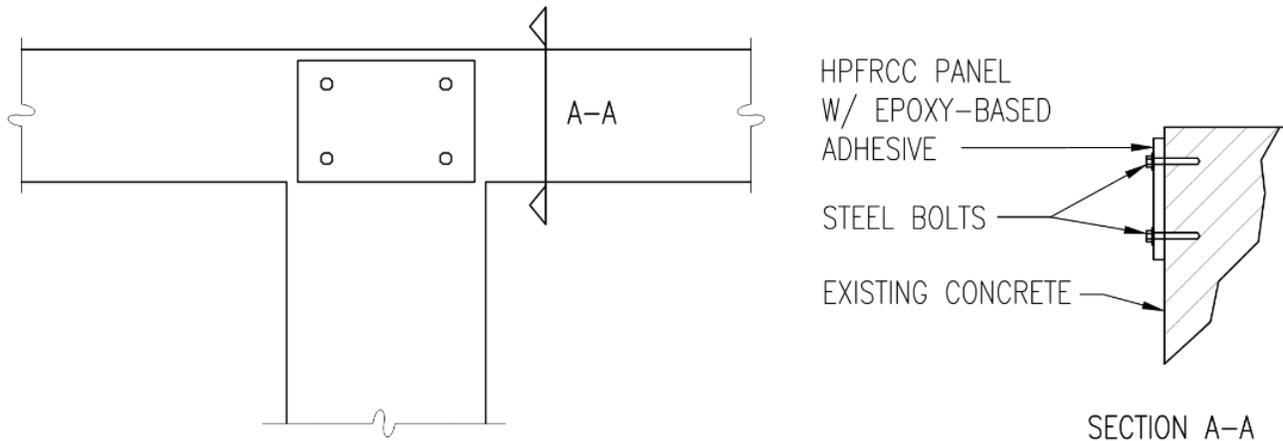
In order to achieve seismic retrofit using high-performance fiber-reinforced cement composites, prefabricated panels can be used and attached to an existing structure. The panels are bolted on to the existing elements of the lateral force resisting system to provide additional strength. The panels are best utilized in locations with potential weaknesses in their connections, such as at beam-column joints as shown in Figure 5.3-1. For even better performance, panels can be applied to each side of the joint and connected using thru-bolts.

Figure 5.3-1: Application Detail of HPFRCC Panels. Recreated from ‘Innovative Techniques for Seismic Retrofit of Reinforced Concrete Joints’ by I. Bedirhanoglu, A. Ilki, N. Kumbasar, 2015.

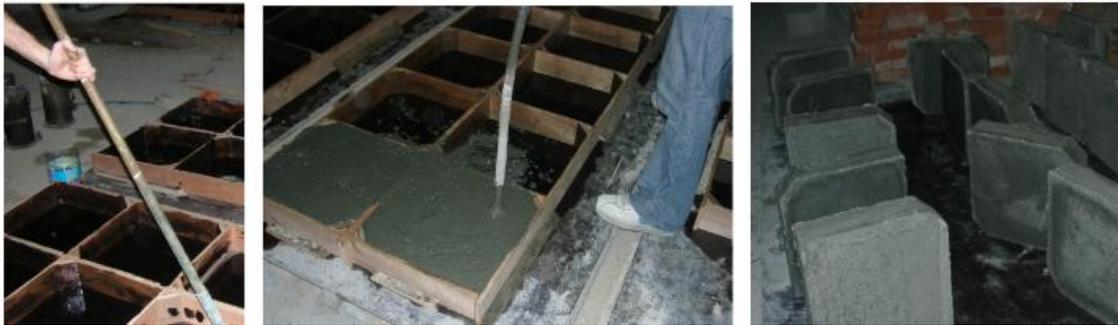
The fiber-reinforced cement composite panels were cast in wooden forms and placed on a vibration table to ensure adequate compaction (Bedirhanoglu, Ilki, Incecik, & Kumbasar, 2008). After the curing process, they were then attached to either side of normal concrete test specimens that measured 100 mm thick. The panel was attached using an epoxy-based adhesive and steel bolts as illustrated in Figure 5.3-3. Ordinary Portland cement was used for the concrete test specimens. The resultant concrete had an average compressive strength of 8 MPa and modulus of elasticity of 14000 MPa. The epoxy had a tensile strength of 25 MPa and a compressive strength of 75 MPa (Bedirhanoglu, Ilki, Incecik, & Kumbasar, 2008). Two concrete test specimens were analyzed without the addition of the prefabricated panels to determine the base strength and to highlight the improvement made through the addition of the panels. Different thicknesses of the HPFRCC panels, measuring 20, 30, and 40 mm, were also tested.

Figure 5.3-2: Test Specimens. Reprinted from ‘Retrofit of concrete panels with prefabricated HPFRCC plates’ by I. Bedirhanoglu, A. Ilki, O. Incecik, N. Kumbasar , 2008.

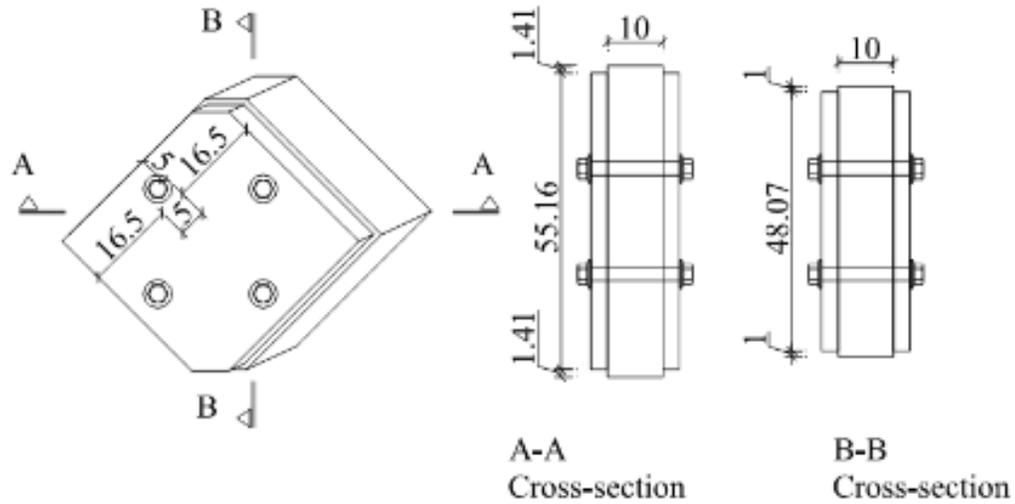
The high-performance fiber-reinforced cementitious composite panels were positioned with 10 mm distance to the edges of the concrete test specimen as shown in Figure 5.3-3. The diameter of the steel bolts used for attachment was 16 mm (5/8 in). This configuration was used in order to simulate a beam-column joint, that is loaded in shear, likely to be found in moment resisting frames.

Figure 5.3-3: Attachment of HPFRCC Panels. Reprinted from ‘Retrofit of concrete panels with prefabricated HPFRCC plates’ by I. Bedirhanoglu, A. Ilki, O. Incecik, N. Kumbasar , 2008.

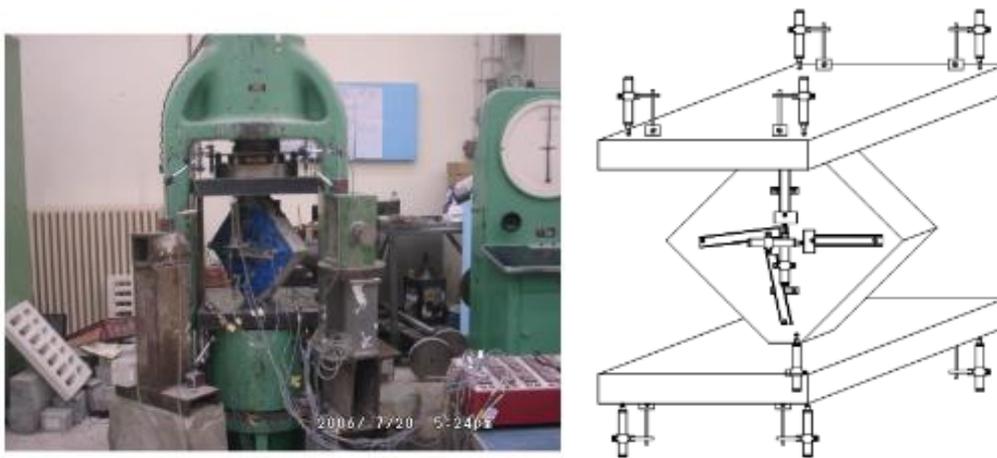
A concentric compressive load was applied to the specimens in the diagonal direction to simulate the shear force in the joint, and the load that caused failure was recorded. The vertical displacements were measured with displacement transducers throughout the test.

Figure 5.3-4: Loading of Specimens. Reprinted from ‘Retrofit of concrete panels with prefabricated HPFRCC plates’ by I. Bedirhanoglu, A. Ilki, O. Incecik, N. Kumbasar , 2008.

After testing, the results showed an increase in shear strength ranging from 45-150% for the retrofitted specimens (Bedirhanoglu, Ilki, Incecik, & Kumbasar, 2008).

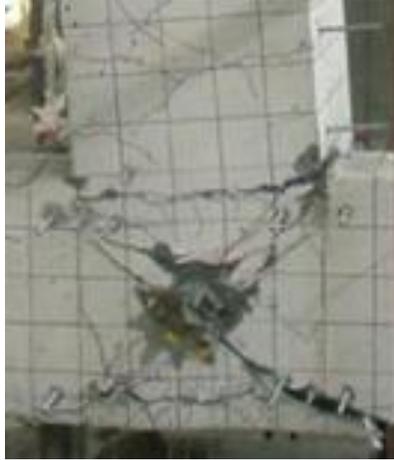
The results of this study have shown that prefabricated HPFRCC panels can be used to strengthen existing systems in order to improve the seismic response of a structure and to prevent brittle shear failure at the joints. In a separate experimental study, it was found that the main deficiency of joints in a lateral force resisting system is the slip of beam longitudinal bars combined with shear damage at the joint after large drift ratios (such as 4%) occur (Bedirhanoglu, Ilki, & Kumbasar, 2012). Figure 5.3-5 illustrates the damage incurred.

Figure 5.3-5: Damage due to Shear Loading. Reprinted from ‘Innovative Techniques for Seismic Retrofit of RC Joints’ by I. Bedirhanoglu, A. Ilki, N. Kumbasar, 2015.

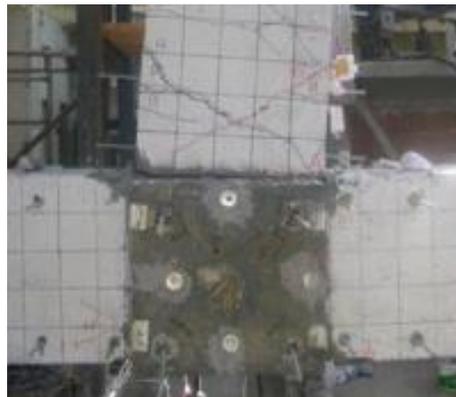
The damaged joints were then retrofitted with high-performance fiber-reinforced cement composite panels. They were bonded over the surface using an epoxy-based adhesive.

Subsequent tests showed that the method prevented strength decay due to shear damage at the joint. The retrofitted joints did not show signs of strength degradation even under significantly higher drift ratios (Bedirhanoglu, Ilki, & Kumbasar, 2012).

Figure 5.3-6: Damage after HPFRCC Panel Retrofit. Reprinted from ‘Innovative Techniques for Seismic Retrofit of RC Joints’ by I. Bedirhanoglu, A. Ilki, N. Kumbasar, 2015.
