INFLUENCE OF RIPARIAN VEGETATION ON THE KANSAS RIVER  
FLOOD OF 1993: AN ASSESSMENT OF STREAMBANK EROSION,  
DEPOSITION, AND CHANNEL MIGRATION

A THESIS

MASTER OF LANDSCAPE ARCHITECTURE

KANSAS STATE UNIVERSITY  
Manhattan, Kansas

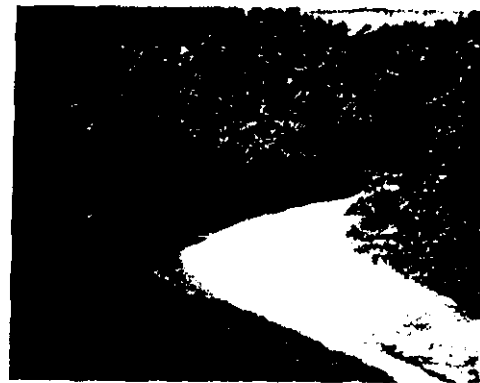
Figure 1.3a: Diagrammatic sketch of forest land classification (from Kansas Water Office riparian survey definition).
