Determining the Health of Prestressed Concrete Railroad Ties

A THESIS

submitted in partial fulfillment of the requirements for the degree

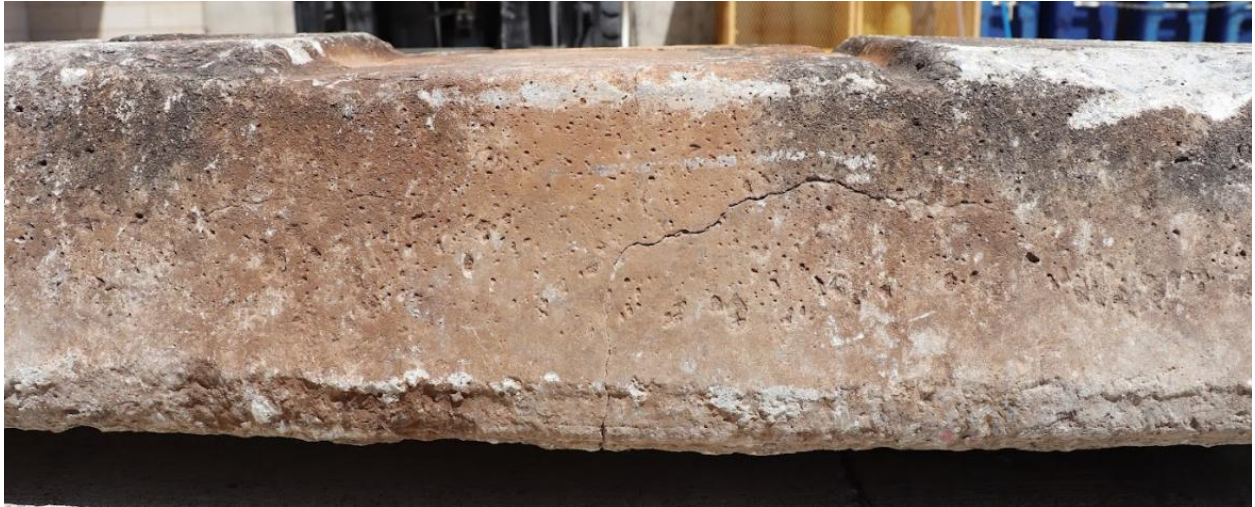
Upon arrival to Kansas State University, each tie was inspected, photographed, and inventoried to assess its initial condition state. Since the Post-2003 and PT ties were new, only minor scratches and chipping from transport were observed. While significantly older, the SV ties were found to have remained resilient, with occasional small concrete sections missing but did not appear to compromise their overall performance. However, the RCCC ties raised some initial concerns. Of the 14 RCCC ties provided, approximately 85.7% exhibited existing cracking under the rail seat, starting at the bottom and extending to the lowest reinforcement layer, creating a T-shaped crack as shown in Figure 1. The cracking was found to range from minor to significant, often affecting either one or both rail seats, with some concrete loss like the SV ties.

**Figure 1: Pre-existing Damage of RCCC Tie**

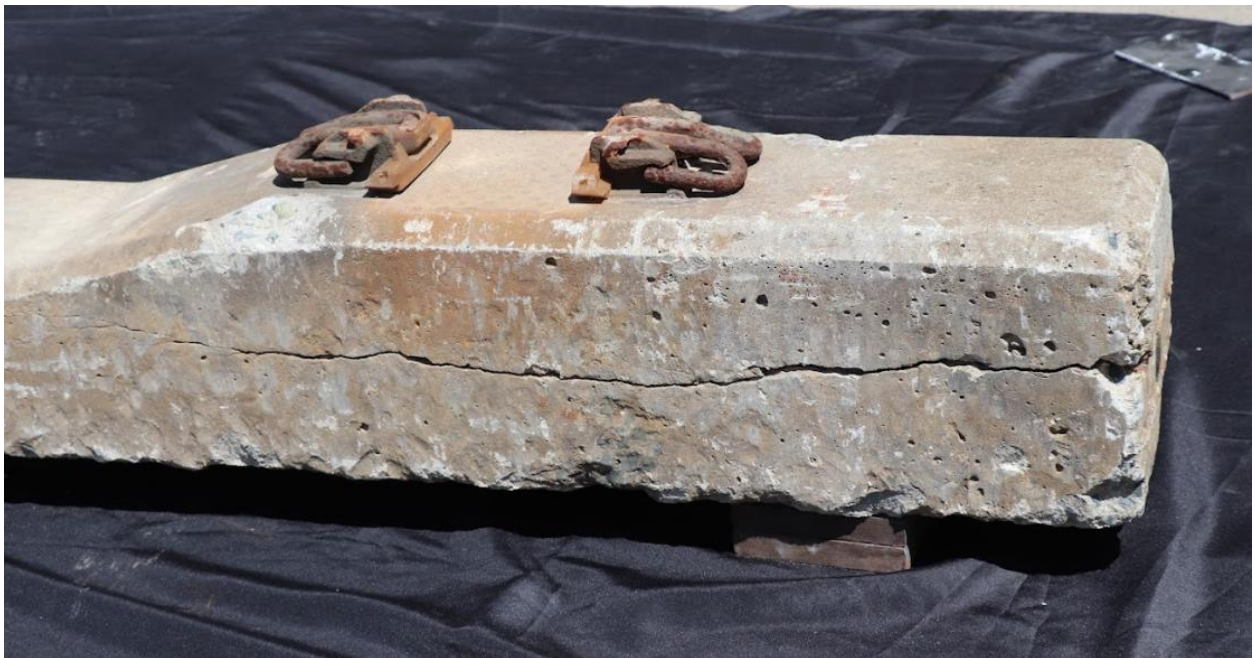
The Pre-2003 ties were found to exhibit the worst deterioration of the five tie designs with approximately 87.5% showing predominant damage consisting of major cracking of a horizontal orientation intersecting with the top row of reinforcing strands as shown in Figure 2.

**Figure 2: Pre-existing Damage of Pre-2003 Tie**

These cracks, which were generally found near the ends of the ties, are often not visible in the railway track due to being covered with ballast, similar to the cracking formed on the RCCC ties. Past research found that this cracking was possibly attributed to a high concentration of tensile stress in the ties at the level of the prestressing steel due to forces associated with the transfer of load from the steel to the concrete during the strand detensioning process. These stresses were greatest at the top row of tendons, which were the bottom row during the casting process. While alkali-silica reaction (ASR) was viewed to be an additional cause of deterioration in previous research, no signs of ASR damage was observed on the investigated concrete ties. While past research found likely deterioration causes, it was also determined that the distress was not caused by freezing and thawing cycles, delayed ettringite formation (DEF), or other stresses from mechanical effects, such as from fastener inserts or unusual tie vibrations [16].

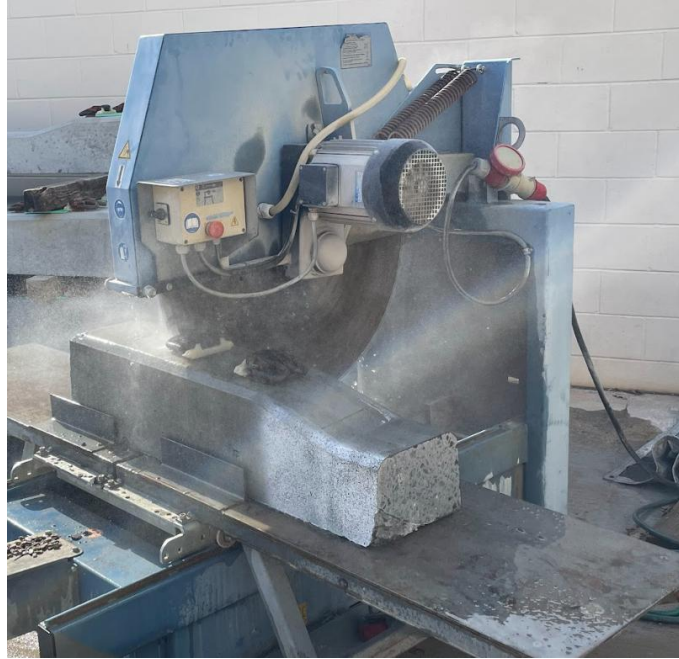
Understanding the performance and durability of concrete ties begins with a comprehensive systematic dissection. While external observational methods described previously did not evaluate internal stresses, material inconsistencies, and subtle degradation; cutting open a concrete tie revealed many of these hidden factors. Using a 36” diameter diamond tip concrete saw as shown in Figure 3, each tie was carefully cut allowing for detailed measurements of the reinforcement and possible stirrups locations while revealing any inconsistencies in the concrete mixture itself.

**Figure 3: Dissecting Ties With the Diamond Tip Saw**

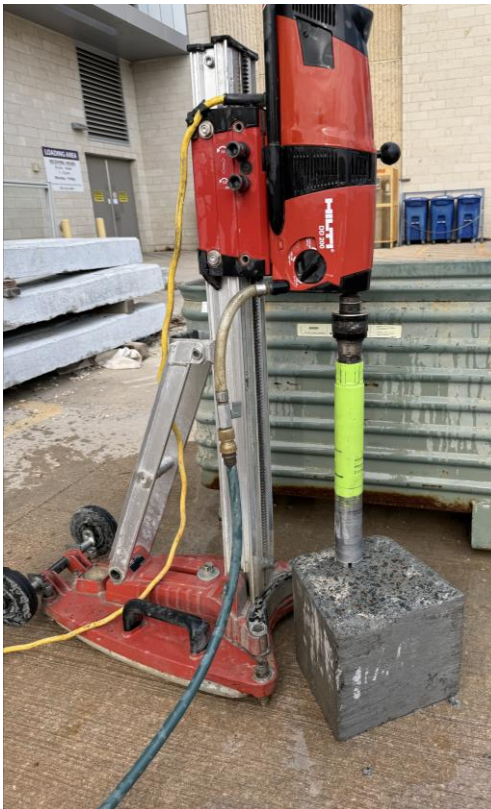
Following the systematic dissection of each concrete tie, a compact diamond coring rig (as shown in Figure 9) was utilized to extract a minimum of three cores per tie. Each core was drilled parallel to the prestressing tendons, ensuring that both damaged regions and tendon interference were avoided.

**Figure 9: Concrete Coring Rig**

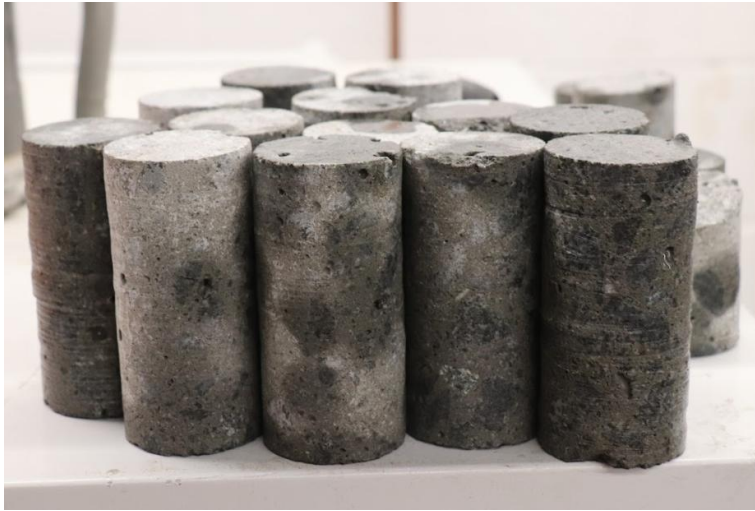
According to ASTM C42/C42M-20 [24], in order to test cores for compressive strength, the cores shall have a minimum diameter of 3.7 inches or at least two times the nominal maximum size of the aggregate. Due to the reinforcement pattern of the ties, core diameters were limited to a diameter of 2 inches. After extraction, the cores were precision-cut to 2 inches by 4 inches specimens as shown in Figure 11. To ensure uniform load distribution during compressive testing (shown in Figure 10), the specimens were capped with sulfur mortar, creating flat surfaces perpendicular to the specimen axis.

**Figure 10: Cored Samples**

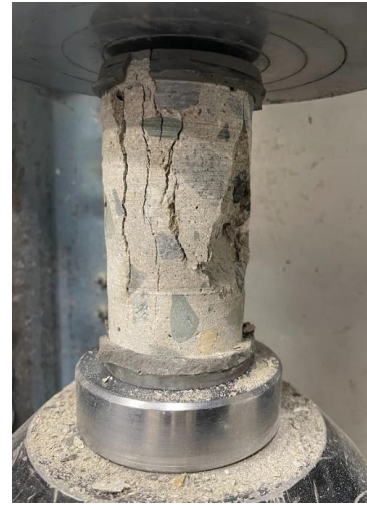
**Figure 11: Broken Specimen**

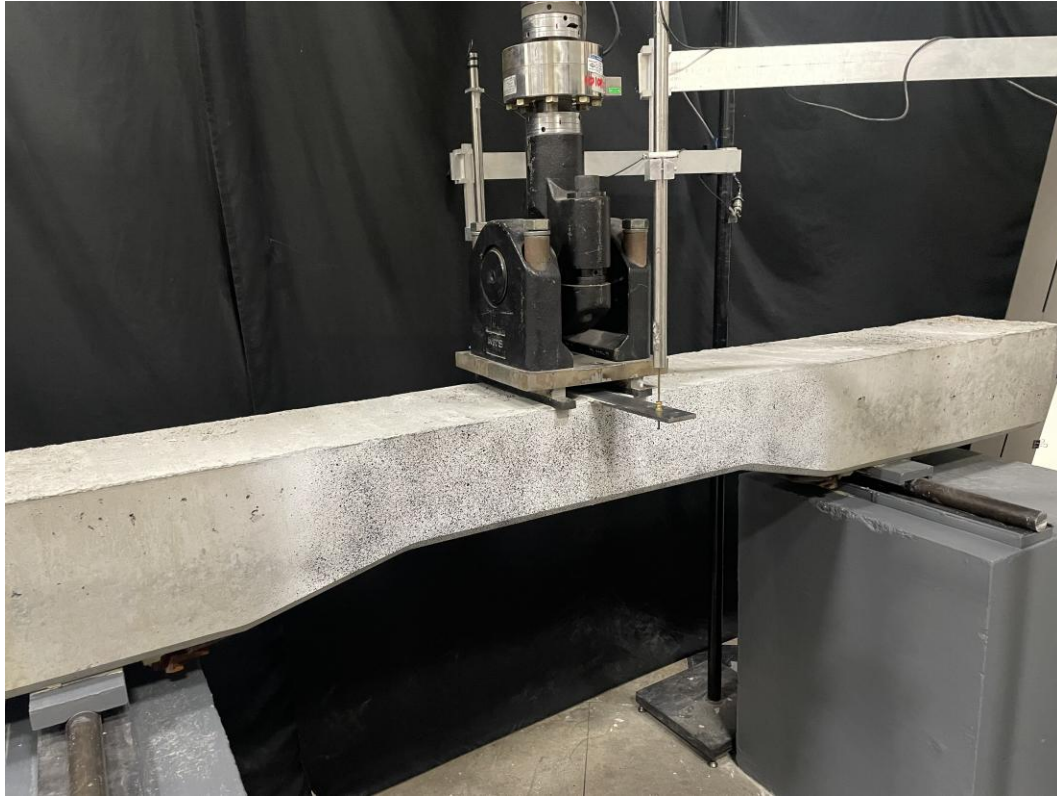
To assist in the analyzation of the older railroad ties, a modification to the AREMA loading protocol was performed. By deviating from the specified center negative design moment by applying load until failure, a comprehensive assessment of each concrete tie's ultimate strength, ultimate deflection, and failure mode was achieved. Midspan deflection was measured using two linear variable differential transformers (LVDT), having a stroke of 10 inches, that were positioned on opposite sides of a flat bar spanning across the uppermost surface at the center of the tie shown in Figure 15.

**Figure 13: Tie in Center Negative Orientation**

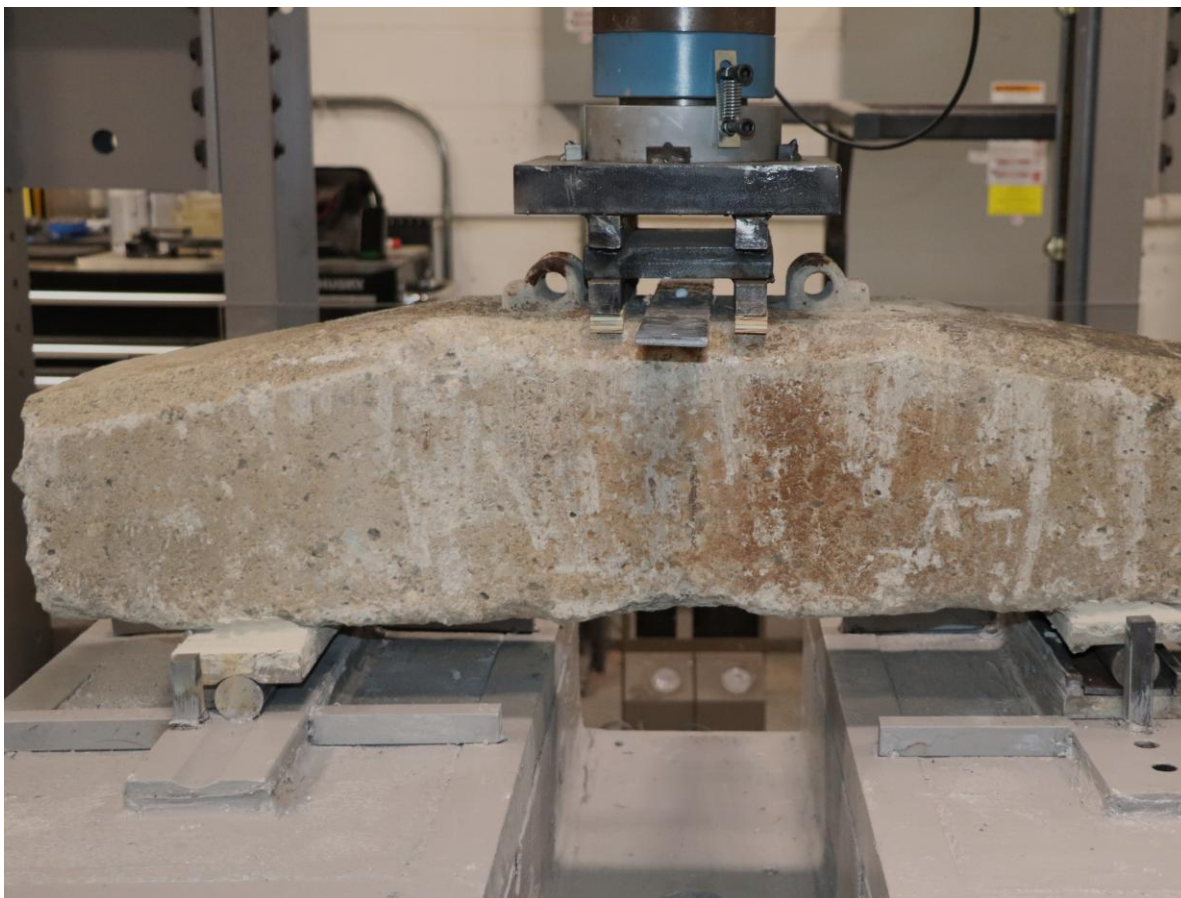
Similar to the center negative bending test, the deflection at the midpoint of the loading was measured through the use of two LVDTs located on a flat bar spanning the rail seat. Due to the shortened span, LVDTs with a stroke of 0.5 inches were utilized to accurately collect the displacement. Due to compressive failure cracking the concrete under the flat bar prior to the ultimate failure of the tie, the flat bar was attached to the tie with silicone to avoid improper readings. This allowed the LVDTs to accurately record data until the ultimate failure of the tie.

**Figure 15: Tie in Rail Seat Positive Orientation**

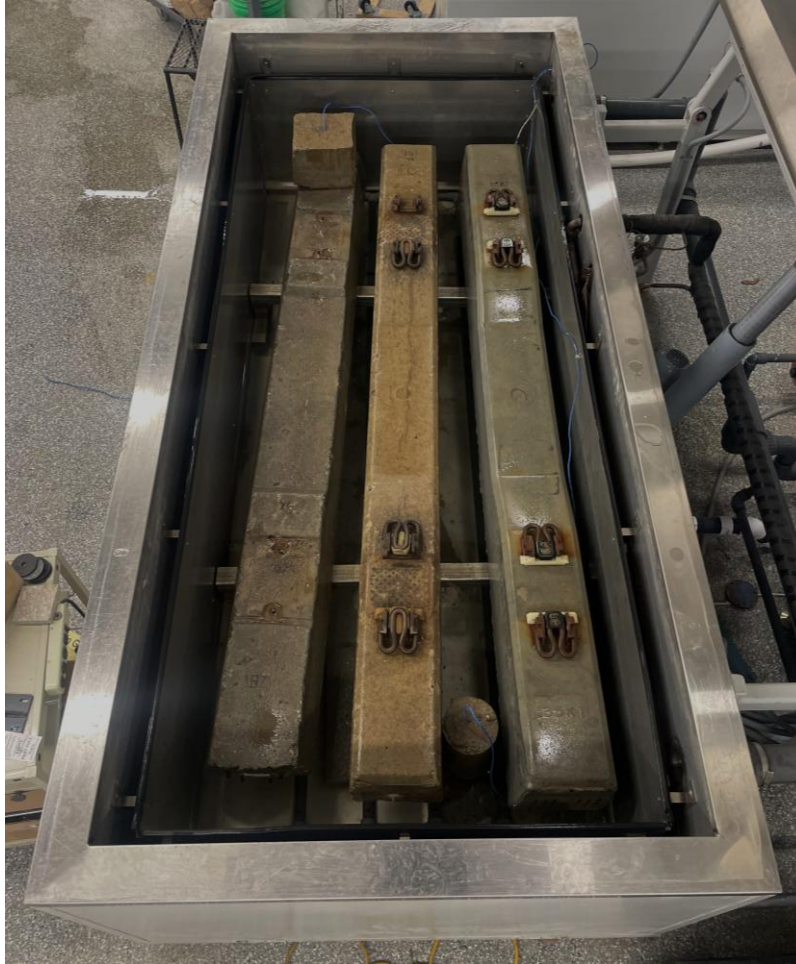
Each concrete tie was initially loaded in the rail seat positive configuration, including midspan LVDTs, until a visible crack reached the bottommost layer of reinforcement. The tie was then flipped, and the process was repeated on the opposite rail seat. Following cracking, the tie was placed in a Scientemp freeze-thaw machine capable of simulating three freeze-thaw cycles per day while accommodating up to three ties simultaneously as shown in Figure 18.

**Figure 16: Railroad Ties in Freeze-Thaw Machine**

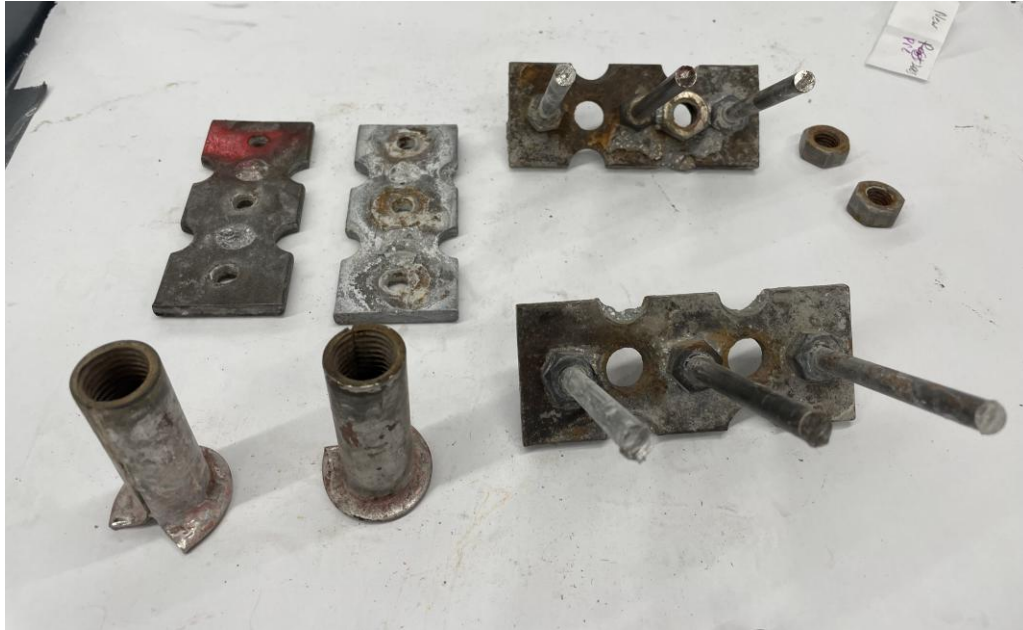
To simulate real-world field conditions, scavenged tendons and other metallic components of the prestressing system were subjected to repeated submersion, followed by periods of exposure of air to allow for oxidation.

**Figure 17: Post-Tension Components**

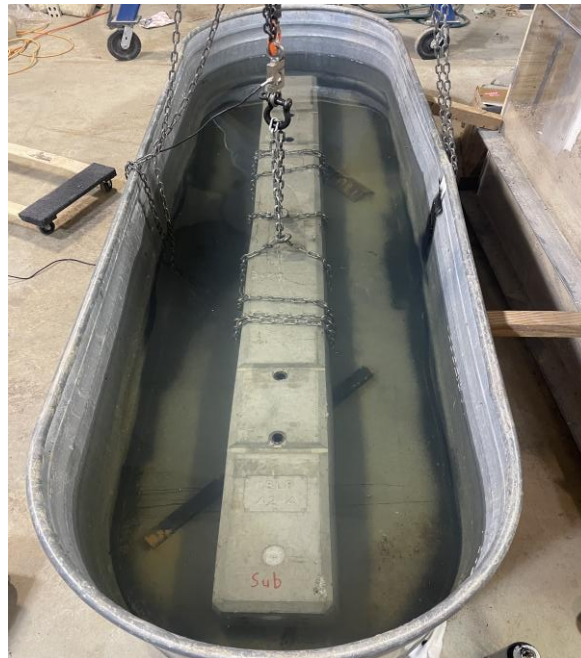
Prior to submersion, the concrete tie was cracked at both rail seats and the center negative region, with each crack extending to the first layer of reinforcement. These cracks were introduced to facilitate water ingress. Although present, each crack reduced in size to the extent that they were not visible to the naked eye. The tie was then fully submerged in water with its weight-in-water being recorded daily throughout the week-long test using a 500 kg. load cell as shown in Figure 20.

**Figure 18: Post-Tensioned Tie Submerged in Water**

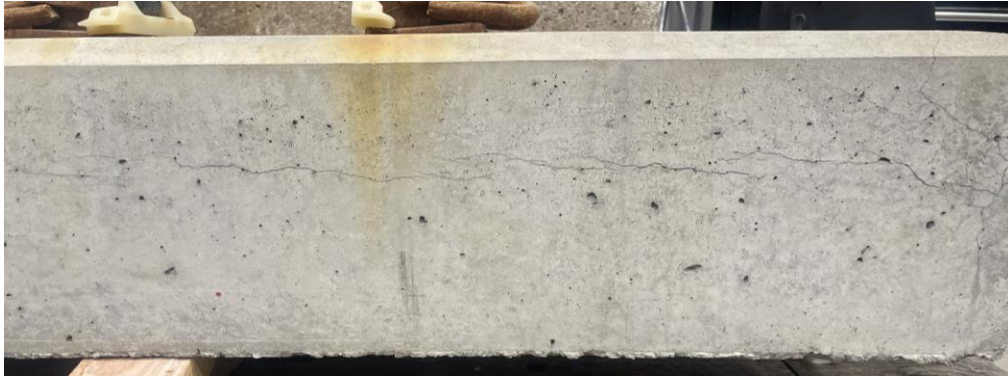
After 60 freeze-thaw cycles, the SV concrete tie showed slight corrosion and minimal strand end slippage, which is where the concrete typically loses bond with the prestressing tendon causing the tendon to slip and move relative to the concrete. It was noted at 120 cycles that a crack start forming at the upper strand of reinforcement traveling along the top face of the tie towards the rail seat. Due to the pre-existing damage of the Pre-2003 concrete ties, observational differences were limited. It was found that at 30 cycles, corrosion began, followed by end slip before a crack at midspan on the top face of the tie formed around at approximately 90 cycles. Pre-existing cracking continued to expand as the freeze-thaw cycles continued.

**Figure 21: Post-2003 Cracking at 90 Freeze-Thaw Cycles**

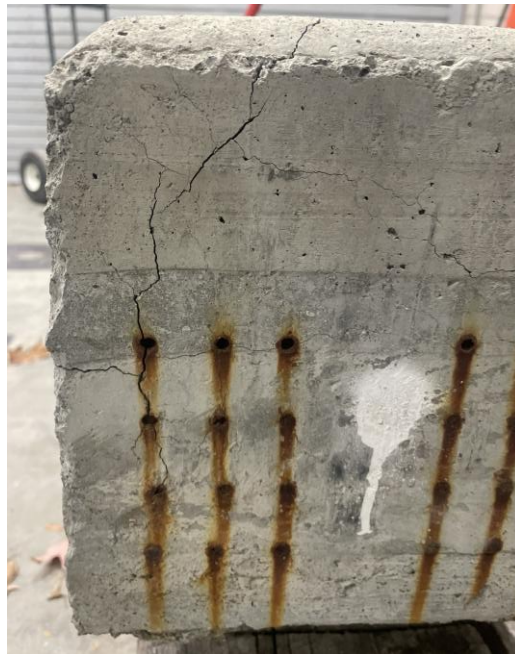
While the Post-2003 concrete ties were new upon arrival at Kansas State University, they were found to have most severe deterioration of the pre-tensioned ties. Similar to the other concrete ties, corrosion and end slip occurred first. At 30 cycles, the Post-2003 tie exhibited more visible corrosion when compared to the other concrete ties. However, this was primarily attributed to its higher quantity of reinforcing steel. By 90 cycles, most of the tendons had slipped into the concrete and major cracking had appeared starting at the tendons and traveling along the side of the tie reaching under the rail seat as shown in Figures 23 and 24.

**Figure 22: Post-2003 End Slip**

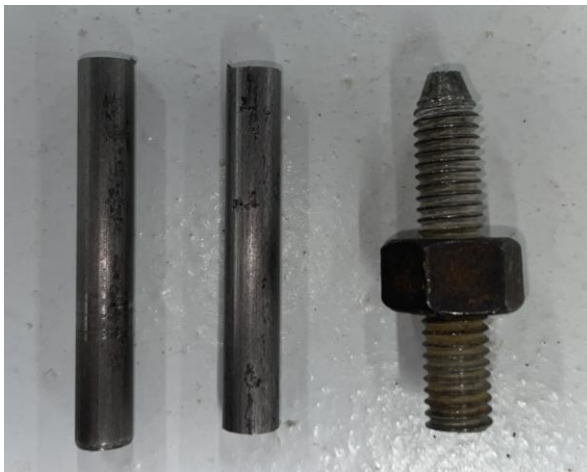
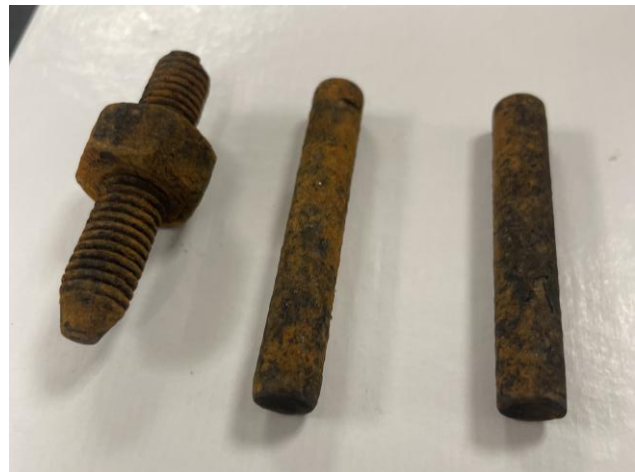
For pre-tensioned tendons, visual inspections revealed surface oxidation and potential structural compromise almost immediately as shown in Figures 27 and 28. The larger pre-tensioned tendons were found to have significantly more oxidation than the smaller pieces of the post-tensioned tendons. Therefore, the it is speculated that if water were to enter the ties, the corrosion of unbonded tendons that could occur would eventually lead to the deterioration of the concrete ties.

**Figure 26: Corrosion at 0 Cycles**

**Figure 25: Corrosion at 25 Cycles**

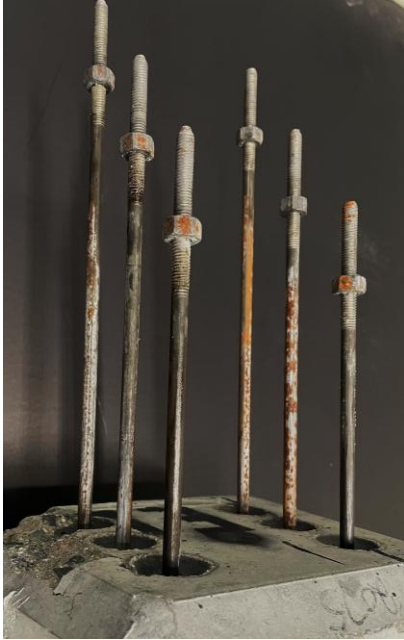
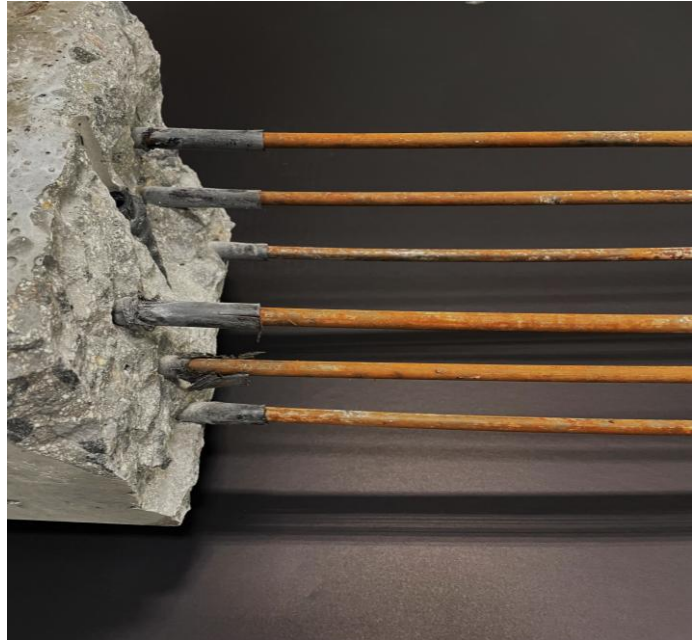
Following the conclusion of tests on the post-tensioned concrete tie, extensive visible damage at the midspan led to a dry dissection of the affected area to inspect the health of the post-tension tendons. Removal of the protective sleeves revealed a noticeable layer of corrosion on every tendon as shown in Figures 32 and 33, despite the tie being less than a year old.

**Figure 30: Live Threaded Ends**

**Figure 31: Corrosion at Midspan**
