SPATIAL PATTERNS AND IMPACTS OF SLOPE FAILURES IN FIVE CANYONS OF THE
TETON MOUNTAINS, GRAND TETON NATIONAL PARK, WYOMING

A THESIS

MASTER OF ARTS

KANSAS STATE UNIVERSITY
Manhattan, Kansas

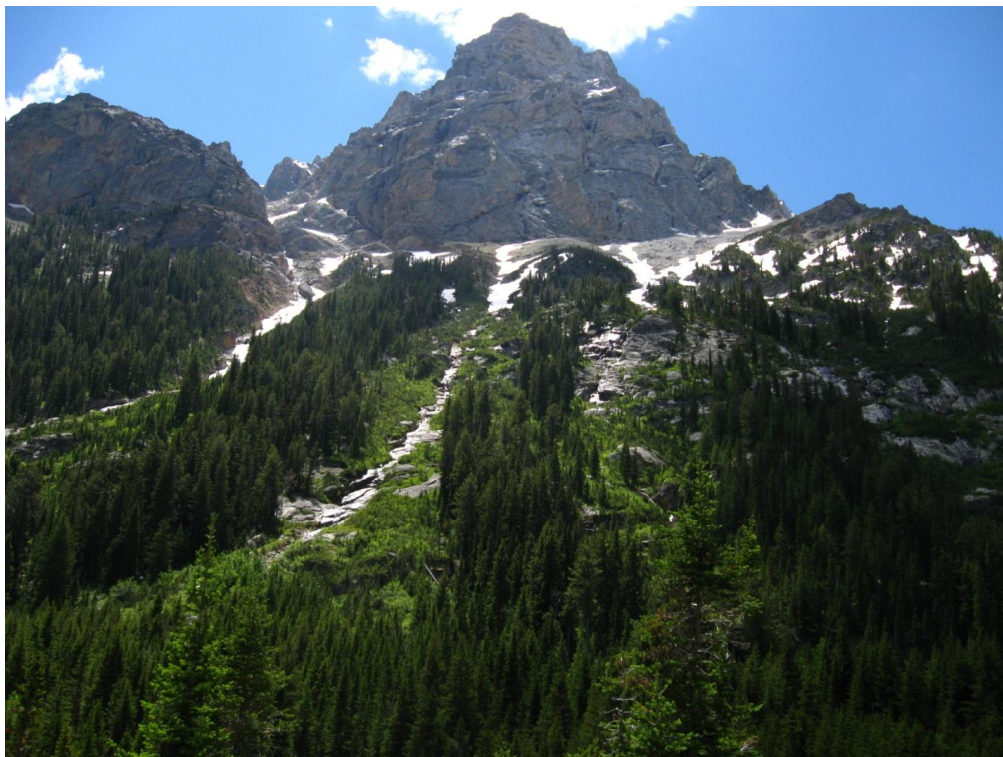
Figure 2.1: Examples of snow avalanche paths in Cascade Canyon, Grand Teton National Park, Wyoming. Note the stark contrast of low-growth, light-colored vegetation of the avalanche paths in comparison with the high-growth conifer forests next to the paths.

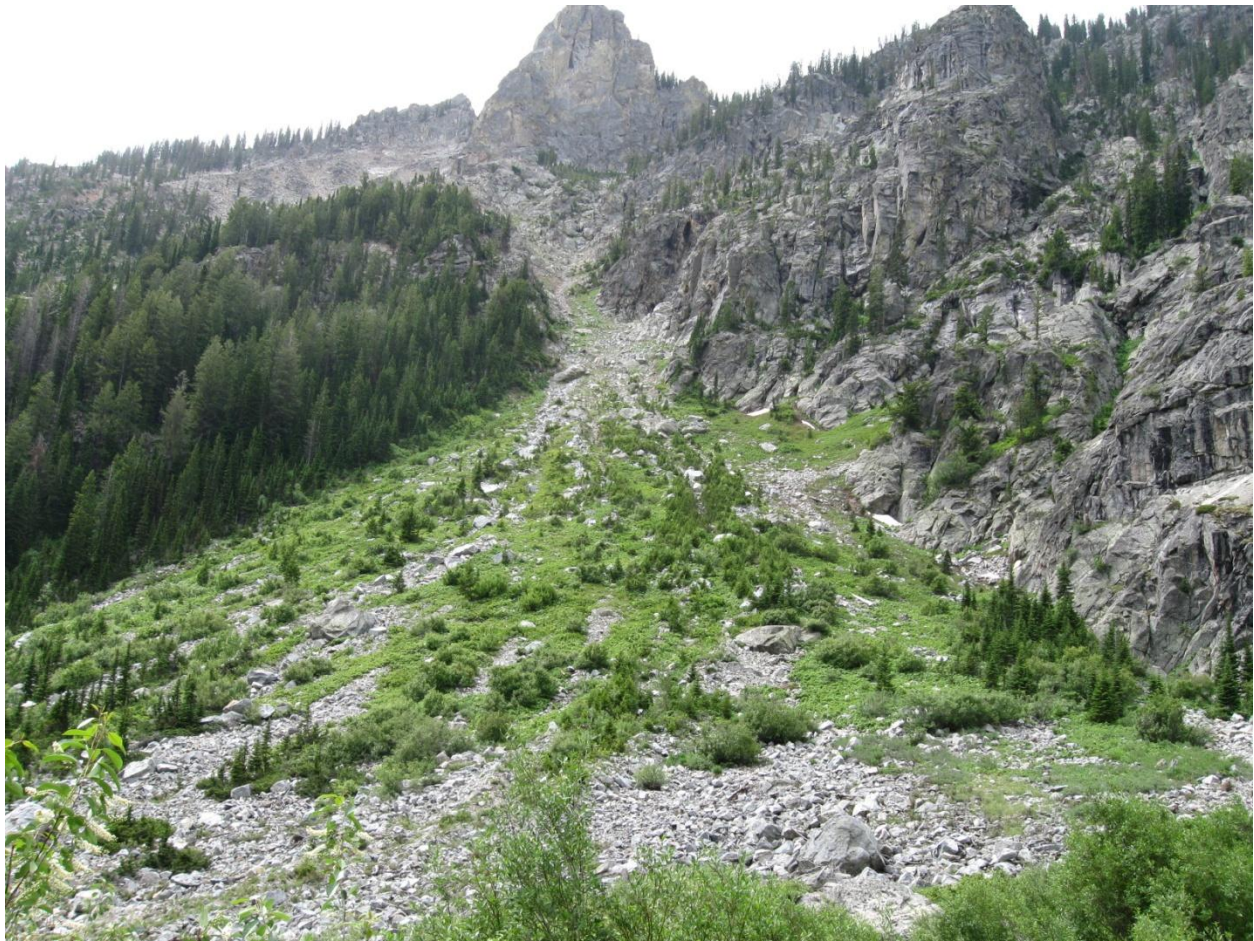
Figure 2.4: Example of a debris flow deposit in Granite Canyon, Grand Teton National Park, Wyoming. Note the lobate shape of the deposit and coarse soils that spread out from the source point upslope.

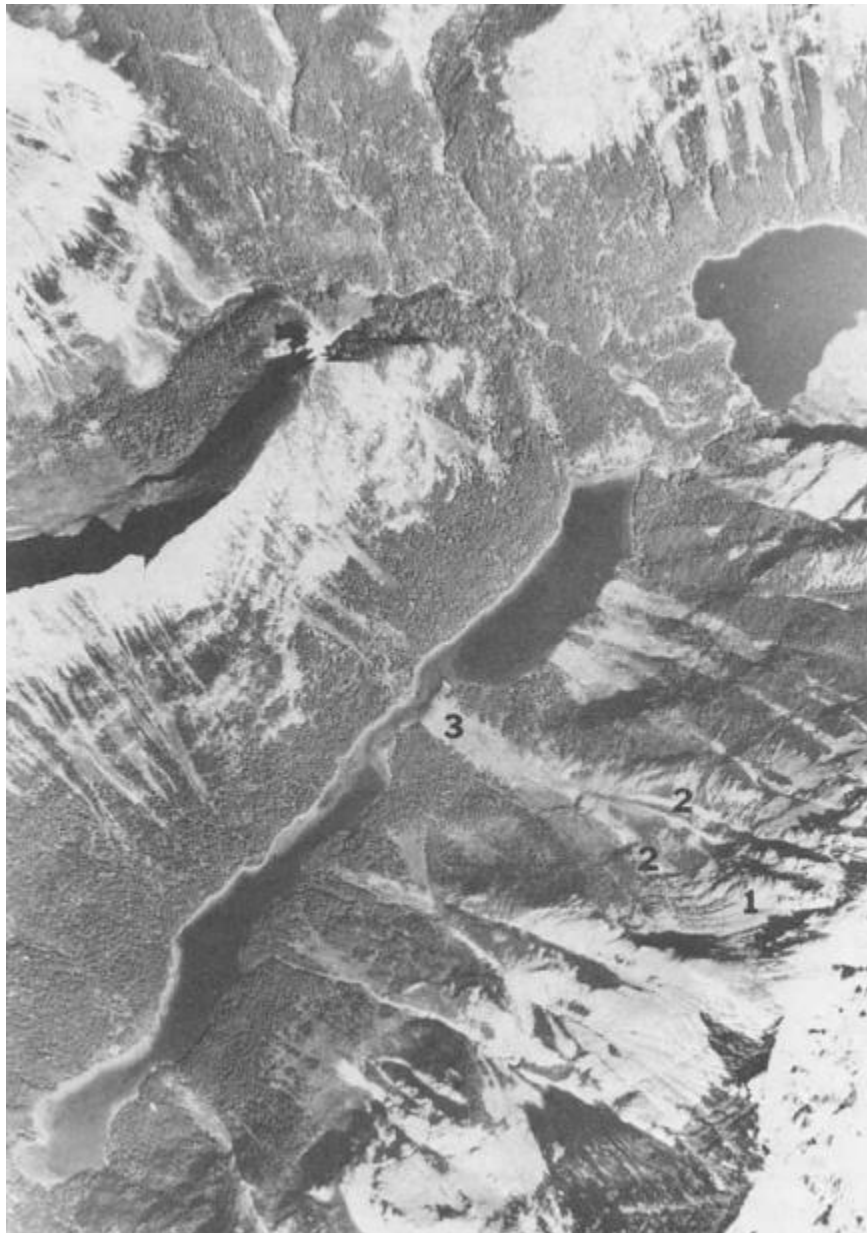
Figure 2.6: Example of a snow avalanche path on aerial imagery from Glacier National Park, Montana. “1” is the starting zone, “2” is the track, and “3” is the run out zone. Source: Butler and Walsh, 1990.

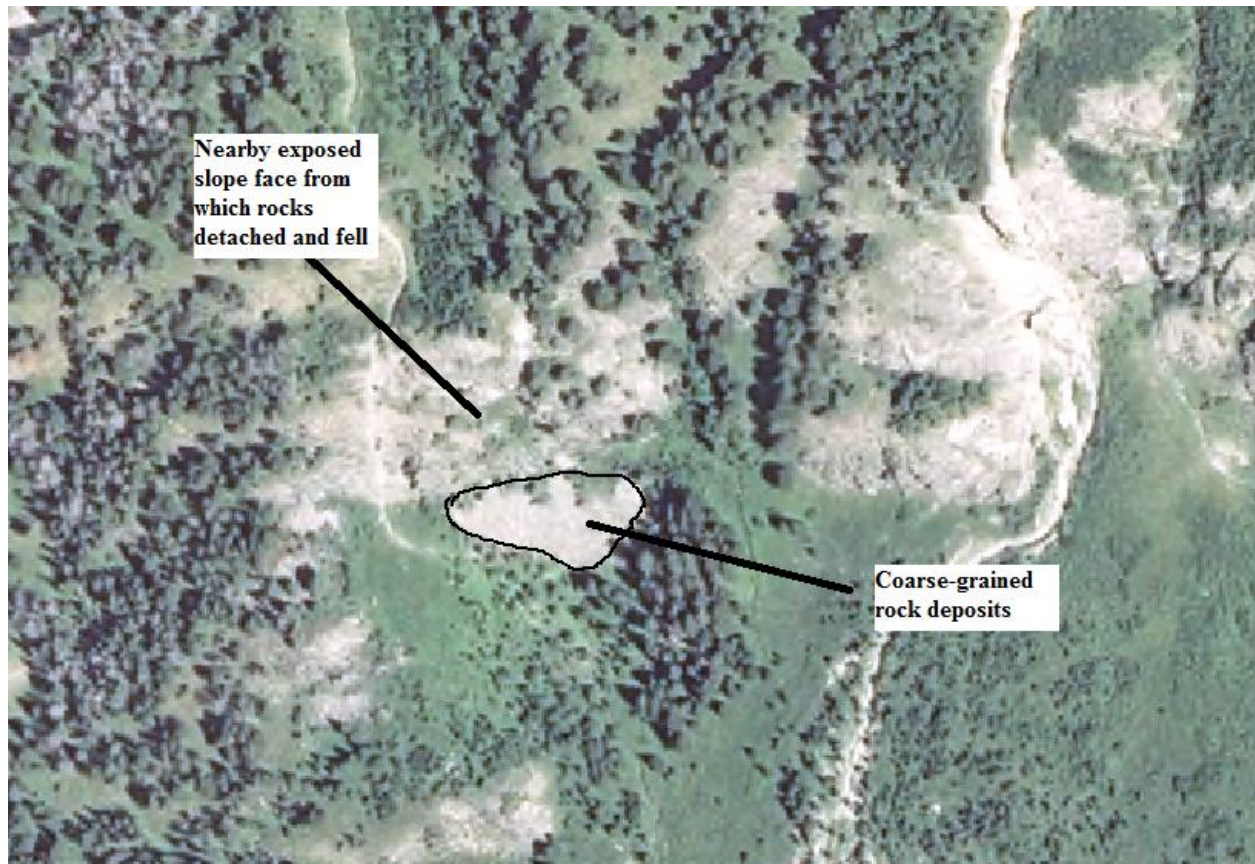
Figure 4.7: Diagram of a rock fall deposit in Granite Canyon on NAIP satellite imagery. Note that this image has been outlined to show the extent of the rock fall deposit. Two primary elements were used in determining rock fall deposits: A steep, exposed rock face from which rocks could detach and fall to the ground and a clear spatial extent of coarse-grained rock deposits in contrast to local vegetation.
