ACOUSTIC EMISSION MONITORING
ON FIBER REINFORCED BRIDGE PANELS

A REPORT

MASTER OF SCIENCE

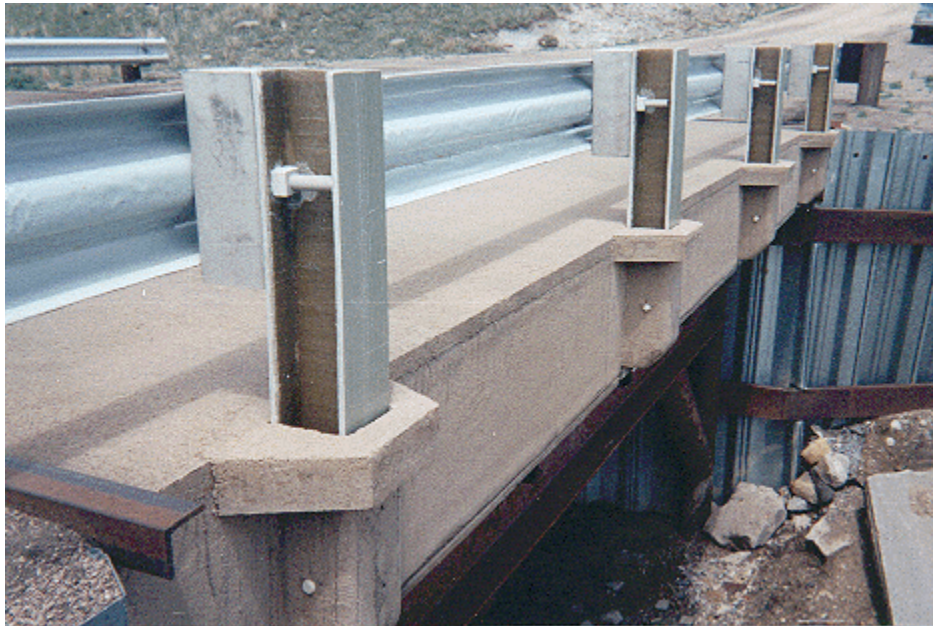
Figure 1-1 No-Name Creek FRP Bridge (Original Source: KSCI.com)

The first FRP Bridge in the United States, and first in the western hemisphere to allow free flows of two-lane traffic, was built by Kansas Structural Composites Inc. (KSCI) in 1996 to cross No-Name Creek near Russell, Kansas. While not technically the first bridge of its kind, the advancements in design and the material's relatively new type of construction won it overwhelming praise from a variety of sources. Organizations ranging from the scientific community to the media broadcasters quickly praised it as one of the biggest advancements of its kind in several years. The accolades included the awarding of both 'Best of Market' and the prestigious 'Counterpoise Grand Design Award' from the International Composite Expo held in January of 1997, as well as being recognized at The R&D 100 Awards for being one of the most

important developments made that year. The bridge can be seen in the following figure. [KSCI, 2007]

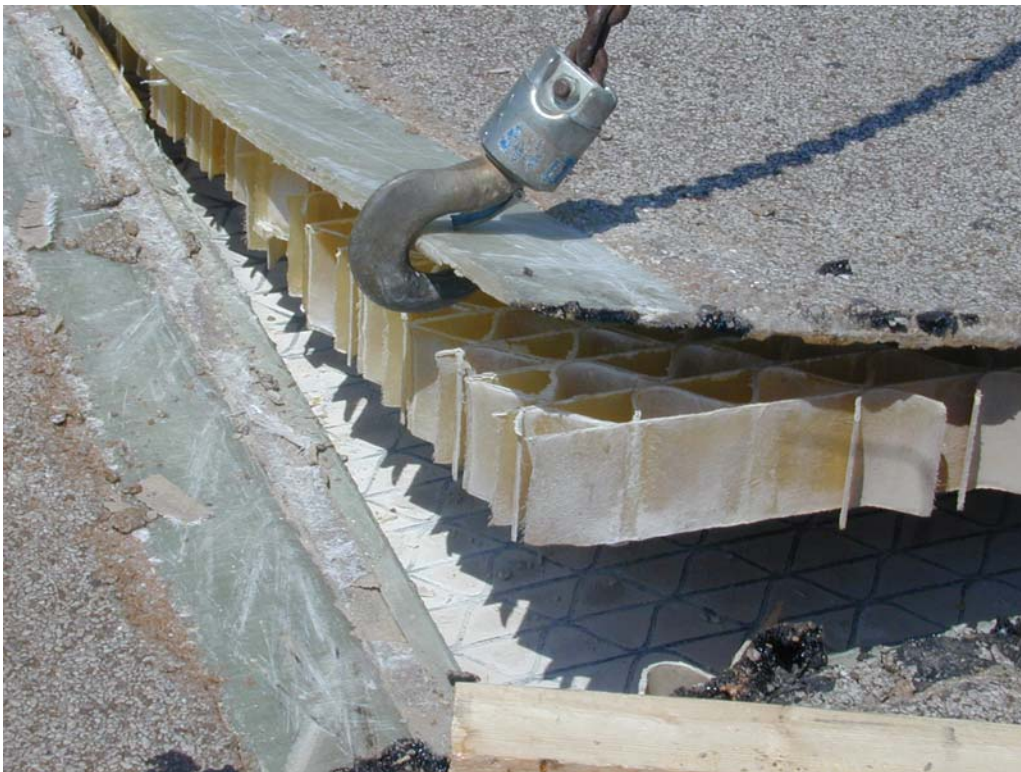
Figure 1-2 Material delamination in bridge panel (Original Source: D. Meggers)

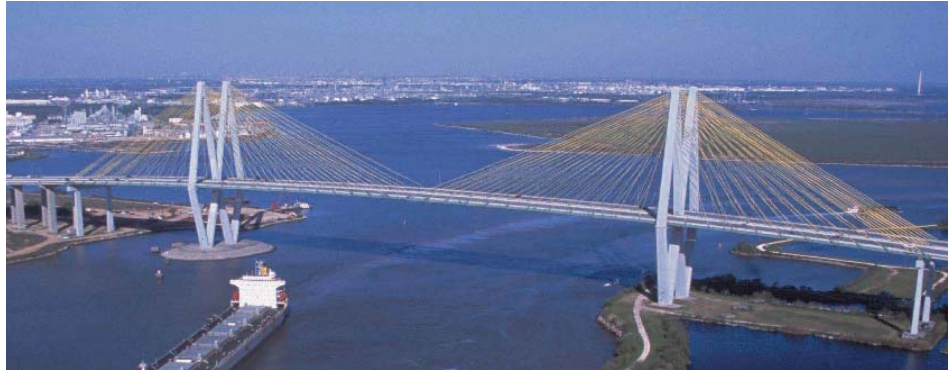
Figure 2-2 Fred Hartman Bridge (Source: Bayareahouston.com)

The Texas DOT applies AE sensors to many of its bridges, including the Fred Hartman Bridge shown on the next page in Figure 2-2. The bridge was officially opened in 1995, and is responsible for carrying State Highway 146 over the Houston Ship Channel. However, it was soon discovered that large oscillations occur on the stay-cables and through visual inspection the cables were creating cracks in the welds between the fixture holding the cables and the rest of the superstructure. In order to monitor the situation it was decided that a fatigue examination of an AE device with four sensors, supplemented by strain gauge monitoring, would be conducted at the Ferguson Lab at the University of Texas on a similar cable specimen. [Kowalik]

During the study it was determined that there were several breaks at the anchor and near the loading end. In all cases the breaks were found within the section of cable expected or in a section next to it. Since 2002 the Fred Hartman Bridge has had three acoustic sensors on each of the 192 cables monitoring at a near constant rate. The data is also filtered in the main Data Acquisition System in order to expel background noises and sends the information to a central processing unit where it can be categorized and uploaded to an online resource to be downloaded when needed. [Kowalik]

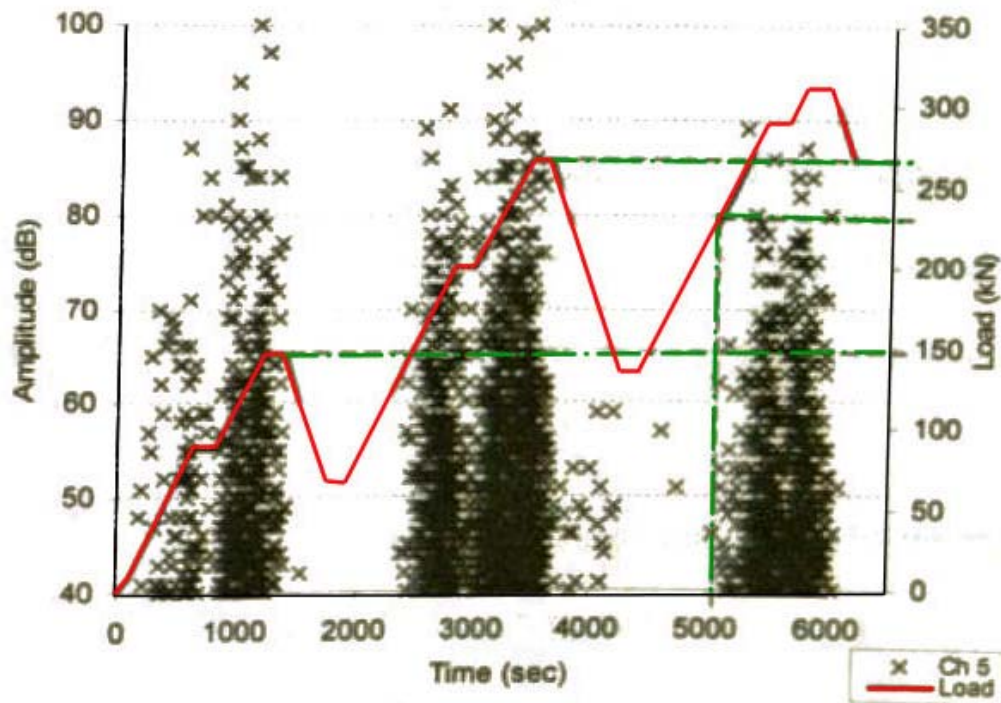
Figure 3-1 Load application in Keiser Effect analysis. (Original Source: Gostautus)

From examining the Keiser Effect it was demonstrated that the emissions recorded occurred when the loads were being increased and occurred more often after the previous maximum loading peak was approached. This outcome would be expected, as an increase in the load would infer an increase in the stress of the panel, as well as the fibers and matrix within it. In order for the material to remain unbroken, they would have to be able to support a stress equal to that experienced in earlier peaks, and would therefore not fracture until a higher load was applied [Gostautus, 2005].

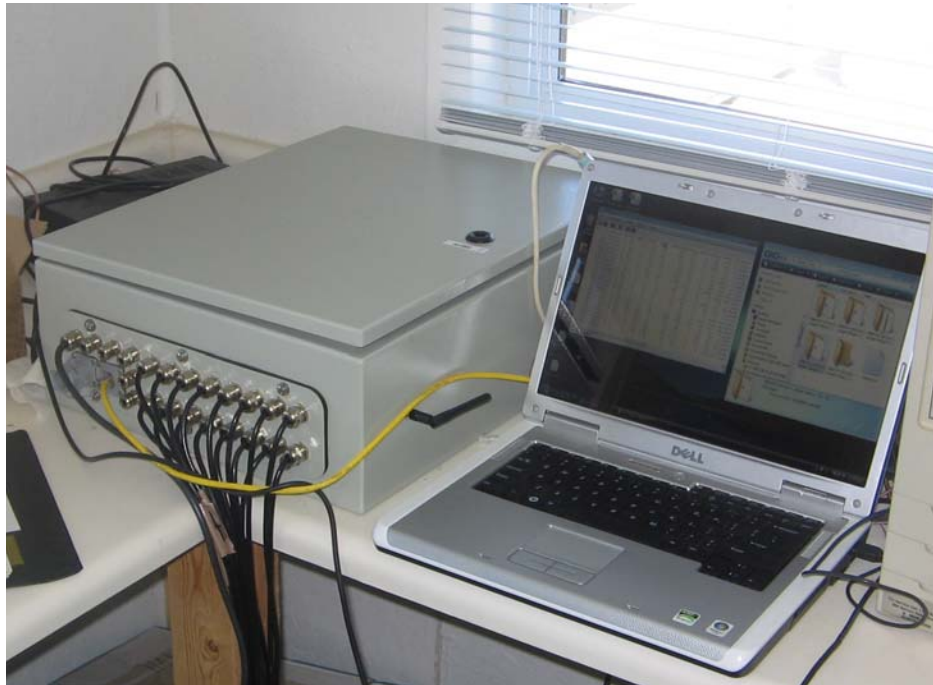
The SH-II DC system is a data acquisition module comprised of many individual components. The overall DC is located within its own enclosure, protecting it from the environment and allowing all the parts to be in a controlled, safe space regardless of local weather conditions. The complete enclosed system and the Dell Laptop PC used to communicate with the system in this project can be seen below in Figure 3-3.

Figure 3-3 System Enclosure and Laptop PC at testing site.

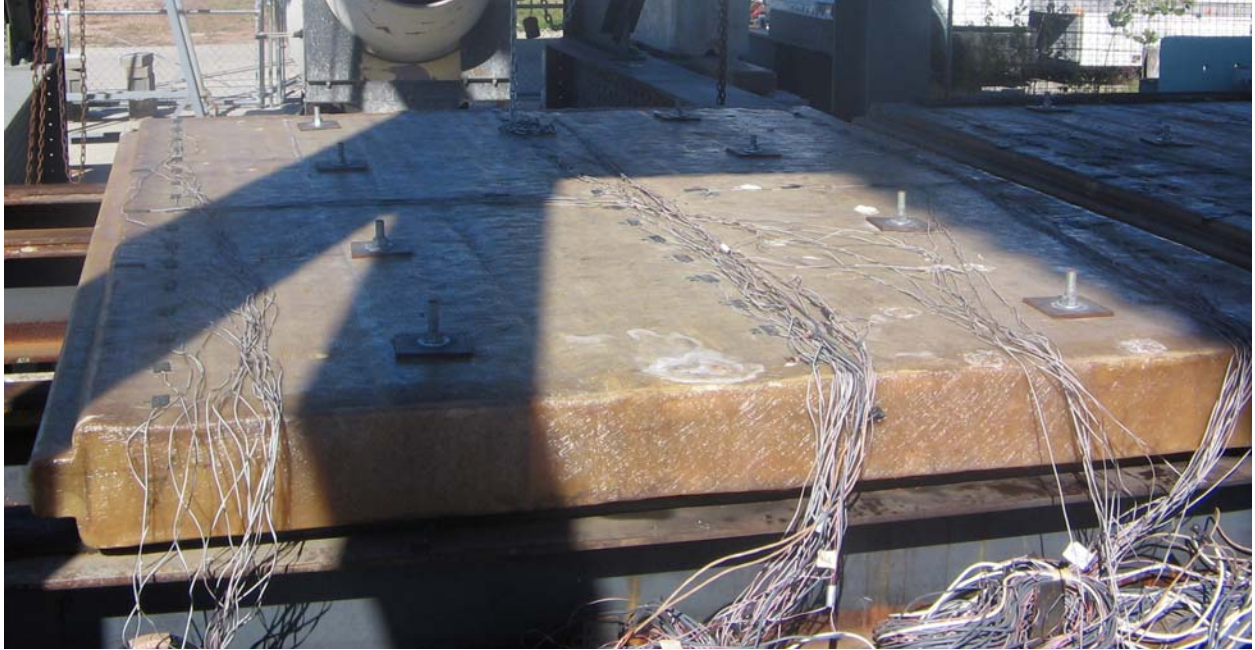
Three FRP bridge decks were built by Kansas Structural Composites, Inc., designated Panel-A, Panel-B and Panel-C. Each is comprised of a mostly hollow 74" long by 102" wide by 6" high structure made of glass fiber-epoxy material designed by the Kansas State team after stage one activities were completed. This design consists of three layers of plates laid up to create a sinusoidal wave and stacked upon one another with a flat layer of fiber between them. The structure was then wrapped in chopped-strand mat and the epoxy resin is allowed to harden, the resulting plates have a ridged cross section but are capable of tolerating applied bending forces. Throughout the tests discussed Panel-A was monitored at all times to some degree, while Panel-B was monitored only during instances where interaction between two panels was necessary. Panel-C was not used in this research at all and was held in reserve in case massive failure occurred in Panel-A or Panel-B. Panel-A can be seen in Figure 3-4.

Figure 3-4 Panel-A on testing platform.

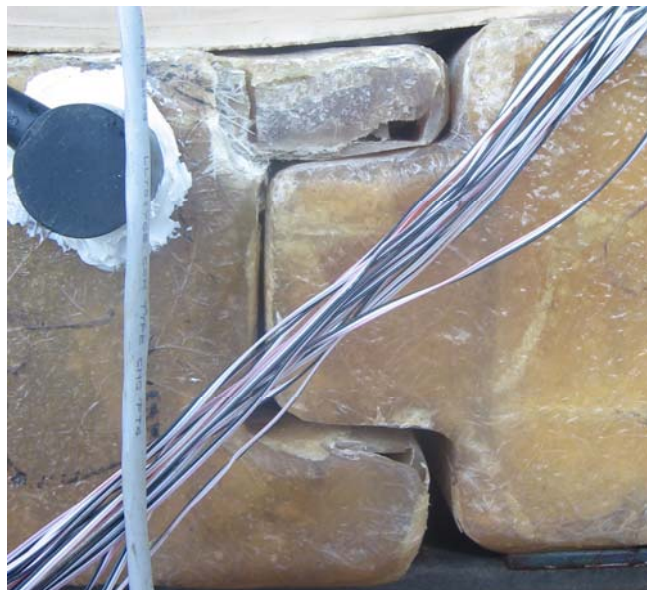
The overall structure of the panels was designed to allow bending forces to exist without damaging it to failure under regular loading cycles. To help create added strength to the bridge structure, when used in series the decks will be interlaced with one another by use of tongue-and-groove connections on either end of the structure as shown in Figure 3-5 below.

Figure 3-5 Close-up of Lip-and-groove connection between two panels

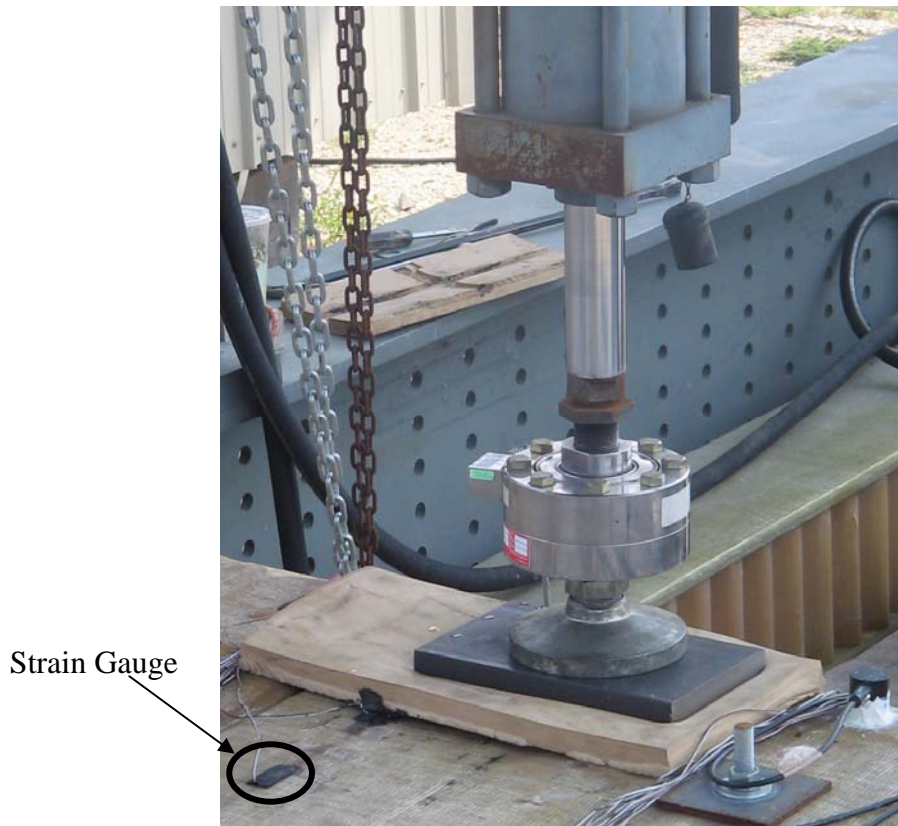
The bending force is generated by a hydraulic cylinder statically suspended over the structure, capable of applying forces anywhere on top of the panels. These forces can be in excess of 35 kips and applied in a way that allows for distribution to be over an area approximately the size of an automobile tire. This distribution is achieved by use of a specially designed “boot” on the end of the piston consisting of a steel plate and rubber-foam matting. This setup is similar to the one used in earlier analyses, except the forces exerted in this analysis are less than half of those used in the first stage. This is in part due to the analysis not requiring failure to occur, but just to examine how the data and sensors can be used to determine a source location. In addition, the first stage used a method that created uniform bending, where this stage uses a more specific loading location, allowing for the acoustic data source to be approximated easily; the most likely source will come from the point at which the plate is being exerted onto the panel, giving more accurate results if the plate is smaller. The items used to produce the direct force can be seen in Figure 3-7 on the next page.

Figure 3-7 Pneumatic cylinder and distribution boot.

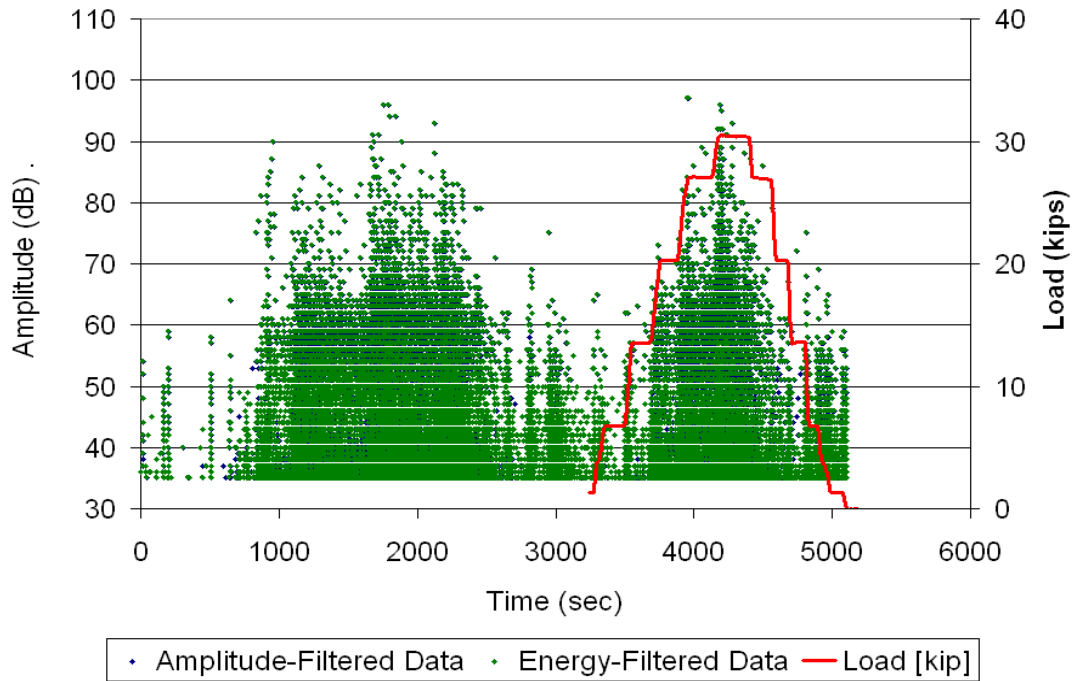
In Figure 3-12 on the next page a comparison of the amplitude charts before and after the energy threshold is applied can be seen, and indicated that it has minor impacts on its appearance at this time.

Figure 3-12 Amplitude comparison of 35 dB Amplitude and 60 Energy Count Filter

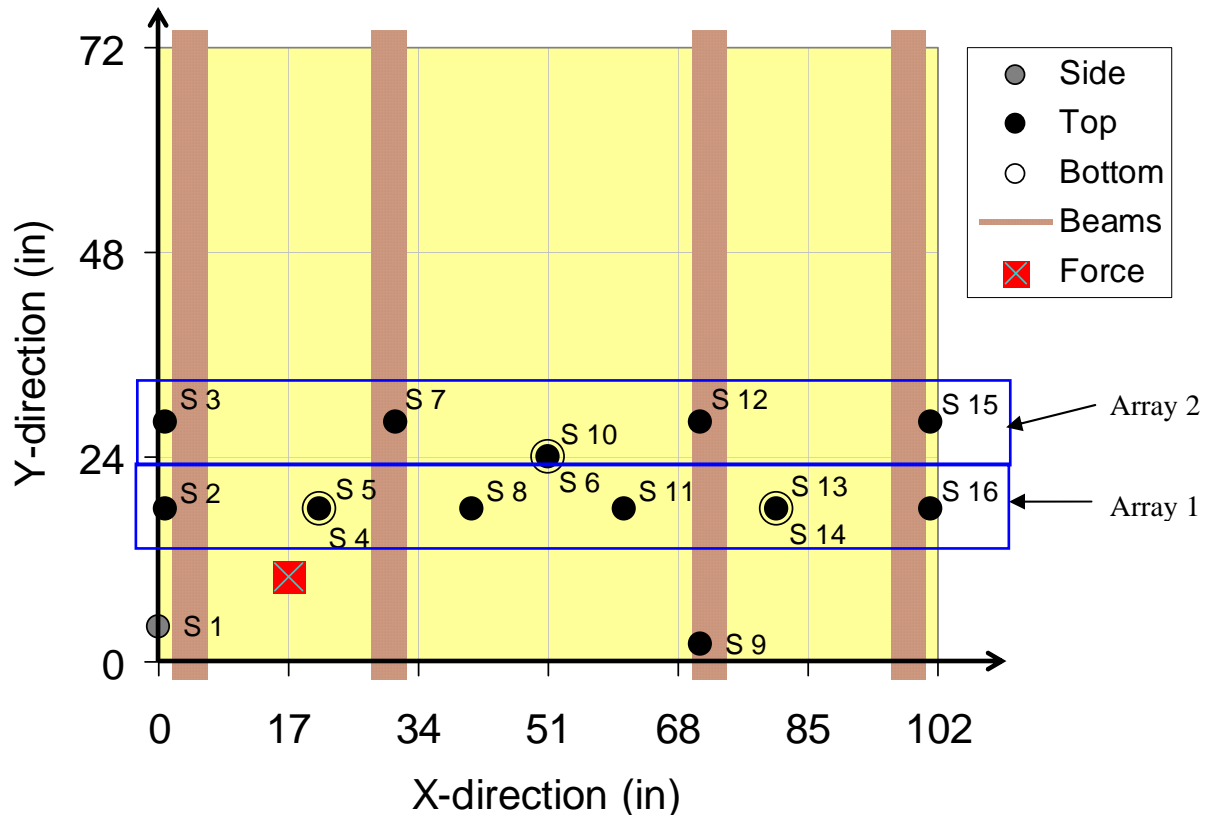
Figure 3-18 Signal Dispersion sensor arrangement.

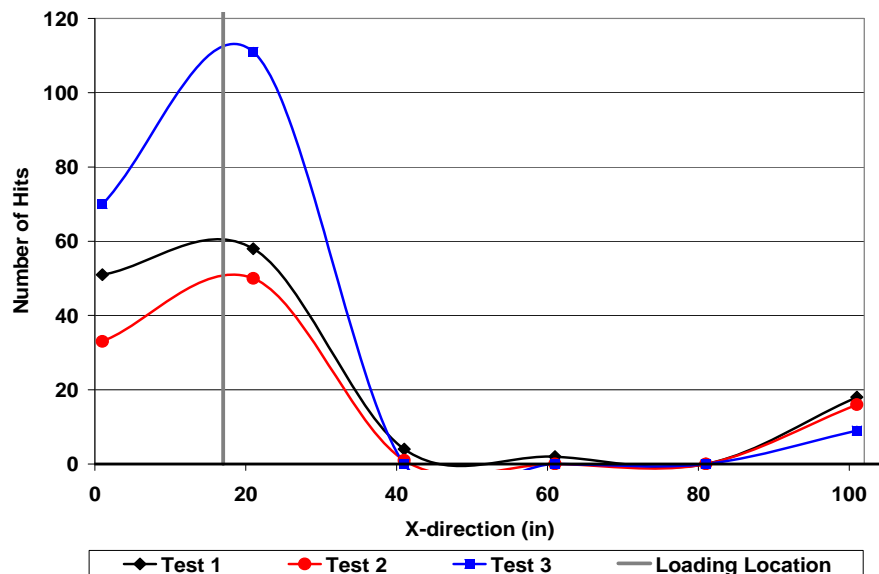
If the number of hits that each sensor detects is plotted, as in Figure 3-22 and Figure 3-23, the hits can be used to get an approximate location of the loading point, but in terms of the testing order, there doesn't seem to be a pattern when below 25 kips, but the values are still similar in terms of the magnitude. The pattern of decreasing in magnitude during each testing sequence does occur once the load is over 25 kips. In either case, each test still could be used to determine the general area of and further aide in locating where the source is closest to the sensor array.

Figure 3-22 Number of Hits on sensor array 1; Over three tests, under 25kips.

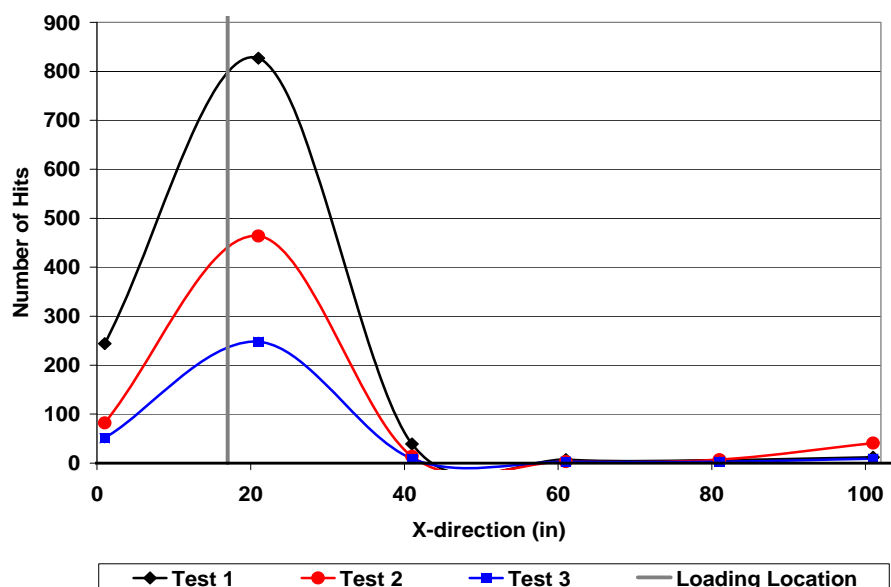
Figure 3-23 Number of Hits on sensor array 1; Over three tests, over 25kips.

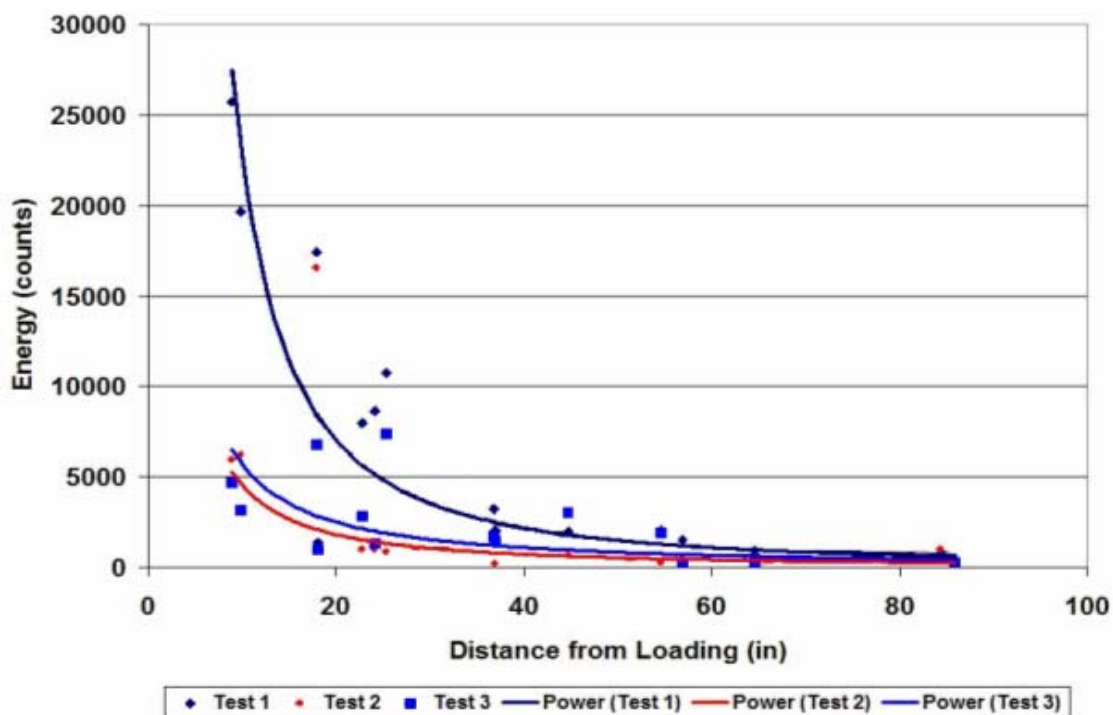
The property that shows the greatest difference between distance points is that of the absolute energy as plotted in Figure 3-27, below. In this figure we can see the decrease in magnitude as the distances increase. In this case the best plot was found to be that of a 'Power Trend-line', not all that surprising as a great deal of acoustic properties have an inverted second-order relationship with regards to distance from the source. It seems in the case of AE in a FRP panel the relationship is no different, as that general trend exists here as well.

Figure 3-27 Average absolute energy plotted at various sensor distances.

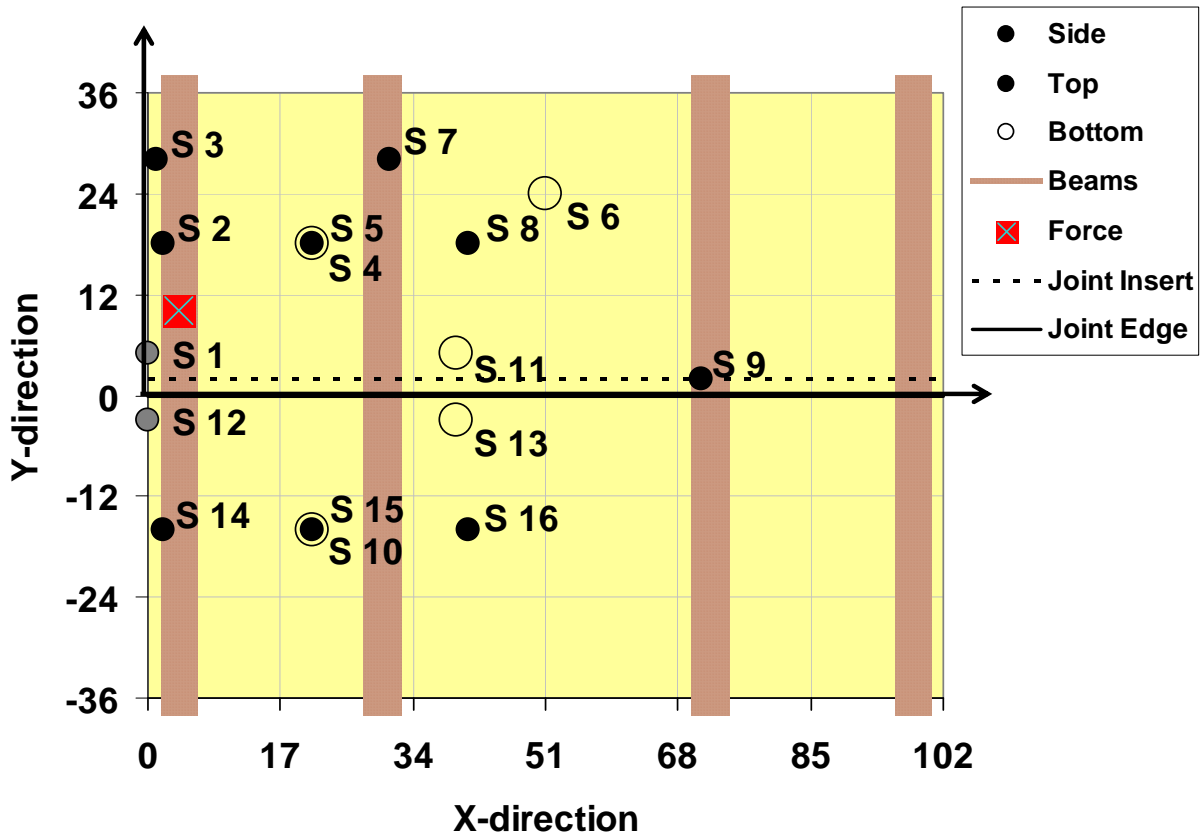
One set of tests focused on analyzing performance along the joint with the force application location, specifically at the middle of the first beam on Panel-A. The sensors were positioned in locations that would result in similar distances from the force being applied, but located on separate panels, as shown in Figure 3-34. By this method a general profile should become apparent as to how well the acoustic data transfers from one panel to the other.

Figure 3-34 Signal Transfer sensor arrangement.
