Campus ecology: assessing the performance and management of green infrastructure at Kansas  
State University

MASTER OF LANDSCAPE ARCHITECTURE

KANSAS STATE UNIVERSITY  
Manhattan, Kansas

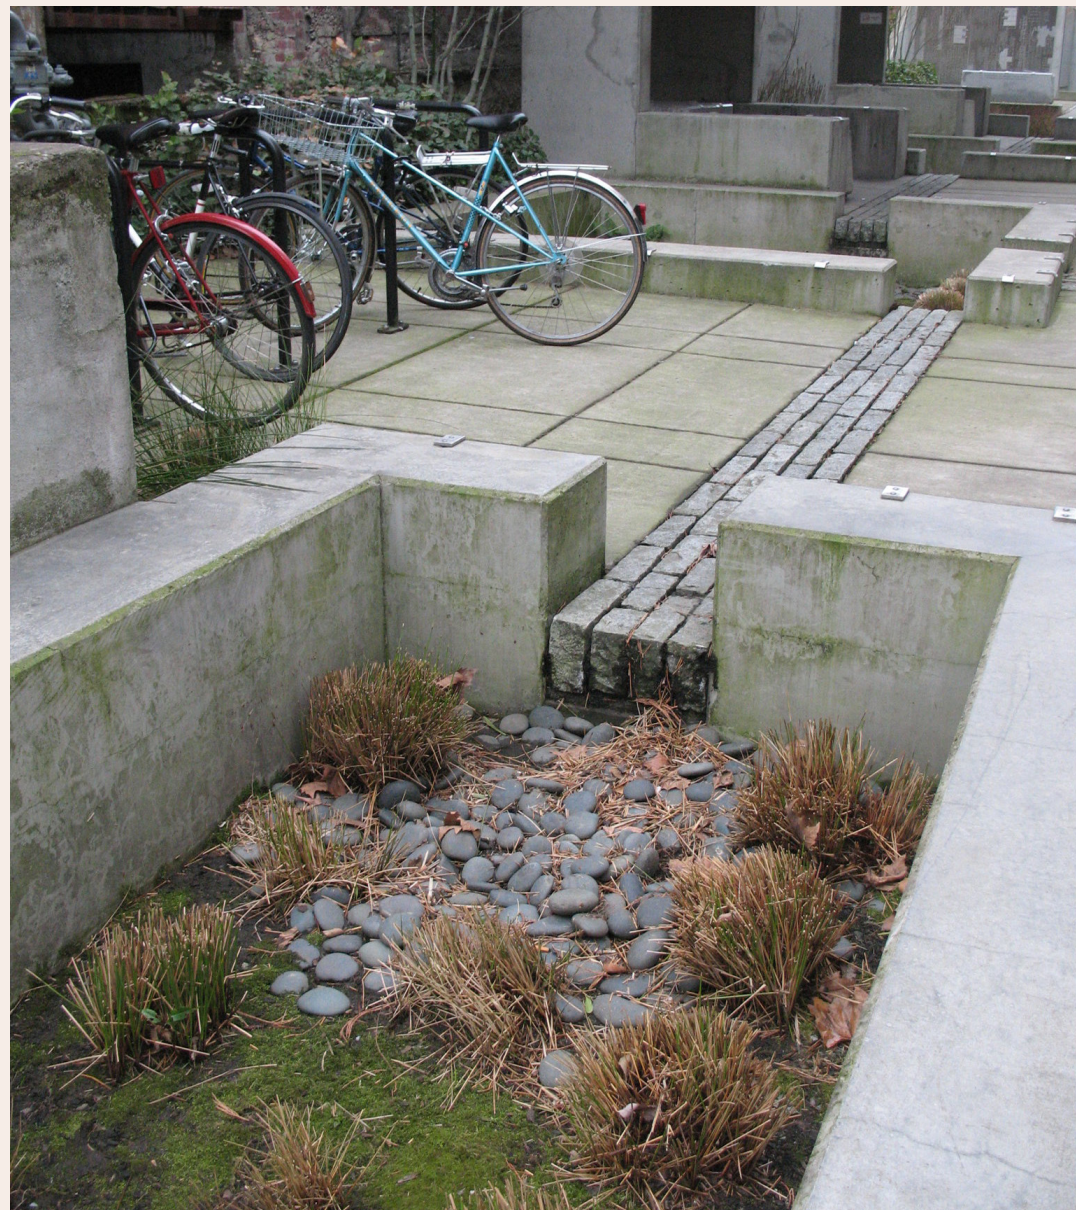
Fig 1.1 Permeable pavement guides stormwater to rain gardens (Boucher 2009).

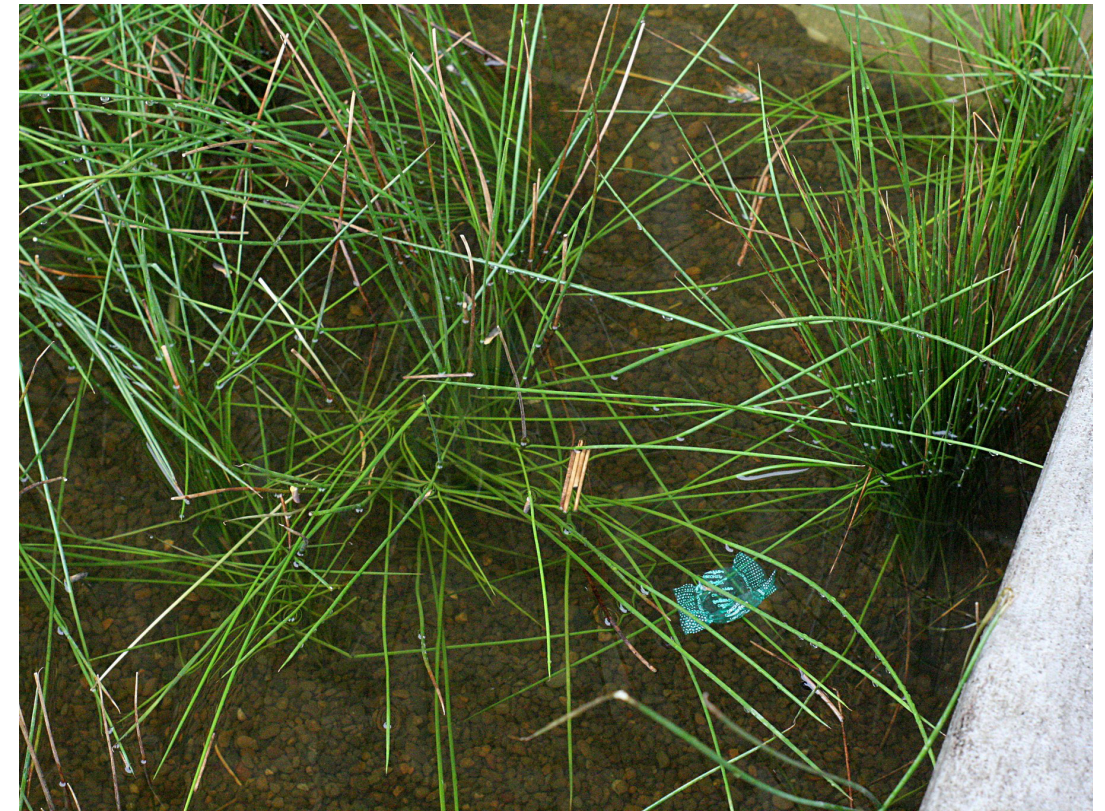
Fig 1.2 Rain garden fills due to large storm event, allowing for stormwater to infiltrate ("Bioswale" 2008).

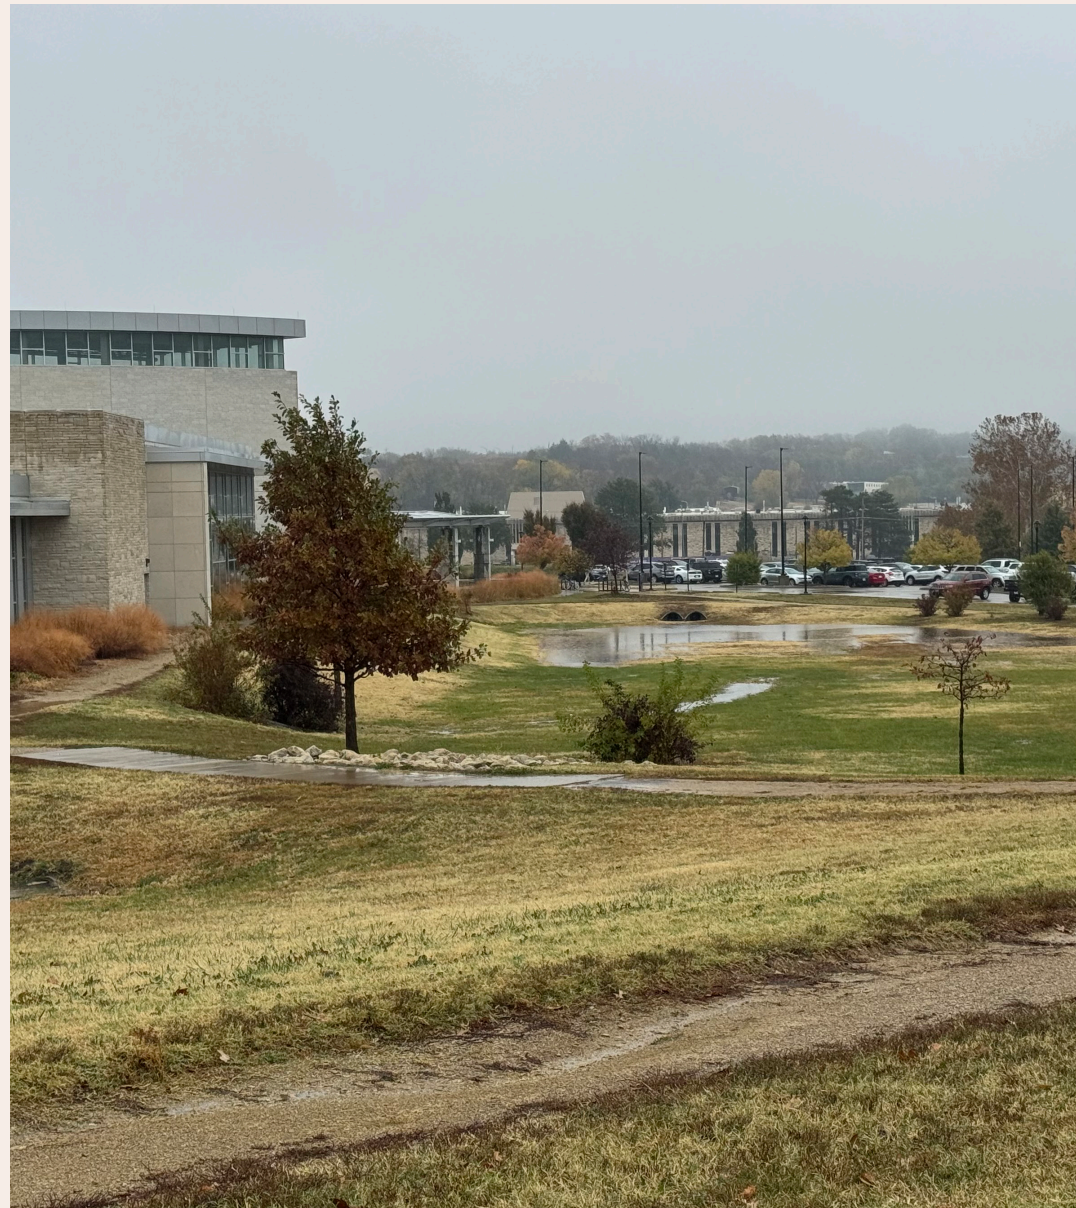
Fig 2.1 Peters Recreation Center's retention basin fills with stormwater runoff from the surrounding context (Freelove 2024).

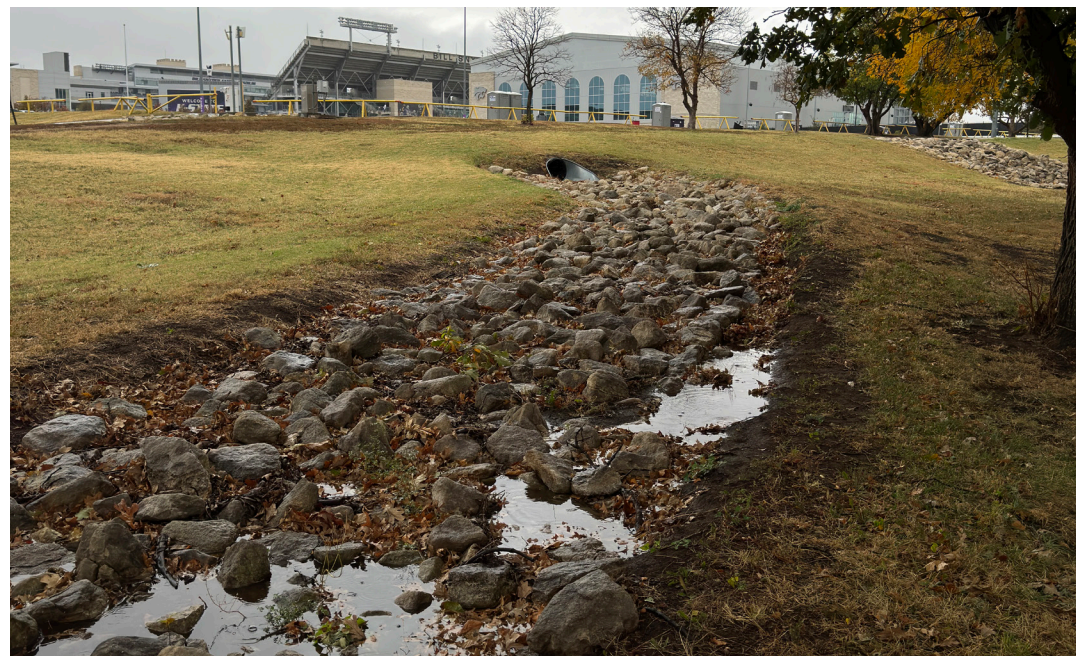
Fig 2.2 Peters Recreation Swales (Freelove 2024).

Currently, our site represents the headwaters of Campus Creek, the primary creek that flows through the campus. However, these headwaters are experiencing significant challenges due to heavy runoff from the surrounding athletic facilities, parking areas, and the Peters Recreation Center. To the west and south of the Peters Recreation Center, there are the only “green infrastructure” projects near the headwaters. Unfortunately, this channel is suffering from severe degradation and erosion, primarily due to the substantial volumes of stormwater rapidly flowing through the area. The grass detention basin is not aesthetically appealing and creates a large mowing issue for maintenance.

The erosion and degradation issues are exacerbated by the high-speed runoff, which undermines the channel’s stability and reduces its effectiveness in managing stormwater. Addressing these problems requires a comprehensive approach that includes improving runoff management strategies, enhancing the green infrastructure project, and implementing additional measures to protect and restore the natural integrity of the headwaters.

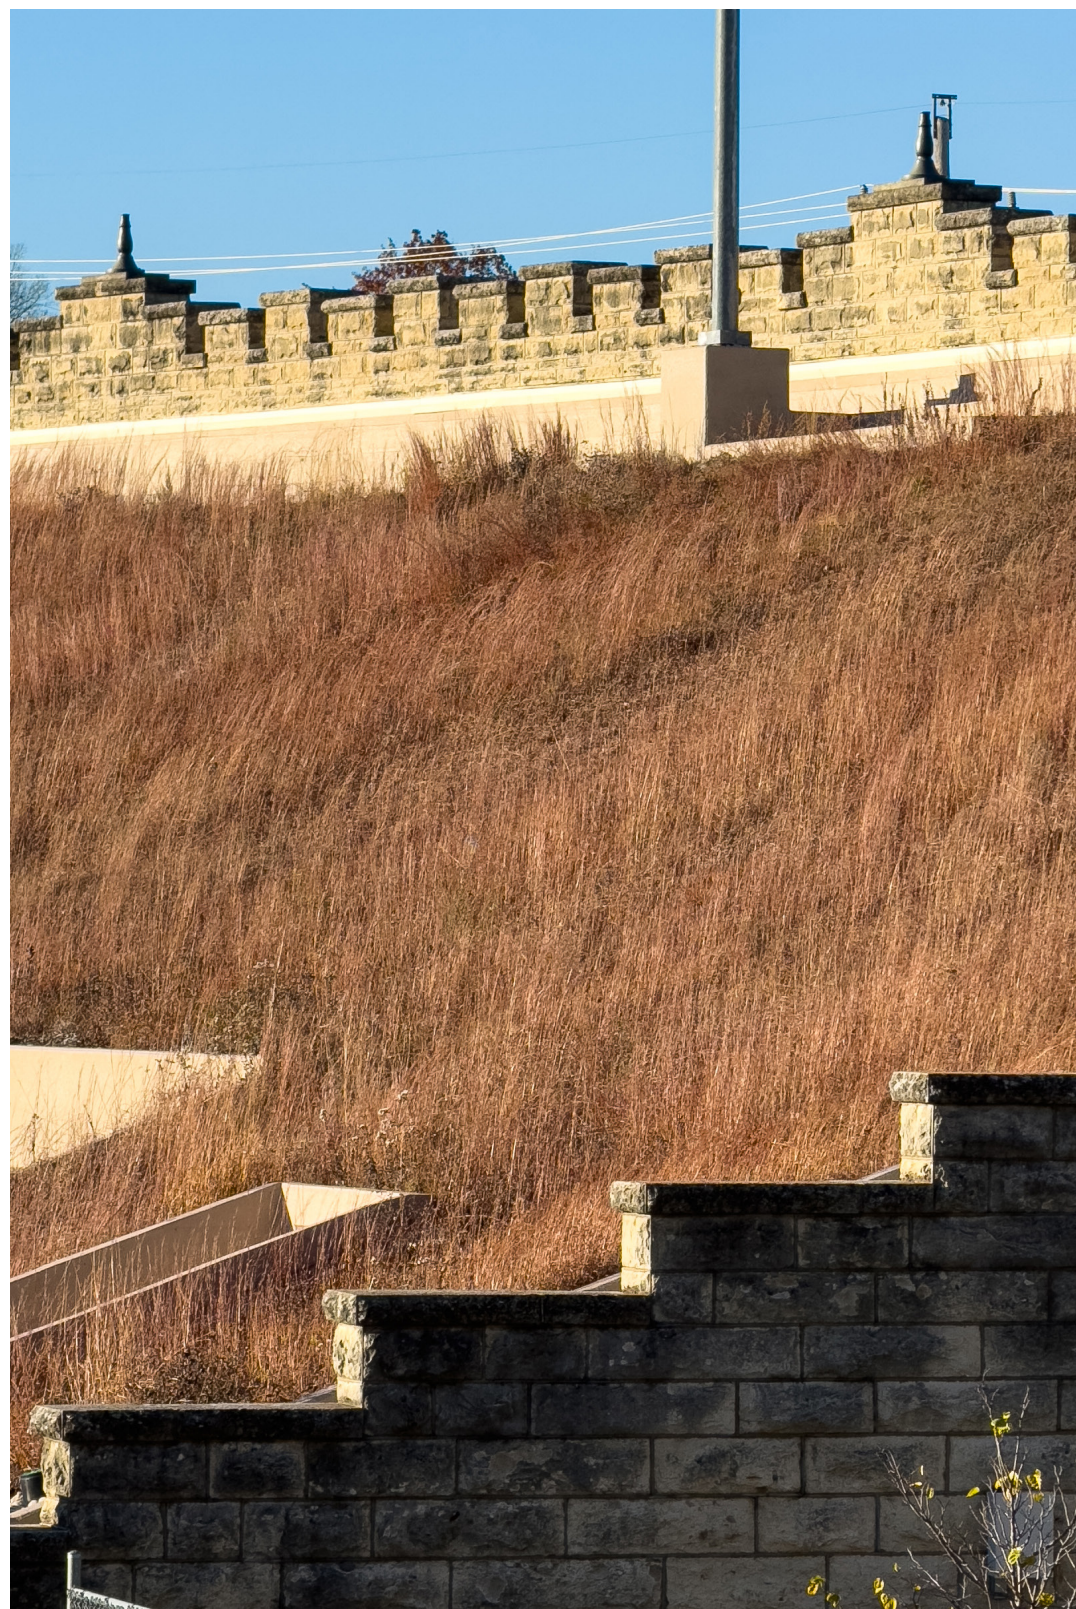
Fig 3.6 The planting of the Memorial Stadium Green Roofs emulates the Flint Hills Ecoregion (Freelove 2024).

The Memorial Stadium green roofs are a combined 43,050 sf. However, the slope of the green roofs was seen as a potential issue. Geofoam was used to fill the existing seats on a 20-degree slope. Then a lightweight engineered sandy soil with a 5–6-inch depth was added. A nylon erosion mat was installed to hold the soil in place. Then, the roof was seeded for plant establishment. A total of 28 species were planted and seeded within the system. Many species that are present resemble surrounding prairies. Some of those species include: multiple coneflower species, Sideoats and Hairy Grama, Prairie Dropseed, Indian Grass, Big and Little Bluestem, multiple species of aster, Wild Blue Indigo, Blue False Indigo, Blazing Star, Purple Prairie Clover, Showy and Foxglove Beardtongue, Bee Balm, yarrow species, etc. Only one of the species is not native to the nearby Konza Prairie (Skabelund & Alam 2021). It has been reported that the plant species have grown well on the steep slope and provide the tallgrass prairie look. For the soil, the slope mattered greatly. With the higher slope, water sheds more quickly, so more irrigation is needed to help the plant life during extended drought periods. Also, since the soil is lightweight and sandy (with some shale added on the east side) it can dry out quickly, leading to a broader range of soil moisture levels depending on precipitation timing and irrigation coverage (Skabelund & Alam 2021).

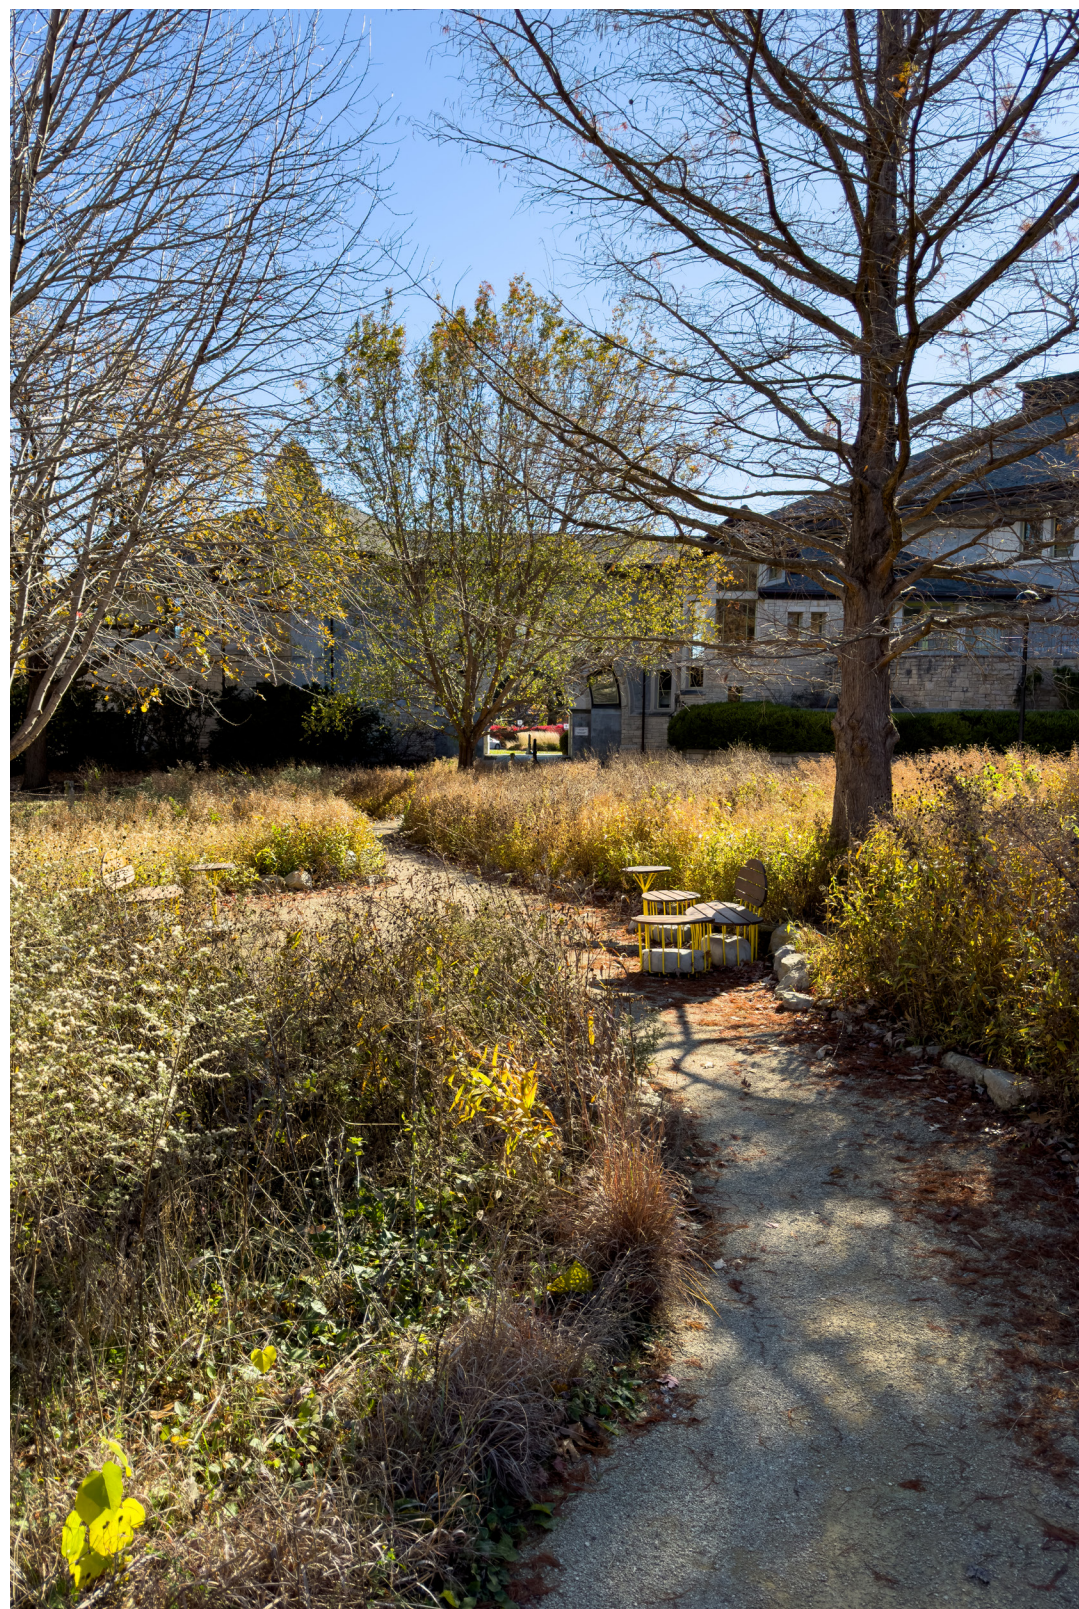
Fig 3.9 This prairie-like area is maintained by student workers and volunteers (Freelove 2024).

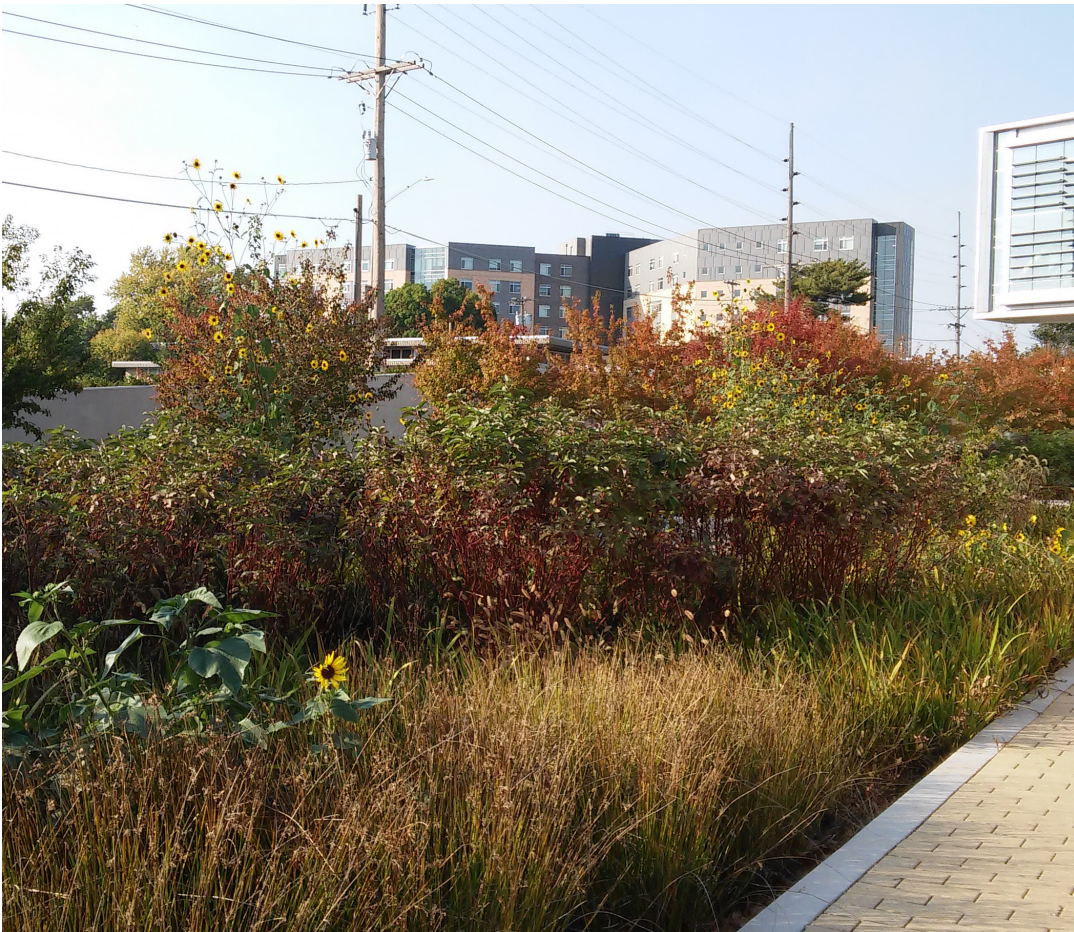
Fig 3.10 The Engineering Bio-Retention originally was successful and had vigorous plant life (Skabelund 2020).

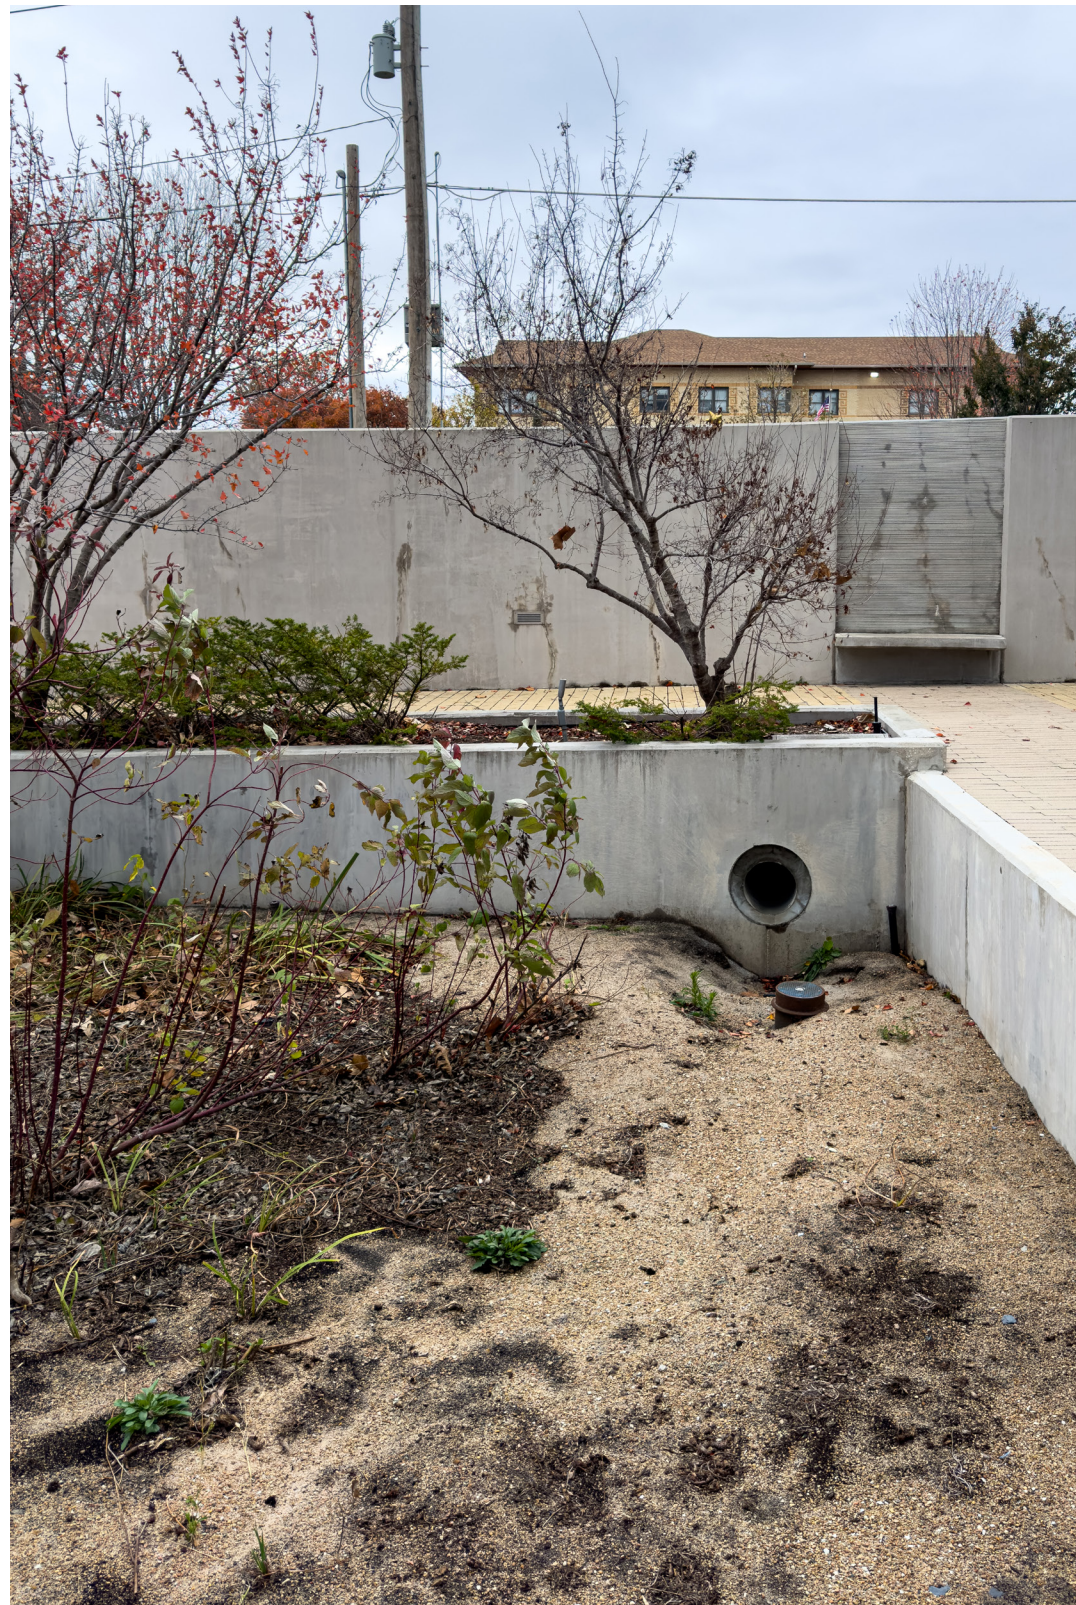
The design of this bio-retention system was fairly simple. Only three species of plants were used throughout. The species include Red Twig Dogwood, Blue Flag Iris, and Common Rush. These are the only species that were planted within each of the cells. Through each cell, water is collected from the surrounding building, impervious surfaces, and permeable pavement. The water is supposed to be slowed and infiltrated by the vegetation into the sandy-engineered soil as stormwater makes its way toward the road and the southwest corner of the bio-retention cells. The system has started to decline due to its overly simplistic design, low biodiversity, and inadequate soil moisture levels during dry spells. Currently, there is a considerable loss of plant life, large bare spots, and many indicators of erosion. Very tall sunflowers, a few little bluestem, wild sweet clover, prickly lettuce, and various other ruderal or pioneering species have started to grow.

Fig 3.12 Engineering Bio-Retention Area (Freelove 2024).

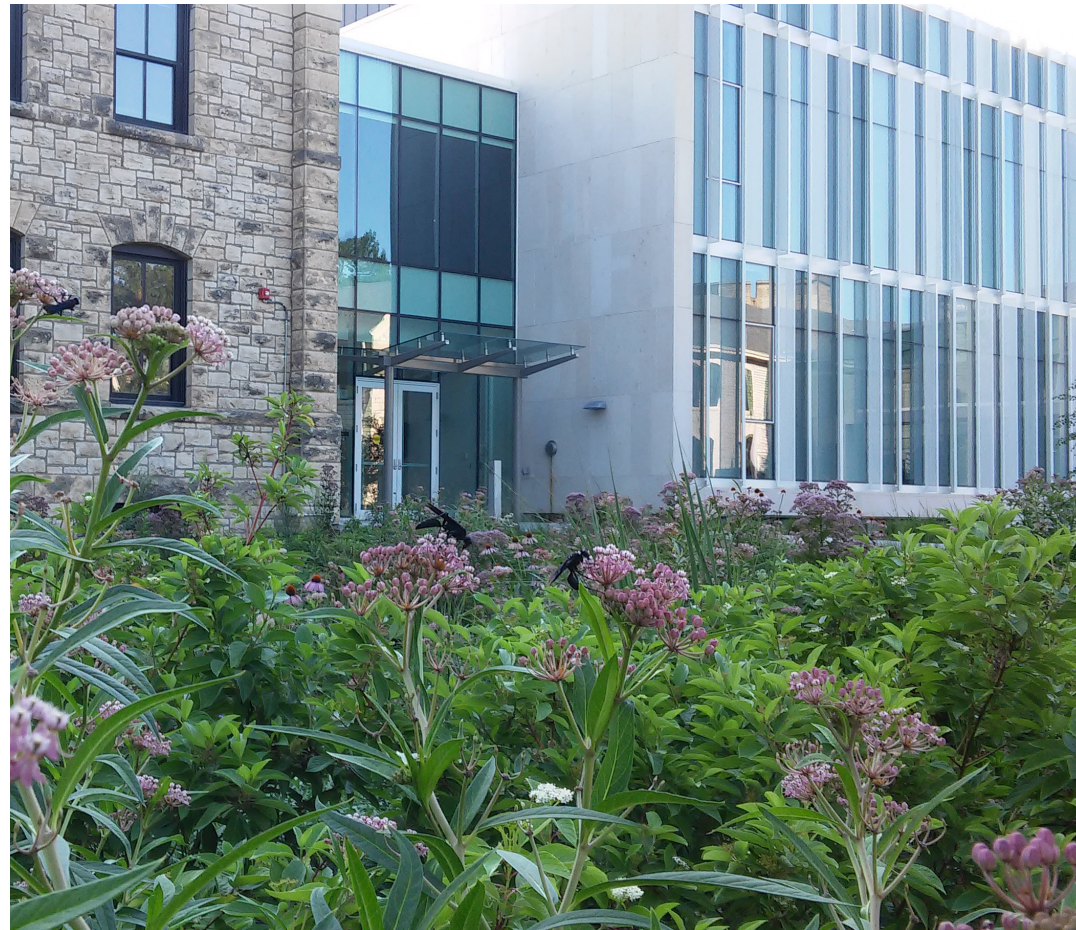
Fig 3.13 Pollinators enjoy plantings within the rain garden south of Regnier Hall (Skabelund 2018).

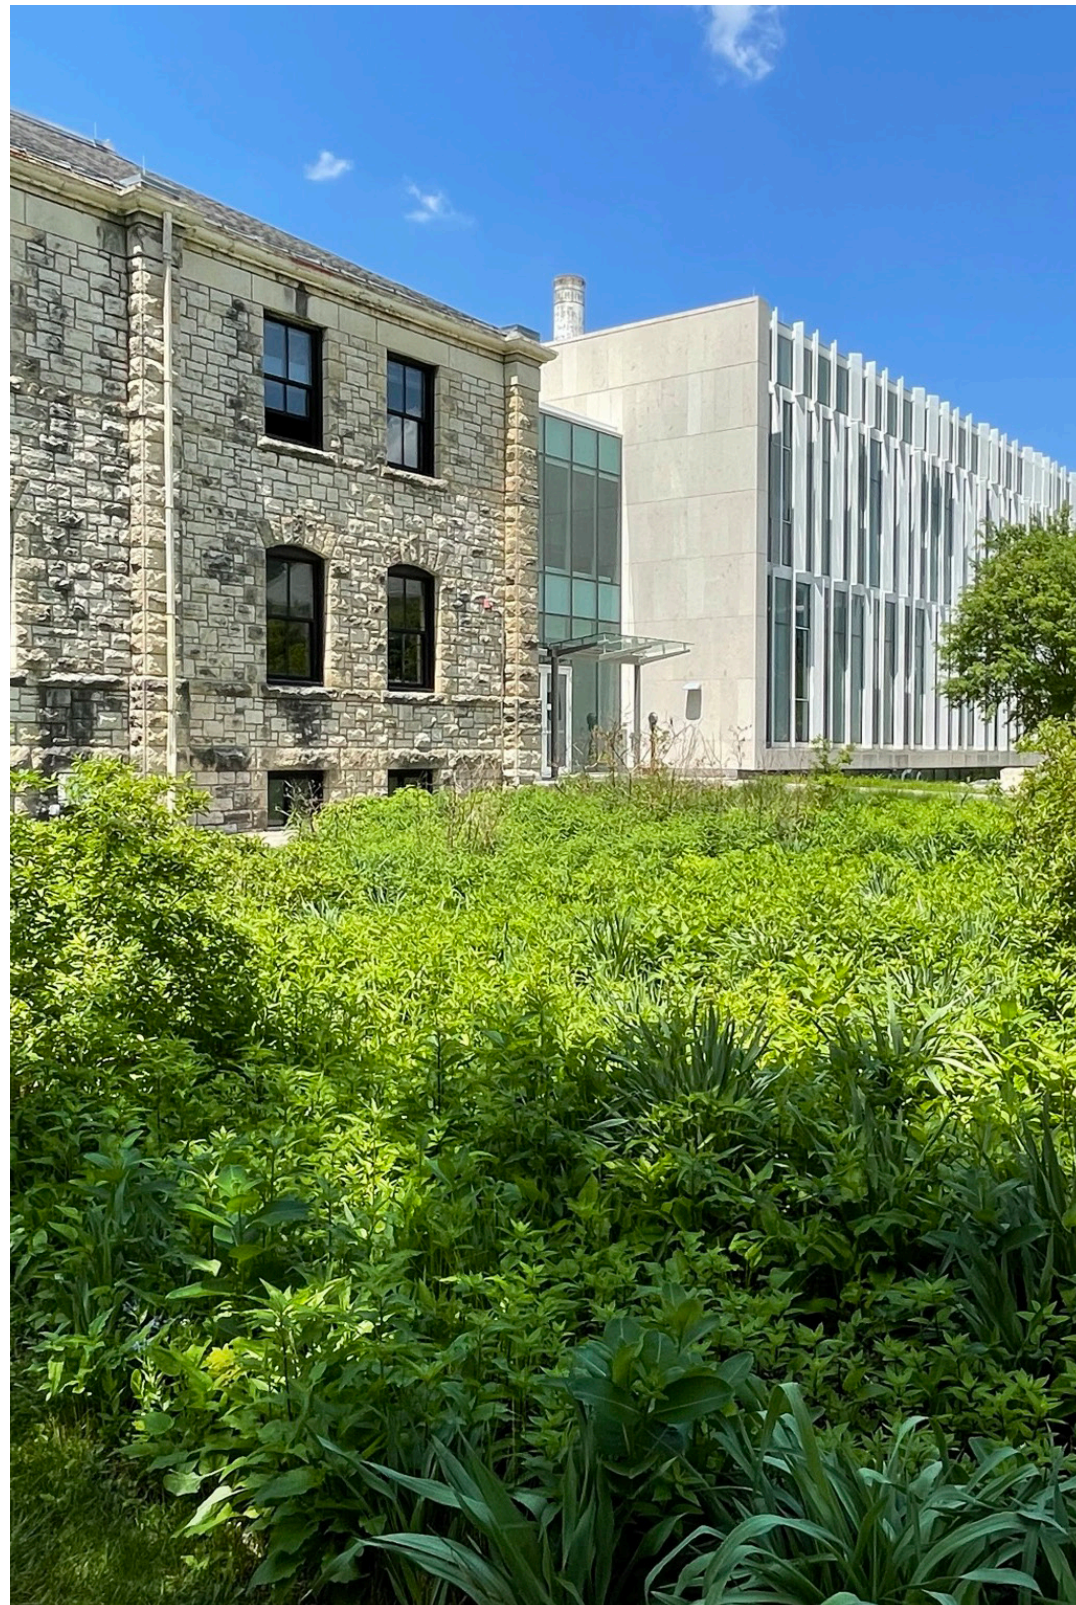
The studied rain garden that is situated on the east side of Seaton Hall is approximately 3,700 sf. With its relatively small size, the rain garden is filled with many native plant species that help with stormwater retention and infiltration. Notable species include Prairie Dropseed, Little Bluestem, Joe Pye Weed, Swamp Milkweed, Rattlesnake Master, Blue Sedge, and Soft Rush. All these species are somewhat evenly spaced within the area with other species of grasses and sedges. Red Twig Dogwood is sporadically placed along with those species, and three Thornless Honey Locusts fill out the system. The rain garden has a concrete pad directly to the west of the main infiltration area that feeds water directly to the rain garden. Under the ground, the system has a sandy-silt mixed, engineered soil to help water move through this system faster. Along with the engineered soil, a large stormwater cisterns lie within a bed of gravel underneath the rain garden.

Fig 3.15 Seaton Hall rain garden (Skabelund 2023).

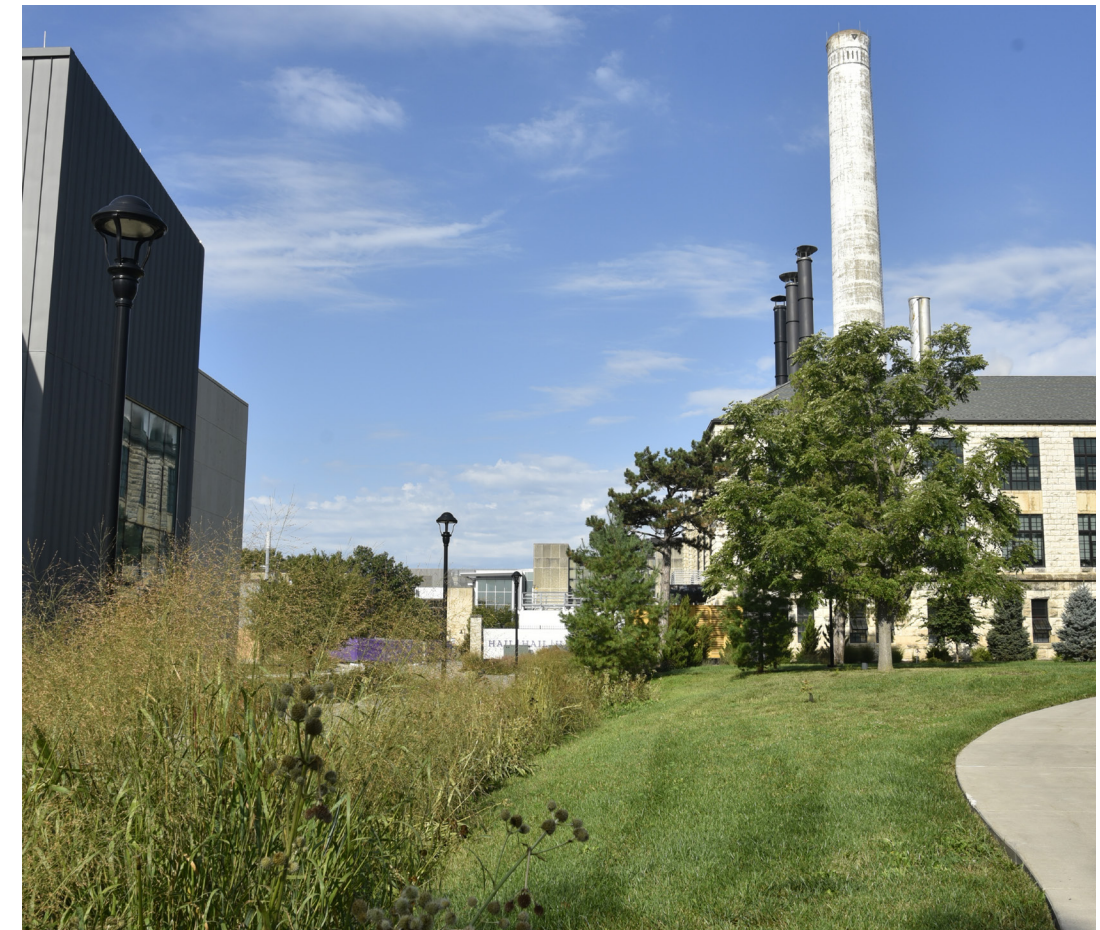
North of Seaton Hall lies a bioswale designed to catch and retain water from the northern area. The bioswale spans approximately 1,150 square feet of planted space that holds water. The plant species in this bioswale are similar to those in the rain garden to maintain a consistent aesthetic appeal. This area also features engineered sandy-silt soil underneath. Although there is no cistern below, water is directed to a low point and inlet in the bioswale during heavy rain events. At that point, the water begins to percolate down into the soil.

Fig 3.17 Seaton Hall Bioswale (Goold 2024).

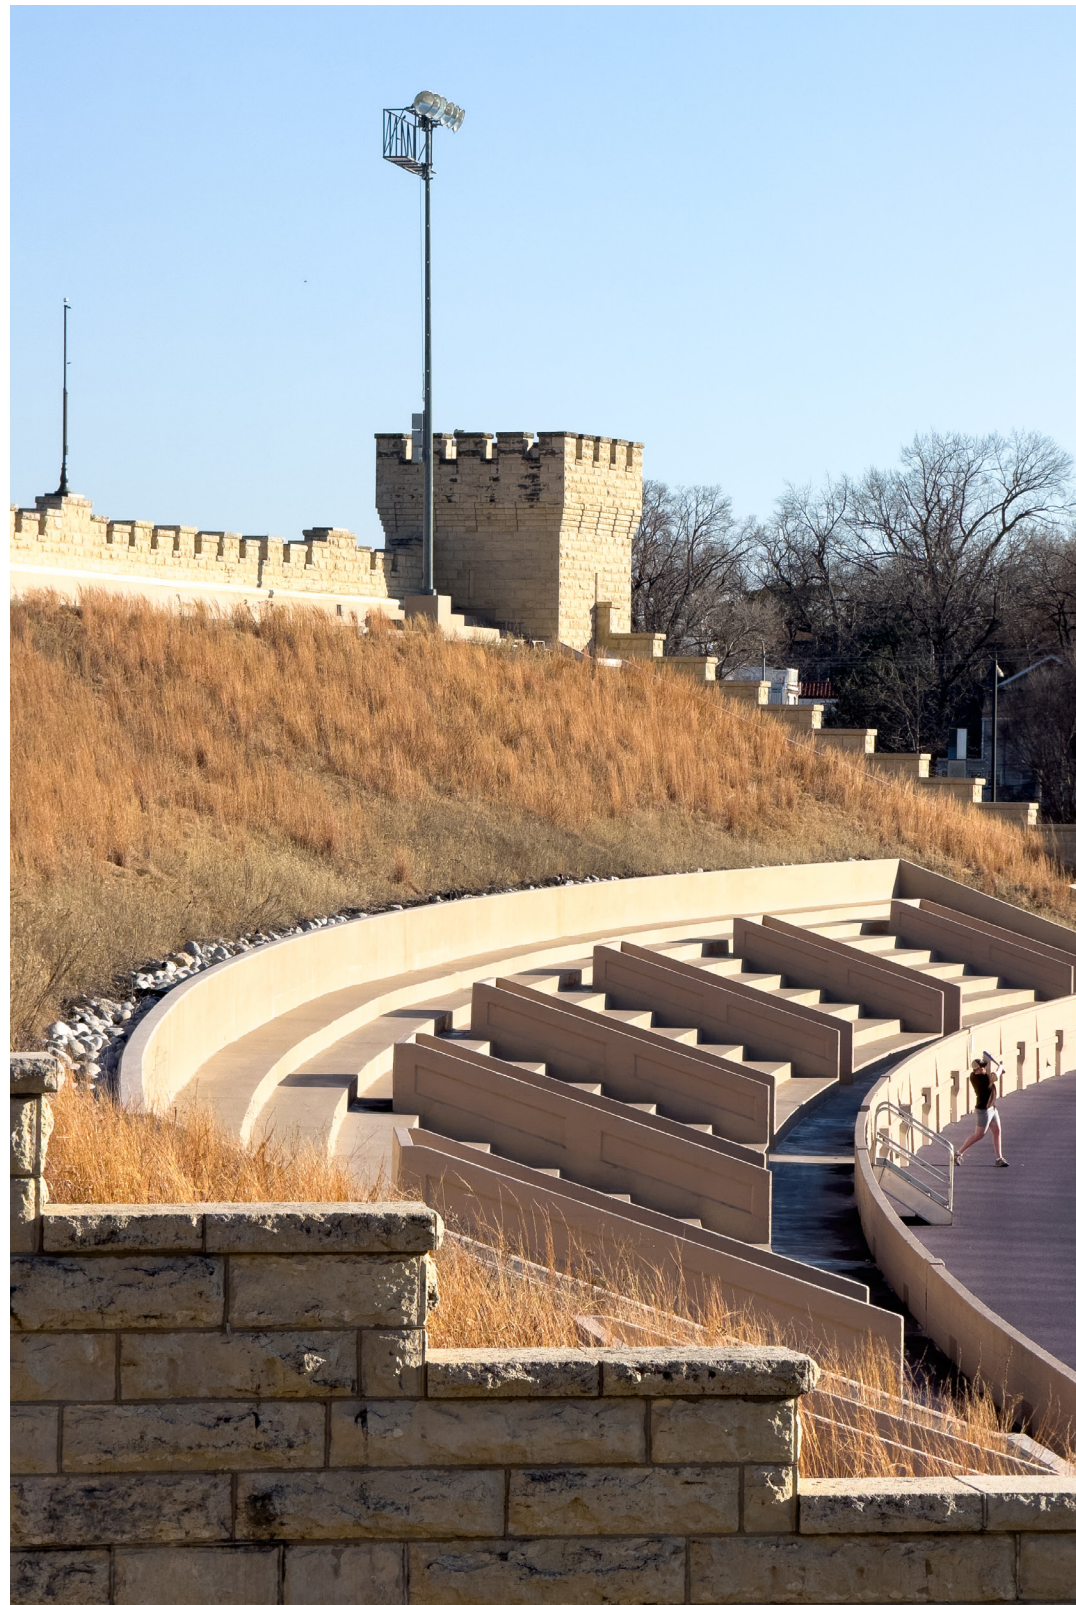
Fig 3.22 East Memorial Stadium Green Roof in the spring (Freelove 2025).

Lee Skabelund weeded out foxtail, fescue, bluegrass, prickly lettuce, ragweed, marestail, wild sweet clover, and sought to keep other weedy species in check between 2016-2024, sometimes working with other volunteers. Hundreds of thousands of weeds have been removed from the two large green roofs by Lee and other volunteers, while woody plants (including bush honeysuckle, elms, hackberry, Prunus, and other species) have been pulled or clipped by Lee, volunteers, and K-State Grounds staff. Professor Skabelund, two botanists, graduate students, and other researchers have worked to identify plants growing on the green roofs and document changes since implementation K-State Grounds staff have sometimes used herbicide to try to kill woody plants on the Memorial Stadium green roofs.

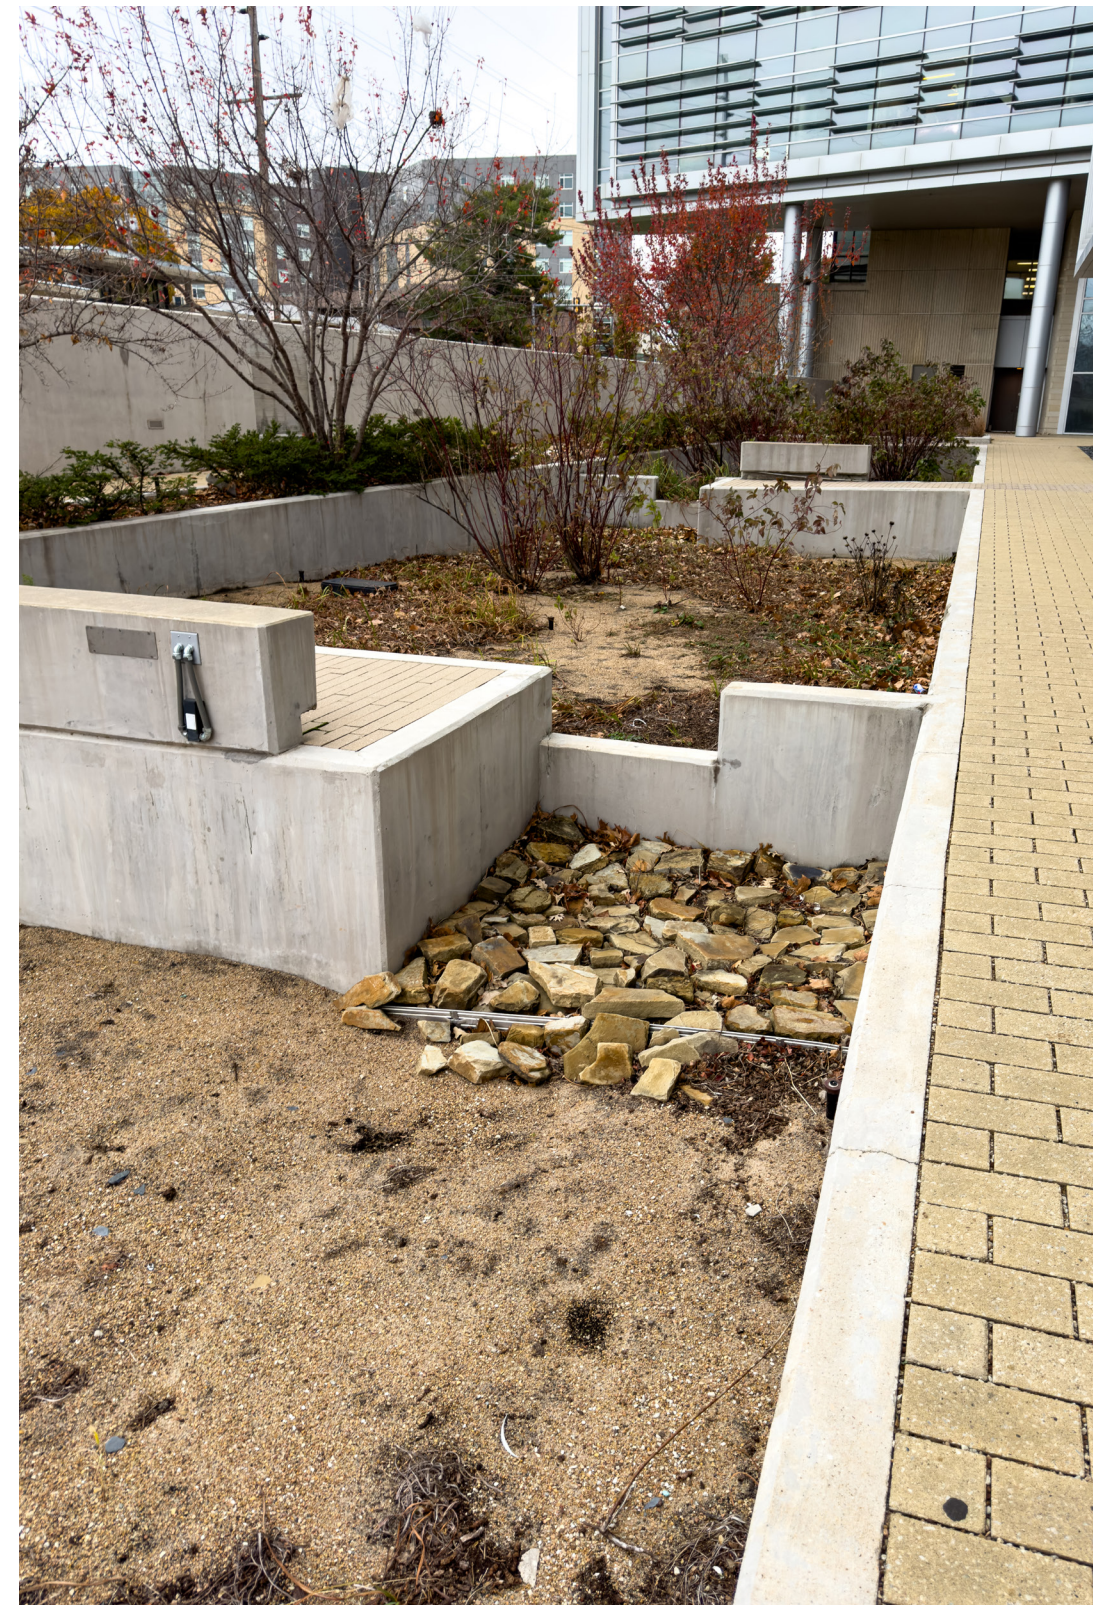
Fig 3.23 Eroded rock transitions between Engineering Bio-Retention Cells (Freelove 2024).

The Engineering Bio-Retention System is presently facing several issues. Most of the plants within the cells have deteriorated. The system's lack of biodiversity and persistent moisture has led to the demise of many plants. Initially, this project received irrigation during its first few years to aid its establishment. However, once irrigation ceased, the plants began to decline due to their moisture needs. Over 60% of the soil surface is exposed across all cells combined. With the loss of plant species, numerous problems are emerging within the soil itself. Much of the soil is being displaced by water, resulting in many gullies and some stone materials being relocated by water. In addition to erosion concerns, the remaining plant life shows visible roots and limited residue in certain areas. The lowest cell is currently facing the most subsoil issues, with little distinction between the topsoil and subsoil. The second lowest cell displays the best soil structure and the healthiest-looking plant life. The soil crumbles quite well in all cells except for the lowest. The cells show decent faunal health, but no signs of the undesired species exist. In this project's plant and soil assessments, the bioretention was rated: 1.3/4 in plant health, 2.1/4 in soil erosion indicators, 2.3/4 in soil health and structure, and 3/4 in faunal health.

To maintain the system, significant damage has occurred to the soil, plant life, and infrastructure. Some control valves are missing or have damaged lids. Pipes have caused erosion spots in the system. High water levels damage some metal trim holding the stones in place. In addition to the infrastructure issues, planting shows evidence of weeds, and no replacement plants have been added to specific cells. K-State grounds regularly manage this project and adheres to service level A standards (Kansas State University 2023). However, there are traces of litter, and the damage has not yet been repaired. Large amounts of leaf litter have accumulated in the system, clogging the drain at the southernmost point of the cells. This can lead to backups within the system, causing further erosion issues. The engineering bio-retention received scores of 3.5/4 in time and personnel, 1.5/4 in damage and issues, and 2/4 in terms of a sufficient management plan.

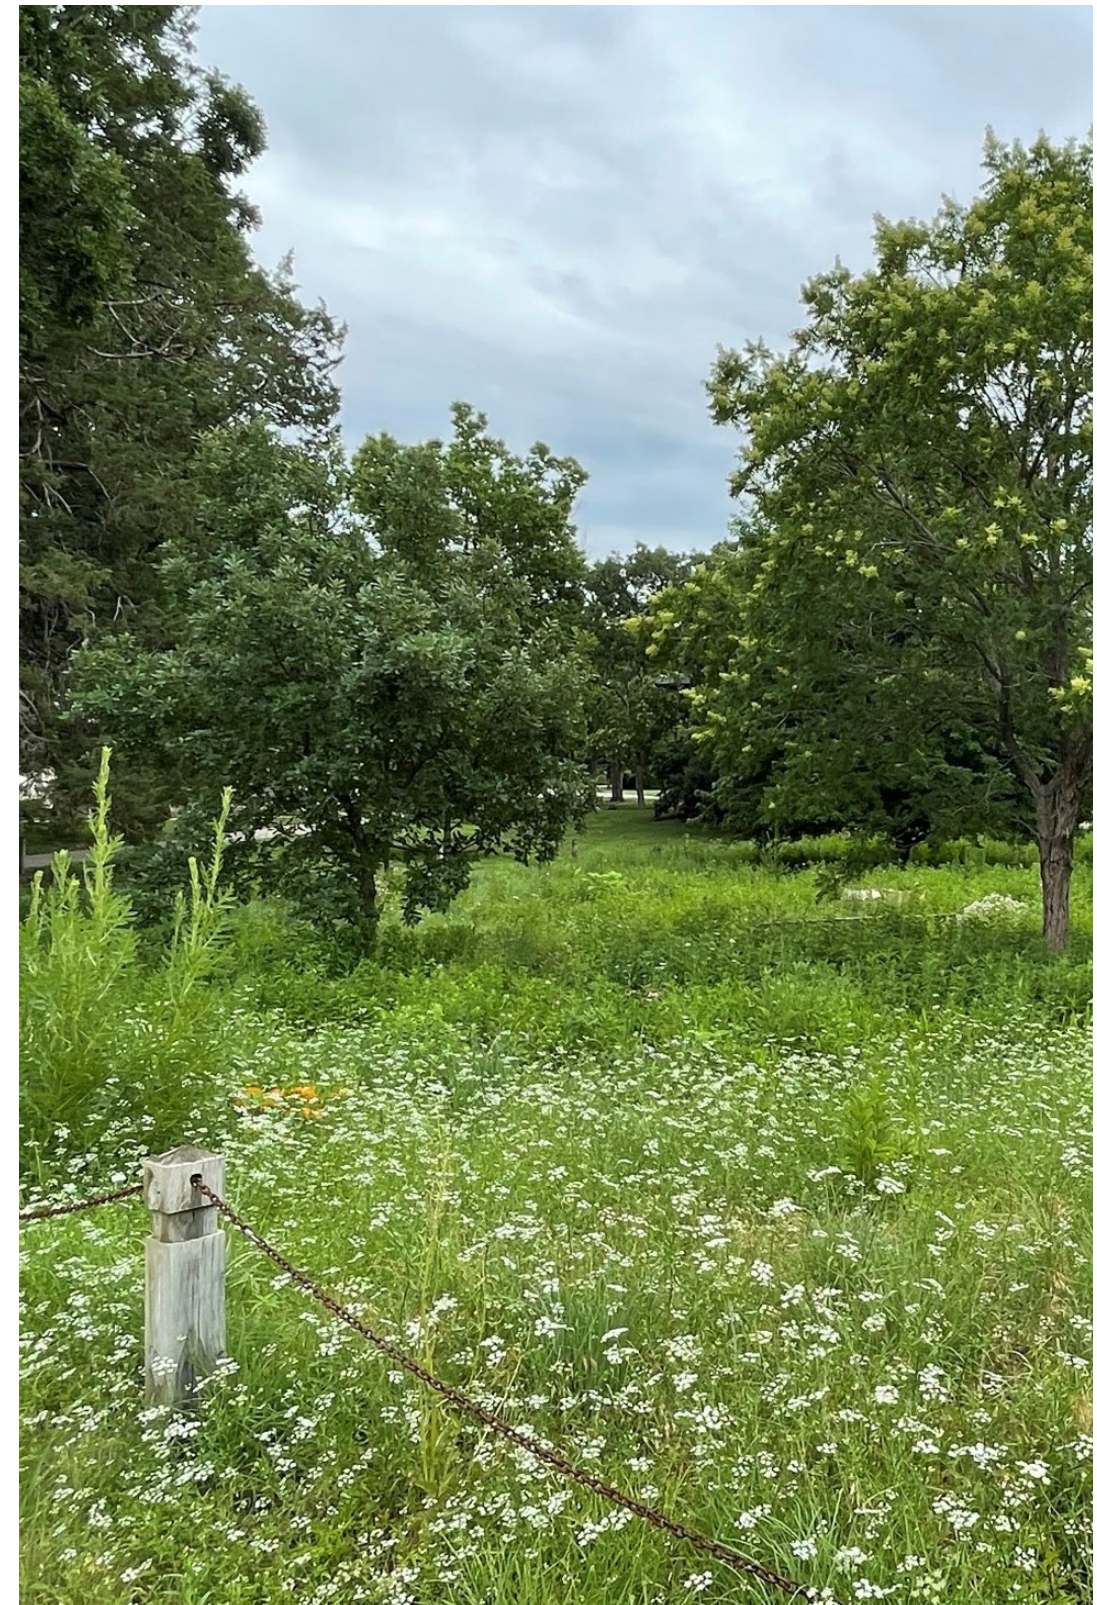
The Kansas State Meadow currently appears to be performing well. All the plantings are in good condition, and the spacing between them leaves little bare soil. However, some undesirable species are present, specifically ragweed and foxtail. Ragweed poses challenges for those with seasonal allergies, while foxtail can dominate the ecosystem, out-competing other species. In terms of soil conditions, there are few to no evident signs of soil erosion. The close planting and variety of species help hold the soil together and facilitate stormwater infiltration from the surrounding area. Overall, the health and structure of the soil are good. The soil layers are mostly distinct, and most roots from the plantings reach a suitable depth. However, certain areas in the meadow experience slightly compacted soil, particularly in the lower sections where more water accumulates. The soil crumbles fairly well, although some clods are present. Overall, faunal health is quite good. There are no mosquitoes, and several organisms inhabit the system. The soil has few earthworms, and a few millipedes were observed. In the plant and soil assessments, the meadow received scores of: 3.75/4 for plant health, 4/4 for the absence of soil erosion, 3.3/4 for soil health and structure, and 3/4 for faunal health.

*Fig 3.24 The K-State Meadow provides a strong sense of place while providing ecosystem services that benefit people and the environment (Skabelund 2022).*
