Campus ecology: assessing the performance and management of green infrastructure at Kansas  
State University

MASTER OF LANDSCAPE ARCHITECTURE

KANSAS STATE UNIVERSITY  
Manhattan, Kansas

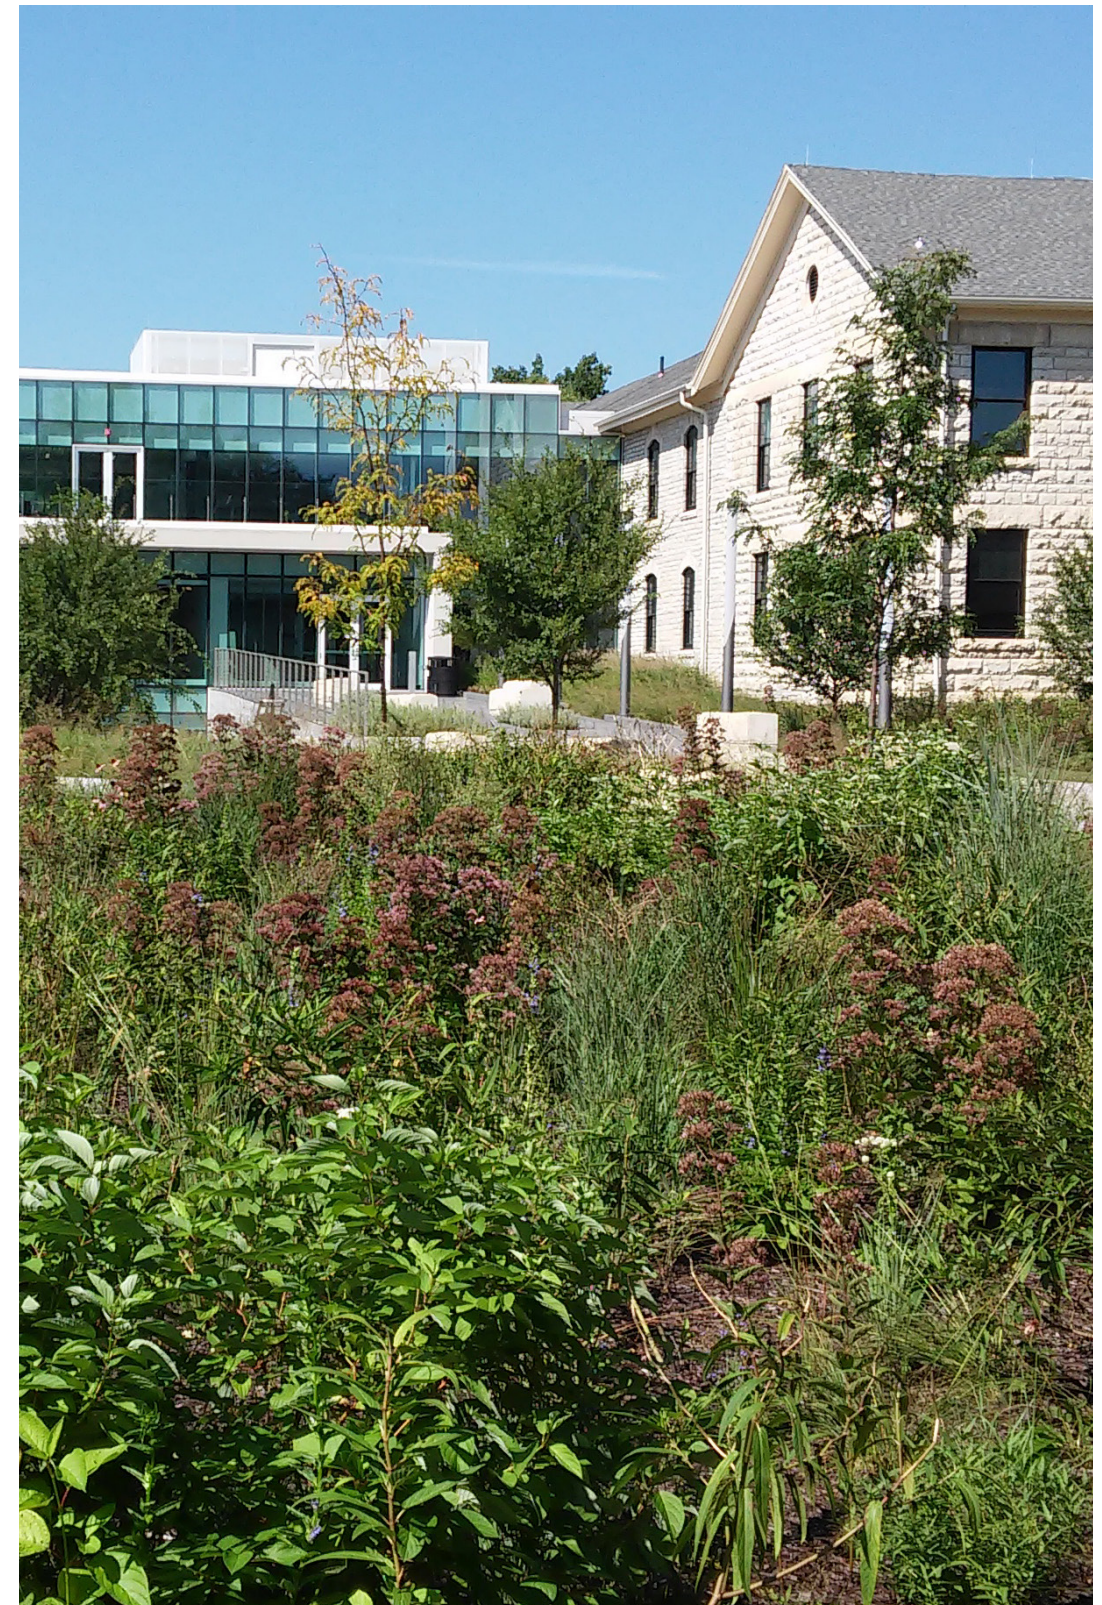
Fig 3.25 Good soil coverage and diverse species allow the rain garden to thrive (Skabelund 2018).

The Seaton Hall Rain Garden appears to be functioning well. Most of the ground is covered by planting, with little bare soil at the low point. The edges around the Prairie Dropseed do not fully cover the soil, allowing water to flow quickly off the sidewalk into the system. The plants are healthy, and there is significant diversity within the system. The rain garden shows no signs of erosion, and the soil crumbles easily. The subsurface of the rain garden exhibits good color and is mostly well-defined, with deep-rooted plants. The soil is not compacted, allowing for effective infiltration. No traces of undesirable species or mosquitoes were found. However, there was a lack of macrofauna in the soil, with few earthworms or other species present. In the assessments of plants and soil, the Seaton Hall Rain Garden received scores of: 3.8/4 for plant health, 3/4 for faunal health, 3.6/4 for soil health, and 3.8/4 for the absence of soil erosion indicators.

The Seaton Hall Rain Garden shows no visible damage within the system. All control valve areas are in good condition, and nothing above ground appears to be damaged. Since none of the plants seem harmed, there is no need to replace any species. In addition to not needing replacement plants, there were few traces of weeds and unwanted species in the system. The rain garden also shows no signs of trash or litter. Some leaf litter was present but not excessive enough to cause blockages. Kansas State Grounds classifies this site as service level A, and it receives regular maintenance (Kansas State University 2023). Volunteer weeding from LARCP staff, Lee Skabelund, weeding prickly lettuce, ragweed, marestail, wild sweet clover, and removing Canada goldenrod due to its weedy nature. Kansas State Grounds has met several times with professor Skabelund to talk about weedy plant concerns. The Seaton Hall Rain Garden received scores of: 3.5/4 in time and personnel, 4/4 in trash and unattended issues, and 3/4 in a sufficient management guide.

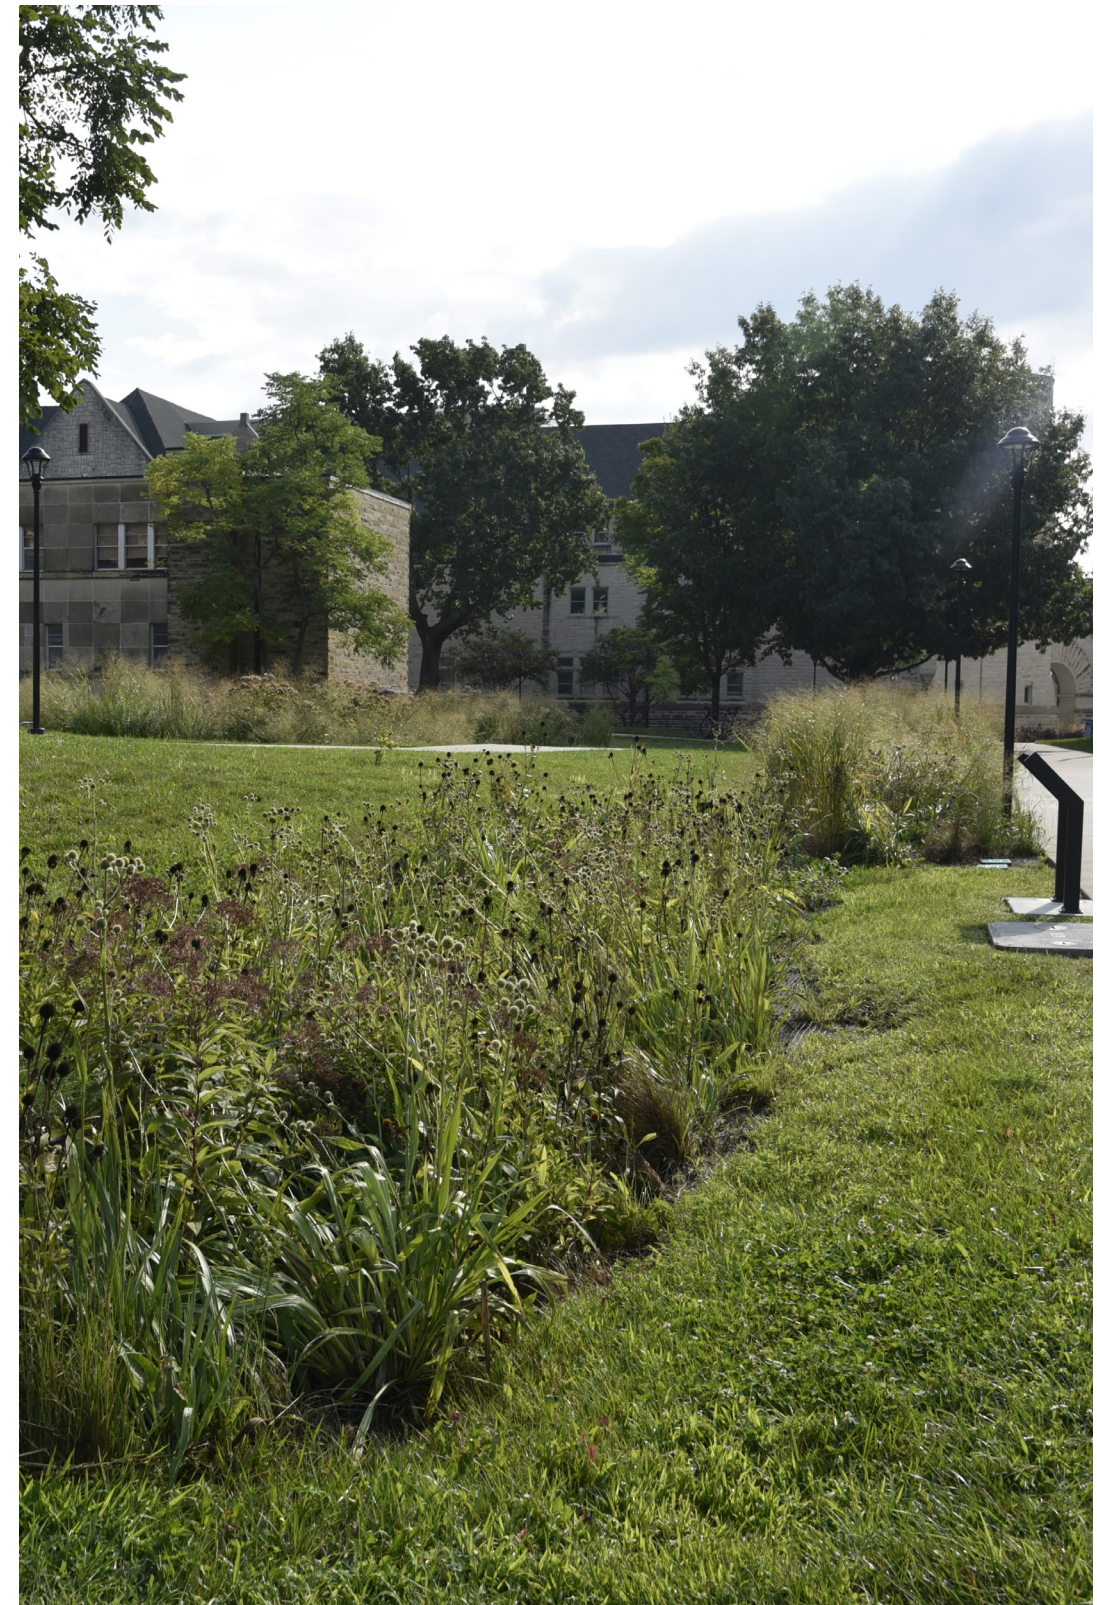
Fig 3.26 The Seaton Hall Bioswale is an example of GI that can take less time to manage than mowing due to its biodiversity and plant spacing (Goold 2024).

The bioswale located north of Seaton Hall currently needs some maintenance. The central area lacks vegetation and requires replacement plants to cover the bare soil, which will help prevent unwanted species and control erosion. LARCP staff Lee Skabelund has assisted with the removal of prickly lettuce, ragweed, maretail, bindweed, and wild sweet clover, and also attempted to keep crown vetch in check the past few years since these species are considered weedy. Kansas State Grounds staff have spot sprayed a herbicide on the crown vetch in this area, but it is still present. The various types of plastic webbing used to keep mulch in place make weeding difficult. There was minimal plant litter causing blockages, and the infrastructure components showed no physical damage. Kansas State Grounds classifies this site as service level A, ensuring it receives regular maintenance and trash removal (Kansas State University 2023). The bioswale has received scores of 3/4 for time and personnel, 2.75/4 for damage and unattended issues, and 3/4 for a sufficient management plan.

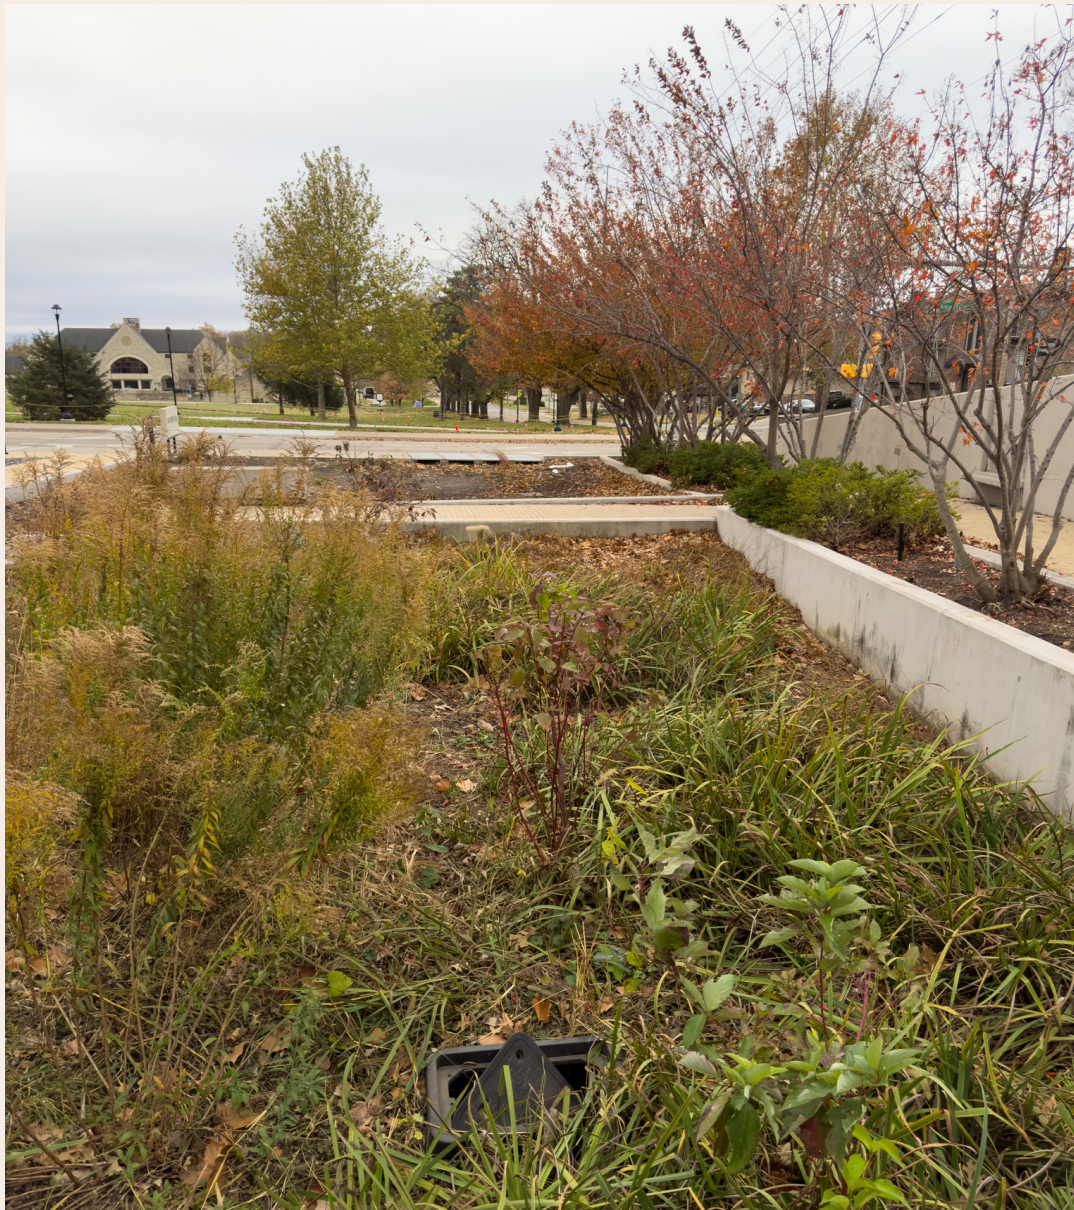
Fig 4.1 Engineering Bio-Retention Area after a storm (Freelove 2024).

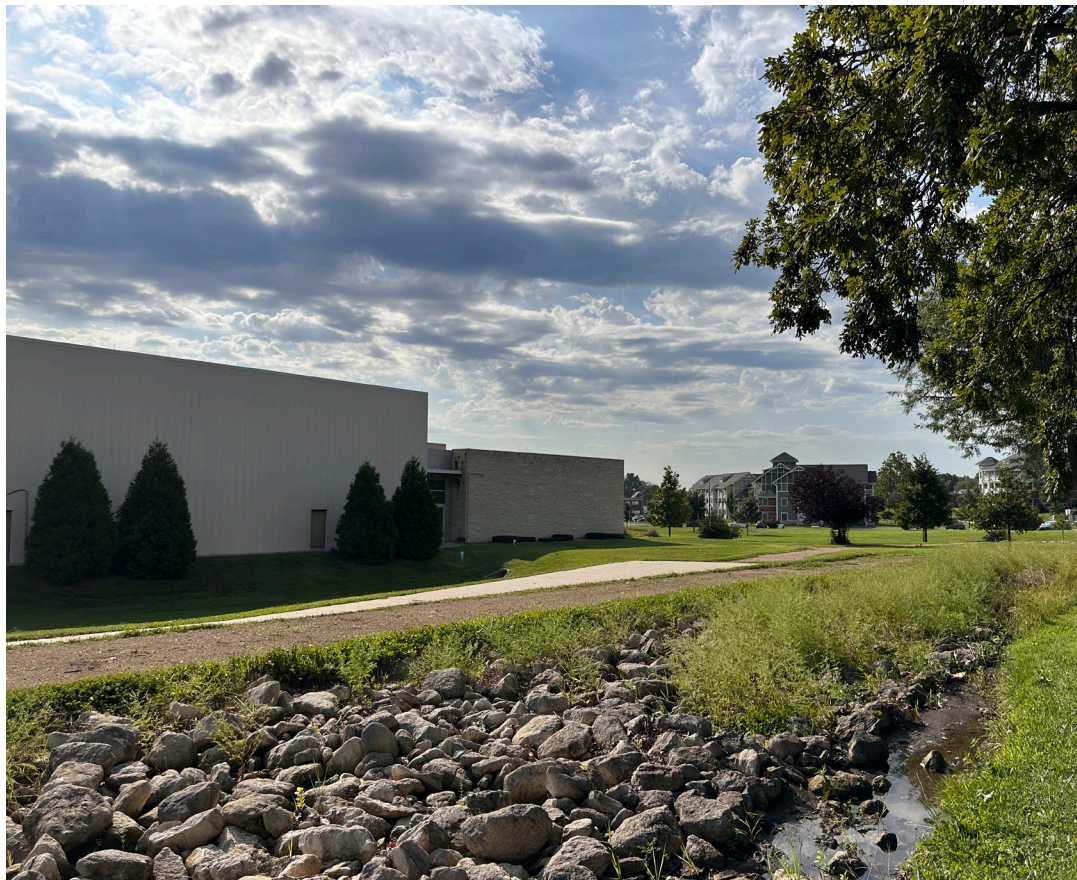
Fig 5.2 The swales around Peter's Recreation Center suffer from fast moving stormwater, leading to erosion and the addition of rip rap (Freelove 2024).

There is a large amount of parking at Peter's Recreation Center, surrounded by the Bill Snyder Family Stadium, and former Edwards Hall. The site currently has two swales from the parking lot, entering from the parking areas west and south of Bill Snyder Family Stadium. With large storm events, high volumes of water have eroded the bank of the grass swale, leading to more limestone rip rap being added. However, the banks continue eroding, and invasive species find a place within the rip rap. Along with that, a large turfgrass basin lies south of Peter's Recreation Center. This basin stores some stormwater during a large storm. However, it is hardly ever filled by water, even for significant rain events. This basin provides low visual and ecological quality. In the site's southeast corner, Edward's Hall was previously surrounded by parking. Now, the parking remains, and a pipe from the Recreation Center sends water onto the west part of the old Edwards Hall parking. This stormwater flows to the low point of the site and eventually sends stormwater across Denison Avenue to Campus Creek. Site analysis and imagery were done to understand the current issues with stormwater and the watershed, hardscape, softscape, soils, and existing drainage ways. With this information, a projective design was completed to provide natural stormwater solutions while providing the Recreation Center Complex with more opportunities to engage in outdoor recreation.

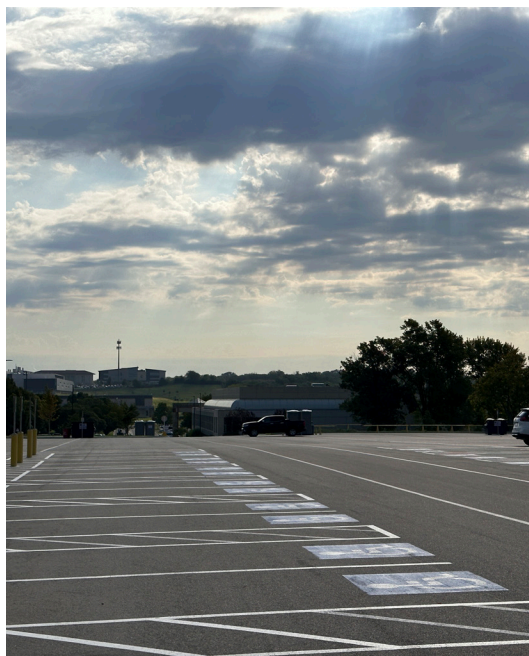
Fig 5.4 The Bill Snyder Family Stadium parking lot currently sheets runoff to the surrounding landscape (Freelove 2024).

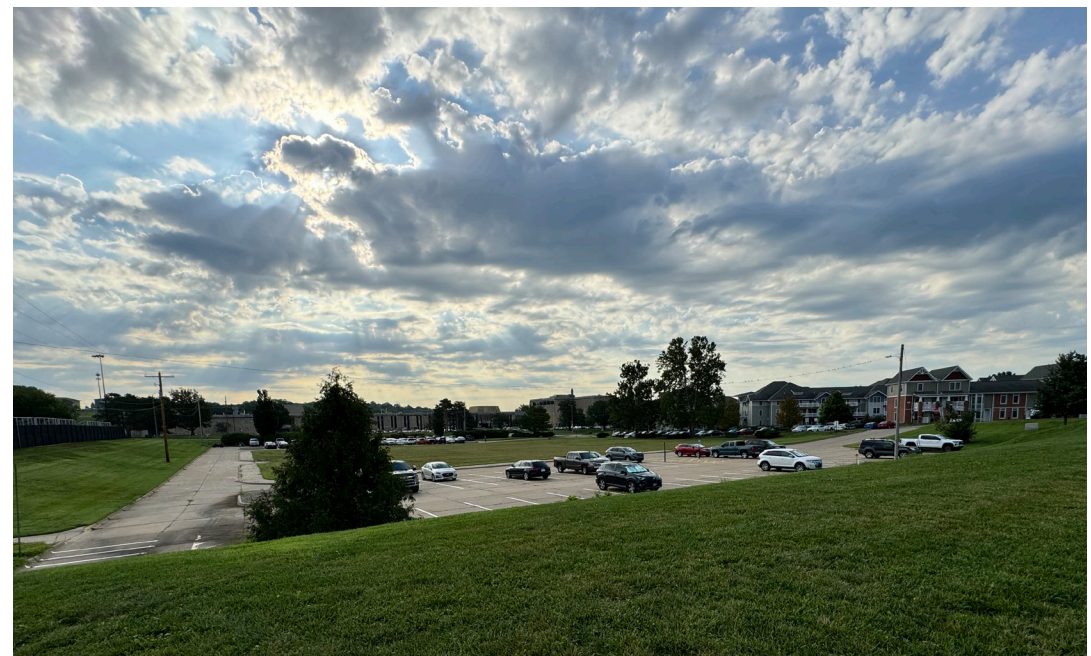
Fig 5.6 Edwards Hall originally was home to campus police within a building. Now the site sits without a building and an opportunity to help with stormwater issues (Freelove 2024).

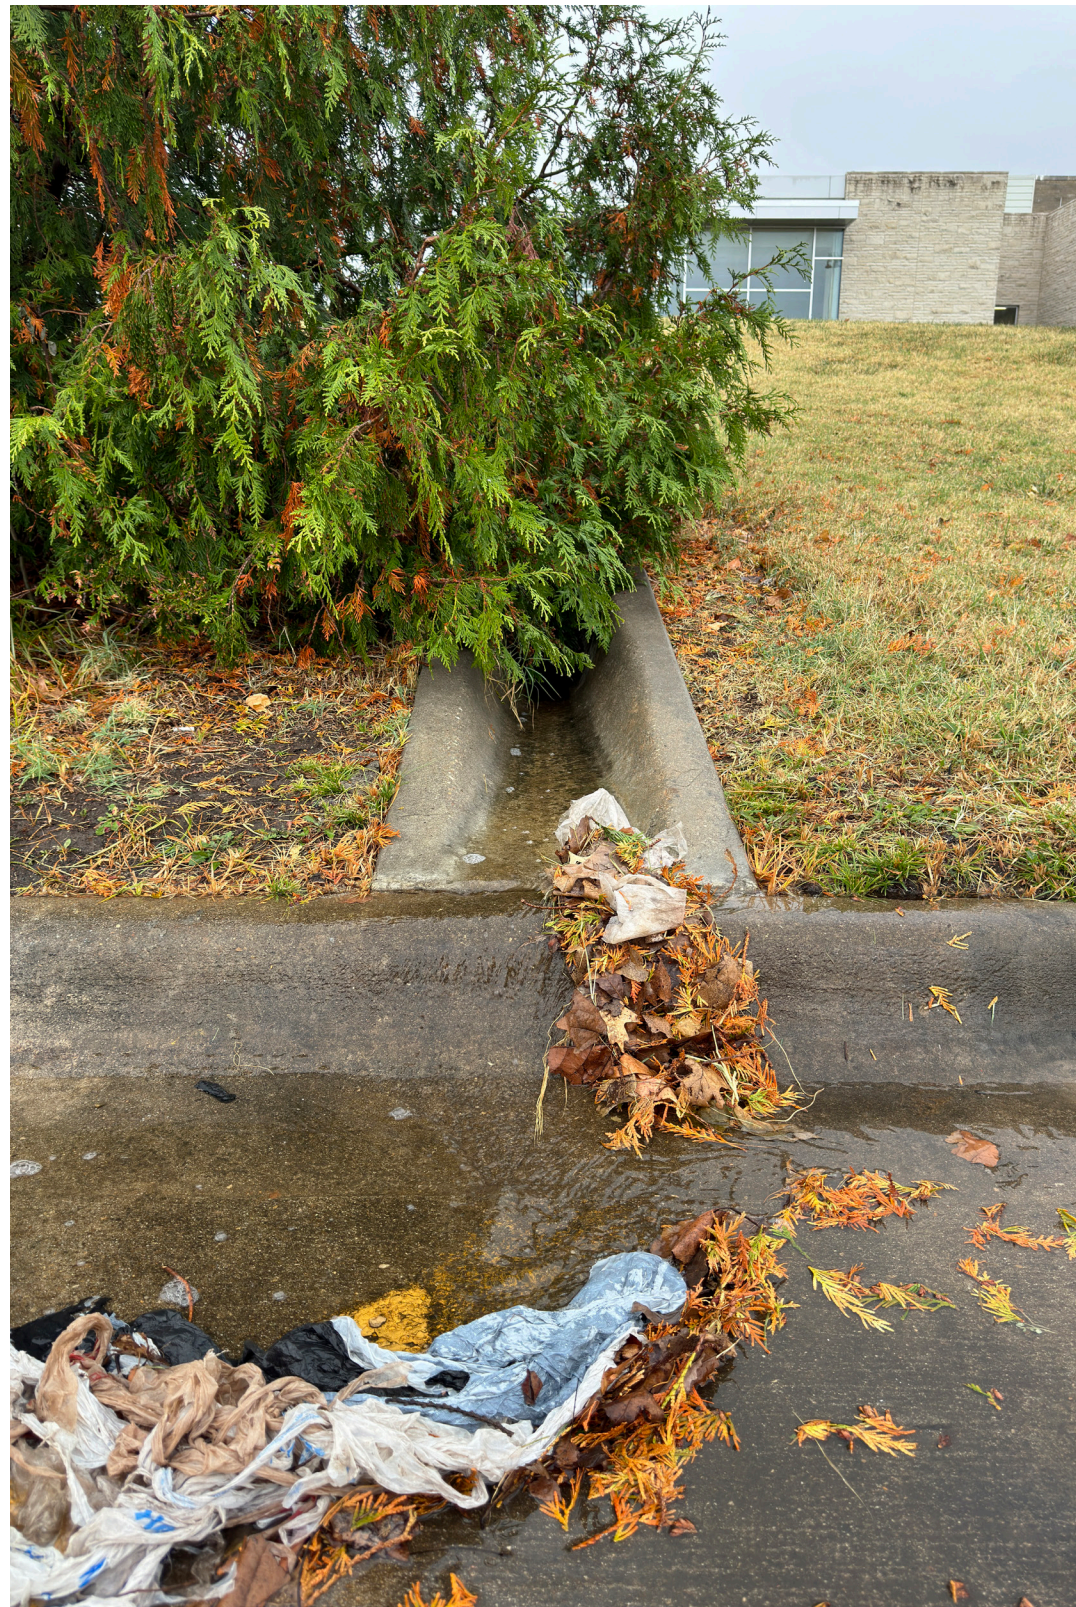
Fig 5.7 Edwards Hall currently has some areas where stormwater expels onto the parking lot, then flows into storm drains without any stoppage (Freelove 2024).

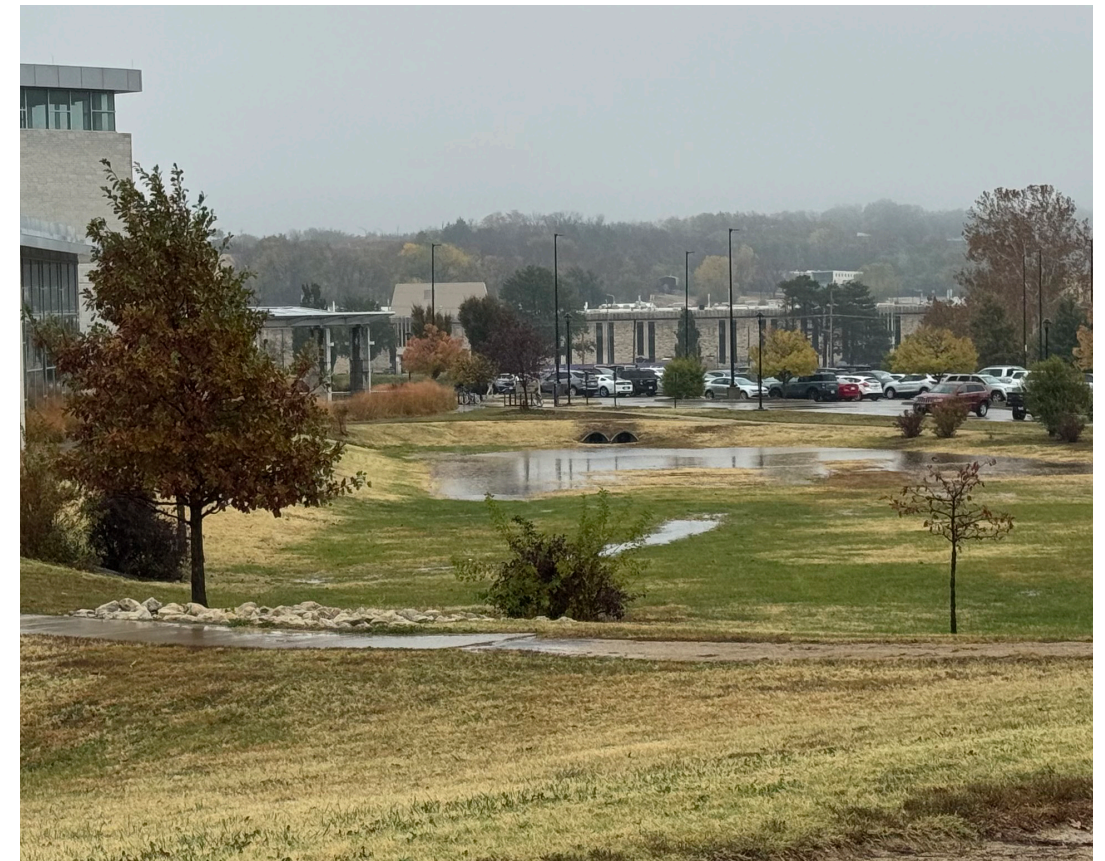
Fig 5.8 The Peters Recreation Complex has a drainage basin in front of the building and could start seeing more runoff with more intense storms (Freelove 2024).

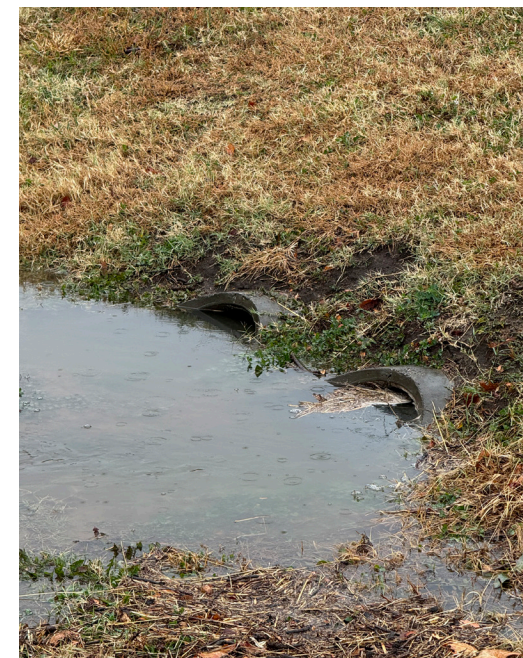
Fig 5.9 Current drainage pipes are filled by off-site sediment, leaves, and debris causing clogging during large rain events (Freelove 2024).

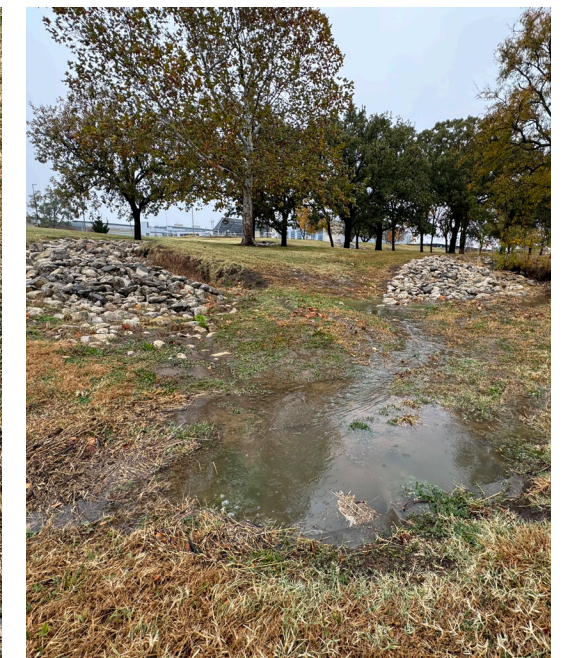
Fig 5.10 The swales on the west side of the Peter's Recreation site see large volumes of water moving through them (Freelove 2024).

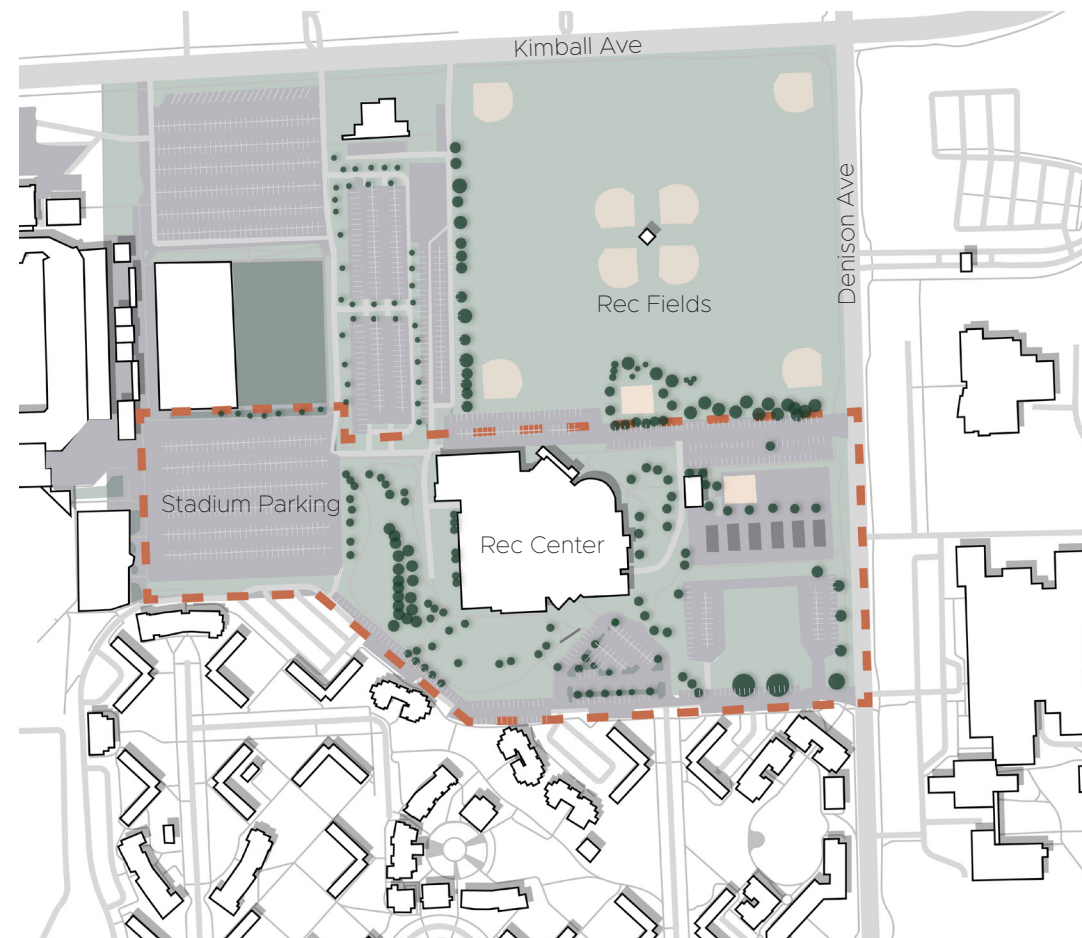
*Fig 5.13 Hardscape and softscape diagram (Kerner 2025).*

Much of the site features hardscape, with large buildings like Peter's Recreation Center, Bill Snyder Family Stadium, and the new practice facility to the northwest. Parking takes up a significant portion of the hardscape, leaving little space for natural plantings that could help slow down fast-moving runoff. Some of the existing trees are in good condition and are included in our design.

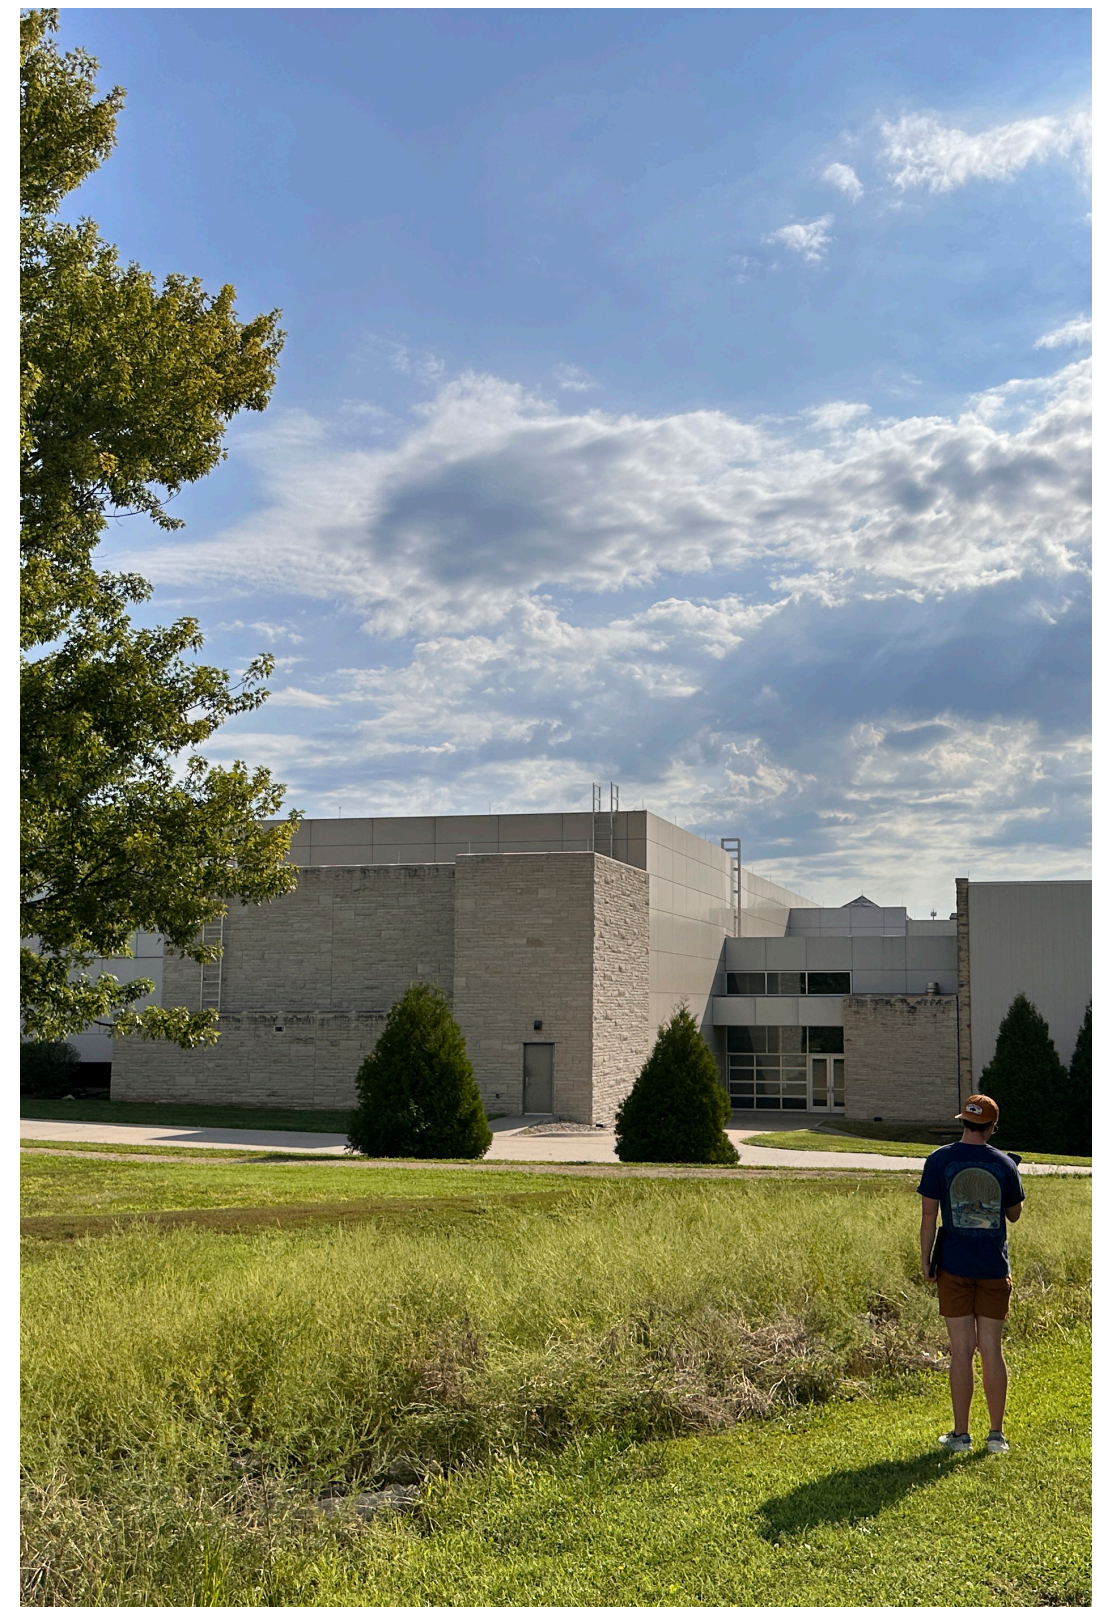
Fig 5.16 The swales provided great maintenance issues with many invasive species, and difficulty in maintaining the swale edges (Tilley 2024).

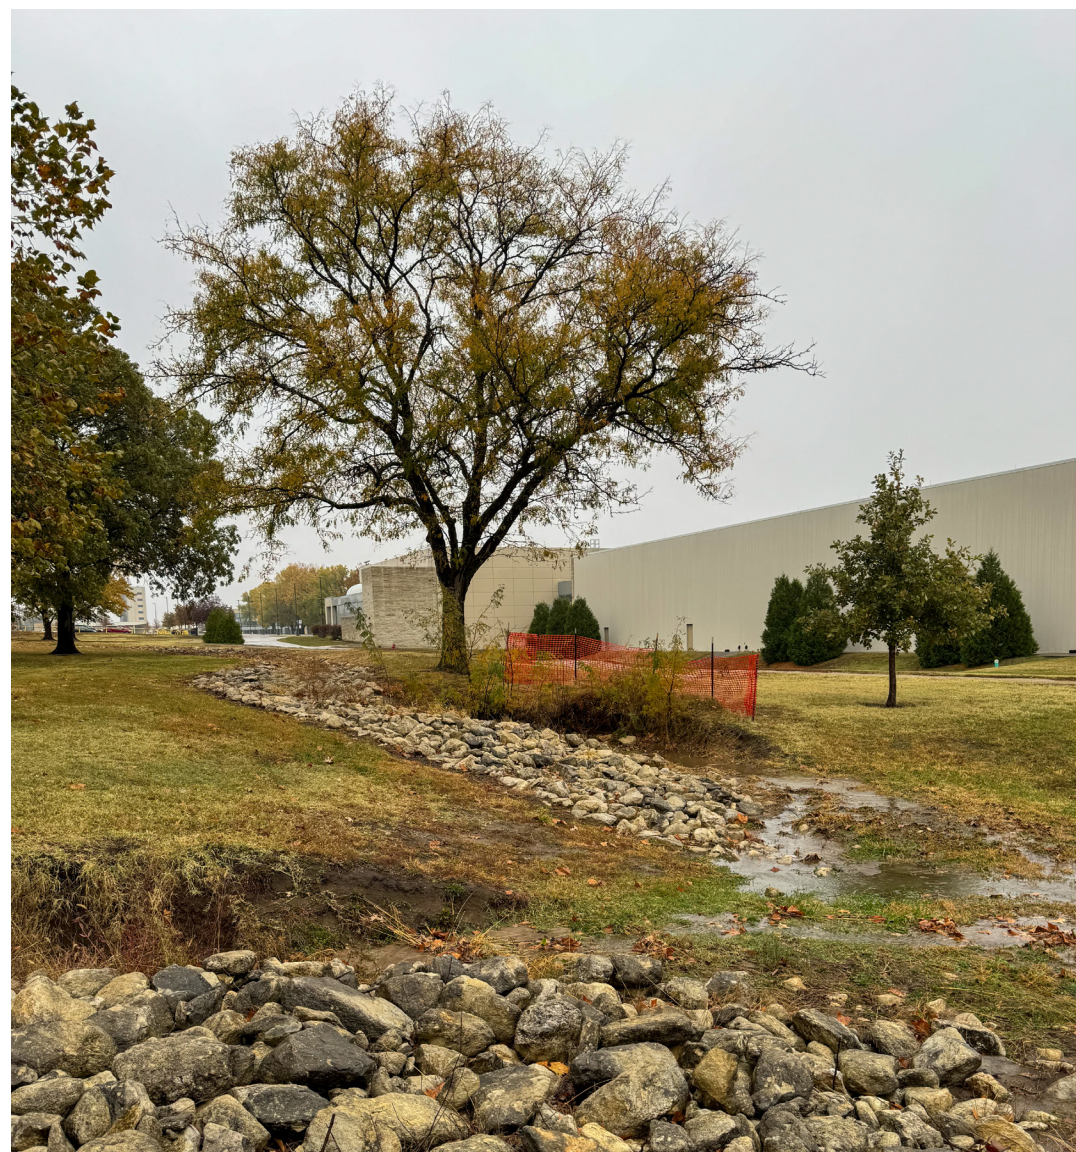
Fig 5.19 Existing conditions of swales west of the Peters Recreation Complex (Freelove 2024).

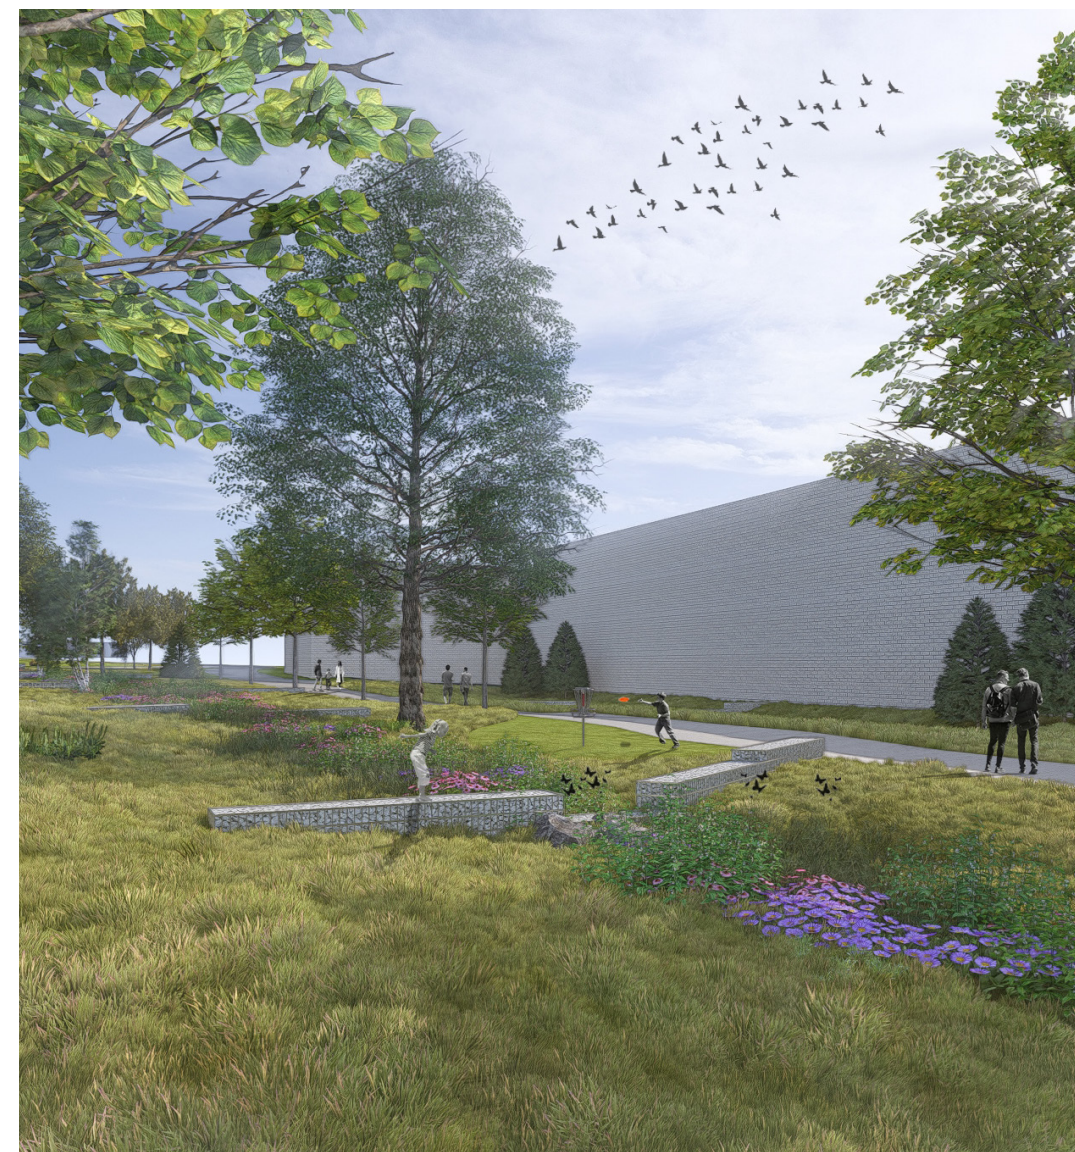
Fig 5.20 Proposed design of swales west of the Peters Recreation Complex (Freelove 2025).

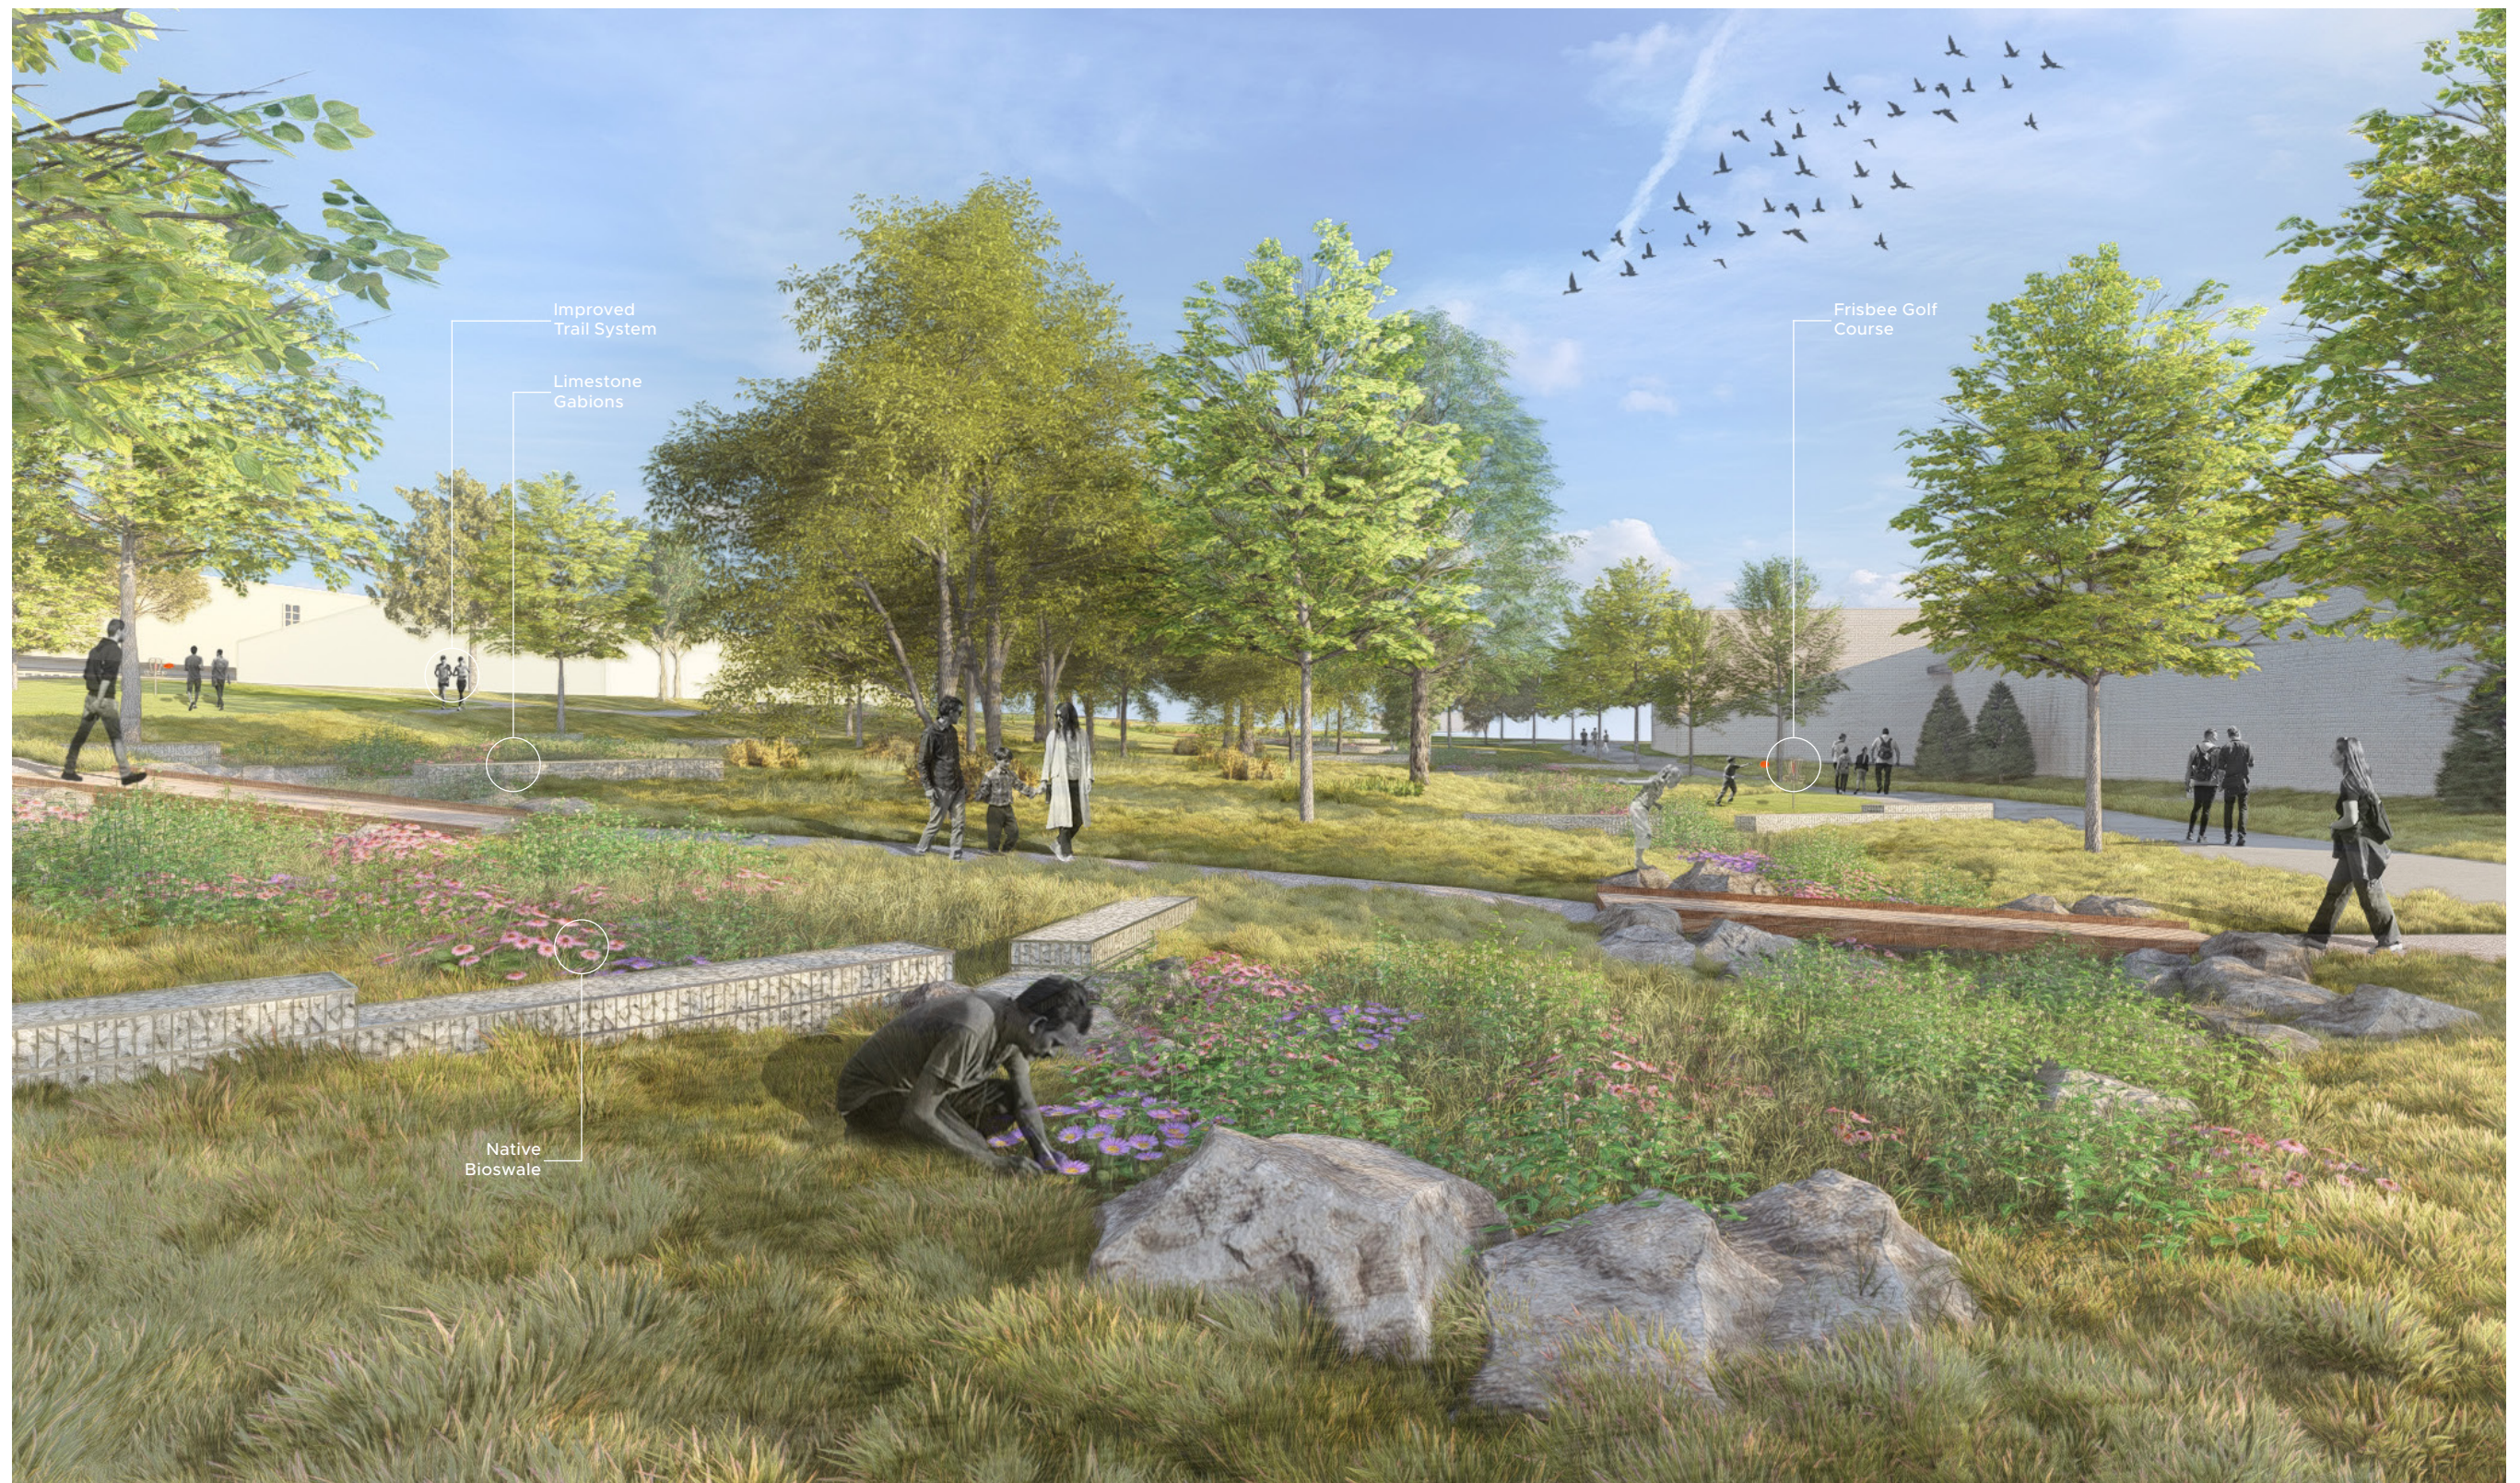
Fig 5.22 The enhanced swale allows for slower water movement, and a more aesthetic and functional landscape. (Freelove 2025).

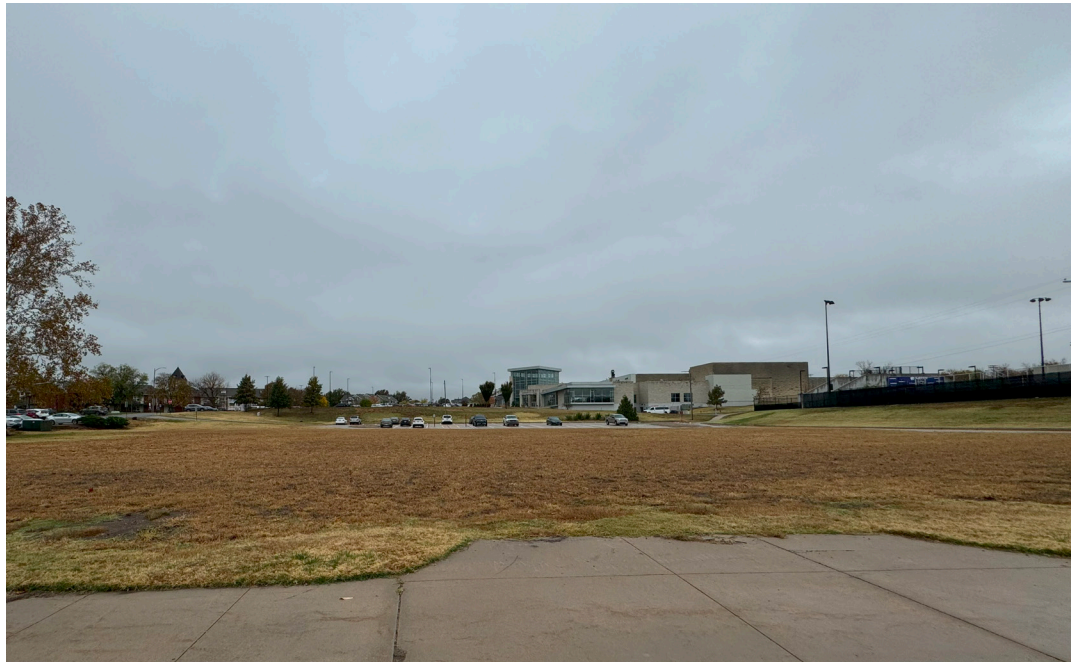
Fig 5.23 Existing Edwards Hall site conditions (Freelove 2024).

The former site was once home to Edwards Hall. Now, an empty turf area is bordered by two impermeable parking lots. Steep slopes from the surrounding area direct fast-moving stormwater along with runoff from the Peters Rec Complex roof. This situation results in unchecked runoff that leads to Campus Creek. This area also undergoes unnecessary and frequent mowing due to the turf area located in the middle of the former Edwards Hall and its surrounding context.

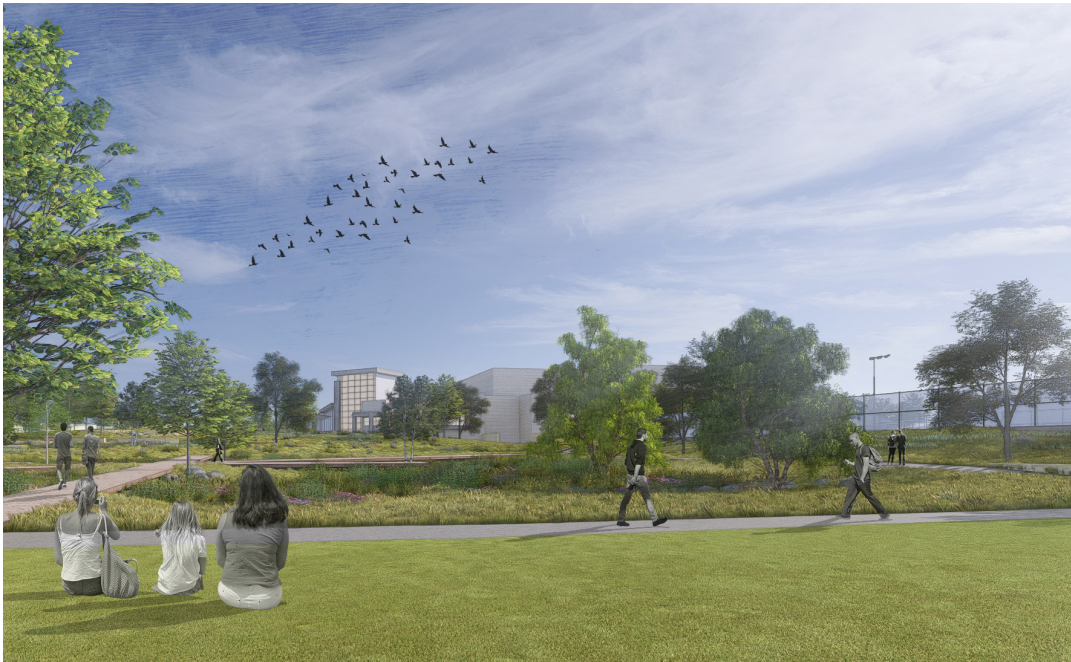
Fig 5.25 Proposed Design of Edwards Hall Site (Freelove 2025).

The projective design transforms the former Edwards Hall into a large, natural bio-retention area. Only one parking area remains, and the surrounding landscape mimics the Flint Hills Ecoregion. Over time, this space will lead to reduced mowing in the area, creating a visually interesting landscape that slows stormwater runoff to Campus Creek. The surrounding slopes have been made less dramatic to ease mowing and have been converted from turf to native grasslands.
