Campus ecology: assessing the performance and management of green infrastructure at Kansas  
State University

MASTER OF LANDSCAPE ARCHITECTURE

KANSAS STATE UNIVERSITY  
Manhattan, Kansas

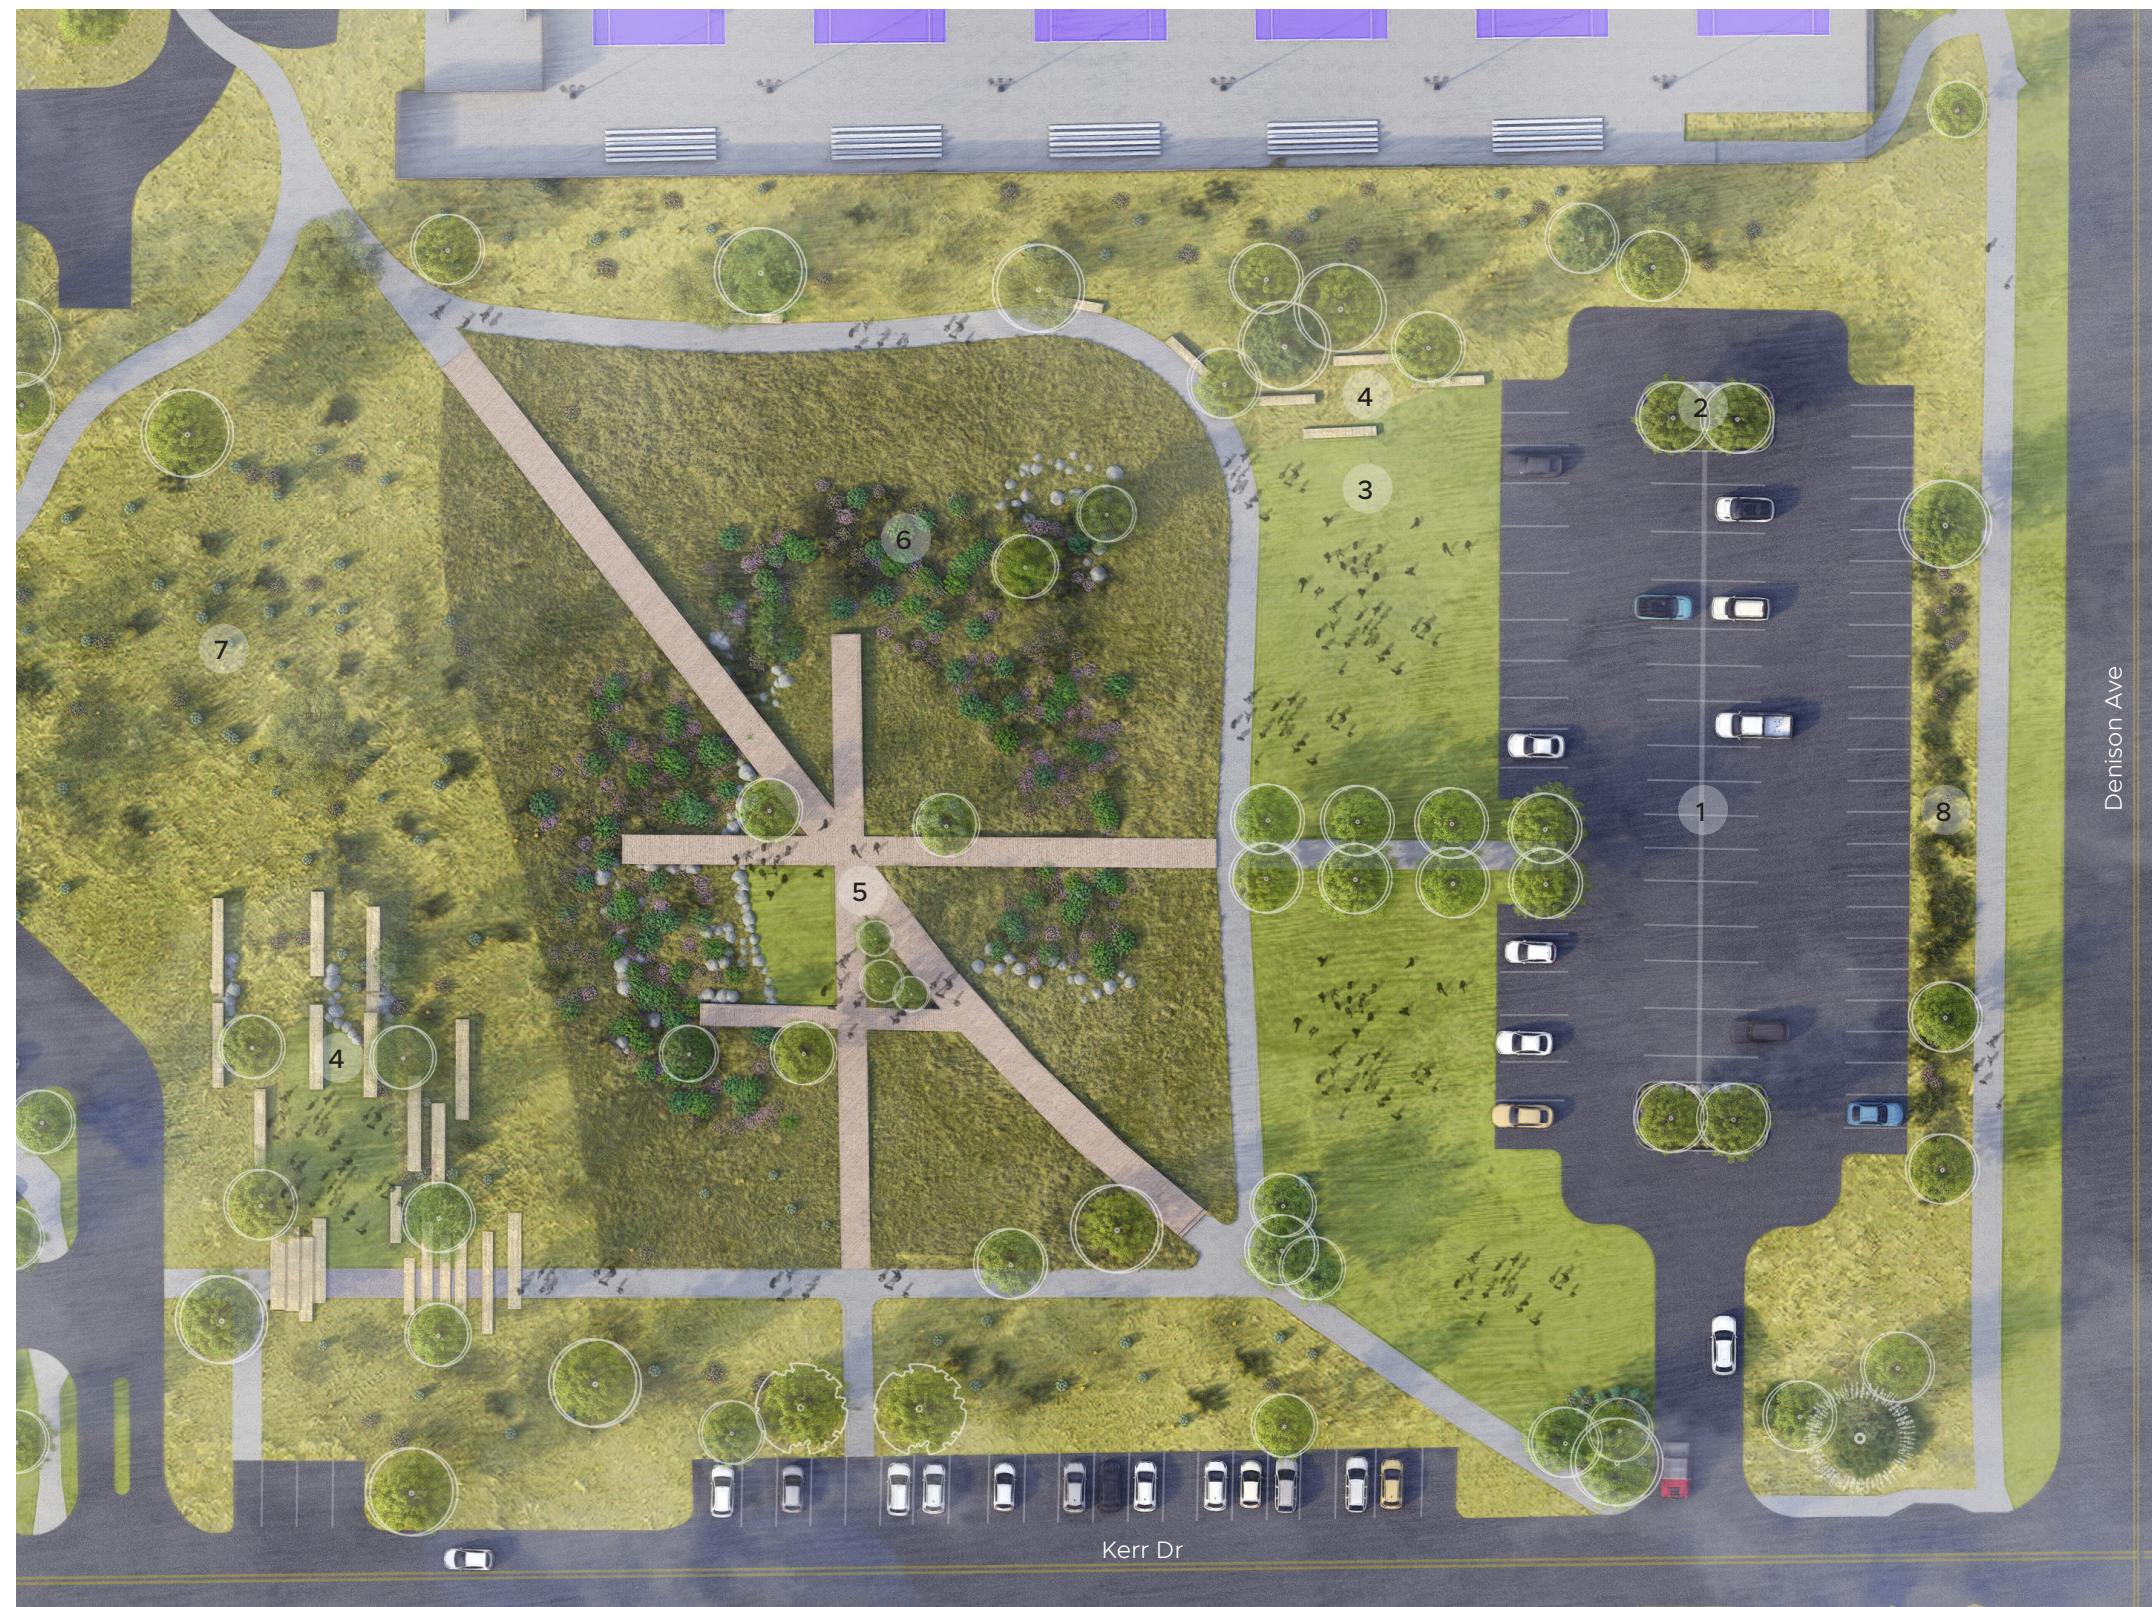
Former Edwards Hall Site Plan

Fig 5.27 Proposed Edwards Hall Site Plan (Freelove 2025).

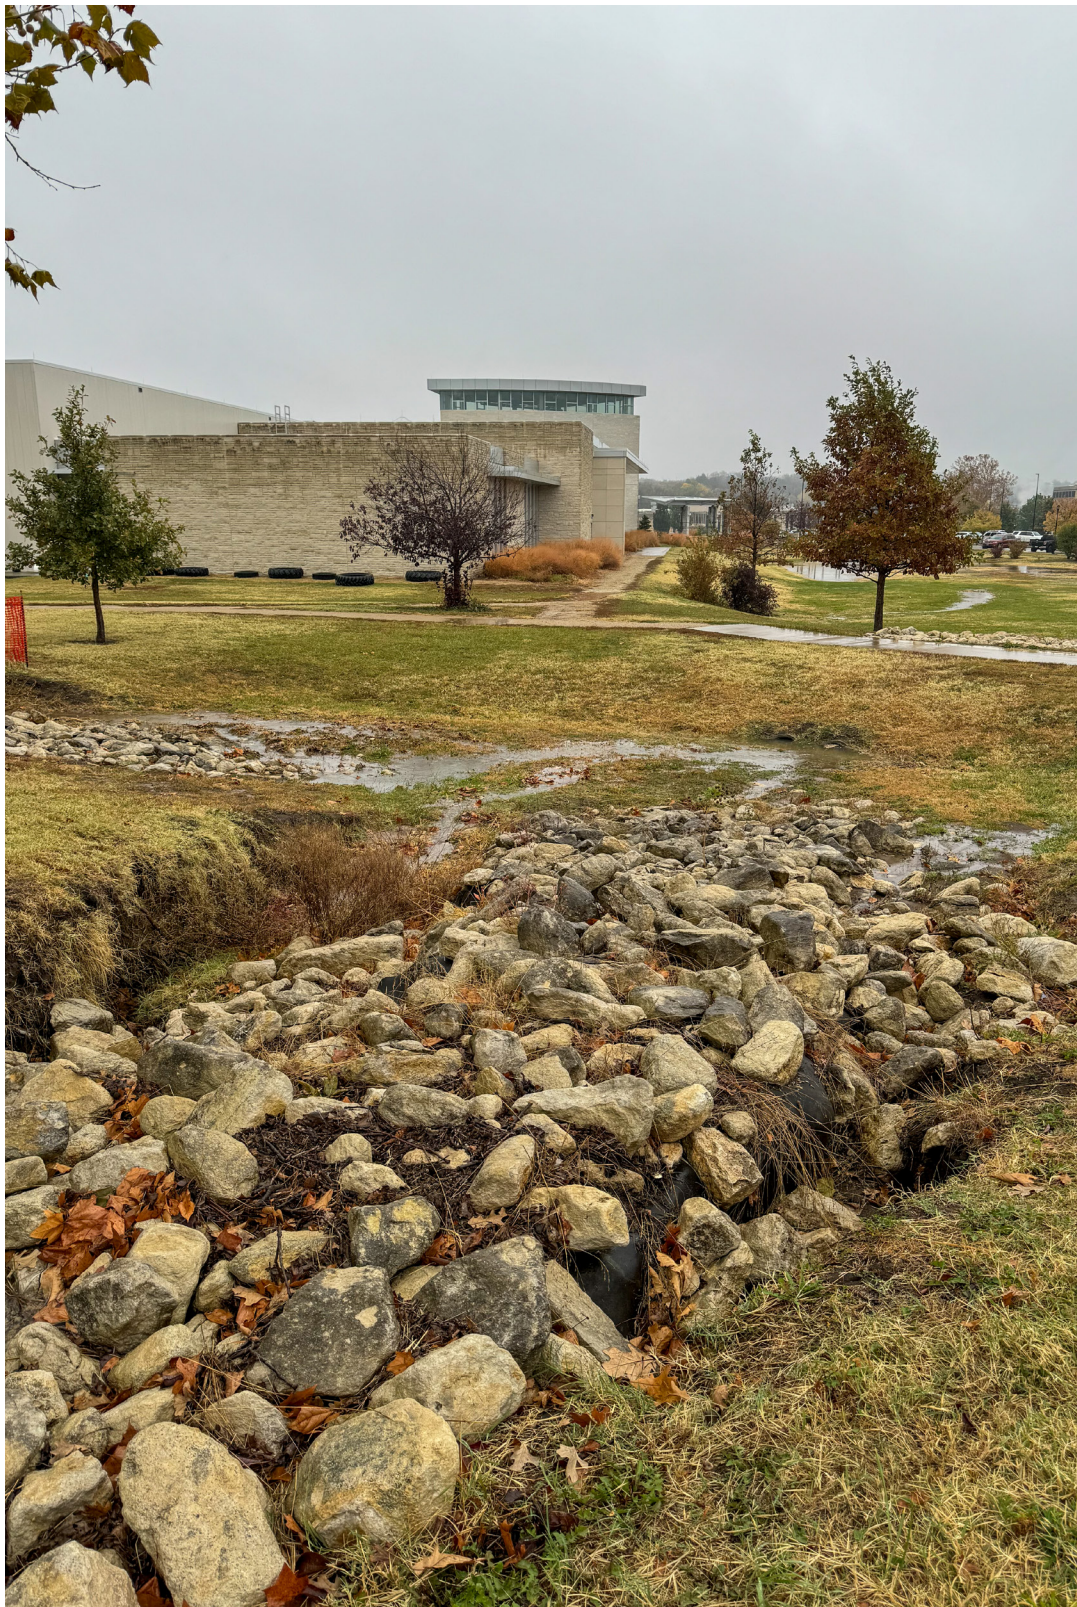
*Fig 6.2 The Peters Recreation Center sees a deluge of stormwater runoff from the surrounding context (Freelove 2024).*

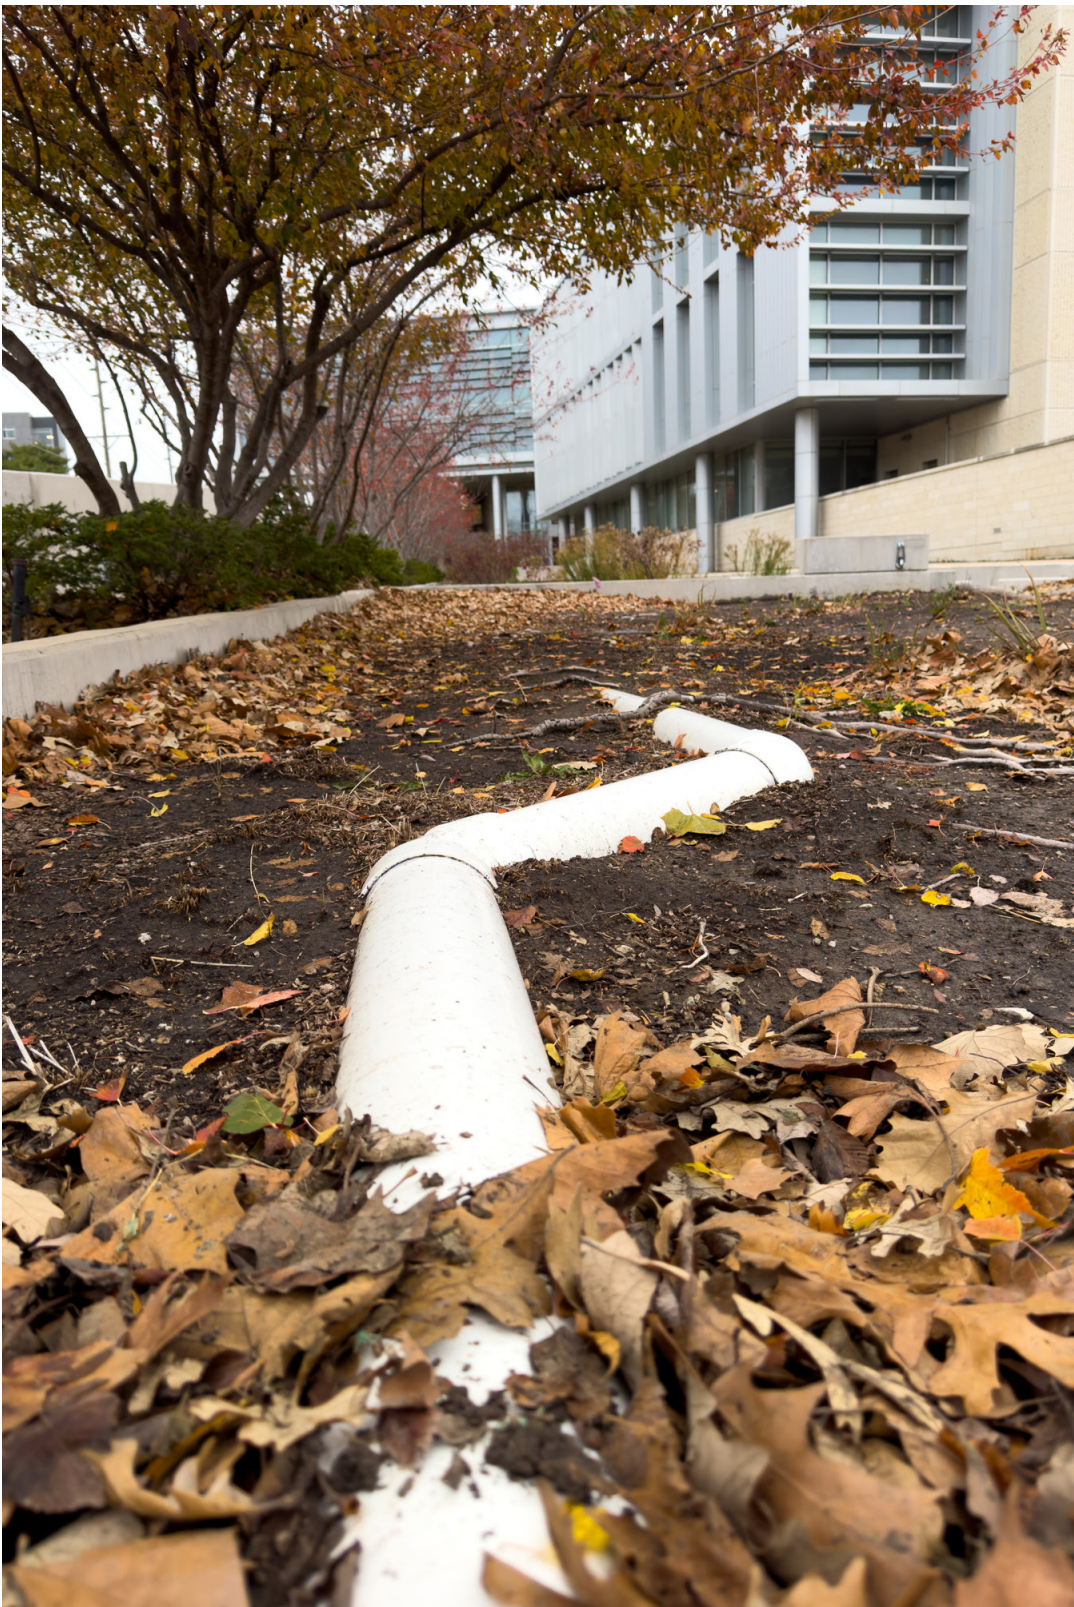
Fig 6.3 Exposed piping in lowest Engineering Bio-Retention Cell at Kansas State (Freelove 2024).

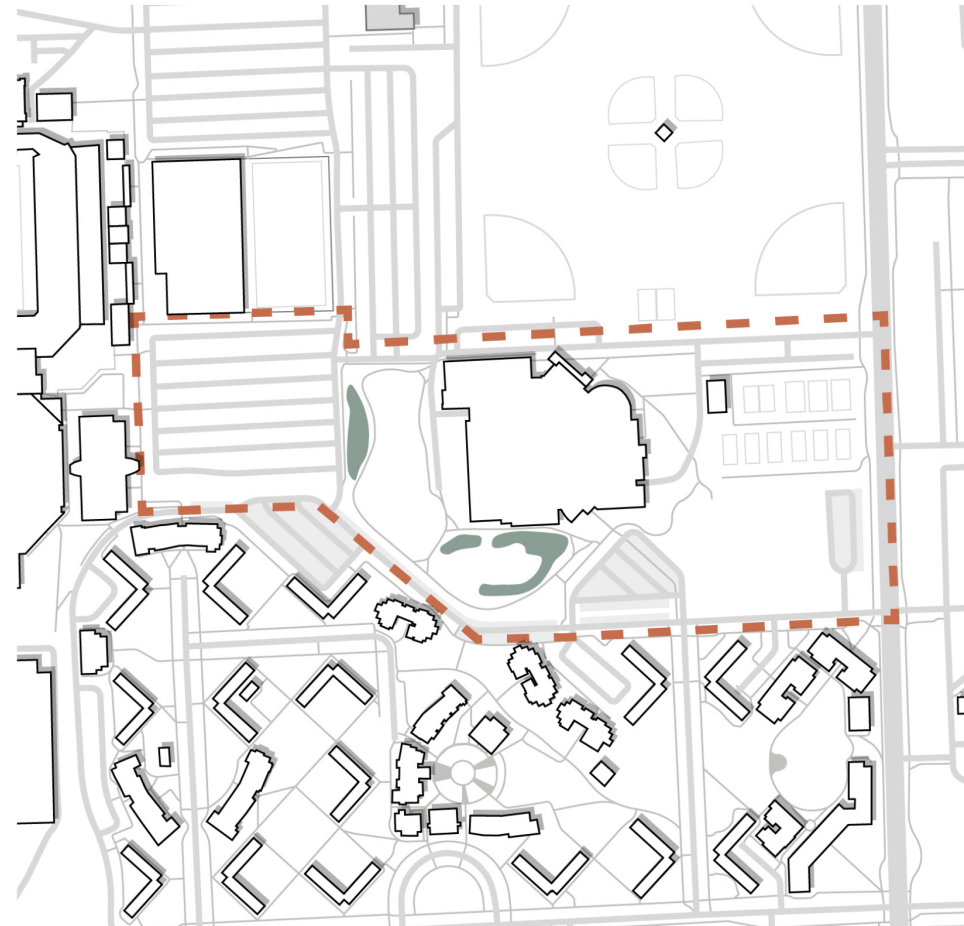
## RAIN GARDENS

- Rain Garden Location
- - - Site Boundary

## GENERAL MAINTENANCE

- Inspect for **erosion, scoured soil, or high levels of deposition** at the bottom of the basin due to high stormwater flow.
- Inspect **inlets, outlets, and piping for erosion, damage, and blockages**. Repair damages and remove blockages. Ensure **easy access**. Remove trash/debris.
- Ensure **water is entering the basin**. There is no deposition of rockery, or within the splash box.
- Remove trash and debris. Inspect for **mosquitoes and remove** from the system accordingly. Ensure **water is drained 48-72 hours after a significant rain event**.

- Remove **invasive, or nuisance species** from the system. Inspect if desired species are dying, and **replace with specified new plants**.
- Ensure adequate plant spacing and soil coverage. **Allowing less than 10% of bare soil in the system**. Trim plantings over pathways.

- Mow edges of planted system to ensure manicured look. Mow system once a year **based on site conditions and plantings**.
- Check during growing and non-growing season to ensure **diversity, density, and vigor**.

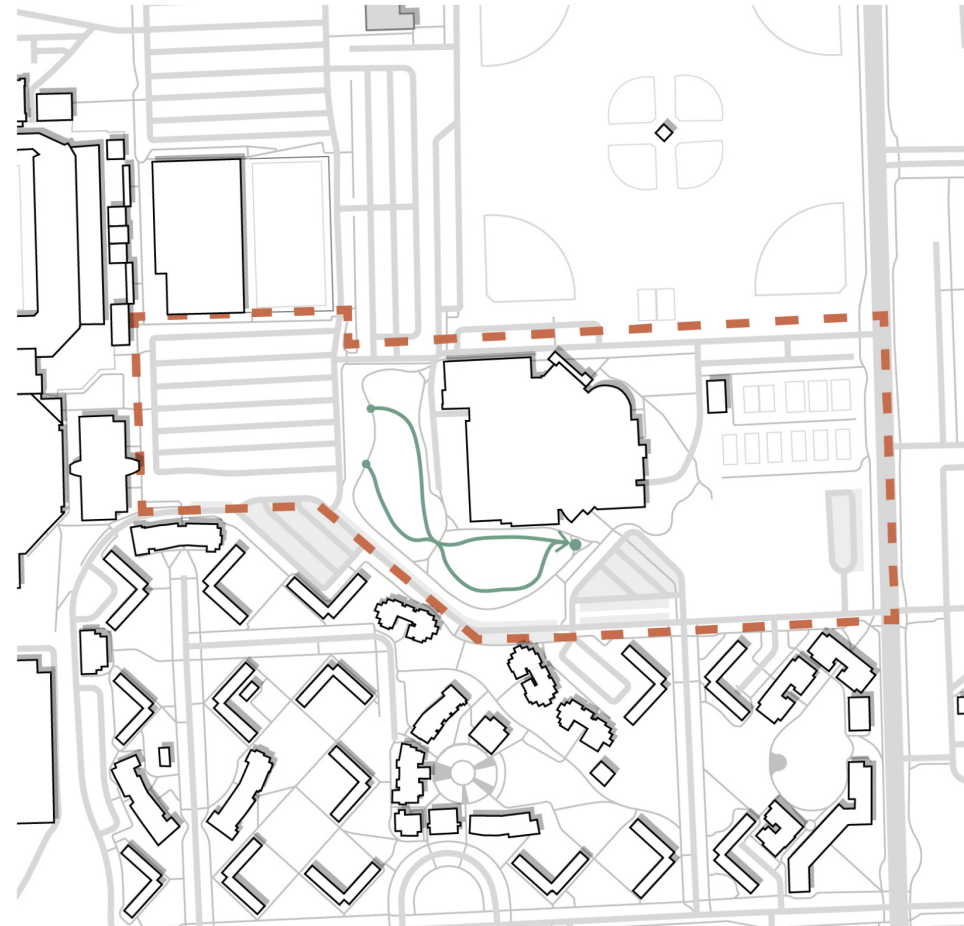
# BIOSWALES

- Bioswale Location
- Site Boundary

## GENERAL MAINTENANCE

- Inspect for **erosion or scoured swale bottom** due to high stormwater flow.
- Remove **trash and debris** from the system.
- Inspect **inlets, outlets, and piping for erosion, damage, and blockages**. Repair if noted. Inspect **gabions for damage or loss of material**.
- Ensure **flow spreader (rip rap) is not moved across or throughout the swale**, and no erosion is taking place.
- Look for any damages to the physical infrastructure, and natural elements, and repair.
- Inspect for **pollutants** such as oil, gasoline, paint, etc. If present after a rain event, dispose of materials accordingly.
- Inspect **swale and step pools 72 hours after rain** event to ensure there is **no standing water**.
- If **mosquitoes** are present, **remove from system** accordingly.

- Remove **invasive, or nuisance species** from the system. Inspect if desired species are dying, and **replace with specified new plants**.
- Ensure adequate plant spacing and soil coverage. **Allowing less than 10% of bare soil in the system**. Trim plantings over pathways.
- Mow edges outside of planted system** to ensure manicured look. **Mow system once based on site conditions** and plantings.
- Check during growing and non-growing season to ensure **diversity, density, and vigor**. **Irrigate during extreme drought periods**.

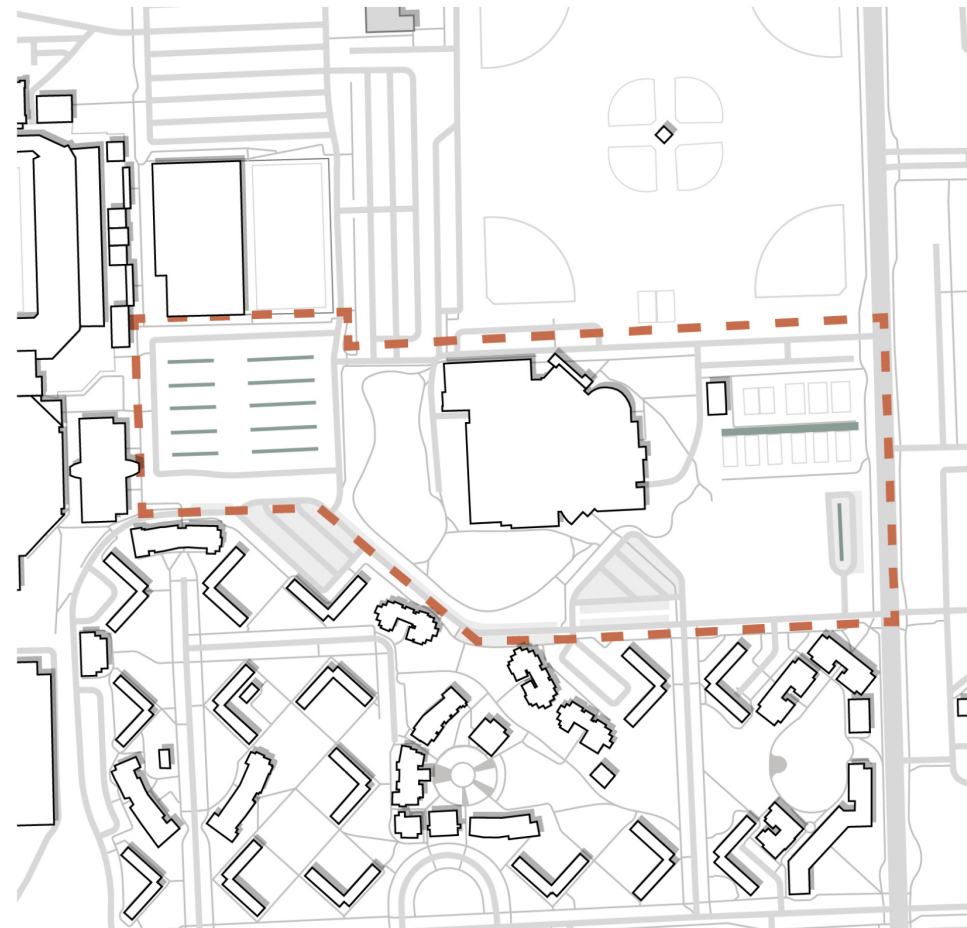
## PERMEABLE PAVING

- Permeable Paving Location
- - Site Boundary

## GENERAL MAINTENANCE

- Inspect surface course after every **storm exceeding 1 in of rainfall. Remove unwanted sediment** after surface is fully drained.
- Surface must be inspected once annually **for cracking, spalling, erosion, and unwanted plants. Herbicides cannot be used.**
- Check for **debris, damage, and blockages. Repair** damage and marks.
- Care should be used when removing snow. **Sand, grit or cinders may not be used for snow or ice control**
- De-icing **chemicals cannot be used** on pervious material **less than one year old**
- Surface **must be vacuum swept 4 times a year**, followed by air blowing or power washing.

- Drain time **must be tested each spring after the last snow or ice event.** This should be based on what infiltration rate is specified for a certain amount of water poured on the surface.
- If actual drain time and design drain time are drastically different, its **components must be evaluated**
- If the system **fails to drain in 72 hours, corrective action must take place.**

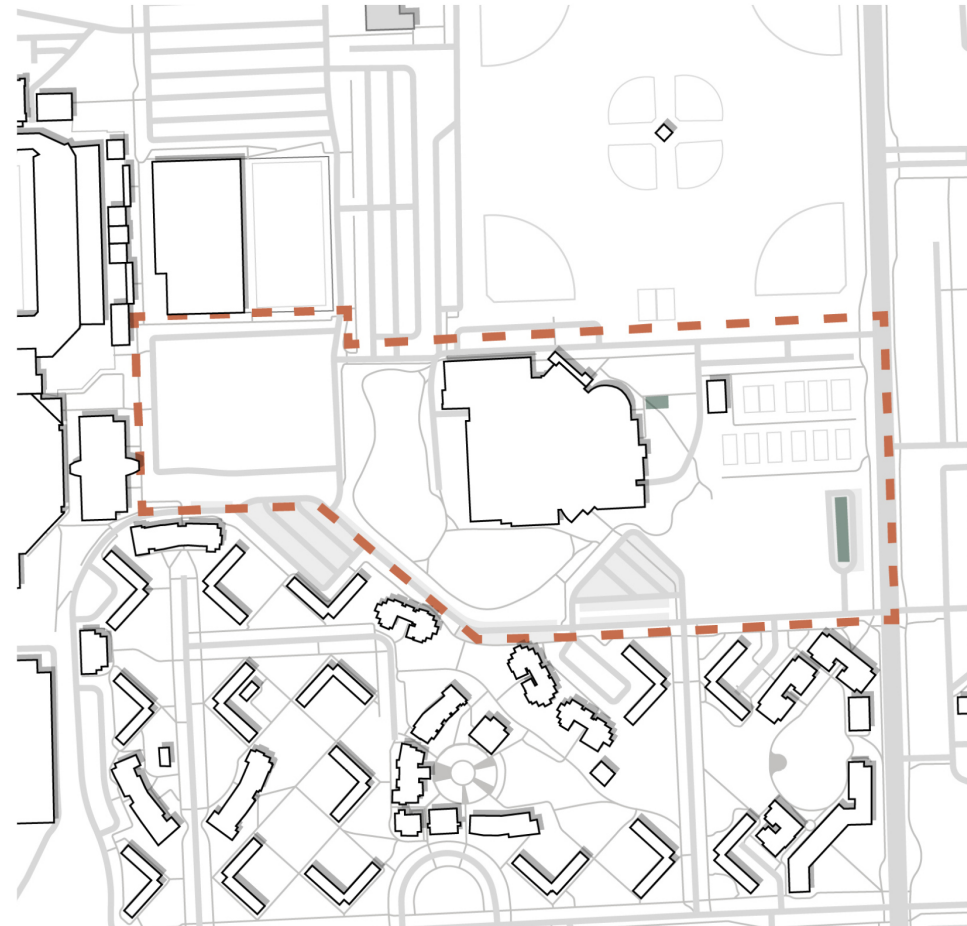
## BELOW GRADE CISTERNS

- Cistern Location
- - - Site Boundary

## GENERAL MAINTENANCE

- Check for **debris, damage, and blockages**. Repair damage if any.
- Check **pumps and controls** for **warnings or failures**.
- **Remove excess debris and sediment** that causes blockages
- Access points must be **clearly defined and visible**.
- Check insect screen for damage. **Replace if damaged or if mosquitoes are present** in the cistern. Remove mosquitoes if present.
- Check **reuse systems and filters for damage and blockages**.

- Inspect **regularly within 72 hours of a rainfall event to ensure the cistern is empty**. If not empty, repair damage, check controls, or remove sediment from the system.
