Innovative stainless-steel connector for double-tee girders under various loading conditions

A THESIS

Department of Civil Engineering
Carl R. Ice College of Engineering

KANSAS STATE UNIVERSITY
Manhattan, Kansas

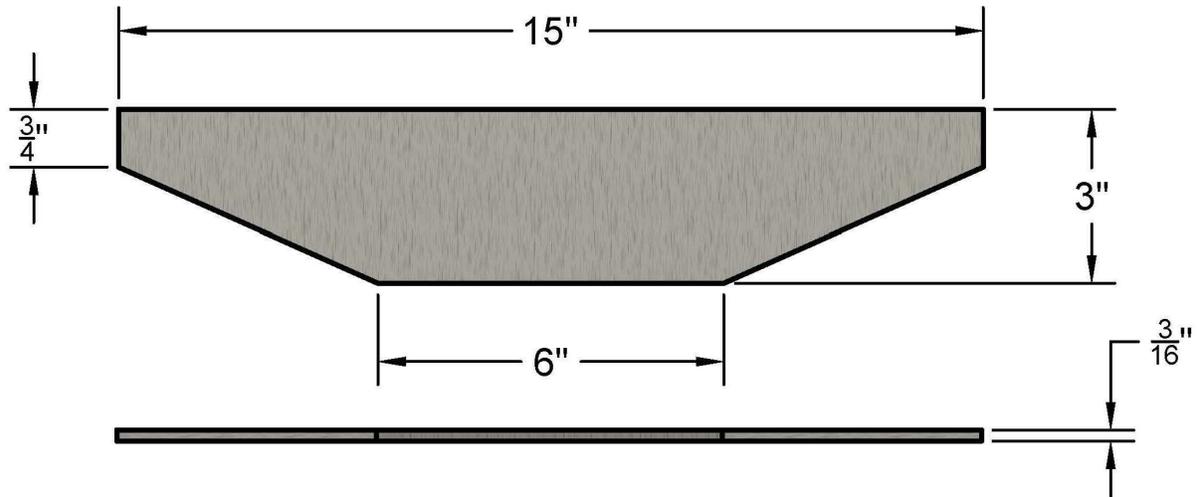
Figure 1.1. V-Wrap Stainless-Steel Shear Connector

The connectors were composed of 3/16-inch thick T316 Stainless-Steel (UNS S31600) and were trapezoidal in shape with a top length of 15 inches, a bottom length of 6 inches, and a height of 3 inches, see Figure 1.1. The concrete slabs that the connectors were embedded in were 48"x48"x4" normal-weight reinforced concrete. The reinforcement in the slabs was 6"x6" wire mesh and two #4 bars that cross diagonally across opposite corners of the slabs with hooked ends, see Figure 1.2. This slab detail is similar to a previous research study from Shaikh and Feile (2004). An additional section of rebar was bent and tied to the slab reinforcement to create a lifting hook on the top face of the slab. The connectors were not cast into the slabs for their embedment but were installed after the slabs had cured. The installation process of the connectors into the slabs followed a procedure for how they would be embedded to repair pre-existing concrete structures. This procedure required the specimens to be prepared with tools and equipment that would be available to construction workers on a job site and not in a lab setting. Epoxy resin was chosen as the material to conjoin the connectors to the slabs.

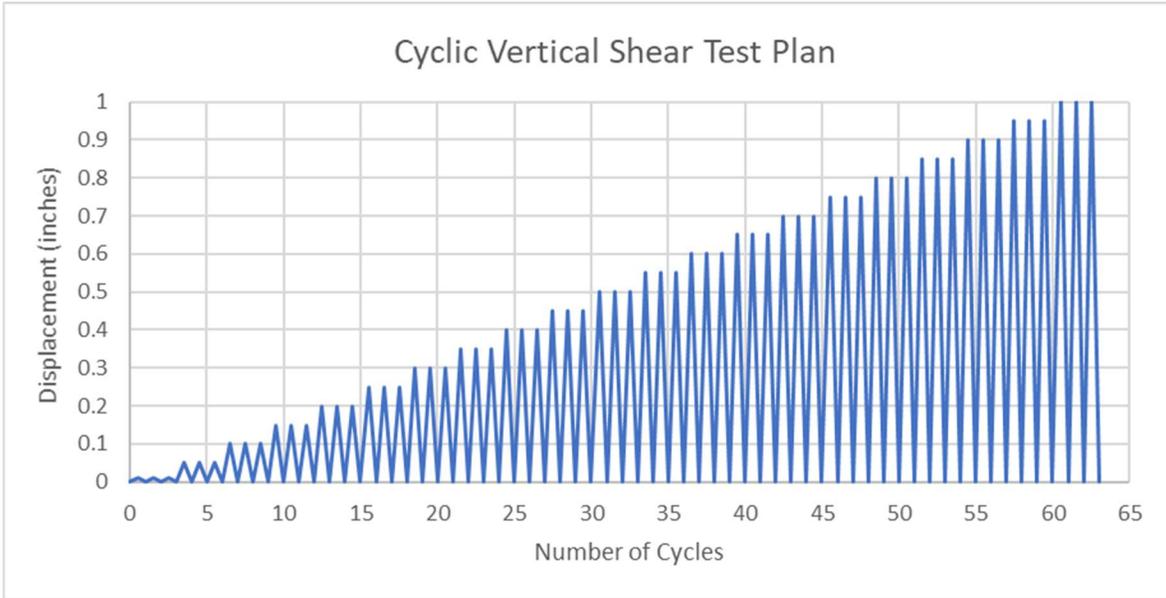
Figure 5.22. Cyclic vertical shear loading

The cyclic vertical shear test setup followed the same displacement envelop as the monotonic vertical shear test except for the addition of a longer loading bar in the test fixture, see Figure 5.23 and Figure 5.24. The longer loading bar allowed another bolt to be added to the fixture, increasing rigidity. The monotonic vertical shear tests experienced peak load at an average deformation of approximately 0.550 inches. Displacement increments of 0.050 inches/step were used until the specimen failed or one inch of displacement was achieved, see Figure 5.22.

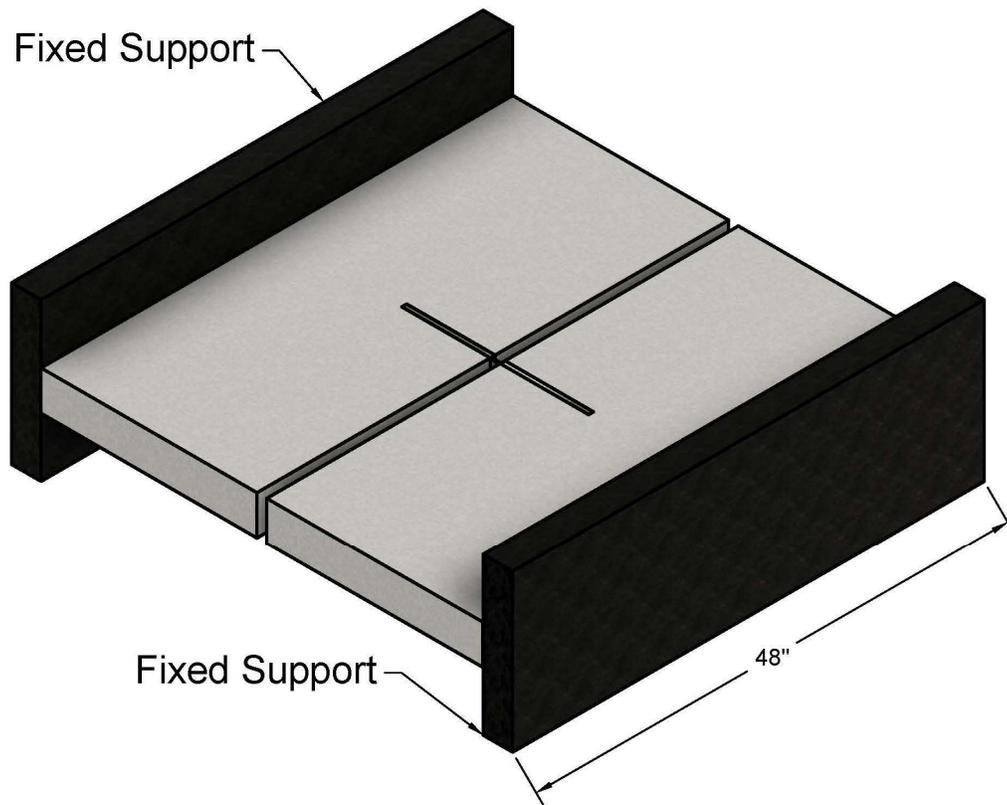
Figure 5.25. Flexural test setup

The flexural test was designed to analyze the response of the connector when it was embedded into two cantilevered slabs that would replicate the connection between flanges of two precast double-tee concrete beams, see Figure 5.25. The two slabs that were used for this test were S8 and S9. Two sides of S8 were used for cyclic horizontal shear tests and S9 was not used in a prior test. The previous tests performed on S8 would not impact the results on this test because the slab did not experience concrete cracking and the embedments were not in the cantilevered span.

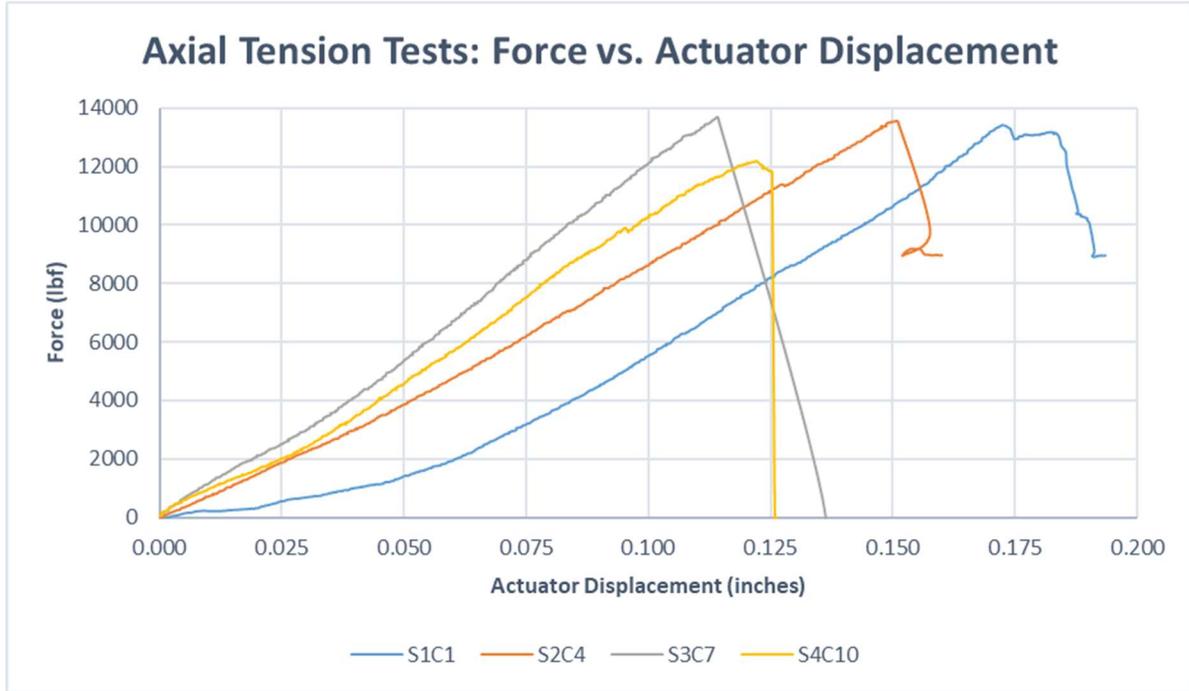
Figure 6.1. Axial tension tests force versus actuator displacement plot

Axial tension tests were the first tests conducted in this research. The connectors that were tested were S1C1, S2C4, S3C7, and S4C10. The tensile force-displacement plots generated from the data show a linear relationship until failure, which was at the maximum load. The average maximum load for the tests was 13,220 lbf, the average actuator displacement at the maximum load was 0.1400 inches, and the average of the recorded string potentiometer displacements at the maximum load was 0.0713 inches. The maximum force and displacements for each test is displayed in Table 6.1. The test plots for the four tension tests were presented in terms of the axial tension force versus the actuator displacement and the string potentiometer displacement and are shown in Figure 6.1 and Figure 6.2, respectively.

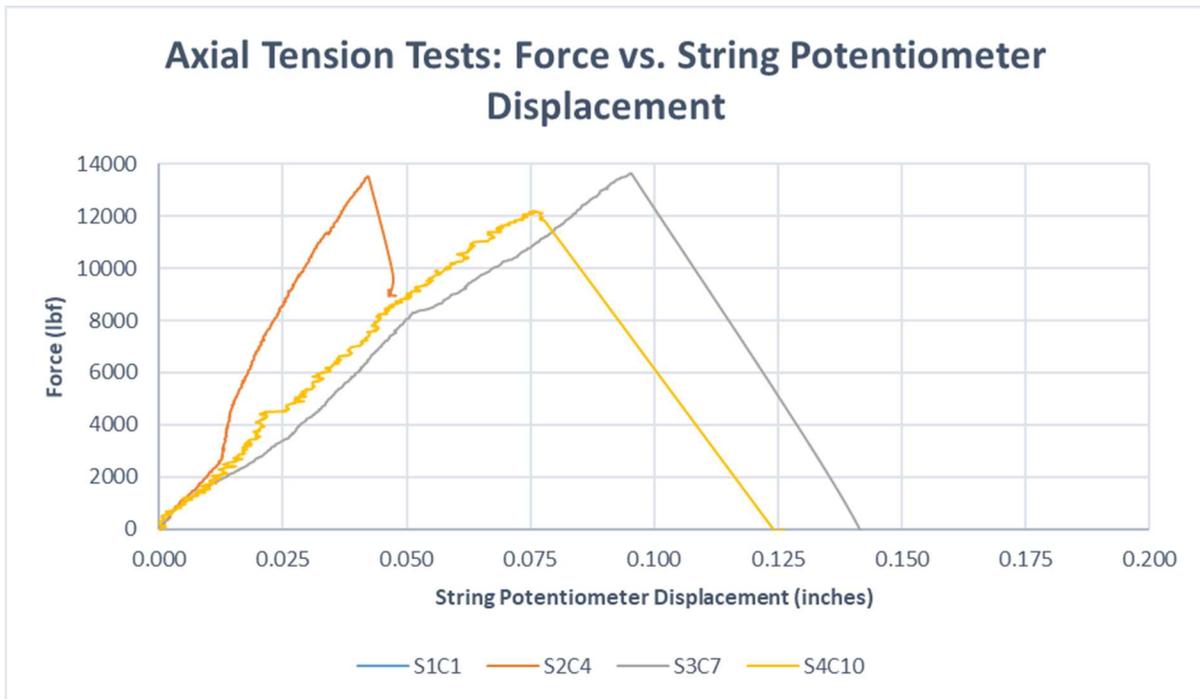
Figure 6.2. Axial tension tests force versus string potentiometer displacement plot

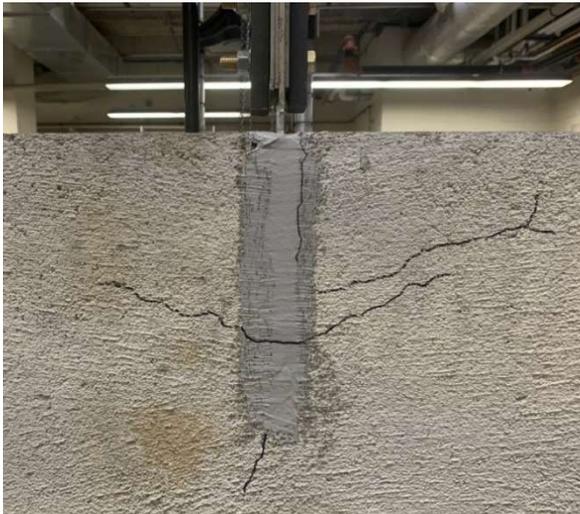
Figure 6.3. S1C1 top slab face cracking

The first axial tension test was on the connector named S1C1. The string potentiometer displacement data was not recorded during this test due to an MTS data acquisition system program error. The actuator displacement recorded for this test was not accurate due to the insufficient supports to restrain the slab from movement during the test. After this test, the steel columns were fabricated and added to the test setup to hold the slab from slightly lifting up during the application of axial tension, as mentioned in the experimental program chapter. This was uniformly done for the other three tensile tests. The force achieved during this test was in the same range as the other tensile tests and was assumed to be accurate. This assumption was verified by the failure mode of concrete cracking under axial tension in a diagonal pattern, which was the same as in tests for S2C4 and S4C10. The cracking of S1C1 is shown in Figure 6.3 and Figure 6.4.

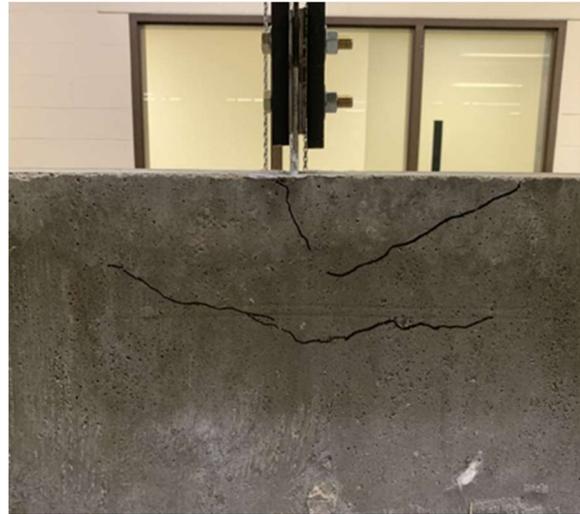
Figure 6.4. S1C1 bottom slab face cracking

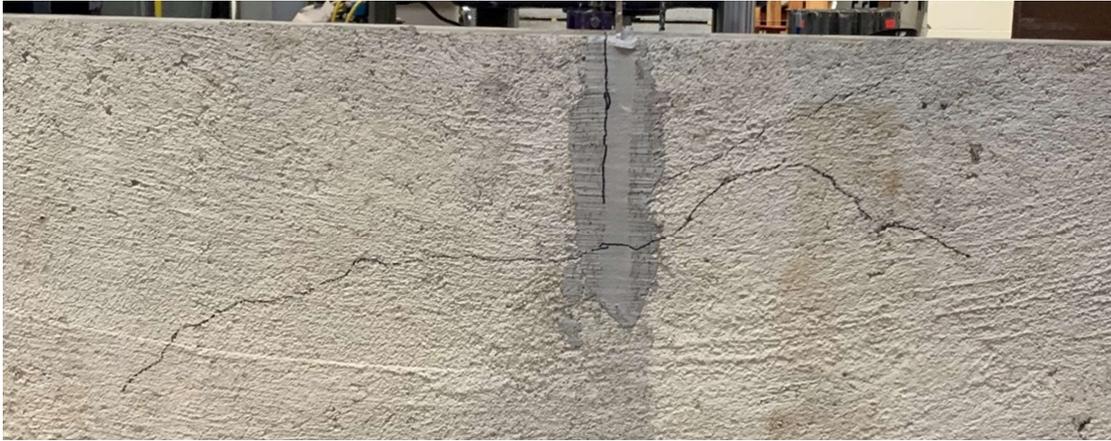
Figure 6.5. S2C4 top slab face cracking

during the two remaining tests. The slab was sufficiently fixed in place and achieved the second largest load of the tensile tests. Figure 6.5 and Figure 6.6 show the cracking around S2C4 after testing.

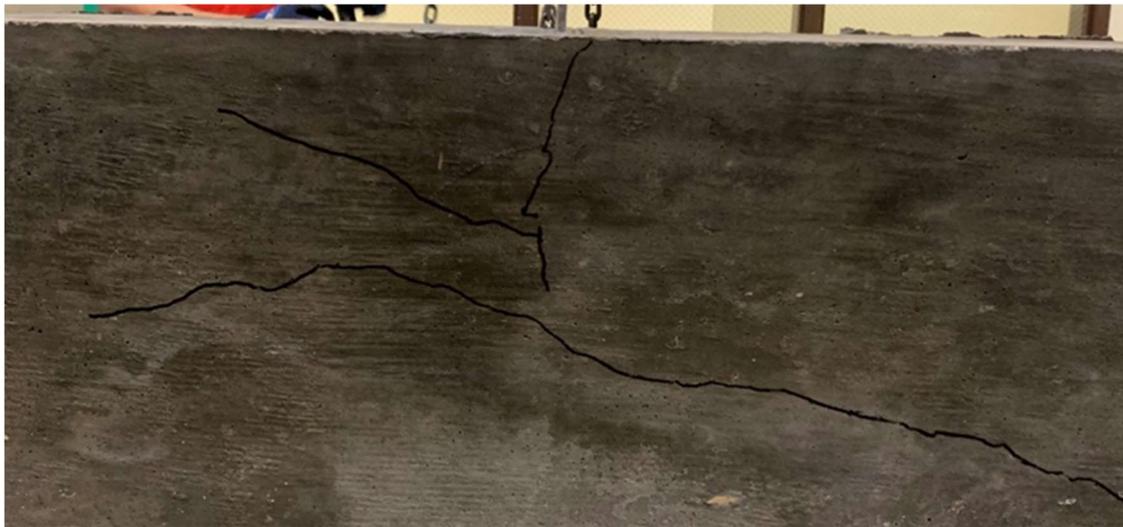
Figure 6.6. S2C4 bottom slab face cracking

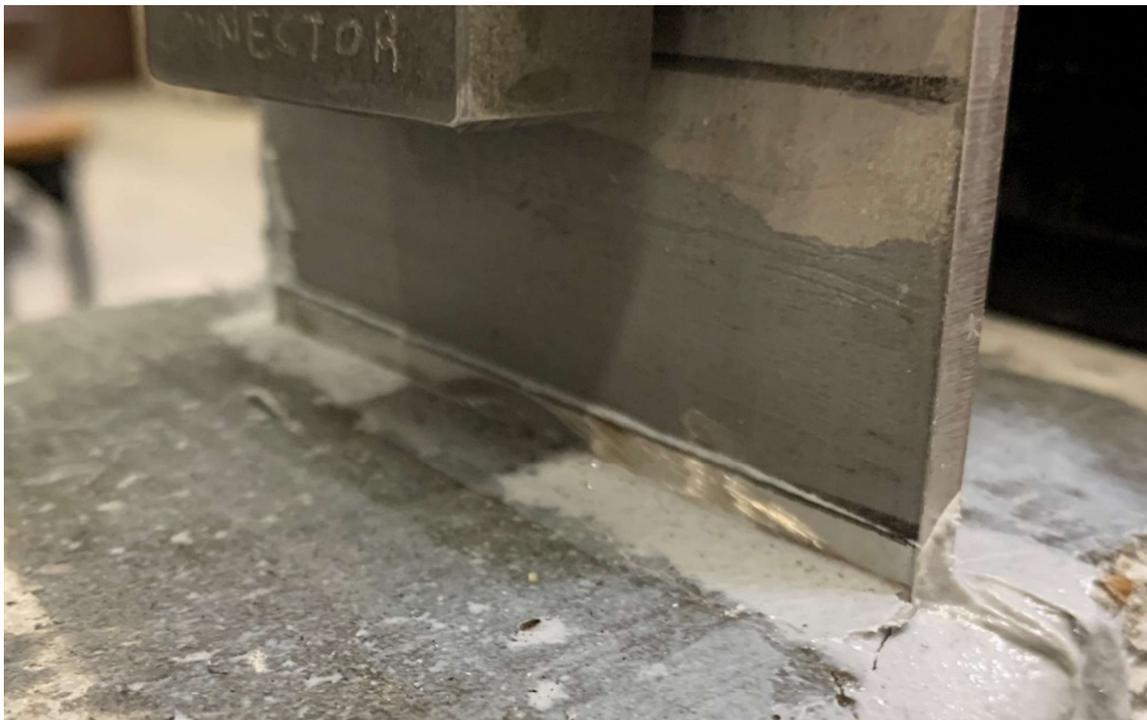
Figure 6.7. S3C7 after the epoxy slipping from around the connector

The third axial tension test was on the connector named S3C7. This test achieved the highest loading of the tensile tests. The failure mode of this test was from the connector instantaneously debonding and sliding outwards away from the epoxy, which caused all the strength to be lost. The failure mode is shown in Figure 6.7. When the epoxy bond failed, it

caused a significant increase in displacement by 0.047 inches on the string potentiometer data and by 0.022 inches in the actuator displacement data. Debonding of the connector from the epoxy only occurred during this test. This was the only test that the concrete slab did not crack in, as seen in Figure 6.8. However, it was noted that this slab was outside the night before the test and had some ice frozen on the connector. All the ice was removed from the connector and slab when it was brought into the laboratory and was indoors for about an hour before testing. This exposure to cold weather was believed to have affected the epoxy resin making it the weak link in this test. Interestingly enough, the ultimate load of this test was still found to be similar to those of the other three tests that failed by concrete cracking.

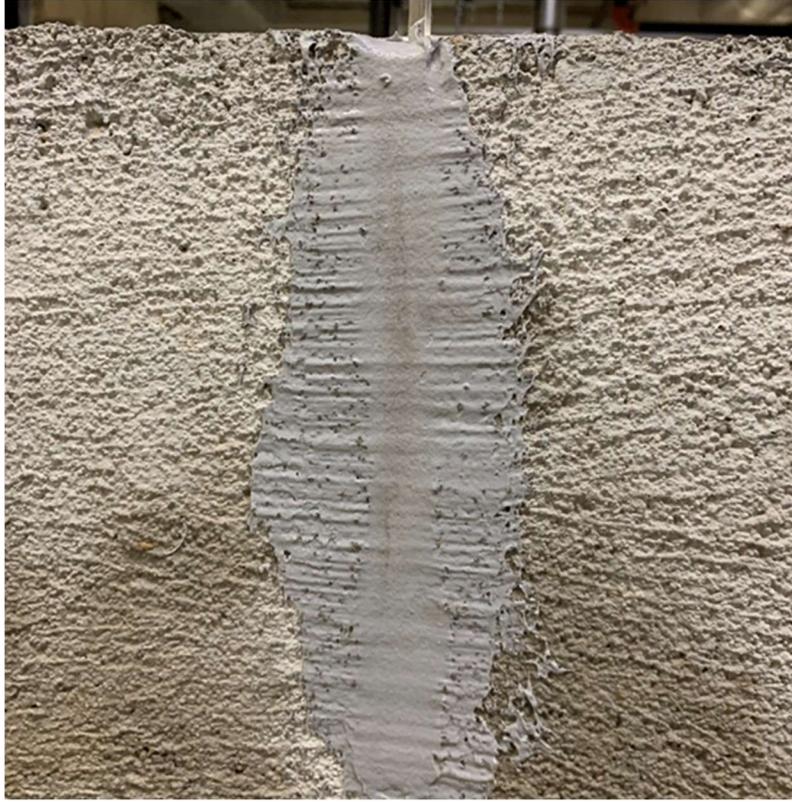
Figure 6.8. S3C7 No visible cracking after testing

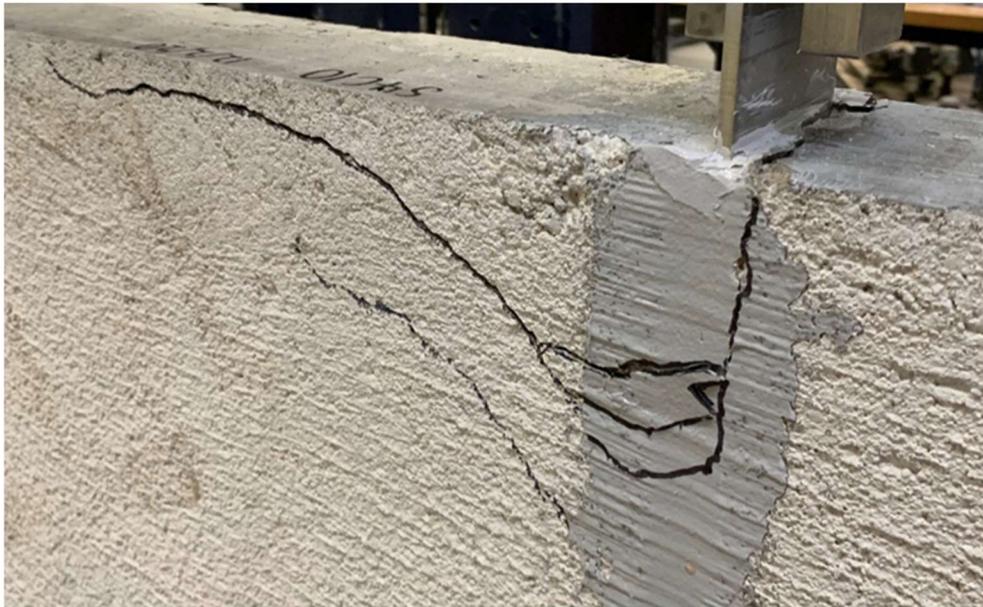
Figure 6.9. S4C10 concrete cracking in tension

Concrete cracking in tension was the most common failure mode of the axial tension tests, occurring in three out of the four tests. This result was anticipated due to the connector's high tensile strength properties. All four tests failed instantaneously as load significantly dropped and displacement jumped. When the concrete cracked in tension, the cracks appeared around the

connector's embedment in the slab and typically formed along the planes where the epoxy was bonded with the slot cut into the slab. From the results of the S3C7 test, the bond between the connector and epoxy should be further investigated to see if the load achieved during that test was the maximum tension strength of the epoxy.

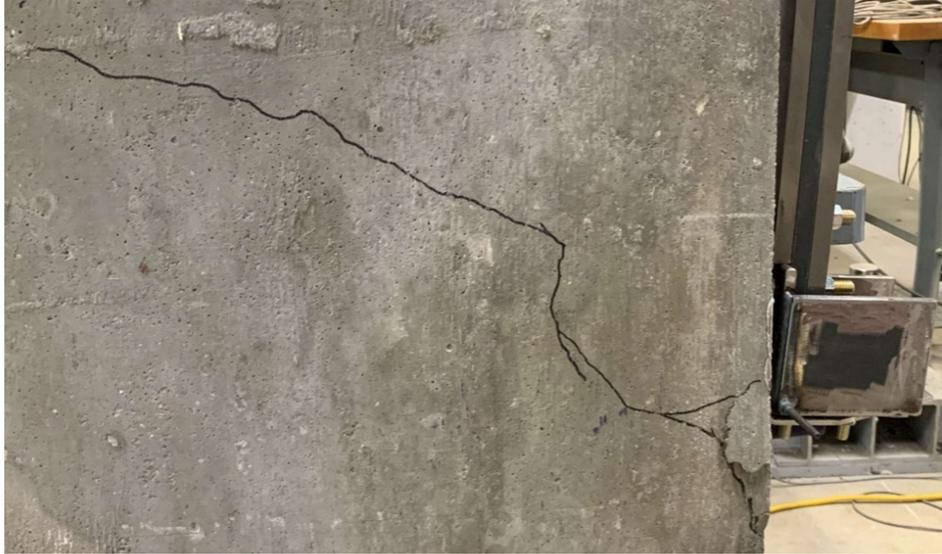
Figure 6.12. S1C3 cracking away from the connector

The horizontal shear test results for the four tests provided consistent data for every test. The only test that provided a failure mode was on S1C3 when the slab cracked away from the connector's embedment, shown in Figure 6.12, and the other three tests (S1C2, S2C6, and S5C13) were stopped after the load was greater than 20,000 lbf to prevent permanent damage to the test fixture caused by buckling. All the connectors separated from the epoxy around 3,000 lbf, shown in Figure 6.13. It was assumed that the connector had been permanently deformed after 3,500 lbf of applied load, see Figure 6.14. The connectors had noticeably rotated at the embedment at 6,000 lbf, shown in Figure 6.15. At around 10,000 lbf, the concrete under the connector started to crush and spall on either side of the connector, shown in Figure 6.16.

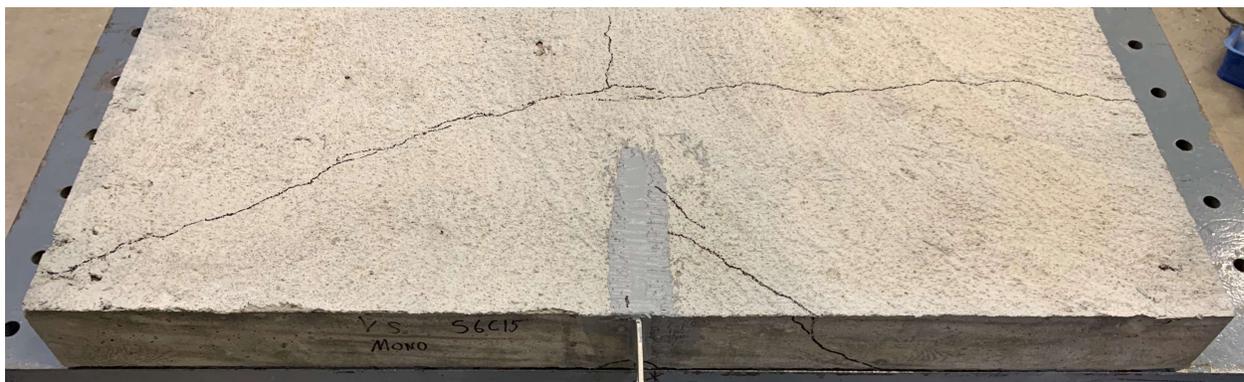
Figure 6.19. S6C15 cracking at the end of the test

The first vertical shear test was on the connector named S6C15. As the experiment was being conducted, the steel table that the slab was fixed to had begun to rotate about the feet nearest to where the load was applied. The test was stopped before ultimate load was achieved so the steel table could be secured to the Strong Floor as described in the test procedure. The slab was cracked when the test was stopped. The slab cracked perpendicular to the connector across the slab and diagonally on one side of the embedment, see Figure 6.19. The concrete under the embedment was cracked as well, see Figure 6.20. The slab cracked this way due to a gap between the bottom face of the slab and the table.

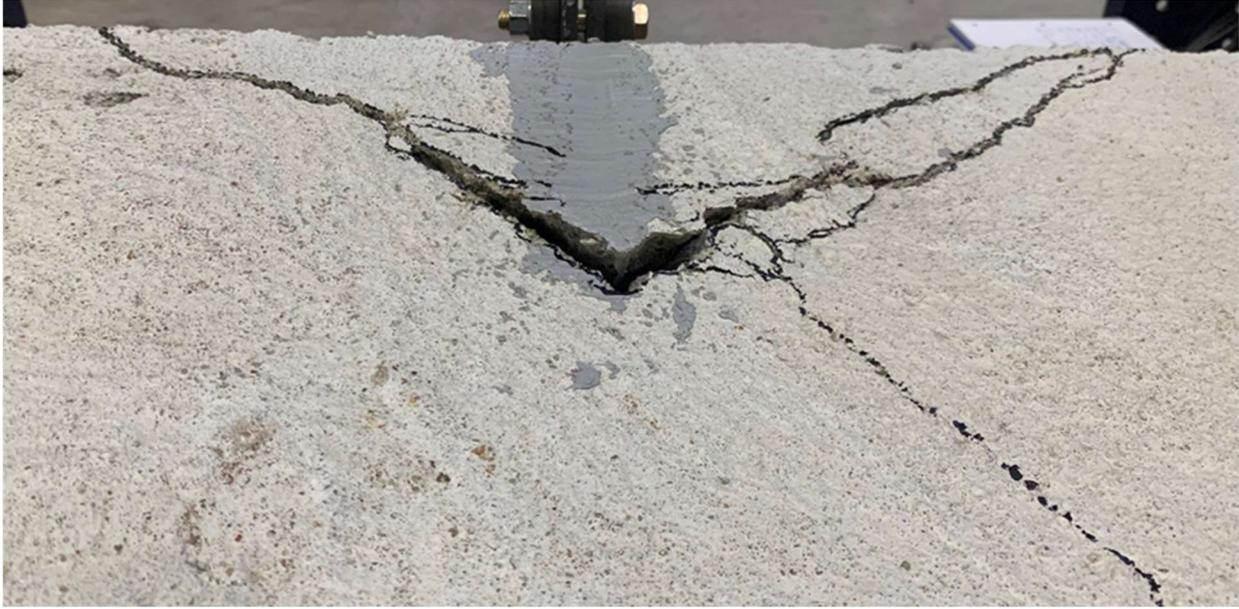
Figure 6.24. Typical large gaps in the cracks after failure for vertical shear tests

The other three vertical shear tests provided consistent data after the steel table was fixed in place. The average of the three tests recorded an ultimate force of 9,027 lbf, an actuator displacement of 0.560", and string potentiometer displacement of 0.350". When the specimens achieved their largest load, the slab around the connector cracked conically from the end of the embedment out the edge of the slab and is shown in Figure 6.21, Figure 6.22, and Figure 6.23. After the maximum load was obtained and the slab cracked, the load would not be regained because large gaps began propagating at the end of the connector's embedment as seen in Figure 6.24.

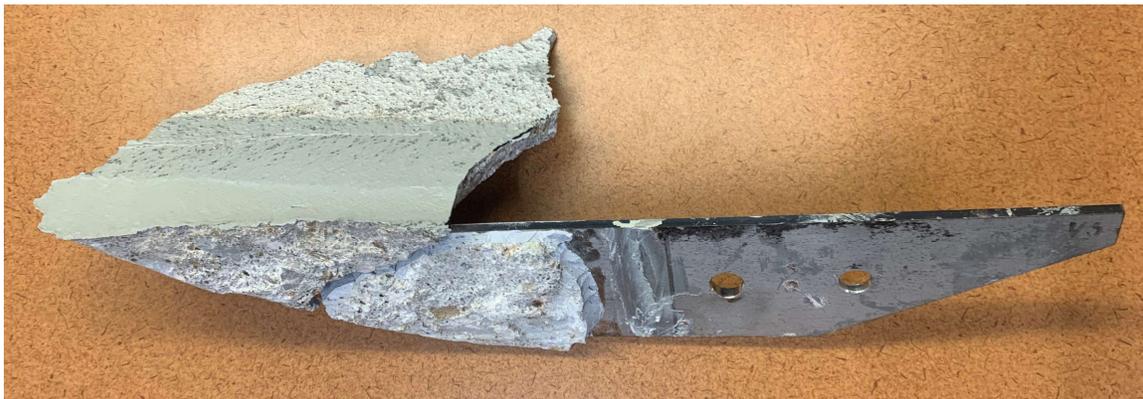
Figure 6.46. S3C9 separated connector

Connector S3C9 obtained the highest load of the cyclic vertical shear tests which was approximately 9,500 lbf on the first cycle of 0.700 inches. Connector S3C9 had the stiffest response of the cyclic vertical shear tests and was outside of the monotonic load-displacement envelope through the first 0.500 inches of displacement cycles. The first crack appeared on the

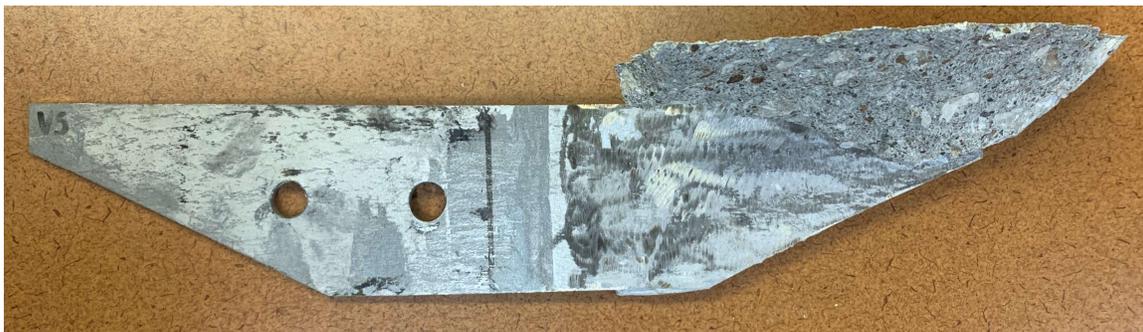
Figure 6.47. S3C9 debonded epoxy

first cycle of 0.200 inches, which caused the load to drop. The load was regained on the next displacement step. The load was maintained until the cracks began to propagate after 0.700 inches. When the loading protocol was finished, the connector's embedment was completely separated from the slab and was able to be removed by hand, see Figure 6.46. The epoxy debonded on most of one side of the connector and the roughed surface of the connector was exposed, see Figure 6.47.

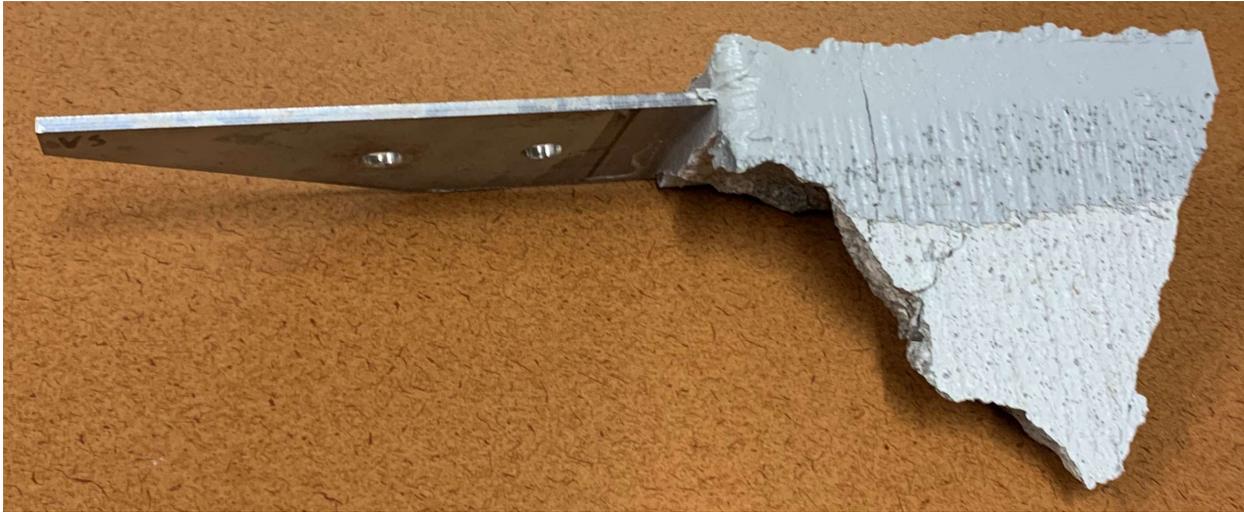
Figure 6.48. S4C11 separated connector

was removed from the testing table the concrete surrounding the embedment was removed by hand and the rebar wire mesh was exposed, see Figure 6.48 and Figure 6.49.

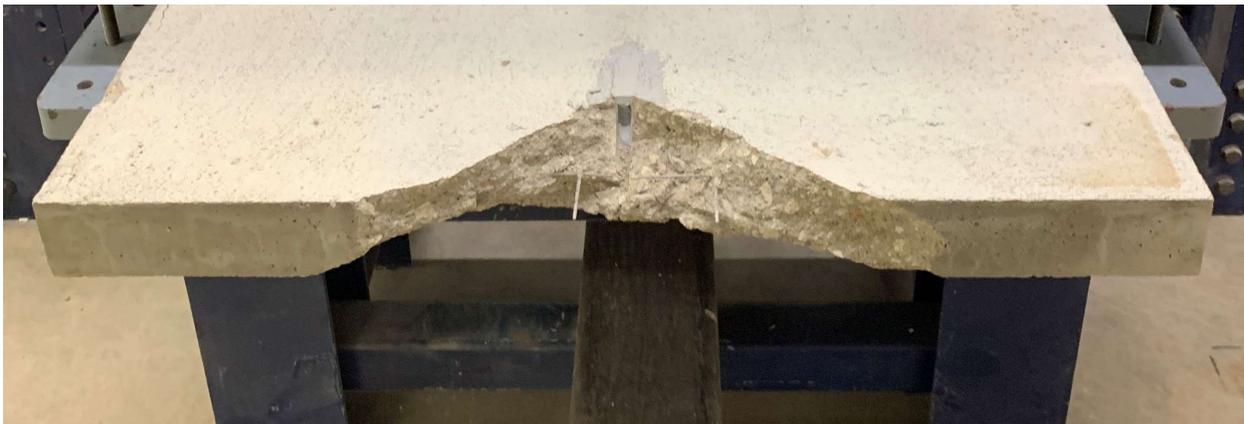
Figure 6.49. S4C11 spalled embedment and exposed wire mesh rebar

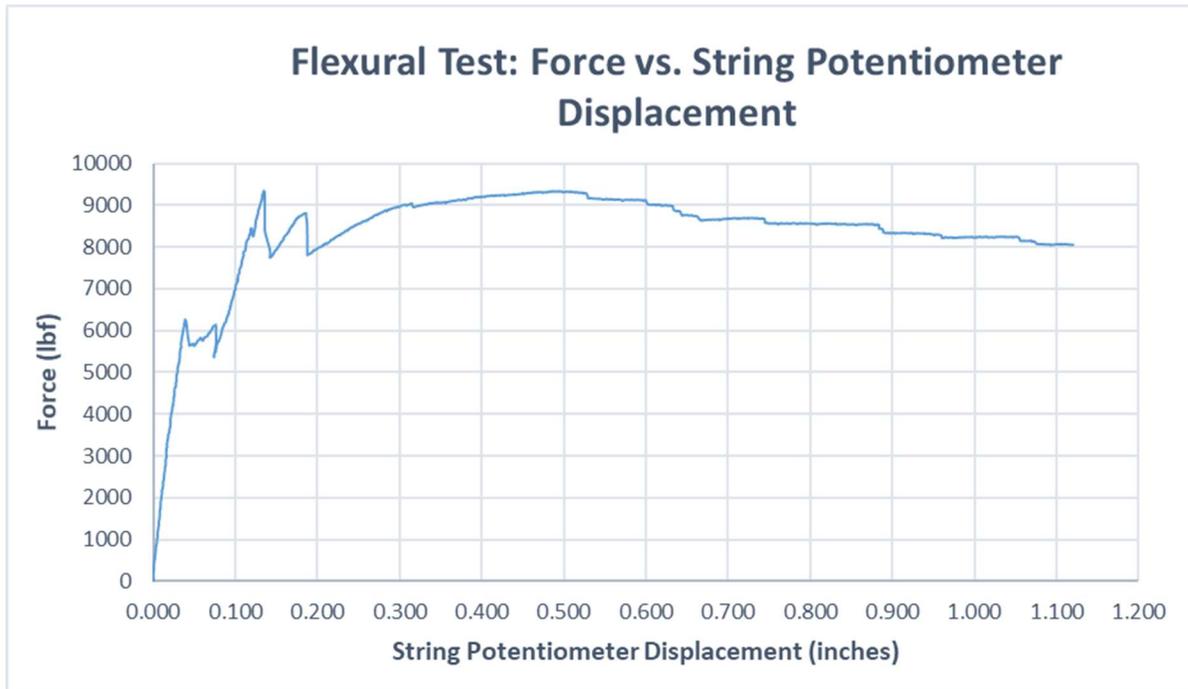
Figure 6.50. Flexure test force versus string potentiometer displacement

Region	Force (lbf)	Displacement (inches)
First Slab Yielding	6258	0.039
Second Slab Yielding	9333	0.135
Ultimate Failure	8717	0.663

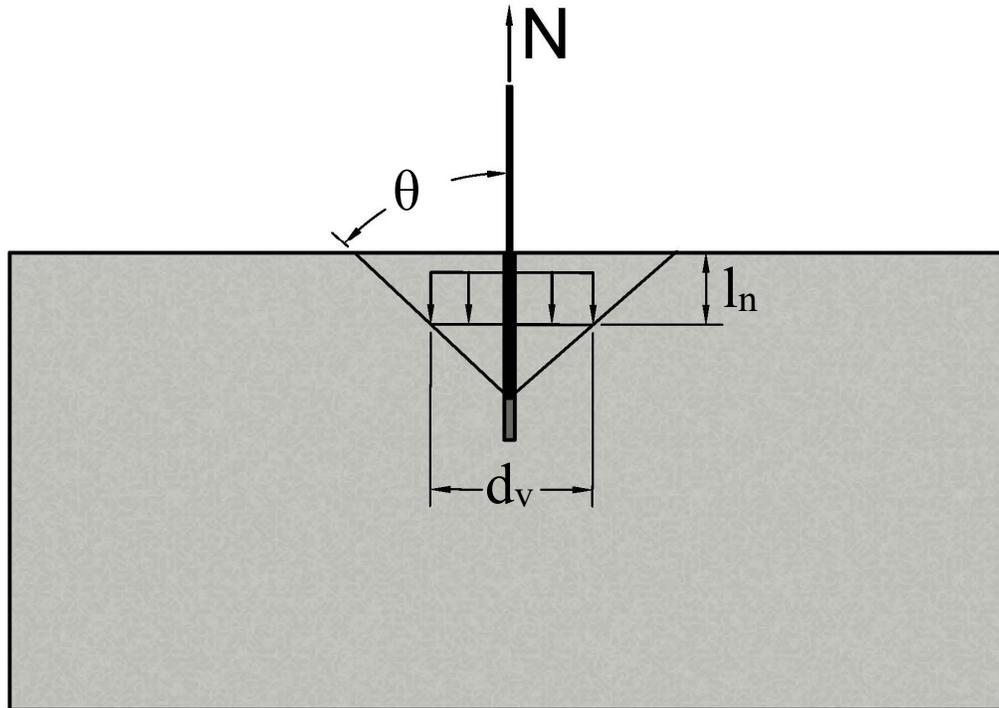
Figure 7.1. Axial tension model diagram

A_s , in tension was located at the tip of the connector's embedment, which is where the axial tension tests first cracked. The effective width of the section, d_v , that resisted the applied axial force was assumed at the center of the depth of the embedded connector. Figure 7.1 provides the detailing for the axial tension model. The general parameters used in the axial tension model are provided in Table 7.1.

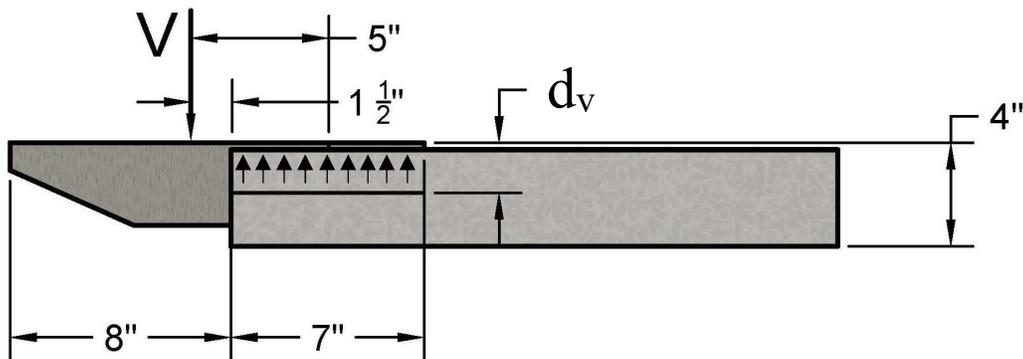
Figure 7.2. Vertical shear model side view diagram

The generated vertical shear model used an iterative step process to calculate the ultimate shear capacity of the connector. The model assumed that cracks would originate diagonally at 45 degrees from the end of the connector's embedment and that the initial effective width, b_w , of the concrete in shear was at the middle of the embedment length. The depth of the steel reinforcement, d , was 1.75 inches, which was half the height of the connector with the additional 0.25 inches from face of the slab. The effective depth of the section, d_v , was calculated to be 72% of the height of the section, h . The detailing for the vertical shear model is provided in Figure 7.2 and Figure 7.3. The general parameters for the model are provided in Table 7.3.

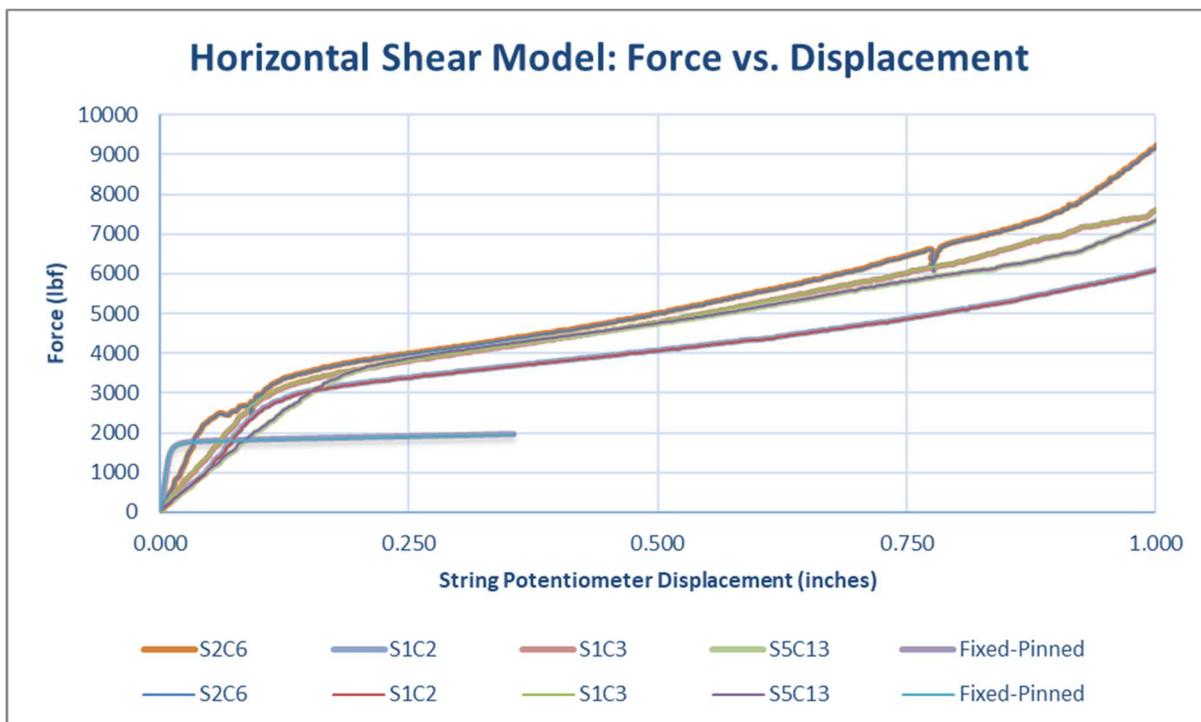
Figure 7.5. Horizontal shear model force versus displacement plot

The horizontal shear model was developed from a plastic nonlinear secant stiffness analysis. The load-displacement responses observed during the experimental tests provided that the connector plastically deformed and experienced strain hardening. The connector was modeled as a beam with fixed-pinned boundary conditions determined from the deformation and rotation that occurred during the experimental tests. The fixed support was at the connector's embedment in the slab and the pinned support was where the connector was attached to the test fixture. The plastic analysis captures the linear-elastic stiffness of the connector when the elastic moment of the connector's cross-section was reached. The elastic moment occurred when the extreme fibers of the cross-section yielded. To further analyze the plasticity of the cross-section, the connector was divided into 100 layers of thickness to observe moment-curvature relationship progress from the extreme fiber down to the centroid of the connector. The horizontal shear model only analyzed 50 layers due to the stress profile being symmetric. The model was incremented 50 times where each increment lowered the distance to the yielded layer. The strain hardening of the connector was adjusted in the stiffness for the layers that had already yielded. As each layer yielded, the moment-curvature relationship increased nonlinearly until the plastic moment of the cross-section was reached, see Figure 7.4. The reaction stiffnesses of a fixed-pinned beam was used to calculate the load and displacement from the moment curvature relationship. The calculated loads and displacements were plotted on the force versus string potentiometer displacements of the monotonic horizontal shear tests and is provided in Figure 7.5.

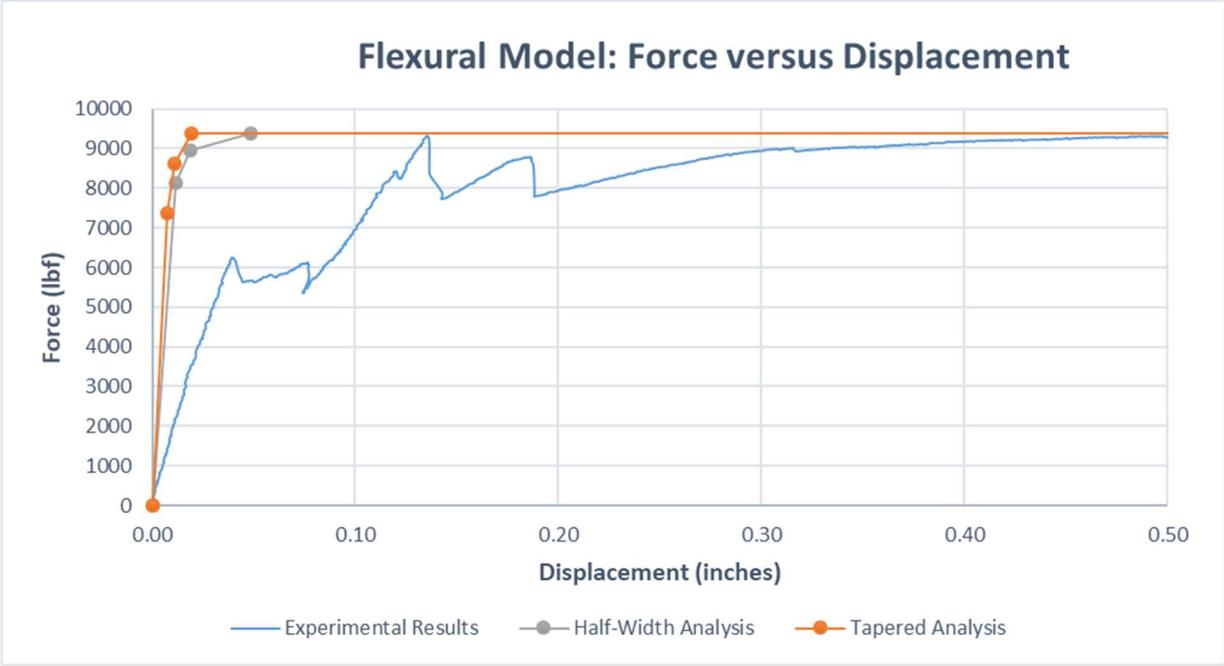
Figure 7.10. Flexural model load versus displacement plot

of the slab was not captured experimentally. The results of the calculated loads were similar to those observed in the experiment. The calculated load at the third plastic hinge was only 38 pounds away from the peak load recorded in the experiment.
