Case study in erosion control at McConnell Air Force Base: redcedar streambank revetments,  
macroinvertebrates bio assessment, and runoff estimation

A THESIS

KANSAS STATE UNIVERSITY  
Manhattan, Kansas

2024

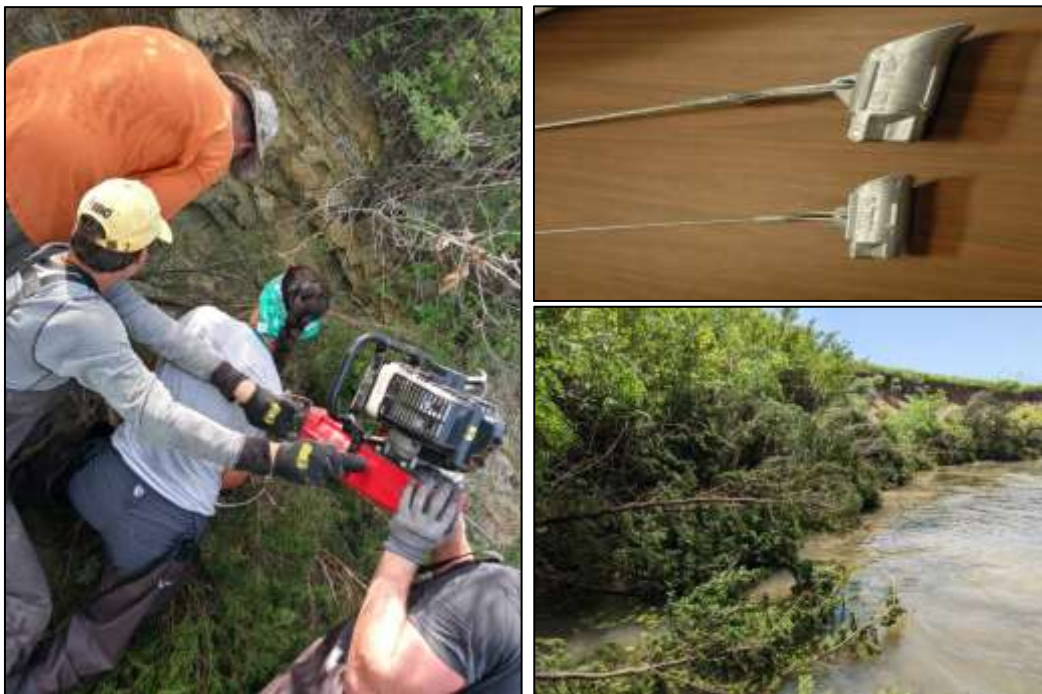
In the stream restoration project, cut redcedar trees were strategically anchored along the streambank area at four different sites as streambank revetments. This innovative approach involved anchoring the cut redcedar trees by securing the tip, base, and center of each tree. The process commenced by anchoring the tip of the first redcedar tree using duckbill anchors and insert them into the soil with a jackhammer, followed by anchoring its base in the same way. Subsequently, from the center of the first redcedar tree, the base of another redcedar tree was anchored. Figure 2.2 shows the installation of revetment 3 (R3), and R3 installed in the last picture.

**Figure 2.2** Visual example of the installation of R3 anchoring redcedar trees using duckbill anchors and insertion to the soil with a gas jackhammer.

This sequential process was repeated until the entire streambank area of the designated sites, labeled as R1, R2, R3, and R4, the most unstable areas with pronounced erosion at the meanders were covered with redcedar revetments. Within the same creek segment where all of the revetments have been placed, the control location was selected based in the sinuosity of the meander, within the same creek, the control was established to compare how a bank without a pronounced curve can have bigger rates of erosion even if their counter parts have a more sinuous meander as long as they are protected by a revetment.

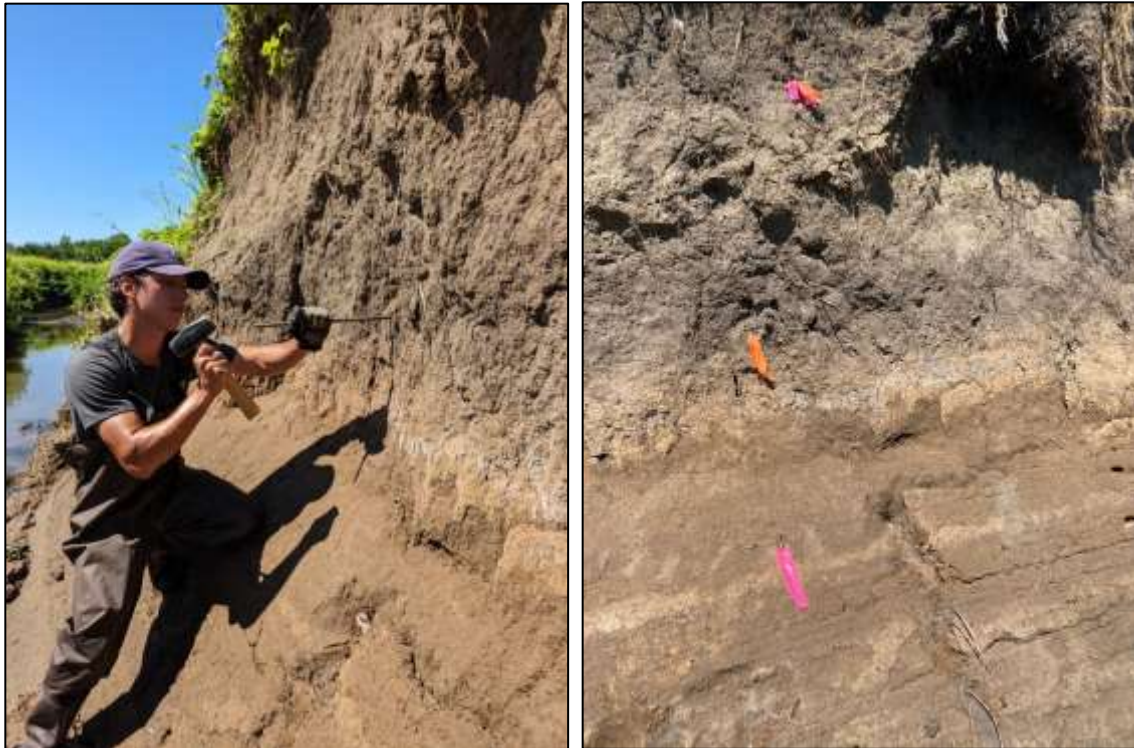
To assess the effectiveness of the redcedar revetments in stabilizing the streambank and reducing erosion, a monitoring method utilizing rebar pins was implemented across all sites, including R1, R2, R3, and R4. These rebar pins, pounded into the streambank area using a hammer as how is shown in Figure 2.5, served as erosion measurement markers, providing valuable insights into erosion dynamics over time (Jugie et al., 2018). During periodic site visits, the exposed length of the rebar pins above the ground surface was meticulously measured using a ruler. This quantitative measurement not only offered a clear indication of the amount of erosion that had occurred since the previous visit but also enabled a comparative analysis between the sites with redcedar revetments and the control site (DeFrancesco and Hansen, 2000). It's important to mention that sandbar willows (*Salix exigua* (Nutt.)) a deciduous shrub or small tree known for its

**Figure 2.5** Rebar pins installed in the streambank revetment sites.

The use of rebar pins as erosion measurement markers is a widely recognized and reliable approach in streambank erosion studies (Ramirez et al., 2010). They were installed in transects of three to five depending on the height of the streambank, by monitoring the exposed length of the rebar pins, changes in erosion rates and patterns can be precisely quantified, providing essential data on the effectiveness of the redcedar revetments in mitigating erosion (Greenway et al., 2012).

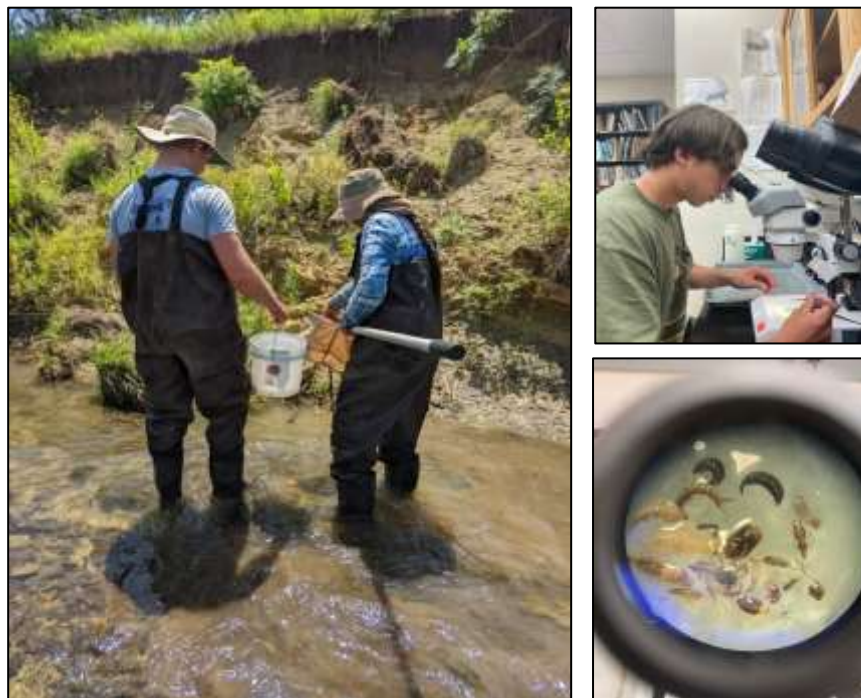
To evaluate water quality, a comprehensive macroinvertebrate sampling was conducted at all sites, including R1, R2, R3, R4, and the control site, following the procedures outlined in the Volunteer Stream Monitoring Training Manual (Hoosier Riverwatch, 2015). The collection of macroinvertebrate samples involved using nets to sample both the pool and cut bank areas of the stream for a duration of 15 minutes.

The collected macroinvertebrates were carefully transferred into water bottles filled with a solution comprising 50% water and 50% alcohol, ensuring their preservation for subsequent analysis in a laboratory setting (Hoosier Riverwatch, 2015). In the lab, the macroinvertebrates were examined to the Order to Family level using a stereoscope, with guidance from the Bioindicators of Water Quality Quick-Reference Guide by Purdue University (Speelman and Carrol, 2012). The process is summarized in Figure 2.6, where it shows the critter collection and their identification.

**Figure 2.6** Macroinvertebrate sampling and identification.

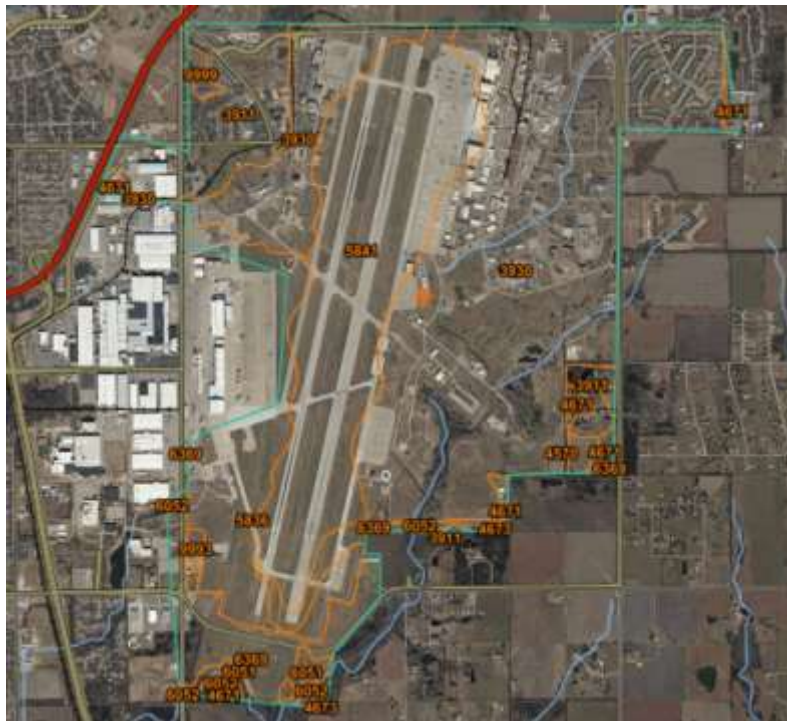
In Figure 2.7, the green line represents the boundaries of the Air Force Base, and the orange lines represent the different groups present in the area of interest (AOI), the numbers in orange are different codes that represent a unique map unit symbol, as how it was mentioned before, are the different unit symbols determine the Hydrological Soil Group ratings, for example 3911 is equal to D and 6052 represents B.

**Figure 2.7** Image of the Air Force Base showing different infiltration rates, retrieved from WebSoilSurvey website.

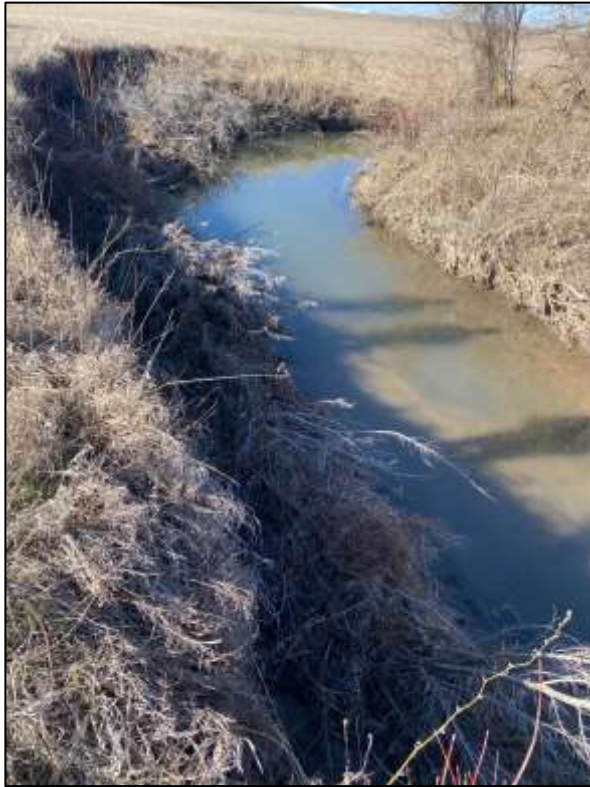
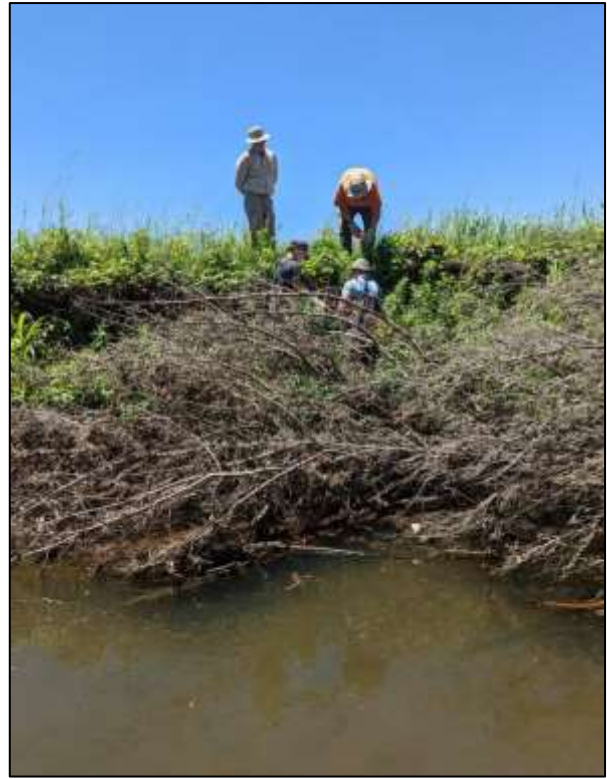
R1 is the oldest of the points in the case study and is the one with the most vegetation to this date, providing shade and suitable habitat for different species, the last time that the place was visited, various species of frogs, fish, and some turtles were spotted, among all the sites, is the one with more biodiversity based in what can be casually observed

**Figure 3.10** Picture of R1 taken in November (Left) and in May (Right)

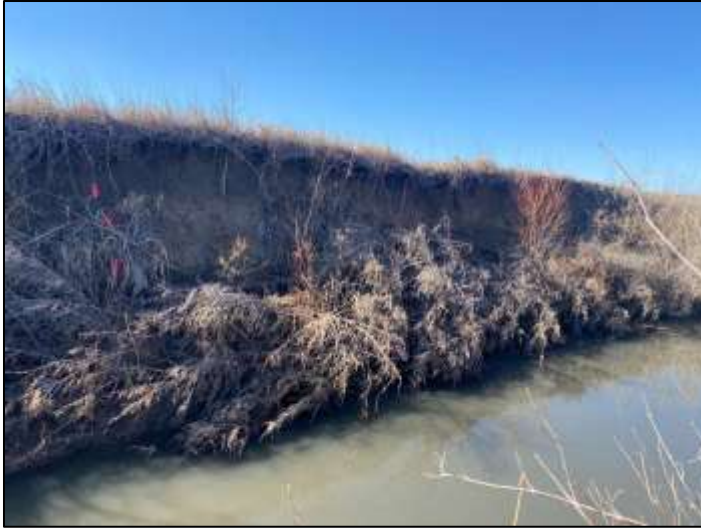
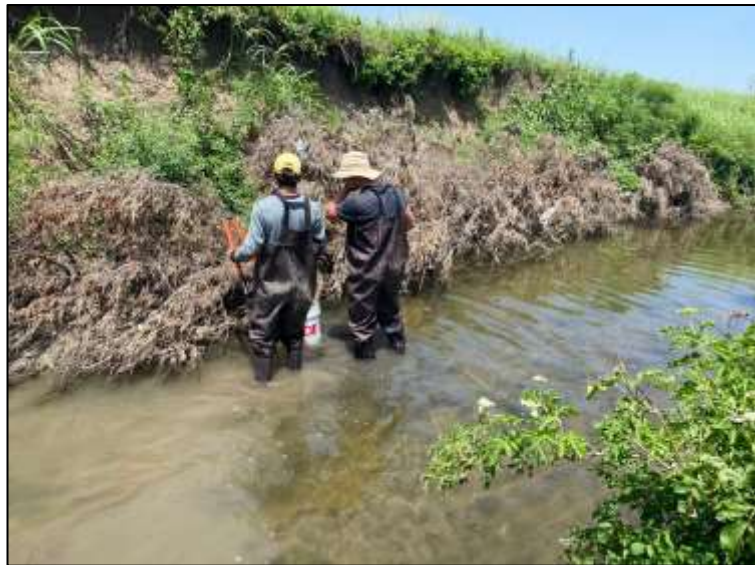
In the same way as how it was witnessed at R1, R2 has been installed with anticipation, as there is a high amount of vegetation growing in the bank, and in Figure 3.12, the presence of sandbar willows can be appreciated in a better way, showing how well adapted this species are to growing under this condition.

**Figure 3.11** Picture of R2 taken on November (Upper) and in May (Lower)

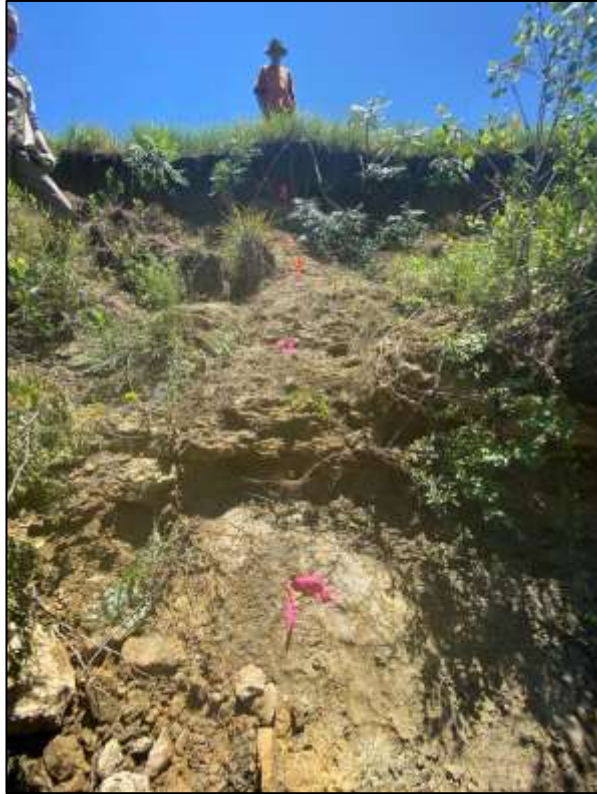
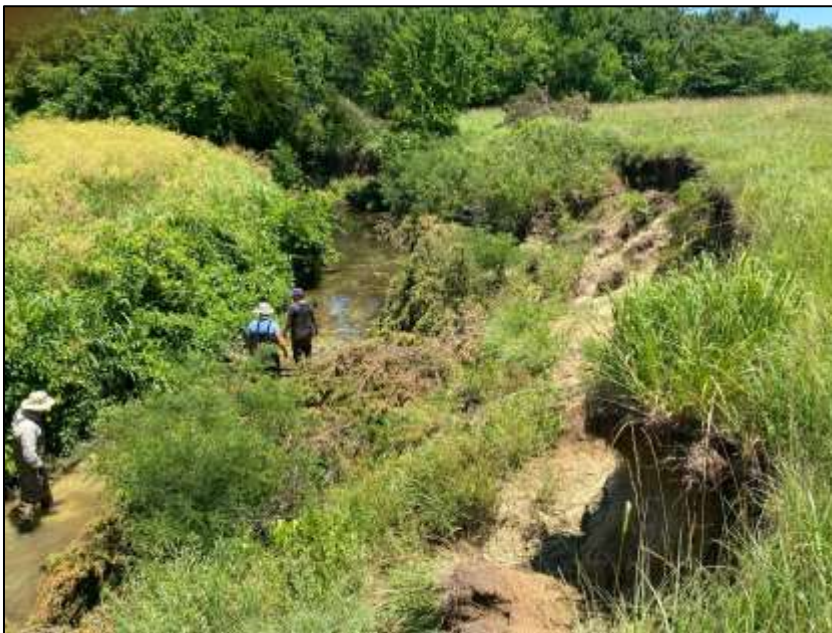
The pictures of R3 were taken before winter, so greener vegetation can be appreciated in the different perspectives provided, different species of grass, shrubs and forbs can be identified, as well as the planted sandbar willow. Despite the fact that it is a very rocky bank, vegetation regrowth is very noticeable at this sample point.

**Figure 3.12** Picture of R 3 from different angles (ground and aerial).

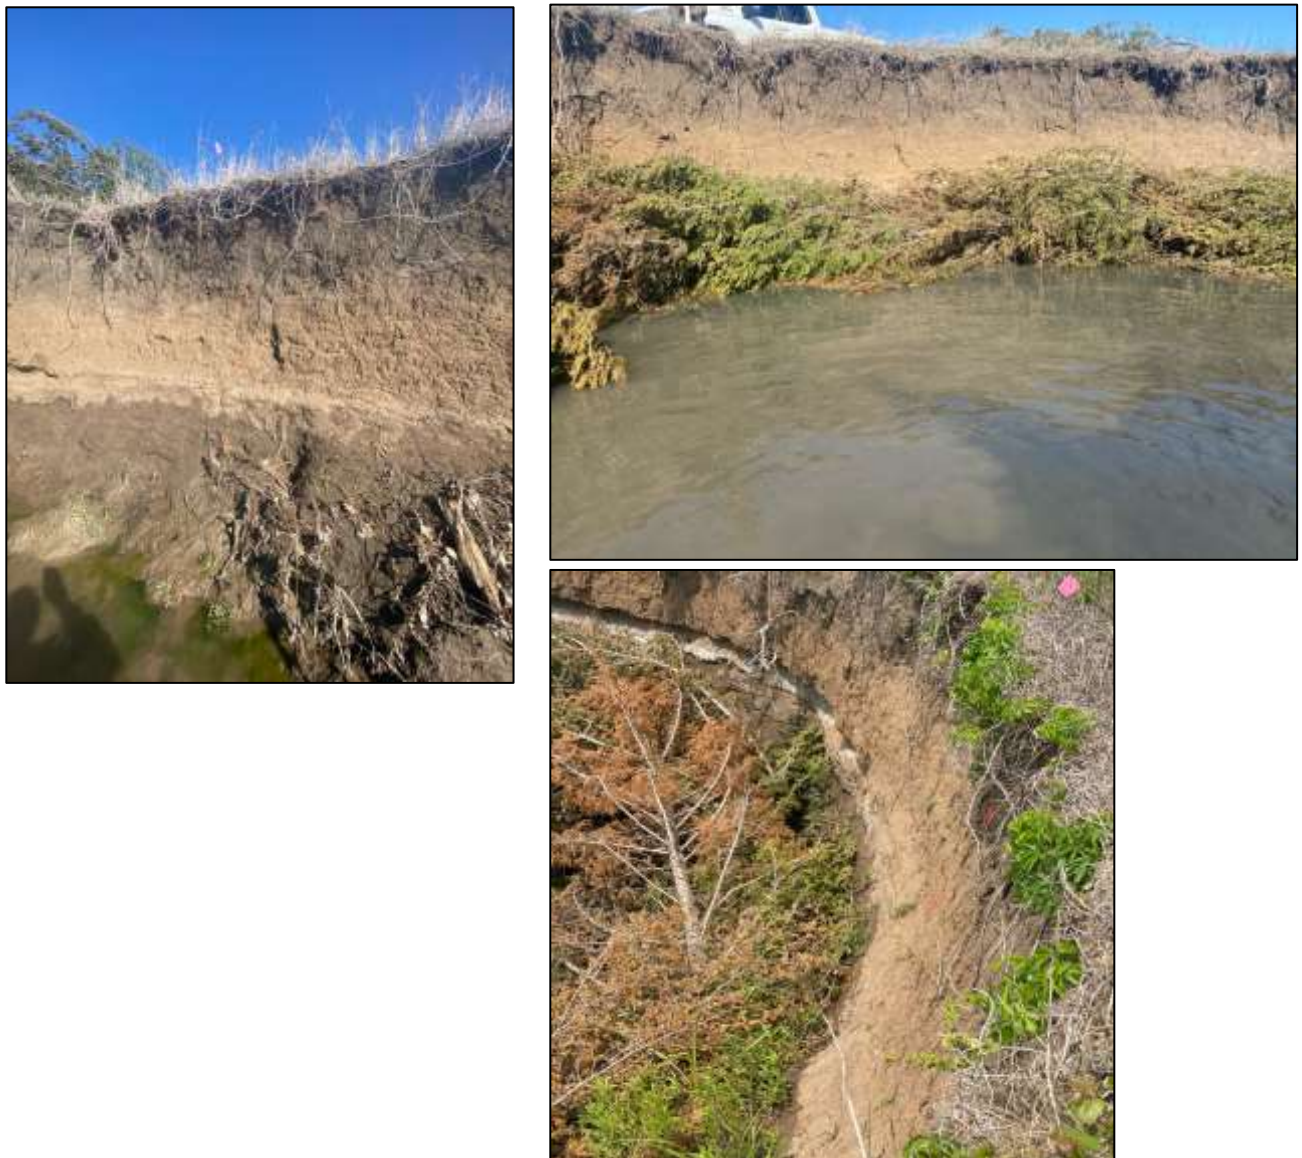
Figure 3.13 show the last revetment installed so is more pertinent to show how it looked like before the installation and after its installation to demonstrate the area of bare soil that can be covered just by using the revetment. The area will likely be vegetated with time in the same way as it happened in the previous revetments; sandbar willows were planted at this point as well. The picture in the bottom of Figure 3.13 show how even if R4 is the newest installment, it is already capturing sediment allowing vegetation to regrow.

**Figure 3.13** Picture of R4 site before and after the installment of the revetment.

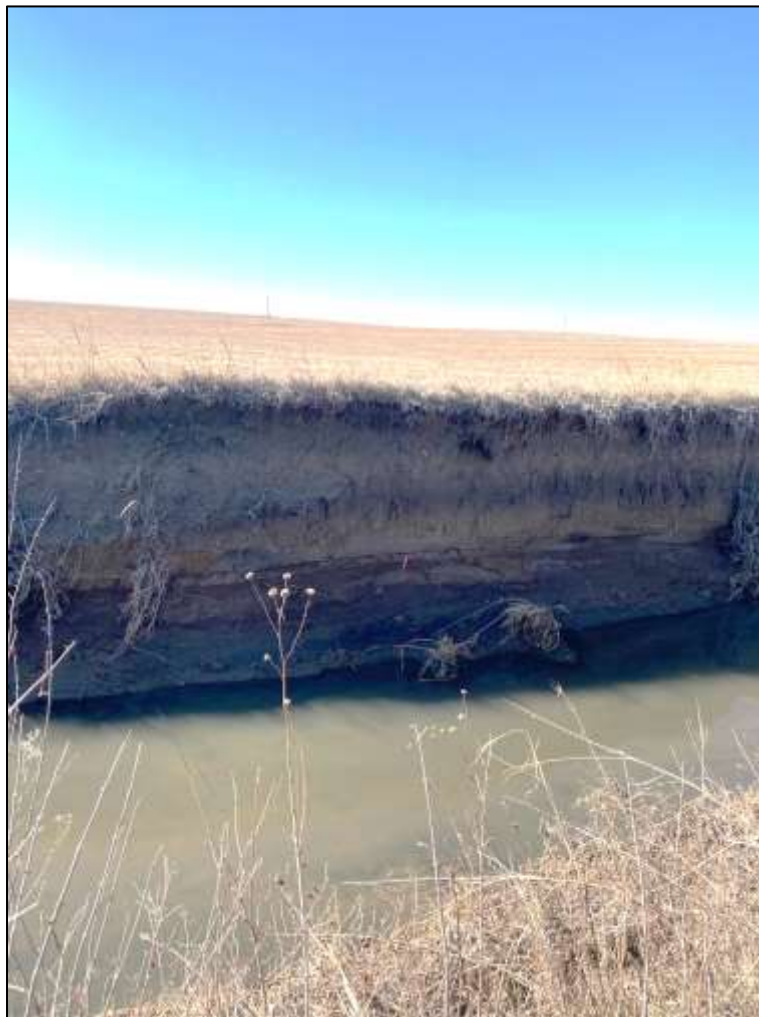
The picture in Figure 3.14 serves as a comparison point to demonstrate how different are the areas covered with the revetments to an uncovered and exposed zone, erosion rates are higher in this spot, and vegetation in the streambank area is few to nonexistent, is a good highlight of the effectiveness that revetments can have as a positive impact for promoting biodiversity and stream health.

**Figure 3.14** 14 Picture of the Control site at McConnell Creek.

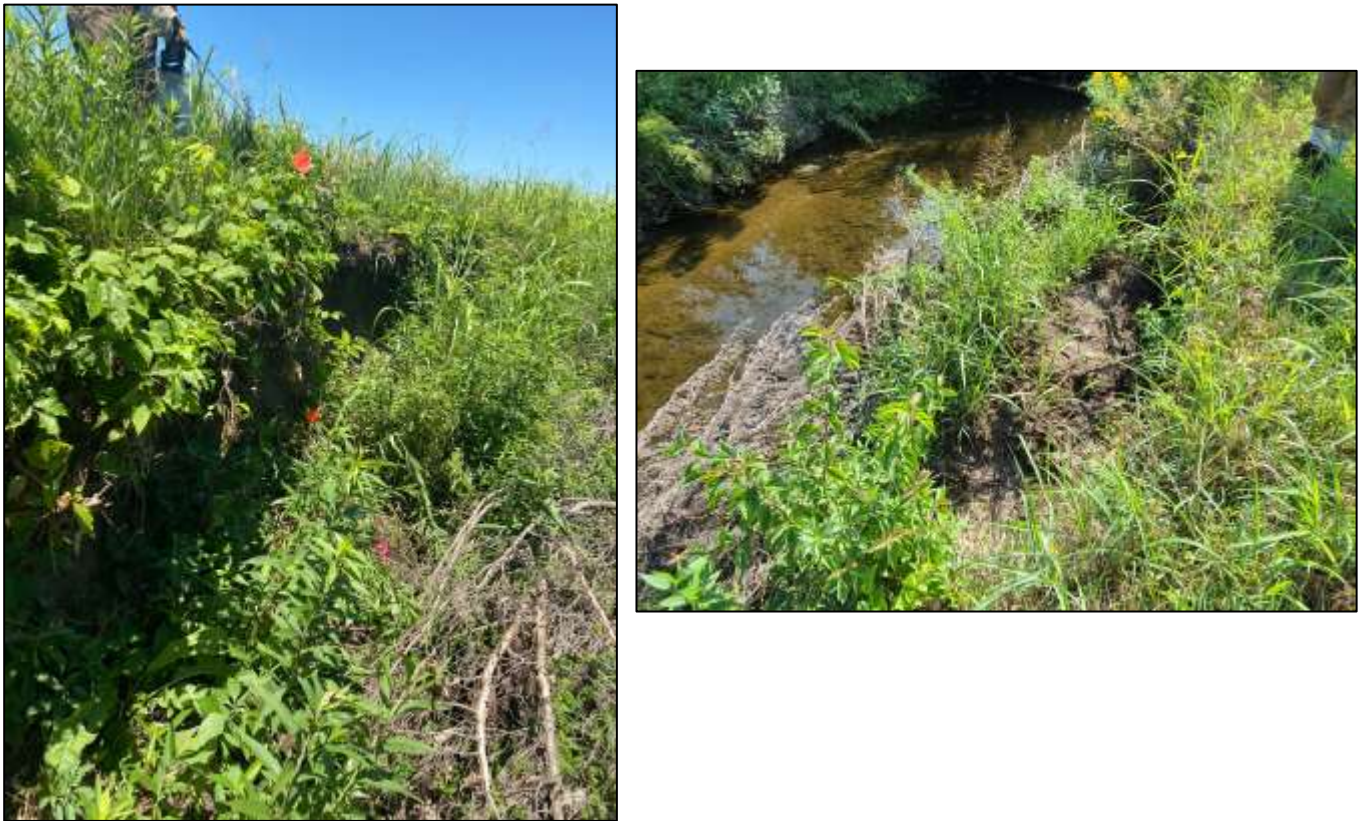
By summing up the volumes obtained from both sets of measurements in the two areas with high deposition captured in the same revetment, we found that the volume of new sediment captured by R1 is approximately 2.8 cubic meters. This comprehensive approach ensures a thorough understanding of the sediment volume, accounting for all relevant measurements and providing an accurate representation of the sedimentary deposition in the streambank.

**Figure 3.15** Visual representation of the sediment captured in R1.
