Streambank erosion downstream of a flood control dam: Processes, rates,  
and management

AN ABSTRACT OF A DISSERTATION

DOCTOR OF PHILOSOPHY

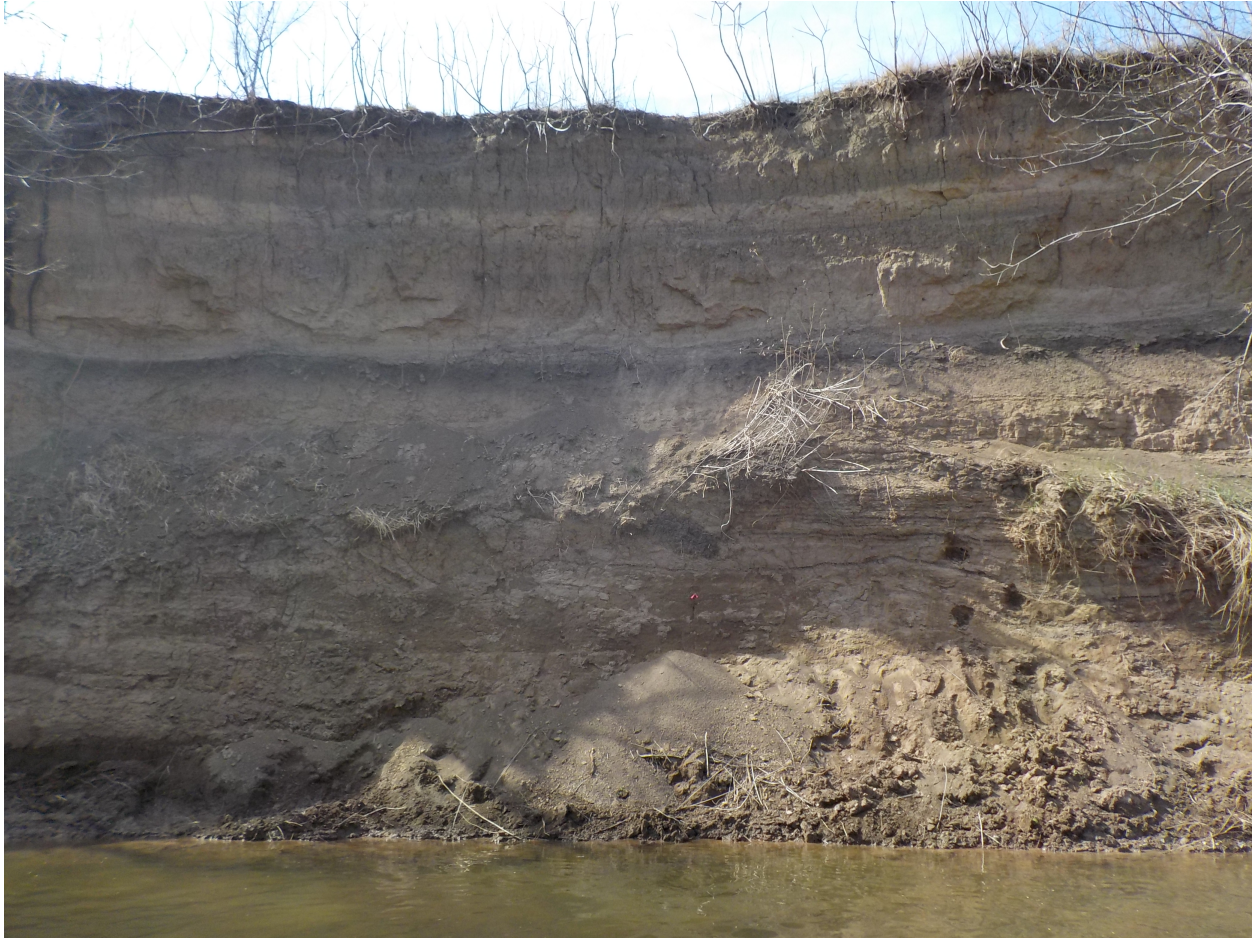
Figure 6.4: Photograph of the Streambank Erosion Cross Section of Interest along Site 1 on the Lower Smoky Hill River, March 2017. *Note:* Above the dark, thin layer at about 3m in depth represents the Honey Creek Member while below represents the Gunder Member of the DeForest Formation of Holocene Alluvium.

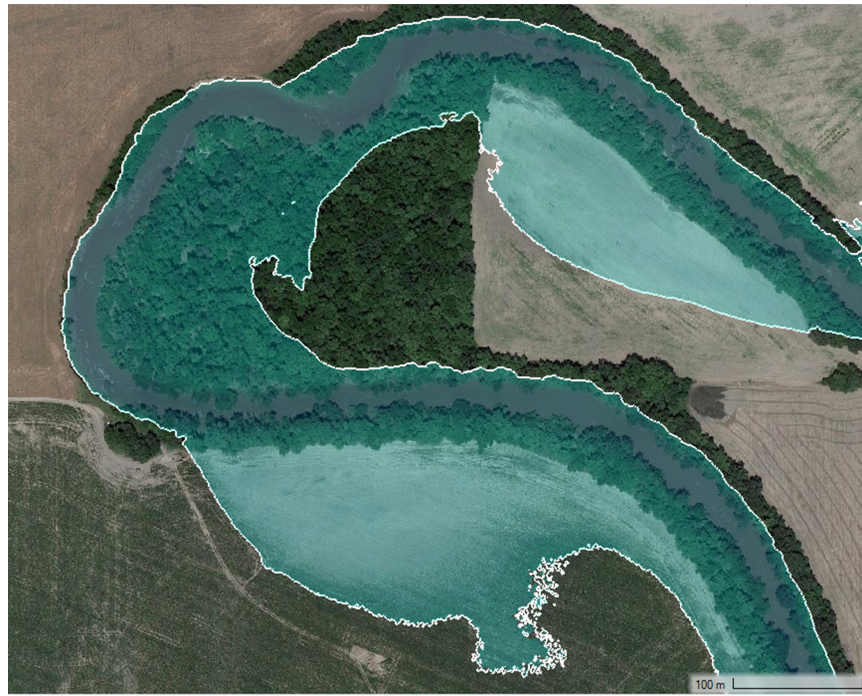
Figure 6.9: Example of 2D Hydraulic Model Calibration using June 27, 2019 Google Imagery showing May 2019 Flood Damage, Site 1.
