PRESIDENT'S RESIDENCE ENERGY ANALYSIS

A REPORT

submitted in partial fulfillment of the requirements for the degree

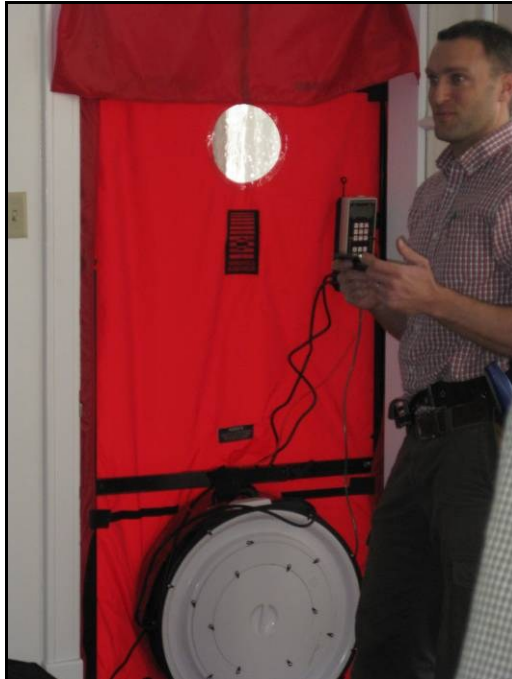
**Figure 2.2 Chad Robinson Conducting a Blower Door Test**

Mr. Robinson first installed a blower door test on the door to the sunroom to measure the house's infiltration rate. He then walked through the residence taking detailed measurements of each area. The measurements were used to determine the volume of the house, which, in turn, was used to calculate the infiltration rate of the residence. He also examined the appliances both in the upstairs kitchen, the downstairs kitchen, and the laundry room on the first floor. The

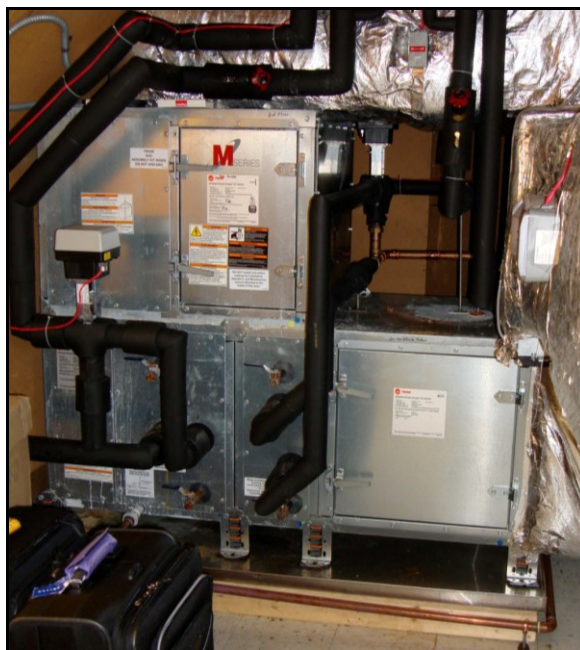
**Figure 2.3 Attic AHU**

Problems first arise when inputting data regarding the house. Many of the President's Residence features are not listed in the software libraries. For example, the heating and cooling system in the President's Residence is air handling units (AHUs) as shown in Figure 2.3 and a split system air conditioning unit as shown in Figure 2.4. There are two AHUs in the home: one serves the basement and the first floor while the other serves the second and third floors. Because there was not space available for ductwork to be routed throughout the home from one unit, two AHUs were installed. Steam from the power plant on campus is provided to the President's Residence where it is sent to a heat exchanger. The heat exchanger uses the heat from the steam to heat the water in the hot water coil in the air handling unit. Chilled water is provided to the AHU's chilled water coil for air conditioning. The 1998 garage addition discussed in Chapter 3 is served by the split system air conditioning unit. The audit software does not have an option for an AHU; the only choice is a gas-fired furnace. Also, the window choices in the software program do not include the historic windows that are used throughout most of the President's Residence. Even though the original windows in the residence are single pane with an exterior storm window, their insulating properties are not the same as the single pane window referenced in the software. More testing would be needed to determine an equivalent in the REM/Rate software.

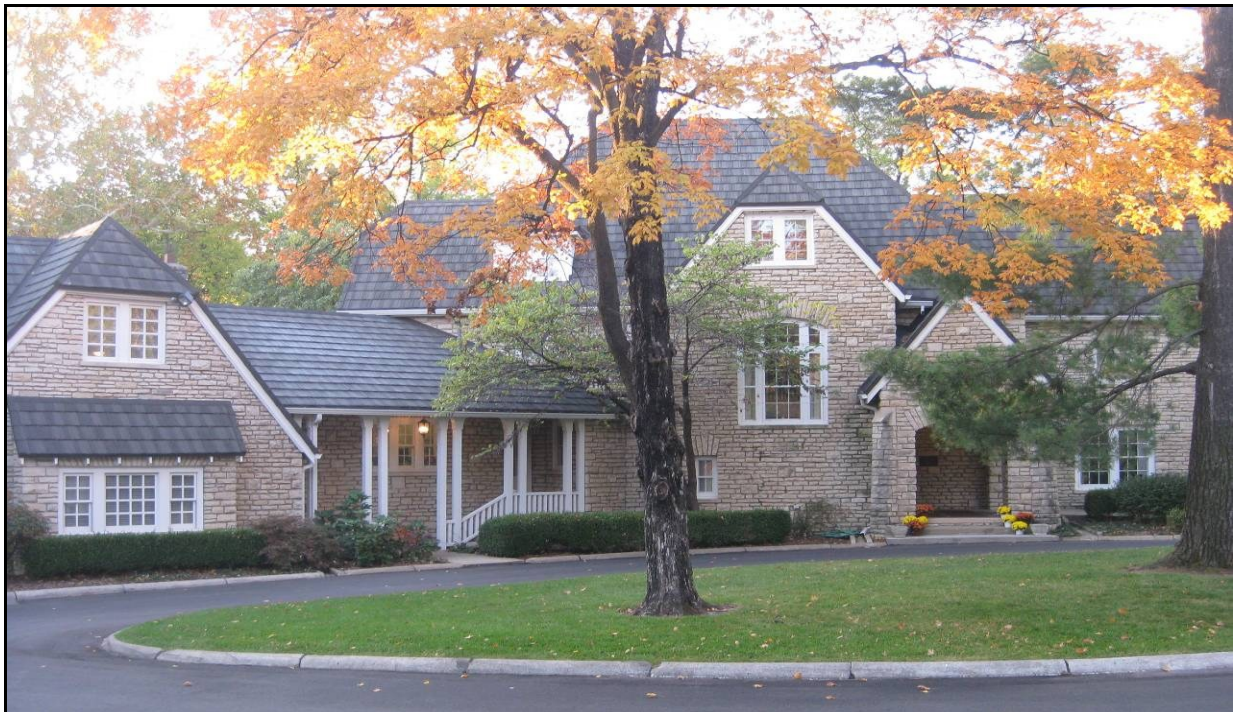
**Figure 3.5 100 Wilson Court September 2011**

trees where the former arboretum was once situated. 100 Wilson Court has housed seven University presidents since its completion in 1923. It has also changed over time to stay current in its utilities and amenities. Air handling units and a split system air conditioning unit serve the home and keep it cool in the summer and warm in the winter. The appliances in the kitchen areas have been updated and the lighting is primarily compact fluorescent. The original floor plans from 1923 are shown in Figures 3.6, 3.7, 3.8, and 3.9.

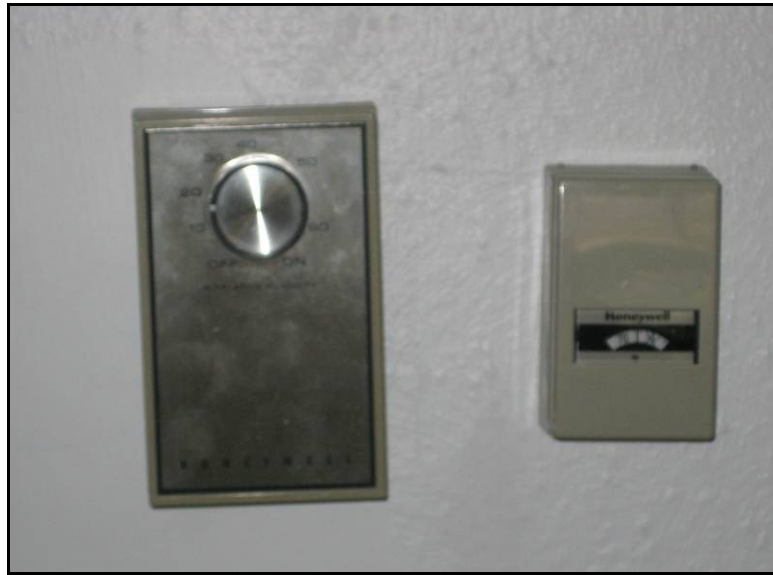
**Figure 4.1 Upper Landing Existing Thermostats**

The first item on the list of upgrades contained in the audit is the installation of programmable thermostats. The new garage addition has a programmable thermostat, but the original section of the house does not. Programmable thermostats allow the house to be conditioned for different occupancies at different times of the day. The installation of a programmable thermostat allows temperatures to be adjusted to reduce the need for heating or cooling during non-peak hours, avoids the need to manually change the temperature, and avoids the risk of forgetting to change the thermostat to desired temperatures. The thermostat placement was also cited as a problem by Mrs. Shultz. She said that the placement of a thermostat in the upper hallway did not allow for an accurate reflection of the temperature conditions in the other rooms. The discrepancies between the set temperature and the actual temperatures throughout the affected rooms indicated that the thermostat should be moved to a different location.

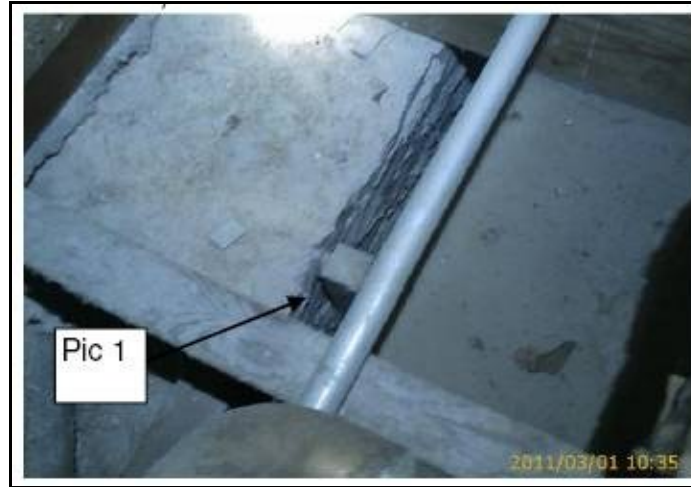
**Figure 4.7 Exterior Wall Air Leakage (Energy Audit)**

To deal with the large problem of infiltration, Mr. Robinson went through the house and detailed ten areas of concern. The first area was in the attic above the second floor. The picture in Figure 4.7 shows a gap between the outside stone and the inside plaster wall in which air is moving into the home. When insulating the attic during the service project, this gap was sealed.

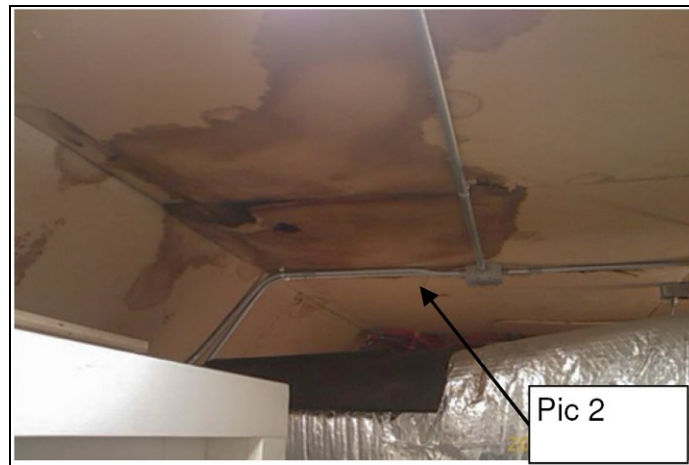
**Figure 4.8 Third Floor Mechanical Room Air Leakage**

The next area of concern was the furnace room walls and ceiling. The furnace room is located in what was originally attic space. Installing air handling units in the basement to serve the upstairs would have been impossible given that there was no practical way to run the ductwork through the home. Therefore, a portion of the attic was finished and now houses an air handling unit, not a furnace as assumed in the audit report. Figure 4.8 depicts an area of air infiltration. During the service project, the accessible areas around the attic mechanical room were insulated.

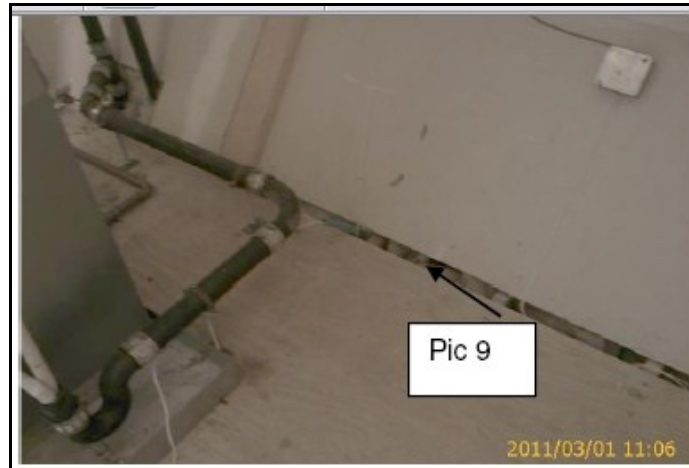
**Figure 4.16 Gap in New Garage Attic**

In the new garage addition completed in 1998, there was a gap where the wall meets the floor in the attic over the garage, as shown in Figure 4.16. Air was also observed to be entering the new living room through a crack above the bookshelf and around the can lights shown in Figure 4.17. The gap in the attic was sealed during the service project along with the crack above the bookshelf, as shown in Figure 4.18. However, it was not necessary to insulate the can lights, due to the sealing of the gap in the attic.

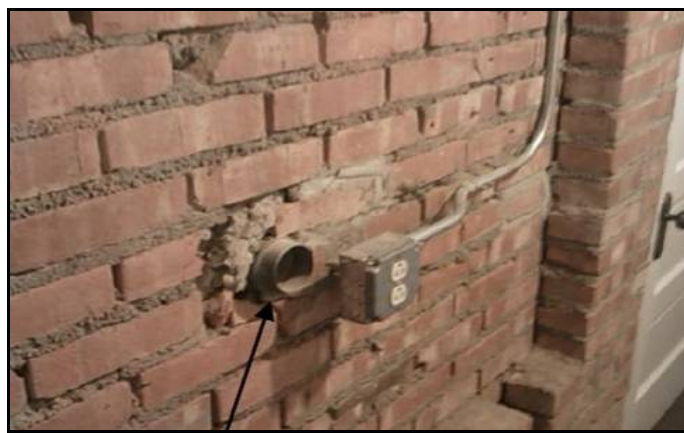
**Figure 4.19 Open Conduit in Basement**

The next corrective item on the list was to insulate and seal the rim joists and crawl space. The issue was taken care of during the service project. The final item on the air infiltration list was to seal an open conduit in the basement wall, as shown in Figure 4.19. The steel conduit penetrated the basement wall and formerly carried wires into the house. Because the conduit no longer holds any electrical wiring, it is safe to seal the conduit and stop the air leakage or to remove the conduit and repair the wall. The conduit item was not addressed during the service project.

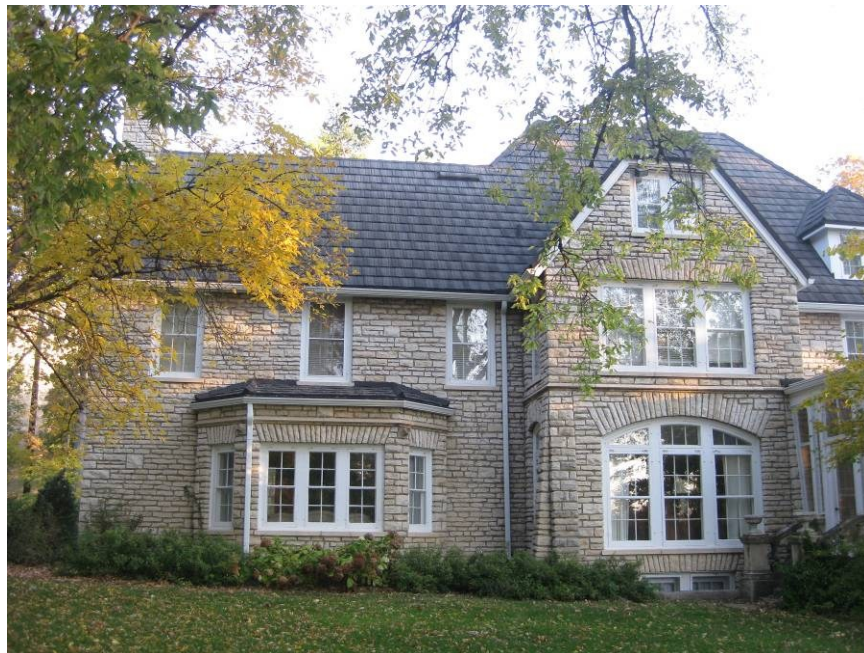
**Figure 4.23 President's Residence Exterior**

The back of the residence provides an unimpeded view of the roof over the attic on the third floor. Figure 4.23 shows the area in a typical picture. Figure 4.24 show the same portion of the home, but the image is a thermal image. The gradient scale on the right of the image shows that white is the warmest area of the image and black is the coldest. Figure 4.24 clearly indicates heat loss through the roof in the attic. Figure 4.25 is another thermal image of the same area, but the thermal image was taken by the author after the attic had been insulated during the service project. There is a marked difference between the heat loss shown in Figure 4.24 and the heat loss shown in Figure 4.25. Figure 4.25 shows the roof as a green-blue color, which means it is a cooler temperature than in Figure 4.24 which shows the roof as red and white. The cooler temperature indicates that less heat is escaping through the attic due to the added insulation.
