SPATIAL EXTENT, TIMING, AND CAUSES OF CHANNEL INCISION, BLACK  
VERMILLION WATERSHED, NORTHEASTERN KANSAS

A THESIS

MASTER OF ARTS

KANSAS STATE UNIVERSITY  
Manhattan, Kansas

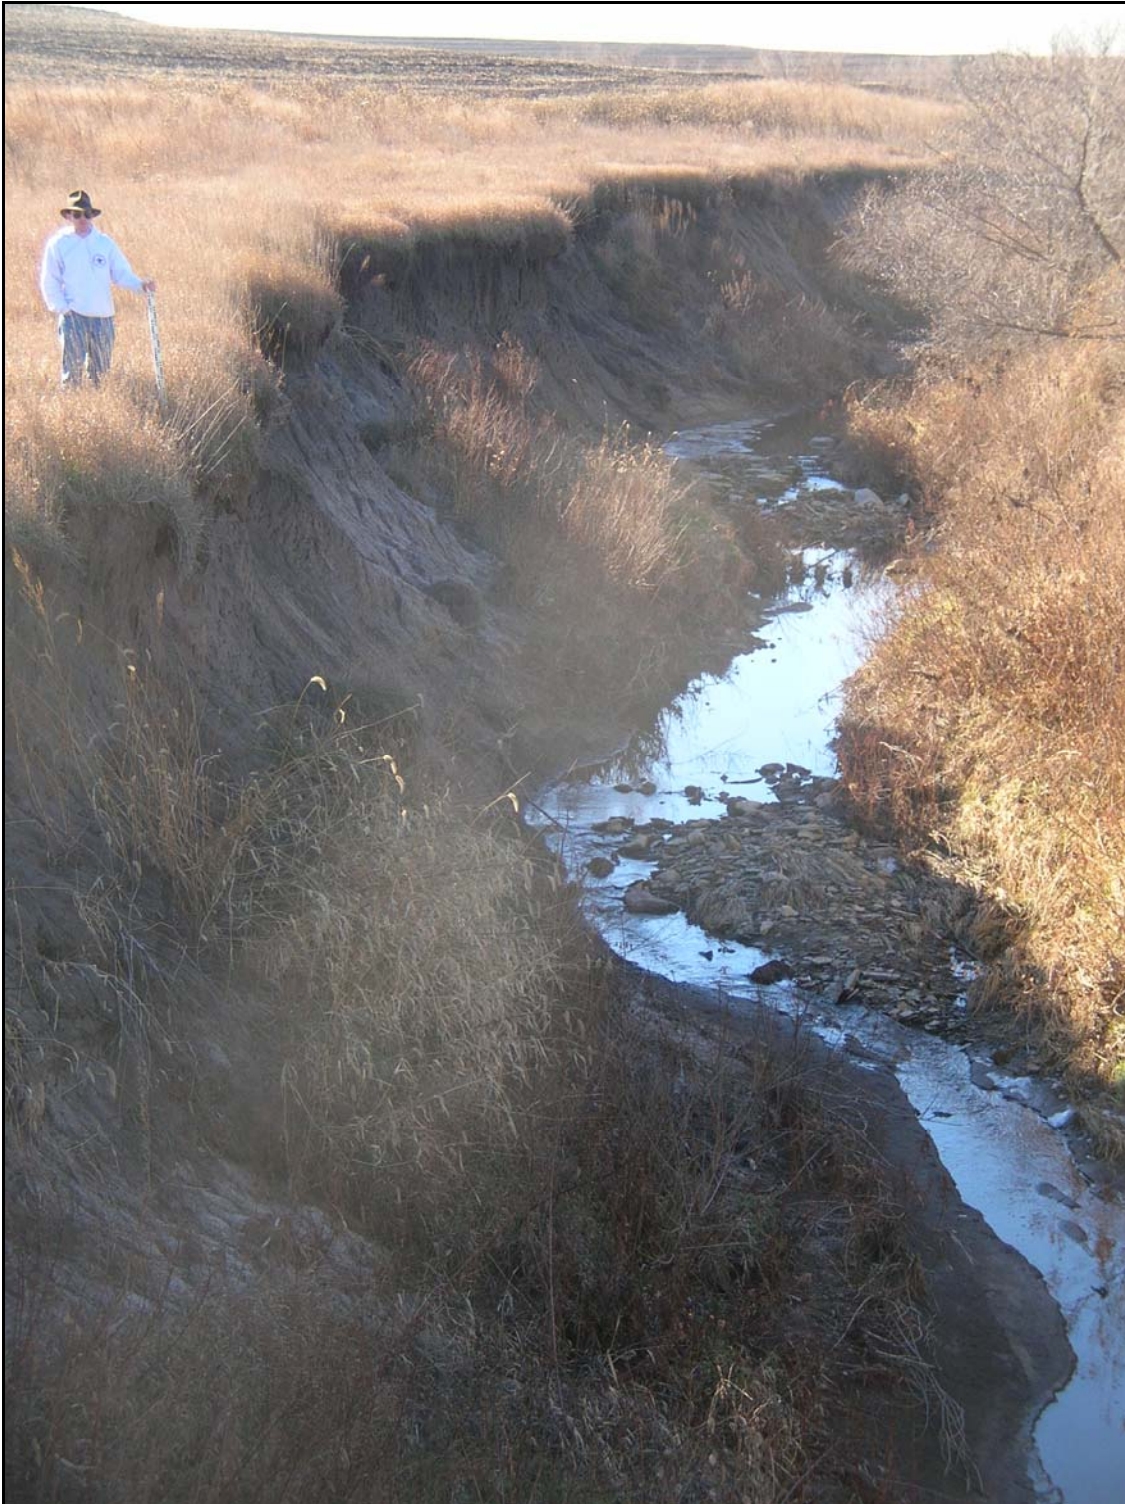
**Figure 2.1 Site 13056 looking upstream (Northwest). Source: author, November, 2008.**

Incised river channels have several defining characteristics. One such characteristic is an increase of bank heights as the channel bed degrades over time (Figure 2.1). Increasing bank heights decrease the stability of those same banks (Hanson and Simon, 2000). When a critical height and bank angle is reached, bank failure and erosion due to slumping can occur. This results in channel widening (Simon and Darby, 1999). Bank erosion is a natural process that creates and promotes wildlife habitats and the succession of riparian vegetation (Florsheim et al., 2008). However, in incised channels bank erosion is instigated by channel bed degradation and is considered to be a consequence of that rapid morphologic change (Simon and Darby, 1999). As noted by Simon (1992) channel widening is an important process for promoting the recovery of incised streams. This recovery occurs because widening helps to reduce available shear stress, lowers the sediment-transport capacity of the stream, and also reduces the depth of flows (Simon, 1992).

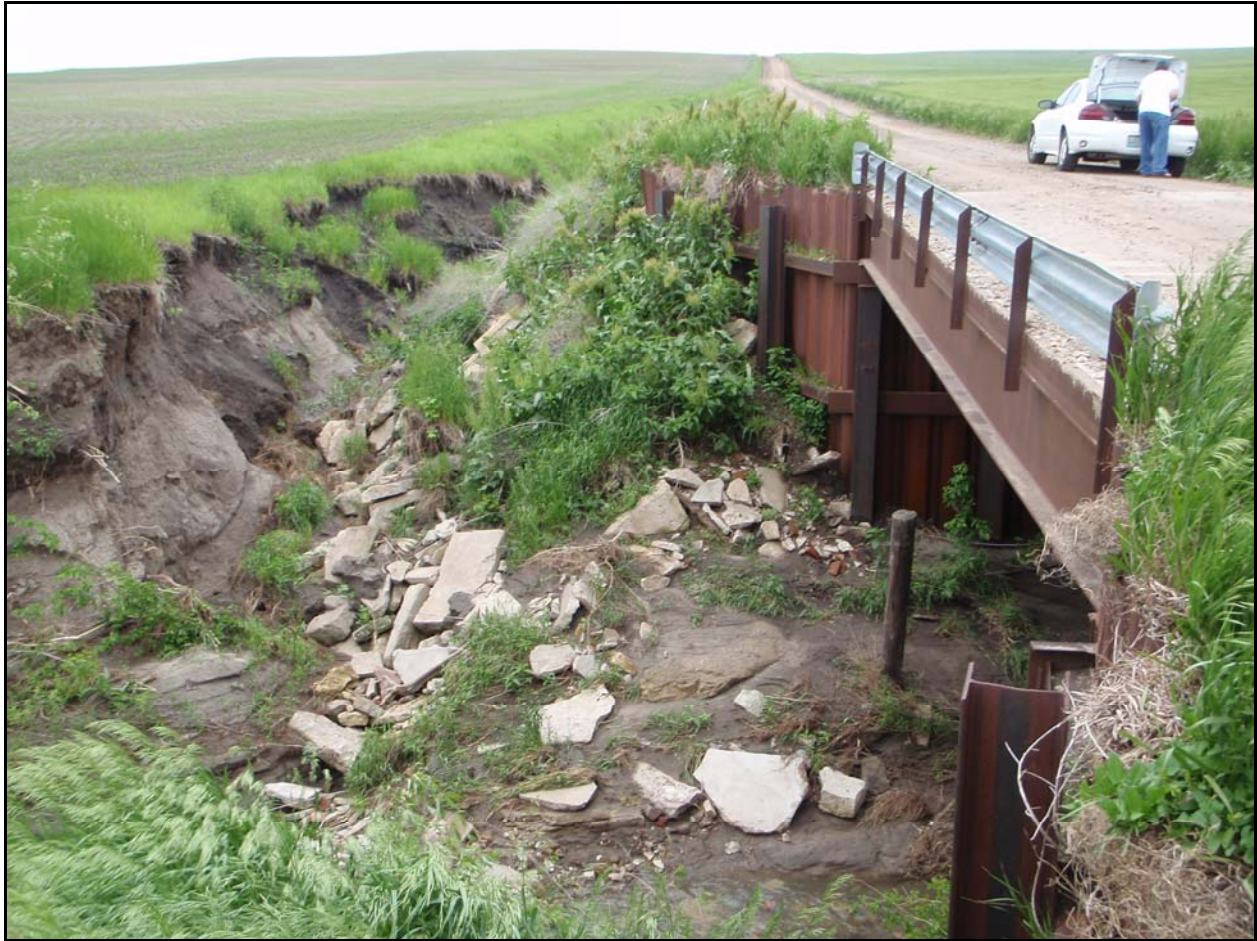
**Figure 2.2 Site 13056 looking perpendicular to channel (South). Source: author, May, 2008.**

their classification. Figure 2.1 (looking upstream) illustrates an incised stream where channelization has been completed in the past. Figure 2.2 (looking perpendicular to channel) shows the same incised stream and a gully in the same location as Figure 2.1.

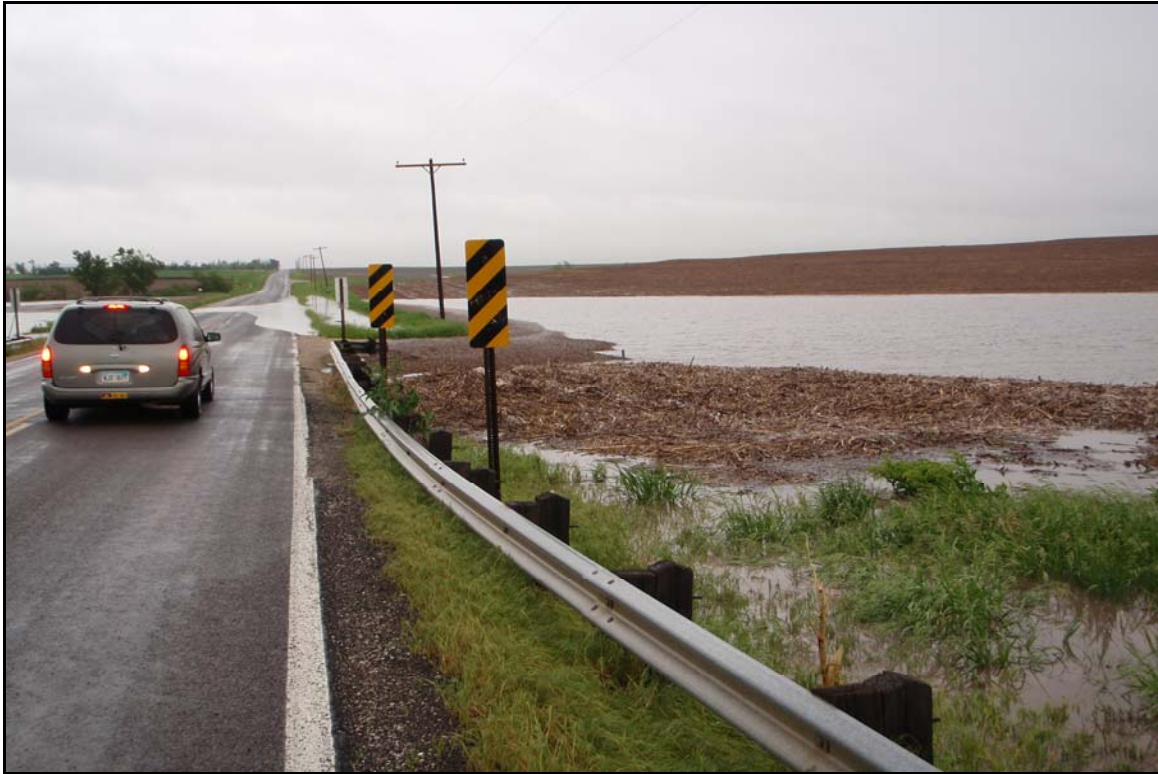
**Figure 2.3 Flooding on Weyer Creek. Source: author, May 22<sup>nd</sup>, 2008.**

The flashy flow conditions and problems caused by flooding in the watershed were visible on May 22<sup>nd</sup>, 2008 when a rainstorm caused 108 mm of rain to fall in Axtell in the headwaters of the North Fork watershed. The flooding in Figure 2.3, Figure 2.4, and the hydrograph shown in Figure 2.5 all result from this same storm. Eventually, due to flooding problems and channel sedimentation, channelization practices began to be implemented in the Black Vermillion watershed.

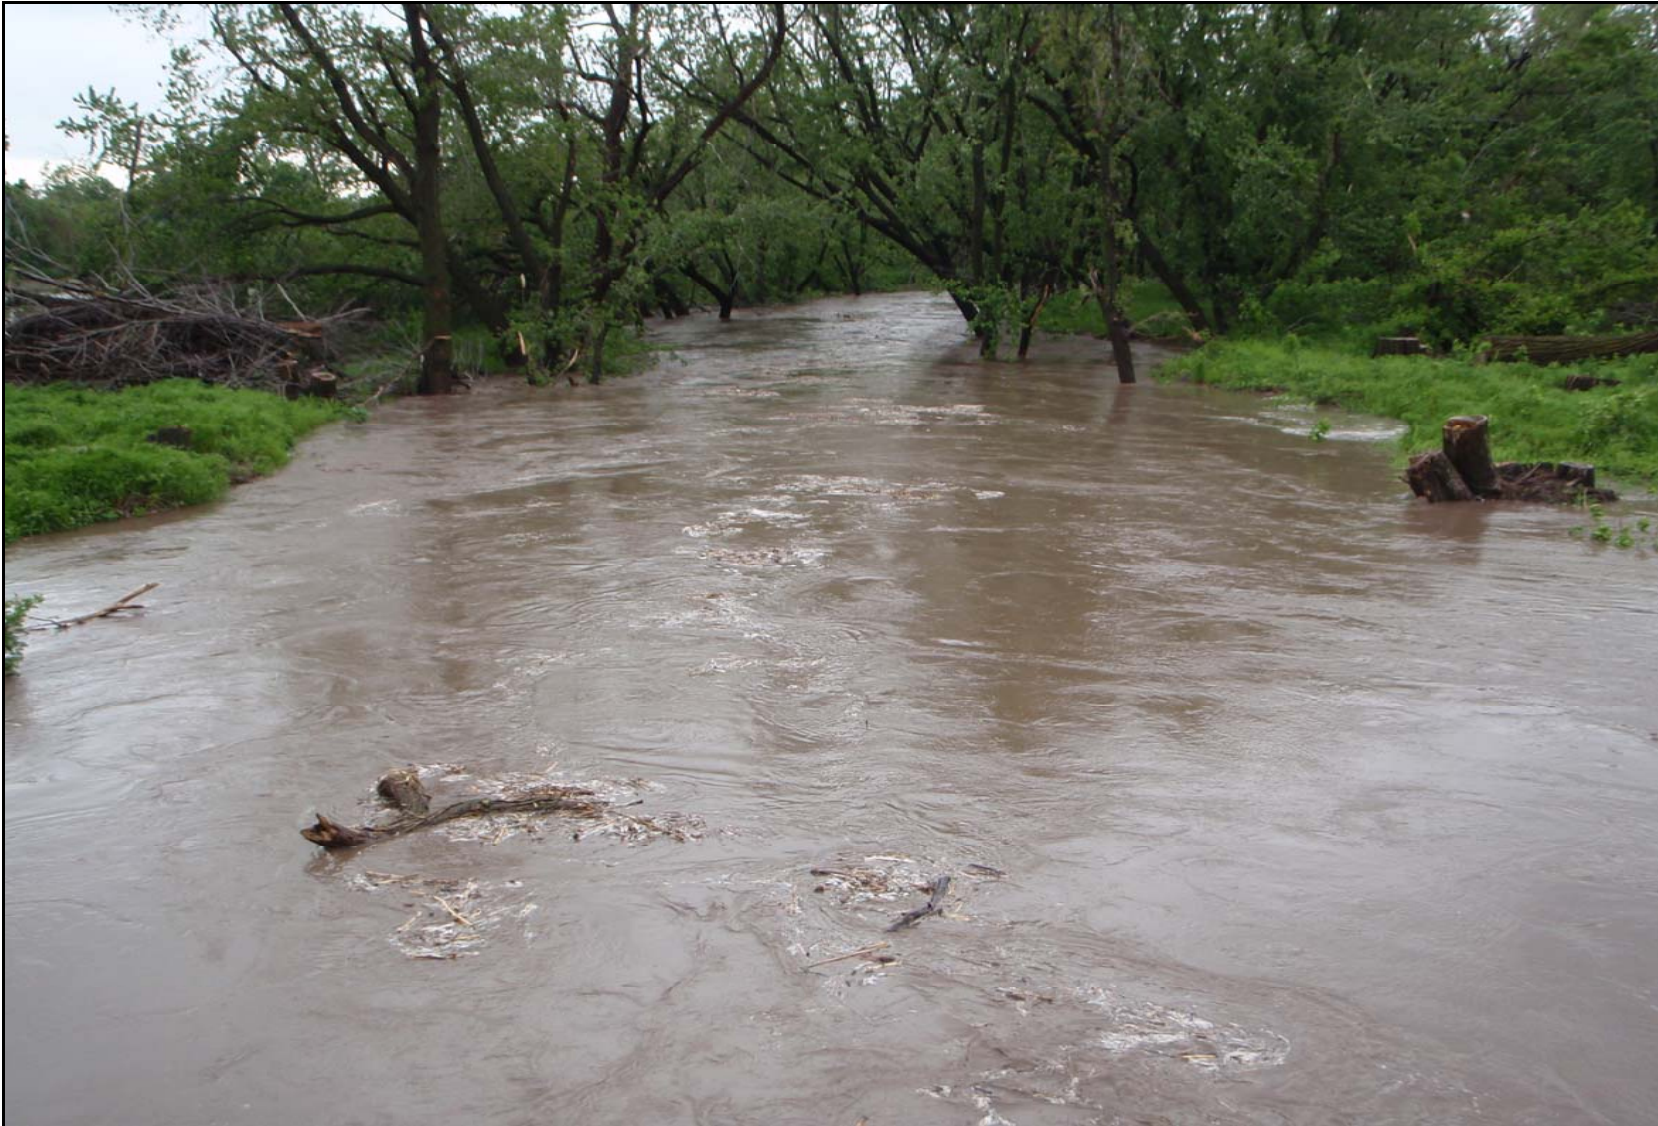
**Figure 2.4 Flooding on the North Fork of the Black Vermillion River on Kansas route 9. Source: author, May 22nd, 2008.**

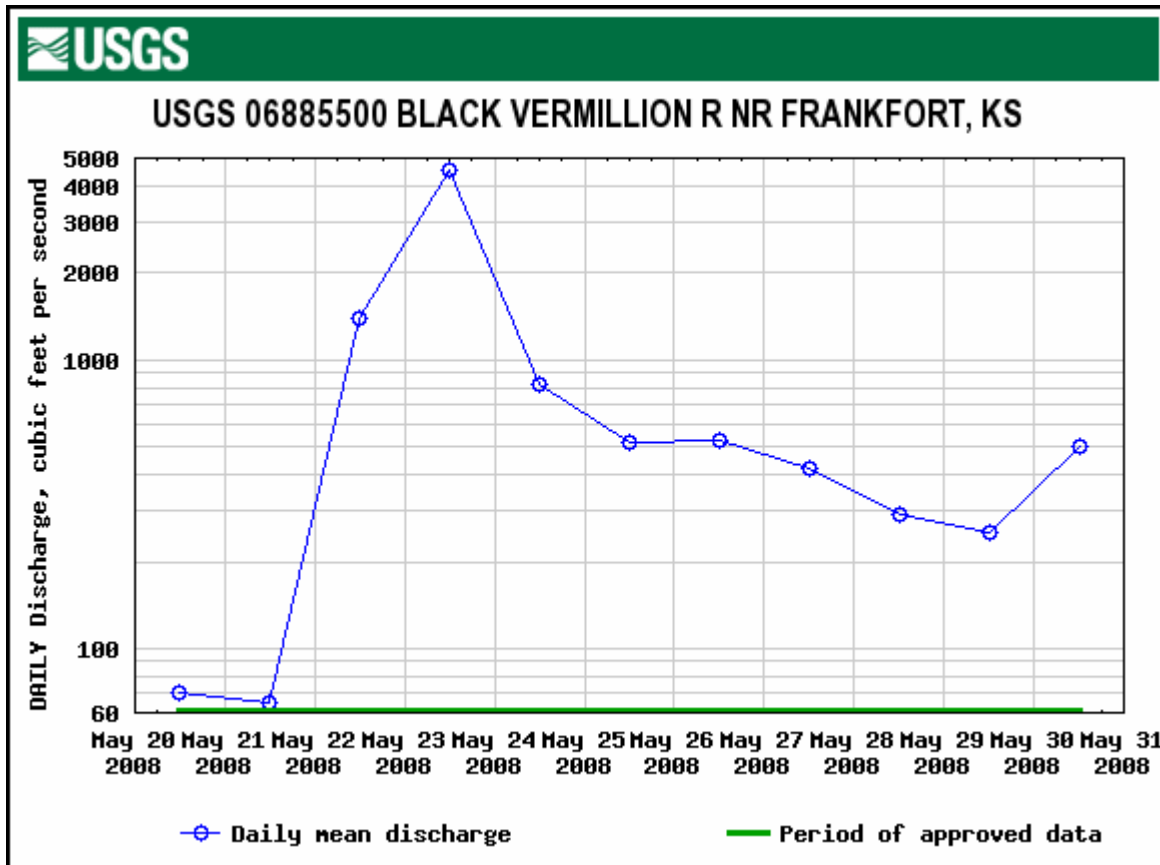
**Figure 2.5 USGS hydrograph for the streamflow gauge at Frankfort, Kansas after a rainstorm caused 108 mm of precipitation in Axtell, Kansas and 11 mm of precipitation in Frankfort, Kansas. Source: USGS.**

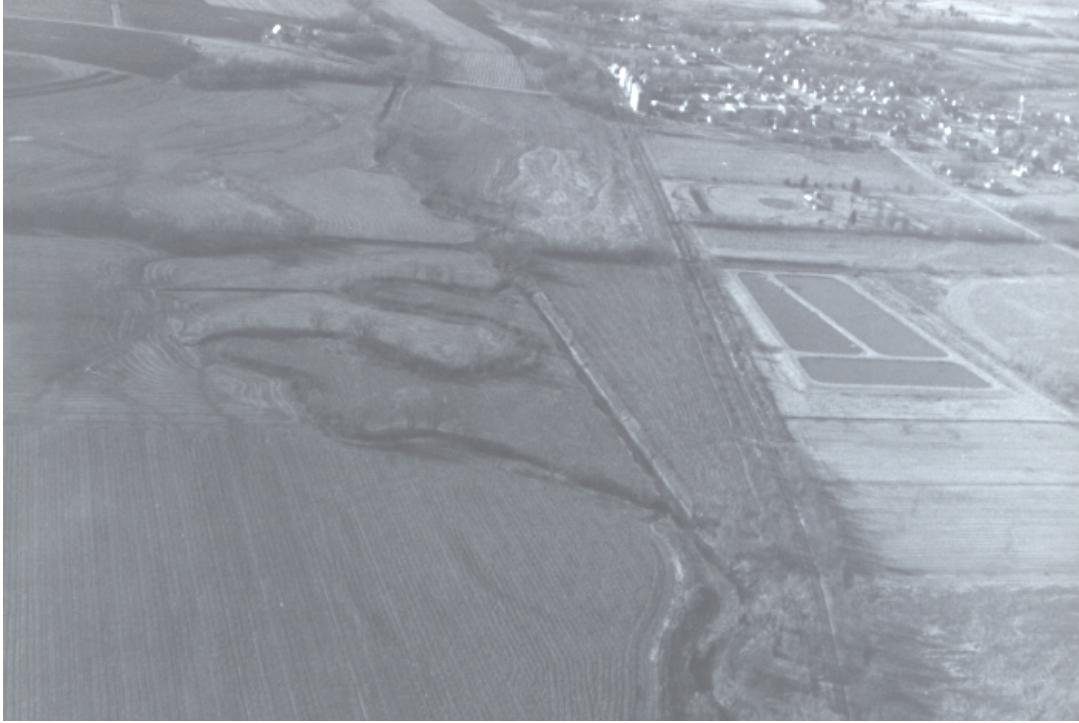
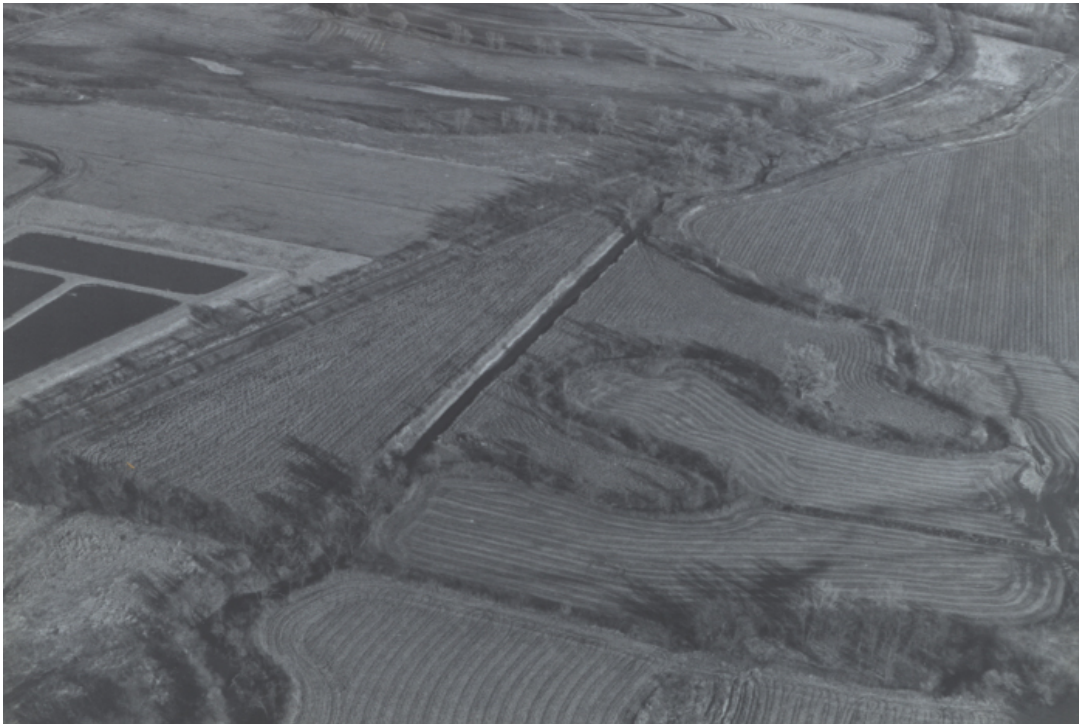
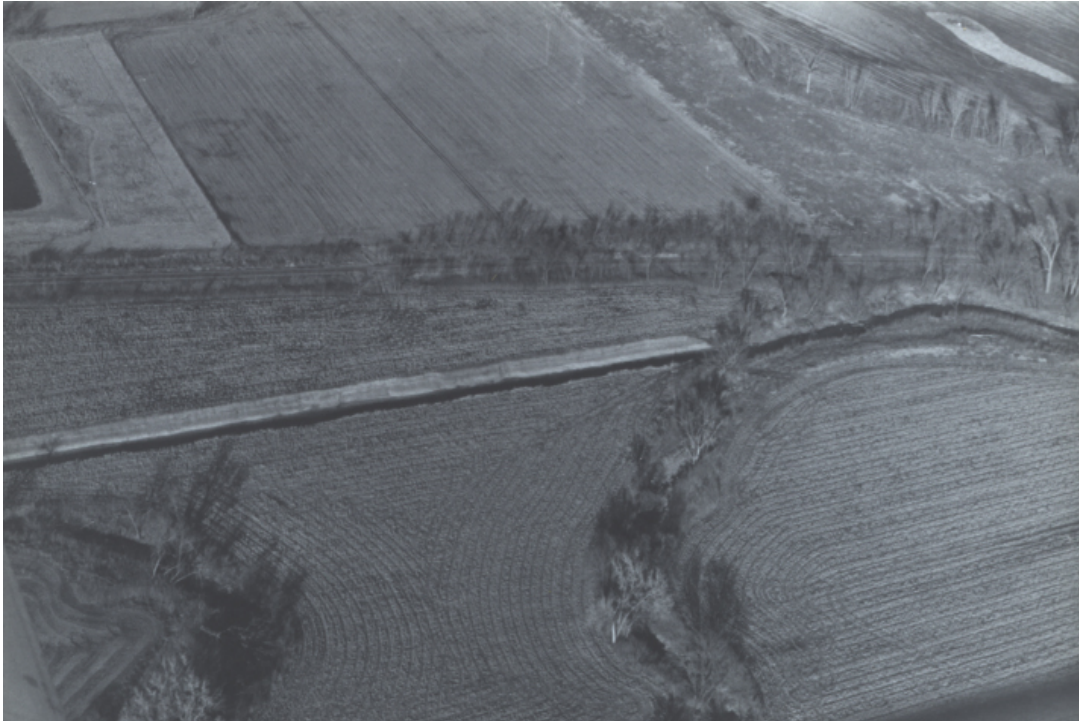
**Figure 2.8 Channelization on the Main Branch of the Black Vermillion River near Vermillion, Kansas. Source: Erik Peterson, January, 1987.**

**Figure 2.9 Channelization on the Main Branch of the Black Vermillion River near Vermillion, Kansas. Source: Erik Peterson, January, 1987.**

**Figure 2.10 Channelization on the Main Branch of the Black Vermillion River near Vermillion, Kansas. Source: Erik Peterson, January, 1987.**

Today, channelized stream reaches are readily visible in the Black Vermillion watershed from the air (Figure 2.8, Figure 2.9, and Figure 2.10) and are also visible at ground level (Figure 2.6). The fragmented nature of the timing of channelization and the almost complete spatial coverage of channelization throughout the watershed are deserving of attention (Figure 2.7).

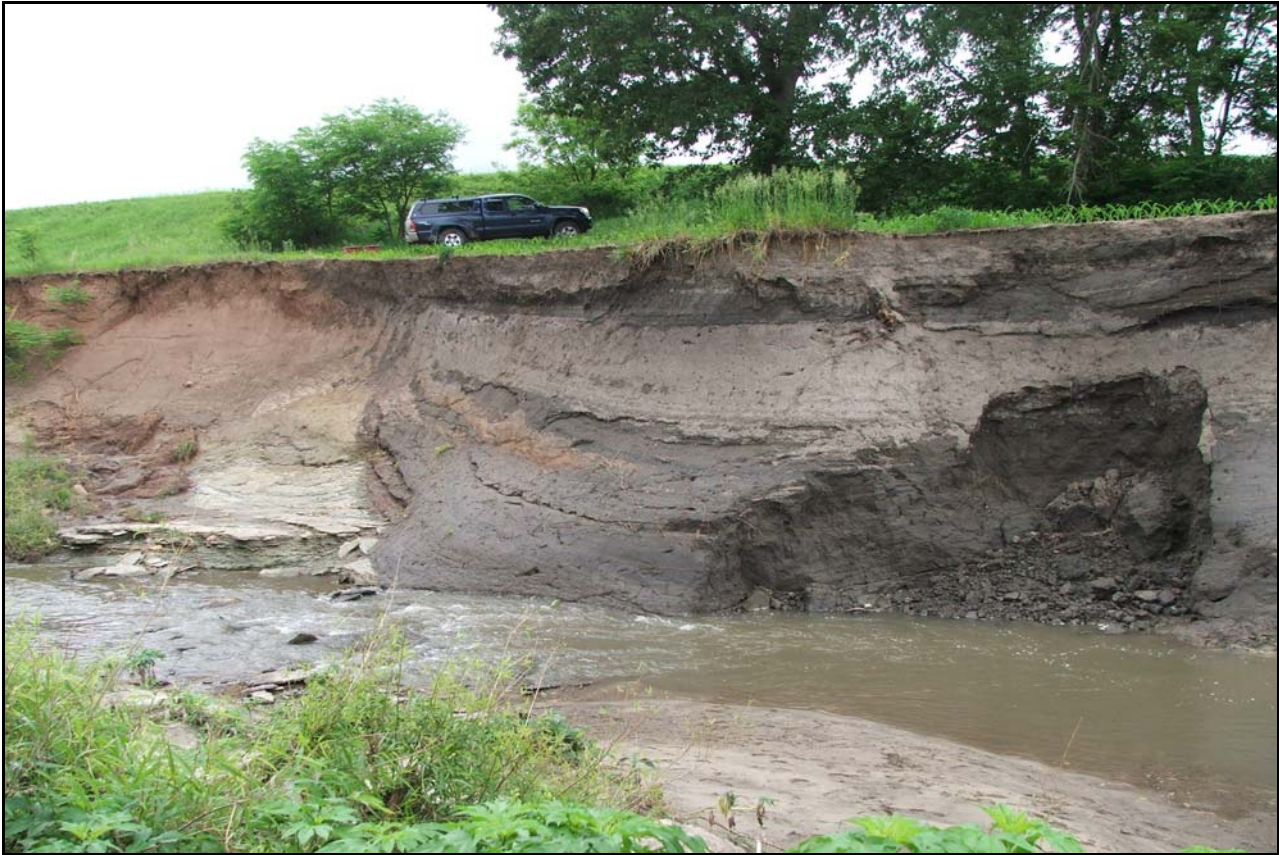
**Figure 2.11 Bank erosion on the North Fork of the Black Vermillion River. Source: Chris Sass, June, 2008.**

As stated by Simon and Rinaldi (2006), channel incision contributes to the generation of higher and steeper streambanks. In turn, these banks are more susceptible to failure and are commonly found along streams that have been severely incised (Figure 2.11). According to Langendoen and Simon (2008) bank erosion occurs for two reasons. First, lateral erosion of the bank toe occurs because of the fluvial entrainment of in situ bank materials. This process is known as hydraulic erosion. Second, gravity can cause mass failure (slumping) of the upper part of the bank. Both of these processes can be triggered by channel incision since channel incision increases instability at the bank toe due to the lowering of the streambed. Hence, channel incision contributes to channel widening due to bank erosion and subsequent channel-width adjustment. Mass wasting of bank deposits can also result from increases in bank heights and angles, a direct result of channel incision (Darby and Simon, 1999). Decreases in shear strength of bank materials due to loss of matric suction are an attributed cause of bank erosion in incised channels as well. As a result, incised streams actively widen, triggering even more channel instability. Furthermore, past studies in nearby eastern Nebraska (Hanson and Simon, 2001) confirmed that channel bed materials that had originated from bank failures were found to have the weakest shear stresses, and subsequently, were the most easily erodible. Zaimis et al., (2005) found that bank erosion can contribute up to 50-90% of any given's stream sediment and phosphorous load. Simon and Rinaldi (2006) were more precise and stated that stream banks can contribute up to 80% of a stream's total suspended load. However, Simon (1992) found that channel widening and bank erosion are important processes in helping the incised channel to recover over time because these processes can effectively reduce flow depth, shear stress, and therefore slow the sediment transport capacity of the fluvial system.

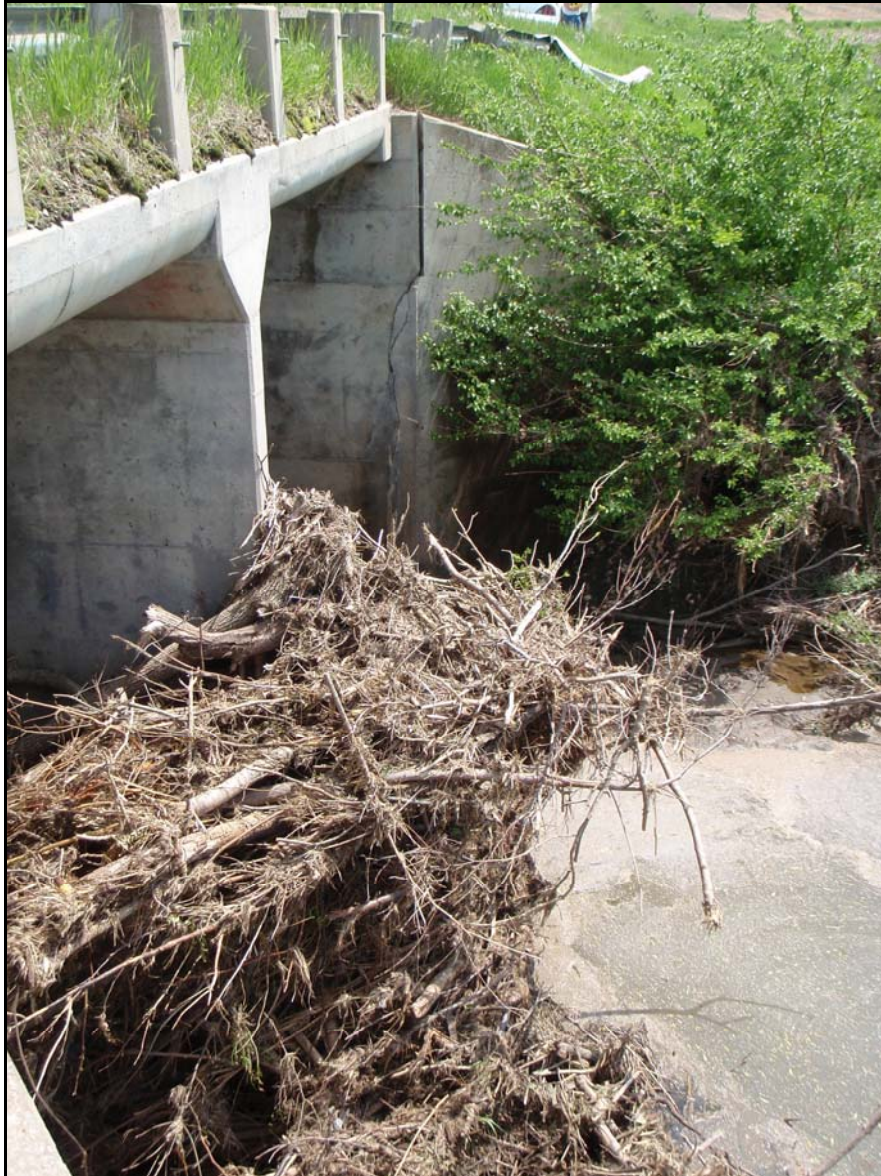
**Figure 2.12 Large woody debris upstream of bridge at Site 3210. Source: author, June, 2008.**

Simon and Darby (1999) also wrote that materials such as large woody debris (LWD) that fall into incised channels due to bank failures can be hazardous to in-channel structures such as bridges (Figure 2.12). Such LWD can potentially cause bridge failures in incised channels (Simon and Darby, 1999).

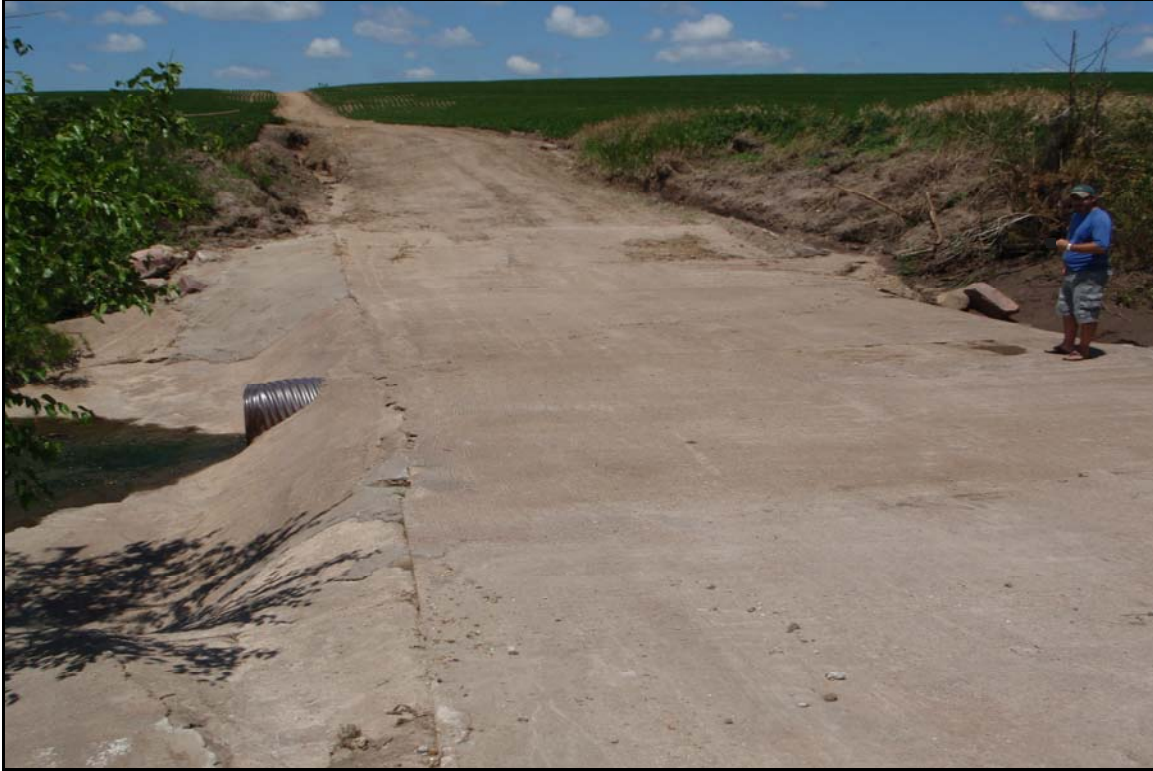
**Figure 3.2 Low water crossing at Site 13103. Source; author, July, 2008.**

for data collection. The first reason for this elimination was that the channel under the bridge was very small and/or only contained a very small intermittent channel. Since channel incision was being studied for this thesis, any location where the stream channel was too small to actively incise is not necessary to be included. A second reason for this elimination was the bridge at the study site was a box culvert. Since box culverts are installed complete with a concrete channel bed lining, they successfully prevent the channel from downcutting at that location. The third reason for a site location being eliminated from this analysis was the presence of a low-water crossing at that location. Low water crossings completely alter the previous channel configurations and measurement of channel dimensions are not possible (Figure 3.2).

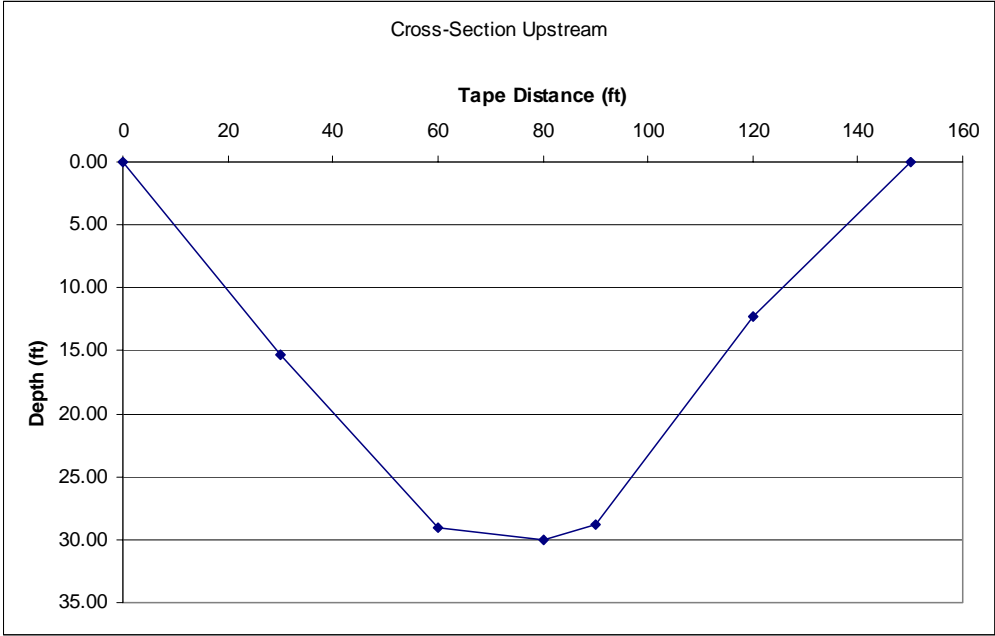
**Figure 3.3 Channel cross section for site 3697, upstream of bridge.**

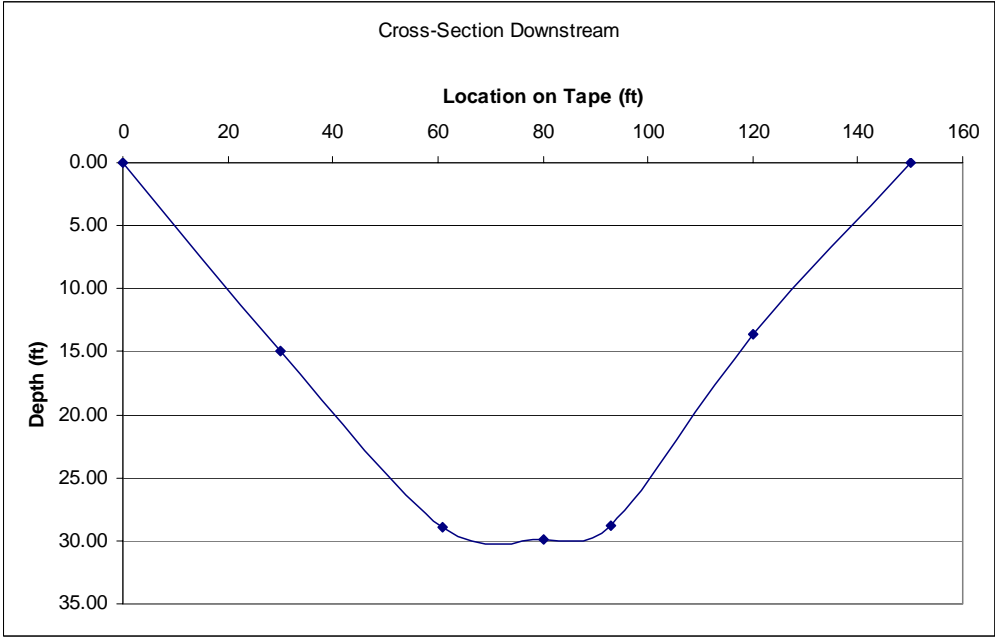
**Figure 3.4 Channel cross section for site 3697, downstream of bridge.**

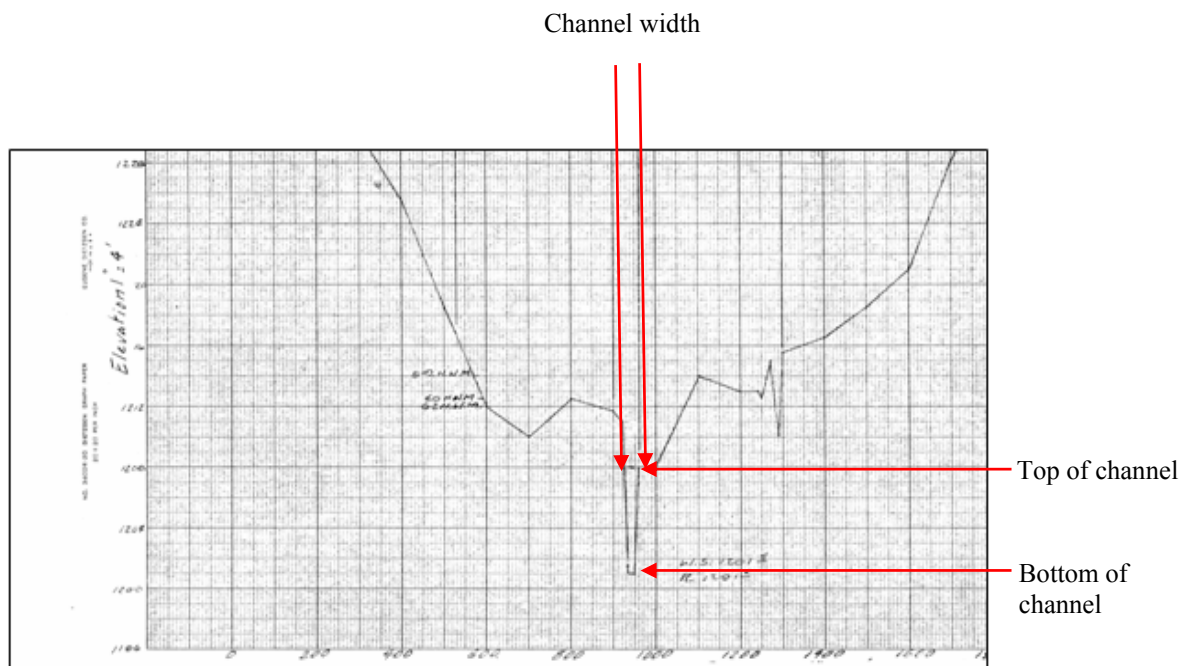
**Figure 3.6 Example of valley cross section collected in 1963 by the SCS. Vertical exaggeration 50X.**

Channel width was identified by measuring width of the deep V-shaped channels that were visible on each of the valley cross sections (Figure 3.6). These widths were then recorded in Microsoft Excel along with the corresponding number of the cross section.

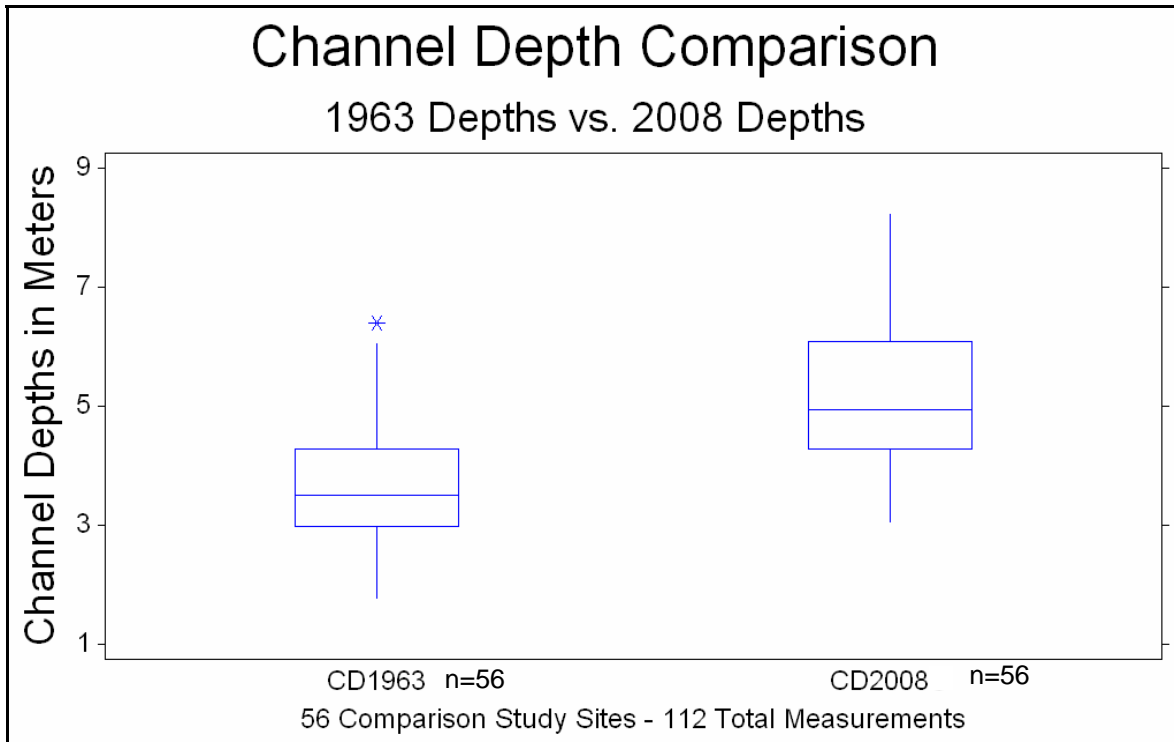
**Figure 4.2** Box plot showing comparison between 1963 and 2008 channel depths for the 56 comparison study sites.
