IMPROVING THE USABILITY AND ACCESSIBILITY IN AGING RURAL COMMUNITIES

MASTER OF REGIONAL AND COMMUNITY PLANNING

## Peabody, Kansas: Study Boundary of Streetscape Audit

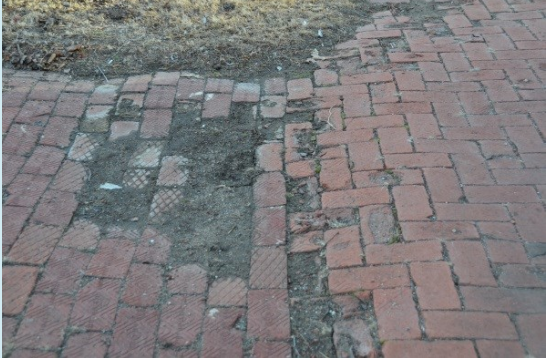
Streetscape Element to Evaluate	Streetscape Element Features Evaluation		
<b>Walkways &amp; Sidewalks Textures</b>  <b>Examining: Tread Path Integrity Design Features</b>	<b>Block A: Northern Half</b> <ul style="list-style-type: none"><li>• No pavement of any type</li><li>• Paved with deteriorated bricks due to erosion</li><li>• Multiple tree lifts</li><li>• Poor drainage</li><li>• Uneven walkway surface</li><li>• Substantial over growth of weeds present</li><li>• Leafs &amp; fallen branch debris from trees</li></ul>	<b>North Half</b>

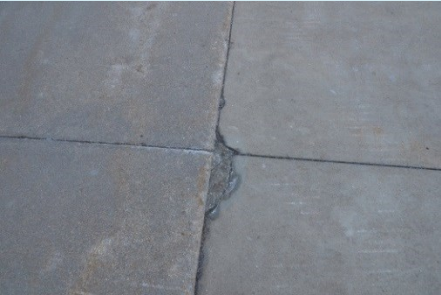
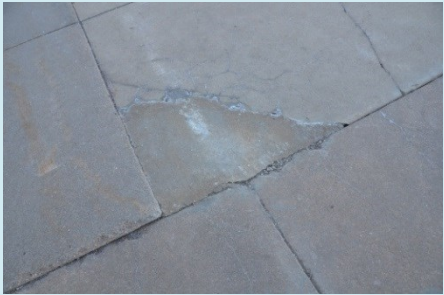
<b>Block A: Southern Half</b> <ul style="list-style-type: none"><li>• Paved with a smooth concrete</li><li>• Walkway is wide for heavy foot traffic</li><li>• Walkways surface featured very few holes</li><li>• Very few cracks or tree lifts</li><li>• Integrity of the walkway is in good shape</li></ul>	<b>Southern Half</b>

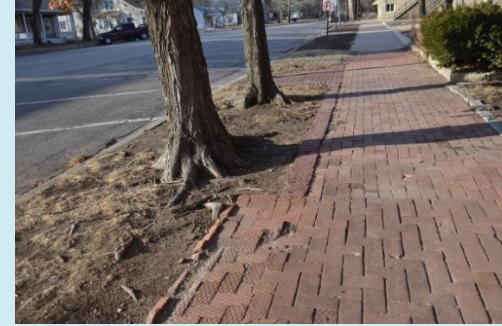
- Brick pavers in good condition
- Smooth concrete with minimal cracks
- Good drainage
- Walkway surface joints are even
- Walkway is free of vegetation over growth
- Fallen leaves, branch and other debris is cleared from walkway

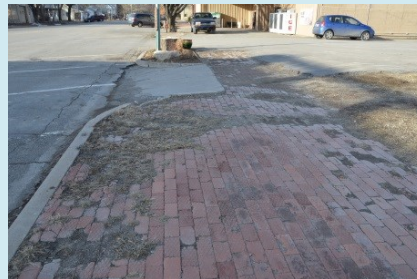
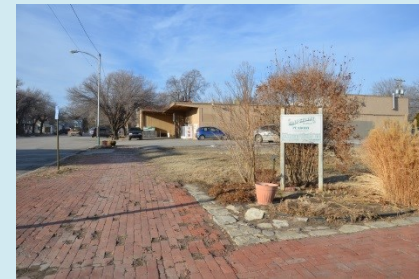
**Southern Half**

- Paved completely with brick pavers
- Majority of brick pavers broken or heavily eroded
- Many breaks, cracks, and holes.
- Walkway is wide for heavy foot traffic

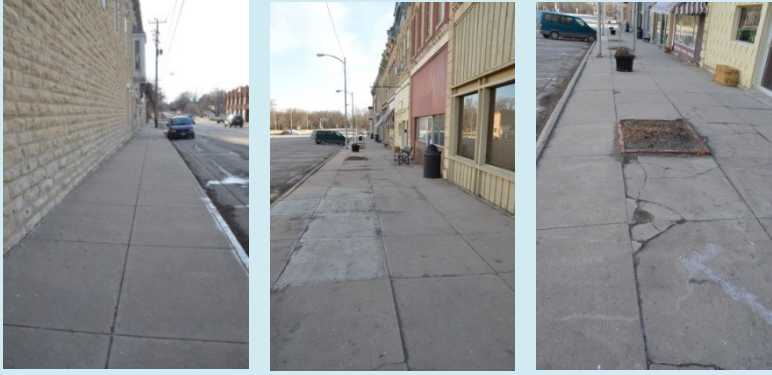
- Paved with a smooth concrete
- Walkway joints are even and match up
- Very few cracks and holes
- Walkway is wide for heavy foot traffic
- No Tree lifts
- Integrity of the walkway is in good shape

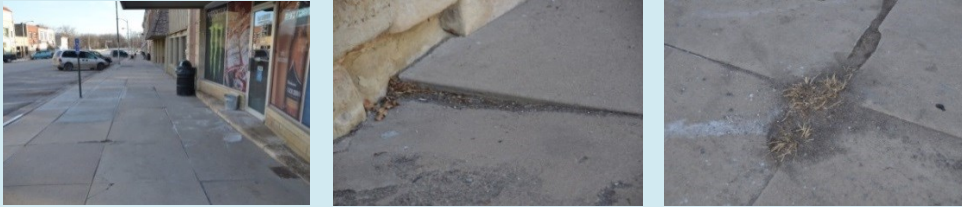
**Block C: Southern Half**

- Uneven walkway surfaces and concrete joints don't match up
- Some over growth of weeds present; potential trip hazard
- Sand from winter road treating covers walkway; potential slip hazard
- Multiple patched sections to repair damaged pavement

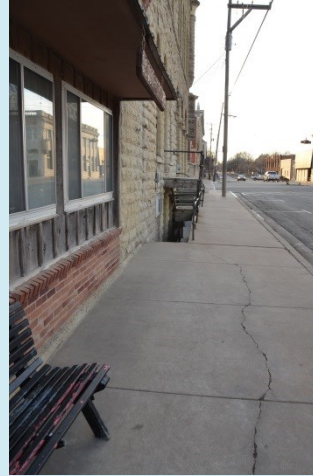
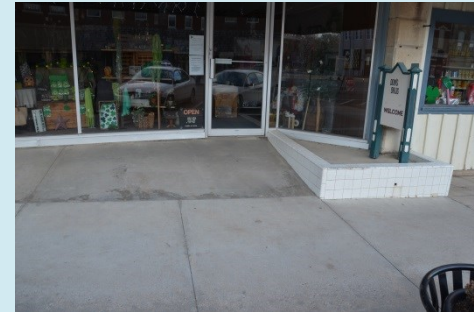
- Paved with a smooth concrete
- Substantial over growth of weeds present on 1<sup>st</sup> street
- Walkway is wide for heavy foot traffic
- Walkways surface featured very few holes
- Very few cracks
- Integrity of the walkway is in good shape

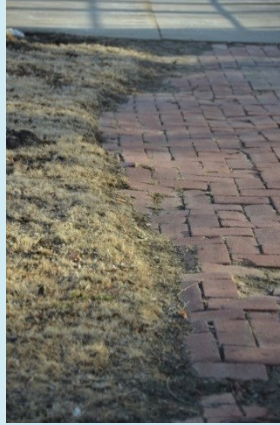
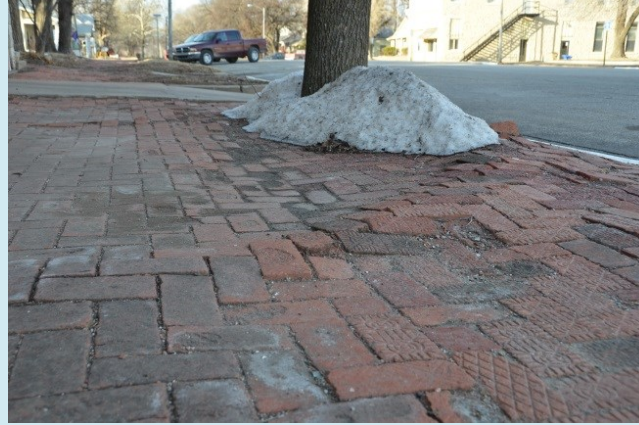
- Edges of pathway are not defined; No pavement of any type on Division Street
- Eroded and deteriorated brick walkway w/ multiple cracks and holes
- Multiple tree lifts
- Poor drainage
- Uneven walkway surface
- Substantial over growth of weeds present
- Leafs & fallen branch debris from trees

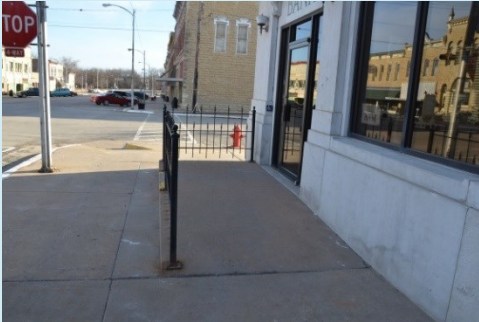
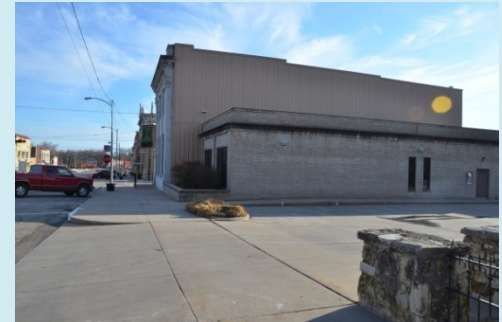
**Block A: Southern Half**

- Paved with a smooth concrete
- Walkway is wide for heavy foot traffic
- Walkways surface featured very few holes
- Very few cracks or tree lifts
- Integrity of the walkway is in good shape

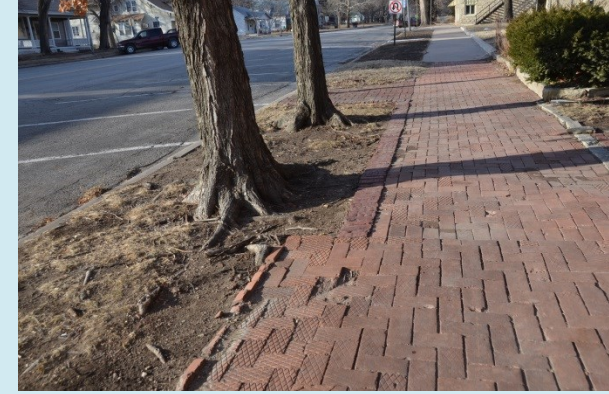
- Lack of clear walkway boundaries near grocery store entrance
- Width of pathway appropriate for expected circulation volumes
- Edges of pathway over run with vegetation overgrowth
- Deteriorated walkway has many holes and cracks; trip hazards

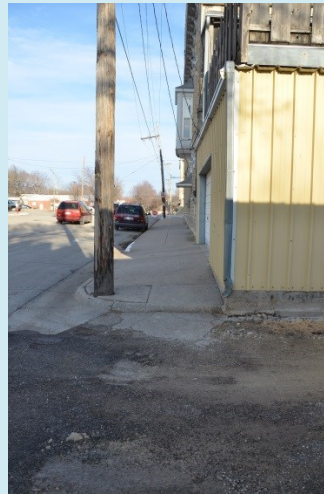
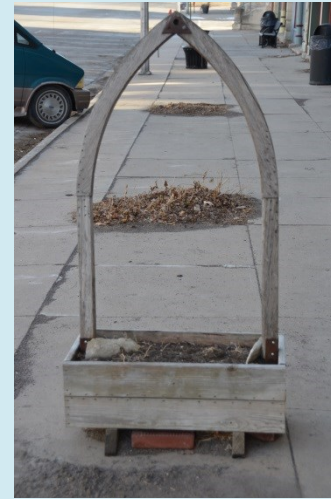
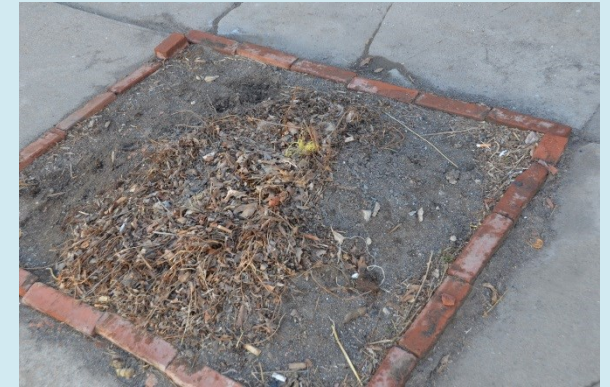
- Paved with a smooth concrete
- Multiple cracks and holes in concrete
- Flower beds and planters obstruct walkway circulation
- Some over growth of weeds present; trip hazard

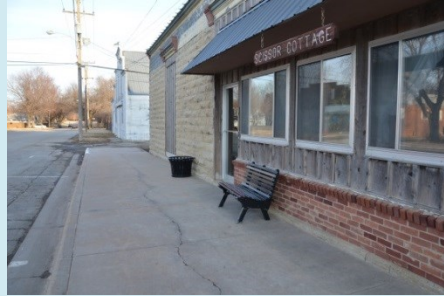
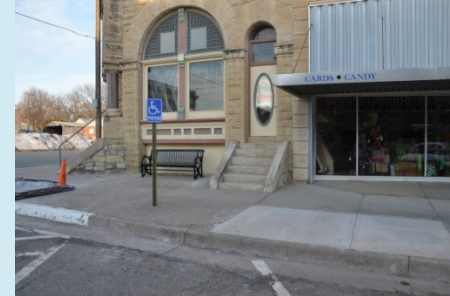
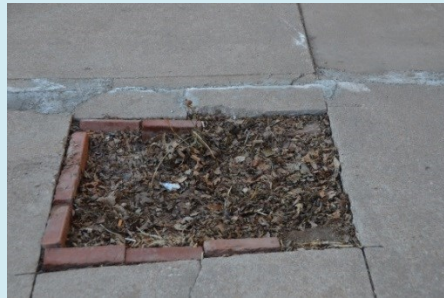
- Paved with a smooth concrete
- Walkway is wide for heavy foot traffic
- Over growth of weeds present along 1<sup>st</sup> street walkway
- Walkways surface featured very few holes or cracks
- Edges of pathway are not defined on 1<sup>st</sup> Street

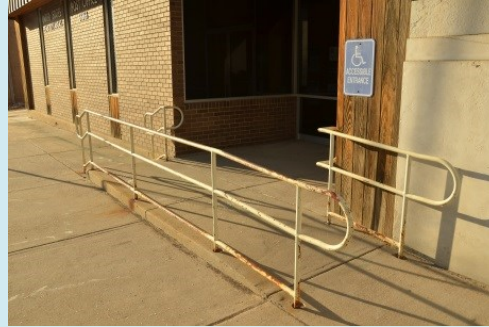
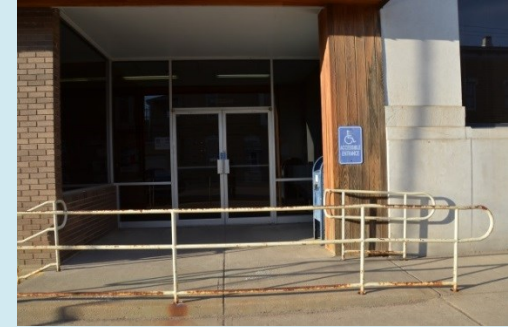
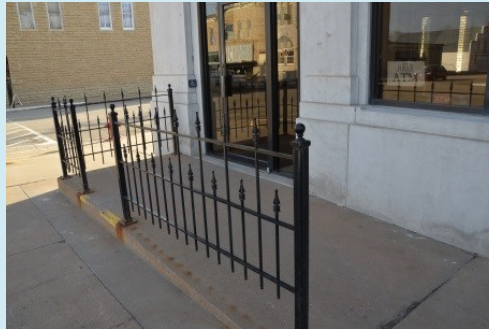
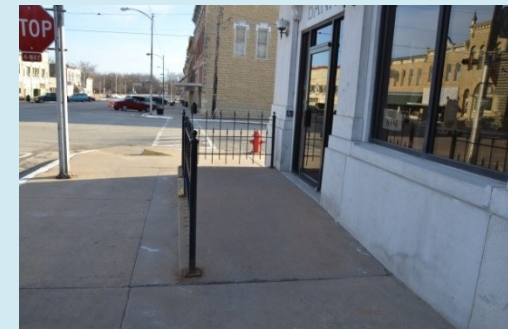
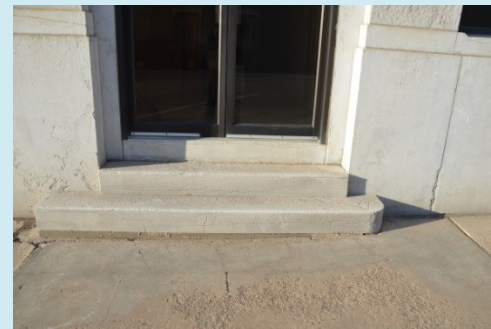
**Block A:**

- Alternatives to stairs are present in two locations: Peabody bank and the post office
- Main access point is shared with stair alternatives
- Stair alternatives feature ramps with handrails
- Ramps and stair transitions are marked with contrasting indication colors
- Stairs and ramps do not feature slip resistant traveling surfaces
- Tactile indicators on railings such as groves or bumps are not present
- Northern half staircases do not have handrails

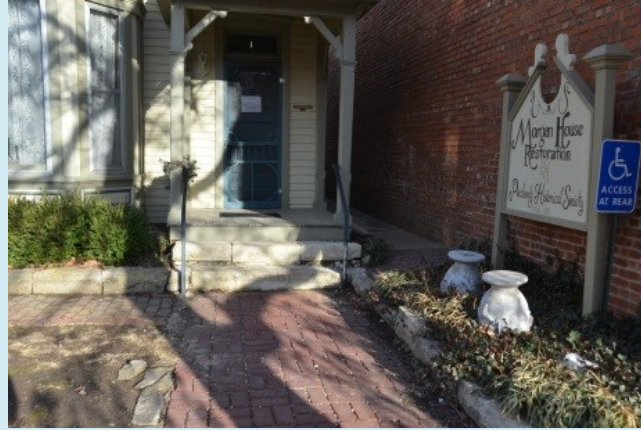
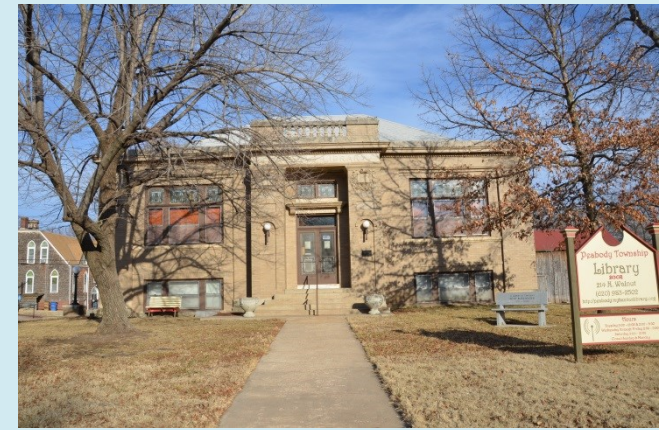
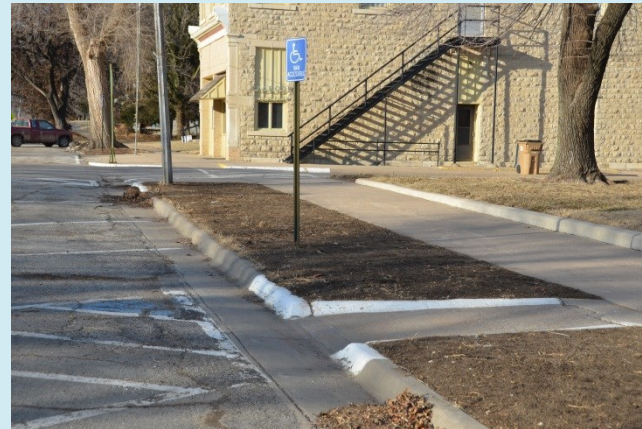
**Block B:**

- Alternatives to stairs are present for the Morgan House Museum (accessible entry at building rear)
- Stairs and ramps do not feature slip resistant traveling surfaces
- Tactile indicators on railing such as grooves or bumps are not present

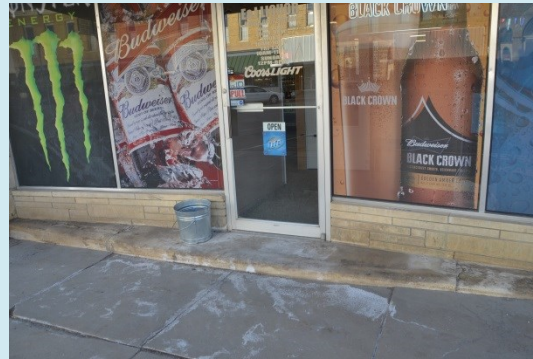
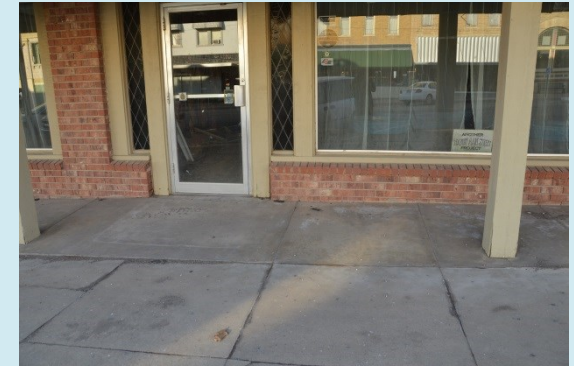
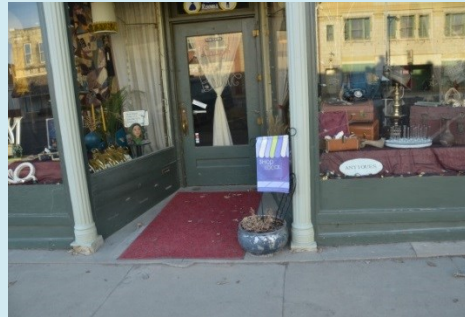
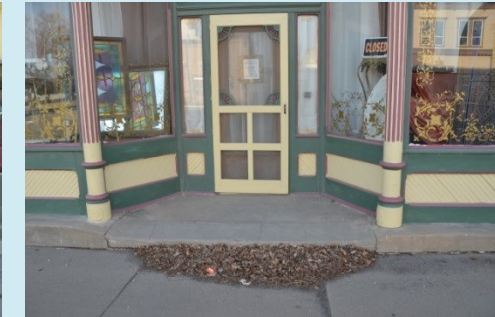
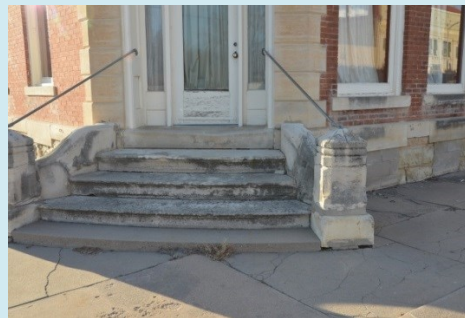
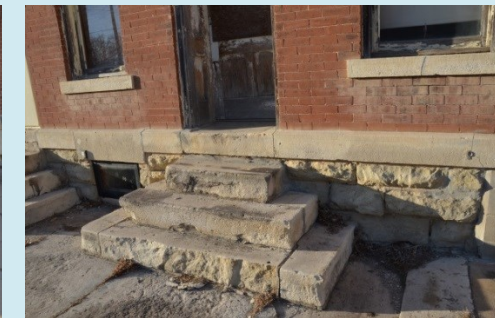
**Block C:**

- No alternatives to stairs are present
- Stairs do not feature slip resistant traveling surfaces
- Railing present at one of four entry points with staircases
- Tactile indicators on railing such as grooves or bumps are not present
- Most of the building entry points have no step up to enter building.
- Some entryways have a one-stair step up to enter building

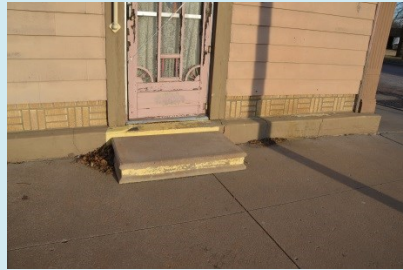
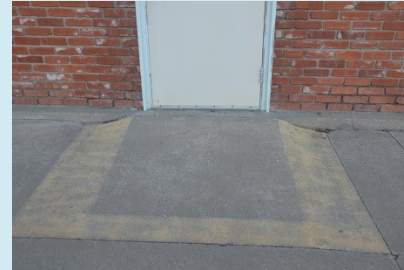
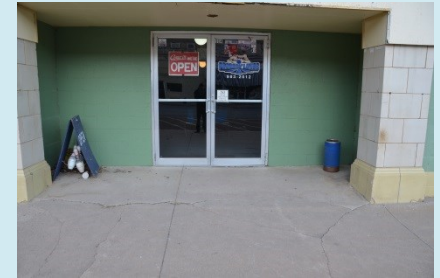
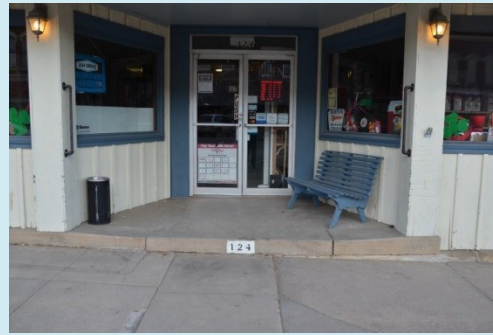
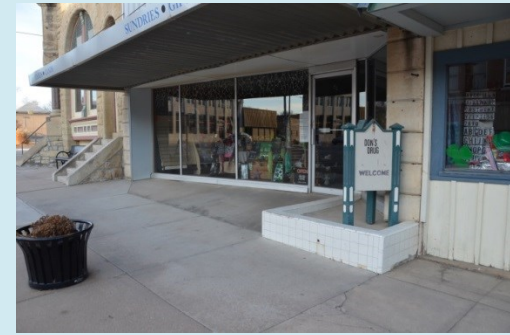
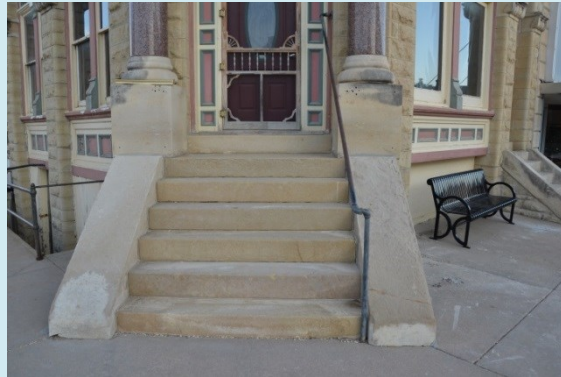
**Block D**

- No alternatives to stairs are present
- Stairs do not feature slip resistant traveling surfaces
- “Step up” entry points are indicated with contrasting paint colors
- The drug store has a smooth inclined entrance for easy accessibility
- Railing for staircase present only at restaurant entry point on 2<sup>nd</sup> street
- Tactile indicators on railing such as groves or bumps are not present
- Most of the building entry points have no step up to enter building
- Some entryways have a one-stair threshold to enter building

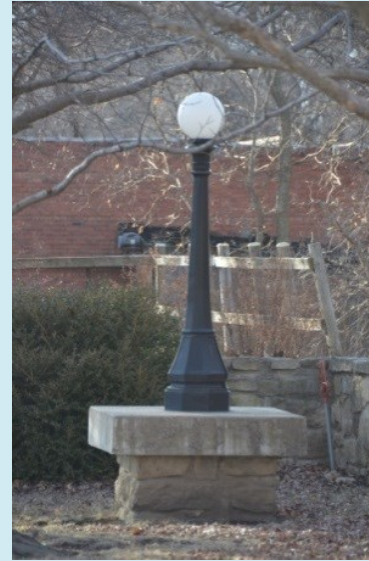
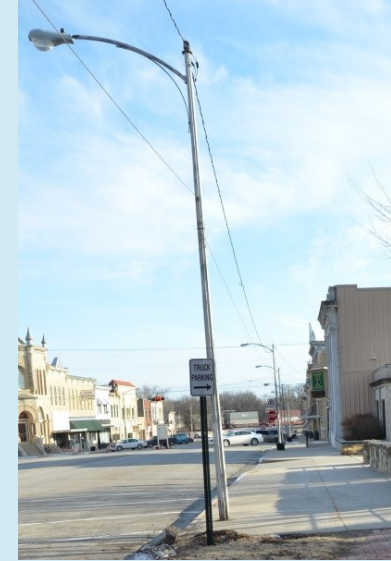
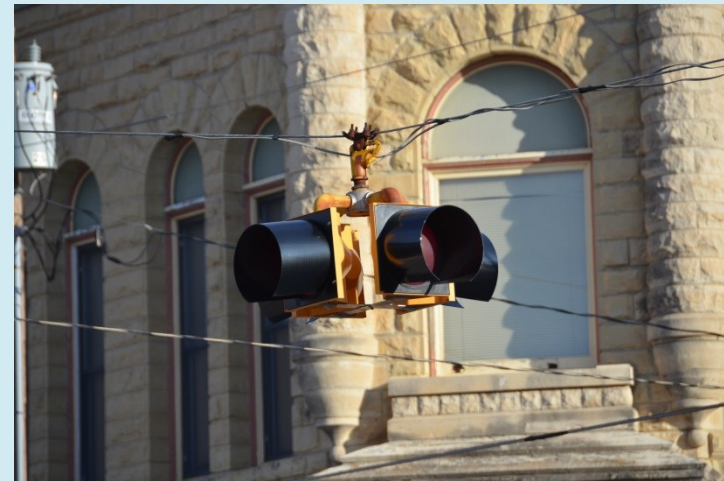
**Block A:**

- Light posts are adequately distributed throughout block
- There is no streetscape lighting in addition to the streetlight posts
- Extra lighting is present at landmark memorial park
- No lighting features to emphasize way finding signs or building entry points
- The four-way red flashing traffic light is the only traffic light in study area
- Light post placement is prioritized along the Main Street and intersections less lighting if any along side streets
- Most intersections and crossing zones are adequately illuminated for pedestrians

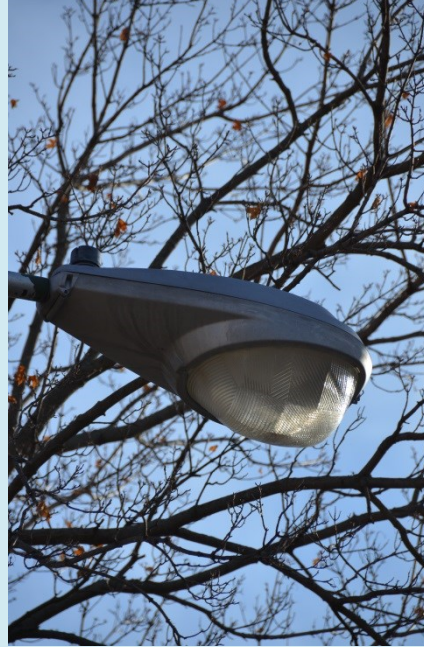
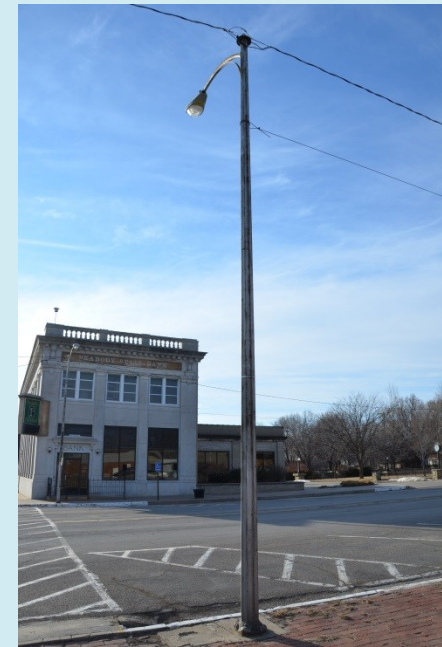
**Block B:**

- Light posts are adequately distributed throughout block
- There is no streetscape lighting in addition to the streetlight posts
- No lighting features to emphasize way finding signs or building entry points
- The four-way red flashing traffic light is the only traffic light in study area
- Light post placement is prioritized along the Main Street and intersections less lighting if any along side streets
- Most intersections and crossing zones are adequately illuminated for pedestrians

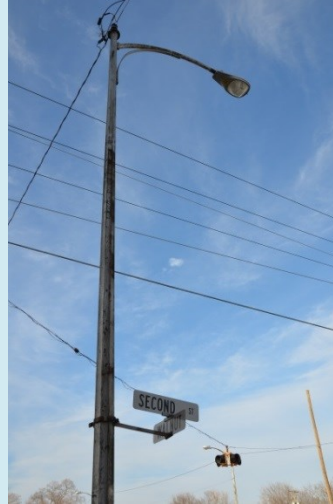
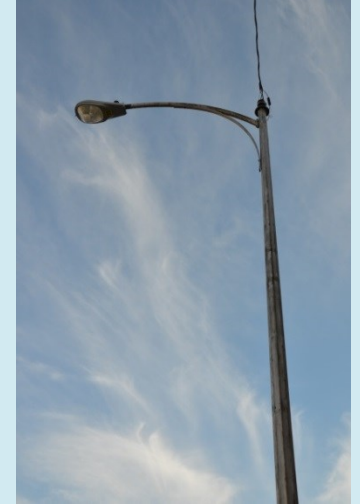
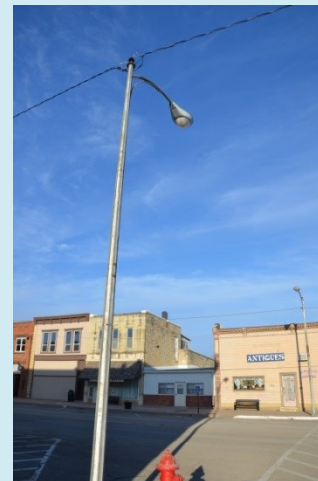
**Block C:**

- Light posts are adequately distributed throughout block
- Standard streetlights used; There is no streetscape lighting in addition to the streetlight posts
- No lighting features to emphasize way finding signs or building entry points
- The four-way red flashing traffic light is the only traffic light in study area
- Light post placement is prioritized along the Main Street and intersections less lighting if any along side streets
- Most intersections and crossing zones are adequately illuminated for pedestrians

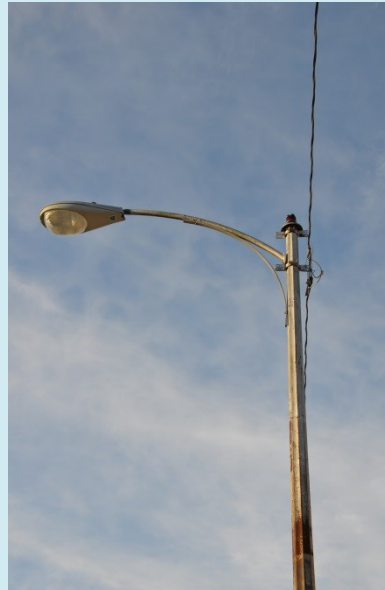
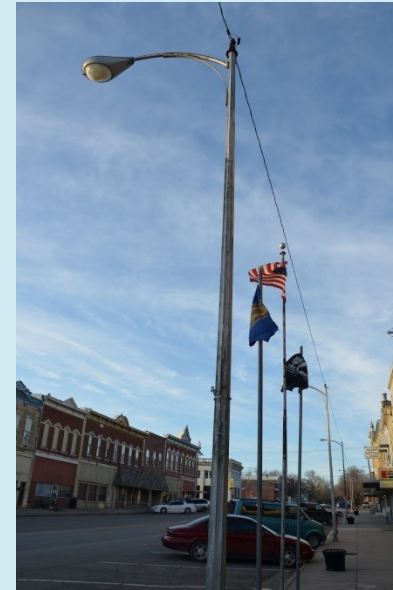
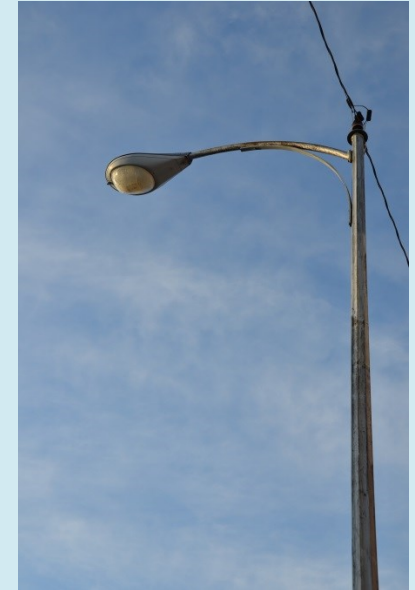
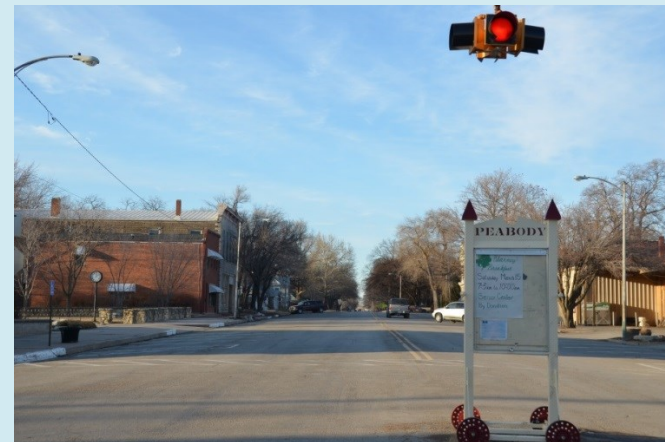
- Light posts are adequately distributed throughout block
- There is no streetscape lighting in addition to the streetlight posts
- No lighting features to emphasize way finding signs or building entry points
- Light post placement is prioritized along the Main Street and intersections less lighting if any along side streets
- Most intersections and crossing zones are adequately illuminated for pedestrians

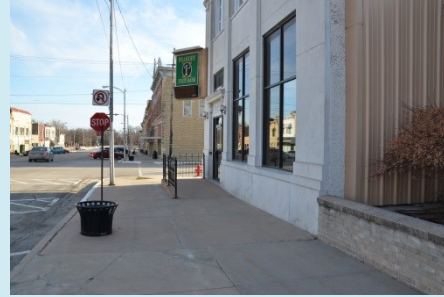
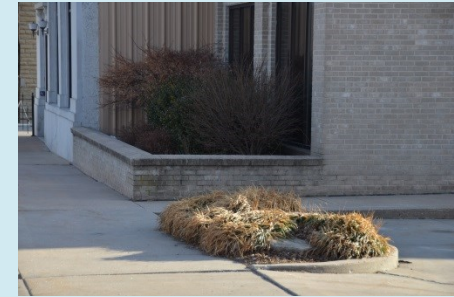
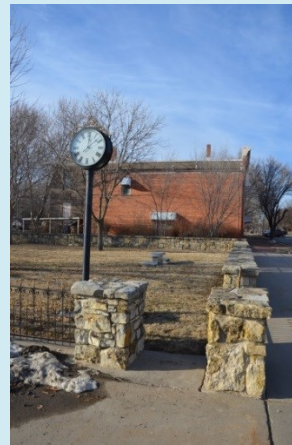
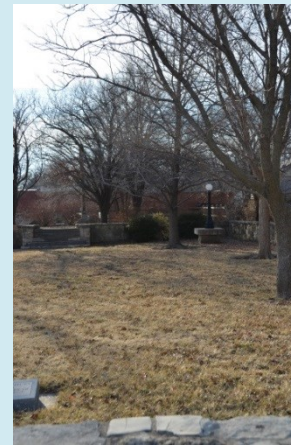
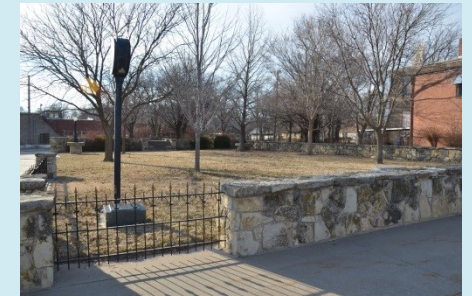
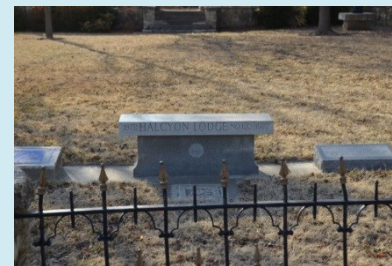
**Block A:**

- No Garbage cans or recycle bins
- Placement of streetscape features lacking on block A
- No Seating Areas for resting provided at intervals
- Amenities are along accessible path, have wheelchair clearance space
- Well-designed flowerbed along Peabody bank
- Amenities are located to the side of the direct path of travel.
- Planter is featured on block

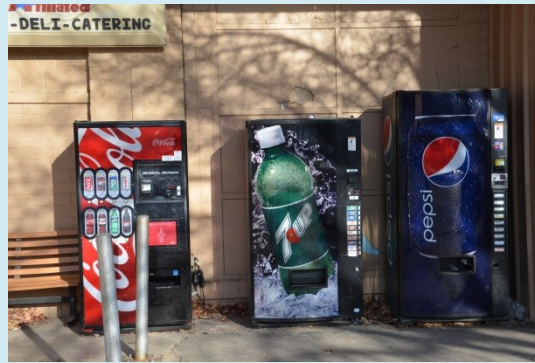
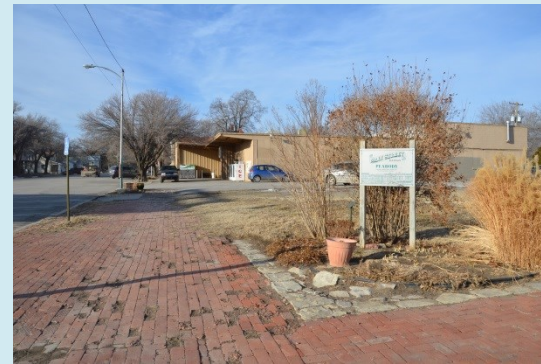
**Block B:**

- No Garbage cans or recycle bins
- No placement of streetscape features provide except for flower beds and trees
- Only one bench for seating

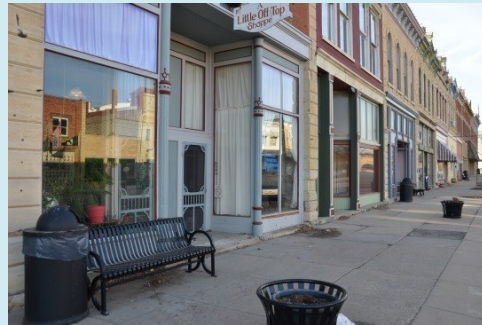
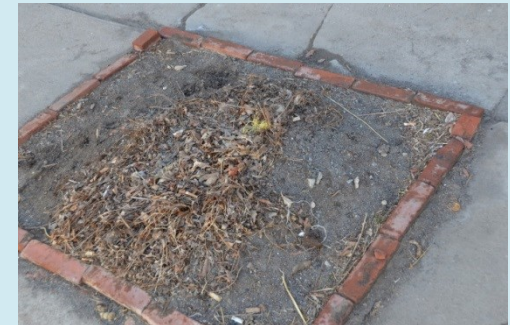
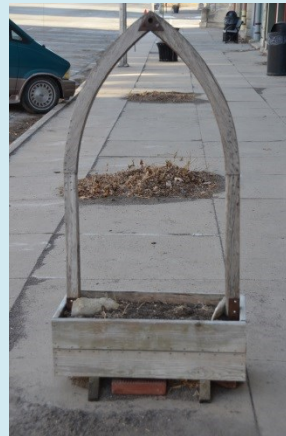
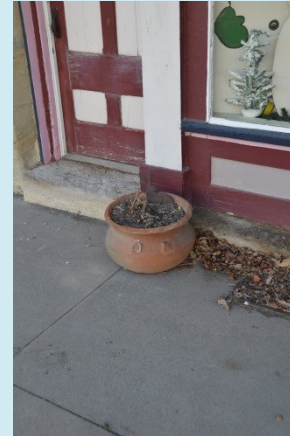
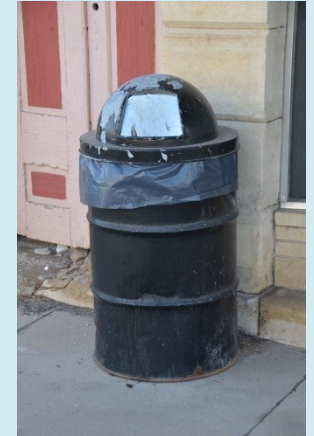
**Block C:**

- Evenly distributed availability and placement of the Garbage cans, benches for seating, and planters for aesthetics
- Seating Areas for resting are provided at intervals out of the circulation path.
- Amenities have wheelchair clearance space for access
- Very few trees on block but are evenly spaced

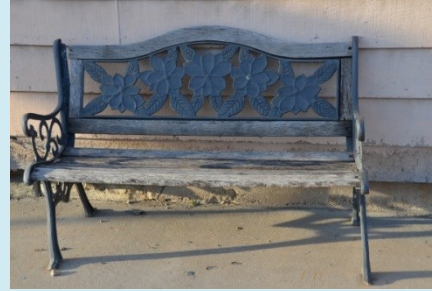
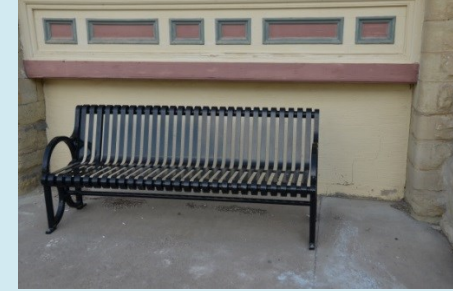
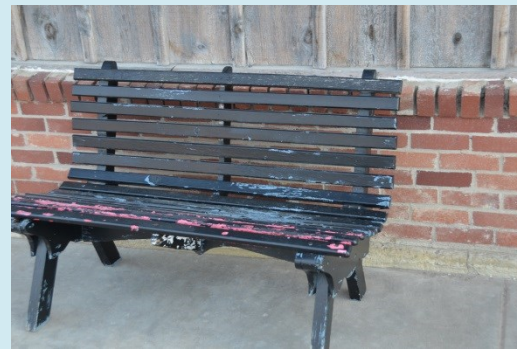
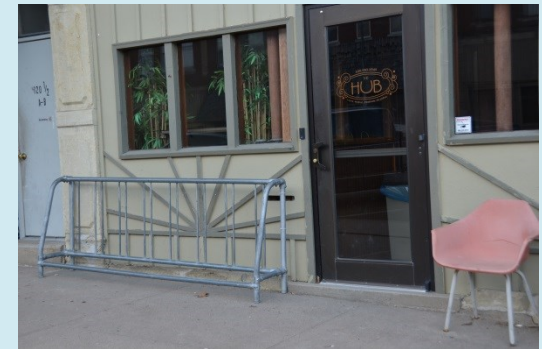
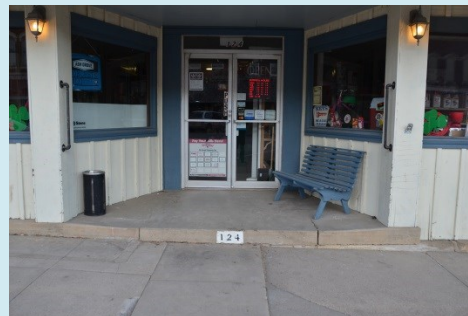
**Block D:**

- Evenly distributed availability and placement of the Garbage cans, benches for seating, and planters for aesthetics
- Seating Areas for resting are provided at intervals out of the circulation path.
- Amenities have wheelchair clearance space for access
- Very few trees on block
- Bike rack available

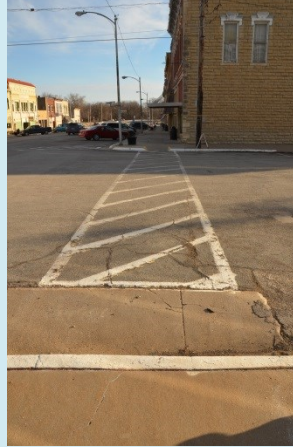
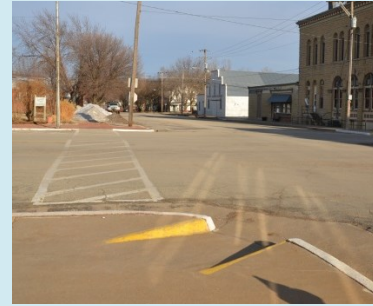
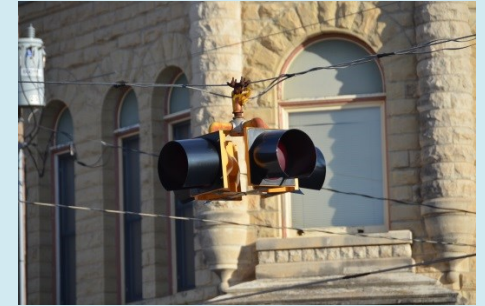
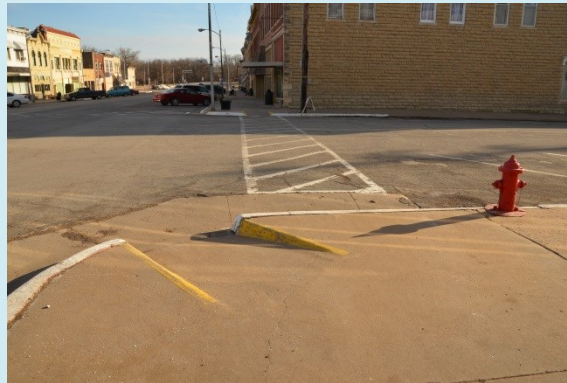
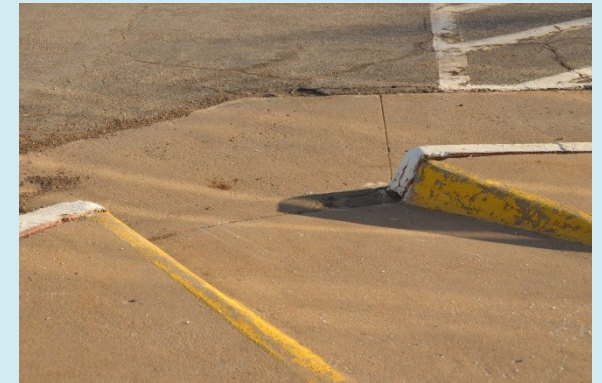
**Block A:**

- No Street- signals for pedestrians
- No street light for pedestrians
- Street-markings for pedestrians are present; white painted lines indicate crossing zones
- No Bump Outs or pedestrian islands utilized
- Curb Cuts are present at crosswalks but not all major points of access
- Pedestrian crossing distances are normal lengths and have not been reduced by providing expanded corners and/or safety islands
- Storm drains are not located outside marked crossings.
- Crossings are not marked permanently with special materials or a change of paving material (e.g. brick in contrast to concrete or asphalt roadways.)
- Lack of crossing on north end of block

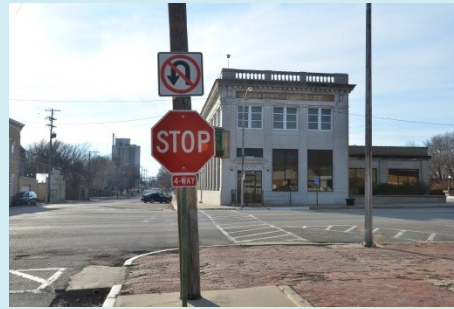
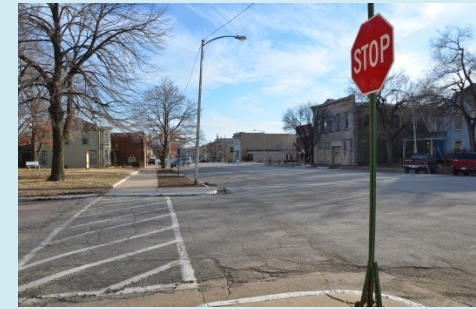
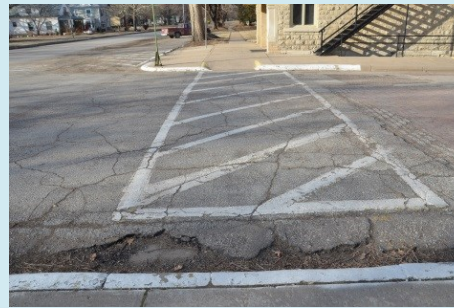
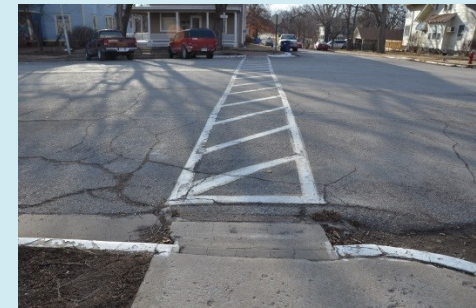
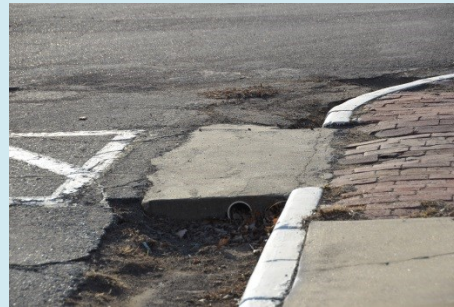
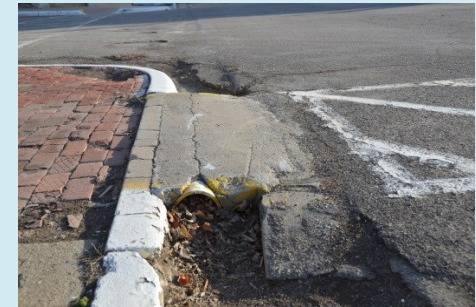
**Block B:**

- No pedestrian crossing signage
- No Street- signals for pedestrians
- No street light for pedestrians
- Street-markings for pedestrians are present; white painted lines indicate crossing zones
- No Bump Outs or pedestrian islands utilized
- Curb Cuts are present at crosswalks but not all major points of access
- Pedestrian crossing distances are normal lengths and have not been reduced by providing expanded corners and/or safety islands
- Storm drains are not located outside marked crossings.
- Crossings are not marked permanently with special materials or a change of paving material (e.g. brick in contrast to concrete or asphalt roadways.)

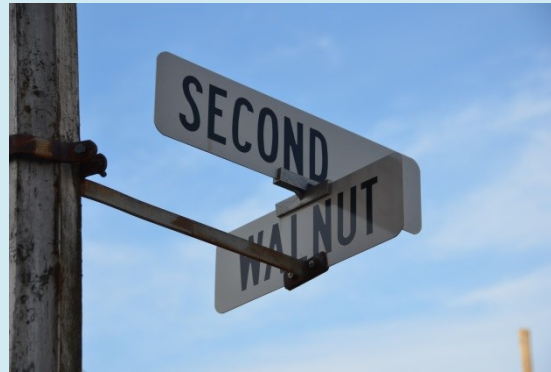
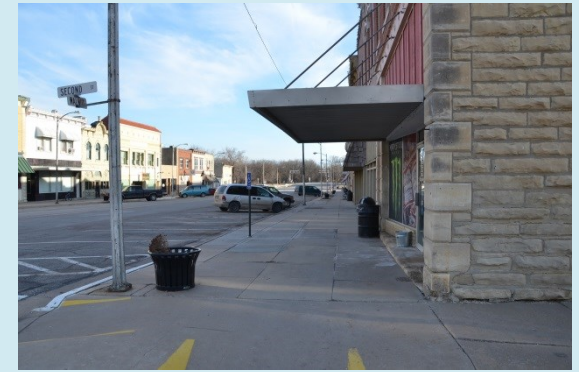
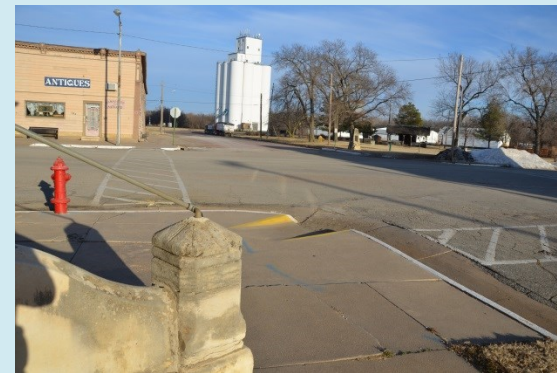
**Block C:**

- No Street- signals for pedestrians
- No street light for pedestrians
- Street-markings for pedestrians are present; white painted lines indicate crossing zones
- No Bump Outs or pedestrian islands utilized
- Curb Cuts are present at crosswalks but not all major points of access
- Pedestrian crossing distances are normal lengths and have not been reduced by providing expanded corners and/or safety islands
- Storm drains are not located outside marked crossings
- Crossings are not marked permanently with special materials or a change of paving material (e.g. brick in contrast to concrete or asphalt roadways.)

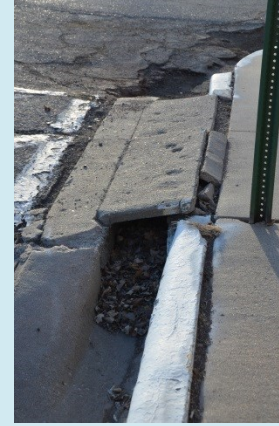
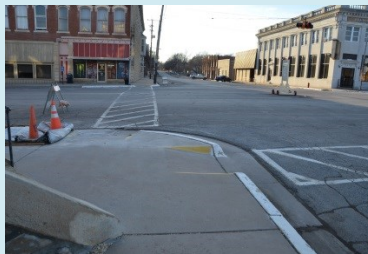
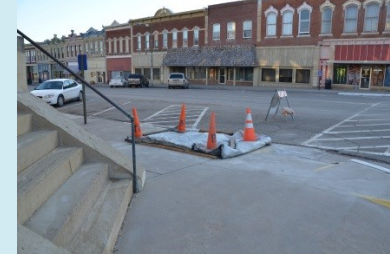
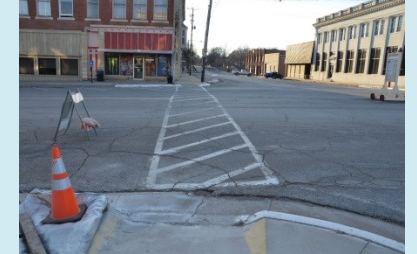
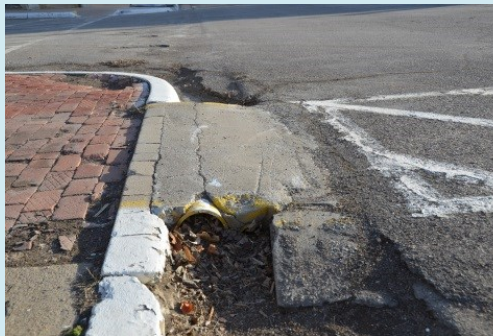
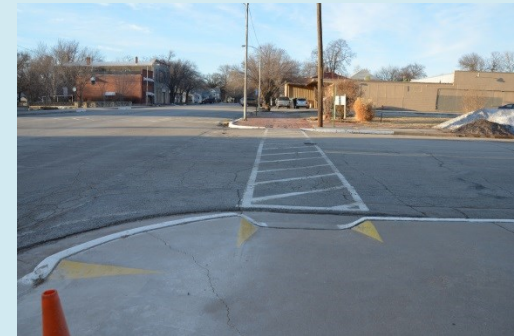
**Block D:**

- No pedestrian crossing signage
- No Street- signals for pedestrians
- No street light for pedestrians
- Street-markings for pedestrians are present; white painted lines indicate crossing zones
- No Bump Outs or pedestrian islands utilized
- Curb Cuts are present at crosswalks but not all major points of access
- Pedestrian crossing distances are normal lengths and have not been reduced by providing expanded corners and/or safety islands
- Storm drains are not located outside marked crossings.
- Crossings are not marked permanently with special materials or a change of paving material (e.g. brick in contrast to concrete or asphalt roadways.)

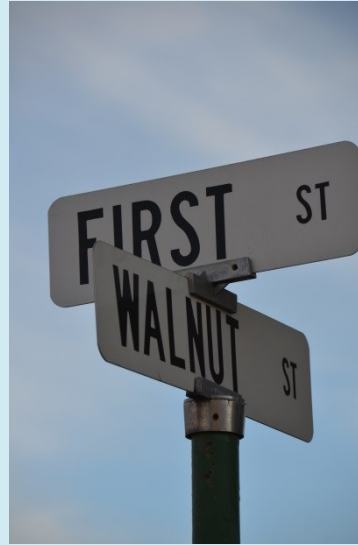
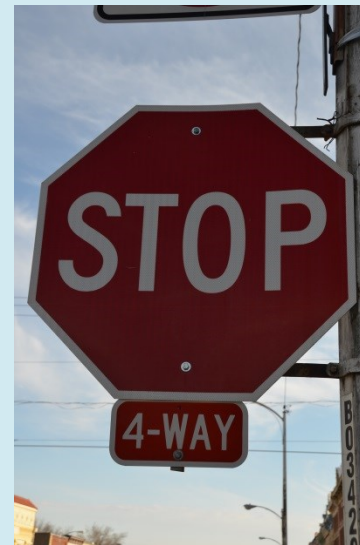
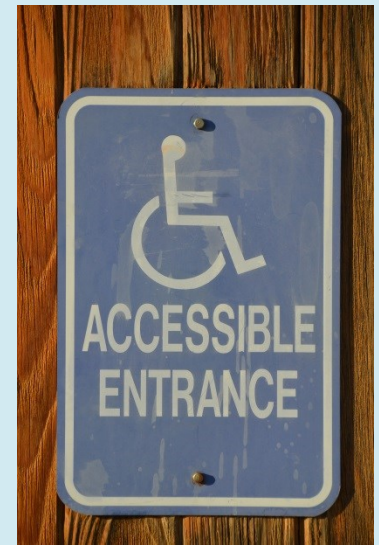
**Block A:**

- Stop signs are present at major intersections
- No Pedestrian Crossing signs are present at major intersections and crossings.
- Signs for Street names are small and hard to read
- Informative and way finding signs are not present
- Signs for information are not present.
- Signage is small print and not well-proportioned or well-contrasted for easy reading
- Signs are in prominent locations
- No Pictograms and or alternative languages

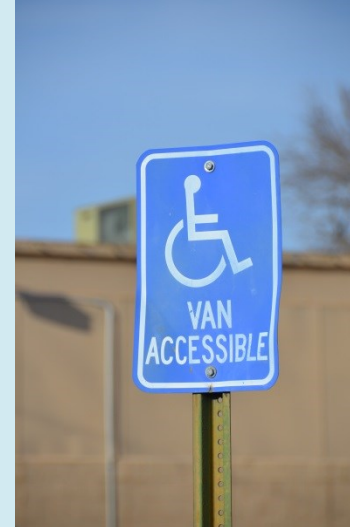
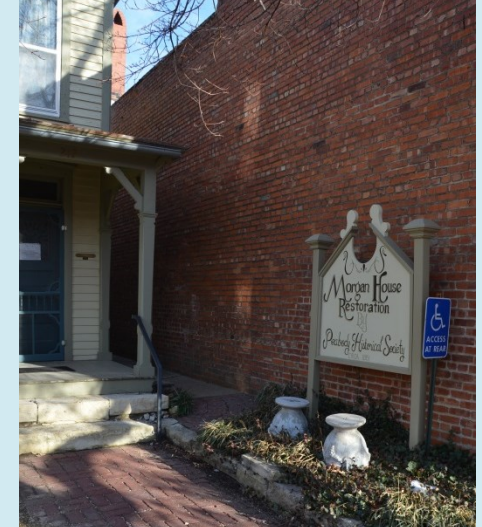
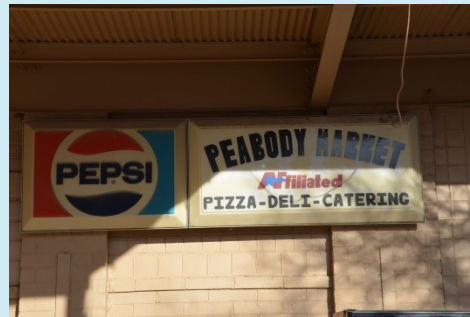
Block B:

- Stop signs are present at major intersections
- No Pedestrian Crossing signs are present at major intersections and crossings.
- Signs for Street names are small and hard to read
- Informative and way finding signs are present
- Library signage is large well-proportioned characters, good contrast, easy to read fonts.
- Signs are in prominent locations and worded effectively.
- No Pictograms and or alternative languages

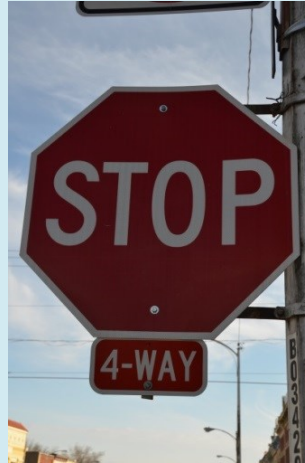
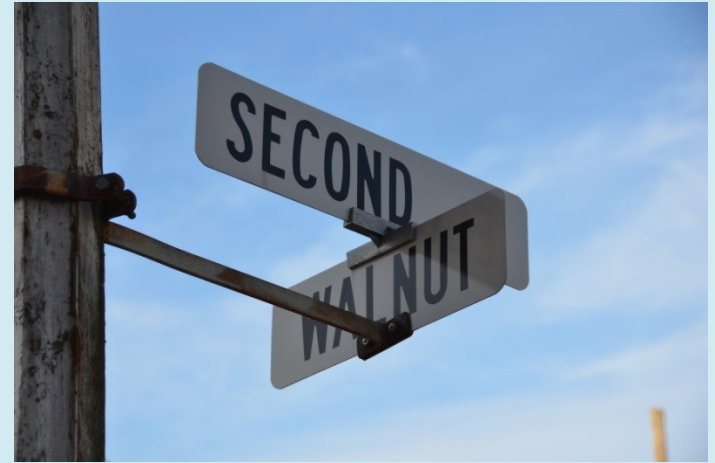
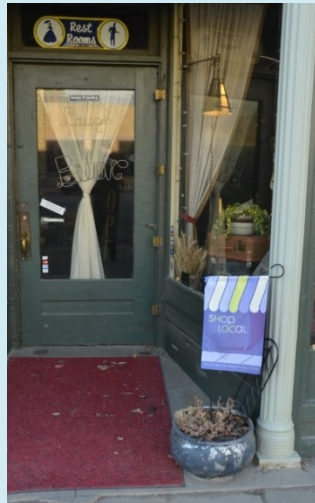
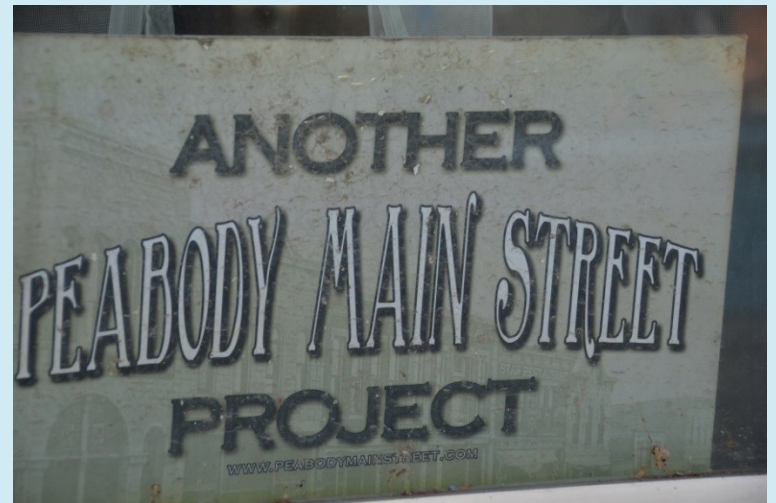
**Block C:**

- Stop signs are present at major intersections
- No Pedestrian Crossing signs are present at major intersections and crossings.
- Signs for Street names are small and hard to read
- Informative and way finding signs are not present
- Signs for businesses are prominent and well positioned
- Signage is small print and not well-proportioned or well-contrasted for easy reading
- No Pictograms and or alternative languages included.

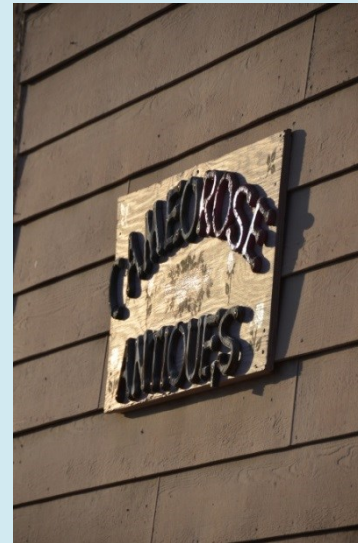
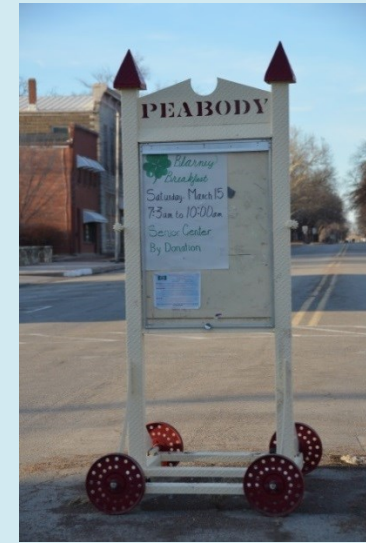
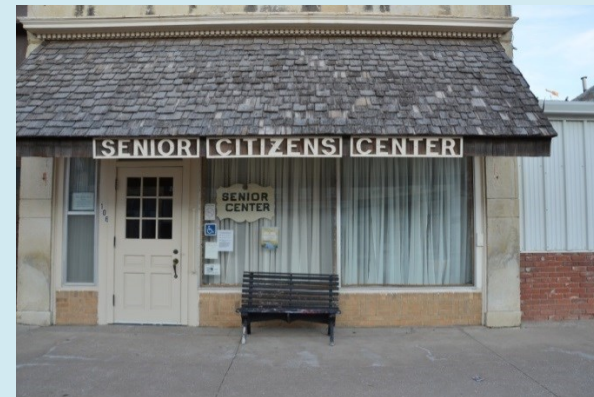
**Block D:**

- Stop signs are present at major intersections
- No Pedestrian Crossing signs are present at major intersections and crossings.
- Signs for Street names are small and hard to read
- Informative and way finding signs are not present
- Signs for information are not present.
- Signage is small print and not well-proportioned or well-contrasted for easy reading
- Signs are in prominent locations
- No Pictograms and or alternative languages included.

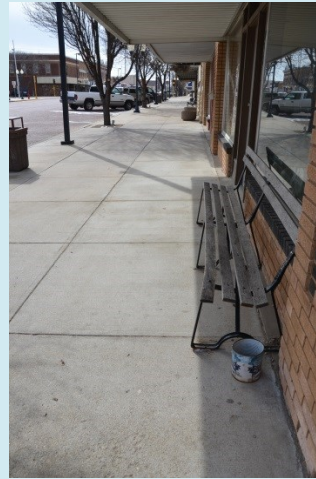
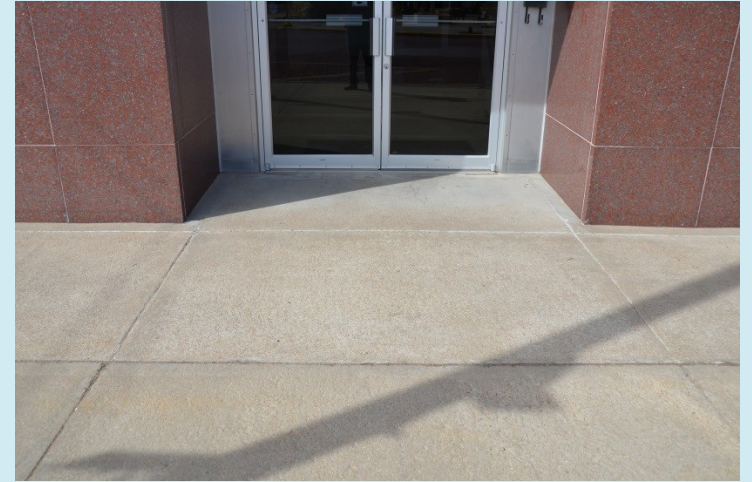
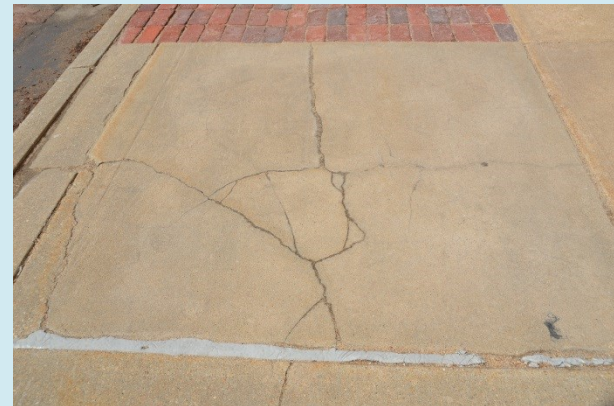
**Block A:**

- No tree lifts
- Slight erosion of concrete pavement
- Walkway is even and smooth
- Walkway is free of debris and trip hazards
- Walkway is wide for heavy pedestrian circulation
- Walkways surface featured very few holes
- Integrity of the walkway is in good shape
