IMPROVING THE USABILITY AND ACCESSIBILITY IN AGING RURAL COMMUNITIES

MASTER OF REGIONAL AND COMMUNITY PLANNING

## Peabody, Kansas: Study Boundary of Streetscape Audit

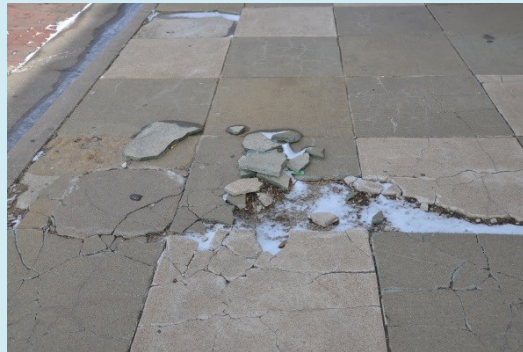
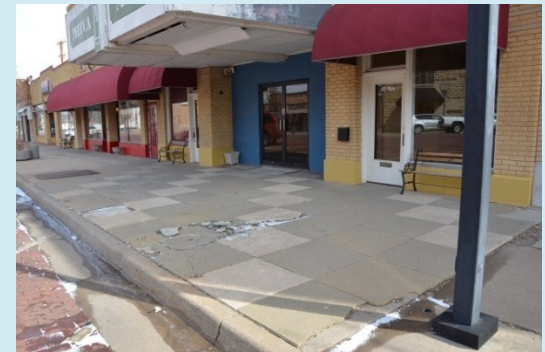
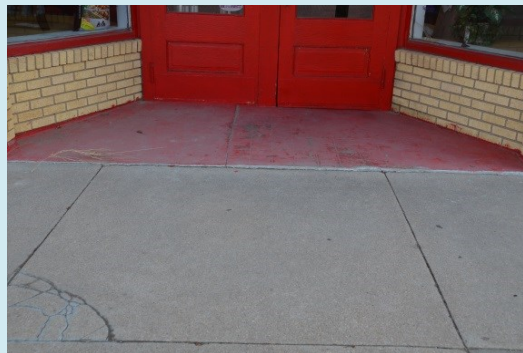
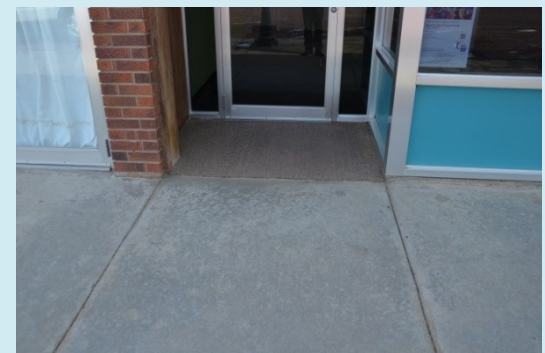
**Block B:**

- No tree lifts
- Slight erosion of concrete pavement
- Walkway is even and smooth
- Walkway is free of debris and trip hazards
- Walkway is wide for heavy pedestrian circulation
- Walkways surface featured very few holes
- Integrity of the walkway is in good shape
- Pavement cutout due to removal of a temporary structure never repaired.

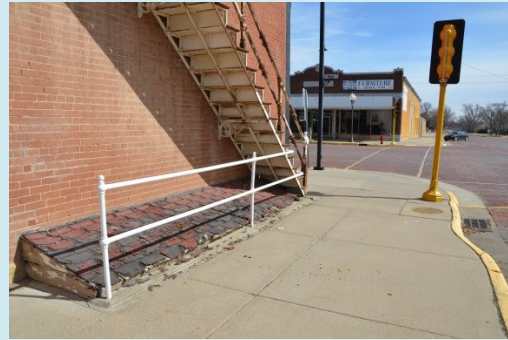
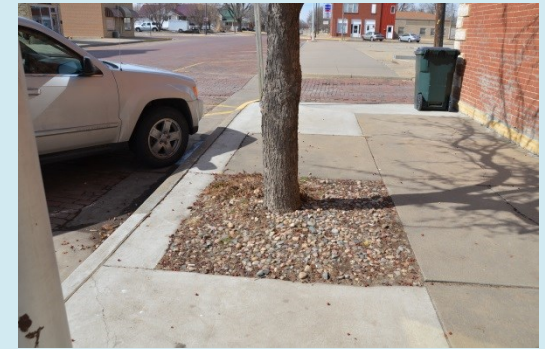
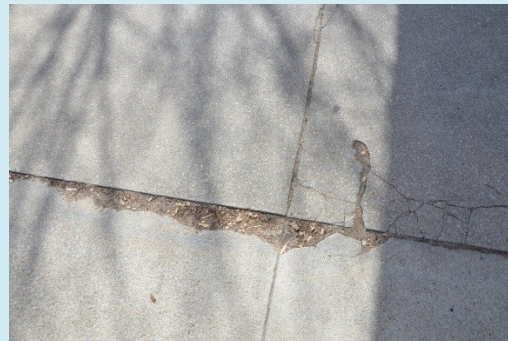
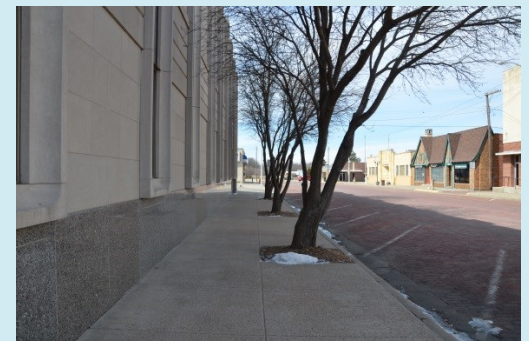
**Block C:**

- No tree lifts
- Slight erosion of concrete pavement
- Walkway is even and smooth
- Walkway is free of debris and trip hazards
- Walkway is wide for heavy pedestrian circulation
- Walkways surface featured very few holes
- Integrity of the walkway is in good shape

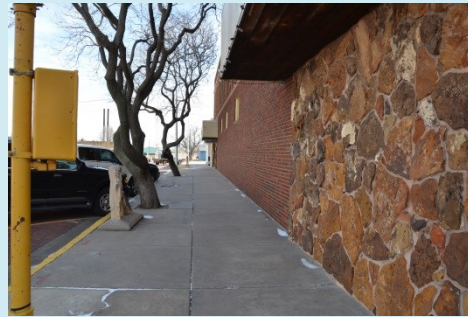
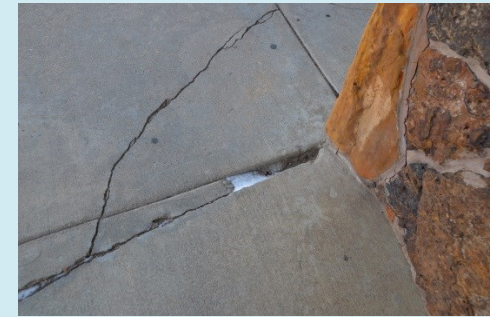
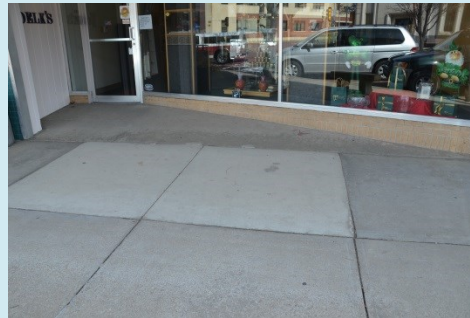
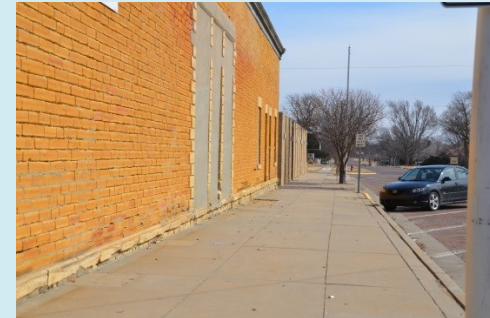
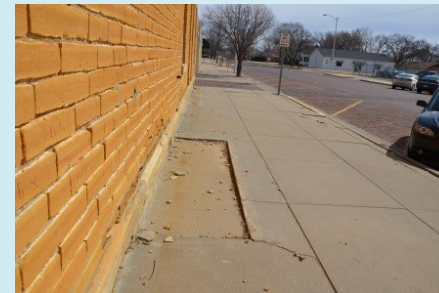
**Block D:**

- No tree lifts
- Slight erosion of concrete pavement
- Walkway is even and smooth
- Walkway is free of debris and trip hazards
- Walkway is wide for heavy pedestrian circulation
- Walkways surface featured very few holes
- One large hole on side street due to removal of some preexisting structure
- Integrity of the walkway is in good shape

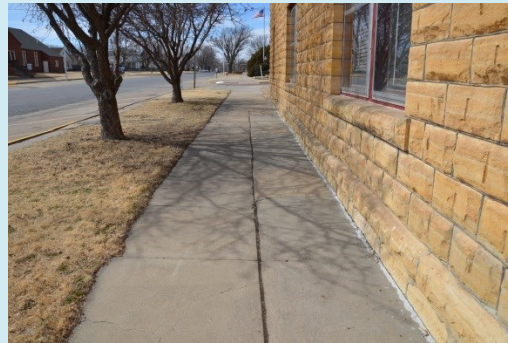
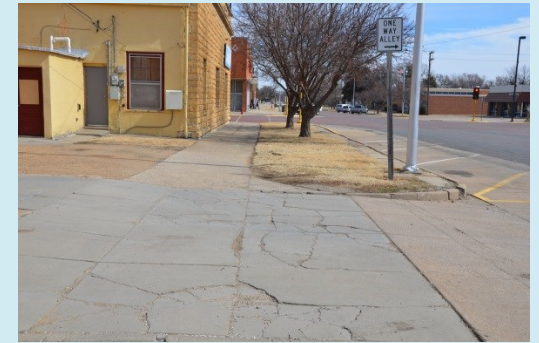
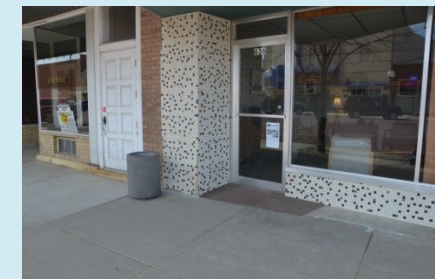
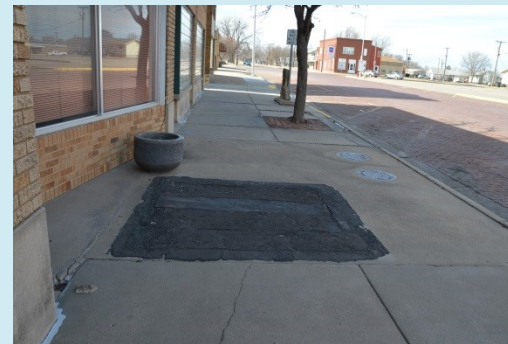
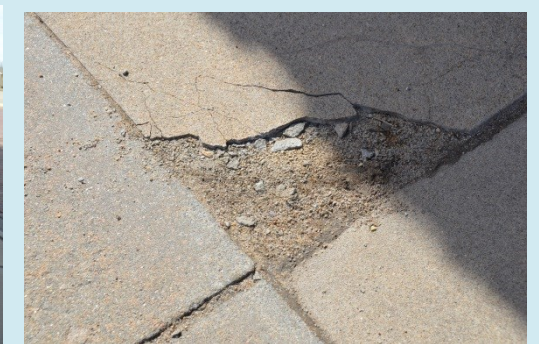
**Block E:**

- No tree lifts
- Slight erosion of concrete pavement, especially near and around pedestrian crossing curb ramps
- Sidewalk cellar access pit door sealed with tar creates an uneven walkway texture and potential trip hazard
- Driveway entrances on block are heavily cracked from heavy traffic wear
- Walkway is even and smooth
- Walkway is free of debris and trip hazards
- Walkway is wide for heavy pedestrian circulation
- Walkways surface featured very few holes, however there is one really big hole due to erosion

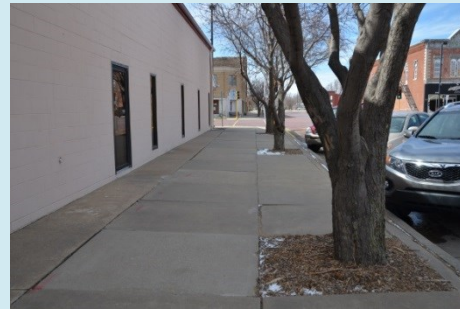
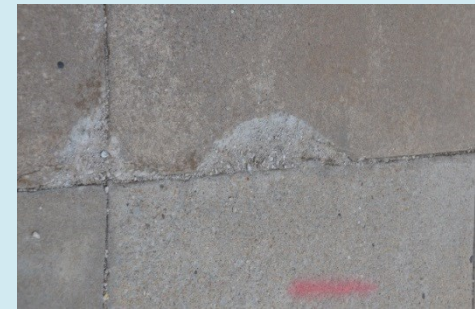
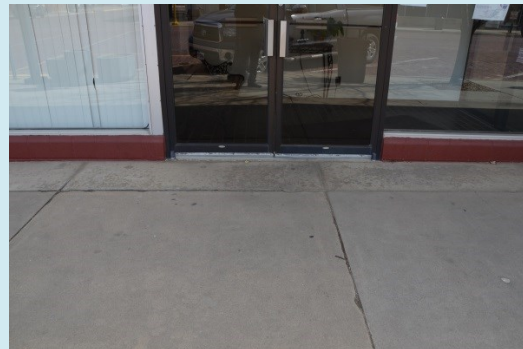
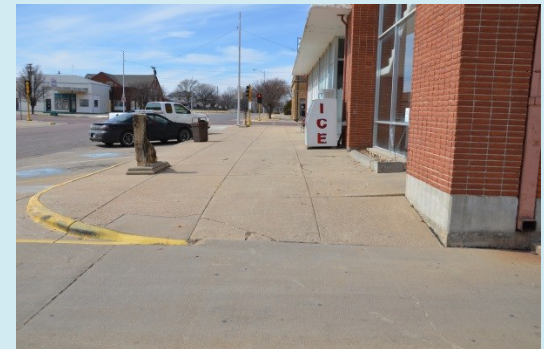
**Block F:**

- No tree lifts
- Walkway textures are for the most part even and smooth
- Very few instances of uneven joints along walkway and cracks, holes and fractures are minimal
- Greater part of walkway damage and erosion of concrete pavement located at pedestrian crossings, curb cuts, and curb ramps
- Walkway is free of debris and trip hazards
- Walkway is wide for heavy pedestrian circulation
- Walking surface is stable firm and non-slip concrete

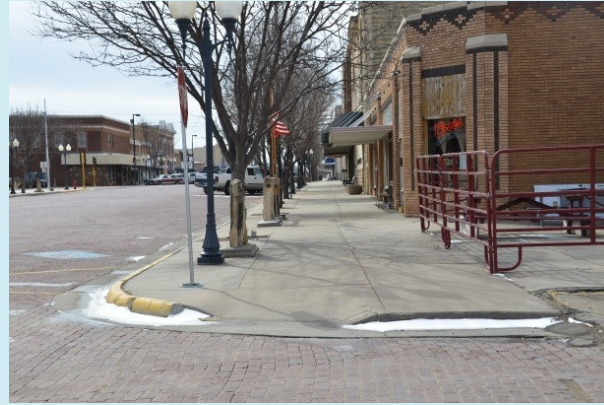
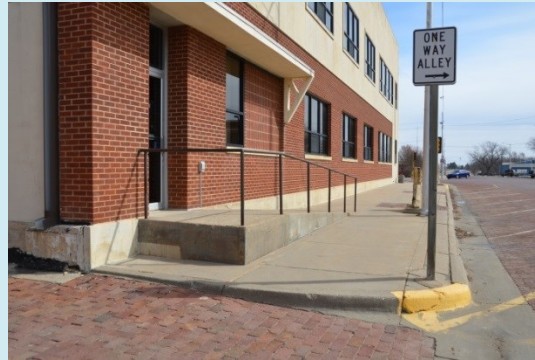
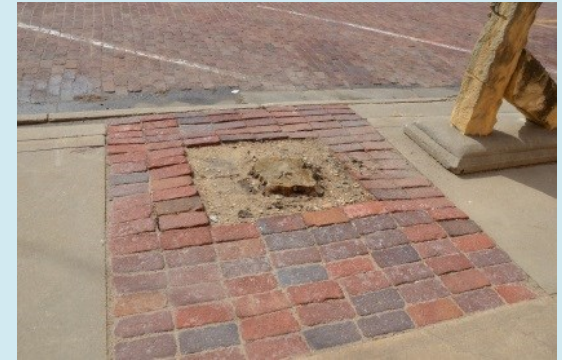
**Block A:**

- Some uneven joints in concrete pavement. They are indicated with paint to warn pedestrians
- Walkway is even and smooth
- Walkway is free of debris and trip hazards
- Walkway is wide for heavy pedestrian circulation
- Amenities are off to the side out of the way of pedestrian circulation

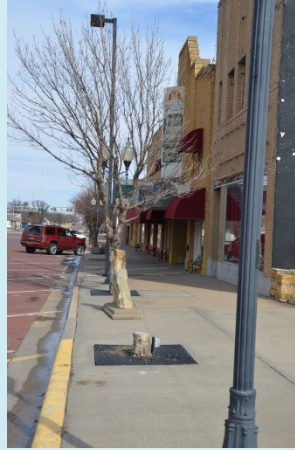
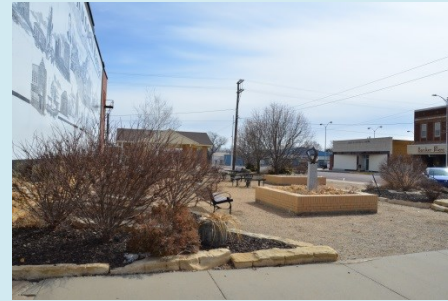
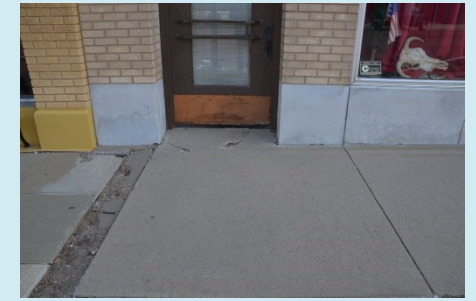
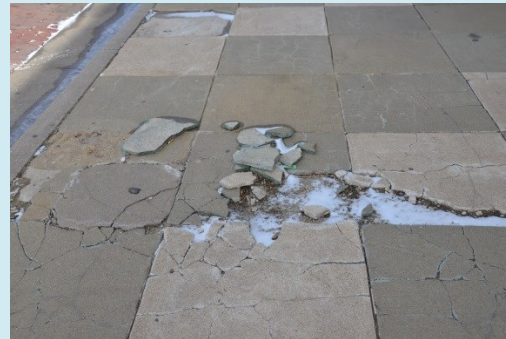
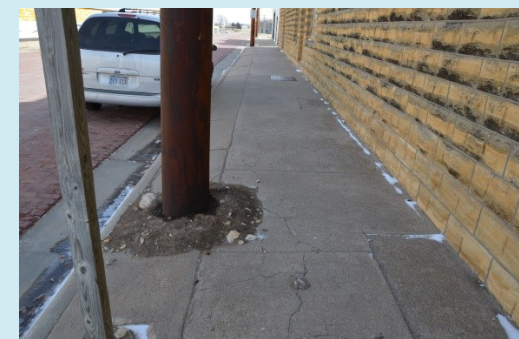
**Block B:**

- Walkway obstacles and obstructions are blocked off from pedestrians to prevent accidents and create a clear boundary
- Walkway is even and smooth
- Walkway is free of debris and trip hazards
- Walkway is wide for heavy pedestrian circulation
- Amenities are off to the side out of the way of pedestrian circulation

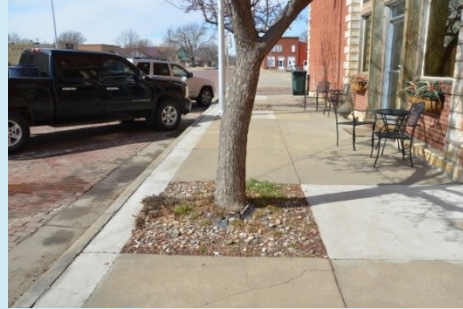
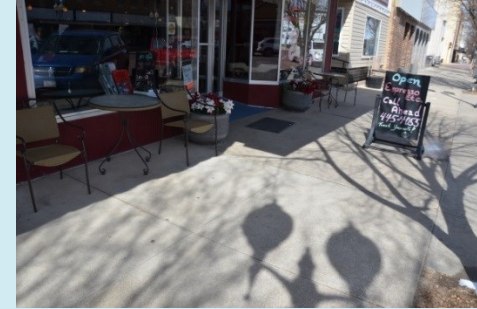
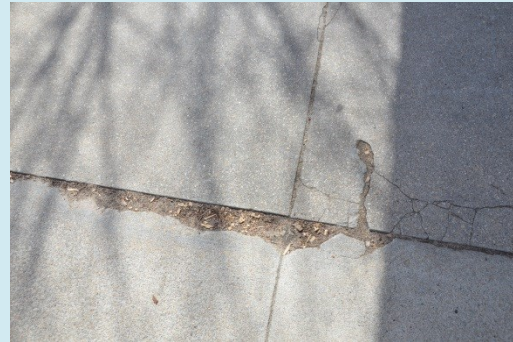
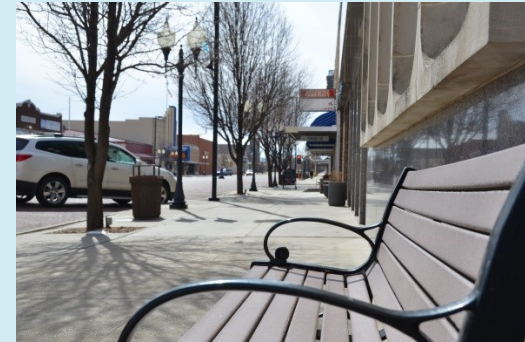
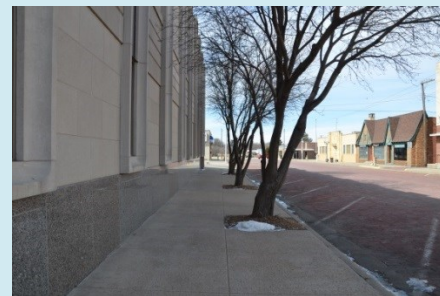
**Block C:**

- Some uneven joints in concrete pavement that are not marked
- Walkway is even and smooth
- Walkway is free of debris and trip hazards
- Walkway is wide for heavy pedestrian circulation
- Amenities are off to the side out of the way of pedestrian circulation

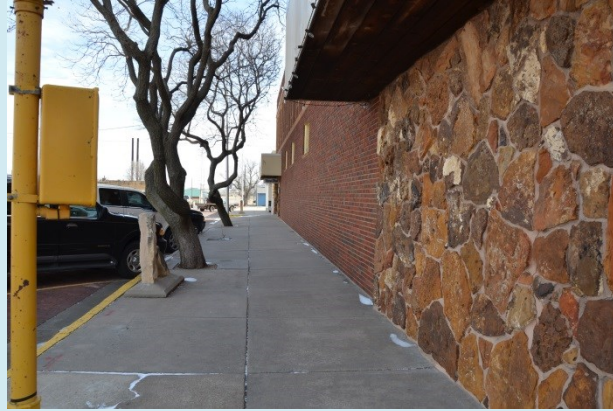
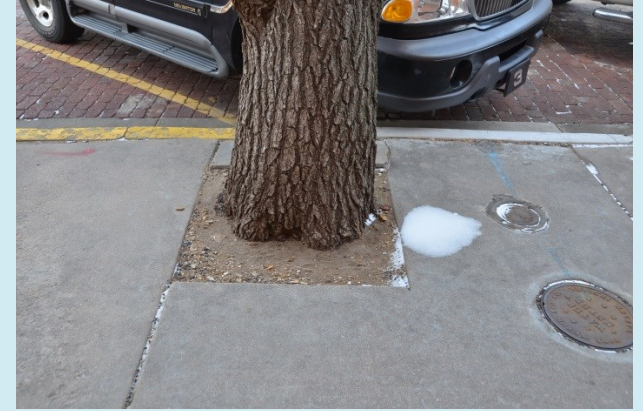
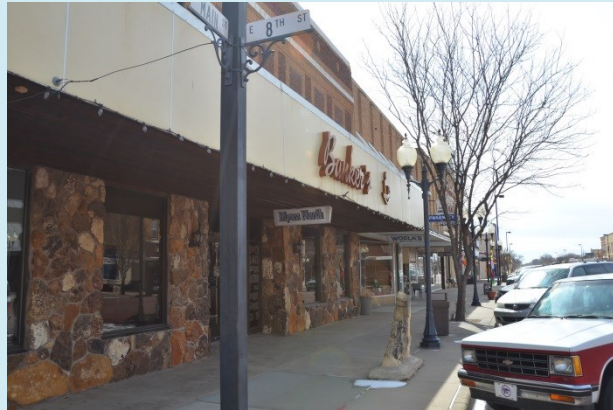
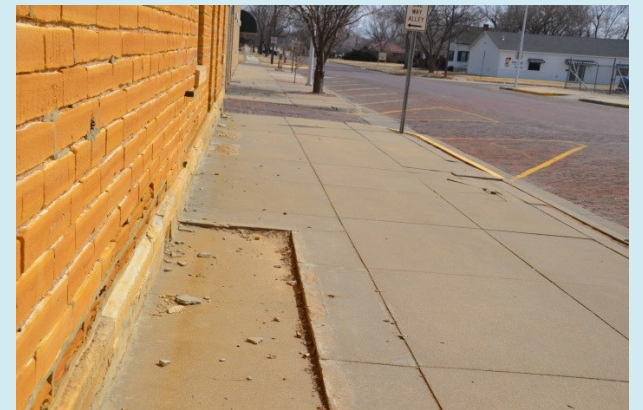
**Block D:**

- Some uneven joints in concrete pavement that are not marked
- Walkway is even and smooth
- Walkway is free of debris and trip hazards
- Walkway is wide for heavy pedestrian circulation
- Amenities are off to the side out of the way of pedestrian circulation

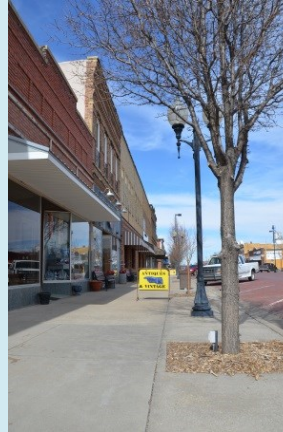
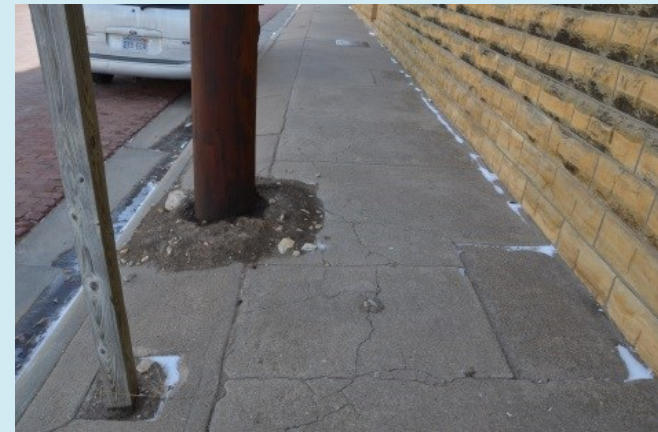
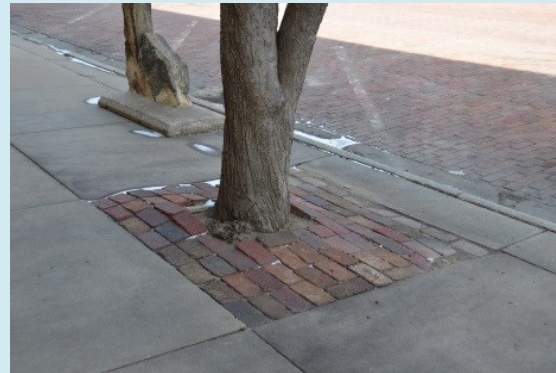
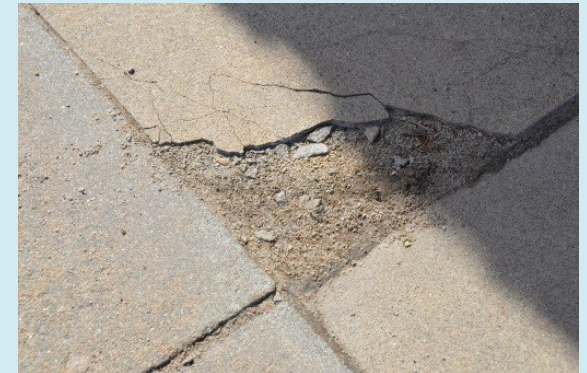
**Block E:**

- Some uneven joints in concrete pavement that are not marked
- Walkway is even and smooth
- Walkway is free of debris and trip hazards
- Walkway is wide for heavy pedestrian circulation
- Amenities are off to the side out of the way of pedestrian circulation

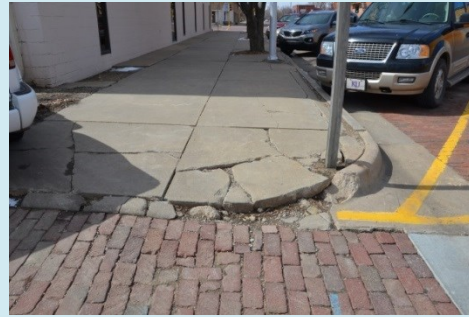
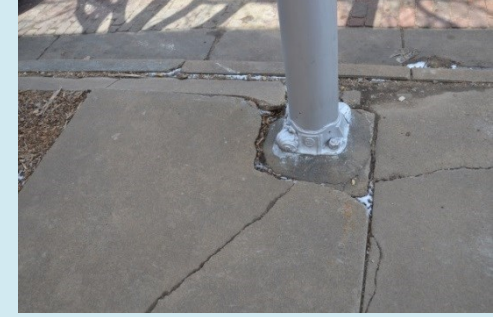
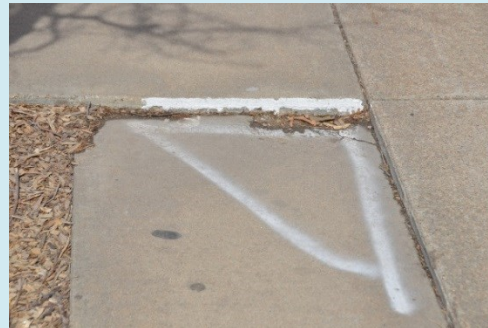
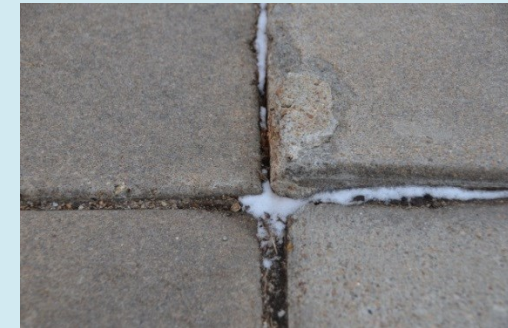
**Block F:**

- Some uneven joints in concrete pavement that are not marked
- Walkway is even and smooth
- Walkway is free of debris and trip hazards are marked with contrasting paint
- Walkway is wide for heavy pedestrian circulation
- Amenities are off to the side out of the way of pedestrian circulation

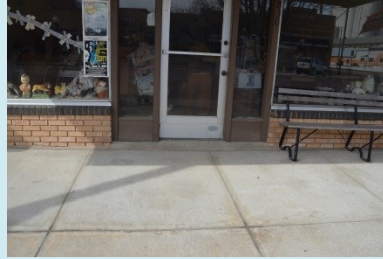
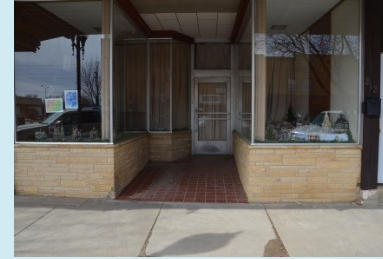
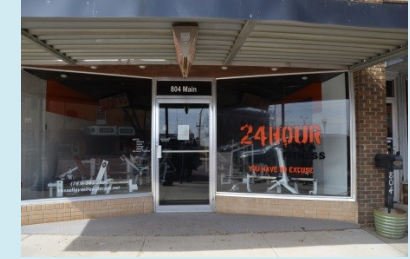
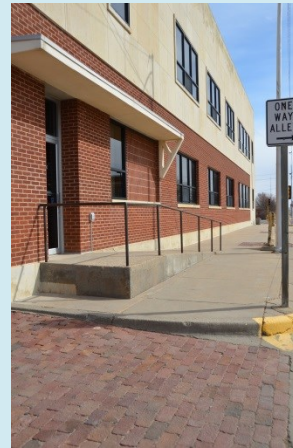
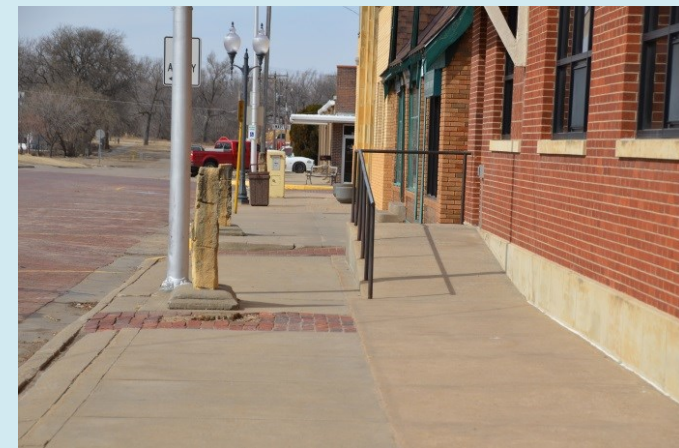
**Block A:**

- All building entrances have a no-step threshold entrance.
- Alternatives to stairs are present near the main entry point
- This block features stores that all have entrances with a no-step threshold for easy access for disabled or elderly
- Stairs and ramps do not feature slip resistant traveling surfaces
- Tactile indicators are not used on the railing

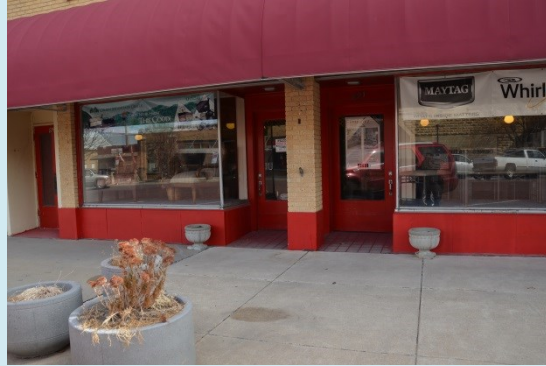
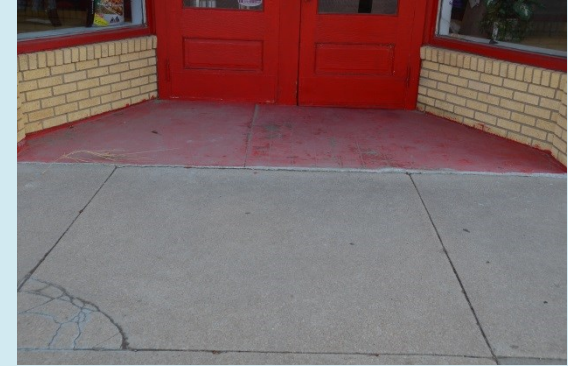
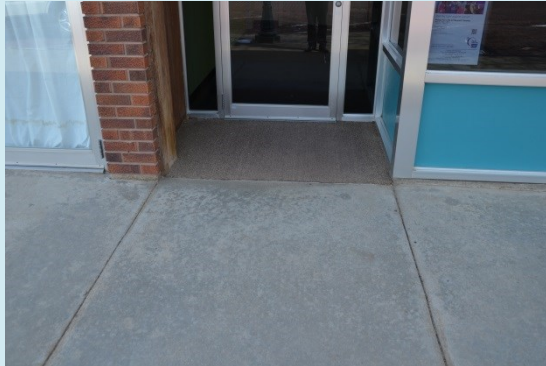
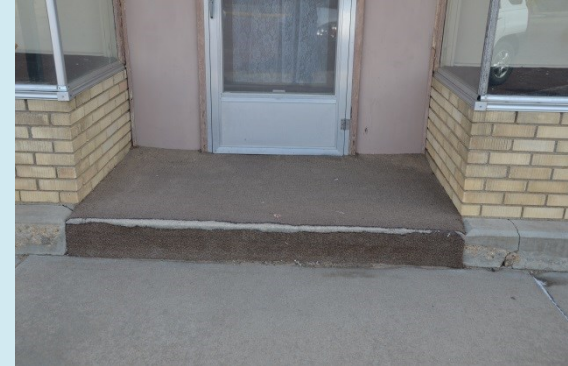
**Block B:**

- Most building entrances have a no-step threshold entrance or slight slop. Entrances that do not have a stair alternative in the front have one in the back alleyway on this block.
- Stairs and ramps do not feature slip resistant traveling surfaces

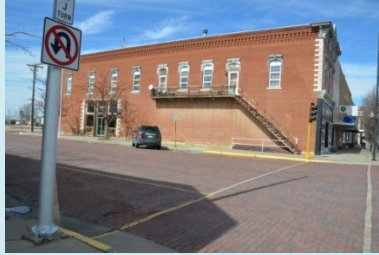
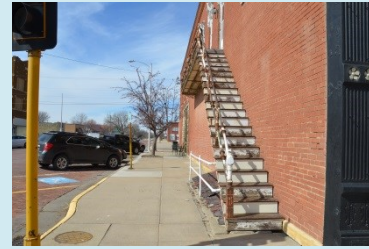
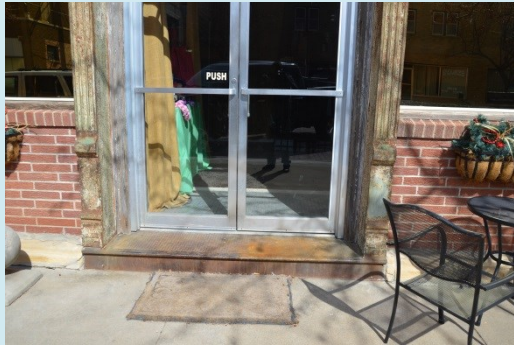
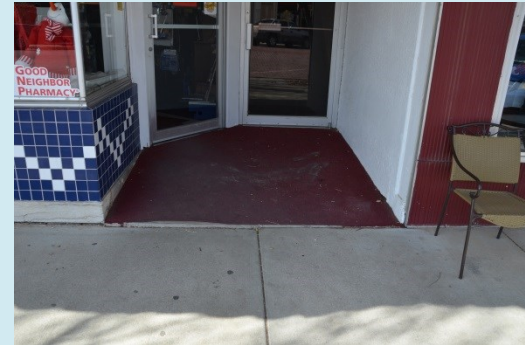
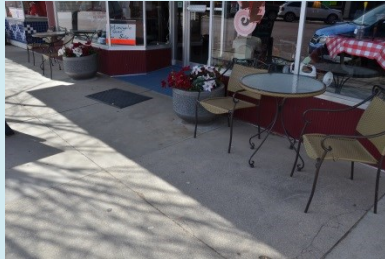
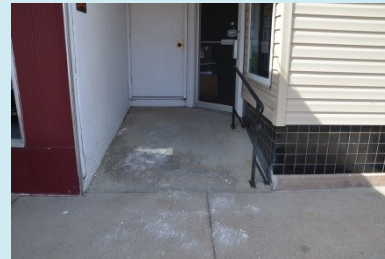
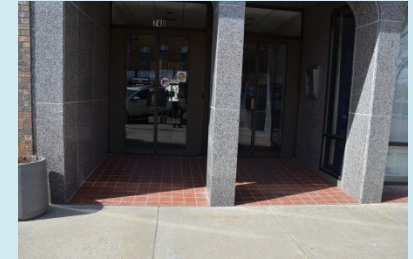
**Block C:**

- Most building entrances have a no-step threshold entrance and those that don't either have a one or two-step threshold or an accessible alternative in the back
- Alternatives to stairs are present near the main entry point for staircase located on side street of 7<sup>th</sup> street
- Stairs and ramps do not feature slip resistant traveling surfaces
- Tactile indicators on railing such as grooves or bumps are not present

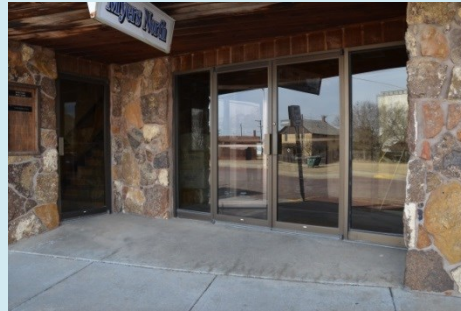
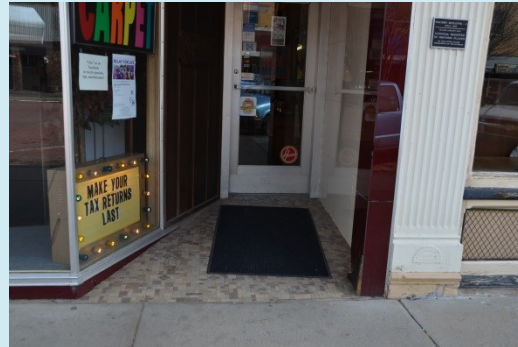
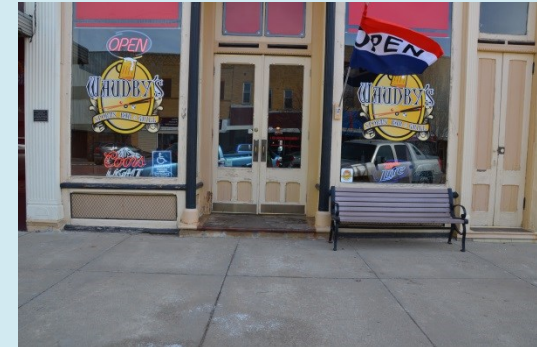
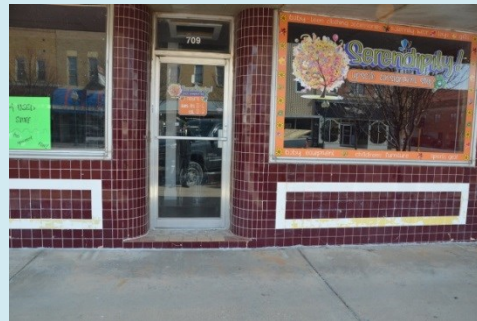
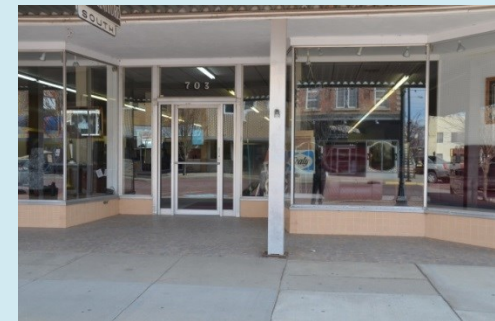
**Block D:**

- Most building entrances have a no-step threshold entrance
- There are a few entrances, which have a step up threshold not conducive to accessibility and usability for elderly; however, some of these entrances have accessible alternatives in the back alleyway
- Stairs and ramps do not feature slip resistant traveling surfaces
- Entrances with inclines and stairs did not feature railings for stability support

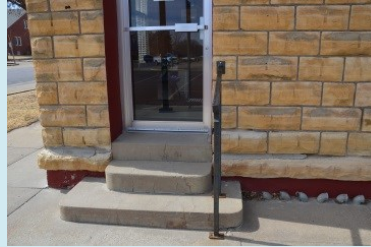
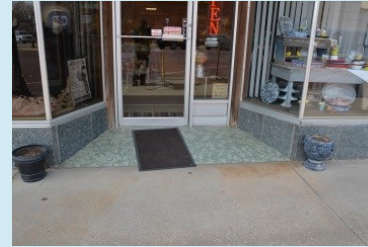
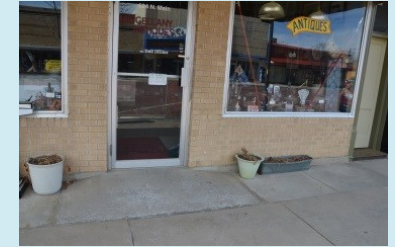
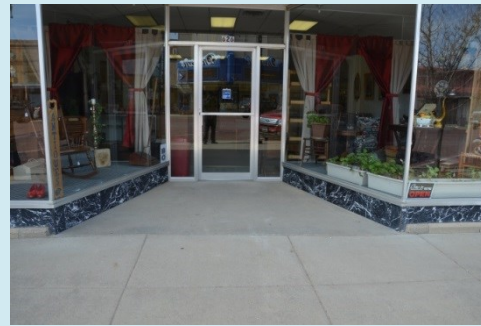
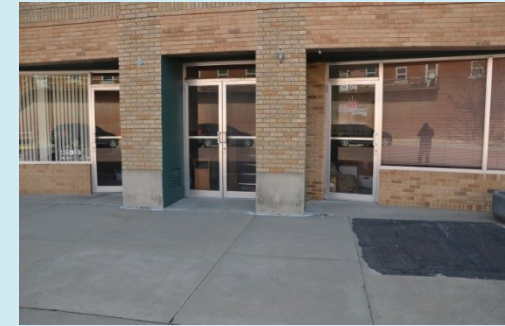
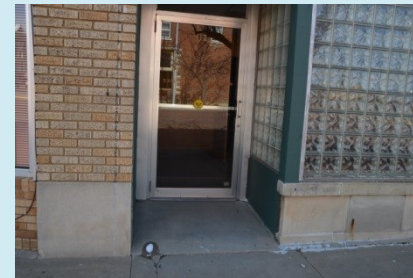
**Block E:**

- Most building entrances have a no-step threshold entrance; one entrance is a one-step threshold with an accessible alternative in the back.
- One building has steps to an apartment and railing is available but lacks tactile indicators such as bumps and groves. An alternatives to stairs are present near the main entry point on the side of the building
- Stairs and ramps are concrete and do not feature slip resistant traveling surfaces
- One entryway features a ramp with a ceramic surface which can become slick in wet weather

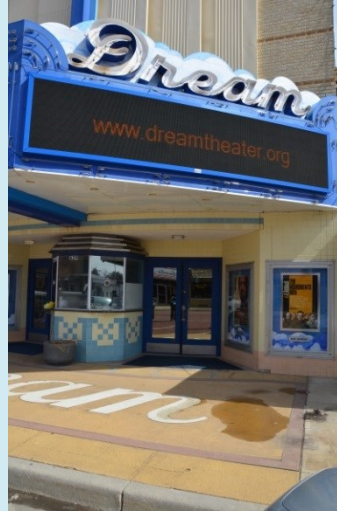
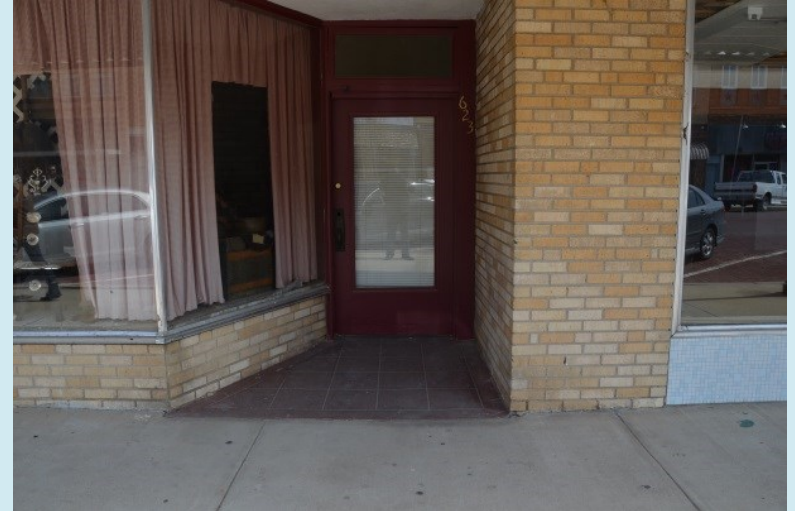
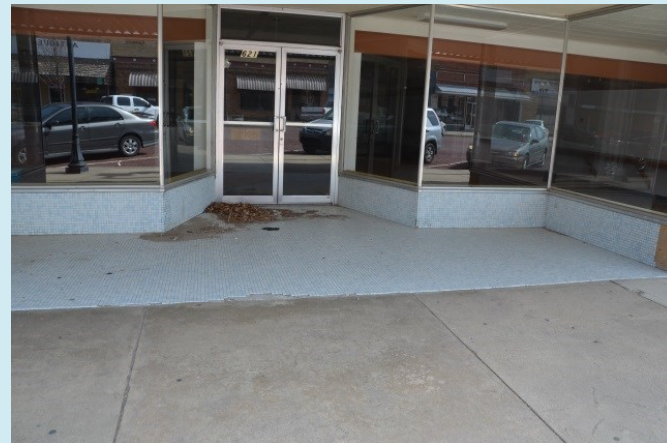
**Block F:**

- Most building entrances have a no-step threshold entrance
- There are a few entrances, which have a step up threshold.
- Alternative entrances with a no-step threshold entry are present near the main entry point

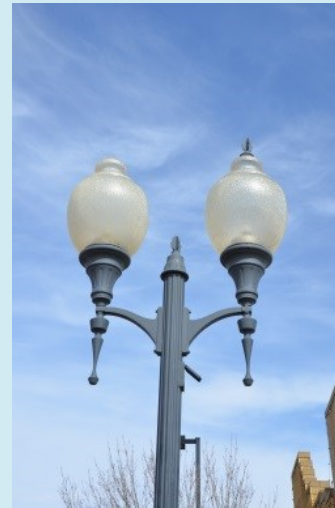
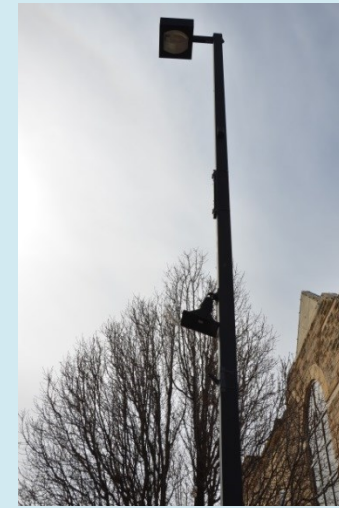
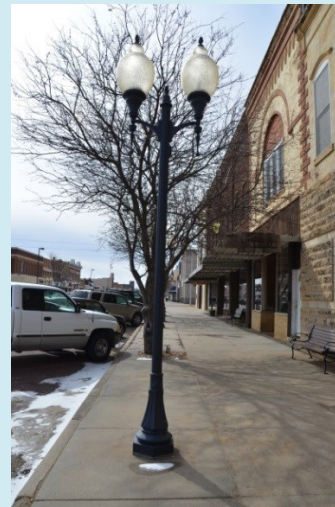
**Block A:**

- Streetlights adequately distribute lighting throughout the streetscape. (There are two street box lights per block and four or so historical streetlamps for each block in Russell)
- Additional lighting from historical lamp posts provide extra illumination
- Streetlights provide additional illumination at intersections at each block.
- Artificial illumination is not provided for way finding signs.
- Crosswalks have light signals for stopping traffic flow for safe walking times.
- No higher illumination for key features (for example signs, stair treads)

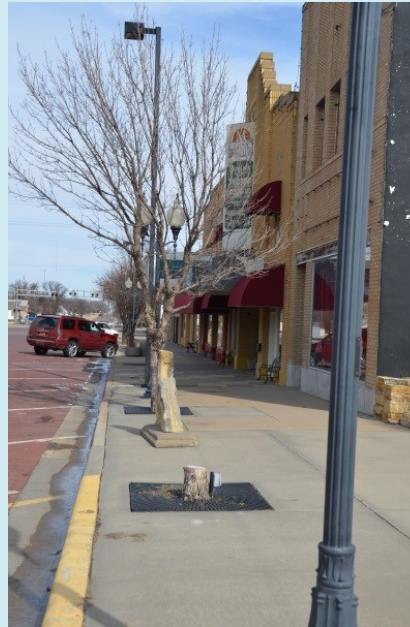
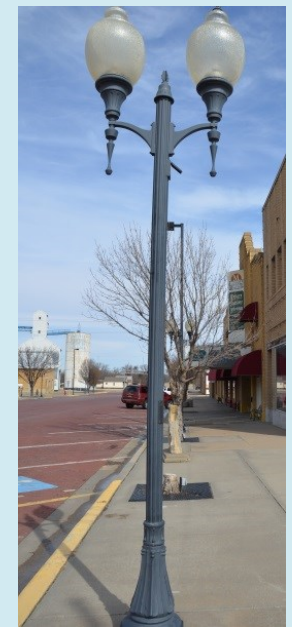
**Block B:**

- Streetlights adequately distribute lighting throughout the streetscape.
- Additional lighting from historical lamp posts provide extra illumination
- Streetlights are distributed evenly to provide additional illumination at intersections at each block.
- Crosswalks have light signals for stopping traffic flow for safe walking times
- No higher illumination for key features (for example signs, stair treads) but is provided for memorial park

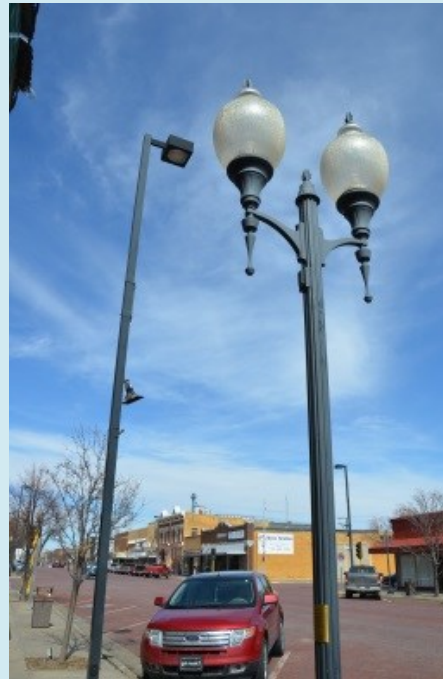
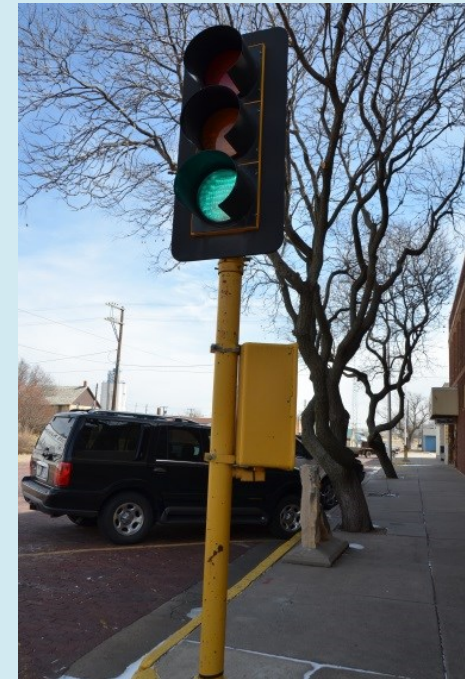
**Block D:**

- Streetlights adequately distribute lighting throughout the streetscape (four historical streetlamps and two streetlights)
- Additional lighting from historical lamp posts provide extra illumination
- Streetlights are distributed evenly to provide additional illumination at intersections at each block.
- Artificial illumination is not provided for way finding signs.
- Crosswalks have light signals for indicating safe walking times.
- No higher illumination for key features (for example signs, stair treads)

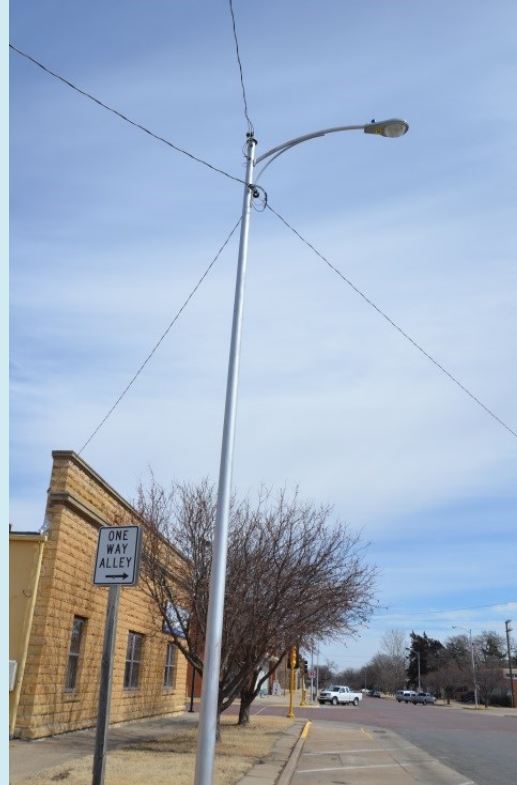
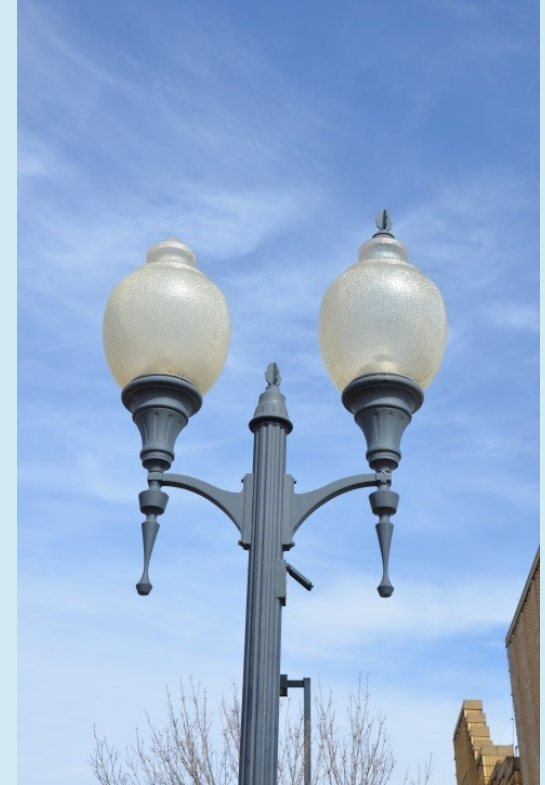
**Block E:**

- Streetlights adequately distribute lighting throughout the streetscape (four historical streetlamps and two streetlights)
- Additional lighting from historical lamp posts provide extra illumination
- Streetlights are distributed evenly to provide additional illumination at intersections at each block.
- Artificial illumination is not provided for way finding signs.
- Crosswalks have light signals for indicating safe walking times.
- No higher illumination for key features (for example signs, stair treads)

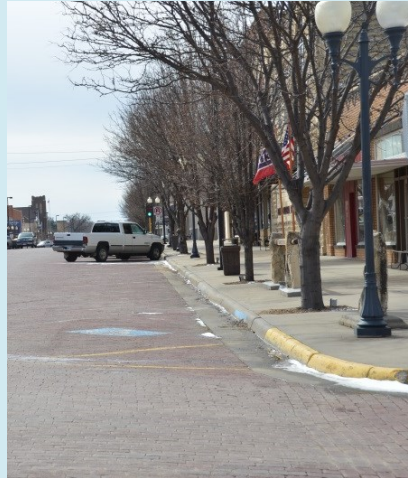
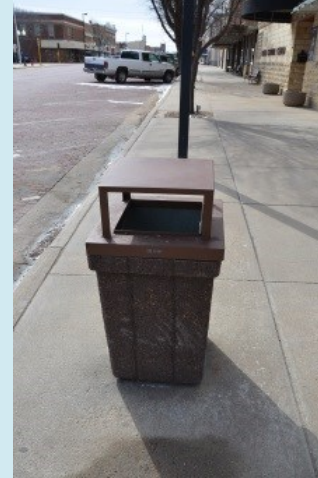
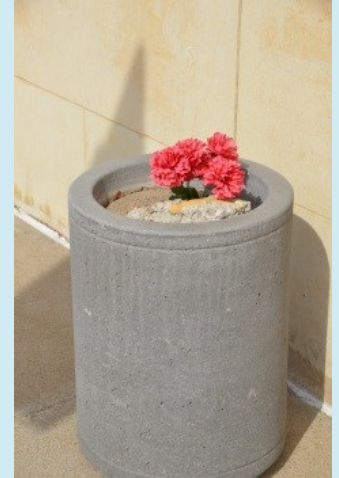
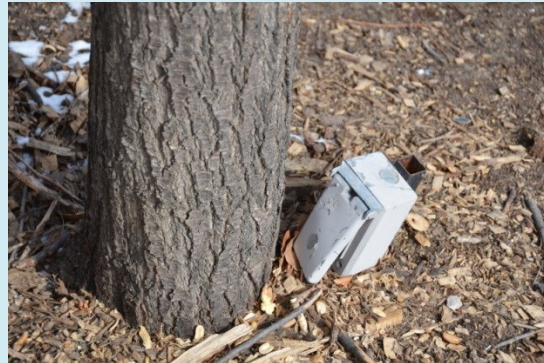
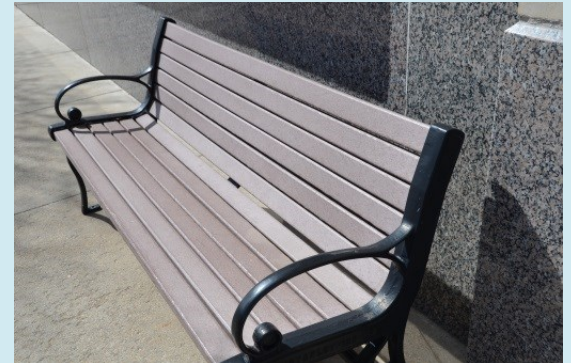
**Block A:**

- Each amenity available on this block is distributed evenly to ensure pedestrians are not too far from walkway seating, radio broadcast from the P.A. system or natural amenities like trees and flower planters.
- All blocks feature a P.A. system attached to each box streetlight, which broadcasts local weather, advertisements, and news
- Benches on each block, which provide seating areas for resting, are provided at intervals out of the circulation path.
- Trees are plentiful and evenly distributed along streetscape
- Amenities are located to the side of the direct path of travel.

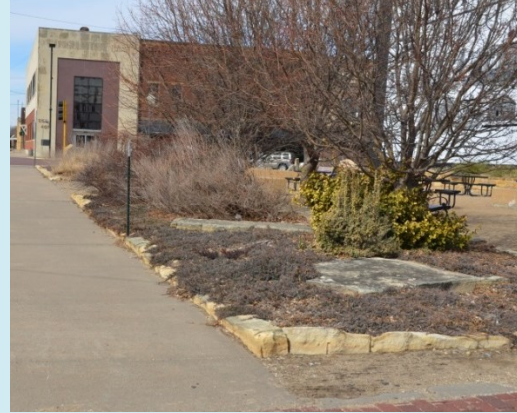
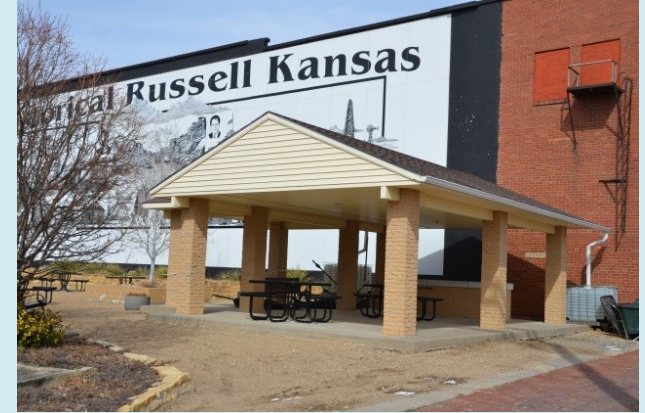
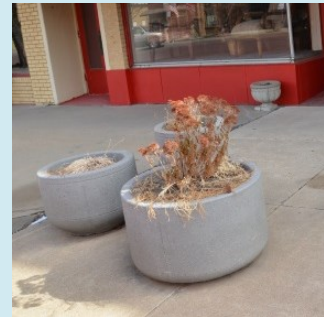
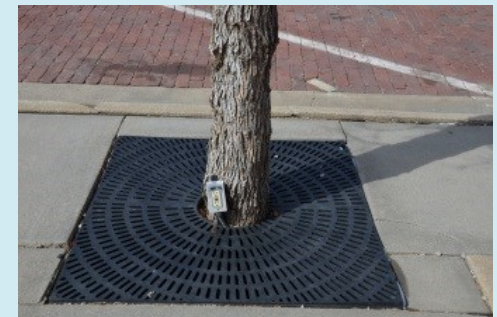
**Block B:**

- Placement of the Garbage cans, benches for seating, and planters for aesthetics are present and in abundance.
- Seating Areas for resting are provided at intervals out of the circulation path.
- Amenities have wheelchair clearance space for access
- Trees are plentiful and evenly distributed along streetscape
- Amenities are located to the side of the direct path of travel
- Block B features a park, which used to be a parking lot. This park features a shelter with tables and seating a gravel walkway and natural landscaping
- Park space provides additional resting area; however its sandy walking surface limits accessibility

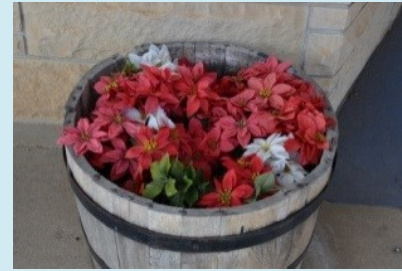
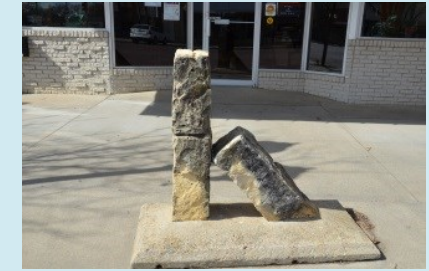
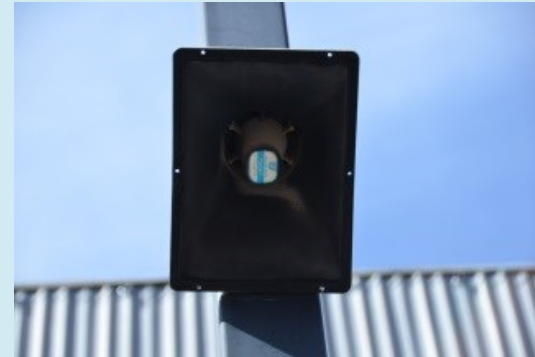
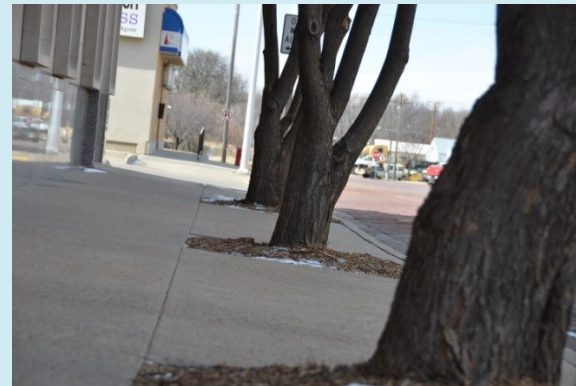
**Block C:**

- Each amenity available on this block is distributed evenly to ensure pedestrians are not too far from walkway seating, radio broadcast from the P.A. system or natural amenities like trees and flower planters.
- Placement of the Garbage cans, benches for seating, and planters for aesthetics are present and in abundance.
- Seating Areas for resting are provided at intervals and placed outside the circulation path to avoid creating obstructions.
- Amenities have wheelchair clearance space for access
- Trees are plentiful and evenly distributed along streetscape
- Amenities are located to the side of the direct path of travel.

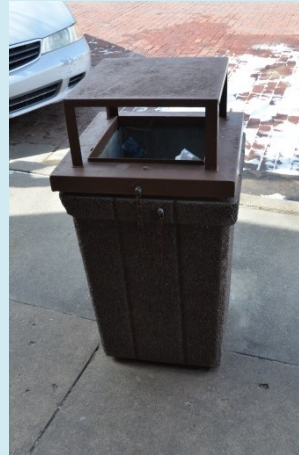
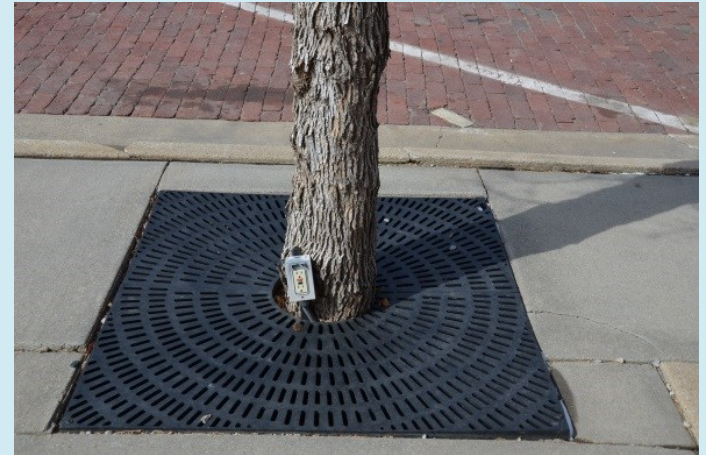
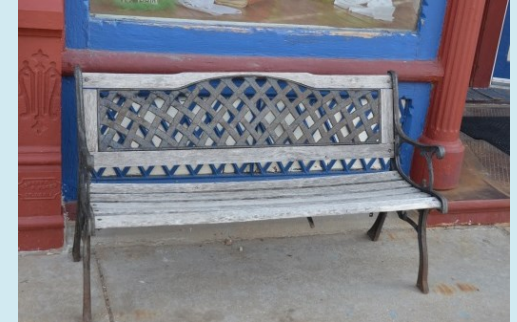
**Block D:**

- Evenly distributed availability and placement of the Garbage cans, benches for seating, and planters for aesthetics
- Seating Areas for resting are provided at intervals out of the circulation path.
- Amenities have wheelchair clearance space for access
- Trees are plentiful and evenly distributed along streetscape
- Amenities are located to the side of the direct path of travel

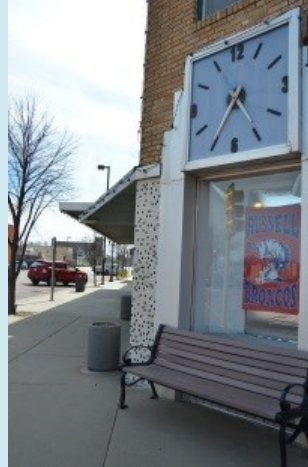
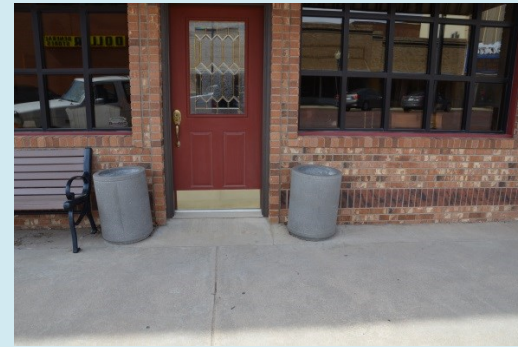
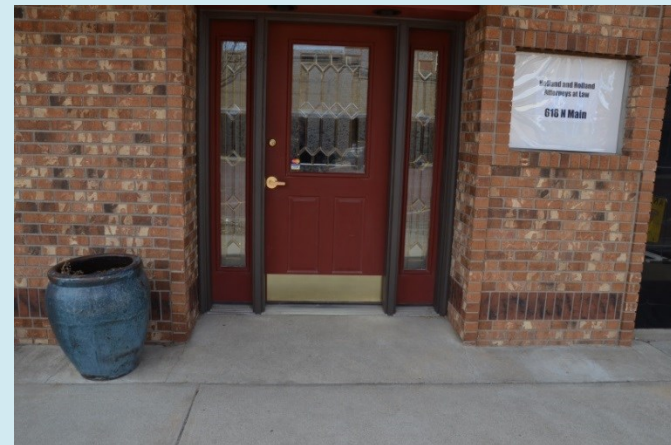
**Block E:**

- Evenly distributed availability and placement of the Garbage cans, benches for seating, and planters for aesthetics
- Many of the planters on this block are owned by local businesses and not city bought and maintained
- Seating Areas for resting are provided at intervals out of the circulation path.
- Amenities have wheelchair clearance space for access
- Trees are plentiful and evenly distributed along streetscape
- Amenities are located to the side of the direct path of travel
