IMPROVING THE USABILITY AND ACCESSIBILITY IN AGING RURAL COMMUNITIES

MASTER OF REGIONAL AND COMMUNITY PLANNING

## Peabody, Kansas: Study Boundary of Streetscape Audit

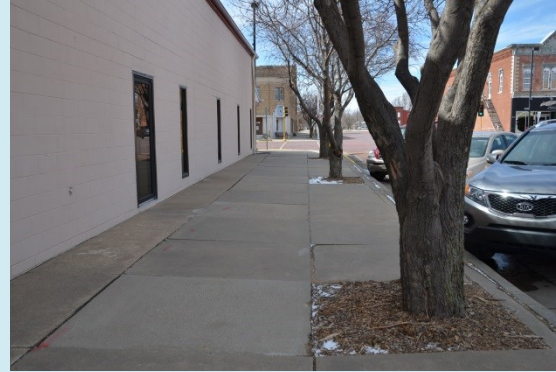
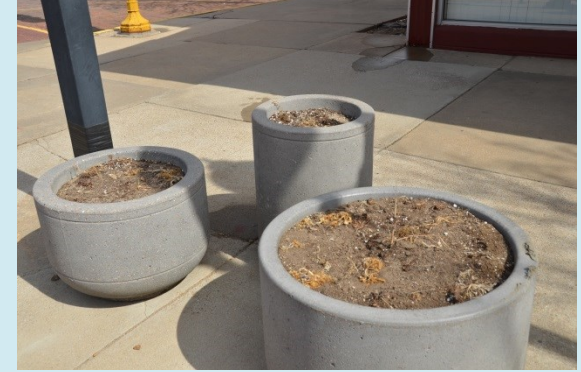
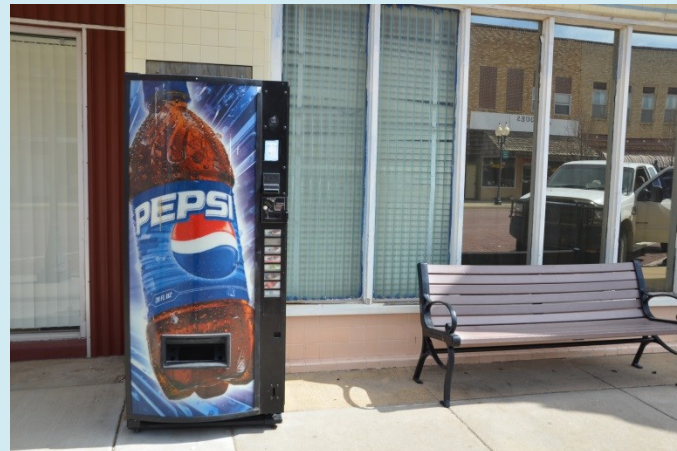
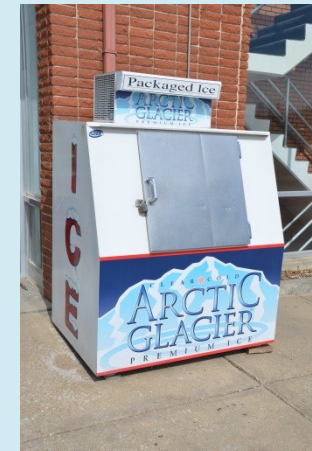
**Block F:**

- Evenly distributed availability and placement of the Garbage cans, benches for seating, and planters for aesthetics
- This block features a soda machine and an ice box provided by the local grocery store
- Seating Areas for resting are provided at intervals out of the circulation path.
- Amenities have wheelchair clearance space for access
- Trees are plentiful and evenly distributed along streetscape
- Amenities are located to the side of the direct path of travel

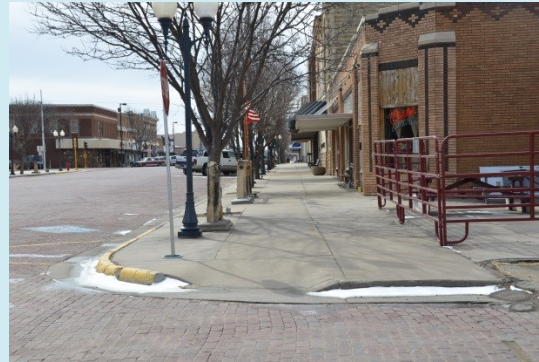
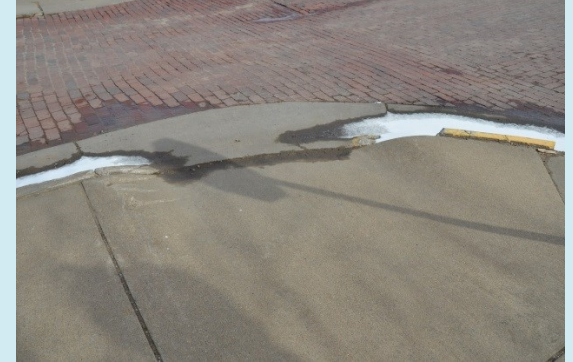
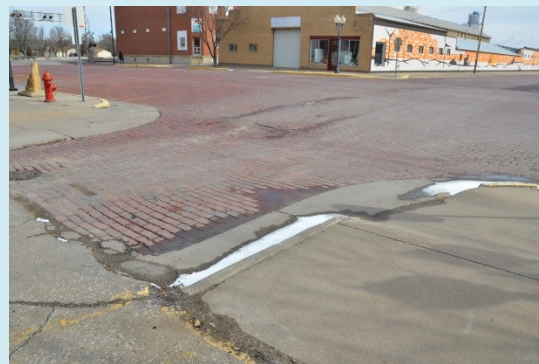
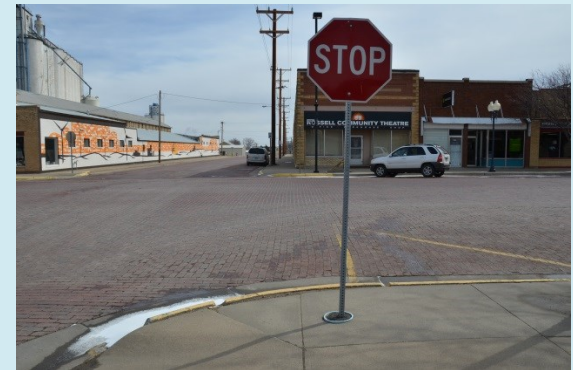
**Block A:**

- Street- signals and street-markings for pedestrians are present.
- No Bump Outs or pedestrian islands utilized.
- Curb Cuts are present at crosswalks and major points of access and curb ramps present at major crossings and access points.
- Pedestrian crossing distances on crossing routes are standard length. Crossings are not reduced with expanded corners and/or safety islands.
- Storm drains are located outside marked crossings.
- Crossings are clearly marked with painted yellow and white lines. Crossing boundaries are permanently marked with change of paving material (e.g. brick in contrast to concrete or asphalt roadways.)

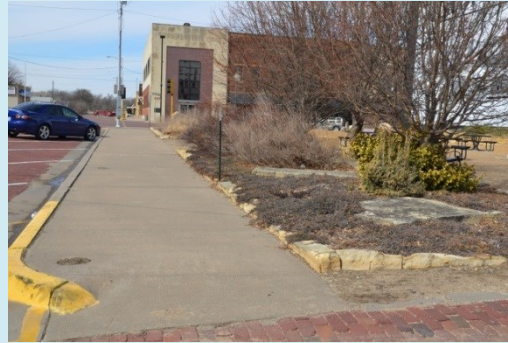
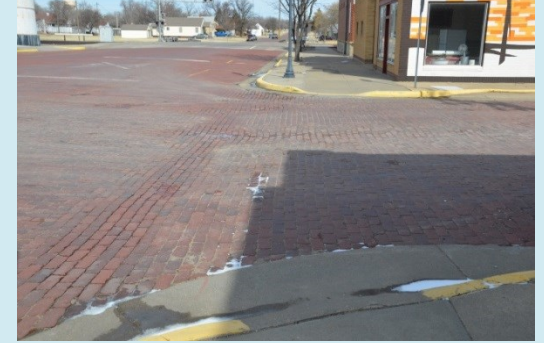
**Block B:**

- Street- signals and street-markings for pedestrians are present.
- No Bump Outs or pedestrian islands utilized.
- Curb Cuts are present at crosswalks and major points of access and curb ramps present at major crossings and access points.
- Pedestrian crossing distances on crossing routes are standard length. Crossings are not reduced with expanded corners and/or safety islands.
- Storm drains are located outside marked crossings.
- Crossings are clearly marked with painted yellow and white lines. Crossing boundaries are permanently marked with change of paving material (e.g. brick in contrast to concrete or asphalt roadways.)

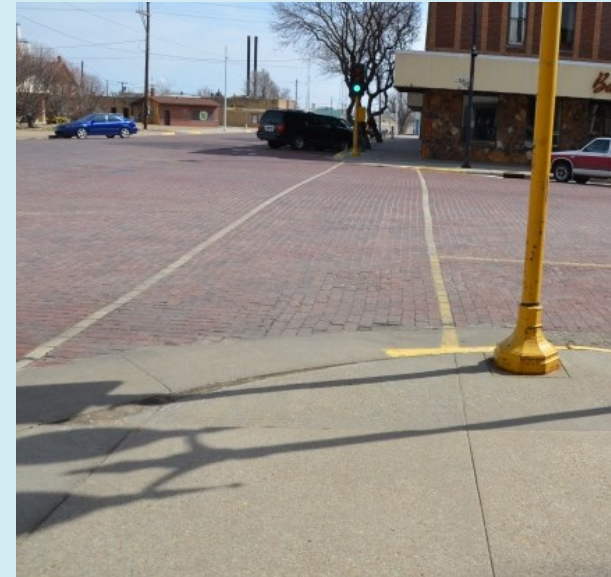
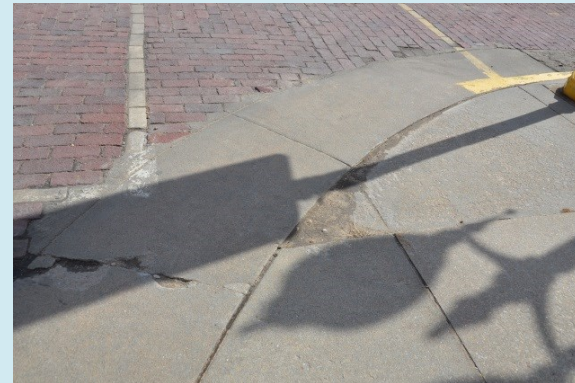
**Block C:**

- Street- signals and street- markings for pedestrians are present.
- No Bump Outs or pedestrian islands utilized.
- Curb Cuts are present at crosswalks and major points of access and curb ramps present at major crossings and access points.
- Pedestrian crossing distances on crossing routes are standard length. Crossings are not reduced with expanded corners and/or safety islands.
- Storm drains are located outside marked crossings.
- Crossings are clearly marked with painted yellow and white lines. Crossing boundaries are permanently marked with change of paving material (e.g. brick in contrast to concrete or asphalt roadways.)

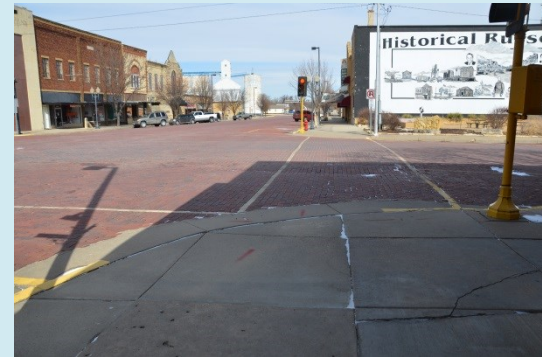
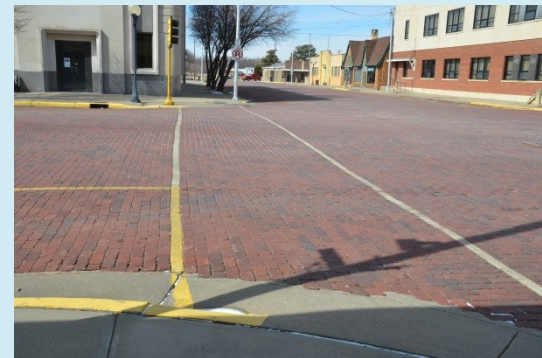
**Block D:**

- Street- signals and street-markings for pedestrians are present.
- No Bump Outs or pedestrian islands utilized.
- Curb Cuts are present at crosswalks and major points of access and curb ramps present at major crossings and access points.
- Pedestrian crossing distances on crossing routes are standard length. Crossings are not reduced with expanded corners and/or safety islands.
- Storm drains are located outside marked crossings.
- Crossings are clearly marked with painted yellow and white lines. Crossing boundaries are permanently marked with change of paving material (e.g. brick in contrast to concrete or asphalt roadways.)

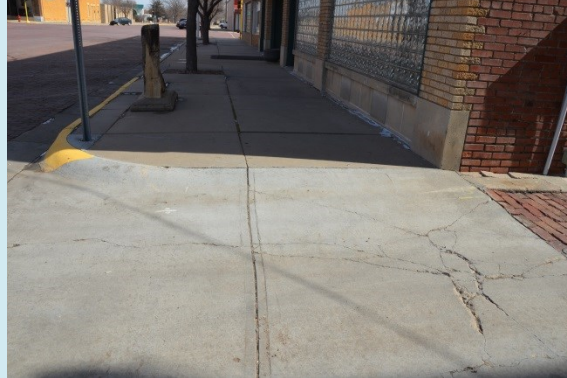
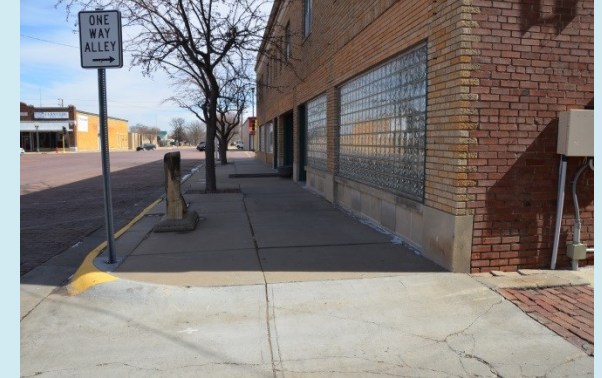
**Block E:**

- Street- signals and street- markings for pedestrians are present.
- No Bump Outs or pedestrian islands utilized.
- This block features curb ramps at the alleyway for easy access for elderly and disabled, even away from the main street
- Curb Cuts are present at crosswalks and major points of access and curb ramps present at major crossings and access points.
- Pedestrian crossing distances on crossing routes are standard length. Crossings are not reduced with expanded corners and/or safety islands.
- Storm drains are located outside marked crossings.
- Crossings are clearly marked with painted yellow and white lines. Crossing boundaries are permanently marked with change of paving material (e.g. brick in contrast to concrete or asphalt roadways.)

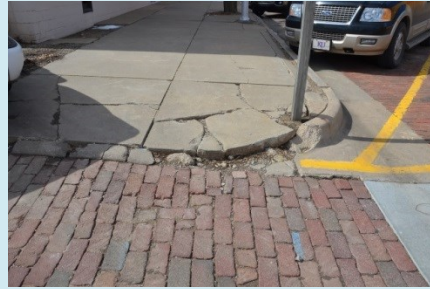
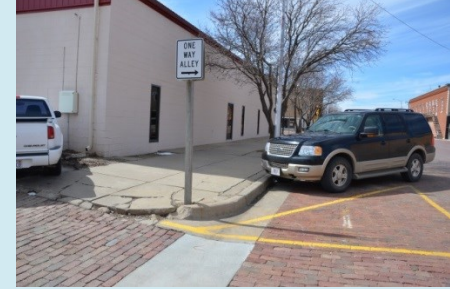
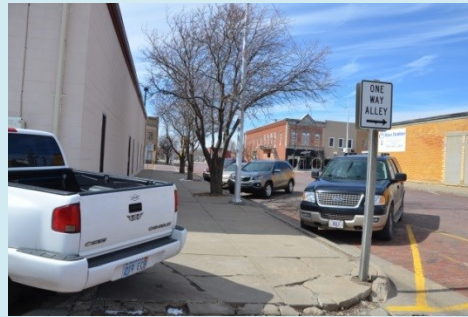
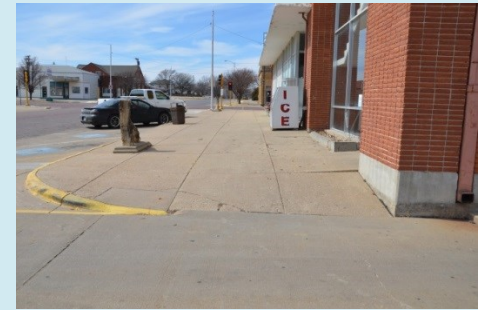
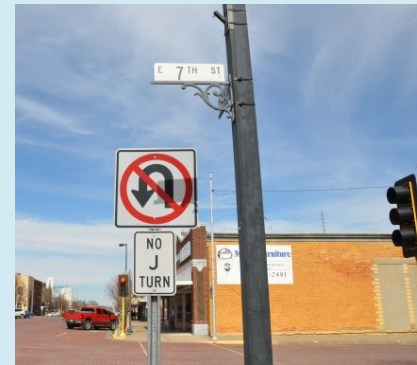
**Block F:**

- Street- signals and street- markings for pedestrians are present.
- No Bump Outs or pedestrian islands utilized.
- Curb Cuts are present at crosswalks and major points of access and curb ramps present at major crossings and access points.
- Pedestrian crossing distances on crossing routes are standard length. Crossings are not reduced with expanded corners and/or safety islands.
- Storm drains are located outside marked crossings.
- Crossings are clearly marked with painted yellow and white lines. Crossing boundaries are permanently marked with change of paving material (e.g. brick in contrast to concrete or asphalt roadways.)

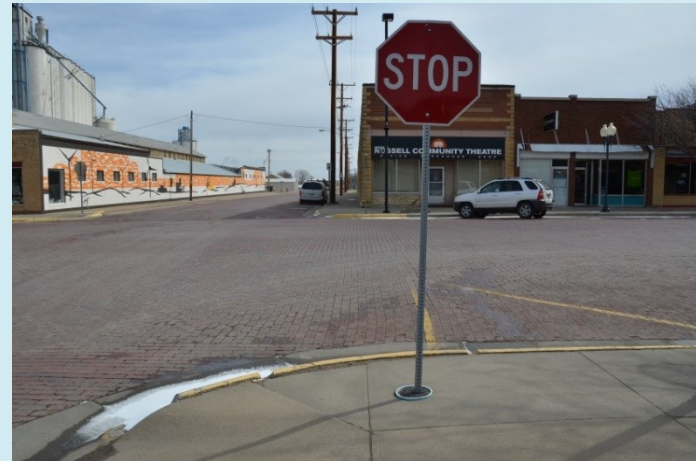
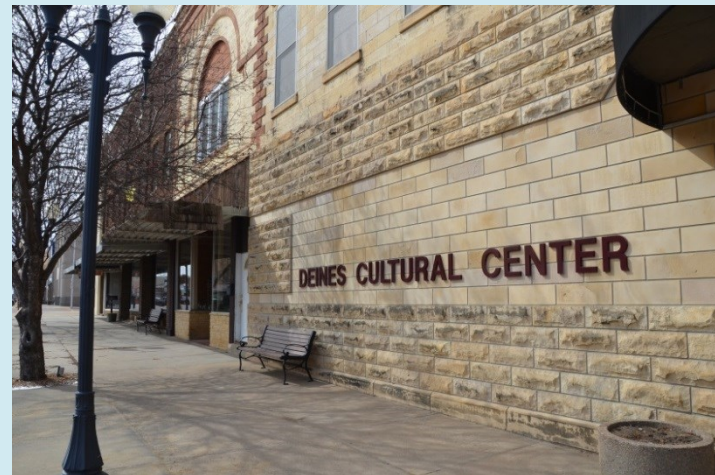
**Block A:**

- Stop signs are present at major intersections
- No Pedestrian Crossing signs are present at major intersections and crossings.
- Signs for Street names are small and hard to read
- Informative and way finding signs are not present
- Signs for information are not present.
- Signage is small print and not well-proportioned or well-contrasted for easy reading
- Signs are in prominent locations
- No Pictograms and or alternative languages included.
- Signs for businesses are prominent and well positioned

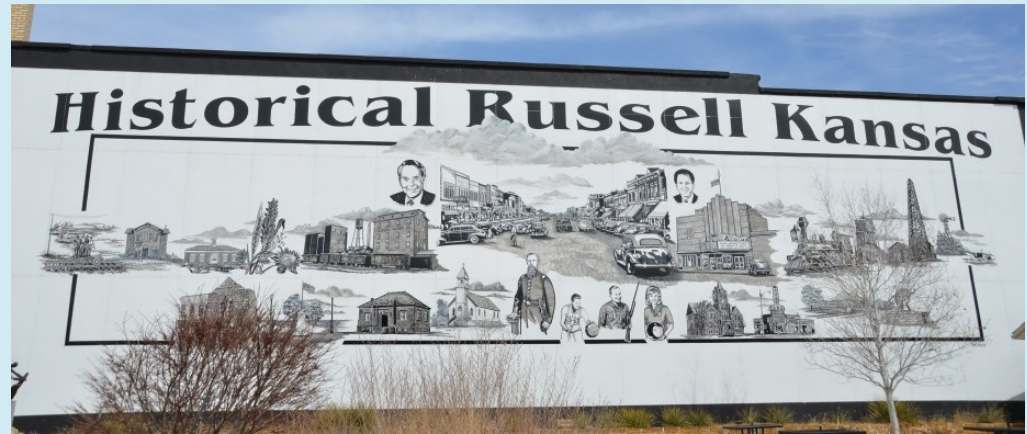
**Block B:**

- Stop signs are present at major intersections
- No Pedestrian Crossing signs are present at major intersections and crossings.
- Signs for Street names are small and hard to read
- Informative and way finding signs are not present
- Signs for information are not present.
- Signage is small print and not well-proportioned or well-contrasted for easy reading
- Signs are in prominent locations
- No Pictograms and or alternative languages included.
- Signs for businesses are prominent and well positioned

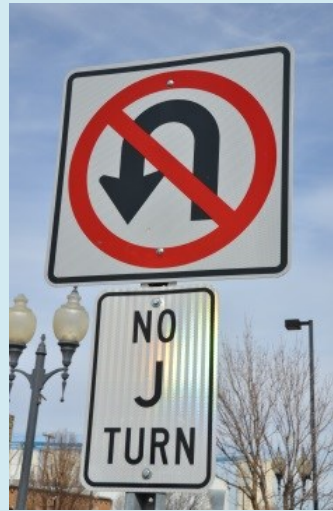
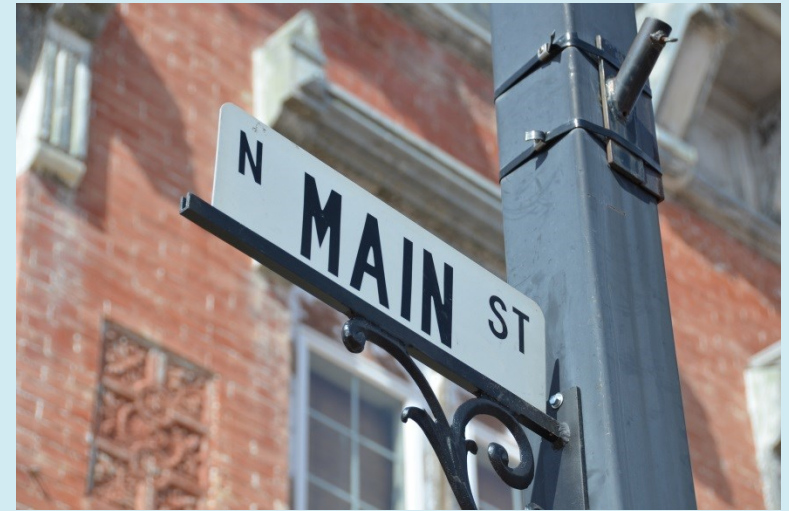
**Block C:**

- Stop signs are present at major intersections
- No Pedestrian Crossing signs are present at major intersections and crossings.
- Signs for Street names are small and hard to read
- Informative and way finding signs are not present
- Signs for information are not present.
- Signage is small print and not well-proportioned or well-contrasted for easy reading
- Signs are in prominent locations
- No Pictograms and or alternative languages included.
- Signs for businesses are prominent and well positioned

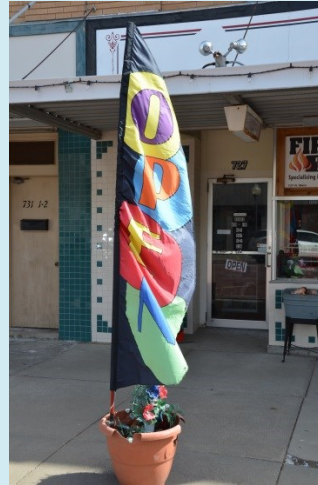
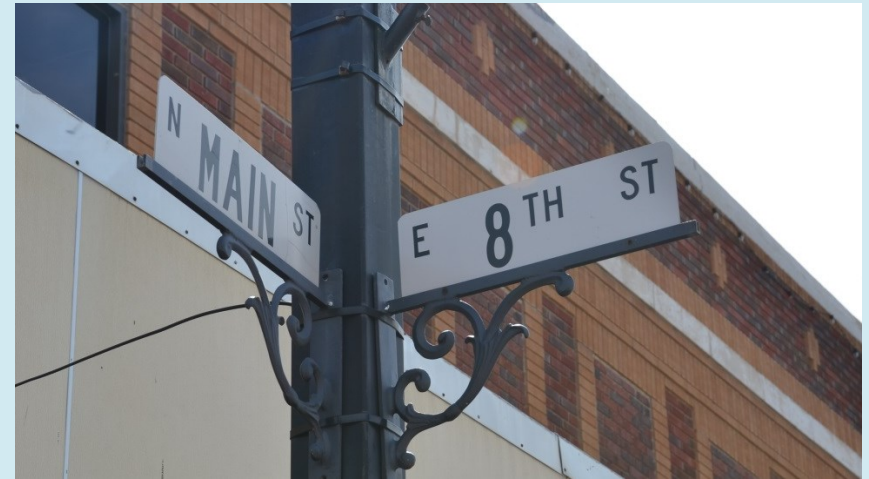
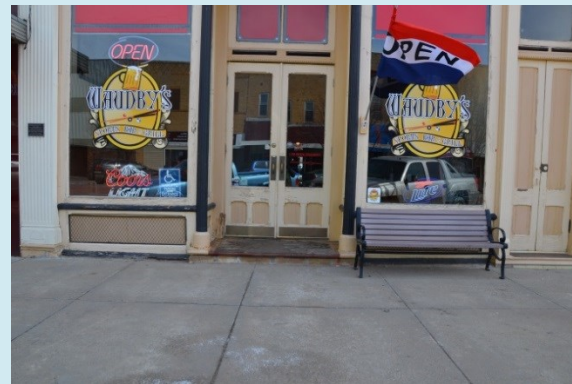
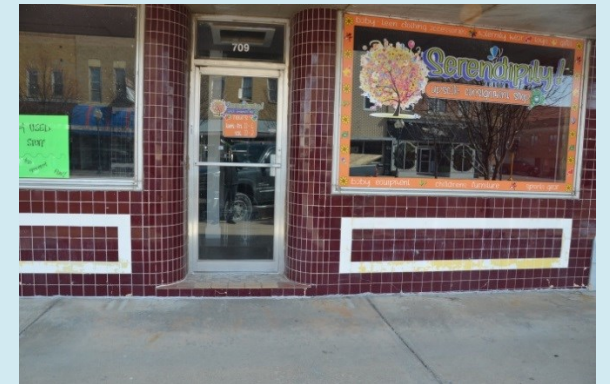
**Block D:**

- Stop signs are present at major intersections
- No Pedestrian Crossing signs are present at major intersections and crossings.
- Signs for Street names are small and hard to read
- Informative and way finding signs are not present
- Signs for information are not present.
- Signage is small print and not well-proportioned or well-contrasted for easy reading
- Signs are in prominent locations
- No Pictograms and or alternative languages included.
- Signs for businesses are prominent and well positioned

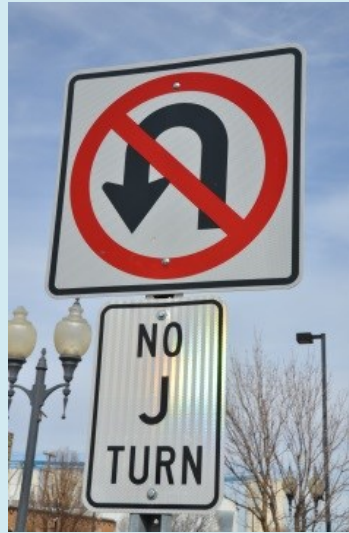
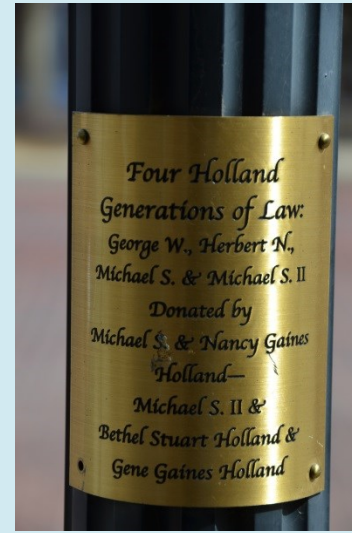
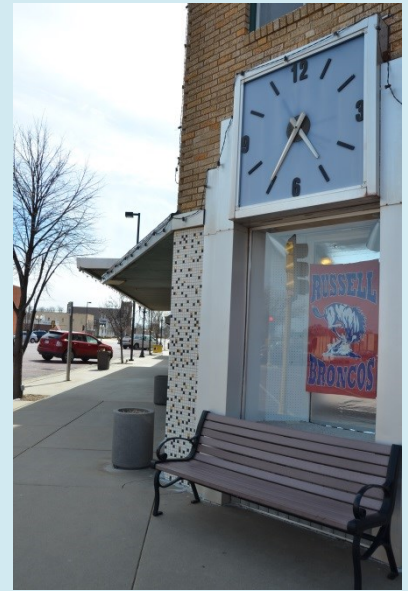
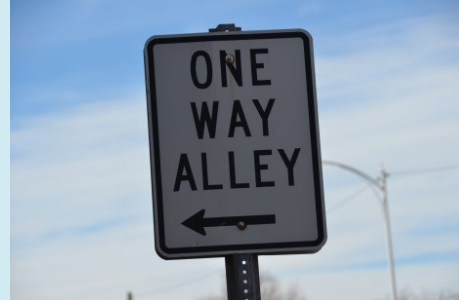
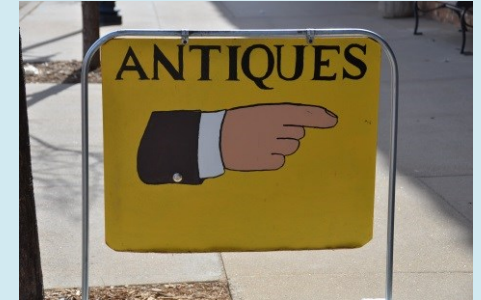
Block E:

- Stop signs are present at major intersections
- No Pedestrian Crossing signs are present at major intersections and crossings.
- Signs for Street names are small and hard to read
- Informative and way finding signs are not present
- Signs for information are not present.
- Signage is small print and not well-proportioned or well-contrasted for easy reading
- Signs are in prominent locations
- No Pictograms and or alternative languages included.

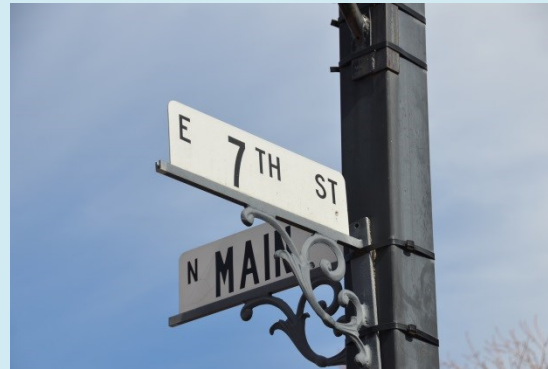
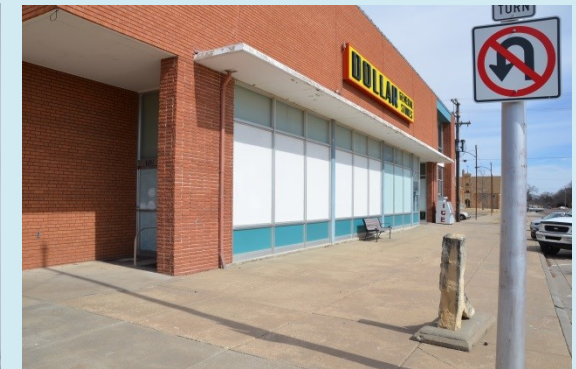
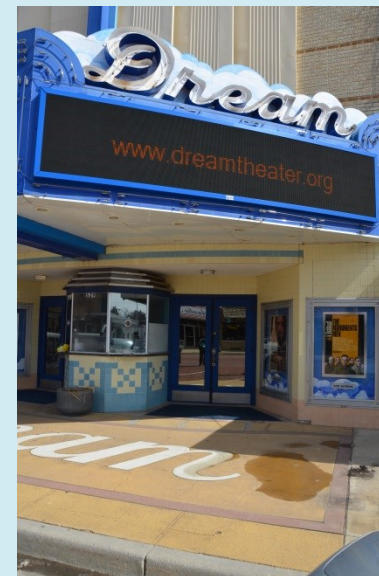
**Block F:**

- Stop signs are present at major intersections
- No Pedestrian Crossing signs are present at major intersections and crossings.
- Signs for Street names are small and hard to read
- Informative and way finding signs are not present
- Signs for information are not present.
- Signage is small print and not well-proportioned or well-contrasted for easy reading
- Signs are in prominent locations
- No Pictograms and or alternative languages included.
- Signs for businesses are prominent and well positioned
