EVALUATION OF BONDING AGENT APPLICATION ON CONCRETE PATCH
PERFORMANCE

A THESIS

Department of Civil Engineering

Kansas State University

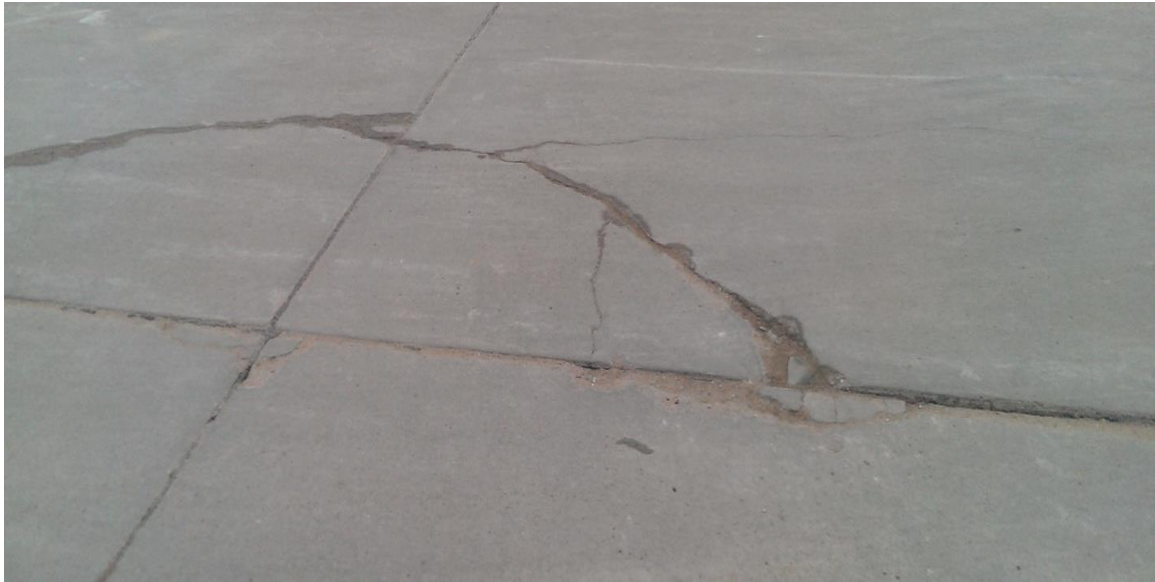
Figure 2-1 Pavement with Surface Cracks

Once cracking occurs introduction of foreign containments into the pavement can accelerate the rate at which cracks propagate. Incompressibles become lodged in the cracks, and when the pavement experienced expansion or contraction the incompressibles cause stress in the pavement (T.P. Wilson, 2000). Traffic loads can accelerate the rate of deterioration if cracks are present. When pavement deterioration is left unintended cracks are allowed to propagate and the condition of the concrete worsens. *Figure 2-1* shows a pavement where the cracks have been allowed to propagate, and the quality of the pavement has deteriorated. *Figure 2-2* illustrates cracks on a pavement that has started on the pavement with only minor cracks being present.

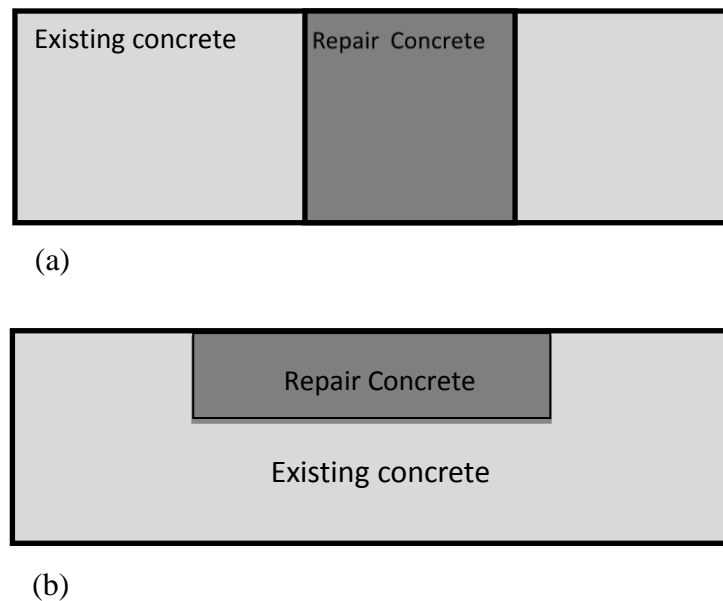
Figure 2.1 Pavement Repair (a) Full Depth (b) Partial Depth

Pavement repairs can be categorized into two types: partial-depth repairs and full-depth repairs (Felt, 1960). Partial-depth repairs require the removal of damaged concrete on pavement only near the surface and replacement with repair material. Once the repair material has been placed monolithic composite action is required for the pavement to be successful (ACI International, 2003). Full-depth repair requires removal of the full-depth pavement section and replacement of the damaged concrete. Pavements with reinforcement, such as steel or dowels, the reinforcement will need to be either replaced or cleaned before the repair concrete is applied. If the steel is replaced, the new steel is attached to the existing steel on the pavement (ACI International, 2003). *Figure 2-3.* shows cross sections of a) full-depth concrete repair and b) a partial depth concrete repair

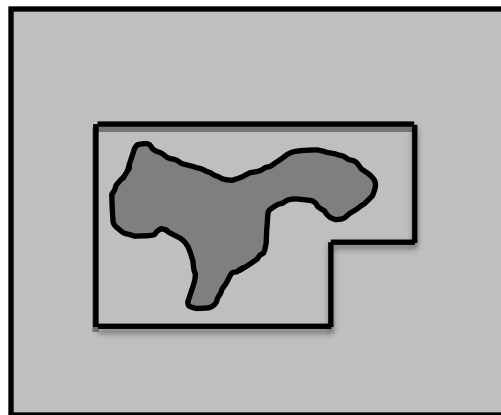
Figure 2.2 Setting Boundary Conditions

repair cost, even if more repair material is needed because it lowers the amount of saw cutting required and can help the bond last longer by reducing stress concentrations and cracking. Good performance on field patch repairs can be obtained, but only when all of the damage has been removed by removing slightly more concrete than is known to be damaged (Dar-Hao Chen, 2011). This helps ensure that any difficult to detect micro cracking at the edge of the damaged concrete is removed. The minimum depth of a partial depth patch should be more than two inches (KDOT, 2007) in depth but no more than 1/3 slab thickness (T.P. Wilson, 2000). The outside boundaries should be a minimum of 2 inches from the spalled concrete and a maximum of 6 inches (T.P. Wilson, 2000). An example boundary layout for a damaged area is illustrated in *Figure 2-4*. Boundaries with four edges are ideal since boundaries with more edges will require additional cuts to be made (Emmons, 1993; Fowler D, 2008; Dar-Hao Chen, 2011)

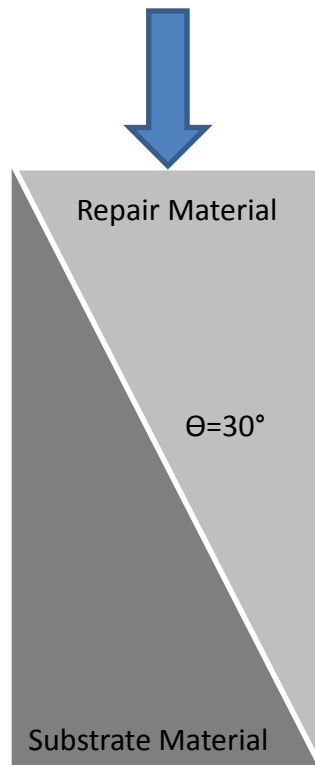
Figure 2.3 Slant Shear Test

The slant shear test is used to evaluate bond strength by the resin manufacturing industry (A. Momayeza, 2005).

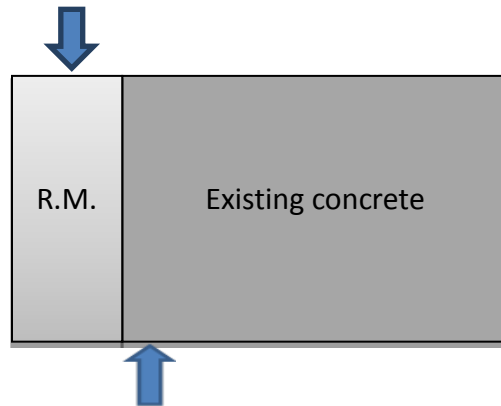
Figure 2.4 Direct Shear Test

The direct shear test applies shear using a Brookhaven National Laboratory Guillotine Shear Test (Illinois Department of Transportation , 2012) apparatus. Substrate parent samples must first be made using a 4 in. X 4 in. concrete cylinder. The samples being tested are cast by placing repair material 1.25-in. thick on the pre-made concrete cylinder. Composite samples are loaded at a rate of .22 inches per minute; shear strength is derived by dividing the maximum load recorded to cause failure by the cross-sectional area of the sample. The direct shear test is illustrated in *Figure 2-6*.

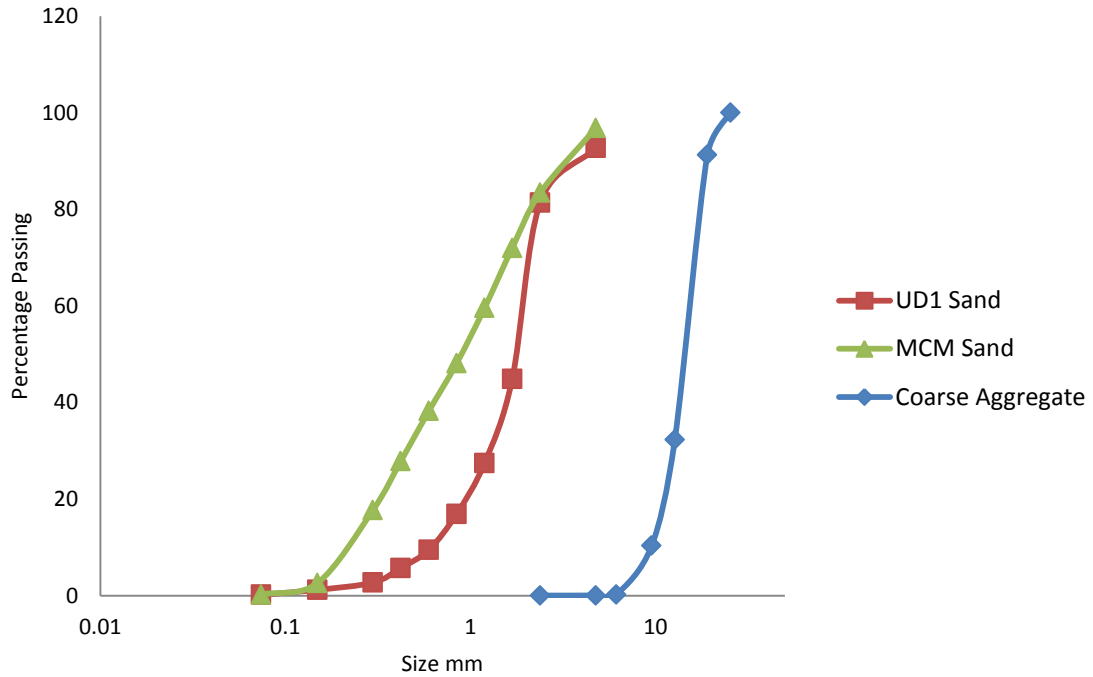
Figure 3.1 Aggregate Gradation

called limestone. The repair mortars used for the field tests were made using MCM sand and the UD-1 sand with a fineness modulus of 4.23 called hereafter UD1 Sand. The aggregate gradations are shown in *Figure 3-1*

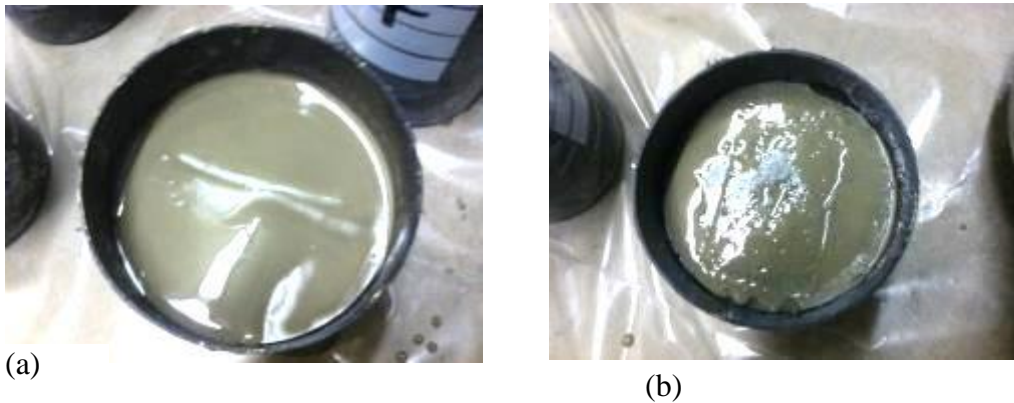
Figure 4.1 Substrate Samples with Applied Bonding Agent

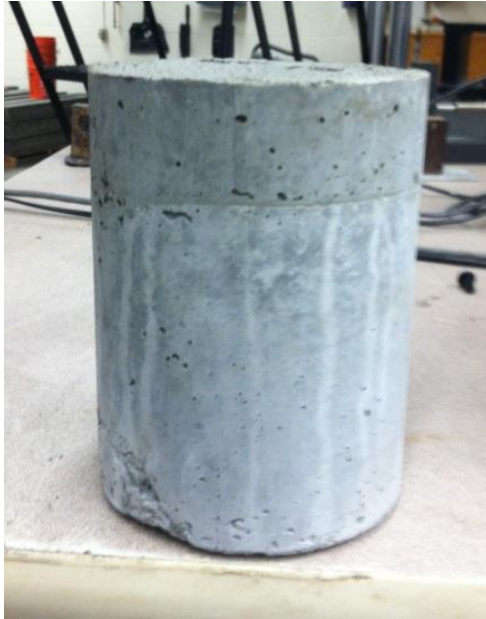
Figure 4.2 Composite Concrete Sample

The same mortar mix design was used for all of the bonding agent tests as well as the samples that didn't have bonding agents, except for the rapid repair materials that were tested without bonding agents. The repair material was rodded 20 times with a 1/4 in steel tamping rod following the Illinois Standard Method of Test of Shear Strength of Bonded Polymer Concrete. After rodding, the samples were covered with plastic lids and stored in a 73 °F 50% relative humidity room for a period of 24 hrs. The samples were then de-molded and freeze-thaw cycles commenced. Figure 4.2 shows an example of the composite sample.

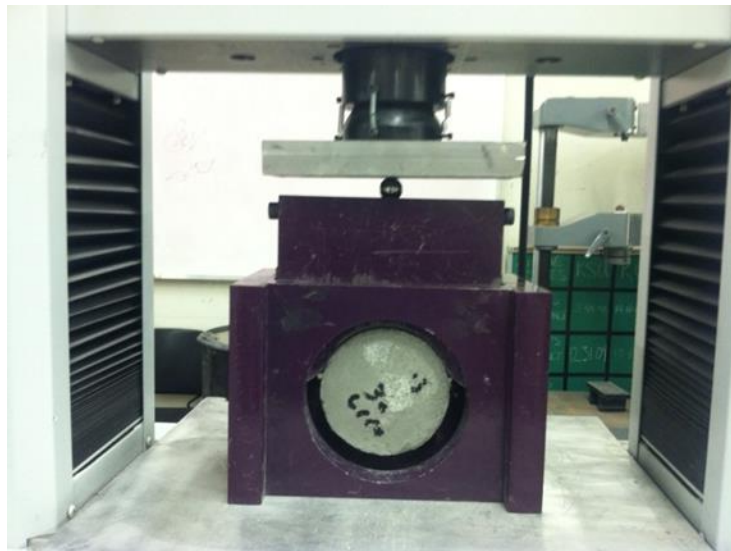
Figure 4.3 BNL Guillotine

The Brookhaven National Laboratory (BNL) guillotine shear test apparatus was used to measure the concrete bond shear strength. When the freeze-thaw cycles were completed both the sample groups that were subject to thermal and non-thermal cycles were loaded until failure as seen in *Figure 4-3* at a rate of .22 in per minute with the BNL guillotine. The shear stress was calculated by dividing the maximum load recorded by the surface area of the cylindrical sample.

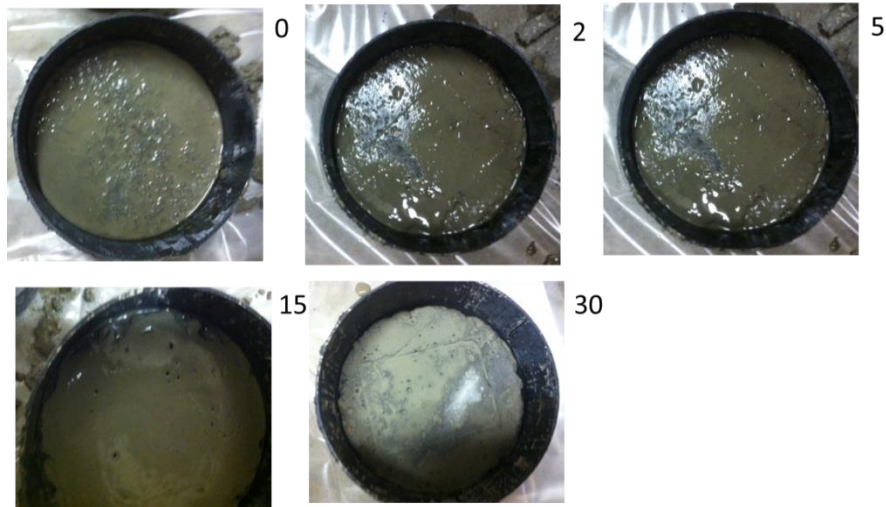
Figure 4.4 Wait Time Effects for 3-1 Grout

The first bonding agent that was subject to the applications testing was the 3-1 water to cement Type III portland cement grout. The grouts were applied with a foam brush to a thickness of 1-2 mm, and allowed have a wait time of 0, 2, 5, 15, and 30 minutes. The effects of the bonding agent grout drying out from evaporation and absorption by the substrate concrete can be seen in *Figure 4-4*. As shown in the figure the sample with 0 wait time is still very fluid. After 15 minutes the grout began to thicken. By the end of the 30 minutes much of the water had evaporated. The grout on the steel samples didn't lose as much water as the samples with the concrete substrate because the steel substrate does not absorb water.

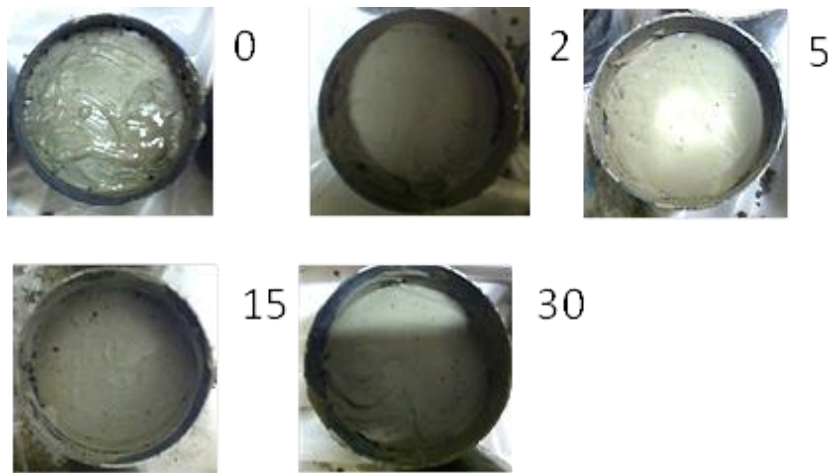
Figure 4.5 0.5 W/C Grout

The 0.5 bonding agent was much more viscous than the 3-1 grout used. *Figure 4-5* illustrates how wait time affected the bonding agent. The 0.5 w/c grout lost its free water much sooner. After the grout dried, instead of becoming more of a paste-like consistency the 3-1 grout used, it started to resemble dried clay.

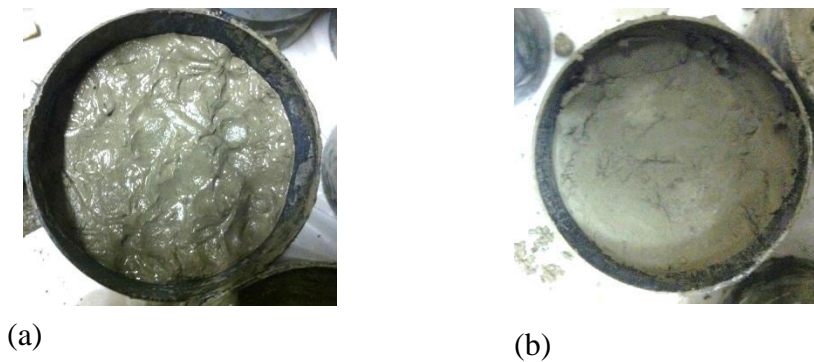
Figure 4.6 Effects of Wait Time on 0.3 Grout, (a) 0, (b) 30 Minutes

The workability of the 0.3 grout was the worst compared to the other grouts. Because of the low workability, it had to be applied by hand applications instead of with a foam brush.

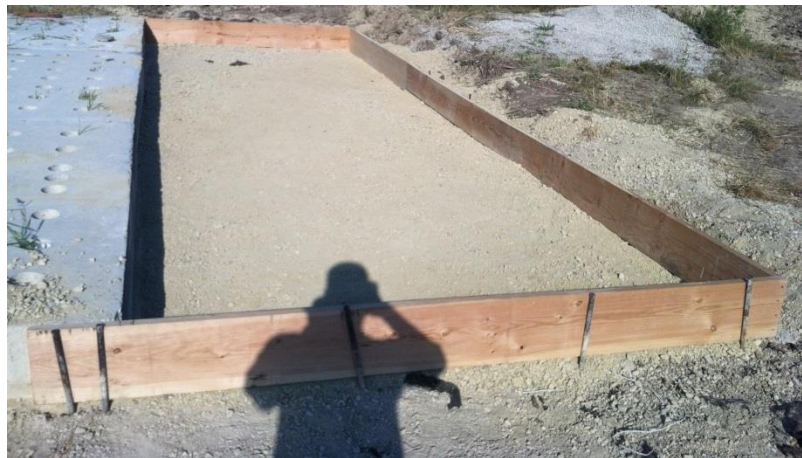
Figure 4.7 Site Preparation

The field testing took place at the Civil Infrastructure Systems Laboratory at Kansas State University. 10 in thick field slabs were constructed, one with dimensions of 8ft X 24ft, and the other 6 ft X 24 ft. The slabs were cast alongside already existing slabs. Ground leveling was completed using a skid-steer loader. Once the ground was level, wooden forms were set, and stakes were placed so that the concrete forms would hold the pressure of the concrete during the placing process. The finished site before the first concrete slab was placed can be seen in *Figure 4-7*.

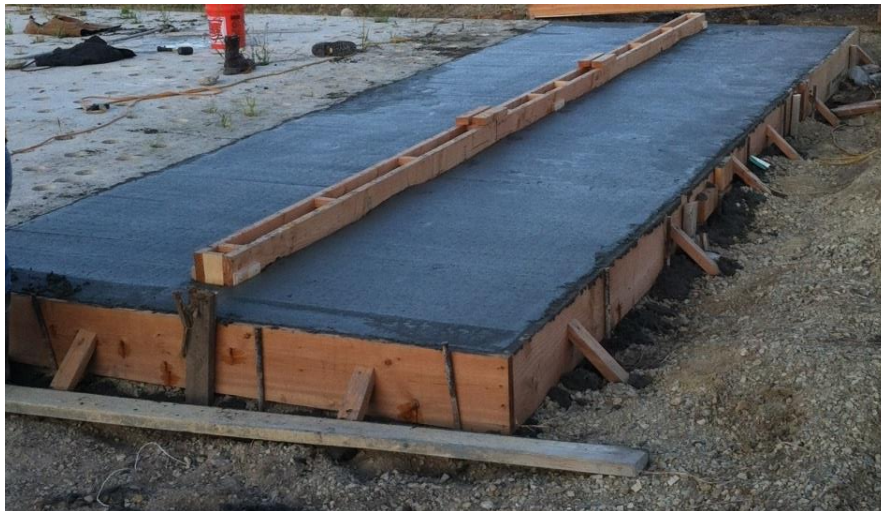
Figure 4.8 Field Slab 1

vibrator having a 1.5 in diameter head was used to consolidate the concrete. The vibrating end was inserted and removed from the concrete in a vertical motion. The concrete slab was screeded with a wooden 2 X 6 in. beam that was ten feet in length. When the surface of the concrete slab was level a 6 x 4 in. wooden box that spanned 22 ft was placed in the center. The wooden box allowed a rectangular section in the middle of the slab to be open that was 6” wide and 2” deep. The cut out section was left in the concrete slab to make space for the repair and lessen the amount of concrete that would need chipped out later. Once the wooden frame was placed in the slab the surface was finished with a bull float. The finished field slab 1 is shown in *Figure 4-8*. After one day of curing, the wooden box frame was removed from the slab.

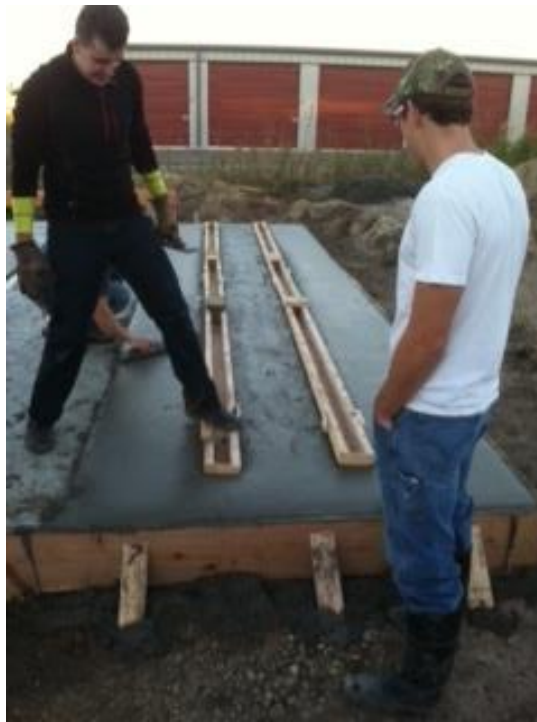
Figure 4.9 Field Slab 2

Field slab two was constructed using the same process and mix design as the first slab placed and was placed on October 4th of 2014. The difference between slab 1 and 2 was that slab two had two box frames placed in the slab. Field slab 2 is shown in *Figure 4-9*. After the two boxes were placed on the slab, weights were used to keep the boxes from being uplifted by the buoyant force.

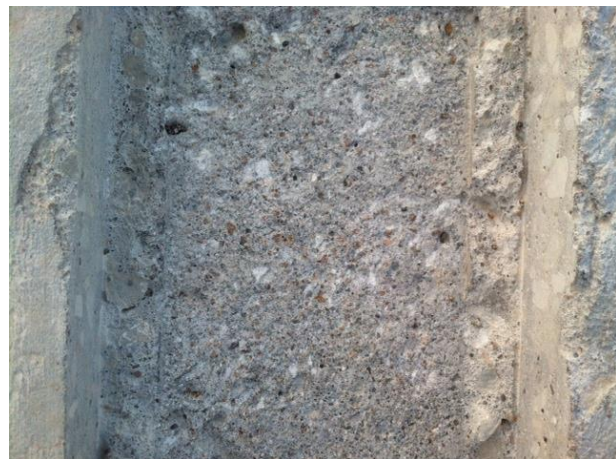
Figure 4.10 Surface Preparation

Before placing the bonding agents and repair materials on the repair sections of the field slabs the surface interface had to be prepared to ensure bond strength development. A saw cut was made one inch from the edge of the formed void in the slab. The concrete between the saw cut and the formed edge was then removed. This left an eight inch wide void two inches deep. Edge removal is shown in *Figure 4.10*. After the edges of the repair section were cut the surface of the repair area was roughened with the use of a needle scaler and is shown in *Figure 4.11*. The top layer of the concrete surface was removed and aggregate was exposed. The surface had a roughness of 5 on the International Concrete Repair Institute surface roughness scale. The interface surface between the field slab and the repair material was kept clean and free of oil and dust. *Figure 4-12* shows the condition of the field slab before bonding agents and repair materials were placed.

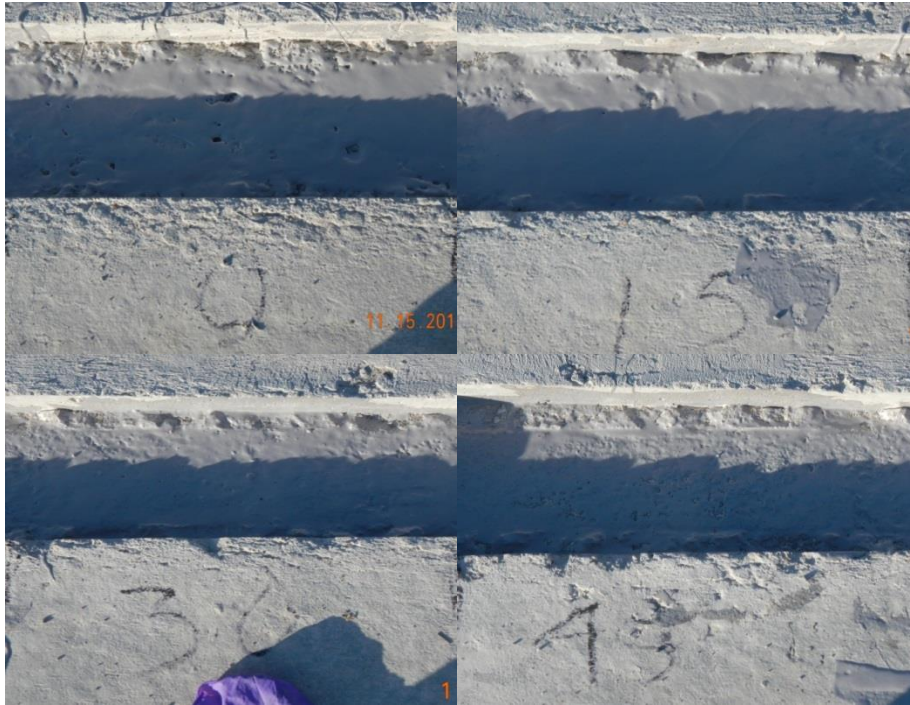
Figure 4.13 0,15,30, and 45 Minutes after Epoxy Bonding Agent Application

The surface of the repair slab sections were cleaned again before bonding agents and repair materials were placed. Because of the difficulty placing the 0.3 w/c grout in the laboratory tests, a grout with a 1 w/c was used instead. The w/c for the portland cement grouts used were 3-1, 1-1 and 0.5. The bonding agent wait times before repair material placement were 0, 15, 30, and 45 minutes. The bonding agents were applied on the surface with a foam brush. Pictures were obtained of the wait time effects for the epoxy, PVA, and acrylic bonding agents, and are shown in *Figures 4-13-16*.

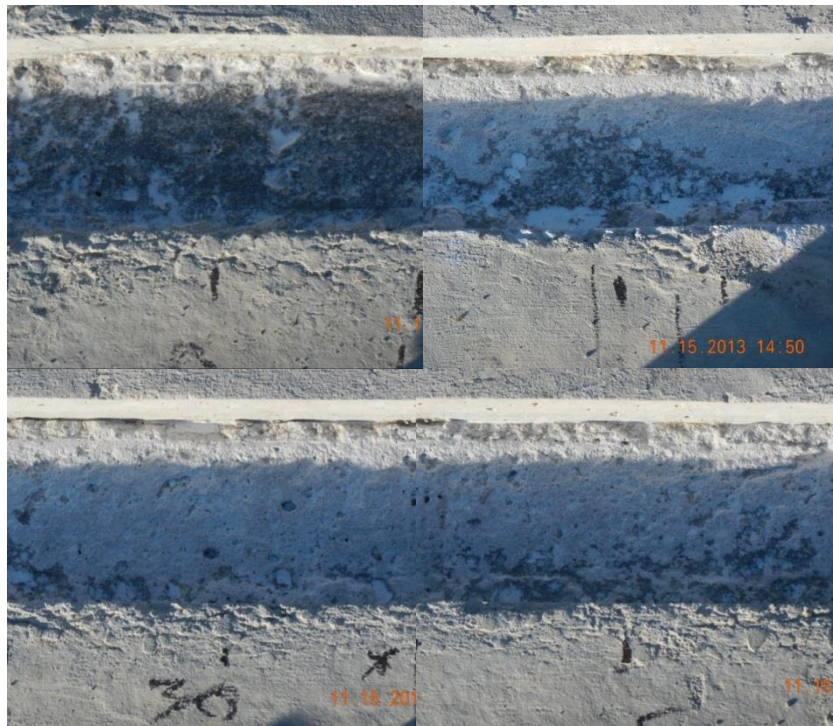
Figure 4.14 0, 15, 30, and 45 Minutes after PVA Bonding Agent Application

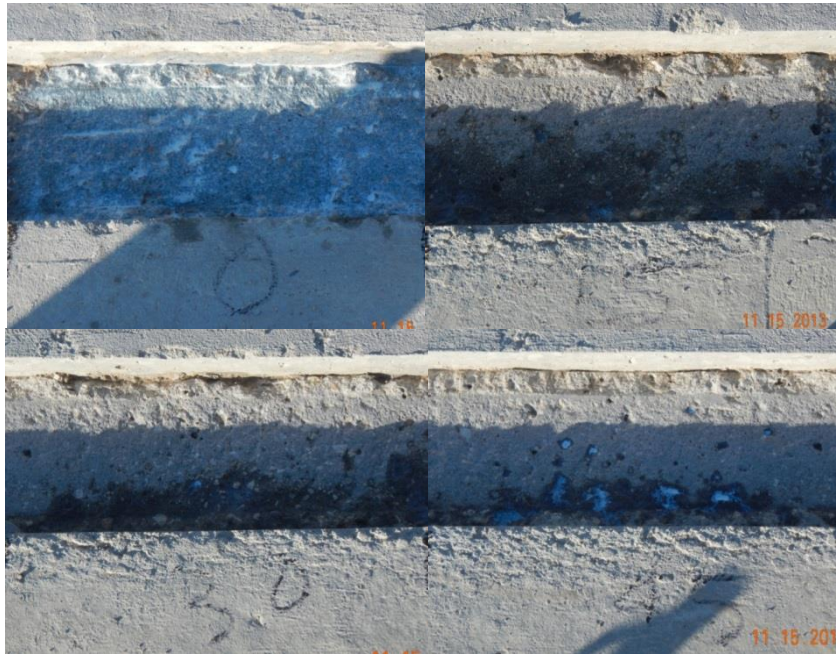
Figure 4.15 0, 15, 30, and 45 Minutes after Acrylic Bonding Agent Application

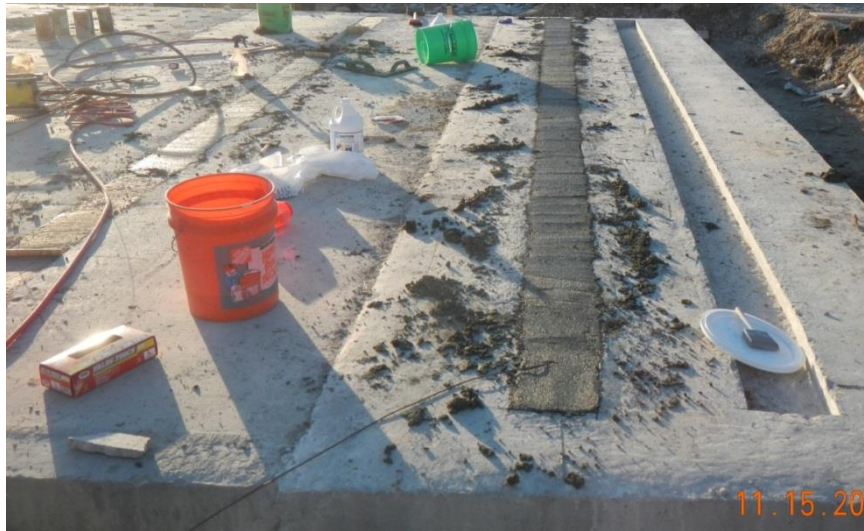
Figure 4.16 Repair Material Placed

taken to ensure that the vibrator would not touch the surface of the field slabs. The repair concrete was then troweled and finished. The repair materials were cured with the use of plastic sheeting for 24 hours. *Figure 4-16* shows the epoxy and latex bonding agent section with repair concrete 1 placed. Thermocouples were placed in the repair materials to measure the concrete temperature evolution.

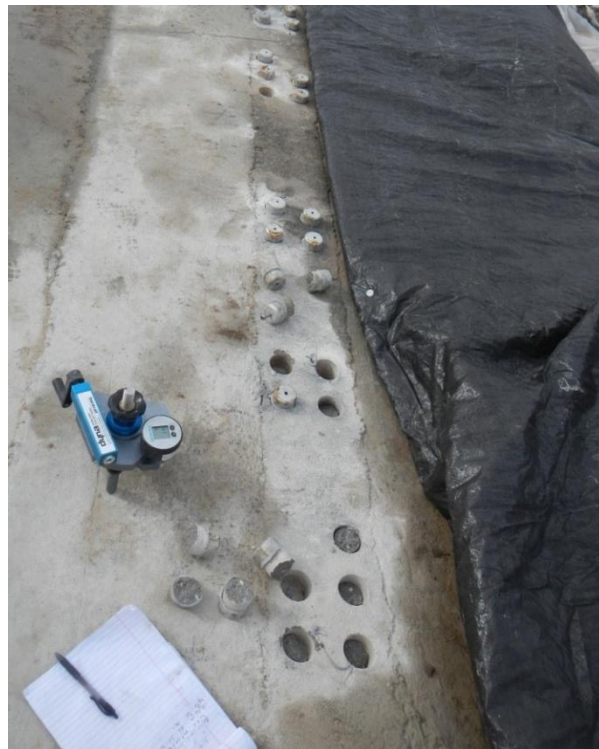
Figure 4.17 Pull-off Tensile Testing

Pull off tensile tests were conducted 7 days and 5 months after repair material placement. ASTM C1583 was followed when using the pull off procedure. Two in. diameter cores were first drilled 2.5 inches deep. ASTM C1583 requires that the cores have a minimum depth of 0.5 inches into the substrate material past the bond interface surface. Four cores were drilled for each waiting time and bonding agent used. After coring, aluminum disks were epoxied onto the core top surface. The aluminum disks were sand blasted prior to being attached to the repair material

to guarantee that the disk was free of containments. The pull off tensile loading was displacement controlled with a loading rate of 0.18 in/min. The concrete repair material after the pull-off tests can be seen in *Figure 4-17*. The maximum tensile force during the pull-off test was recorded. If any failures occurred between the epoxy and the aluminum disk the test was considered invalid according to ASTM C1583. The type of failure that occurred during the pull off test was recorded.

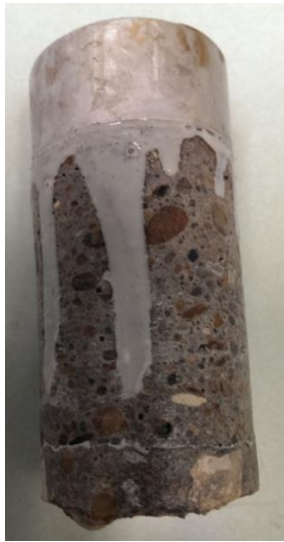
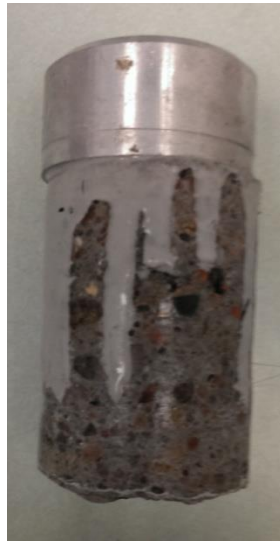
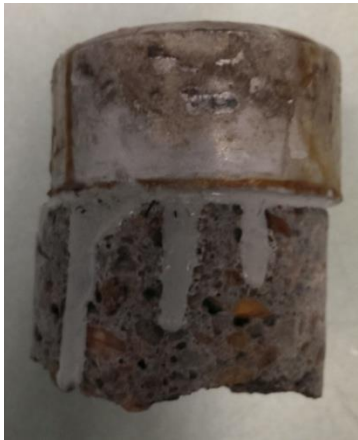
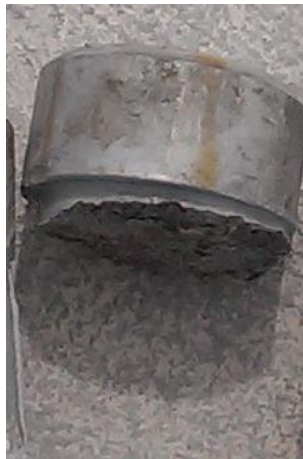
Figure 4.18 Type of Failures

The four types of failure are illustrated in *Figures 14-18 (a),(b),(c),(d)*. For type 1 failure, the substrate concrete is still attached to the repair concrete by the bond interface layer. Type 2 breaks are located right at the bond interface. Type 3 failure is located in the repair material, and type 4 failure is located at the epoxy interface between the aluminum disk and repair material.

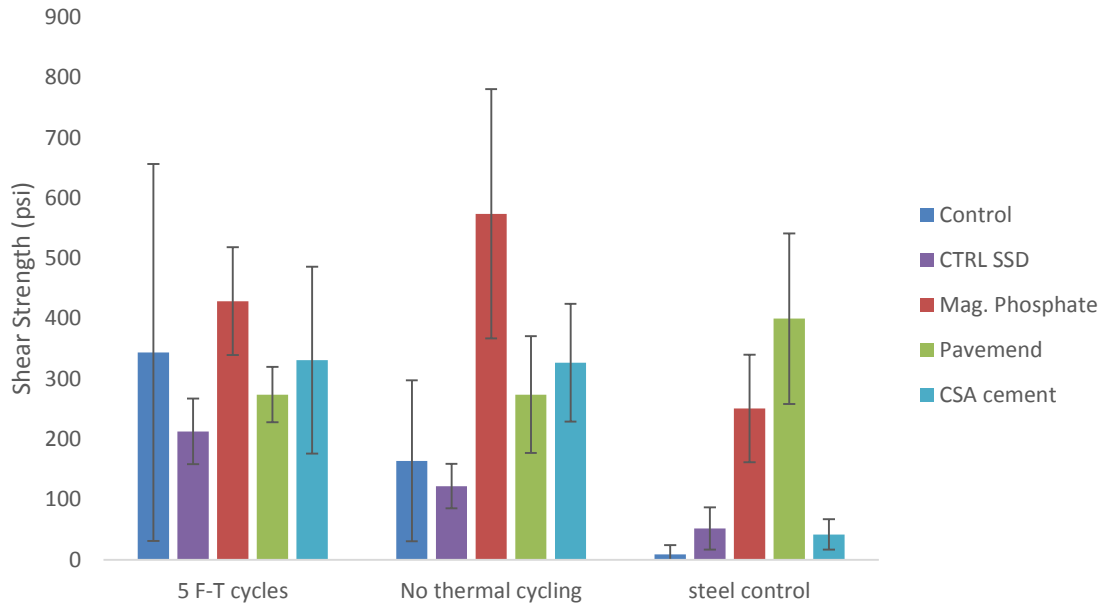
Figure 5.1 CRTL, CTRL SSD, MgP, PM, and CSA Shear Strength

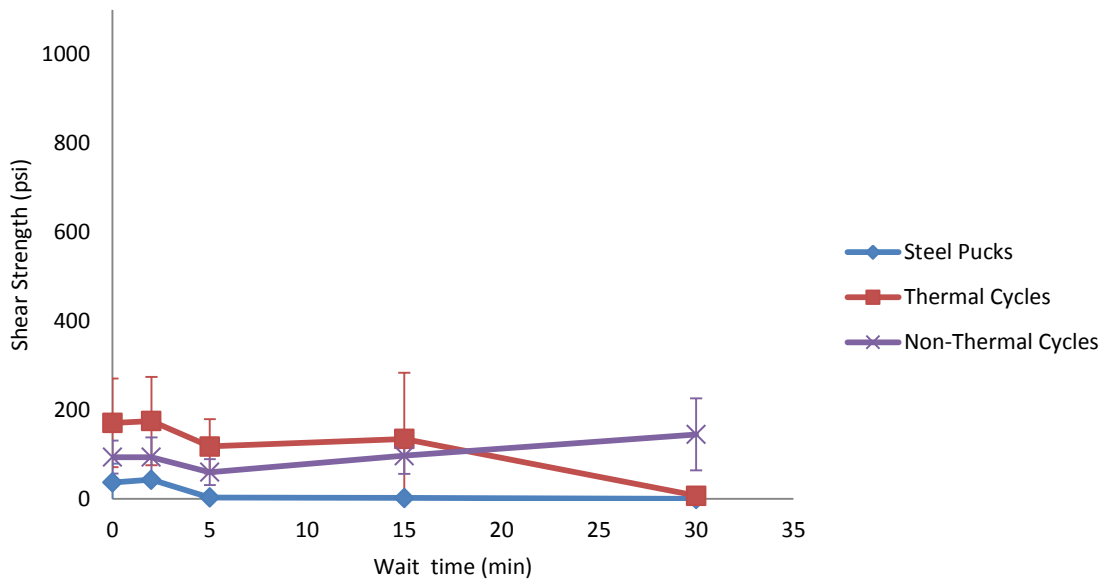
Figure 5.2 3-1 W/ C Grout Shear Strength

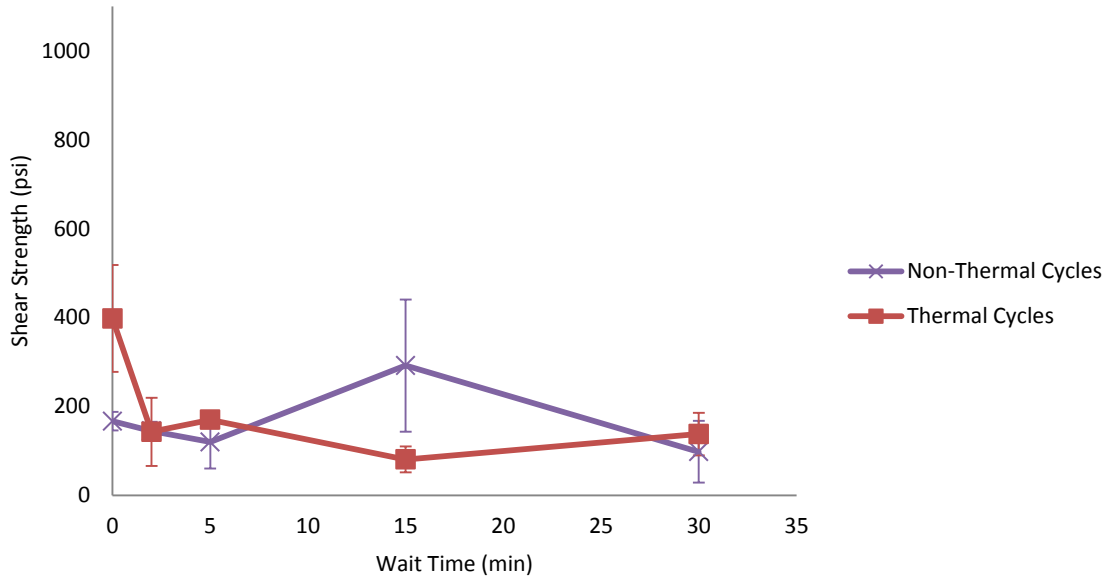
Figure 5.3 0.5 W/C Grout Shear Strength

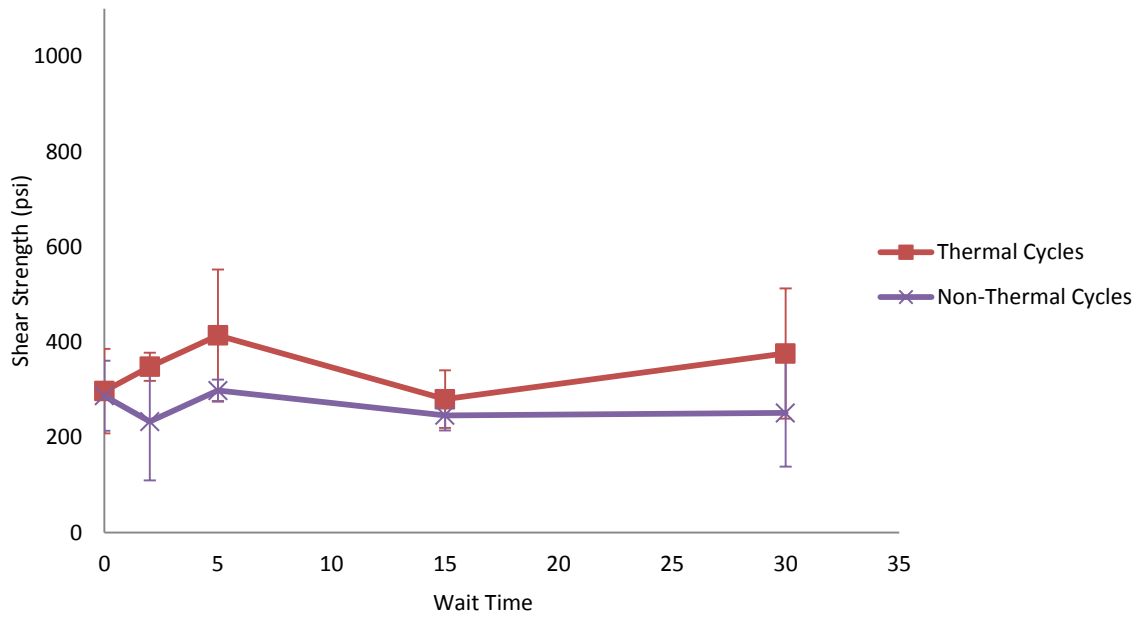
Figure 5.4 0.3 W/C Grout Shear Strength

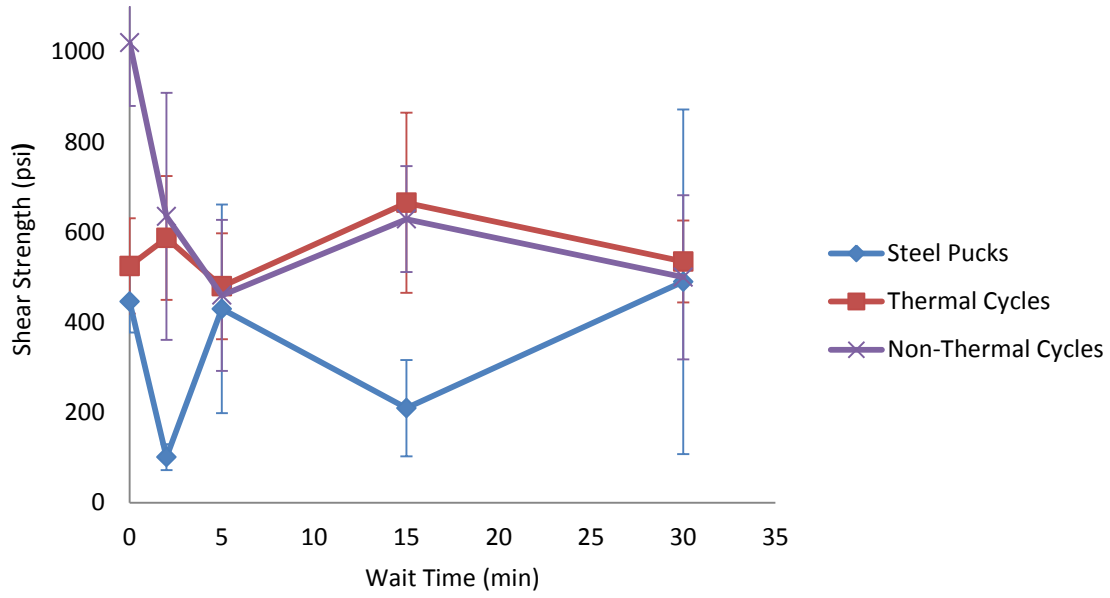
Figure 5.5 Epoxy Agent Shear Strength

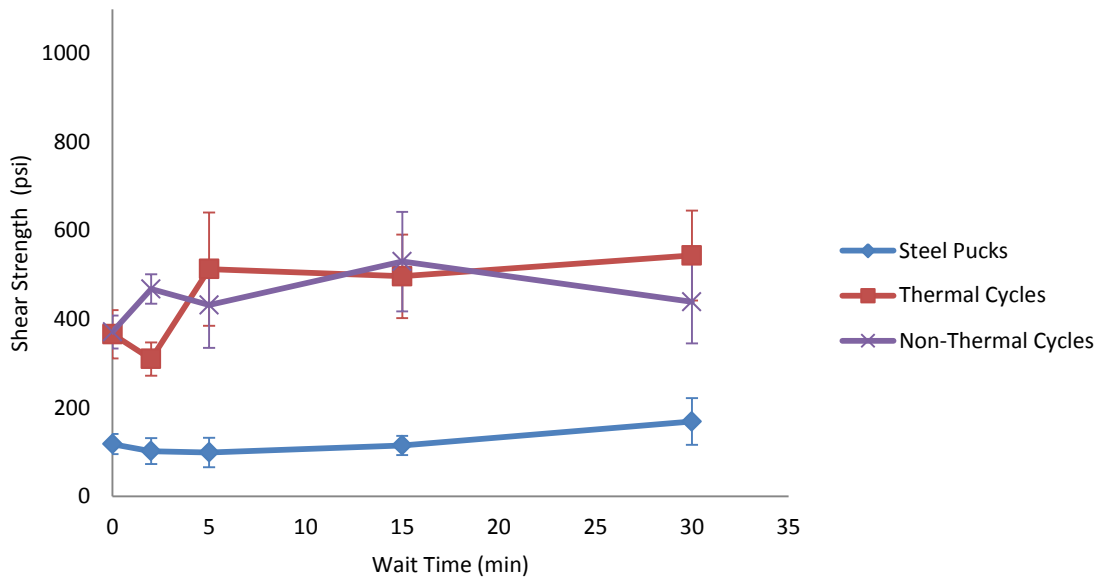
Figure 5.6 PVA Agent Shear Stress

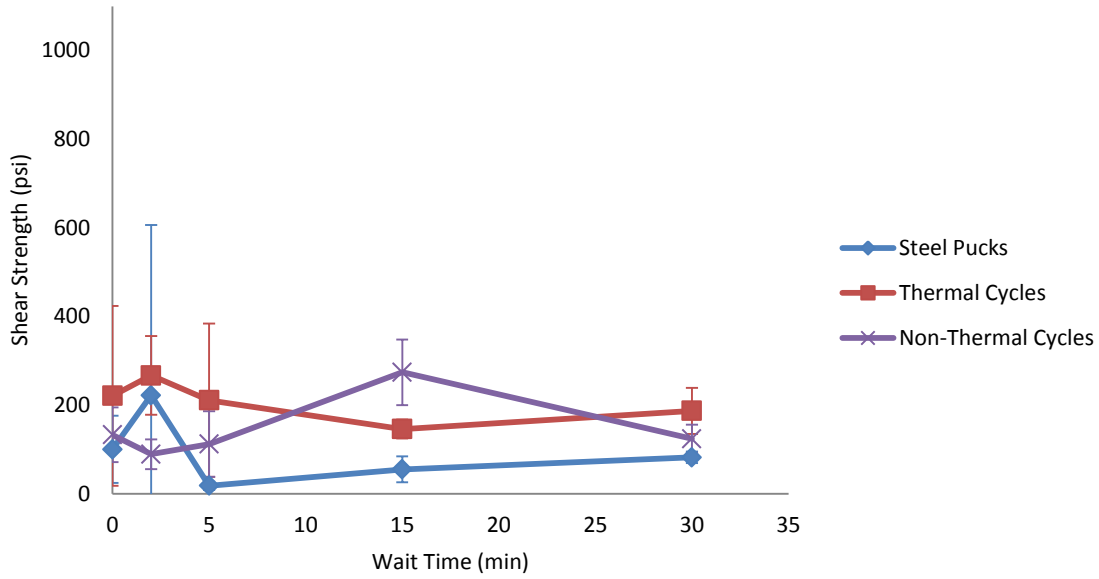
Figure 5.7 Acrylic Agent Shear Stress

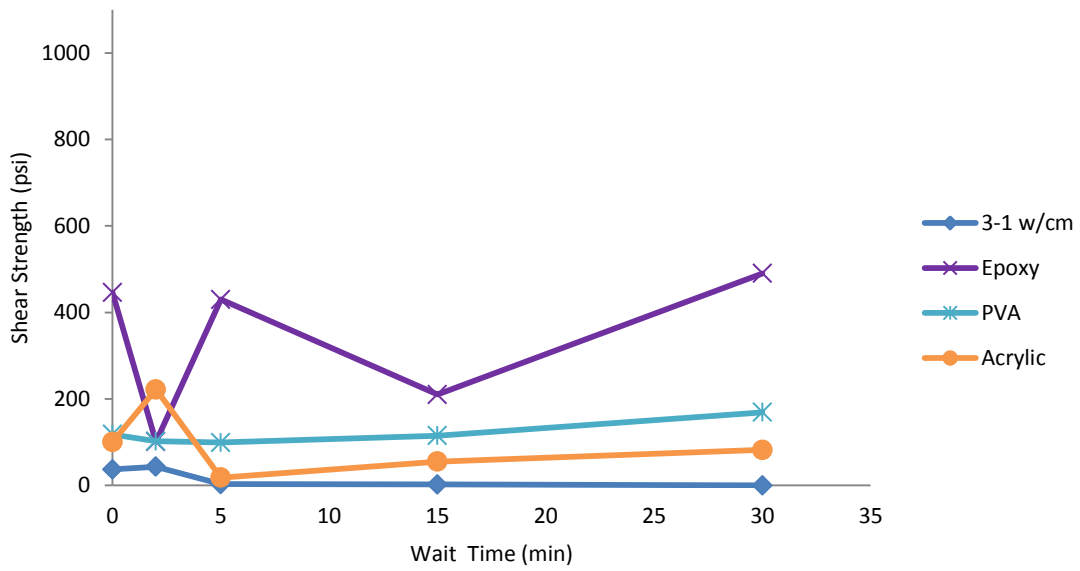
Figure 5.8 Steel Control Samples Shear Strength Comparison

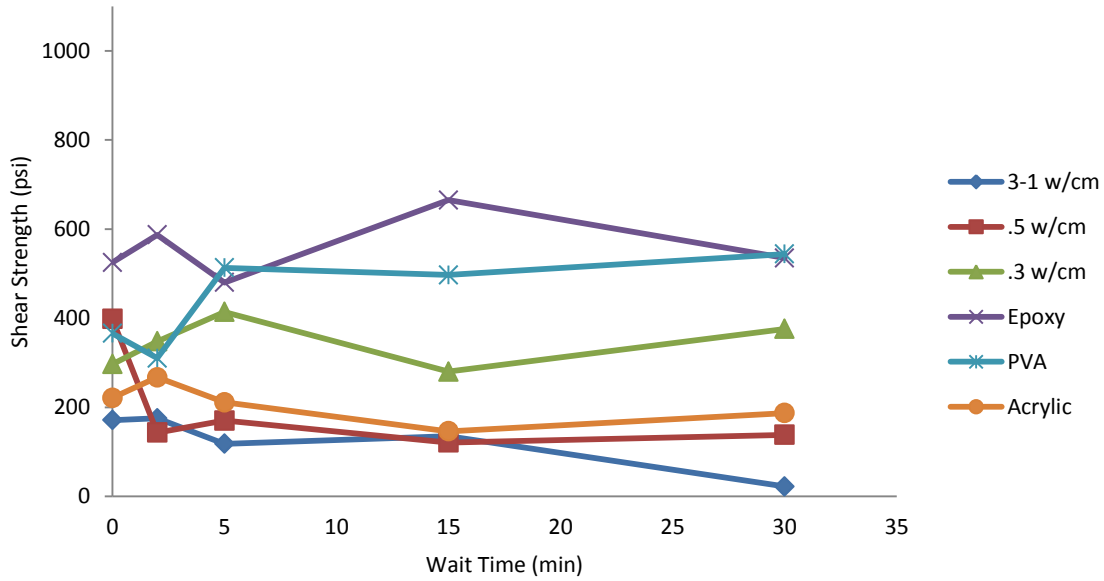
Figure 5.9 5 F-T Thermal Cycles Shear Strength Comparison

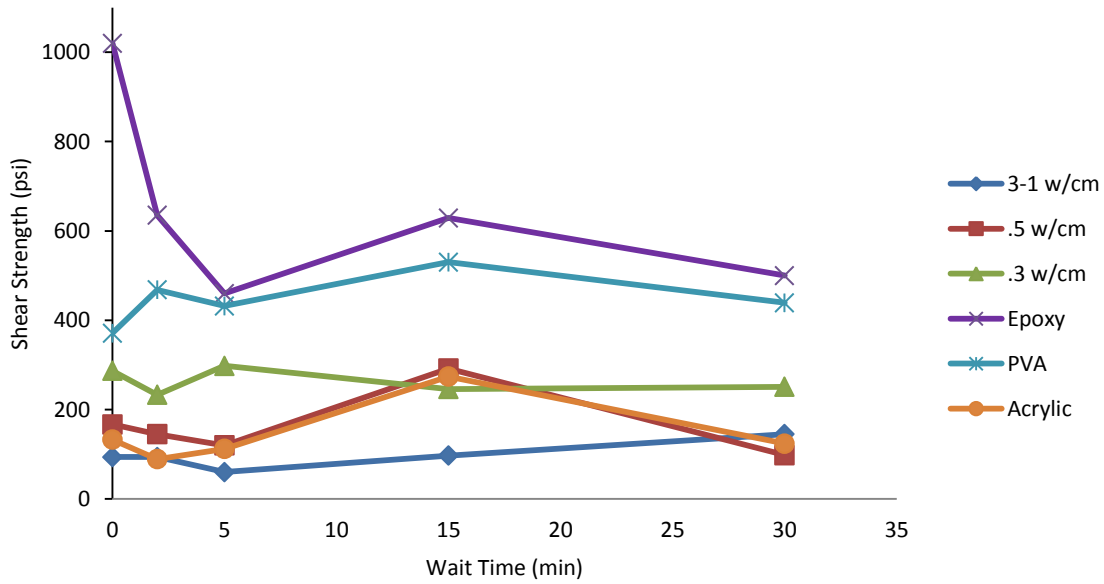
Figure 5.10 Non-Thermal Cycles Shear Strength Comparison

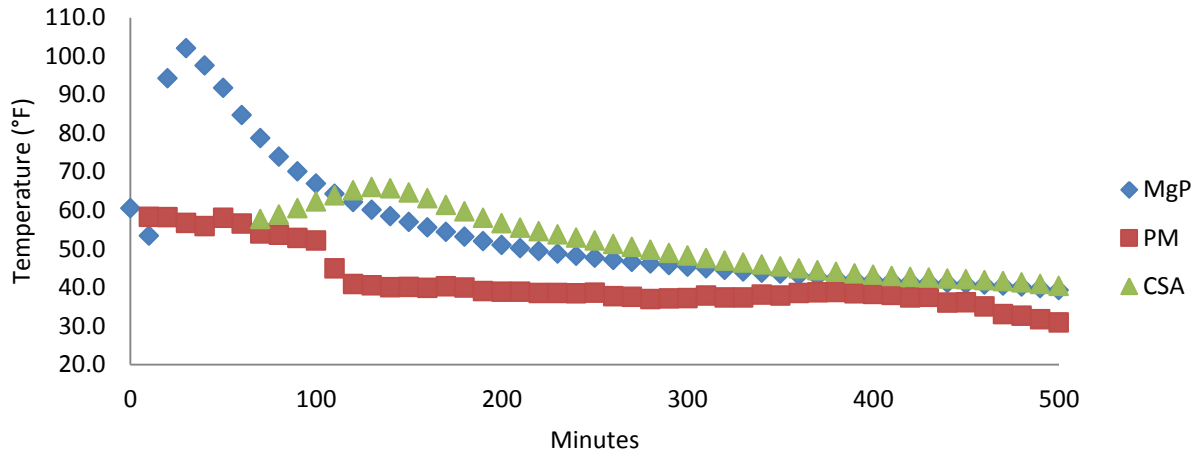
Figure 5.11 Rapid Repair Material Temperature after placement

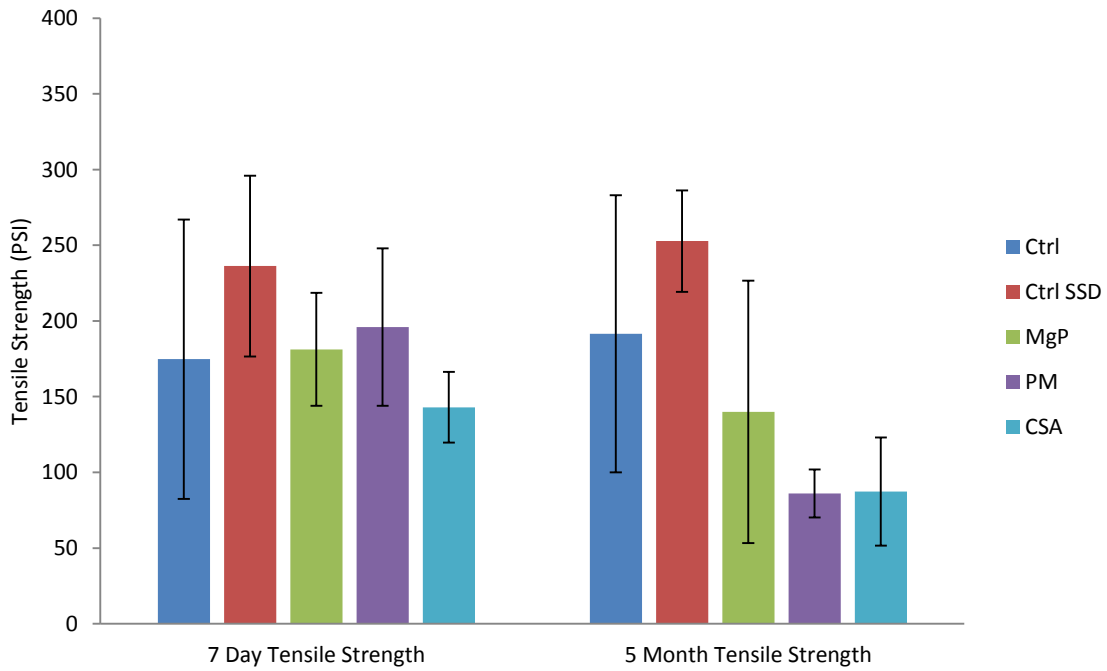
Figure 5.12 Repair Material 7 Day and 5 Month Tensile Strength

For the 7 day pull off test the three rapid repair materials had similar pull off strengths. Both the MgP and the PM had strengths over 180 psi, while the CSA cement strength was over 140 psi. When 5 month test were performed both the PM and CSA cement had strengths reduced below 100 psi and the MgP strength had reduced to 140 psi. As illustrated in *Figure 5.11* the rapid repair materials temperature after placement was low, possibly reducing strength development from *Table 5-3*. The materials were placed in late fall so the cool temperature from the environment during placement could have reduced the heat generation from the materials, thus having low strength gain with the materials. The CSA cement showed signs of surface cracks developing a day after placement as shown in *Figure 6-1*. The MgP cement had scaling visible on the surface after the 5 months of outdoor exposure. The scaling could be an indication of poor frost durability, and could have contributed to the large strength drop with time in the field.

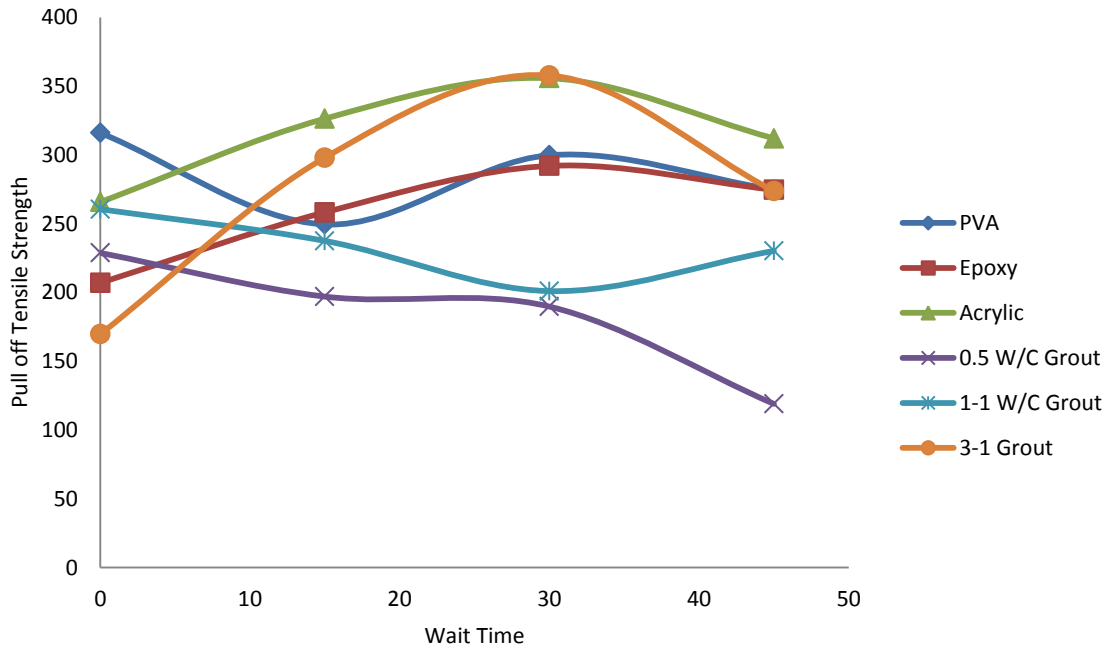
Figure 5.13 Bonding Agent 7 Day Tensile Strength

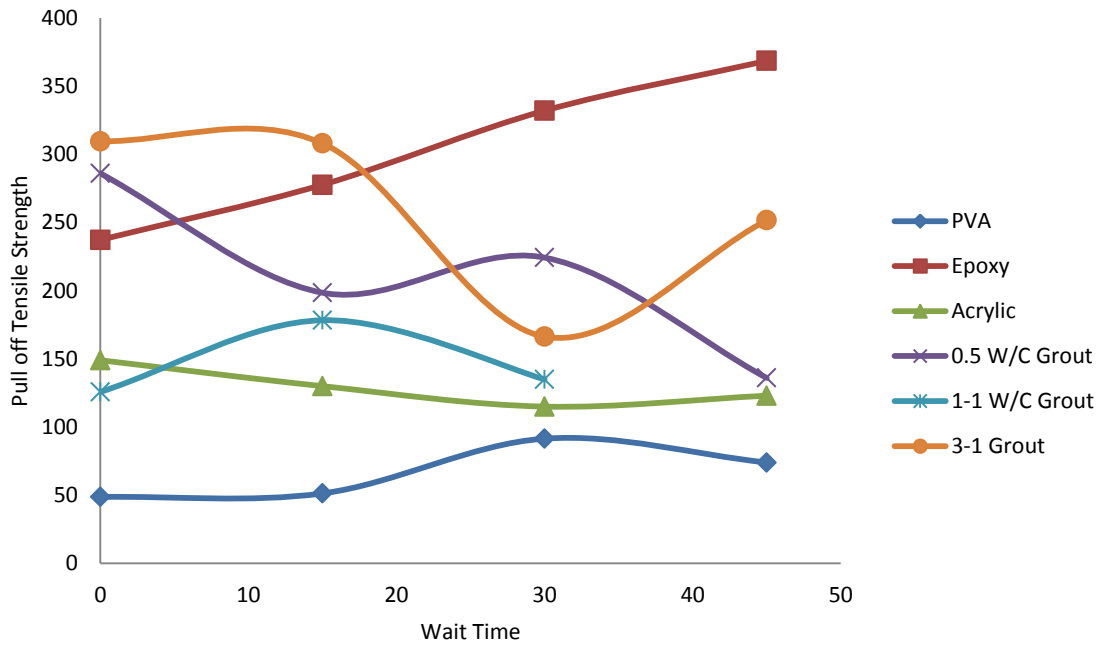
Figure 5.14 Bonding Agent 5 Month Tensile Strength
