EVALUATION OF BONDING AGENT APPLICATION ON CONCRETE PATCH
PERFORMANCE

A THESIS

Department of Civil Engineering

Kansas State University

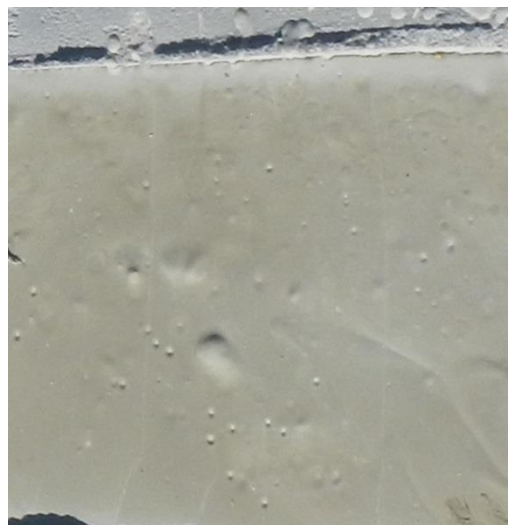
Figure 6.1 CSA Cement with Surface cracks

For the 7 day pull off test the three rapid repair materials had similar pull off strengths. Both the MgP and the PM had strengths over 180 psi, while the CSA cement strength was over 140 psi. When 5 month test were performed both the PM and CSA cement had strengths reduced below 100 psi and the MgP strength had reduced to 140 psi. As illustrated in *Figure 5.11* the rapid repair materials temperature after placement was low, possibly reducing strength development from *Table 5-3*. The materials were placed in late fall so the cool temperature from the environment during placement could have reduced the heat generation from the materials, thus having low strength gain with the materials. The CSA cement showed signs of surface cracks developing a day after placement as shown in *Figure 6-1*. The MgP cement had scaling visible on the surface after the 5 months of outdoor exposure. The scaling could be an indication of poor frost durability, and could have contributed to the large strength drop with time in the field.
