RADIO CONTROLS FOR GATED  
PIPE IRRIGATION SYSTEMS

A MASTER'S THESIS

Department of Agricultural Engineering

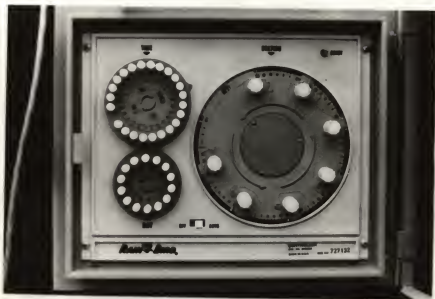
Figure 3. Front View of Controllers Showing Timers.

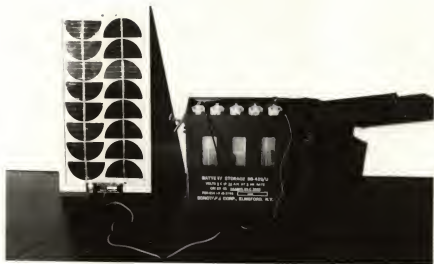
Figure 4. Ni-Cad Battery Used to Power the Receiver and Servos and Solar Panel for Re-charging the Battery.

A 4.8 volt DC, 500 mA Ni-Cad battery was supplied with the radio control equipment to power the receiver and servo. The battery could run the receiver and servo only 16 or 10 hours depending on whether one or two servos were used. A larger battery was found that could power the equipment for more than a week. The battery was a Ni-Cad storage battery with a rating of 14 AH and was manufactured by the Sonotone Corp. of Elmsford, New York. (Figure 4).

615-D manufactured by the Solarex Corp., Rockville, Maryland, and rated at 6 volt DC and 300 mA output, were selected (Figure 4). Calculations showed that a solar panel would have sufficient capacity to run the equipment in the daylight and recharge what was used during the night.

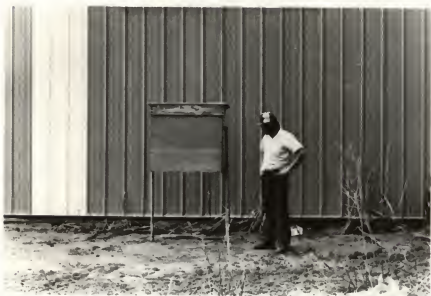
Figure 7. Plywood Box Housing the Controllers and Transmitters.

Transmitters and controllers were mounted in a plywood box installed on two pipes driven into the ground on the south side of the building (Figure 7). The controllers were mounted to the back of the box and the transmitters were mounted one on each side of the box and one in the middle. The transmitters were mounted upside down so their antennas, which were longer than the box, would extend through the bottom. This arrangement reduced the chance of moisture entering the box and damaging the electronic equipment. Theoretically the antennas should have been located one wavelength apart (4 meters) to lessen interference between signals from the different transmitters. The actual distance between transmitters was 1.5 feet but tests showed that, although there was interference, it was not enough to hinder the signals being sent to the receivers. The power supply for the transmitters sat on top of one of the controllers (Figure 8).

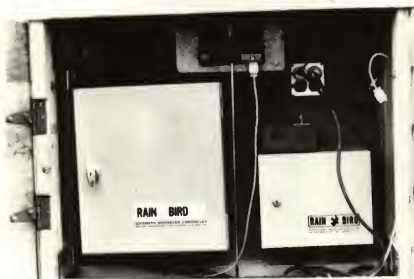
Figure 8. Inside View of Plywood Box Showing the Controllers, Transmitters, Power Supply and Electrical Outlet.

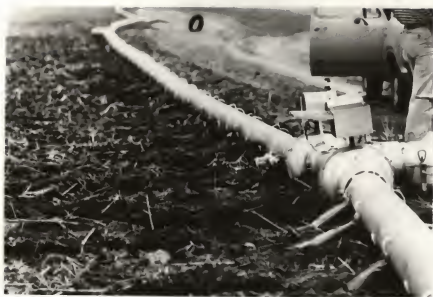
Figure 12. Segment of Gated Pipe Connected to a Flow Control Valve with Soks in Place.

Gated pipe was layed out starting on the south side of the field (Figure 10). Hydrants were placed on the risers with end tees and flow control valves connected to the hydrants (Figure 11). Short segments of gated pipe were connected to the flow control valves (Figure 12). Irrigation soks, to

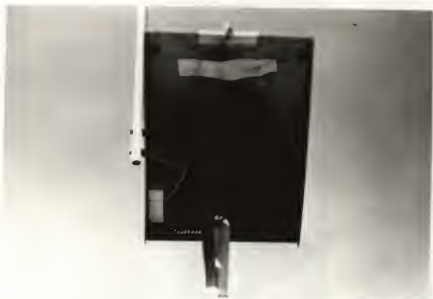
Figure 13. Receiver Mounted under Bracket Supporting the Solar Panel.

The receivers were mounted under a bracket on top of 10 foot long poles (Figure 13). This placed the receiver antenna high enough to receive the radio signals. The original wire receiver antennas were discarded and replaced with sturdy aluminum rods which were mounted to the side of the bracket. Solar panels were on top of the brackets, tilted at a  $20^{\circ}$ - $25^{\circ}$  angle, and faced south (Figure 14). The poles were placed beside the risers and held in place by sliding them inside a larger diameter 2 foot long pipe that had been driven into the ground. The solar panels were 8 feet above the ground and the top of the receiver antennas were 11 feet above the ground.

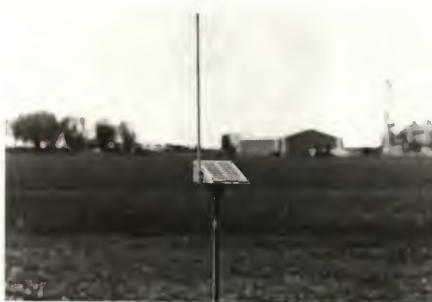
Figure 14. Solar Panel Mounted on a Bracket Supported by a Pole 8 Feet above Ground.

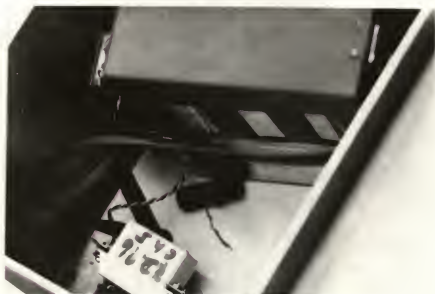
Figure 15. Inside of Flow Control Valve Box Showing the Servo and Ni-Cad Battery.

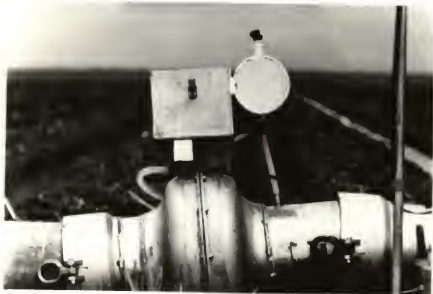
Figure 17. Three Way Slide Valve Mounted on a Flow Control Valve Located in the Field.

The 3-way valves which were mounted on the bottom side of the aluminum box were connected to the servos with a small wire rod (Figure 17). Connections to the pitot tube and diaphragm were through plastic hoses.

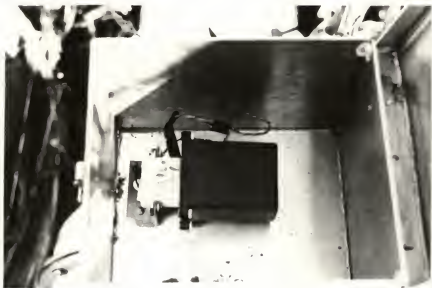
Figure 19. Modified Servo Mounted in Flow Control Valve Box.

board with a new circuit board designed and built in the Agricultural Engineering Department at Kansas State University. The new circuit board compared the incoming radio signal pulse with a standard pulse and directed the motor to turn the servo arm one way or the other. The 1500 ohm control that told the position of the servo arm to the circuit board was modified so that only the ends of the control were usable. The ends corresponded to the two extreme positions of the servo arm. As the servo arm moved to one end of its rotation, it came in contact with the 1500 ohm control end and feedback to the circuit board shut the motor off to stop the arm.

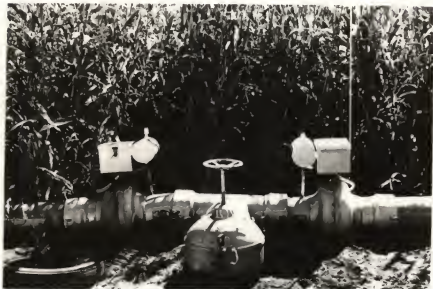
Figure 21. Hydrant and Flow Control Valves without a Solar Panel and Receiver Antenna Mounted on Flow Control Valve Box.

control valves to determine if the radio control system could operate with the antennas lowered and without solar panels. There was less damage to the servos when they were not connected to the solar panels. Without solar panels, the servos and receivers ran off large batteries which will require periodic recharging. Replacing the circuit board in the servos with low power electronic components increased the life of the battery between charges from 10 to 50 days and rebuilding the receiver with low power components could further increase the interval between charges.
