BAE 231 --- Pond Eutrophication  
Final Report

12/13/2017

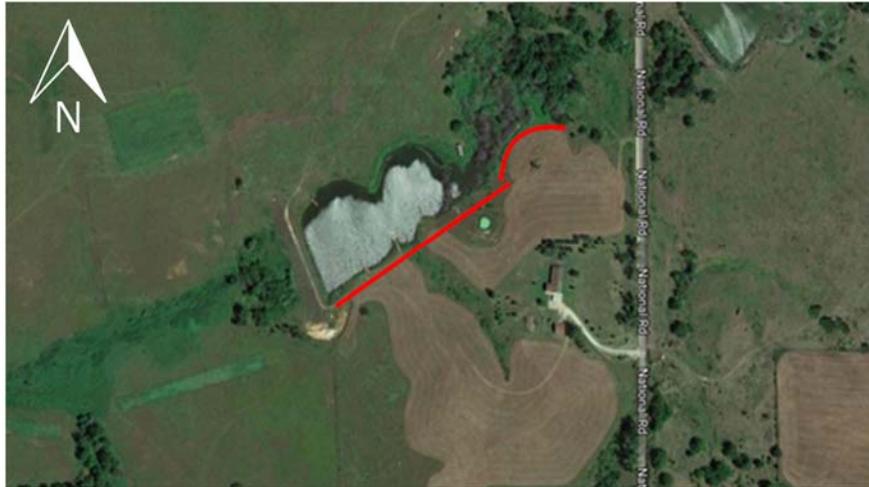
**Figure 1.** Map of Meyer's pond showing proposed site of buffer strip. (Adapted from Google, 2017)

To attempt to reduce the amount of unwanted nutrients that is washed into the Meyer's pond, it was determined that implementing a vegetative filter strip would be a viable solution to the problem. The design involves creating a strip of naturally growing native grass with a width of about 6-10 feet along the southern edge of the pond where it is assumed the excess nutrients are coming from. (Figure 1) Specific native grasses to implement are Big Bluestem, Little Bluestem, Yellow Indian, Switch, and Cord grasses. These grasses are both effective filters of nutrients as well as likely to flourish due to their native roots. As these grasses grow over a few years their roots will grow deeper and deeper into the soil, becoming more effective at filtering the water as time goes on. The implementation of this design is as simple as plowing the area clear of current vegetation, and planting a mixture of the native grasses. To maintain the buffer strip design, the grass would need to be grazed or burned every 2-3 years.

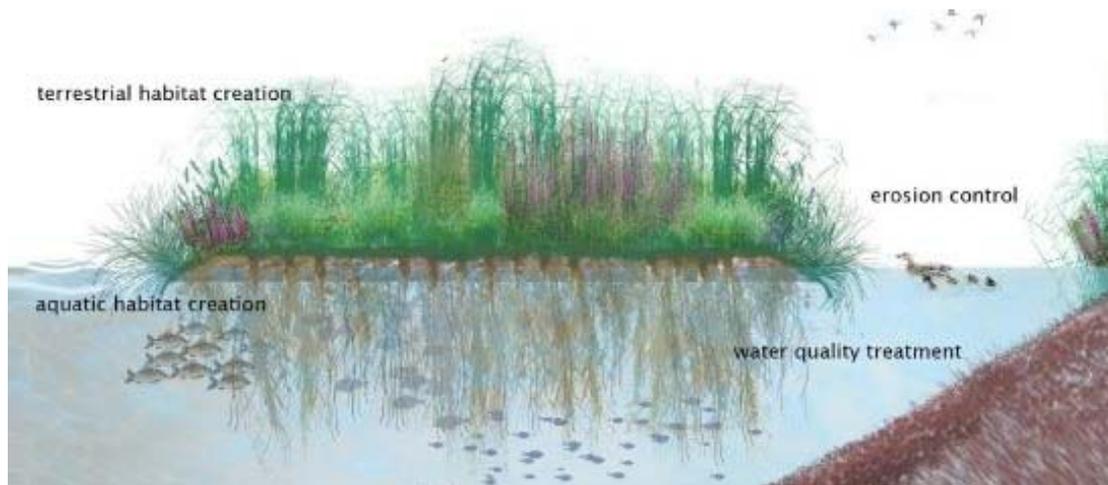
**Figure 4.** Floating garden system showing possible benefits (Midwest Floating Island, 2017).

Over time as the plants grow the excess nutrients in the pond water will be absorbed and utilized by the plant materials and thus recycled out of the water. The floating garden can be designed to be mobile, docked, or anchored within the pond. One of the bigger disadvantages with the floating garden design is that as the growing season comes to an end the garden must be removed from the pond and the decaying plant material must be discarded and the system must be replaced for the next use. The decaying plant material allows for the nutrients to be recycled into another system to replenish nutrients naturally in areas such as, a lawn, compost pile or exposed soil that may already need a fertilizer treatment. This is an advantage biologically for the system as it can take many years for the nutrients in the water to be recycled out of nutrient saturated systems into biological systems lacking nutrients. The floating garden also provides habitats for both aquatic and terrestrial life as shown in Figure 4. However, the maintenance and cost factors that result in having to replace the system each season, was a major drawback of the floating garden design. Before making the final decision to determine which solution to implement, a visit was scheduled with the Meyer's to survey the site of their pond, and to get a better sense of the problem.
