**Practical Application Study For Food Safety
Risk Mitigation In A Nut Processing Facility**

A THESIS

MASTER OF AGRIBUSINESS

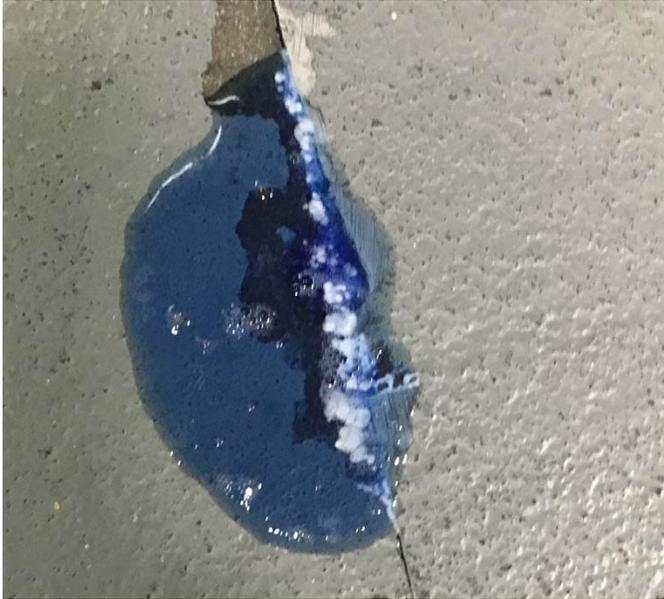
Figure 3.2: Indicon Gel Foam Dry Roast Floor Under Cup Elevator Photograph

the floor along the wall, the Indicon Gel turned white and foam, indicating the presence of a biofilm as demonstrated in Figure 3.2.

It is also recommended that the facility take measures outlined to address the floor / wall junctions and cracks in the porous concrete. As indicated by both vector swabbing and Indicon Gel use, these areas have fostered the development of the biofilm. Because these areas are hard to clean and properly disinfect with traditional methods, changing the structure and design of these areas is recommended so that they may be properly sanitized and eliminate the harborage point of the biofilm.

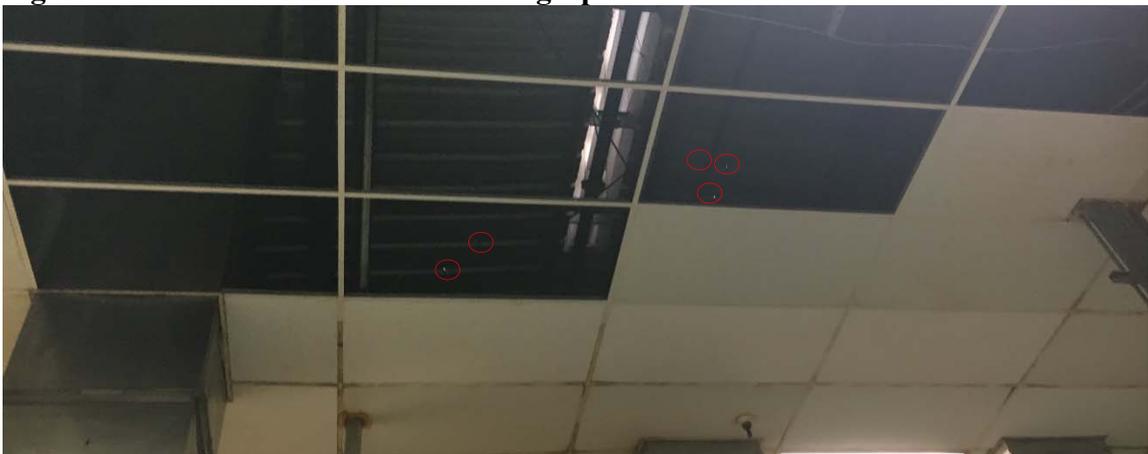
Figure 3.6: Roof Leak Evaluation Photograph

As part of the investigation, the Maintenance Supervisor and Food Safety and Quality Manager removed the drop ceiling tiles to evaluate how the rain was entering into the wall and the processing area. The tin roof was noted to have multiple areas where daylight could be seen, indicating that rain water could enter through the roof and run into the wall between the steam room and dry roast area as noted in Figure 3.6. Evidence of water damage and tracks were observed where rain water was seeping into the wall in question.

Based on the empirical evidence of the presumptive positive swab analyses, visual evidence of the roof disrepair, the exploratory evidence that the rain may carry *Listeria*, and

extensive literature supporting that *Listeria* is known to thrive in cool damp environments (American Bakers Association; et al n.d.), P₃ was accepted.

Based on the investigations and analyses, several recommendations can be made as to how the facility should mitigate the risk until the new facility is built. The first recommendation is that ADM Golden Peanut and Tree Nuts work with the landlord to address the roof leaks since the proposition of rain leaking into the wall has been identified as the probable true root cause of the problem. Eliminating the rain from entering into the wall will eliminate the environment inside the wall that has become conducive to a robust *Listeria* population.

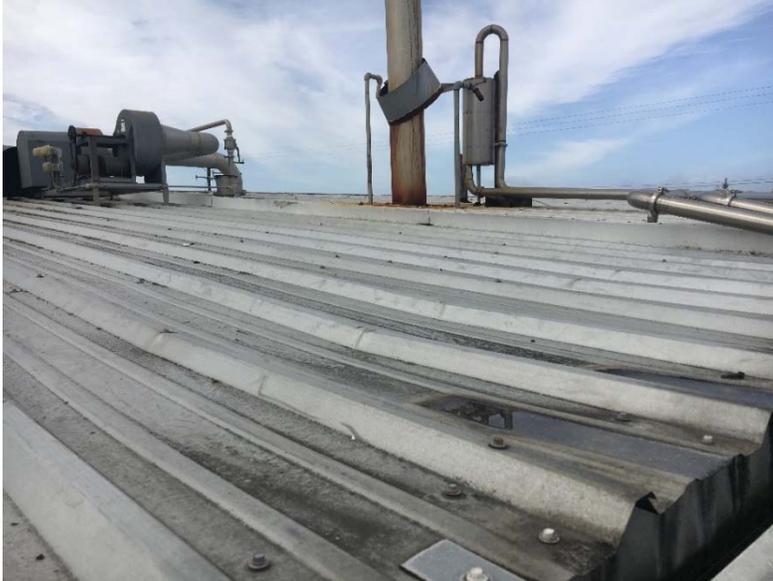
Figure 4.2: Roof Structural Deficiencies and Damages Photograph

Golden Peanut and Tree Nuts rented a boom lift to evaluate the roof damage on April 7, 2018. Structural deficiencies, damages, and pooling water were noted along the edge where the roof extended over the wall that separates the steam room from the dry roast area as depicted in Figure 4.2.

Currently, the landlords are refusing to address the request to repair or replace the roof, as stipulated in the Leasing Agreement section 7.2 (Lease Agreement 2010). Roof inspections found that there are multiple holes, damages, and deficiencies that are beyond the tenant's ability to repair under the current Lease Agreement. The roof allowing rain water to seep into the wall is the true root cause of the problem, as yielded by the exploratory evidence and source proposition investigation performed.
