EVALUATION OF ISO 11785 LOW-FREQUENCY RADIO IDENTIFICATION DEVICES
AND THE CHARACTERIZATION OF ELECTROMAGNETIC INTERFERENCE IN
PRACTICAL CATTLE MANAGEMENT SCENARIOS

A THESIS

Department of Animal Science and Industry
College of Agriculture

KANSAS STATE UNIVERSITY
Manhattan, Kansas

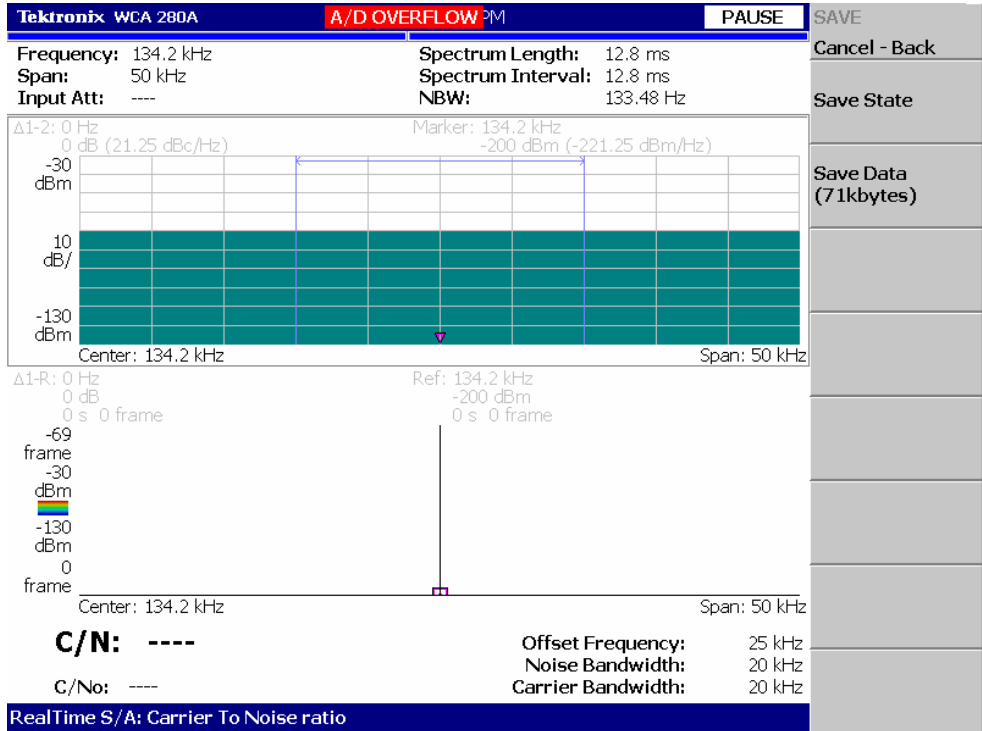
Figure 5.9 Holton Livestock Exchange, Inc., Note TV monitor – SA antenna within 0.15 m caused trigger.

Figure 5.9 Holton Livestock Exchange, Inc., Note TV monitor – SA antenna within 0.15 m caused trigger.....	106
Figure 5.10 J.C. Livestock Sales Company, Free run at unload/load, unusual peaks	109
Figure 5.11 J.C. Livestock Sales Company, -70dBm trigger setting – No triggers received	110
Figure 5.12 Pratt Livestock Inc., Triggers observed, each greater than -70 dBm, at the sale ring exit. 26 total triggers were observed in a 3 hour period.....	118
Figure 5.13 Great Bend Feeding, Inc., Free run observation of processing area, antenna ~2.4 m from hydraulic chute	123
Figure 5.14 Great Bend Feeding, Inc., Free run observation of fluorescent light inside medicine cabinet.....	124
Figure 5.15 Great Bend Feeding, Inc., SA antenna in foreground with hydraulic cattle chute in background.....	125
Figure 5.16 Knight Feed Yard, Free run observation of computer monitor and “Black Box” in south processing area	127
