## **Application of Rosgen's BANCS model for NE Kansas and the development of predictive streambank erosion curves**

Christopher K. Sass, Tim D. Keane

**Citation:** Sass, C. K., & Keane, T. D. (2012). Application of Rosgen's BANCS model for NE Kansas and the development of predictive streambank erosion curves. *Journal of the American Water Resources Association*, 48(4), 774-787.

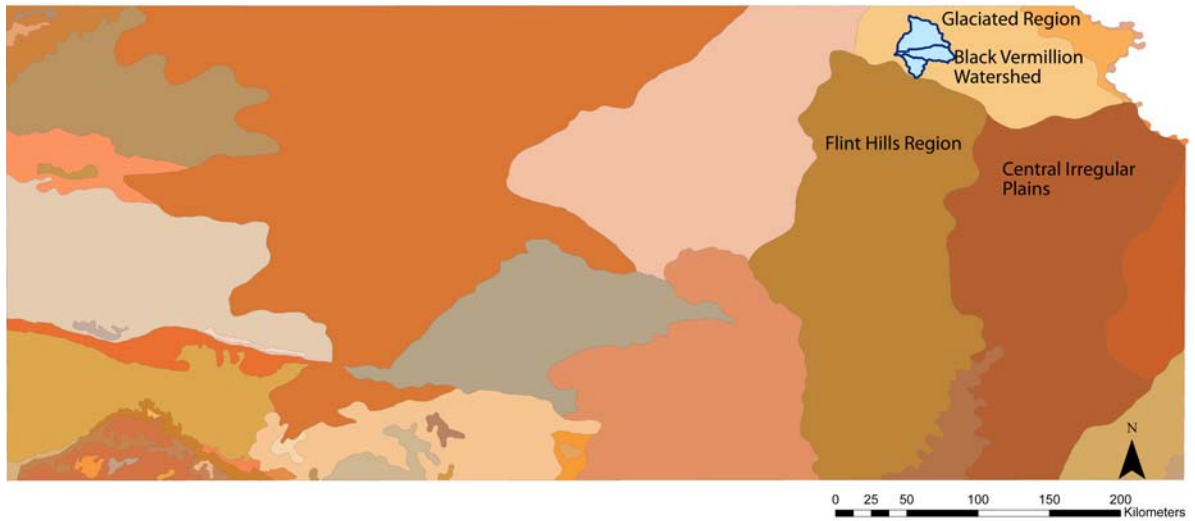
**Figure 1. Black Vermillion watershed located in NE Kansas between the Flint Hills and Glaciated Plains Region.**

The Black Vermillion watershed (1062km<sup>2</sup>) is located in Northeastern Kansas, specifically Marshall County, Kansas, and Nemaha County, Kansas (Figure 1). The Black Vermillion river flows westward to the Big Blue River and ultimately empties into Tuttle Creek Reservoir, a multi-use reservoir maintained by the United States Army Corps of Engineers (US-COE), northeast of Manhattan, Kansas. Tuttle Creek Reservoir is approximately 49.4km<sup>2</sup> in size and swells to 214.8km<sup>2</sup> during full flood capacity (US-COE, 2011). The Black Vermillion watershed lies in the glaciated region of Kansas, northeast of the Flint Hills Ecoregion. Three sub-watersheds from the Black Vermillion watershed were selected for study: Irish Creek, Black Vermillion Main Stem, and North Fork (Figure 2). These sub-watersheds were selected due to varied land uses and conservation practices, varied temporal and structural channel modification, and varied riparian corridor management. Each sub-watershed included three study reaches, for a total of nine study reaches (Figure 2). For each study reach, two study banks (eighteen total) were monumented, profiled (2007) and re-profiled through 2010.

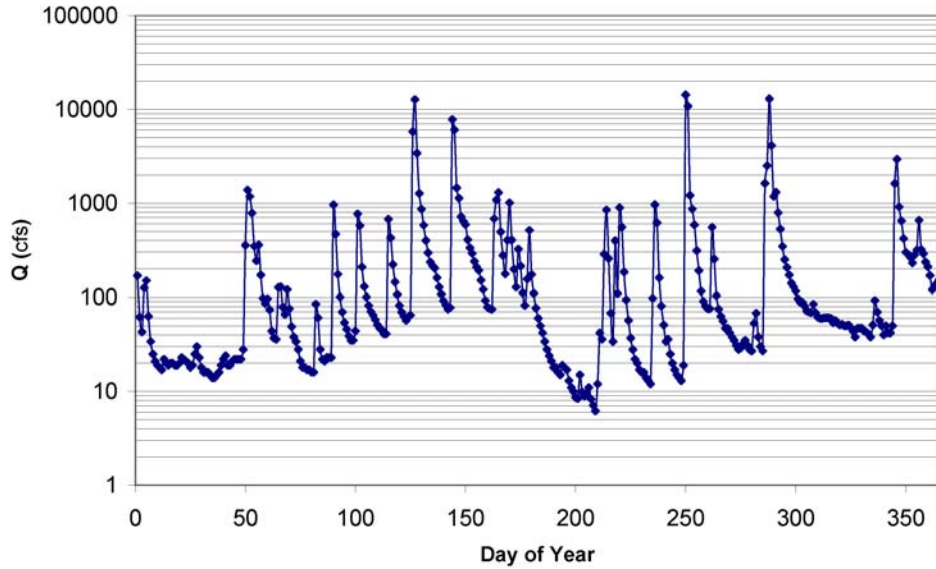
Figure 3. Daily peak max flow data for 2007 (USGS gage # 06885500). The 1.5-yr recurrence interval discharge is approximately 4900cfs. January begins at 0.

Hydrographs in Northeast Kansas are considered flashy, as discharge rises higher, faster, and recedes more quickly than prior to Euro-American settlement. Flashiness is attributed to channelization of the streams themselves along with increased impervious and semi-impervious surfaces conveying more runoff directly to the stream. Figures 3 through 6 illustrate stream flow rates in cfs during the study years. In 2007, the wettest year of the study, three peaks over 10,000cfs occurred and were spread out. In 2008, an average year regarding precipitation totals, peak runoff never exceeded nor reached the 1.5-year recurrence interval of 4900cfs. In 2010, the driest year, the 1.5-year recurrence interval was exceeded during the month of June, as expected due to the excess rainfall for the month.

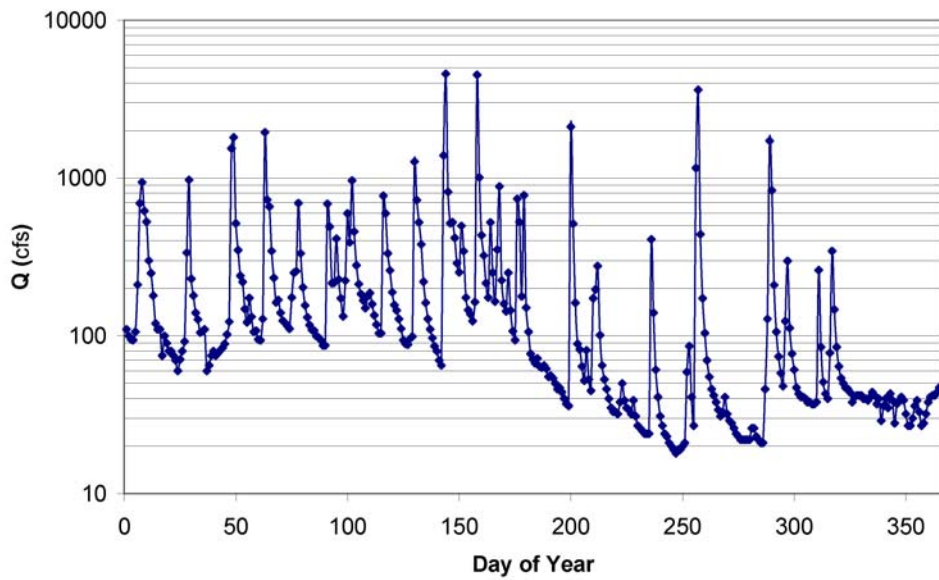
Figure 4. Daily peak max flow data for 2008 (USGS gage # 06885500).

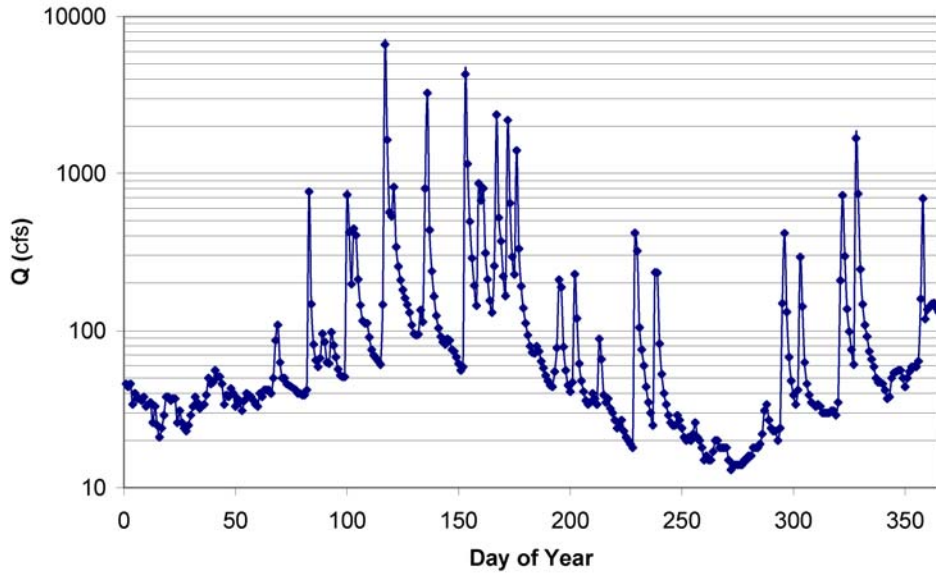
Figure 5. Daily peak max flow data for 2009 (USGS gage # 06885500).

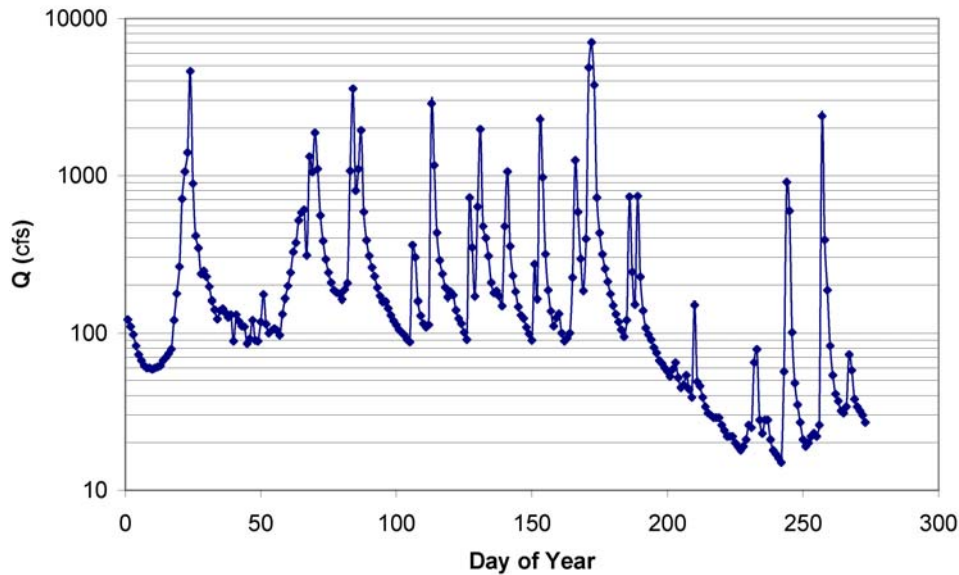
Figure 6. Daily peak max flow data for 2010 (USGS gage # 06885500).

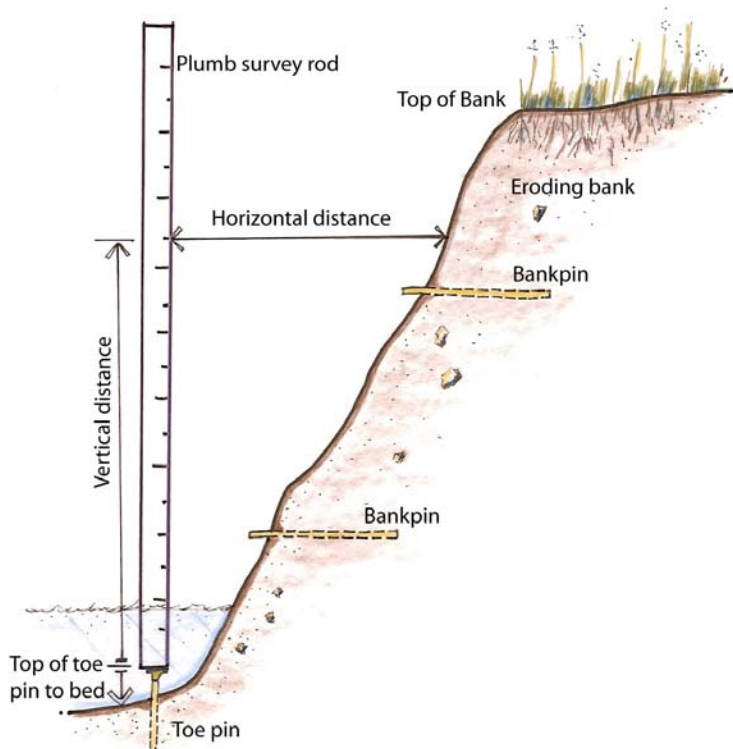
**Figure 7. Bank profile example and measures. Toe pin is used as a control point at the bottom of the bank; vertical and horizontal distances are taken from toe pin to face of bank (authors).**

Streambank profiles were completed on an annual basis over a four-year period, 2007-2010, to assess erosion rates (Figure 7). Bank profiles were completed from the end of May through the end of July and then re-profiled approximately one year later (2007-2010). Bank pins were utilized as a measurement check and additional control points regarding erosion rates. Assessments of BEHI and NBS were completed during the initial bank profile, summer 2007. Table 4 illustrates the results of bank assessments and erosion rates calculated from area change of bank profiles from pool cross-section banks and study banks. The retreat (erosion) rate was calculated by dividing the cross-sectional area difference from each year by the height of the bank, which resulted in an average linear rate of erosion (example of bank difference from 2007 through 2009 can be seen in Figure 8). Bank measures were taken from the toe of the bank to the top of the low bank, which often is the top of the bank in entrenched channels. These banks ranged in height between 4.27m to 6.73m while expected bankfull stage was often less than 1.5m from the bottom of the channel at a riffle. Different portions of the bank may erode at a faster rate than other portions of the bank. However, the predictive capacity of the model should yield an average rate of bank retreat.

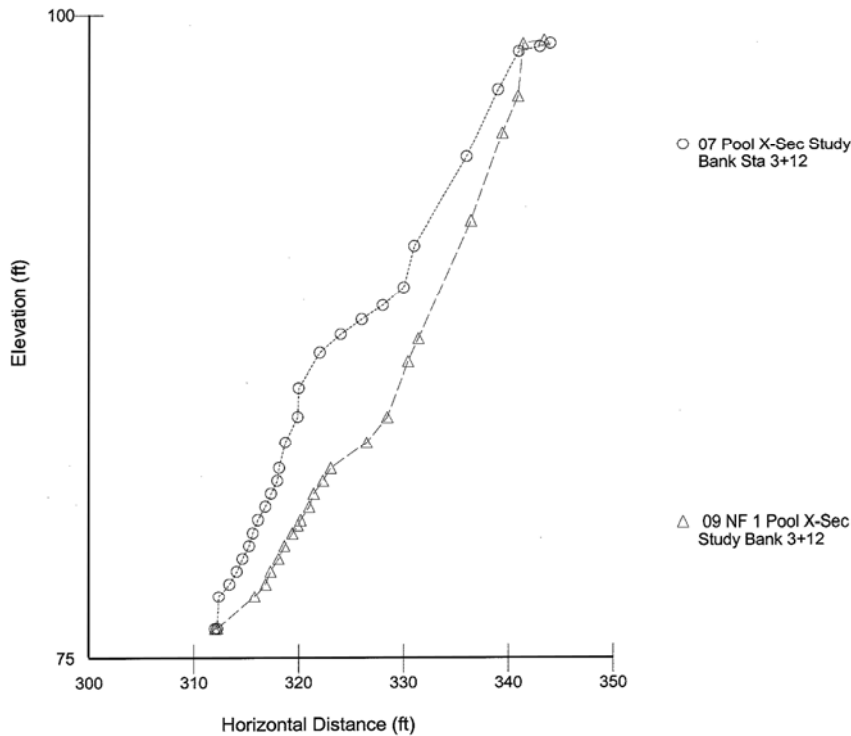
**Figure 8. Bank profile overlay example for erosion measures. This particular bank is located at North Fork reach 1 at the pool cross section.**

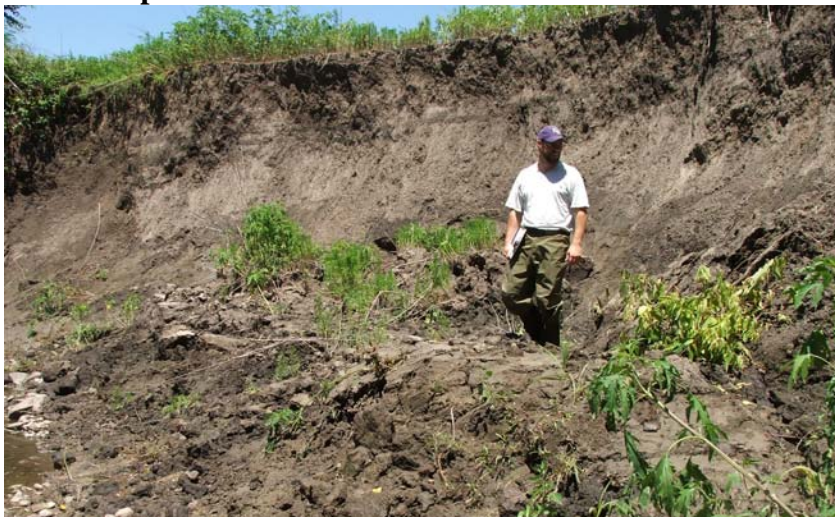
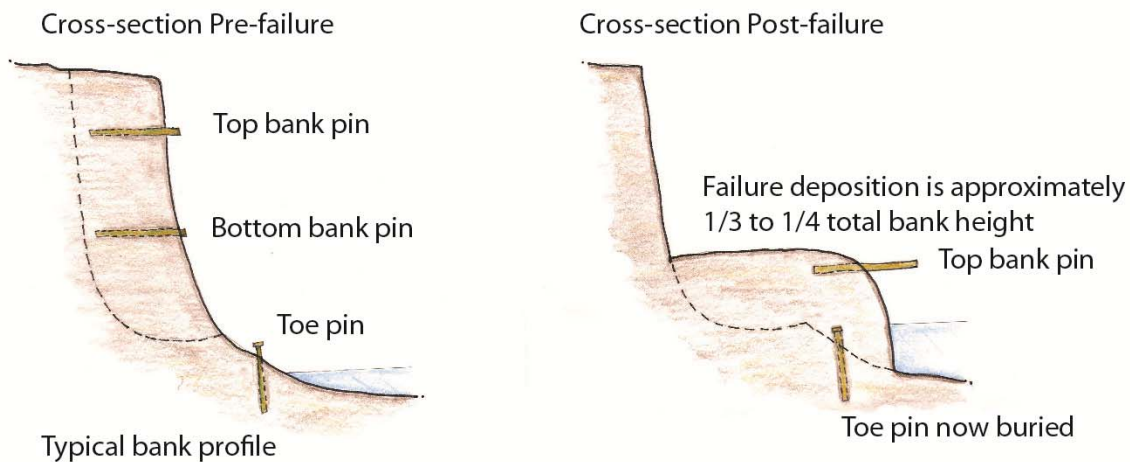
**Figure 9. Irish Creek 2 Study Bank example illustrating loss of bank pins and toe pin. Bank slumped and left approximately one-third of the bank height at the bank toe; thus only 0.91m of retreat was assumed. The accompanying drawing illustrates the assumption of how the bank failed.**

In addition, two study bank erosion rates for 2009-2010 were assumed, as each bank's toe pin and erosion pins were lost due to mass failure of that bank. At North Fork 3 study bank location, all three 1.22m bank pins were found downstream while no toe pin was found at the bank site; thus 1.22m of erosion was assumed. This site was located downstream of an outside bend of convergent stream channels creating high bank stresses. At the Irish Creek 2 study bank site, all bank pins were again lost. However, a bench of failed material covered the toe pin approximately one to 1.25m in depth, which was approximately one-third of the total bank height. Only 0.9m of erosion was assumed due to the subsequent deposition at the bank toe of failed bank material and estimated total toe pin area change (Figure 9). This site was located on the downstream side of a transverse bar creating higher bank stresses.

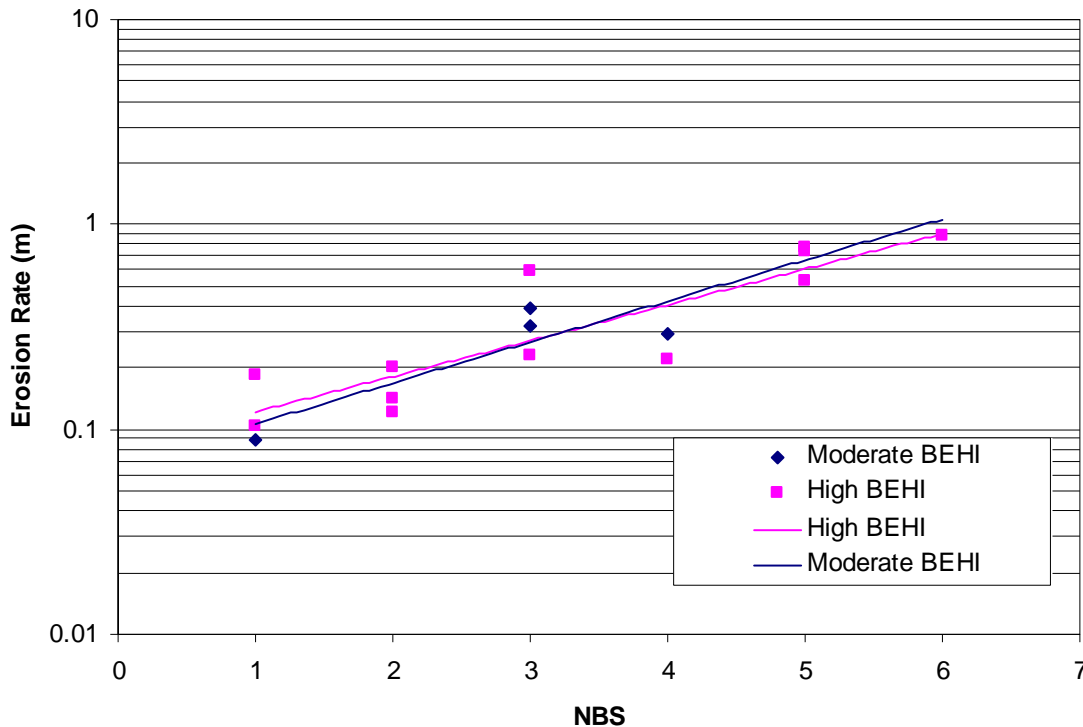
**Figure 10. BEHI - NBS erosion prediction curves developed using average erosion rates over four-year study period with Black Vermillion data in Northeast Kansas. Moderate BEHI (Blue)  $R^2$  0.75 (4 data points) while High BEHI (Magenta)  $R^2$  0.77 (12 data points).**

The BANCS model developed by Rosgen (1996, 2001, 2006, 2008a, 2008b) was used to synthesize BEHI, NBS and measured erosion rate data. Figure 10 illustrates the results of this synthesis where NBS is plotted along the X-axis, erosion rate is plotted along the Y-axis and each trend line is a BEHI rating. This study did not include very low, low or extreme BEHI ratings as conditions meriting those hazard ratings were not present in our

Figure 10 and Table 5 suggest some component(s) of the BANCS model as described by Rosgen (2001, 2006) may not fit our set of conditions in Northeast Kansas. Inconsistencies include the High/Very High BEHI rating curve trend line predicting lower erosion rates than the Moderate BEHI, while the opposite should be true. In addition, trend line slopes should not intersect, as they do at lower NBS ratings (approximately 2.5). Discrepancies such as these indicate an erosion variable or process may not be accounted for, or may be over or under represented, using the BEHI portion of the BANCS model in Northeast Kansas. Since NBS is an approximation of shear stresses, it should approximate similar stress conditions in all systems equally, thus it was not considered for modification in this study. BEHI, which is used as an assessment of bank erosion resistance, may require modification for differing erosional processes and controls in Northeast Kansas.

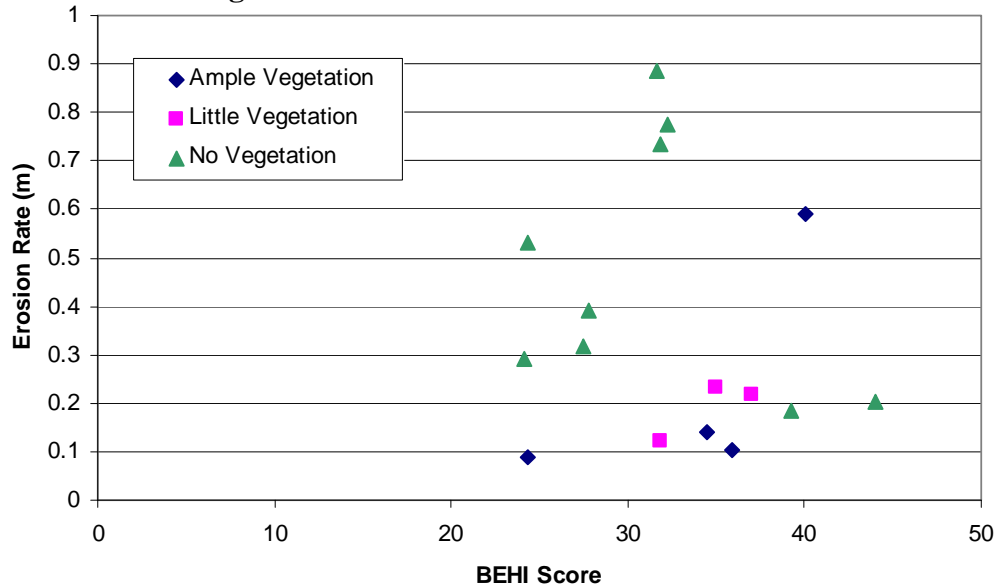
**Figure 12. Plot of BEHI scores versus Erosion rates with corresponding woody vegetation amounts. Plot illustrates low BEHI scores with high erosion rates on banks without vegetation.**

Figure 12 illustrates higher erosion rates occur where no vegetation exists. In contrast, where at least some vegetation exists erosion rates are much less. The BEHI model developed by Rosgen (2001, 2006) incorporates two vegetation components; however, looking at the BANCS model results, the BEHI model may not evaluate vegetation that coincides with conditions in the Northeast Kansas region. As expected, the NBS model developed by Rosgen (2001, 2006) does seem to work in this region. Banks having lower NBS ratings, regardless of the woody vegetation influence, produce lower erosion rates than banks with higher NBS ratings. In addition, banks with vegetation with the same NBS ratings erode approximately half the rate than banks without woody vegetation.

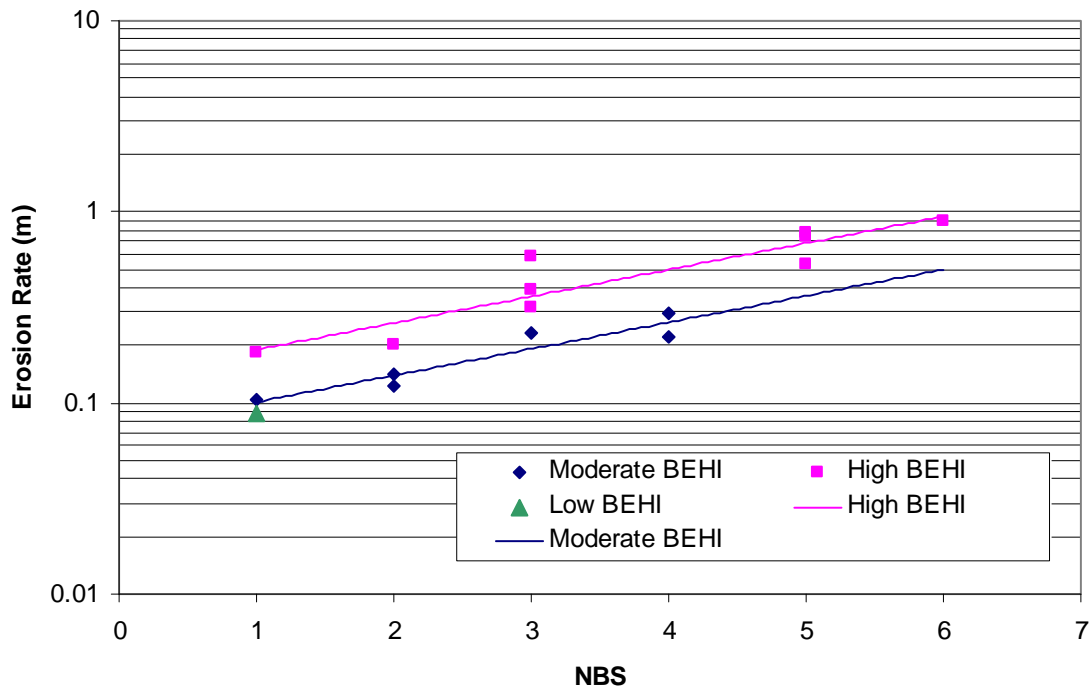
**Figure 13. Adjusted BEHI-NBS erosoin prediction curves for Northeast Kansas. Vegetation modification of 2.5 or 8.5 is included in this edition of curves. Moderate BEHI (Blue) R<sup>2</sup> 0.88 (6 data points) while High BEHI (Magenta) R<sup>2</sup> 0.84 (9 data points) Low (1 data point).**

Note: High BEHI slope :  $y=0.1378e^{0.3213x}$  ; Moderate BEHI slope :  $y=0.0736e^{0.3195x}$  .

As noted in Table 8, 13 of the 18 study banks changed BEHI ratings. Of those, 11 adjective ratings decreased while two increased in erosion hazard. Figure 13 illustrates the changes to the predictive erosion curves utilizing the new BEHI ratings according to vegetation adjacent to the streambank.
