A PRACTICAL APPLICATION OF THEORETICAL
SOIL MECHANICS TO EXPANSIVE SOILS

A MASTER'S THESIS

Department of Civil Engineering

The project developed from an initial request from the director of the Community Memorial Hospital in Marshall County at Marysville, Kansas, for an examination of distress in the internal walls and floors of the hospital. The purpose of this examination was to determine the cause and possible correction of the settlement and to especially evaluate the safety of the structure since its continued use was critical to the community.

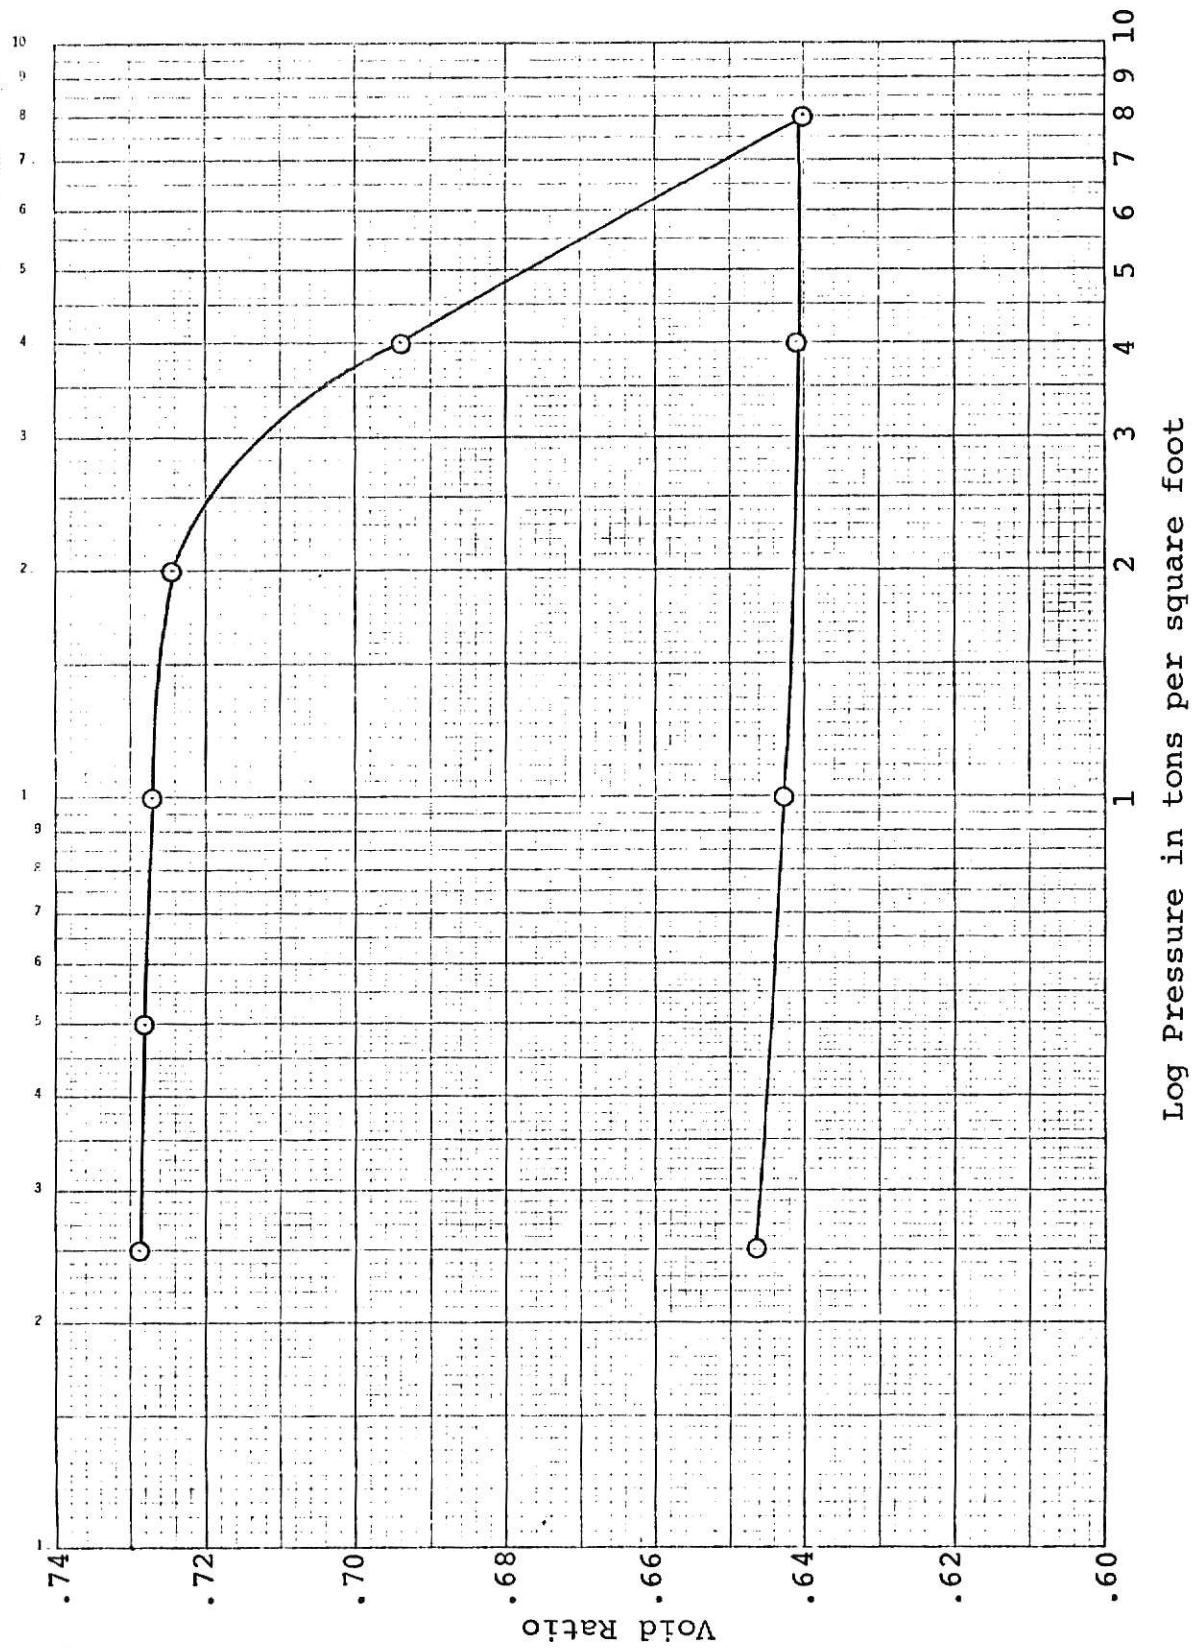
Figure 34. Compression characteristics of the soil outside the structure at a depth of five feet.

The two consolidation tests indicate a $C_c = 0$ for the pressure increment of 1/4 to 2 tsf and thus, settlement would be expected to be near zero. A study of the structure, except for the floor, indicates the validity of this computation.

The shear and compressibility tests confirmed that the causes of failure were not overstressing of the soil. The extreme dryness of the soil inside the structure indicated that the source of the settlement was shrinkage of an expansive soil. The gradation analysis of the soil indicated that an appreciable quantity of clay minerals was present. The liquid limit near 50 indicated a borderline case since most investigators have reported that soils having a liquid limit under 50 will not be found to be troublesome by shrinkage and swelling. The work of Willman, et. al. (19) indicated that the till in the western area should predominate in Montmorillonite, and it is well known that this mineral exhibits more volume change with changing moisture conditions than any of the clay minerals.

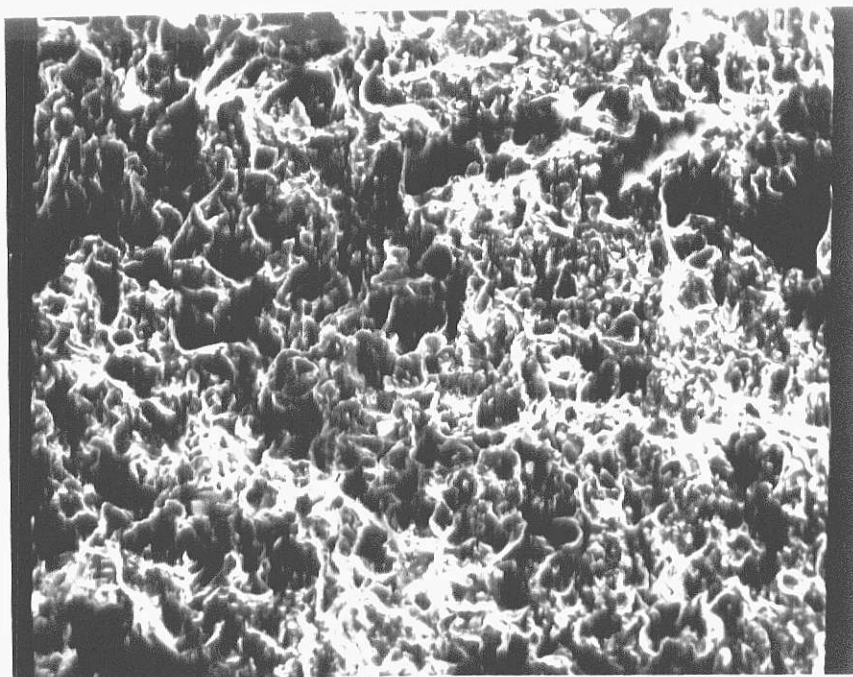
These photographs indicate that the clay particles are concentrated at the contact points of the larger grains. This position allows the clay to cause the greatest volumetric expansion per unit volume of clay.

The transmission of electrons, as shown by the white areas in the photographs, shows the position of the clay minerals. The strength of the transmission indicates that the clay plates are oriented in a parallel direction. The lack of a specific shape of the clay minerals grains at the

Fig. 53. Electron Microphotograph of Glacial Till X200

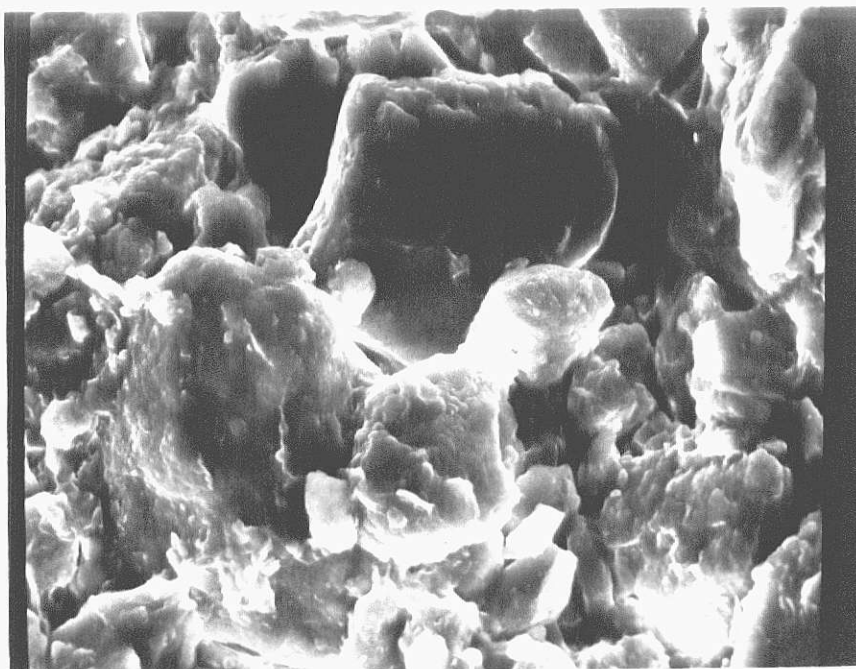
Fig. 54. Electron Microphotograph of Glacial Till X1000

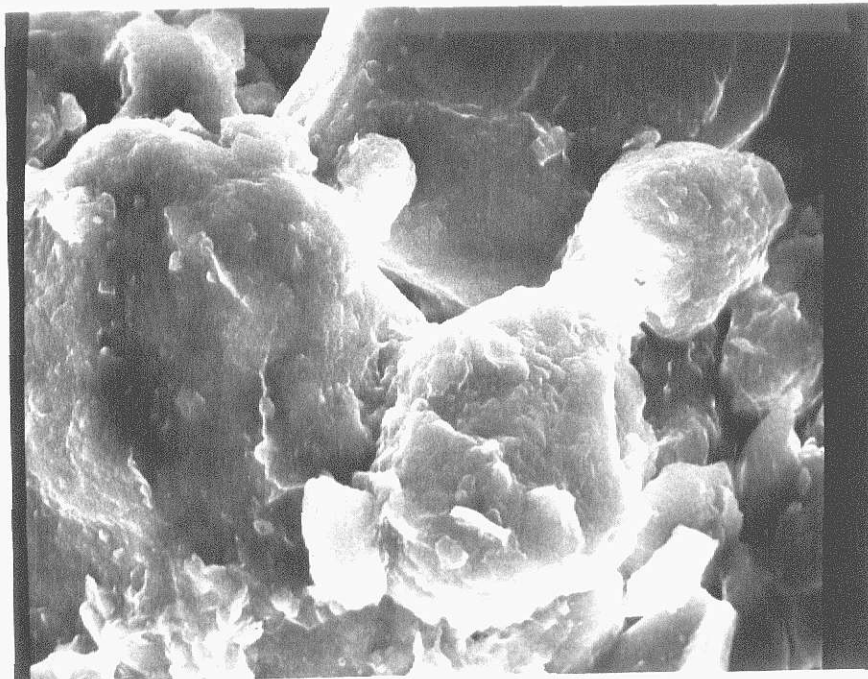
Fig. 55. Electron Microphotograph of Glacial Till X1600

higher magnifications confirm that these are Montmorillonite and Illite.

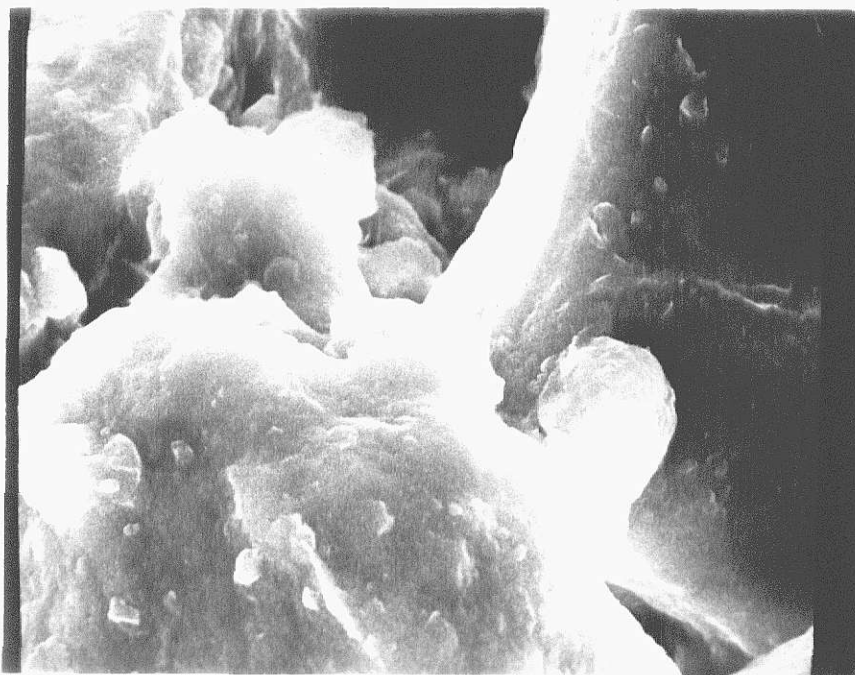
Fig. 56. Electron Microphotograph of Glacial Till X3000
