Field and Laboratory Characterization of Corrosion Potential in Highway Corrugated Metal Pipe

A THESIS

KANSAS STATE UNIVERSITY
Manhattan, Kansas

2018

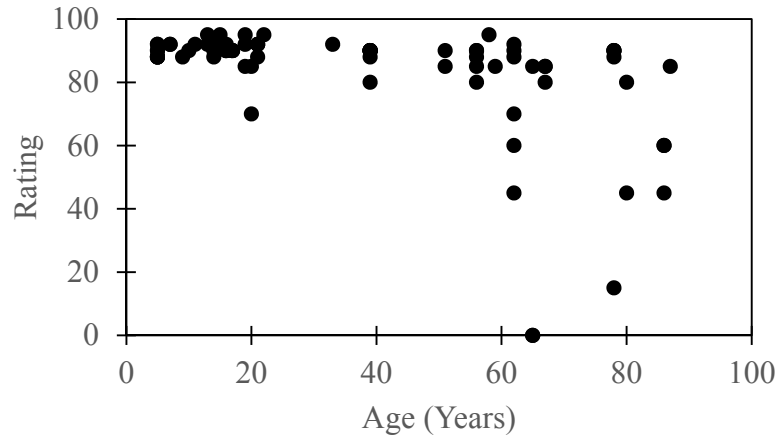
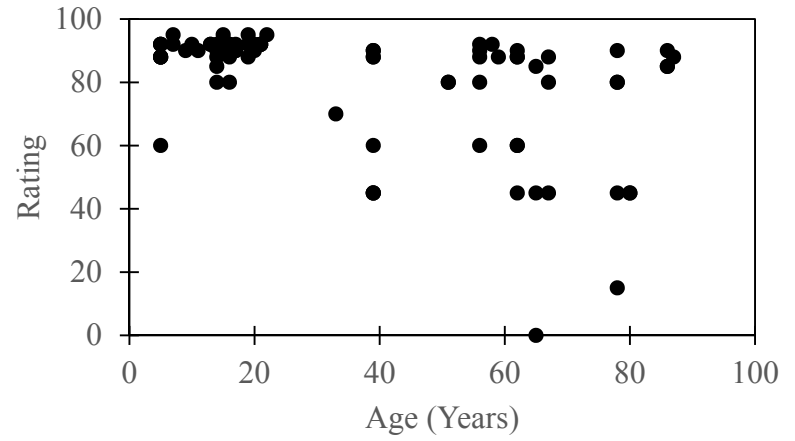
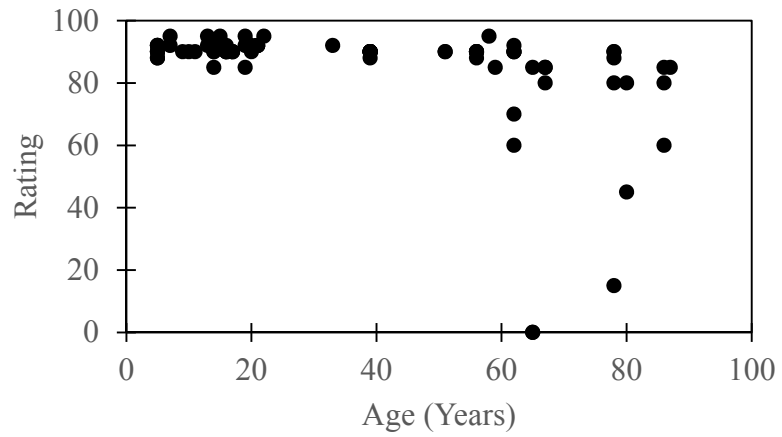
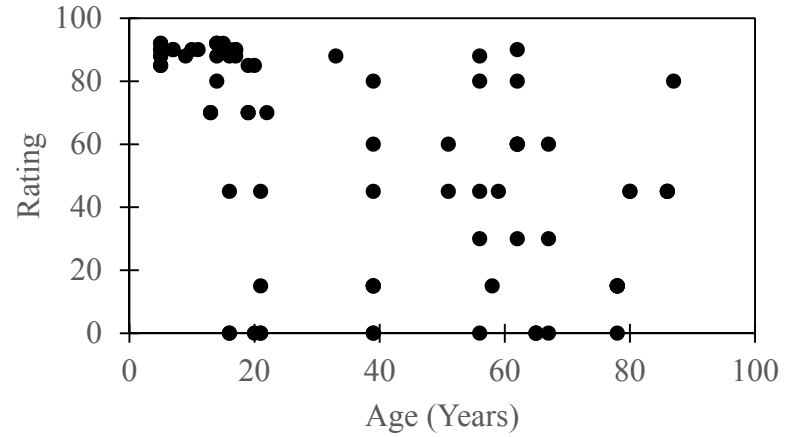
Figure 4-1: Observed Rating versus Age

A total of 80 CMPs were surveyed in KDOT districts one and four between 2016 and 2017, with the goal of creating an even spread of observational pipe data based on age. A numerical rating was assigned for the crown, side, invert and exterior for every surveyed pipe following the Stratton et al. (1990) methodology. Figure 4-1 shows the ratings of each surveyed pipe versus its estimated age. From this data, small trends are observed for the side crown and exterior ratings. Ratings for these pipe locations are relatively high, with the majority of ratings above 60. A trend of slight deterioration of rating with age was observed for side, crown and external ratings for pipes installed within the last 60 years. Pipes 60 years and older were observed having ratings that deteriorated rapidly with age. Invert observations varied widely with no trend observed for the invert rating based on the age of the pipe. This study's results suggest that while the side, crown, and exterior's condition decays based primarily on age, the invert's rating is not primarily dependent on age and must be influenced by other location dependent factors.

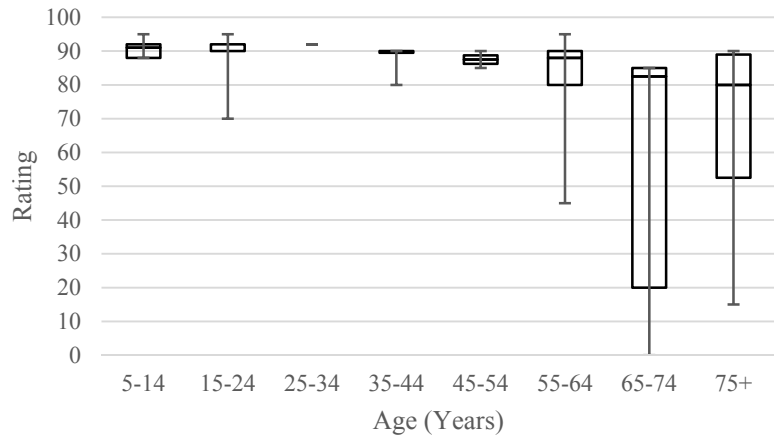
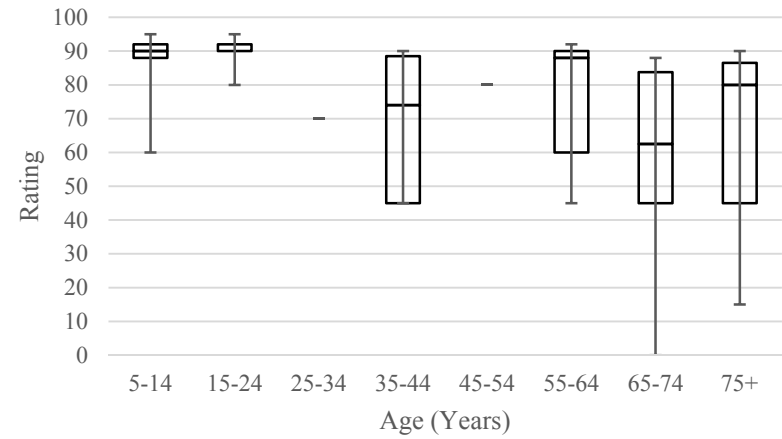
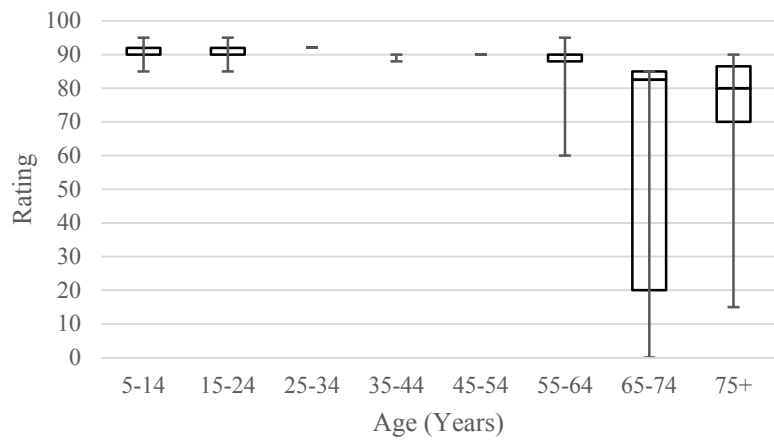
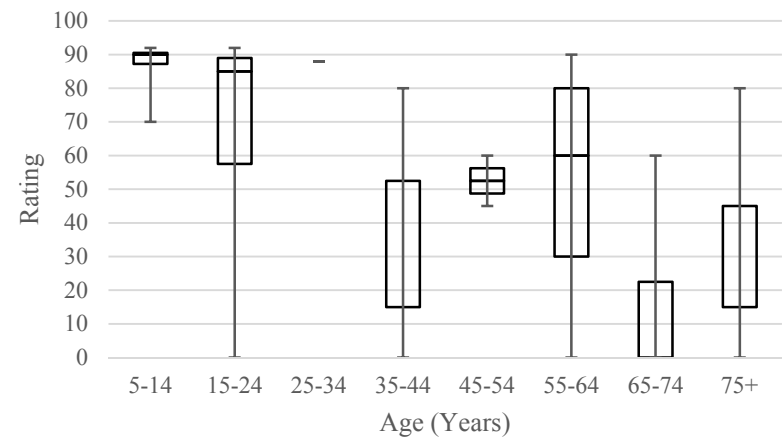
Figure 4-2: Box Plot of Rating versus Age Group

Box plots of the distribution of assigned numerical ratings versus year is presented for each of the four analyzed CMP locations in Figure 4-2. These boxplots show the likely range of variation outlined by the box, the median value as shown by the line inside the box, and maximum and minimum values from the data as the outer lines extending from the box. From the box plot, a trend of variability can be seen with age for side and crown ratings. This is to be expected since the crown and side areas may not be in constant contact with soil and/or water, but are continually exposed to air humidity, precipitation, and air contaminants. The external and invert ratings of CMPs showed considerably more variability in ratings.

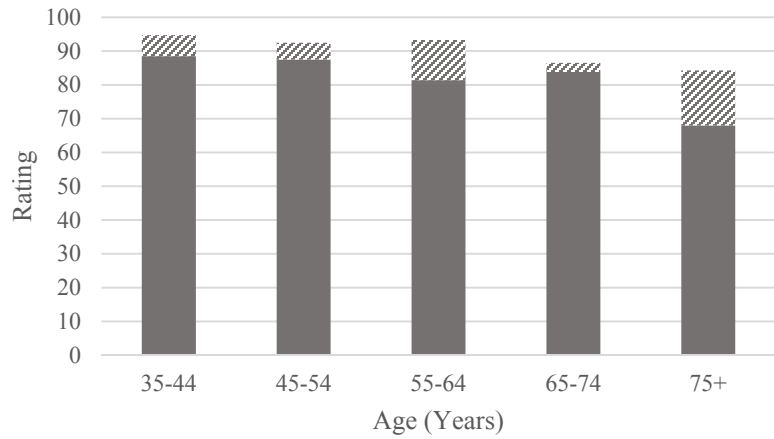
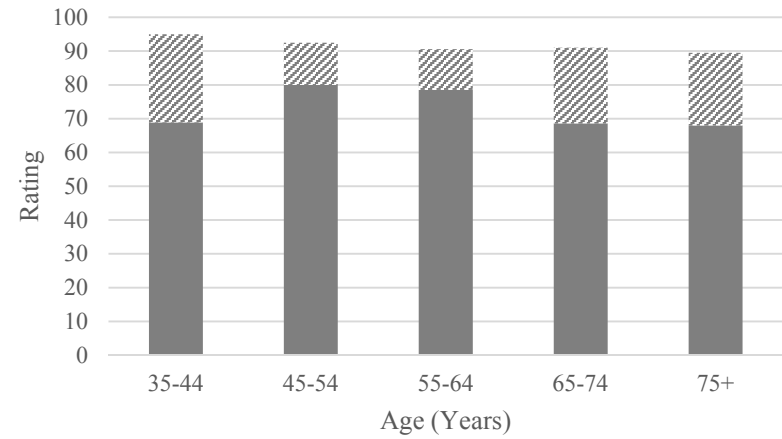
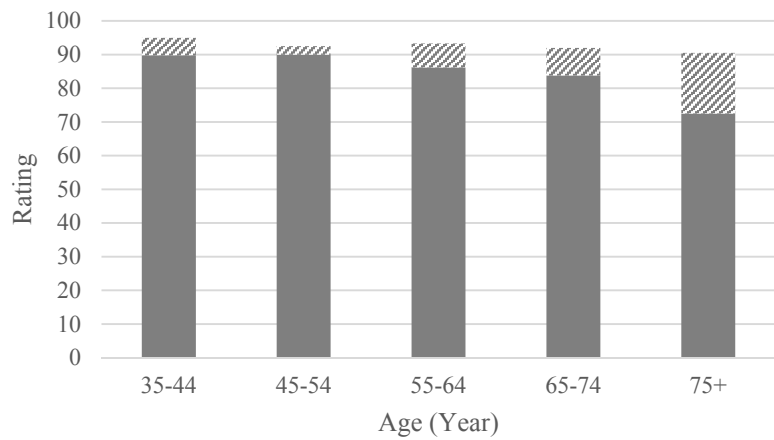
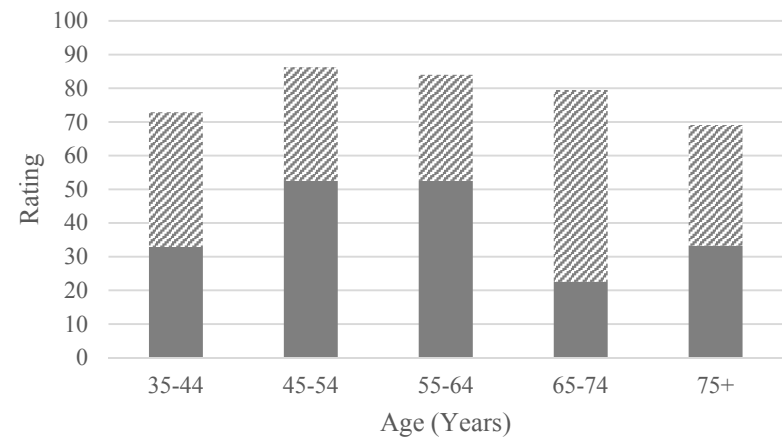
Figure 4-4: Observed Deterioration Since 1989

An effort was made to locate and rate CMPs that had been surveyed by Stratton et al. (1990) to observe the trends of deterioration. A comparison between the ratings of the Stratton et al. study and the ratings of the 2016 survey are shown in ten-year subsets in Figure 4-4. The average rating of the 2016 study (solid) was plotted against the average rating of the same age subset taken corresponding to the 1990 study (hatched). From this data, the invert appears to have degraded more than any other location on the CMPs since the previous study took place. It was determined that the CMP's overall performance and durability would be greatly controlled by the invert's susceptibility to corrode. It was also observed during this study that although the invert had displayed the most deterioration, the majority of CMP locations had been observed to be under dry conditions as shown in Figure 4-5. Because the majority of CMPs were not observed to be subjected to prolonged periods of contact with water, it suggests that other factors besides excessive contact to moisture played a key role in the rapid deterioration of the CMP's inverts compared to other areas of the CMP.

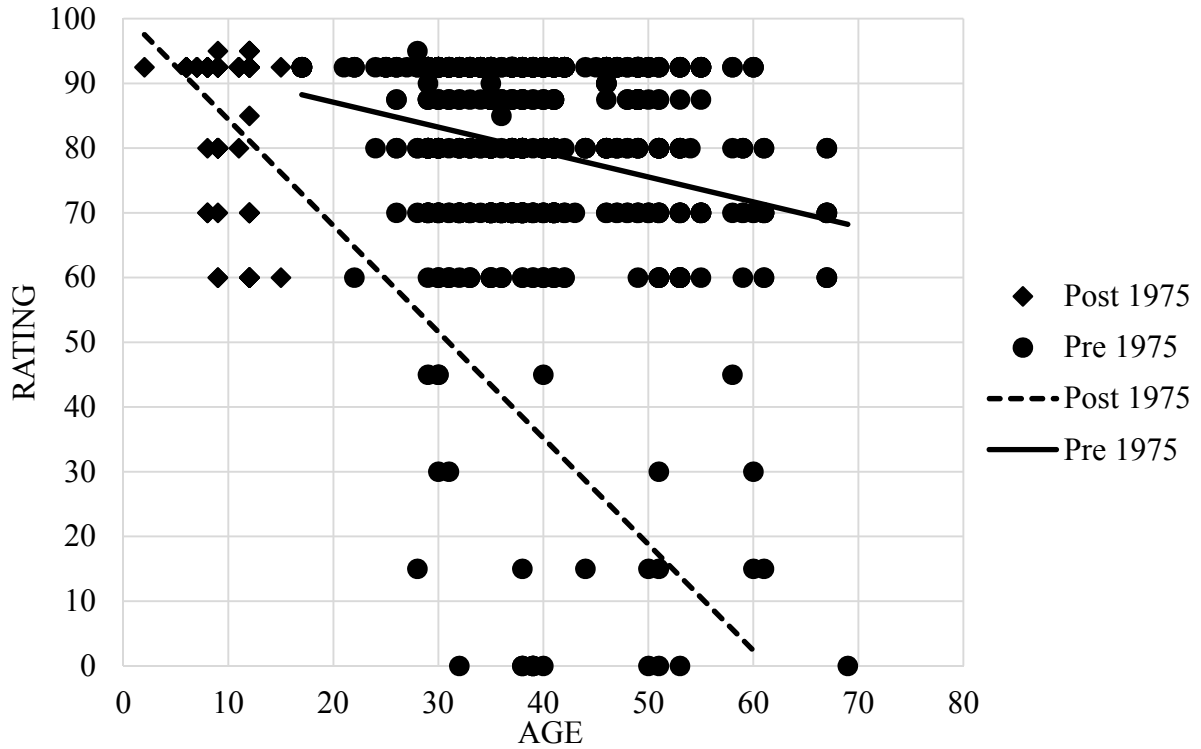
Figure 4-6: Invert Ratings in 1989 (Stratton et al., 1990)

Stratton et al. (1990) concluded that due to a policy change allowing for a lighter gage of pipe, galvanized CMPs installed since 1975 have undergone increased corrosion rate as shown in Figure 4-6. Part of this study was to validate those findings based on the current field survey. This conclusion was validated by comparing the average deterioration rates of the CMPs observed in this study using Equation 4.1. Using the field observations, the rate at which the CMP's invert was deteriorating (D) was found as,

where, R_{2016} is the invert rating taken in the summer of 2016 and Age_{2016} being the age of the pipe at the time the invert rating was reported. Using this method the average deterioration rate of galvanized CMPs installed before 1975 is .92, while the average deterioration rate of CMPs installed in 1975 and later 1.49.

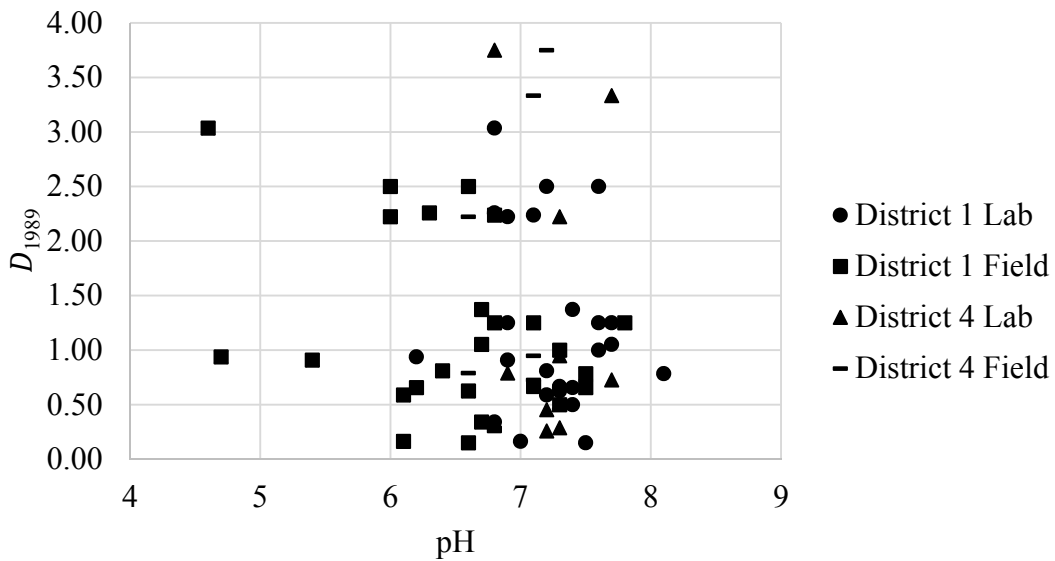
Figure 4-7: Deterioration per Year versus Measured pH

where R_{1989} is the invert rating assigned by Stratton et al. (1990) and Age_{1989} is the age of the pipe at the time of the 1989 report. This assumes that a newly installed CMPs would be given an invert rating of 100, and that the invert deteriorated at a constant rate through time. The invert deterioration rate D_{1989} was compared to the measured pH and resistivity with the results shown in Figure 4-7 and Figure 4-8, respectively. No correlation between the deterioration rate of the invert, pH and resistivity was observed in the sample provided by Stratton et al. (1990).

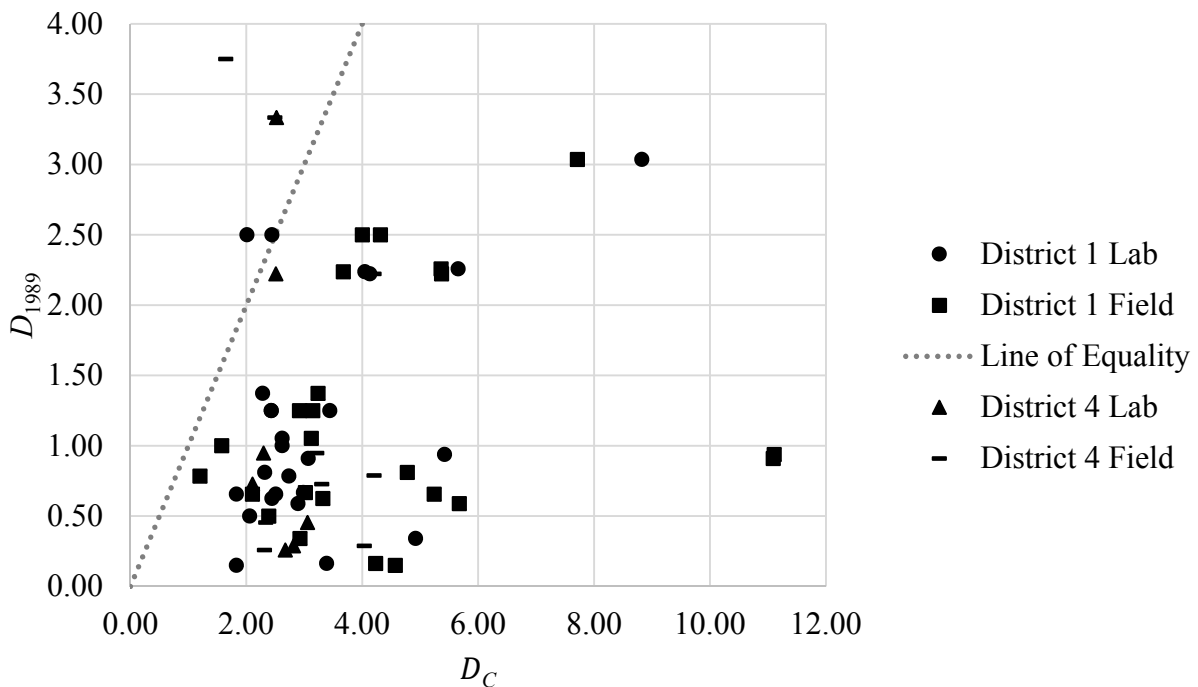
Figure 4-9: Observed Invert Deterioration versus Predicted Invert Deterioration

thickness was used on the majority of the sample set as per KDOT policy at the time. The observed invert deterioration per year D_{1989} was compared to the predicted invert deterioration per year D_C in Figure 4-9. It was shown that the predicted life using the Caltrans method consistently conservatively overestimates the observed invert deterioration. This was evidence that standard resistivity and pH measurements may not provide an accurate estimate on the corrosive potential of a site, and that other field or laboratory methods may provide better service life estimates.

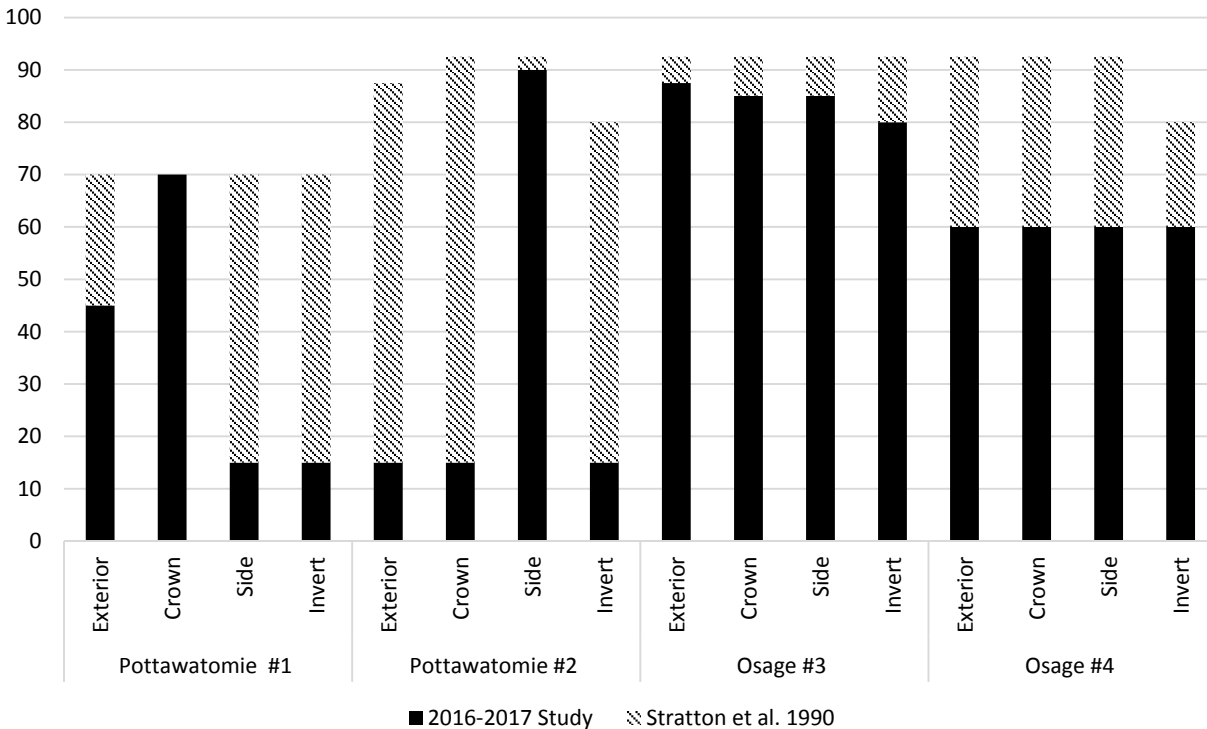
Figure 4-10: Observation Ratings of Sample Pipes

Due to established empirical formulas using traditional field pH and resistivity measurements not accurately predicting the observed deterioration of CMPs in the field, other soil characteristics were considered for better predicting the service life. With the vast majority of CMPs observed to be in dry conditions, water samples could not be taken. This prompted a laboratory study to understand the corrosive potential of water transported in the invert after coming into contact with surrounding soil in the form of leachate. Four locations were identified for soil sampling: two from Pottawatomie County; two from Osage County. The locations were selected based on the differences of deterioration over the past 27 years. The ratings of both studies are outlined in Figure 4-10.

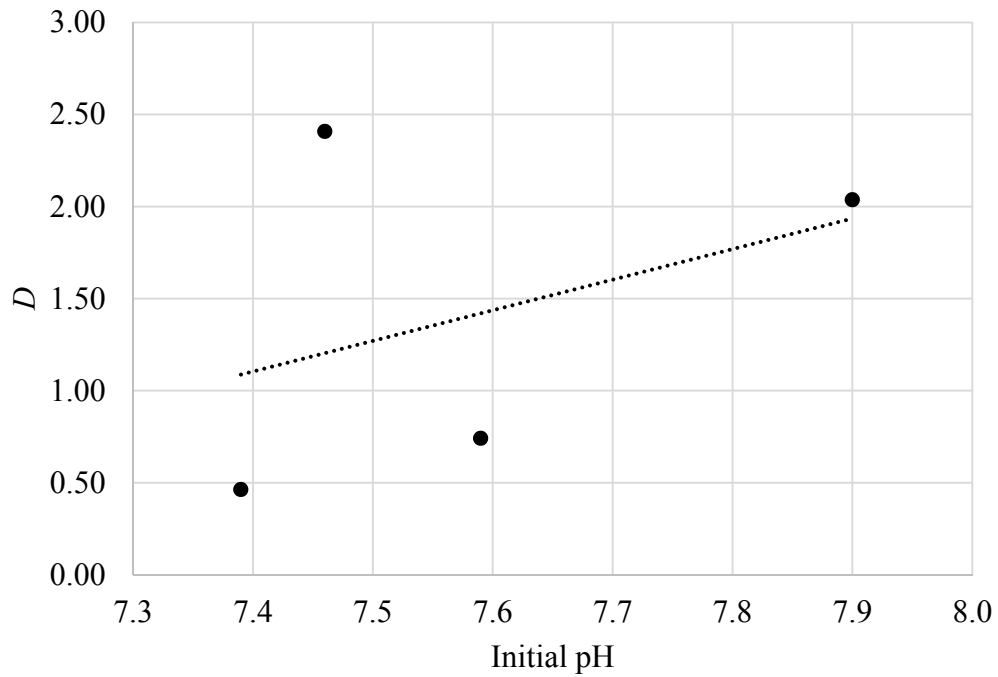
Figure 4-11: Deterioration Rate versus Initial pH

Initial field pH and soil resistivity measurements were taken at the time of pipe survey for the four sample CMP locations. Results of both pH and resistivity measurements vs CMP invert deterioration rate are shown in Figure 4-11 and Figure 4-12, respectively. No significant trends were observed between invert deterioration, pH, and resistivity.

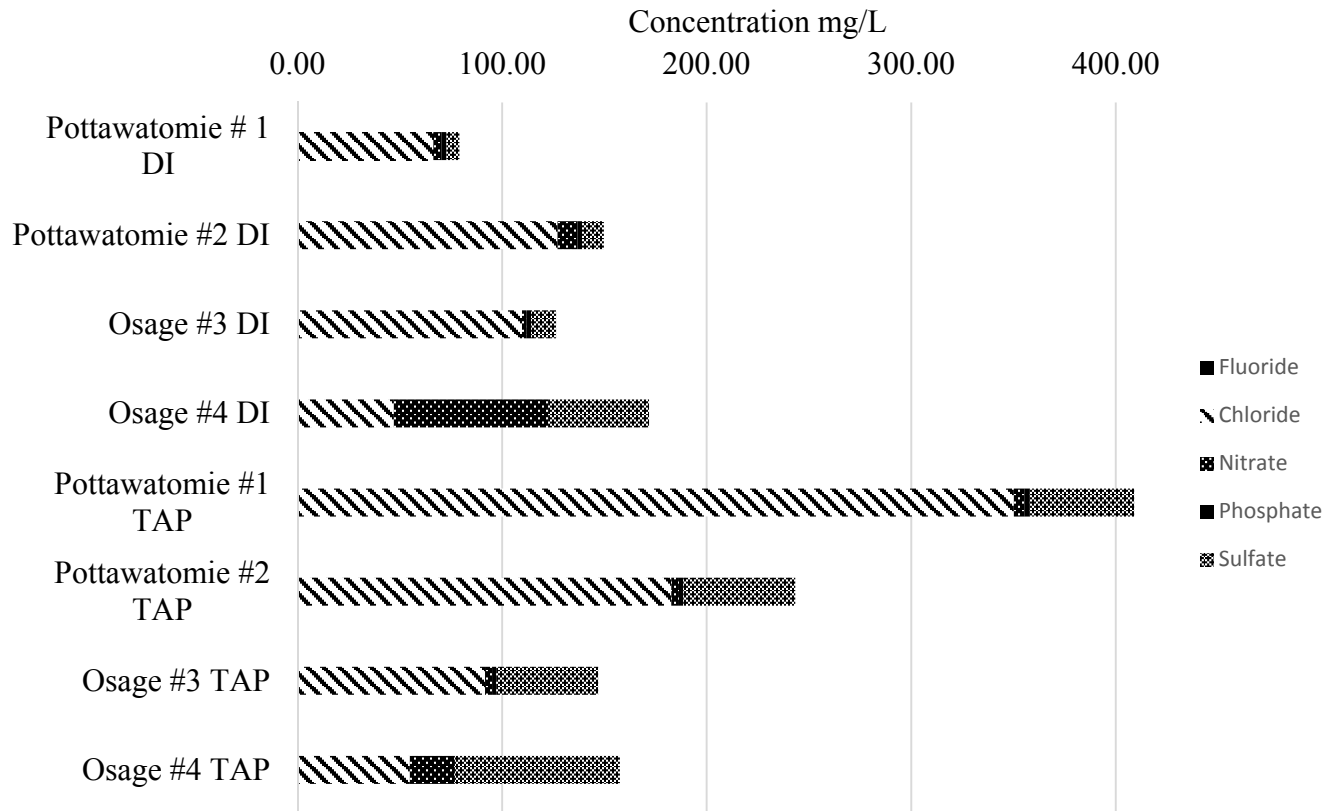
Figure 4-13: Initial Anion Concentrations

Anions of soil slurry in deionized water was measured using ion chromatography, with the results shown in Table 4-1 and Figure 4-13. Relative to the other anion concentrations it was determined that chloride and sulfate anions most easily mobilized after initial contact with water, thus having the greatest presence in water flowing through the CMP's invert after coming into contact with outside soils.

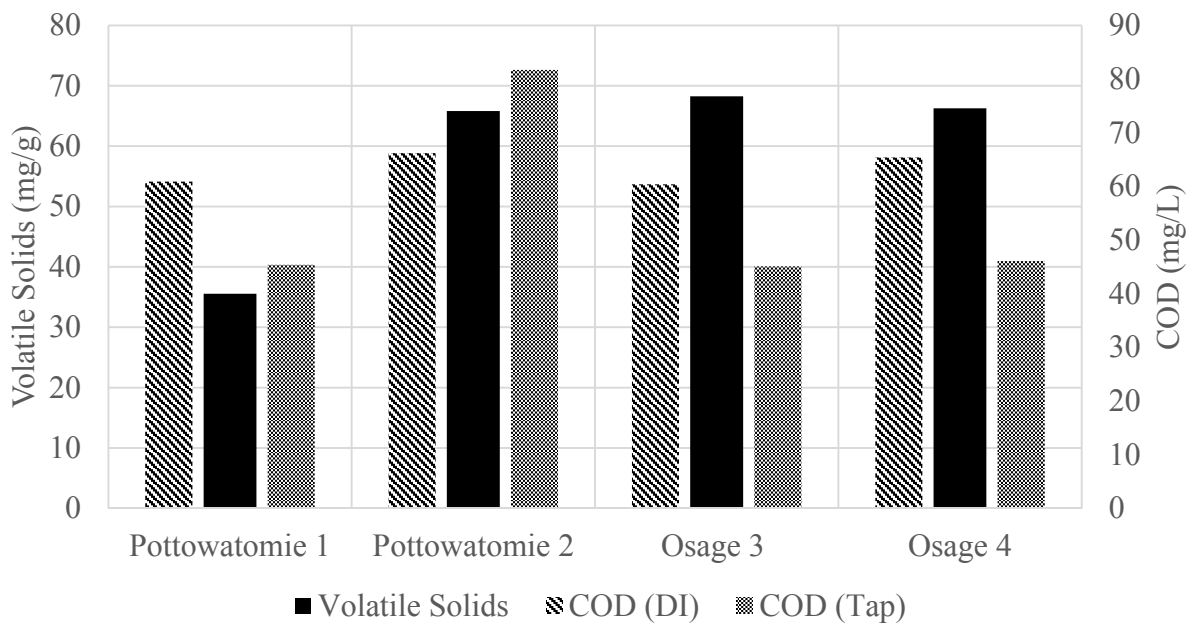
Figure 4-14: Summary of Initial COD and Volatile Solids Test

Figure 4-14 shows the results of the initial COD measurements with that of the measured volatile solids in an effort to determine the significance biological agents had on invert

deterioration. No correlations were found between COD, volatile solids and invert deterioration rate in the initial study.

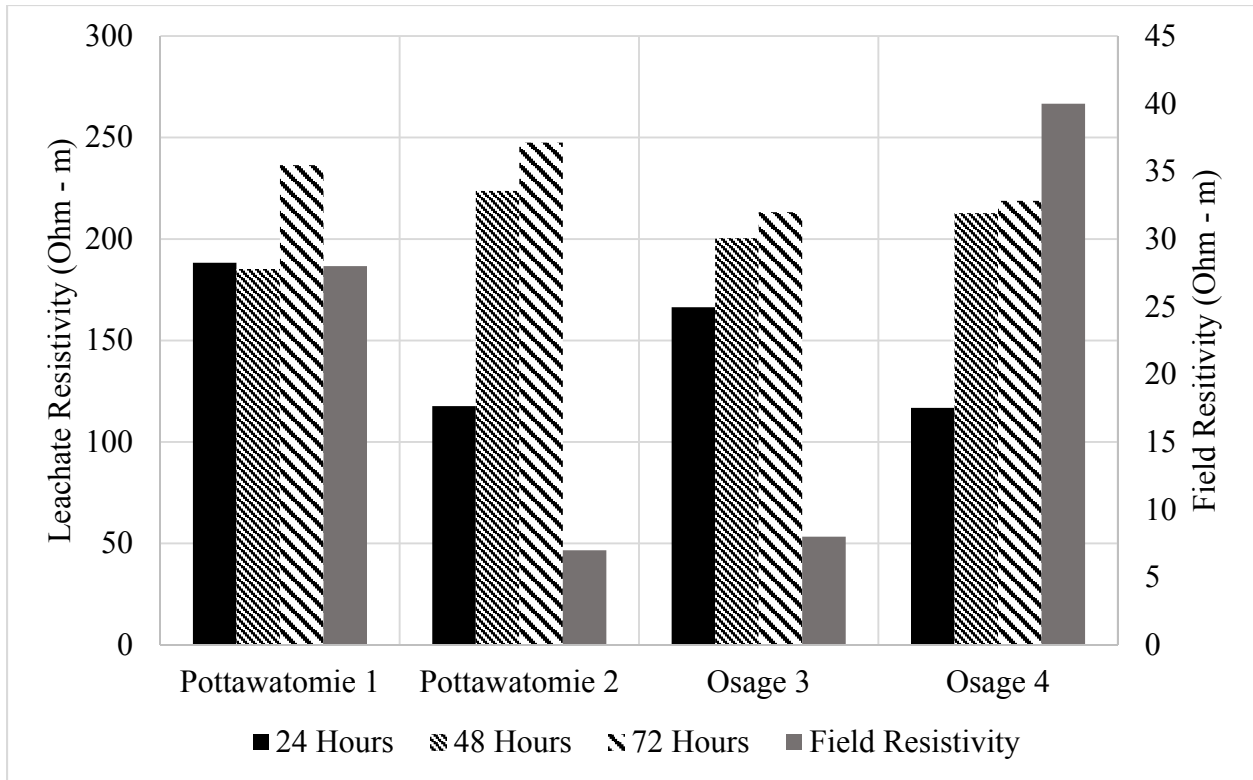
Figure 4-15: Resistivity of Leachate Trial Testing in Deionized Water Medium

A leachate test was conducted to recreate field conditions in the laboratory: pH, resistivity and anion concentration of the water samples were measured after each trial. The results of the resistivity testing shown in Figure 4-15.

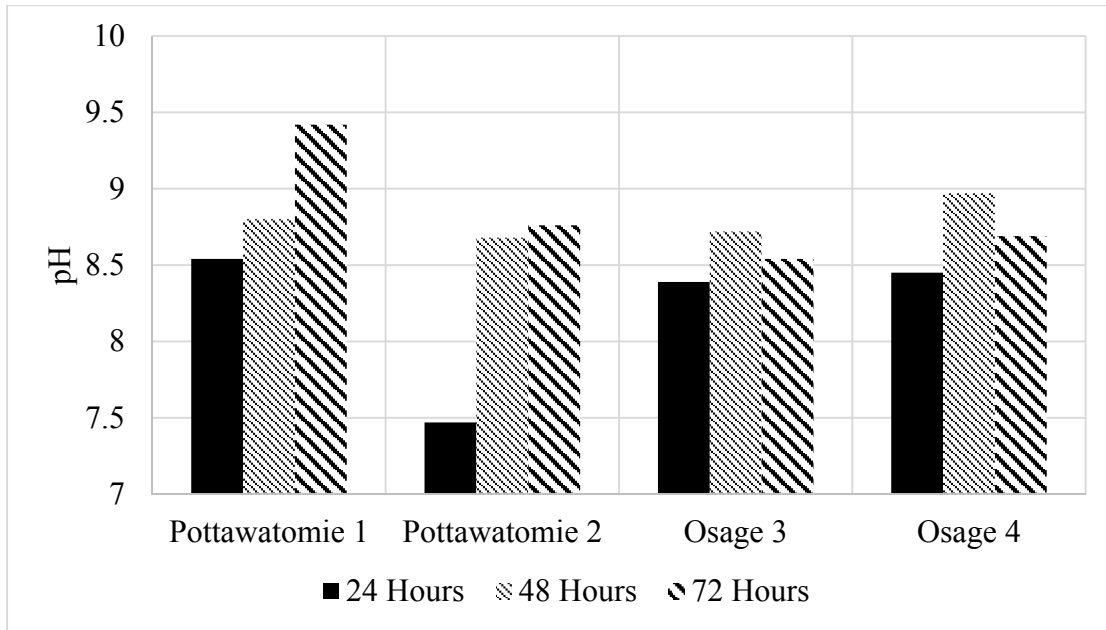
Figure 4-16: pH of Leachate Trial Testing in Deionized Water Medium

The pH of leachate samples was taken after each trial using a deionized water source with a measured pH of 7.75 (shown in Figure 4-16). The pH of leachate samples was observed to be consistent between both water mediums. Unlike the Osage county, the pH samples taken from Pottawatomie counties both showed a trend of decreasing acidity after each trial wash.

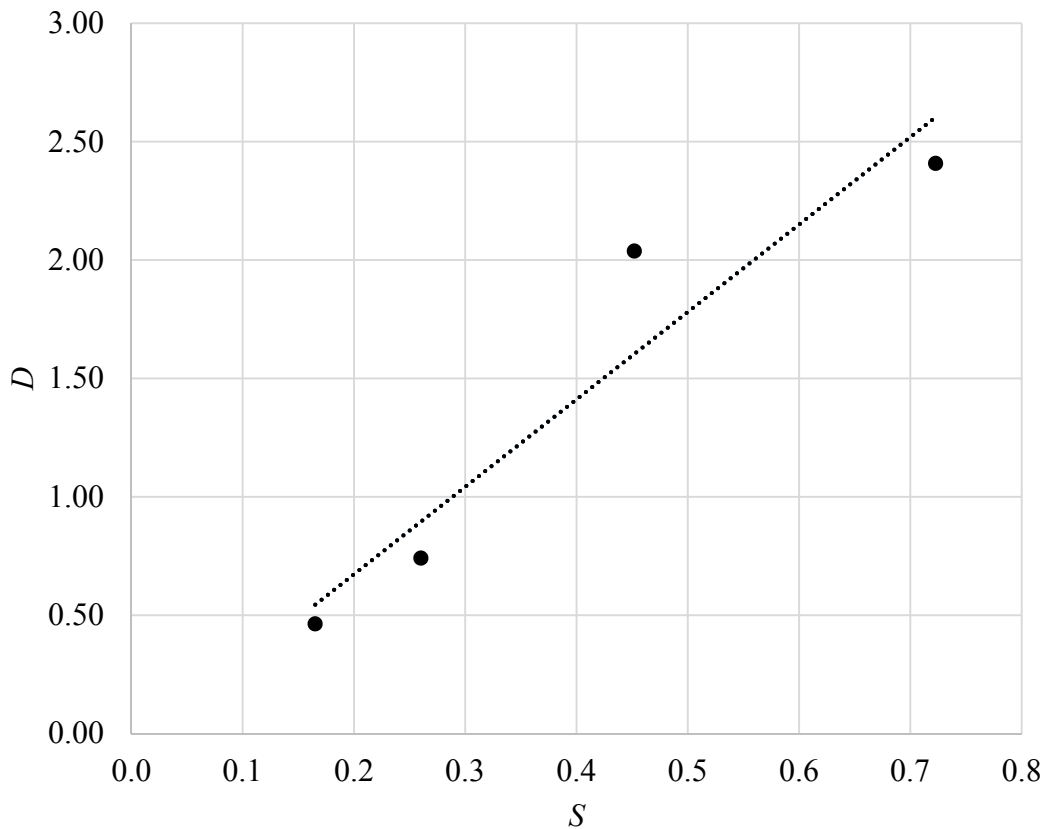
Figure 4-17: Deterioration Rate versus Variance of pH

By comparing the observed deterioration per year versus the calculated standard deviation of pH during leachate testing, a linear trend is shown in Figure 4-17. For the sample population,

CMPs that demonstrated the most deterioration, showed the most variance in the pH of leachate water during bathing tests. The correlation found between deterioration and the variance of leachate pH, along with the evidence showing no relationship exists between observed deterioration and pH taken in the field, indicates that deterioration may be controlled by the buffering capacity soil has on water it comes in contact with instead of the pH of the soil itself. Thus, simple pH measurements taken in the field would not properly estimate the amount of corrosion possible at a given site location.

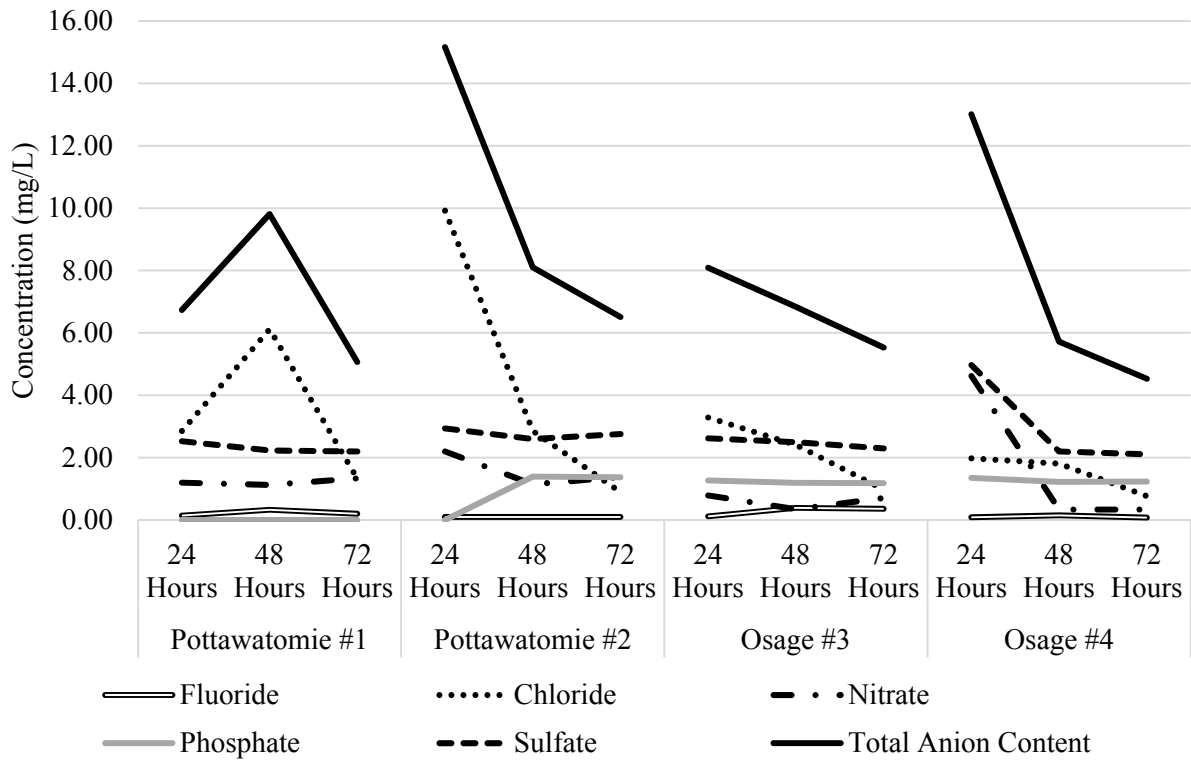
Figure 4-18: Leachate Test Anion Concentrations

Anion concentrations were also measured during the leachate tests. The resulting anion concentrations of leachate along with the total amount of measurable ions are shown in Figure 4-18. The results from the leachate tests suggests that for some cases ions could continuously be

mobilized after initial leaching. Because ions can continuously be mobilized at relatively high concentrations, timed leachate bathing may be a greater indicator of corrosive anion activity than a singular measurement of anion soil chemistry.

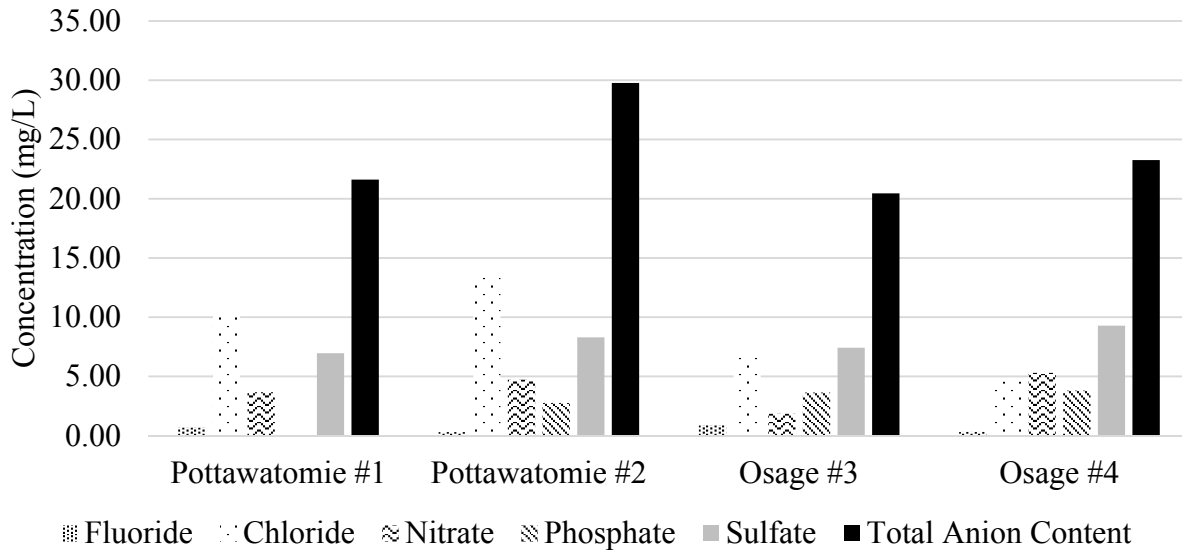
Figure 4-19: Leachate Test Total Anion Concentrations

The cumulative amount of anions mobilized during leachate testing is depicted in Figure 4-19. The total amount of anions mobilized during the leachate baths were compared to the deterioration rate of the invert.

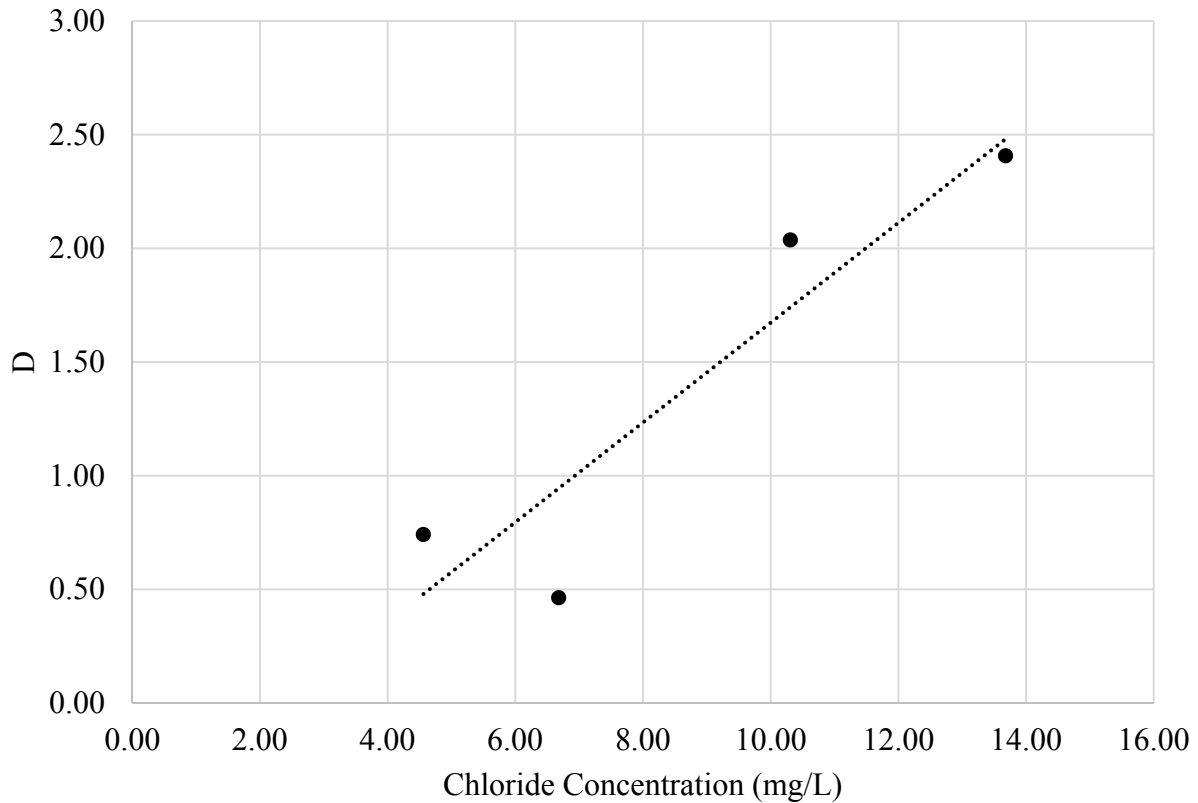
Figure 4-20: Deterioration Rate versus Chloride Concentration

Figure 4-20 shows that a correlation exists between the cumulative concentration of chloride that was mobilized during the leachate testing and the deterioration rate calculated at each site. The accuracy at which the cumulative chloride concentrations predicted the invert deterioration rate may prove to be a stronger indicator of deterioration than that of a typical resistivity test in the field.
