INCORPORATING MECHANICAL, ELECTRICAL AND PLUMBING SYSTEMS  
INTO HISTORIC PRESERVATION PROJECTS – THREE CASE STUDIES

A REPORT

MASTER OF SCIENCE

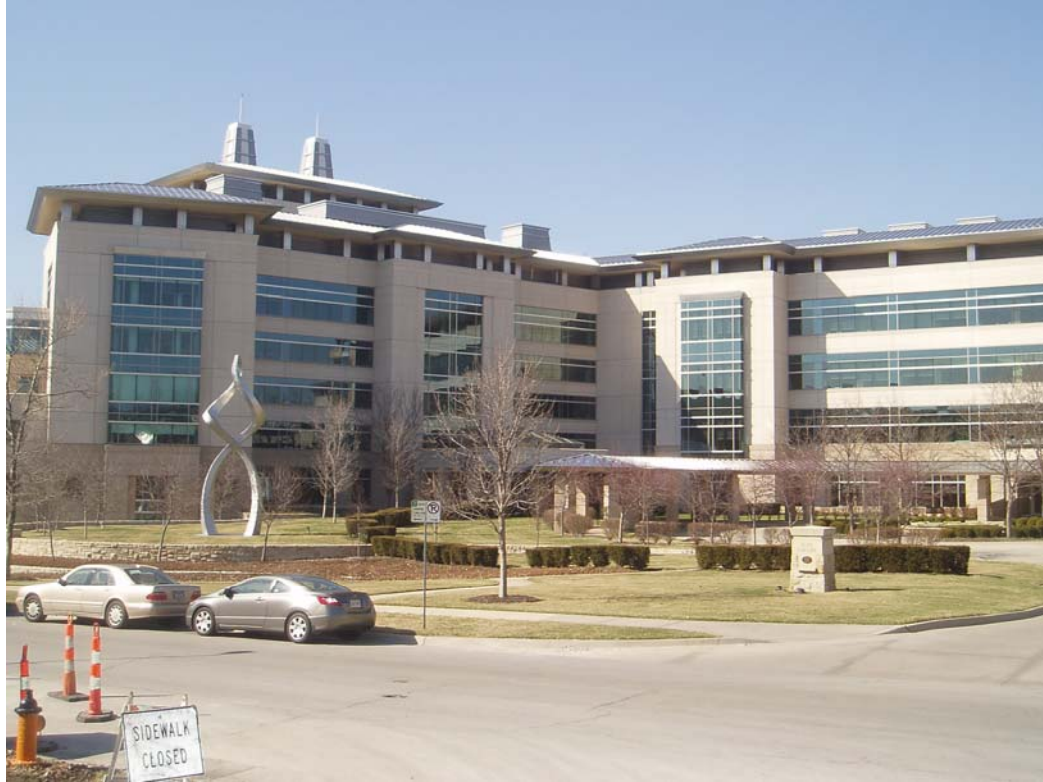
Figure 7. Exterior band of windows

A unifying design aspect to the exterior appearance is the windows. Windows appear horizontally throughout the entire length of the building. However, not every glass pane is a window; primary structural elements and utility shafts are covered with opaque glass with the same exterior appearance. Mike Shaadt of PGAV Architects stated, “The horizontal glazing technique allowed us to diminish the fact that each of the existing buildings was very different. It allowed us to achieve continuity and deal with functional issues. The low-e, green-tinted glass also has a high visible light transmission and lets in as much natural light as possible.” This technique unified the buildings without a disjointed appearance (Newman, 2002). The horizontal window design is depicted in Figure 7.

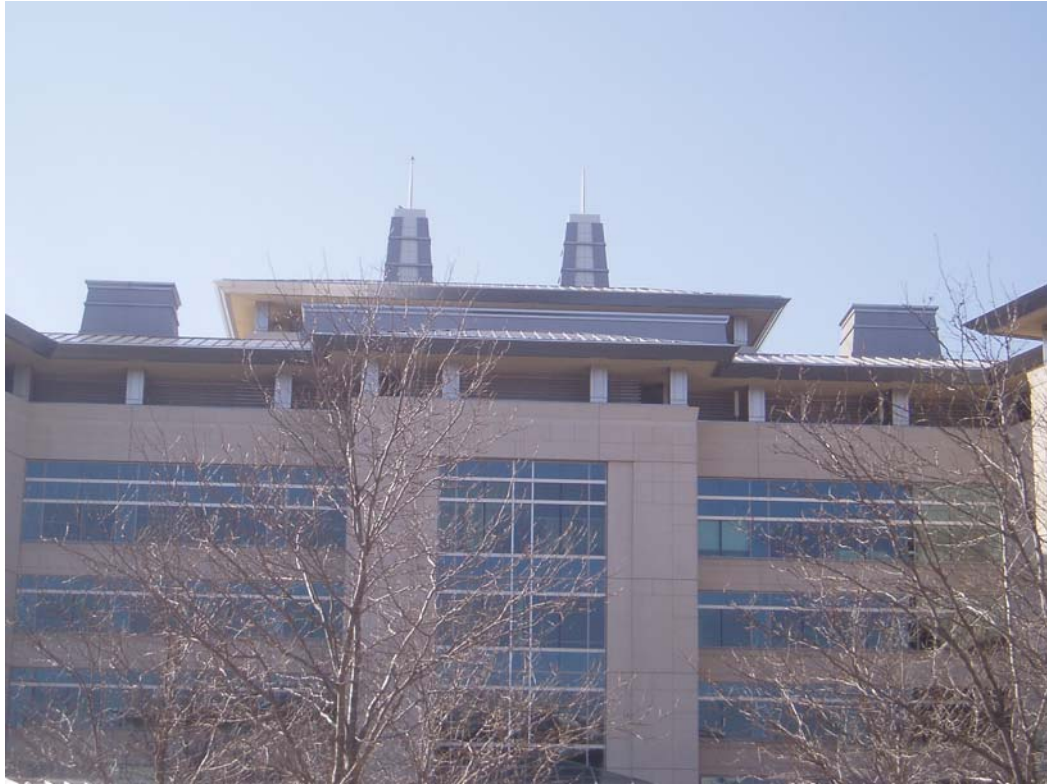
Figure 8. Penthouse roof level

aesthetically pleasing while requiring very minimal maintenance (Newman, 2002). The penthouse roof level covers the mechanical equipment as shown in Figure 8, and the exhausting penetrations through the roof are shown in Figure 9.

These intake air locations bring the outside air to the lowest basement level in order to be supplied upward in the building. The exhausted air is also moved upward vertically from each level to the roof. The roof consists of a penthouse floor for the exhausting equipment (Schaadt, 2008). Cooling towers are also located on the roof, but they are architecturally screened for aesthetic purposes. The only noticeable mechanical features on the roof are the exhaust plenums (Geary, 2008).

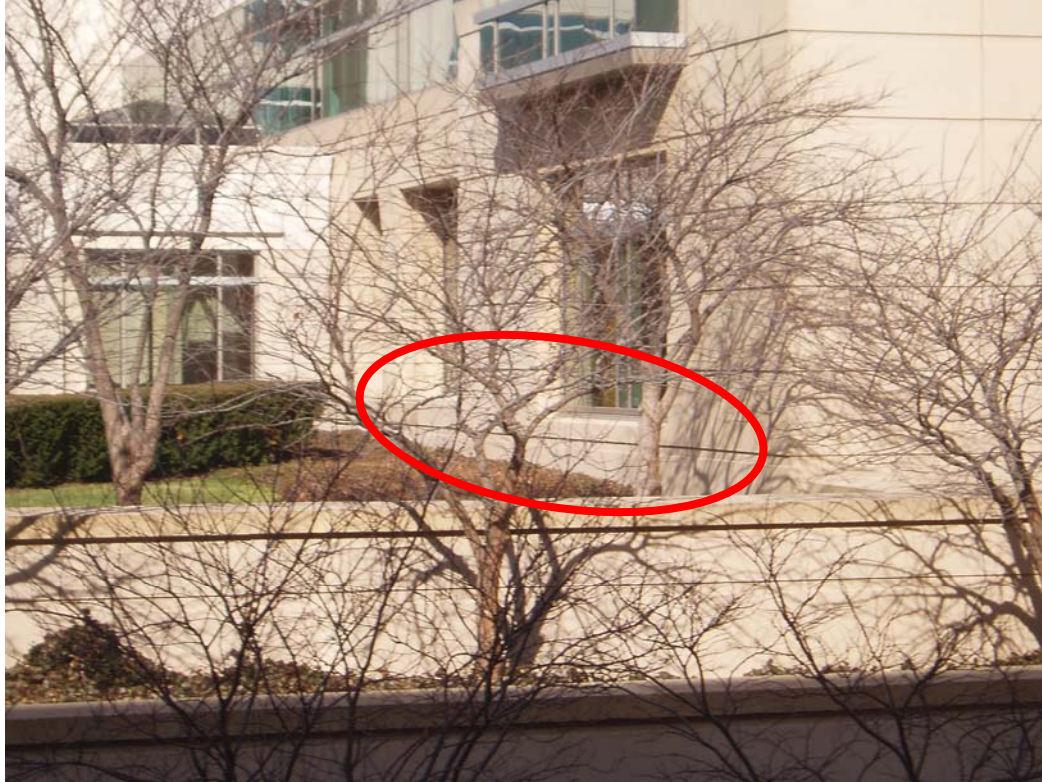
Figure 10. Outside air intakes along the building perimeter.

Outside air is introduced to the Stowers campus along the building exterior ground level. Several steel grates are located along the perimeter of the buildings as shown in Figure 10 (Schaadt, 2008).

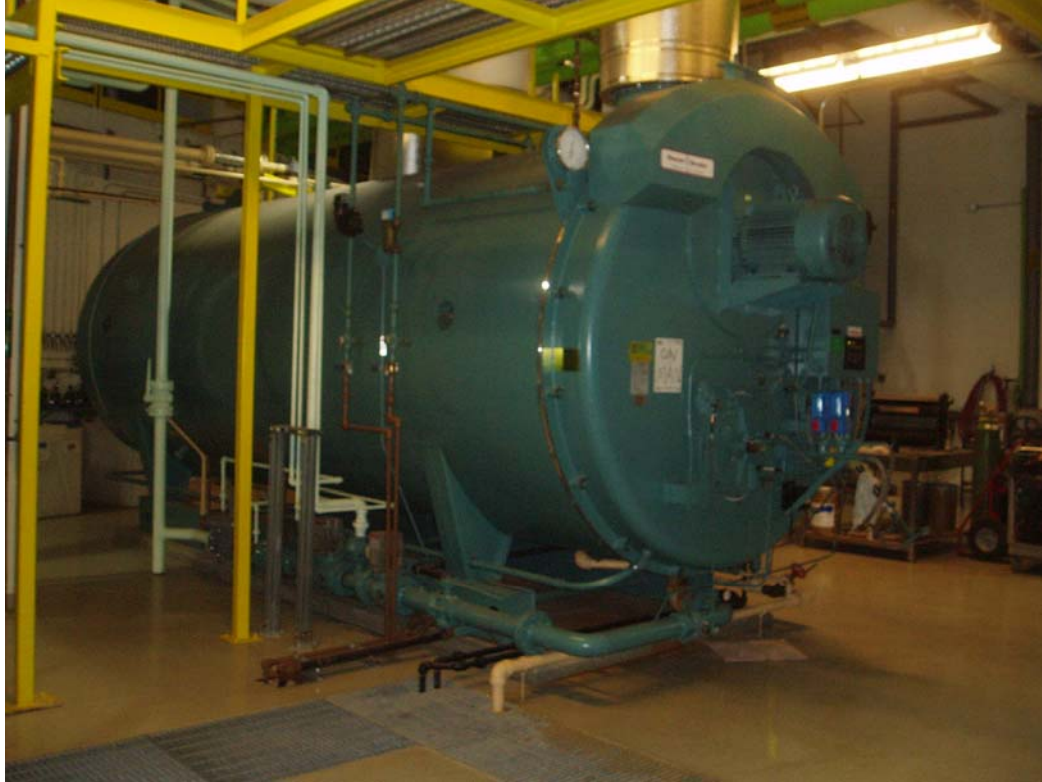
Figure 11. Boiler

Most of the mechanical equipment is located in the lowest basement level of the research facility building (Barber, 2008). The heating and cooling central plant is located here which serves both the new and originally constructed buildings (Schaadt, 2008). Four boilers are located in the lowest basement level for heating; reheat coils are then located in the VAV units closer to the conditioned space (Geary, 2008). A boiler is shown in Figure 11.

Two of these four main boilers are dual fuel, meaning they are supplied by natural gas but they also can run on fuel oil. There are also two separate steam boilers which are used for sterilization procedures. These steam boilers run at higher pressures in order to provide the sterilization process (Geary, 2008). A steam boiler is shown in Figure 12.

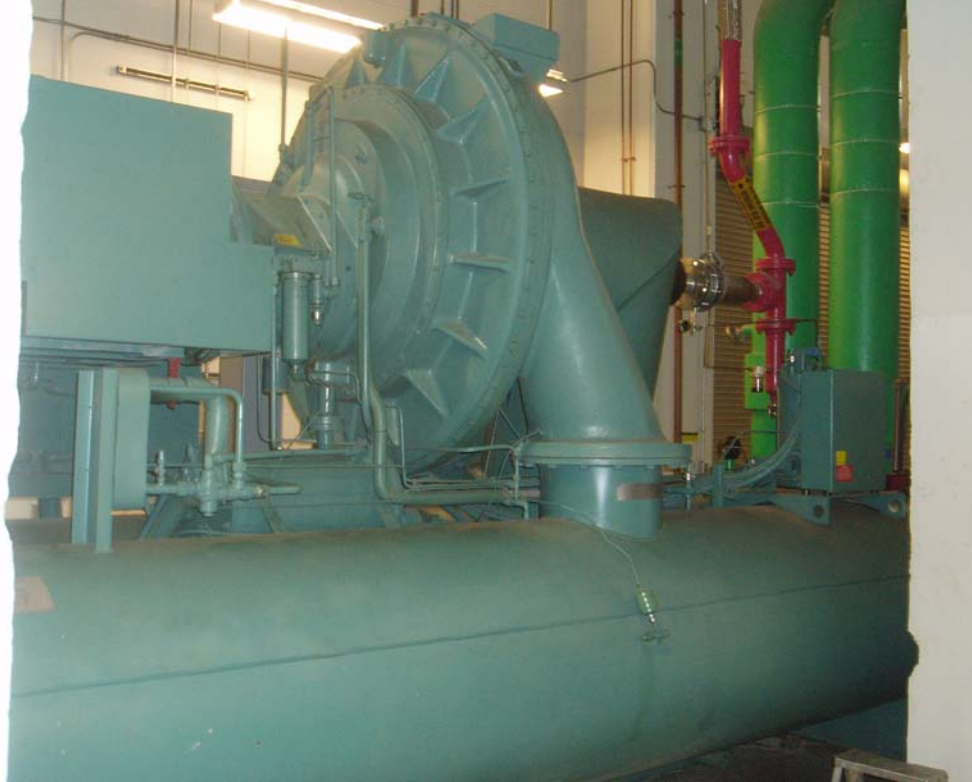
Figure 13. Chiller

The Stowers Institute also has four chillers in a separate designated chiller room (Geary, 2008). A chiller is shown in Figure 13.

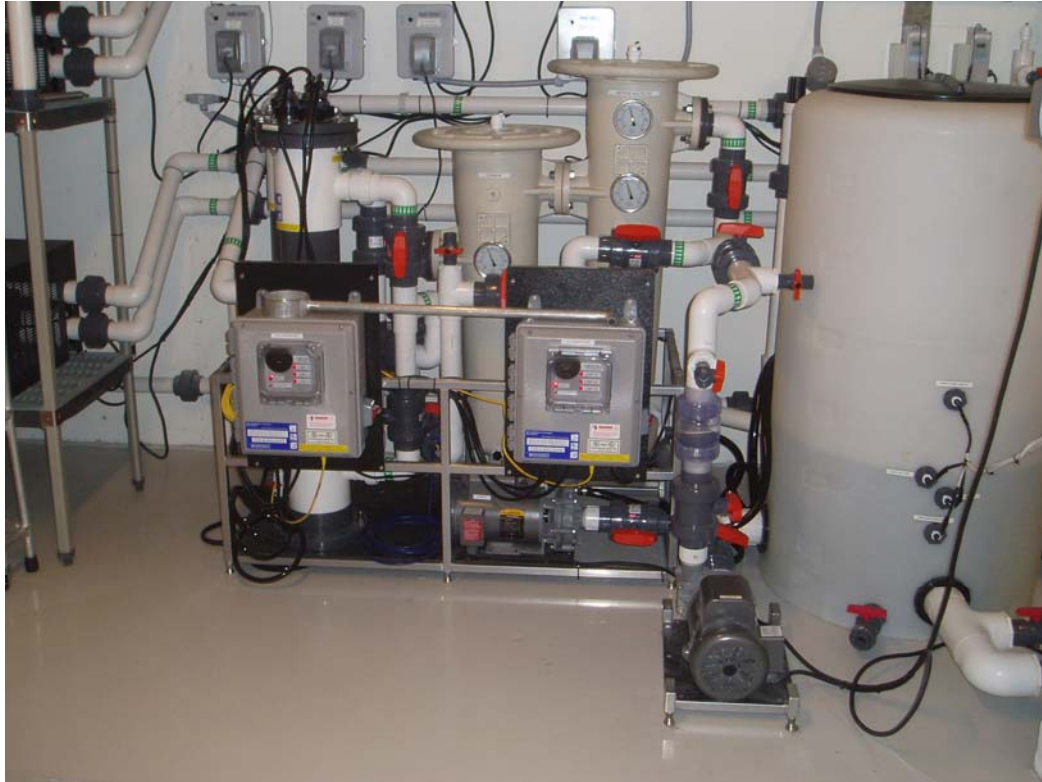
Figure 14. Aquatic system

facility are completely sealed to the ceiling and must be changed out from the B2 level above. An aquatic water system has also been installed to service the animal facility. This aquatic system provides water treated through reverse osmosis for several animal species' rooms such as the frog room (Geary, 2008). The aquatic system is shown in Figure 14.

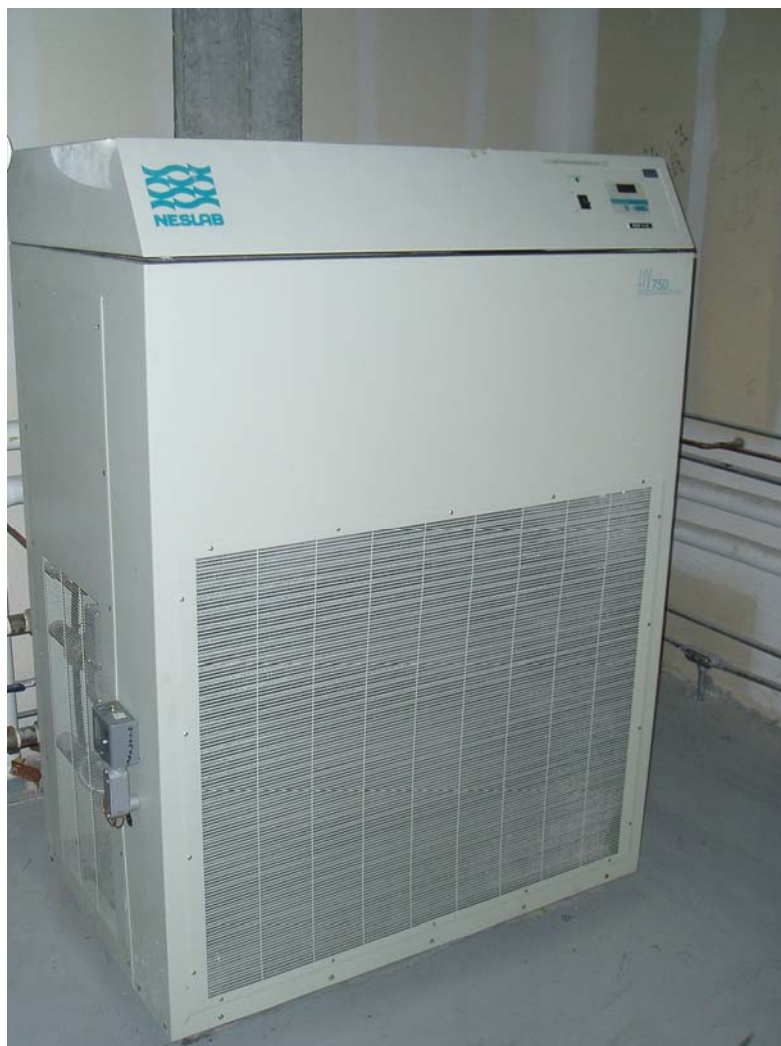
Figure 15. Specialty laser used in research

A specialty laser used in research is also housed in the B2 level which requires three chillers to function. The laser splits cells and particles by using light reflection and projecting a shot of air in order to disrupt the cell by “shooting” it out of the light stream (Geary, 2008). This laser is shown in Figure 15.

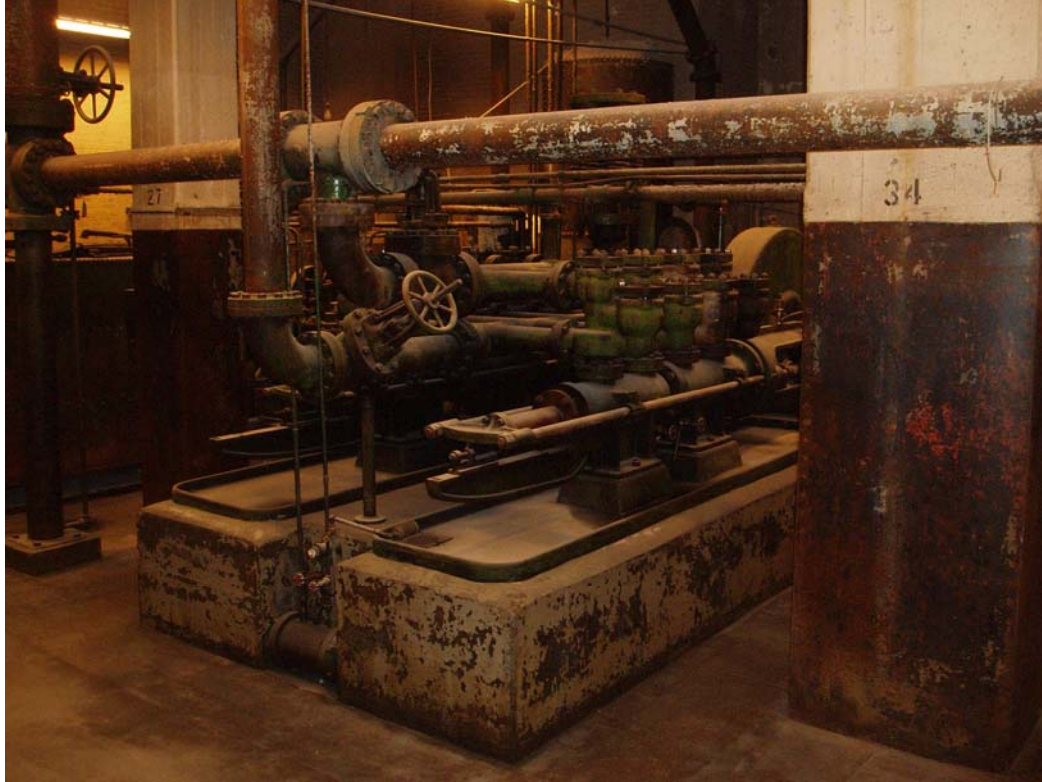
Figure 25. Historic Union Station chiller and valves

The old underground mail sorting system and associated tunnels running underground to the old adjacent post office were taken away and have been converted to new usage areas. Although one lift off of the current parking lot is still visible, this is the only remnant of the old mail system. Much of the old mechanical equipment such as chillers and boilers were also very interesting in their unique historic qualities, but they were in a non-usable state. Therefore, all of the mechanical equipment was completely replaced (Fountain, 2008). A few pieces of the old mechanical equipment, however, are on display in the Union Station's exhibit area. A historic chiller and associated valves are shown in Figure 25.

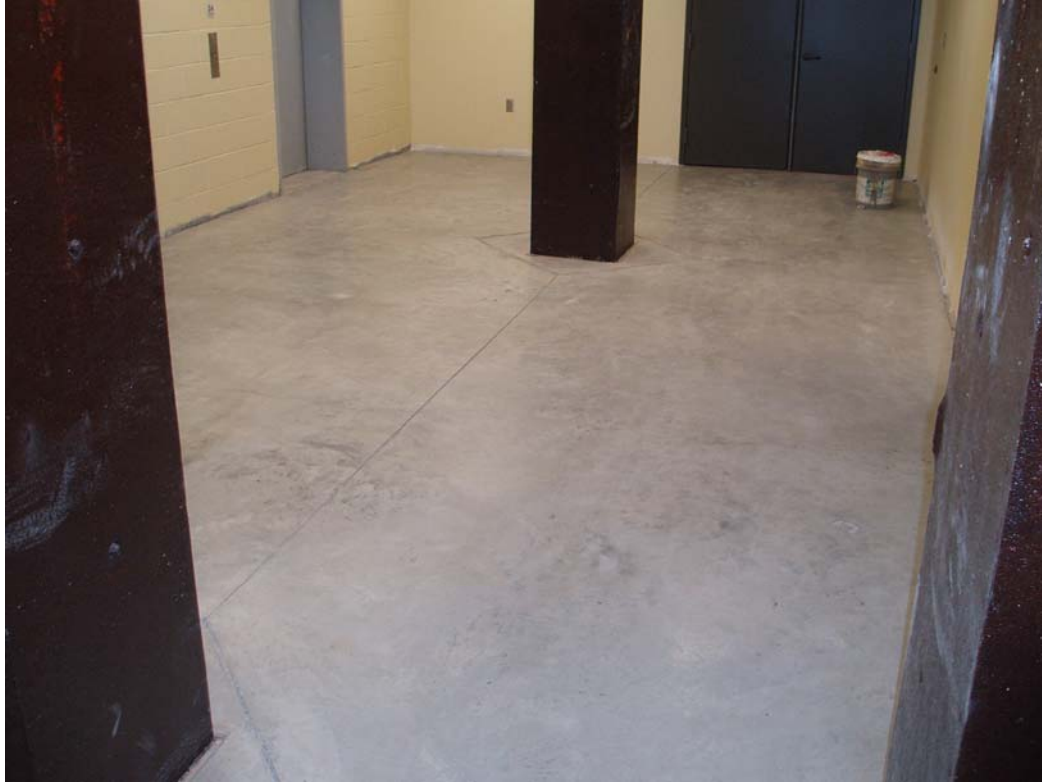
Figure 26. Union Station's basement floor

In the basement freight distribution room, which served as the main baggage area, there was wood floor the same size as the entire north waiting room and grand hall. When the building was left vacant, water damage from the leaking roof warped and destroyed this wood flooring. This historic characteristic of the original design was therefore not restored because of its poor condition. To remedy the problem, concrete topping was poured over all of the wood flooring to finish out the basement floor (Fountain, 2008). The Union Station freight distribution room floor is shown in Figure 26.

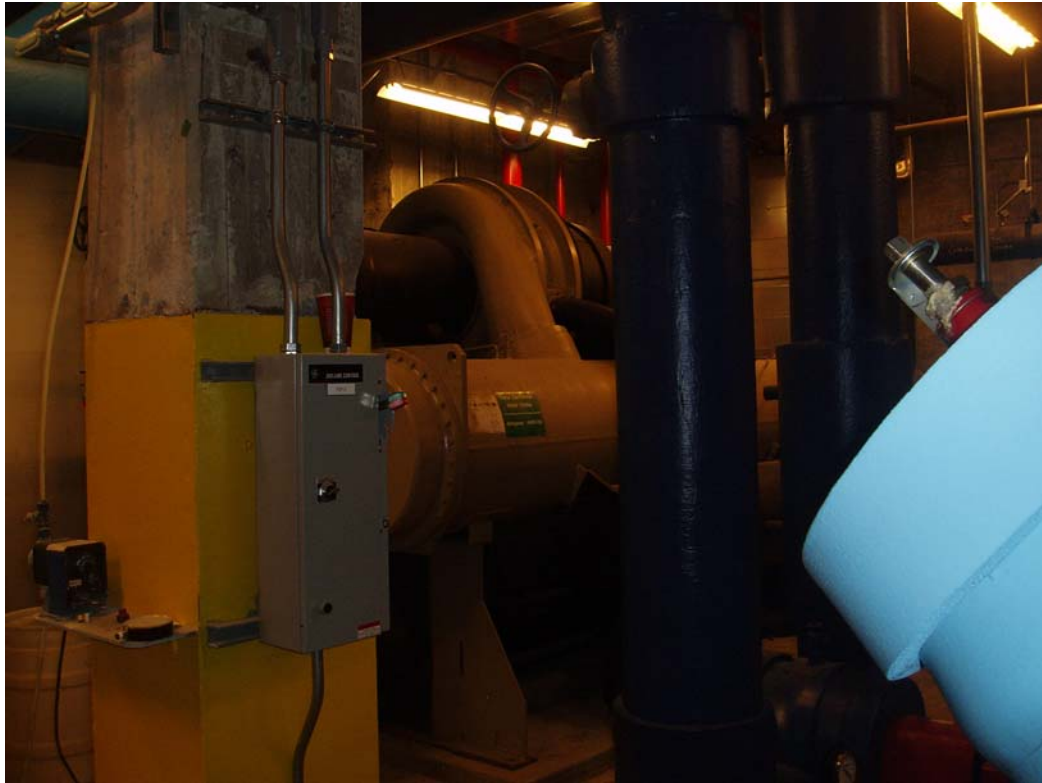
Figure 27. Union Station chiller

The original structure did not contain any insulation on or in the exterior walls. When renovating the space, some insulation was installed in the attic spaces and also along the edges of the small windows and their surrounding walls. However, the large original windows were still non-insulated which allowed more outside air to penetrate the walls (Fountain, 2008). Compared to the old mechanical system of steam and radiators, the new mechanical system consists of a multiple air handling unit system that is very efficient for the Union Station. The new all-electric system consists of using chilled

water to cool the building and electric heating (McCosh, 2008). A chiller is shown in Figure 27.

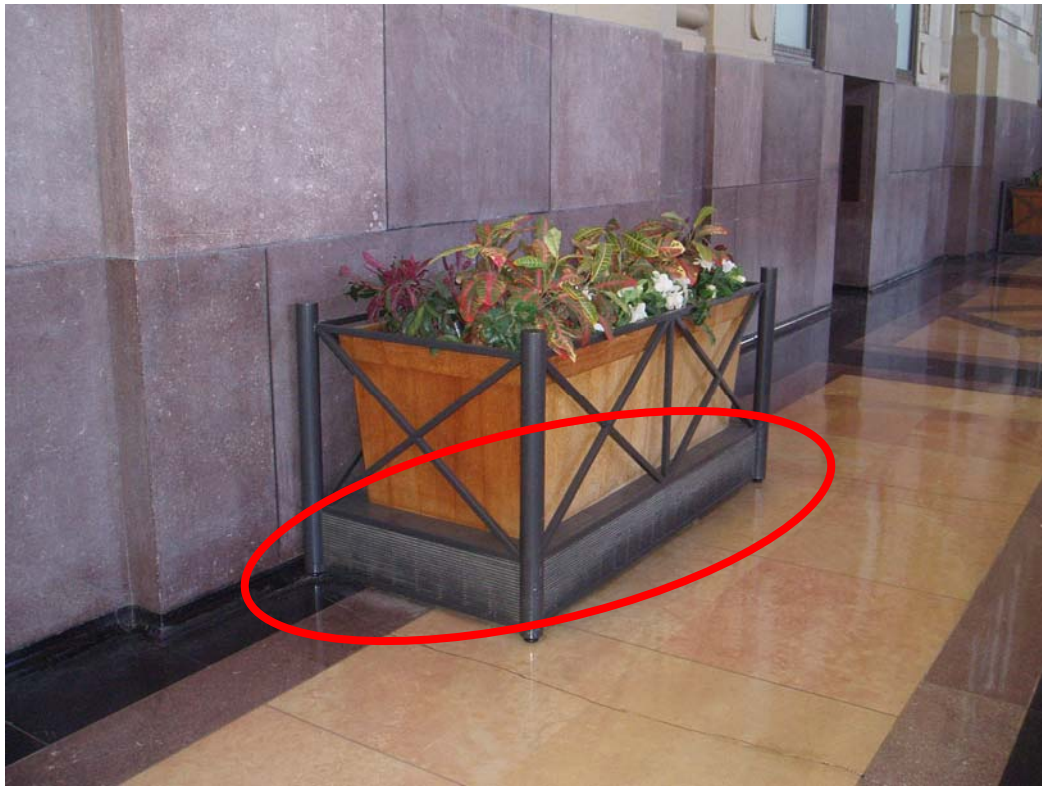
Figure 28. Return air grills

In the mechanical design, return air was therefore taken at the floor level. Radiator cabinet locations from the original design were utilized for the new mechanical system; the previously constructed holes in the floor from the radiator cabinets served as return air intakes (Fountain, 2008). Return air grills are shown in Figure 28.

When designing the new mechanical HVAC system for the north waiting room and the grand hall, only the air at occupancy level was deemed necessary for conditioning. It was determined that if only the air near the floor was conditioned, stratification would occur in the space above (Fountain, 2008). The stratification above the occupancy level in the grand hall and the north waiting room is not a design concern because there is no public access in this space. Stratification is better in this location than trying to heat and cool this above-occupancy level. Otherwise, unnecessary levels of heating and cooling would take place especially because of the large single-paned glass windows. It is now much easier to just let this air get hot because it doesn't affect the occupants (McCosh, 2008).

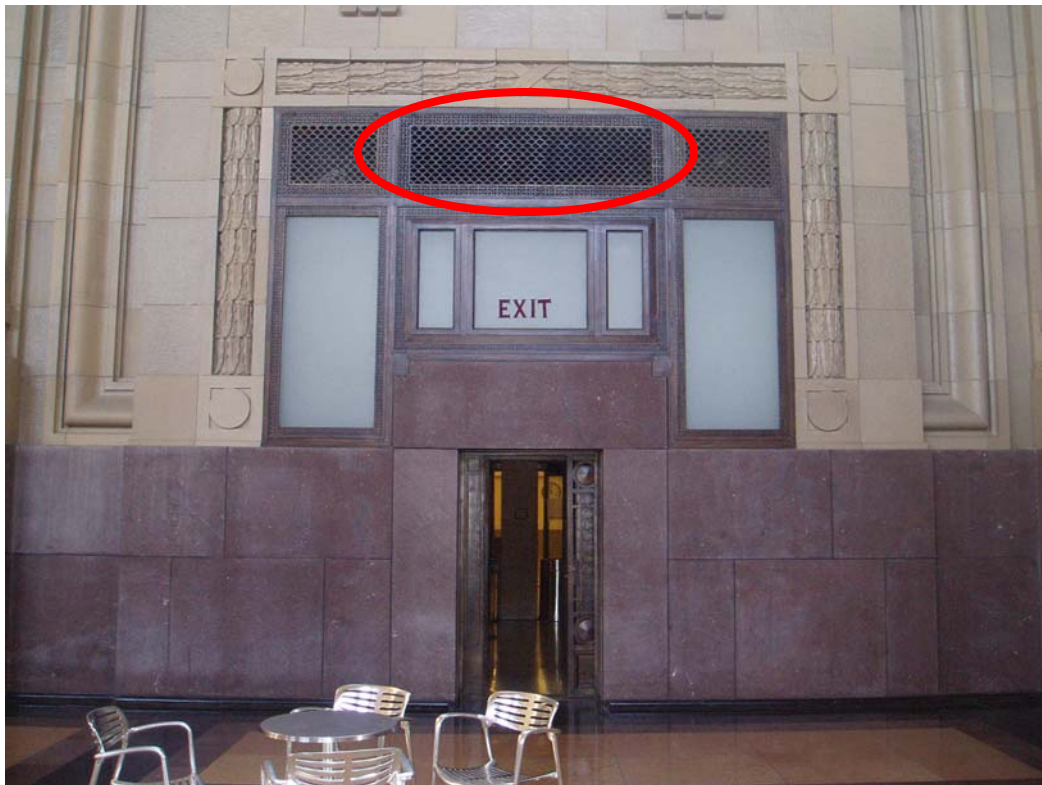
Figure 29. Supply air grills

In the new mechanical design, air is supplied in the grand hall and the north waiting room either at the occupancy level or as high as twelve feet above the floor, and

return air is taken in at the floor level. The balconies which are about twelve feet above the floor are also used for areas of supplying air by putting diffusers below the landings of the balcony walkways, and air is also returned at the kiosk areas throughout the main hallway. Above the doors in the north waiting room are positioned the original grills of the previous mechanical system that are now used for supply air locations (McCosh, 2008). These supply air grills are shown in Figure 29.

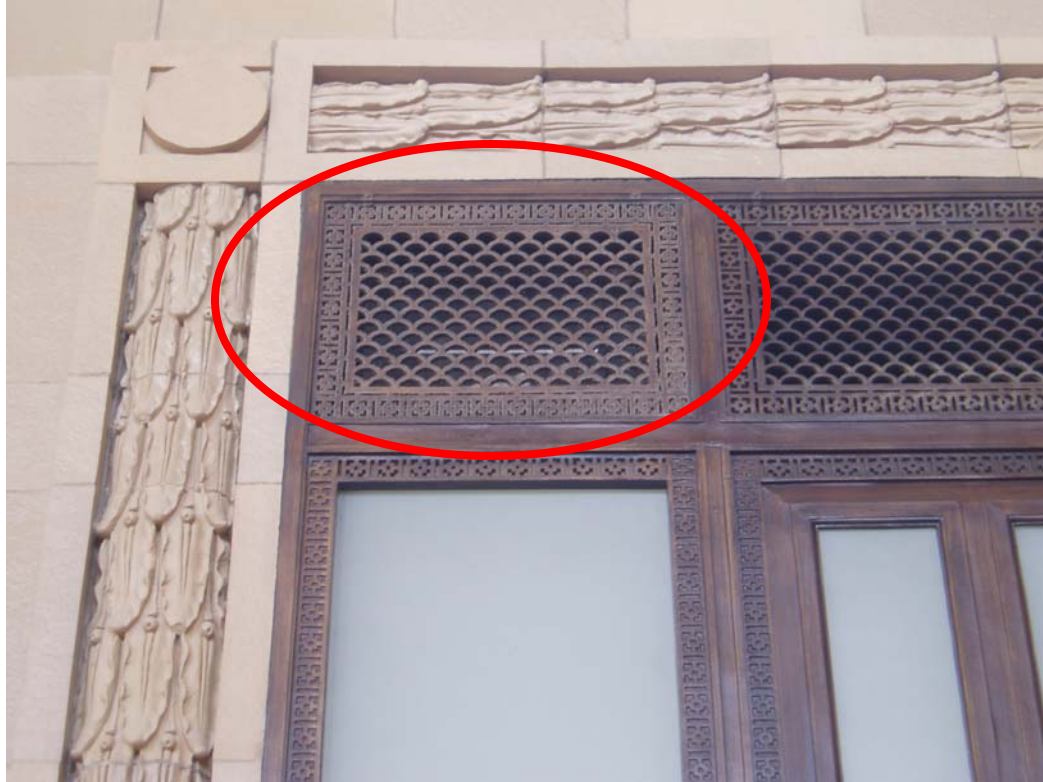
Figure 30. Location of speakers for the fire and evacuation annunciation system

On either side of the center grills are speakers for the fire and evacuation annunciation system. These grills are original so the space behind them has now been reused with new mechanical and electrical equipment (McCosh, 2008). The side grills containing speakers for the fire and evacuation annunciation system are shown in Figure 30.

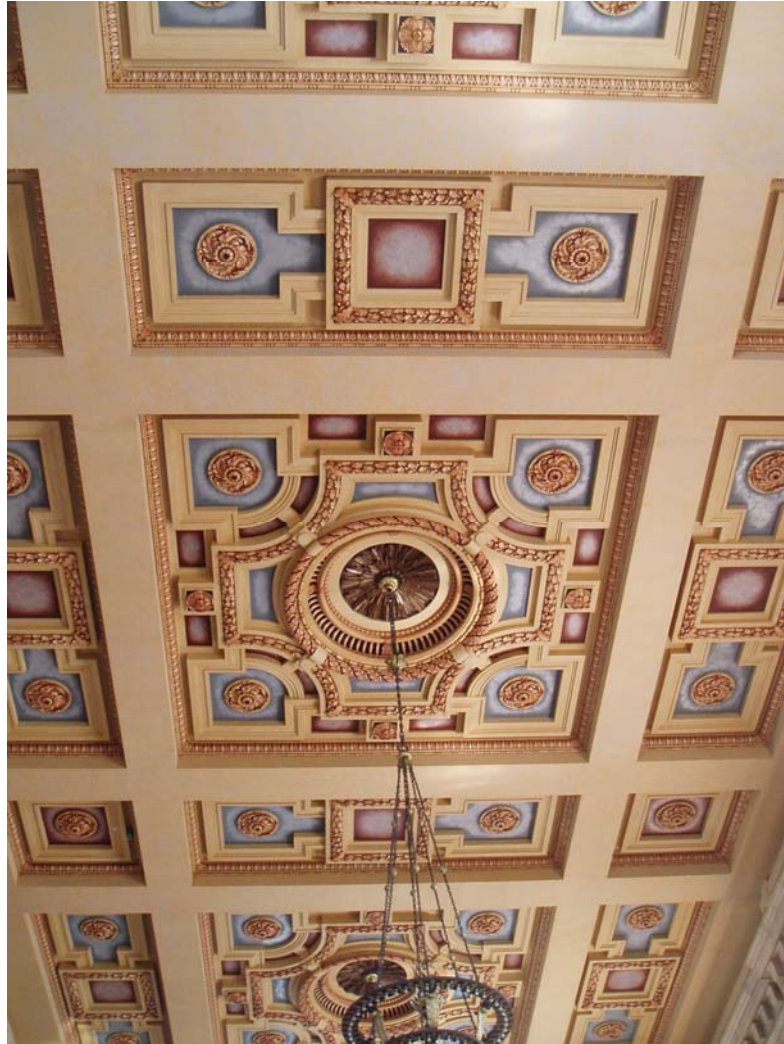
Figure 31. Union Station ceiling

After the roof was repaired, the Union Station ceiling could then be restored. Hayles & Howe were contracted to re-build and preserve the ceiling which had been severely deteriorated by weathering and the water damage from the leaking roof. Hayles & Howe had previously worked on other train stations and high-profile projects including New York's Grand Central Station and England's Windsor Castle. Twenty-two Hayles & Howe employees specializing in ornamental plastering and restoring original moldings and ceilings worked on the Station ceiling (Union, n.d.). Some of the plaster craftsman even came from England where they had experience working on many of the historic churches (McCosh, 2008). The final ceiling appearance is shown in Figure 31.

Because the water damage had terribly destroyed much of the original ceiling, over half of the original ceiling was completely torn down and rebuilt. In the restoration process, every detail was matched to the original appearance (Union, n.d.). Molds of the original ceiling plaster work were made on site, while the larger pieces were constructed and assembled in Baltimore with the use of more sturdy and lightweight materials (JE Dunn, 2008).

recreated pieces incorporated a variety of creative and modern materials along with various application techniques to match the adjacent finishes. The ceiling restoration specialists worked on full-height scaffolding to reach the ceiling. The resulting ceiling is a perfect blend of new and original construction. Because of the restoration efforts, the lines in the ceiling are actually straighter now than they were originally (Fountain, 2008).

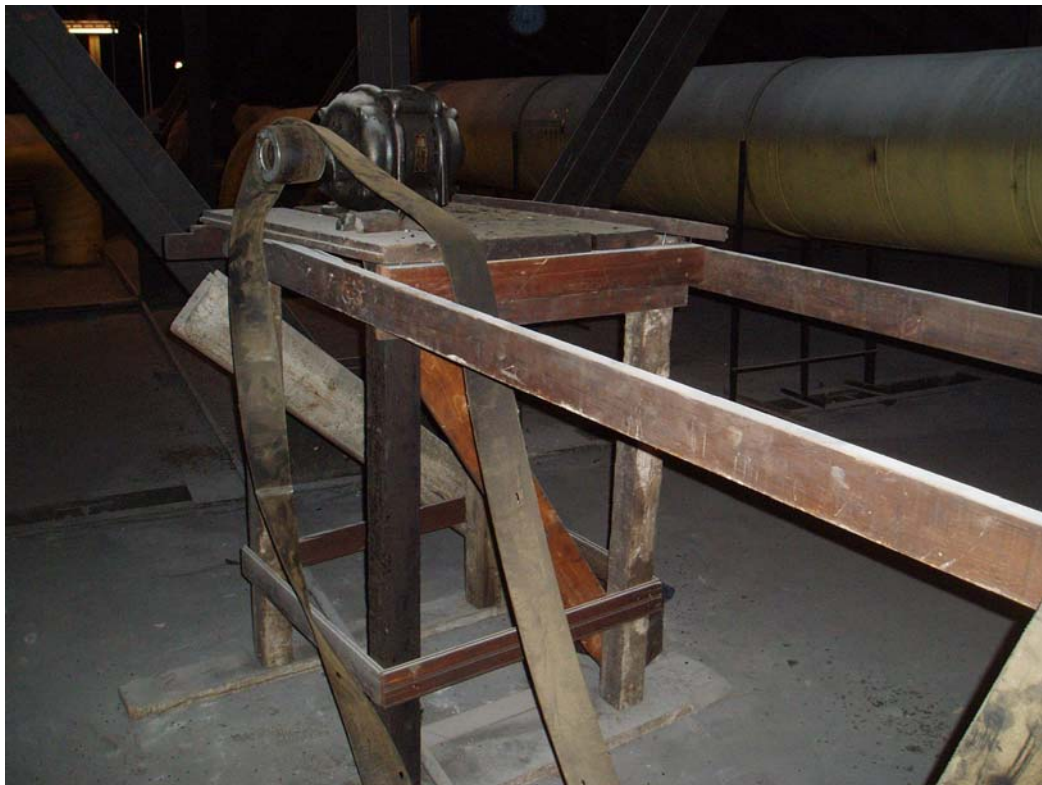
Figure 37. The chandeliers' historic belt system

St. Louis Antique Lighting Company charged \$142,659 to refinish and refurbish the old lighting fixtures. Over time, these lighting fixtures had accumulated plenty of rust. Most of the sconces and all of the chandeliers are the original fixtures for the Station (Downey, 2008). Because of irreversible damage, a few of the sconces were recreated to match the originals (McCosh, 2008). Refinishing the chandeliers was no easy task as each chandelier is twelve feet in diameter and weighs 3,500 pounds. Each chandelier also requires 11,400 watts of electricity and over half of a mile in wiring for the fixture (Union, n.d.). Originally, a belt system lowered the chandeliers for cleaning and the changing of light bulbs (Fountain, 2008). A winch system was therefore located above each of the three chandeliers to raise and lower them (Downey, 2008). Only one motor was originally provided in the attic which had to be moved from one winch system to another. The chandeliers, therefore, could only be lowered one at a time (McCosh,

2008). However, a new pulley system powered by electric motors was installed as part of the renovation above each chandelier to raise and lower them without having to move the motor (Fountain, 2008). The refinishing of the chandeliers and sconces were one of the biggest visual improvements to the building's interior (Downey, 2008). The chandeliers' old belt system is shown in Figure 37, and the new electrical pulley system is shown in Figure 38.

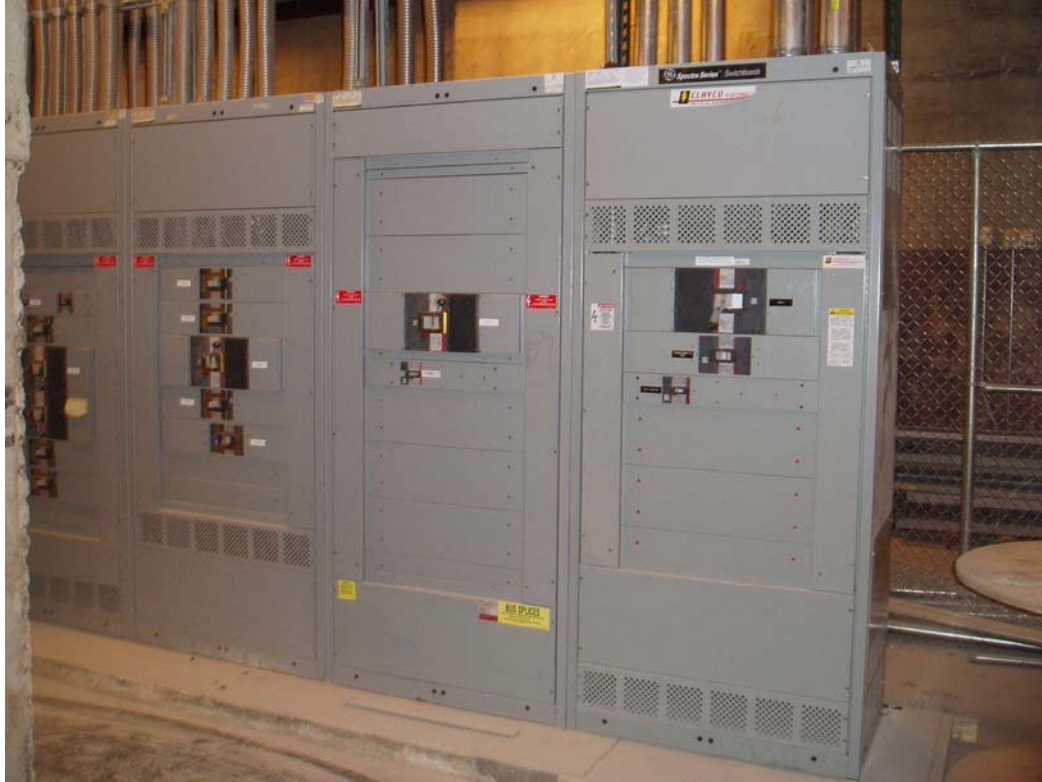
Figure 44. A typical transformer

The engineers on the project had to work with the city to distribute primary power into the building so there would not have to be any outdoor transformers on the site. Outdoor units would just take away from the aesthetic value and historic character (McCosh, 2008). Eighteen single-phase transformers from the Kansas City Power and Light Company (KCPL) electrical service are now located in the Union Station basement (Barber, 2008). A typical transformer is shown in Figure 44.

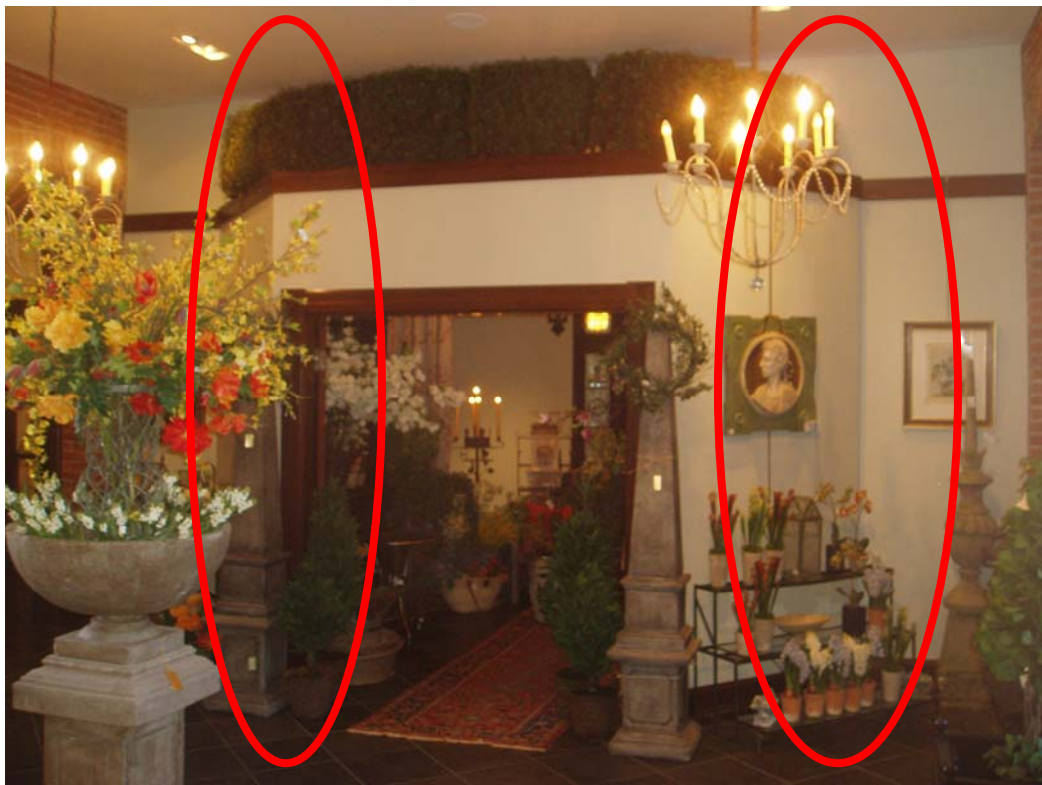
Figure 58. Vertical chases on first floor

plumbing systems inside building had to be redesigned. Even the restrooms were relocated to adapt to the new usage of the building (Oxler, 2008). To facilitate access between floors, vertical chases were constructed with new walls which enclose mechanical ducts, electrical wiring, and plumbing pipes. In these chases run many of the pipes which serve the kitchens. The two kitchens are vertically stacked, but one is located in the basement, and the other is located on the second floor. Therefore, the vertical chases on the first floor provide access for pipe routing between these spaces (Hobbs, 2008). The vertical chases on the first floor are located behind the foreground walls as indicated in Figure 58.

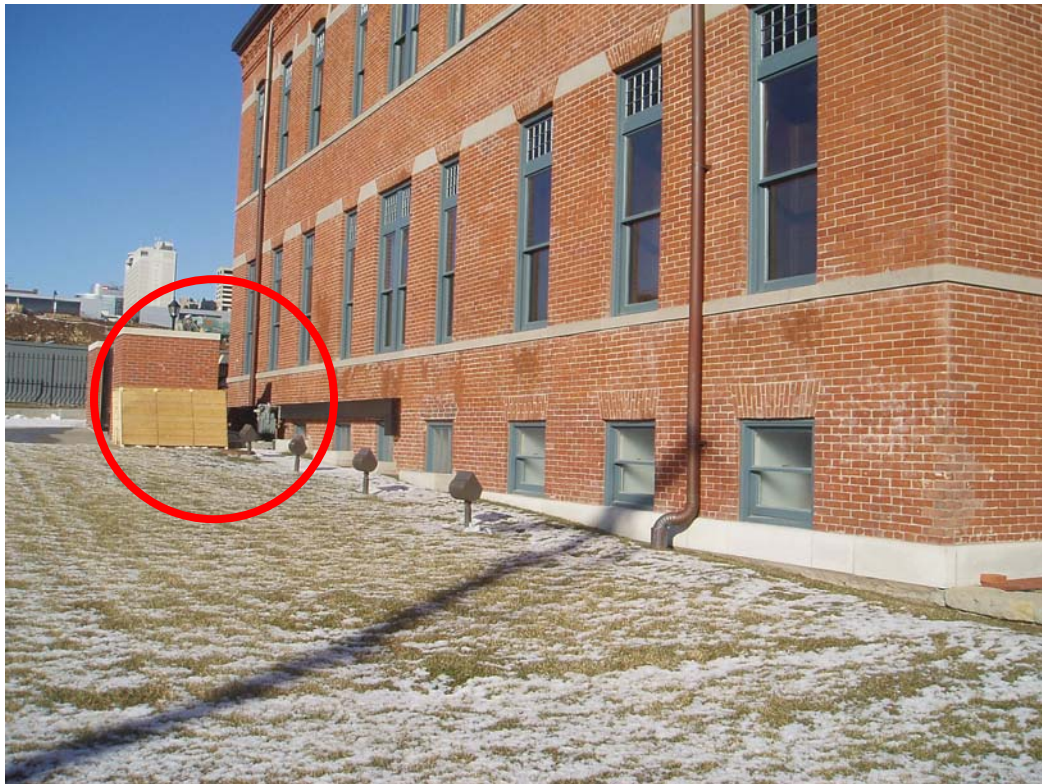
Figure 59. The grease interceptor is located outside of the building and behind brick walls

the addition of two commercial kitchens. Therefore, a new service line was brought in from the water main under the adjacent street to supply the Webster House. Furthermore, each kitchen required a grease waste piping system. The location of the thousand gallon grease interceptor was an issue since this piece of equipment is inherently very large. Because of interior space restrictions and coordination issues, it was determined that the best location for the grease interceptor was outside of the building on the lawn. This piece of equipment would be placed away from the entrances and the main view of the building from the street to hide its appearance. The grease line had to be routed from the basement out to the interceptor on the exterior lawn (Oxler, 2008). The grease interceptor location is shown in Figure 59 enclosed by brick walls.

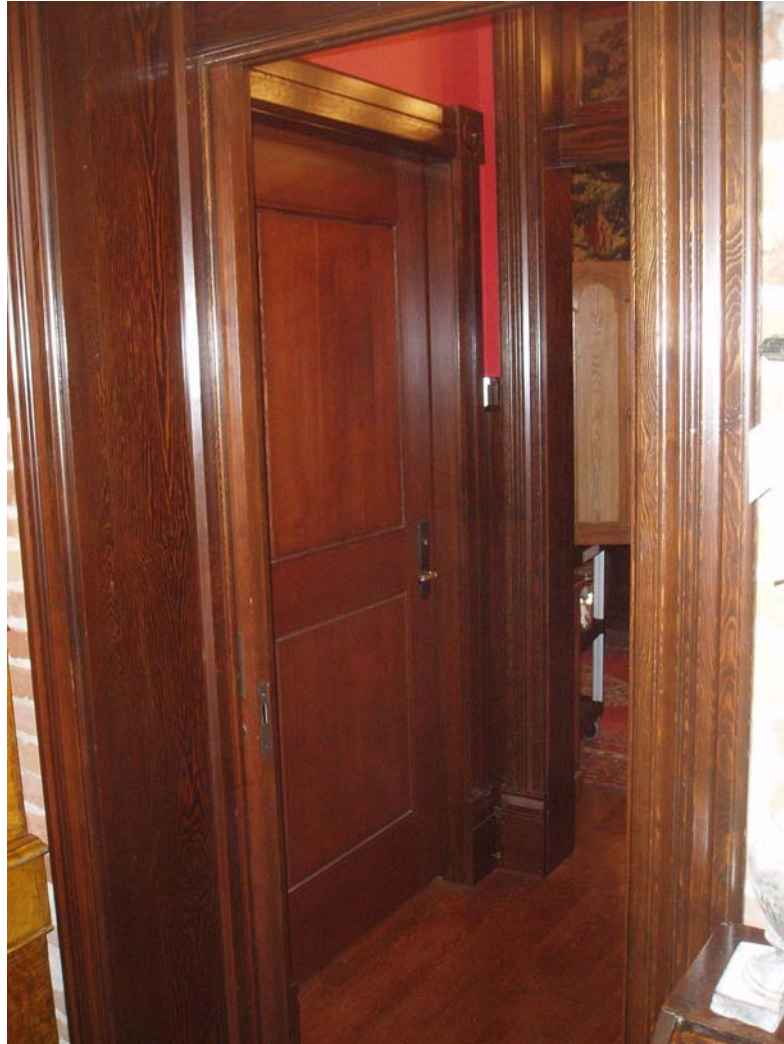
Figure 60. Utility closet

The original coat closets which were located off of each classroom now function as mechanical, electrical, and janitorial rooms. While some of these old coat closets now have janitorial supplies such as mops, brooms, and various miscellaneous maintenance items, other closets now contain electrical breakers and plumbing shut off valves. The locations of these service areas are ideal because they are easily accessible to maintenance staff, but they are also hidden from the eye of customers who only transit between the main rooms and the corridors (Hobbs, 2008). The closets are shown in Figure 60.

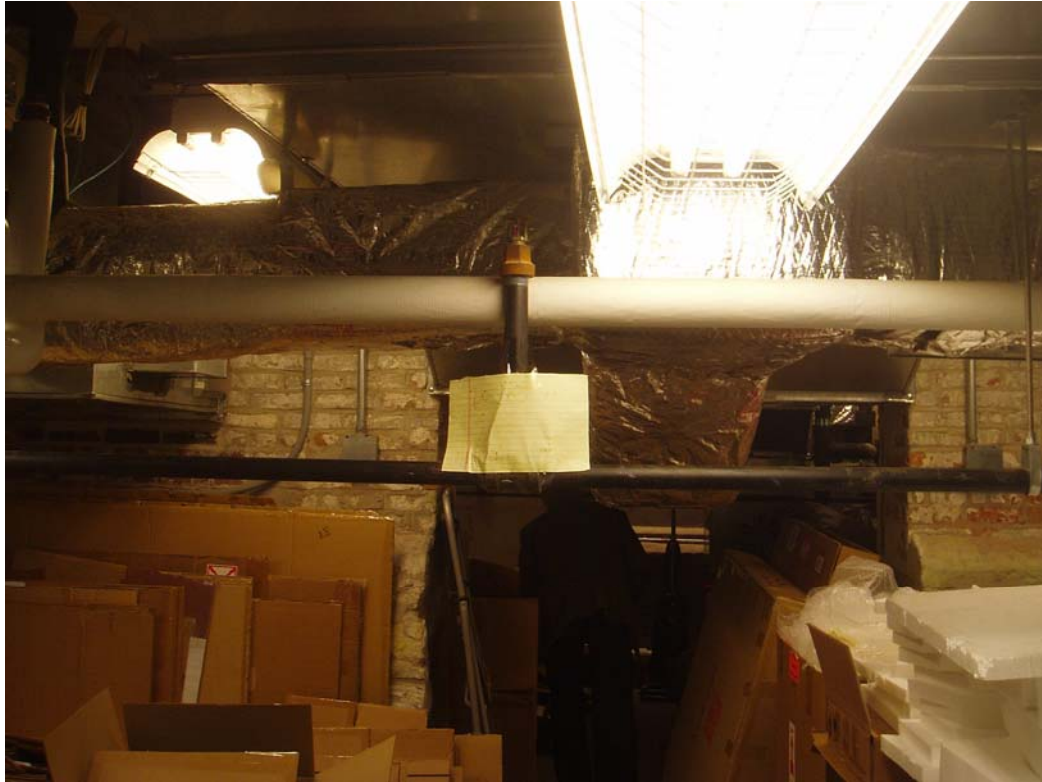
Figure 61. Basement mechanical room

along the exterior walls of the structure. The placement of these mechanical rooms is coordinated with the spatial design of the areas they serve. One of the mechanical and electrical rooms is situated underneath the staircase because this area would have otherwise been unusable space (Hobbs, 2008). One of the basement mechanical rooms is shown in Figure 61.

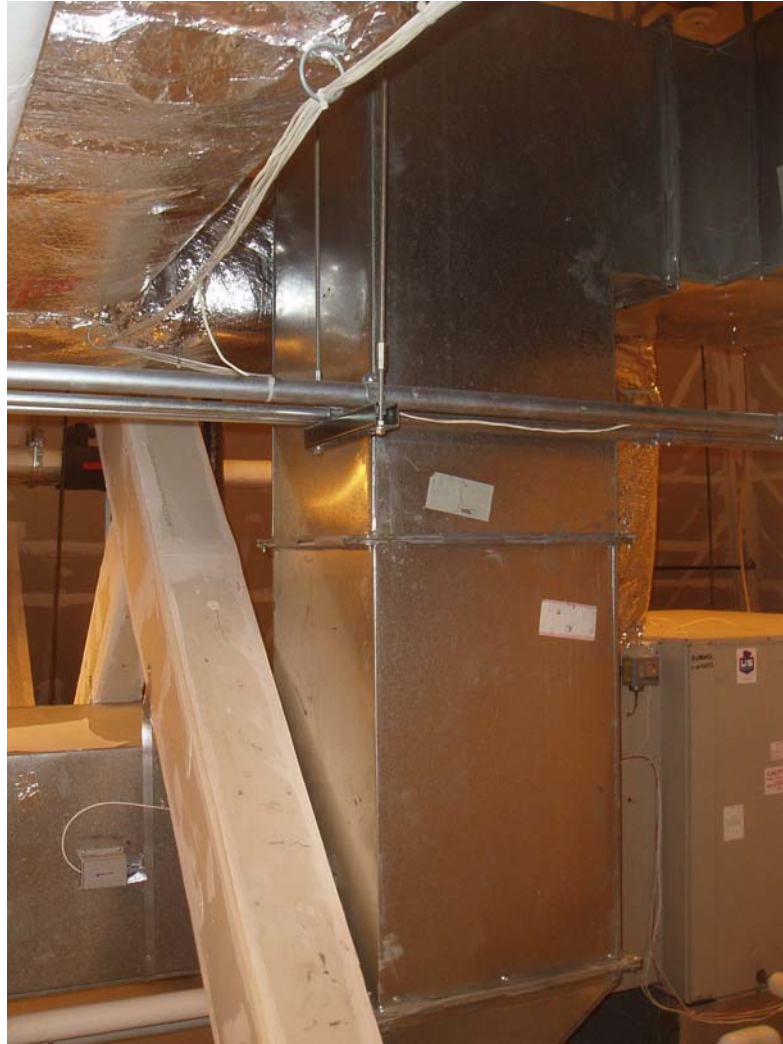
Figure 62. The Webster House attic

The attic is also space that cannot be used by the public because of the structural system that takes up most of the space. Therefore, the attic mainly contains mechanical system equipment and ductwork (Hobbs, 2008). The attic is shown in Figure 62.

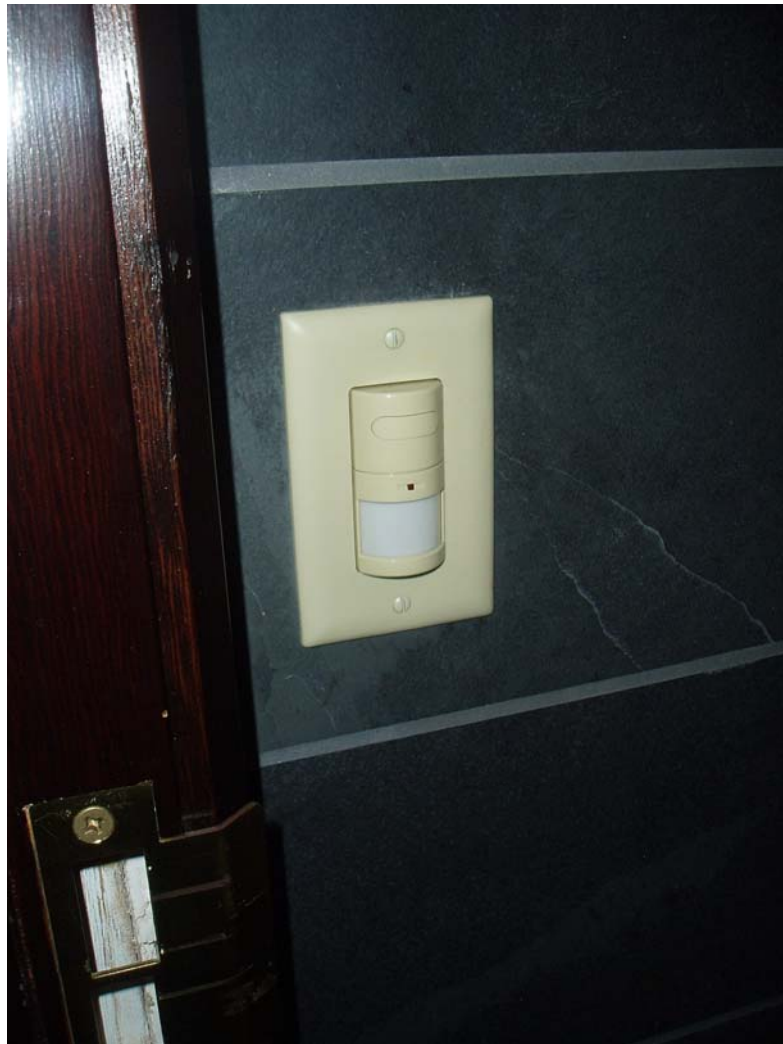
Figure 63. A motion sensor

The basement and attic levels proved to be very useful in their open plan layout to provide the Webster House with both storage and space for the mechanical, electrical, and plumbing equipment (Hobbs, 2008). In total, the Webster House contains sixteen air handling units which are located in either the basement or the attic to condition their respective areas of the building (Oxler, 2008). It is interesting to note that many spaces such as the restrooms, closets, and maintenance areas now have motion sensors on the lights to turn them on and off automatically (Hobbs, 2008). A typical motion sensor is shown in Figure 63.
