INCORPORATING MECHANICAL, ELECTRICAL AND PLUMBING SYSTEMS  
INTO HISTORIC PRESERVATION PROJECTS – THREE CASE STUDIES

A REPORT

MASTER OF SCIENCE

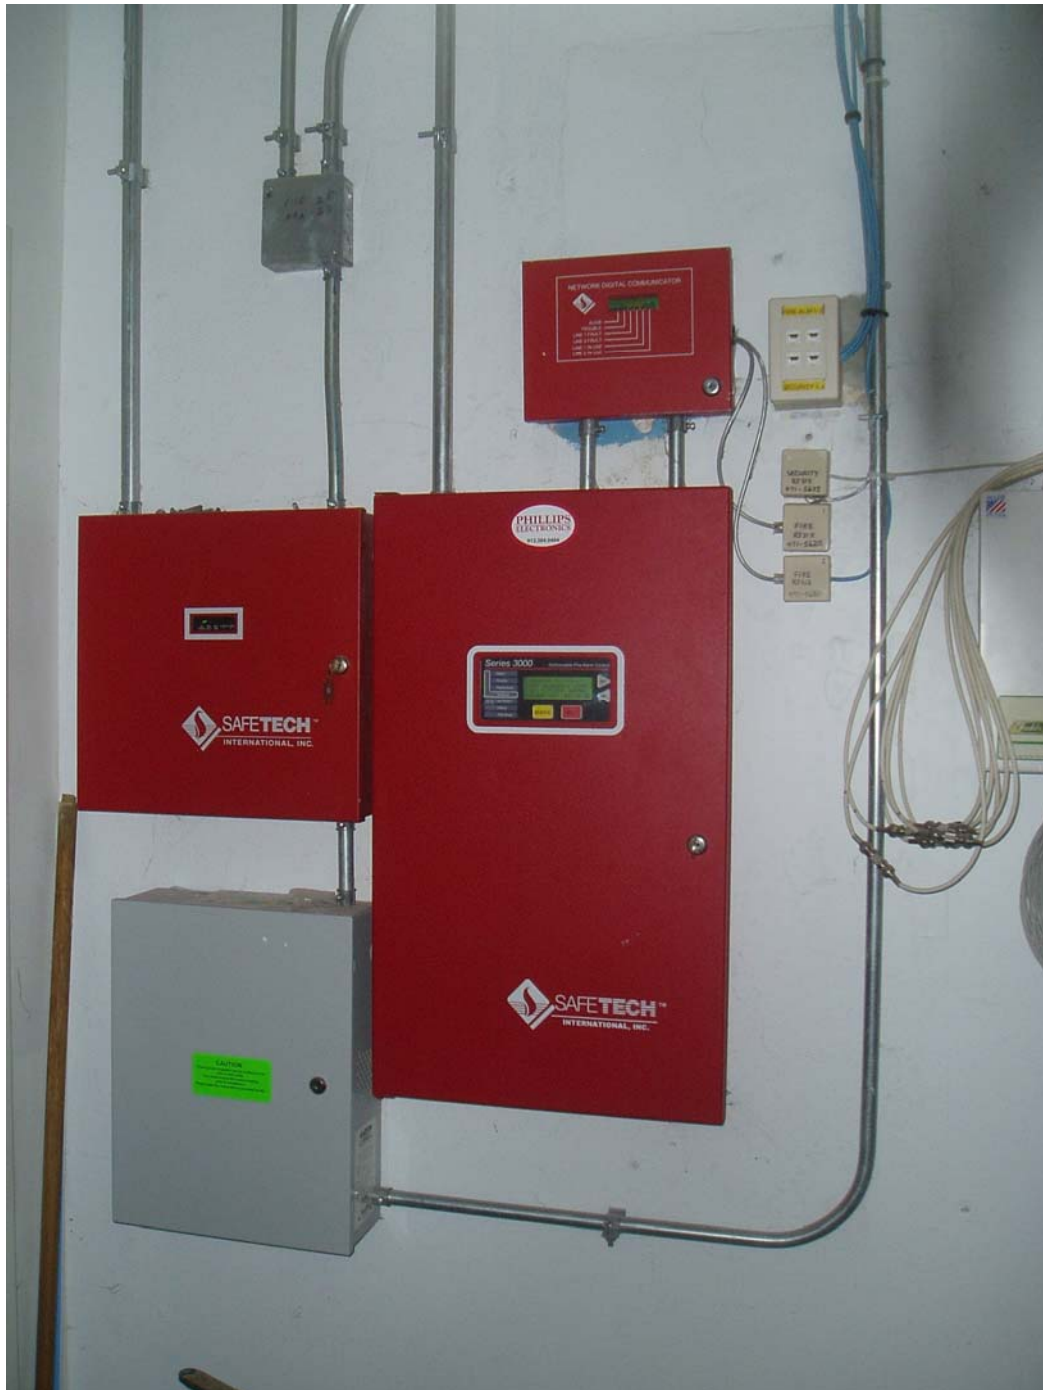
Figure 64. Main fire panels

A remote fire access panel is located just inside the first floor front door. The main fire panels are placed in one of the basement mechanical rooms, as shown in Figure 64 (Hobbs, 2008).

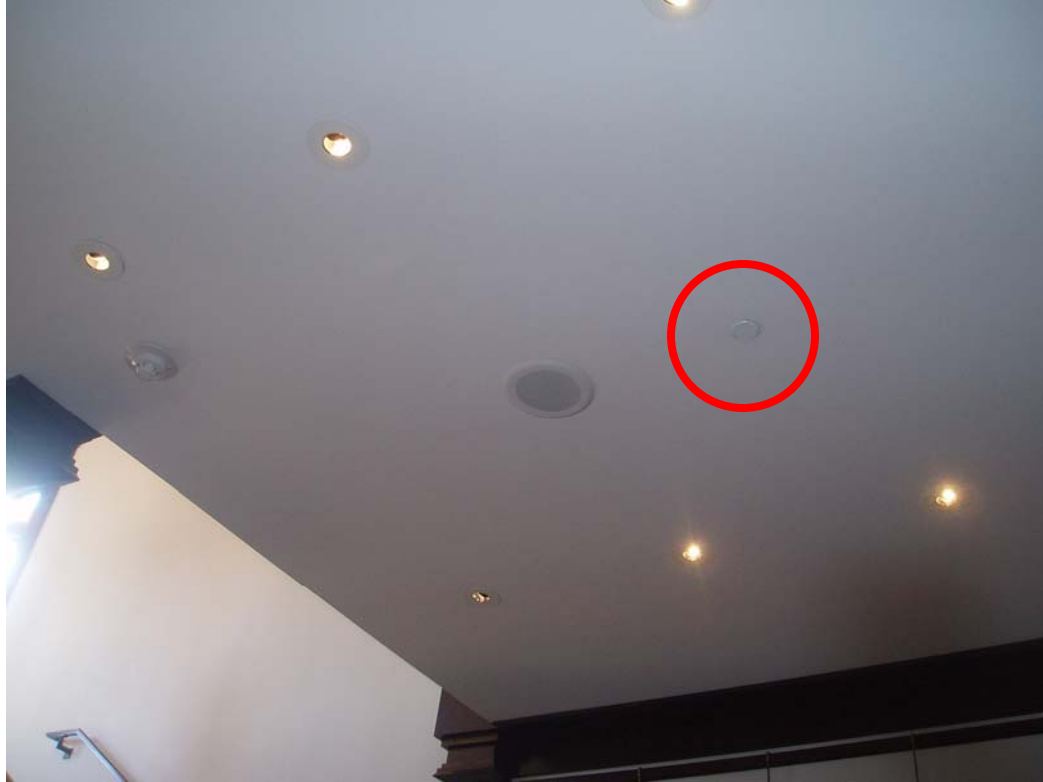
Figure 65. Interior room ceiling and recessed sprinkler heads

Recessed sprinkler heads can be seen throughout the building in the public areas. These recessed heads were architecturally designed to be less obtrusive to the visual appearance of the space, as can be seen in Figure 65 (Hobbs, 2008).

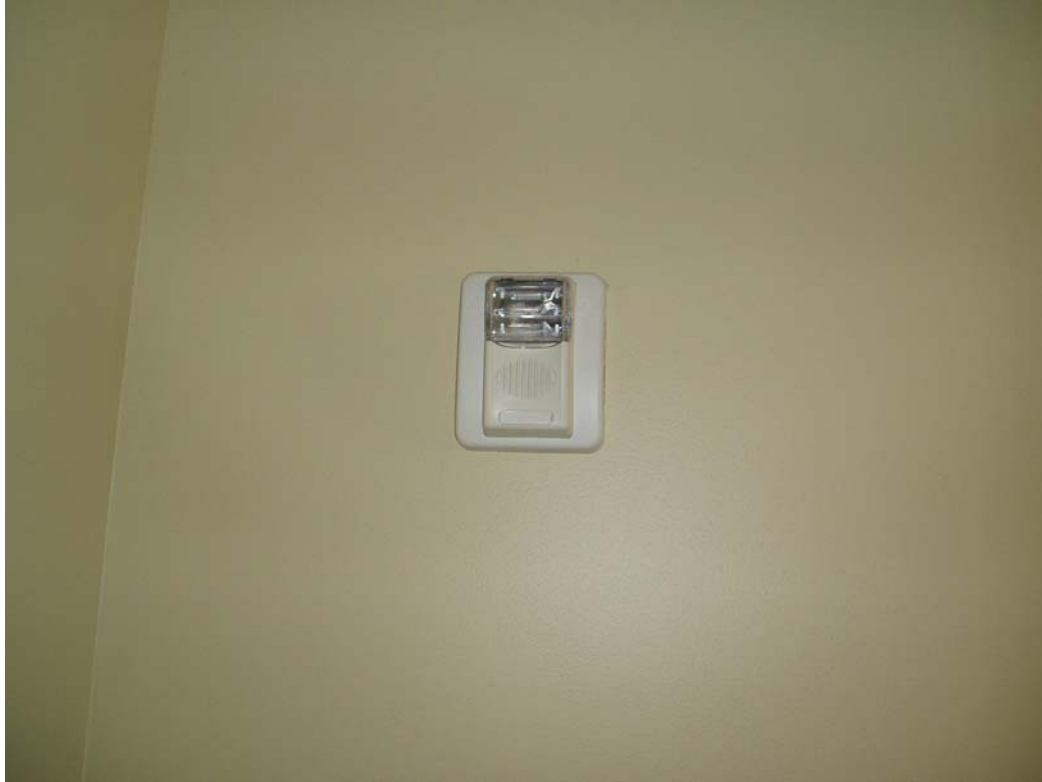
Figure 66. Fire notification device

Pull stations and fire extinguishers are also distributed throughout the building. Smoke detectors were architecturally chosen to blend in with the ceiling and not be obtrusive in the space. To facilitate evacuation and exiting of the building, audio and visual fire evacuation devices are located in the building also, as shown in Figure 66 (Hobbs, 2008).

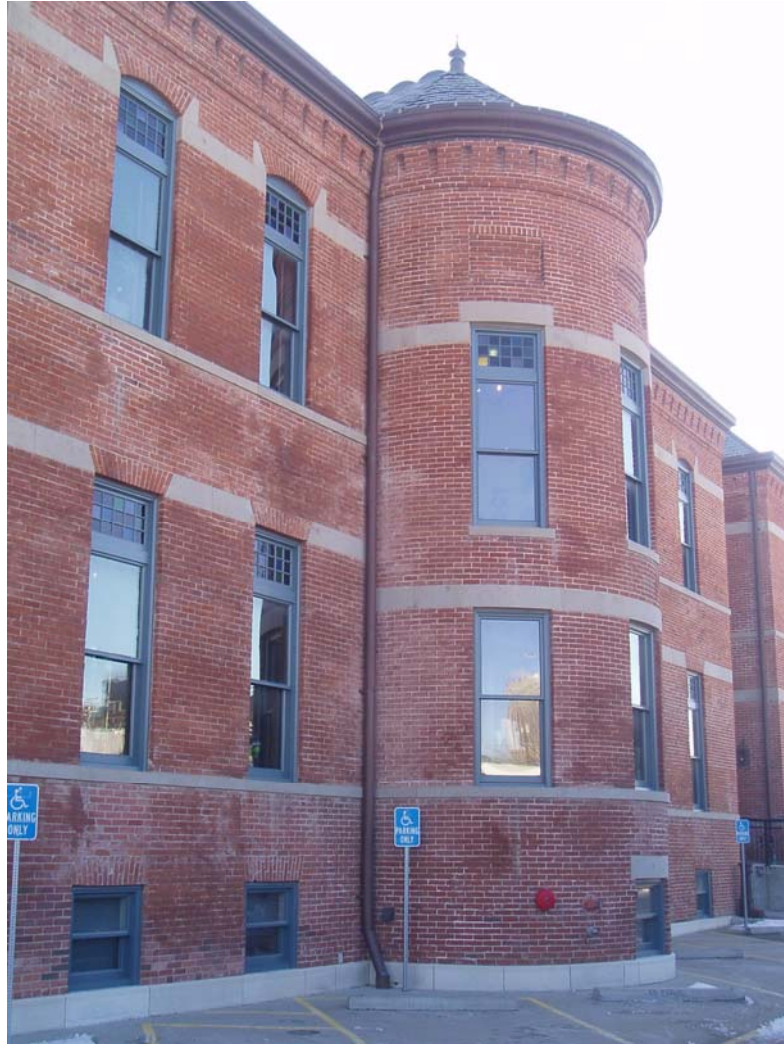
Figure 67. Exterior of the building

The storm drainage plumbing was one of the easiest systems to design and coordinate on the Webster House. The original design consisted of exterior scuppers and downspouts which ran the water along the exterior walls of the building. When renovating the building, this system was replaced with new piping, but the same design was kept. This exterior storm drainage system is important because storm drainage piping is usually very large and can cause coordination issues if located in the interior of a building. Because of this exterior design, no piping larger than four inches is located inside the building. The current storm water design consists of solid copper scuppers and downspouts. Today, the storm drainage system appears tarnished so that it blends in to the exterior of the building (Oxler, 2008). The storm water drainage system can be seen in Figure 67.

There is an interesting story relating to the installation of the new storm water system. Once the new copper scuppers and downspouts were installed on the exterior of the building, they were stolen within a week. To deter future vandalism, a new set of storm water pipes were installed, but this time with the addition of exterior security cameras for surveillance. Needless to say, the increased security has prevented any further major vandalism on the Webster House (Oxler, 2008).

mechanical, electrical, and plumbing systems. The exterior storm drainage system design was kept; the original piping was just replaced with new copper piping (Oxler, 2008).

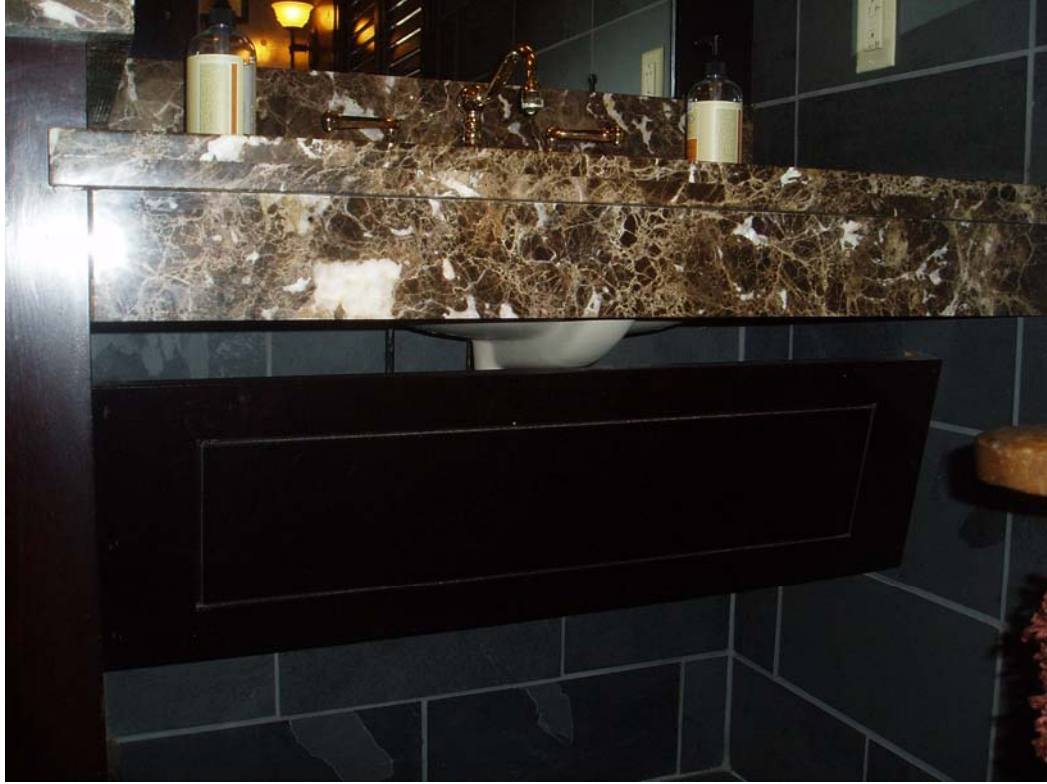
Figure 68. Bathroom lavatory

Because the public has access to the first and second floors of the Webster House, it was very important to make the visual plumbing system as aesthetically pleasing as possible. Shirley Helzburg, the owner of the building, directed the decisions for all of the fixtures and trim in the design. In valuing the historic appearance of the building, the decision was made to incorporate recessed sprinkler heads into the dropped ceiling. Even though the bathrooms are of modern design, the finishes and the plumbing fixtures themselves are made of very high quality materials. The bathrooms do not have the same historic character because of their modern design, but they still present a very elegant and luxurious appearance which complements the architectural and interior design of the building (Oxler, 2008). The public bathrooms in the Webster House are accessible and ADA compliant, as illustrated by the bathroom lavatory in Figure 68 (Hobbs, 2008).
